Date:	7/31/2025	
City:	Wickliffe	
Street/Location:	Parkwood Drive	
Sewer Class:	Sanitary	
Pipe Size:	10"	
Pipe Type:	VCP	
Point of Entry:	MH 0	
Exit Point:	MH 4	
Direction:	DOWNSTREAM	
Disk#:	VTS 01 1.VOB

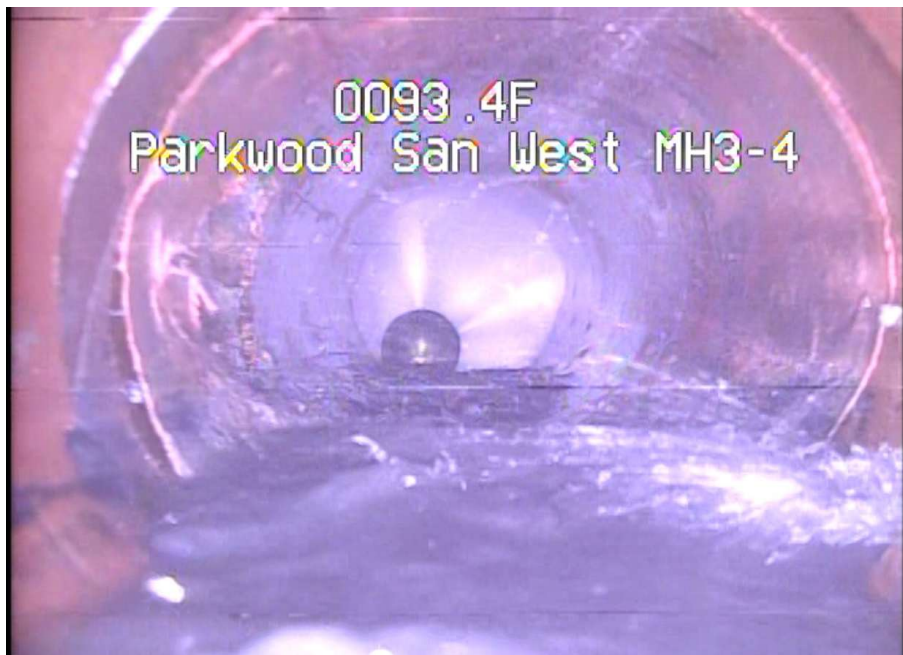
Photo 1. Lateral Point Repair

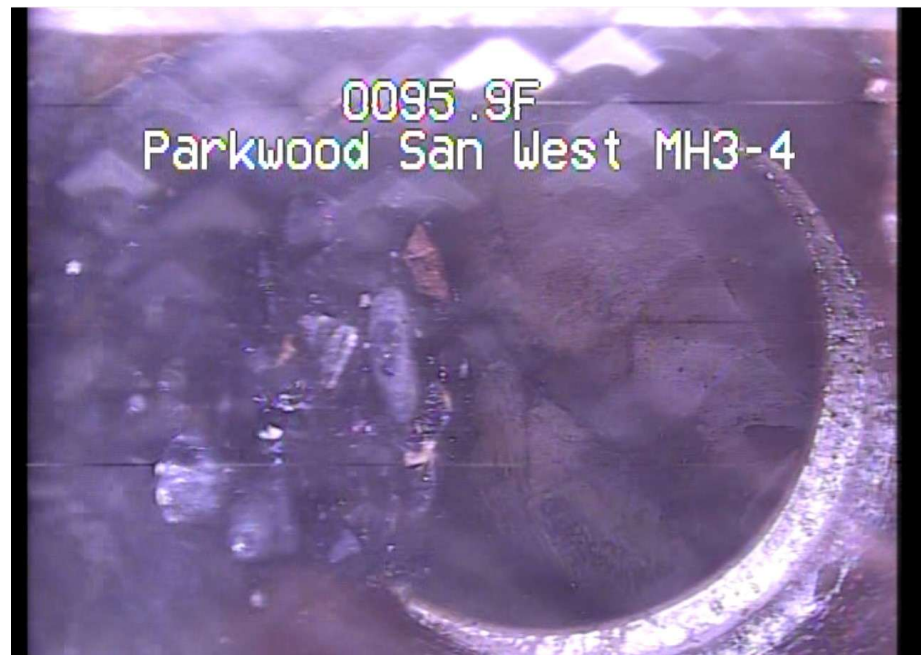
Photo 2. Lateral Point Repair

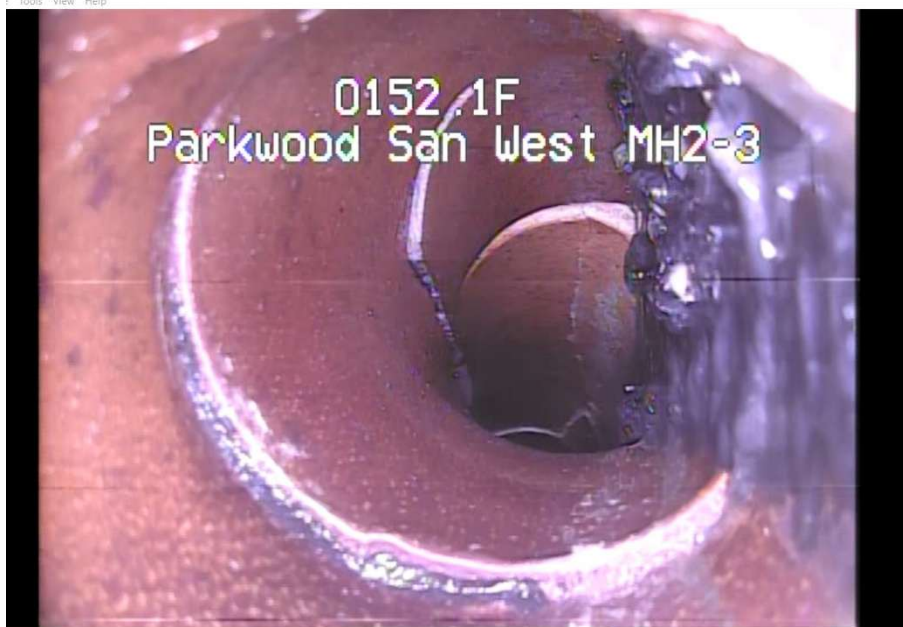
Photo 3. Point Repair (Including Lateral)

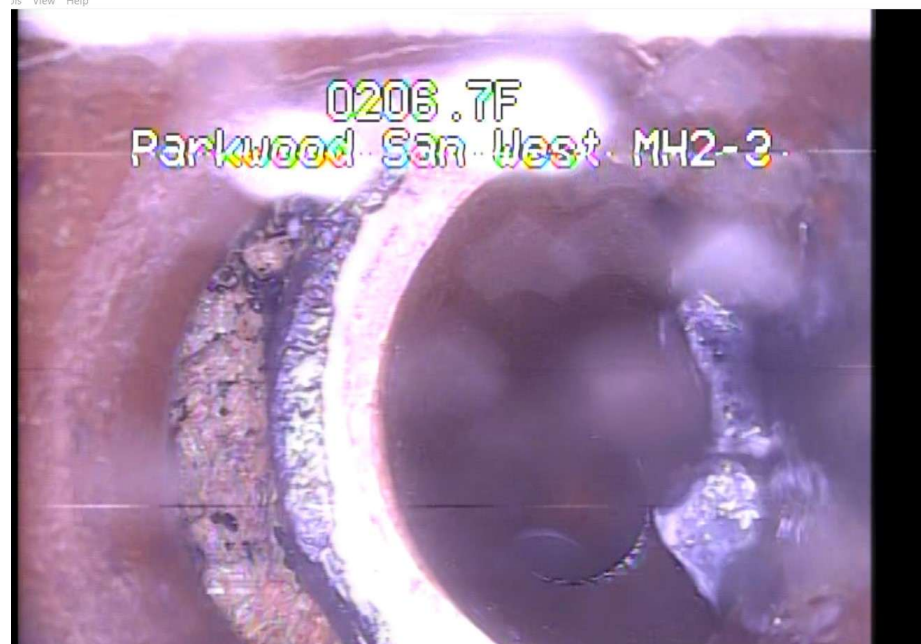
Photo 4. Point Repair (Including Lateral)
