# Geotechnical Subsurface Mentor Recreation Area Park Expansion

Mentor, OH

**Verdantas Project No: 32272**

**April 2025**

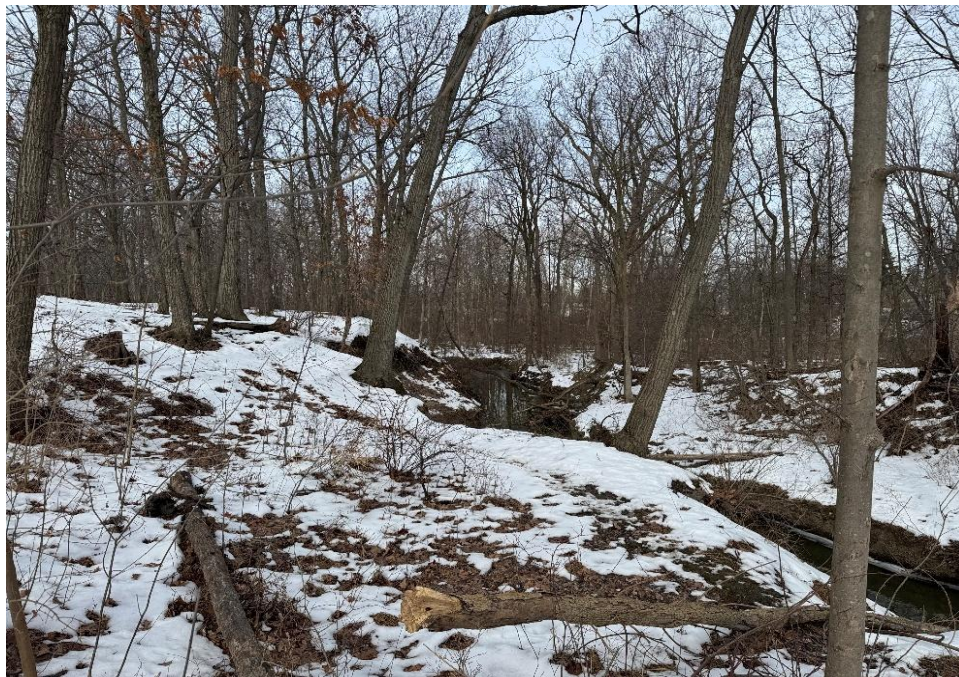
**Photo 2:** Standing on the west bank of Mark Creek looking towards north, showing slope general conditions on the east and west sides of the creek.

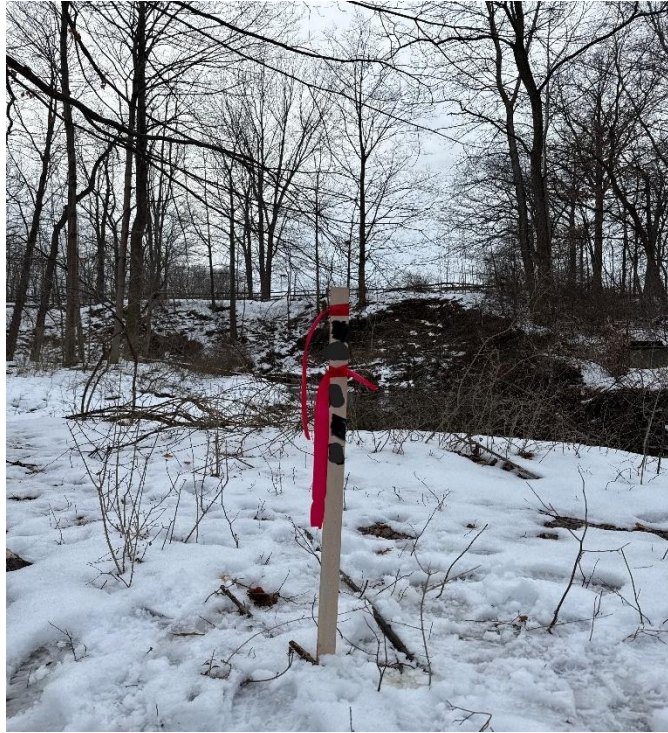
VDT's observations of the slopes adjacent to the proposed development areas revealed that the northern section of the slope, observed from the east bank of Marsh Creek, had gradients of approximately 3 horizontal to 1 vertical (3H:1V). Soil detachment in blocks was prevalent in this section, potentially indicative of erosional features from the creek and a loss of shear strength in

**Photo 3:** View from the east bank of the creek, showing slope general condition on the west bank.

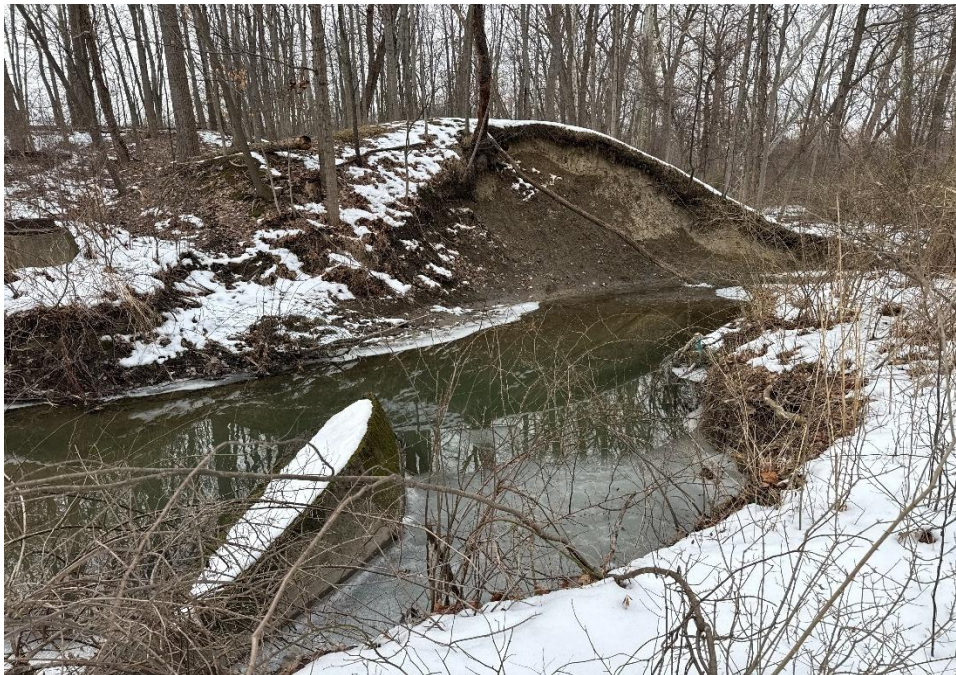
**Photo 4:** View from the east bank of the creek, looking northwest. The west bank shows material detachment likely caused by water flow and features a steep slope with horizontal.

To mitigate these slope failures, it is recommended to construct a retaining wall if the proposed structure encroaches within 5 to 10 feet of the west bank. If a retaining structure is not feasible at this time, all development should be set back a minimum of one-third of the slope height ( $H/3$ ) as per the International Building Code recommendations.

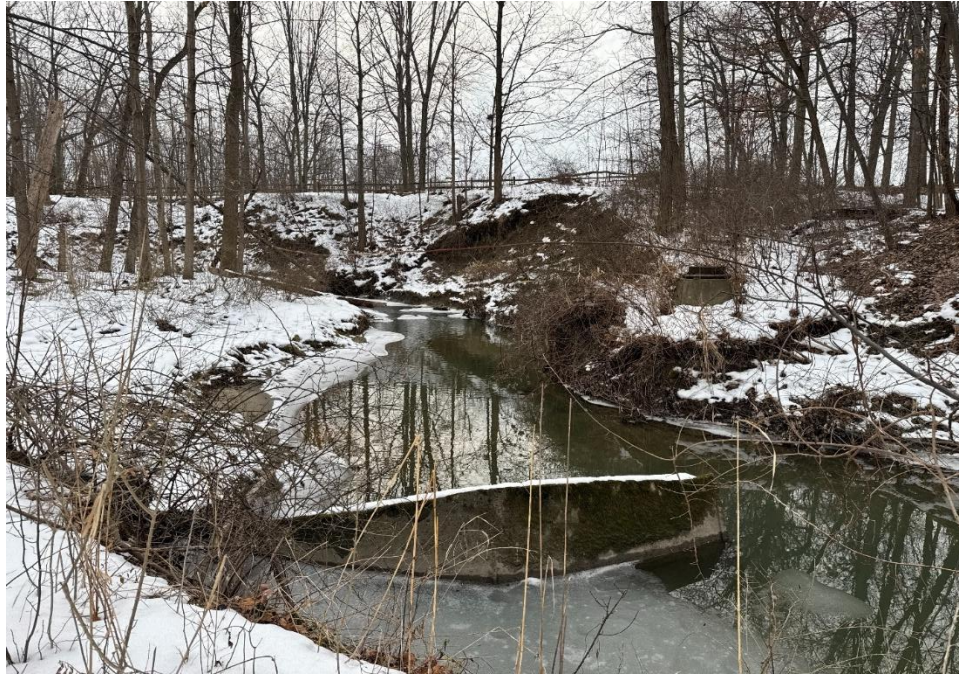
the soil (Photos 3 and 4). Additionally, partially exposed tree roots and utilities were observed (Photos 5 to 9).

**Photo 5:** View from the east bank of Marsh Creek, looking southwest. The slope general conditions, site guardrail, and exposed manhole on the west bank are visible.

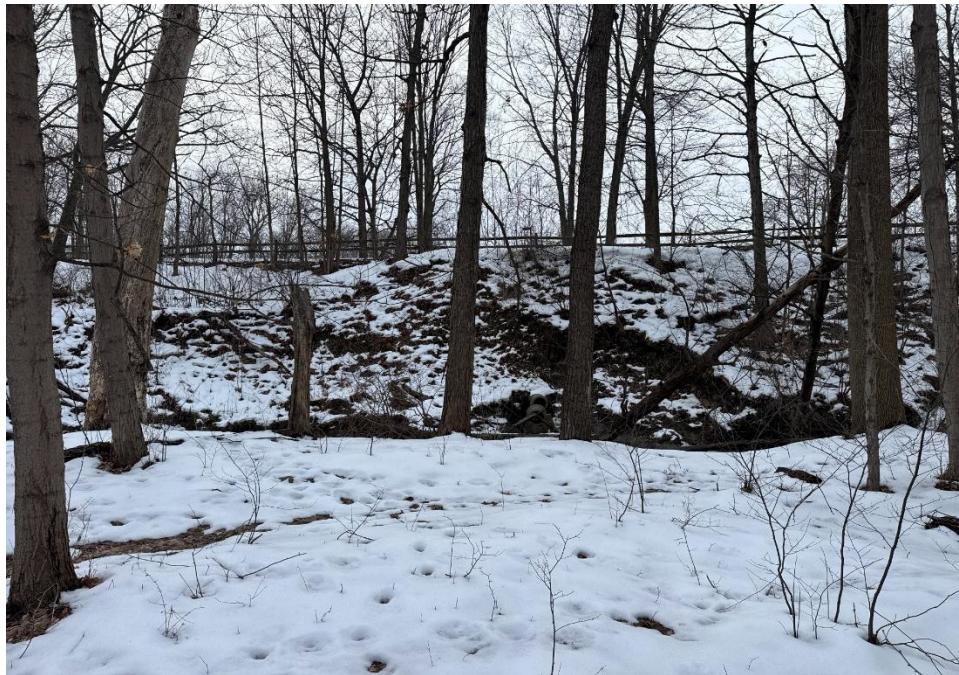
**Photo 6:** This photo shows the view from the east bank of the creek, looking north, and presents the slope general condition on the west bank. The site guardrail is visible at the top of the slope.

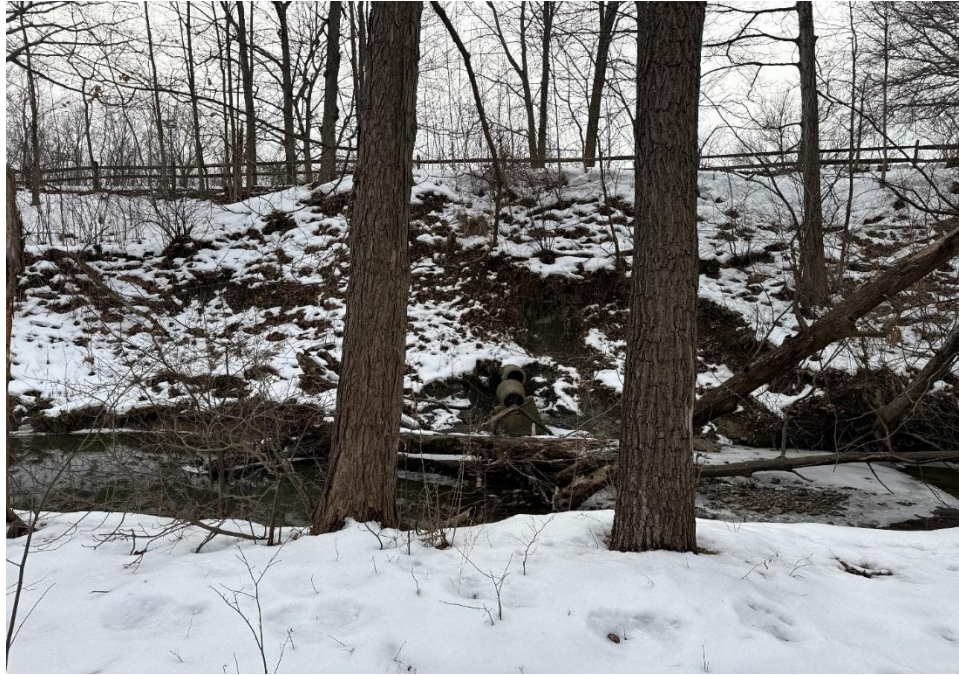
**Photo 7:** This photo shows a closeup from the east bank of the creek, looking north, highlighting the slope condition on the west bank. A broken drainpipe is visible at the bottom of the slope.

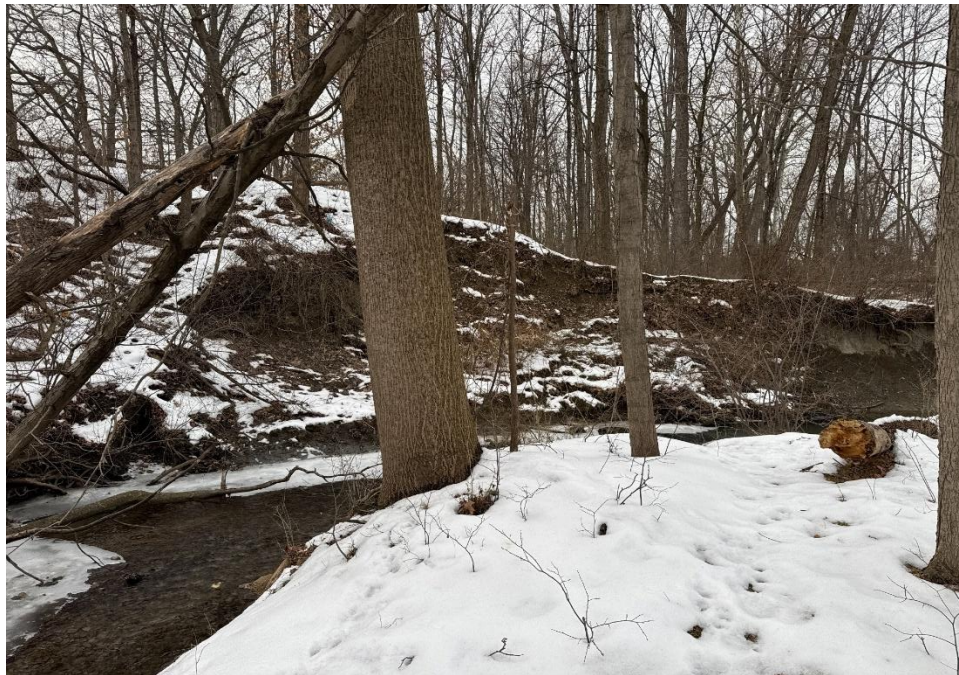
**Photo 8:** This photo shows the slope condition on the west bank, viewed from the east bank looking northwest. Notice the water erosion features and exposed tree roots.

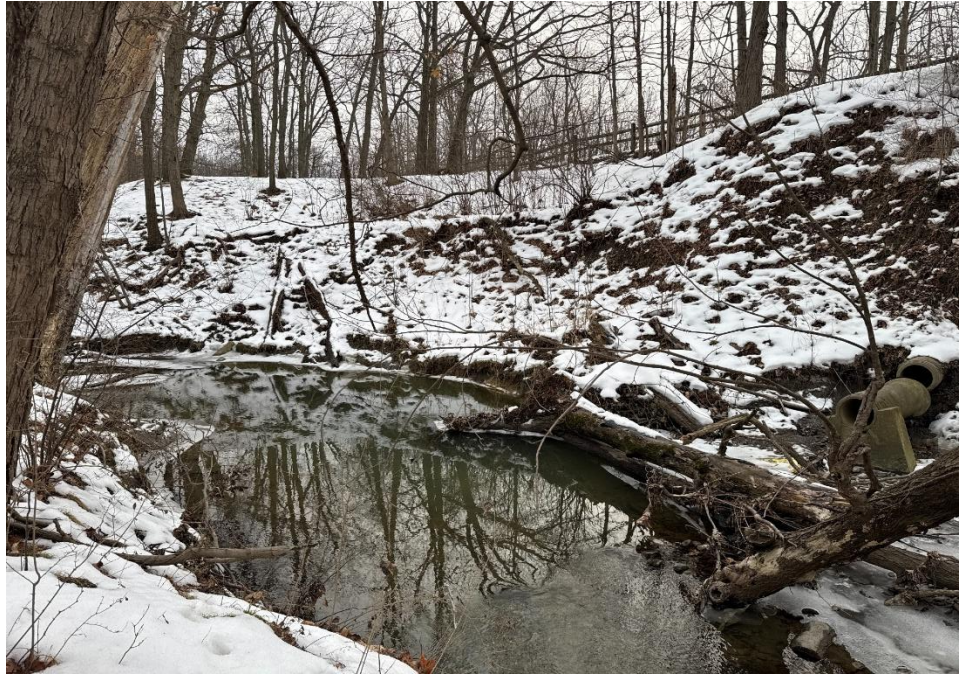
The west bank of the creek exhibited slopes ranging from 2H:1V to 3H:1V in the southern section. This variation is depicted in photo 9. The southern portion of the west bank did not show any erosional features; however, a significant amount of broken tree trunks and drag-wood was observed. An abandoned structure was also noted in the southern section of the west bank.

**Photo 9:** This photo depicts the slope condition on the west bank, as seen from the east bank looking southwest. Slope grade changes are noticeable compared to northwest slopes on the west banks.

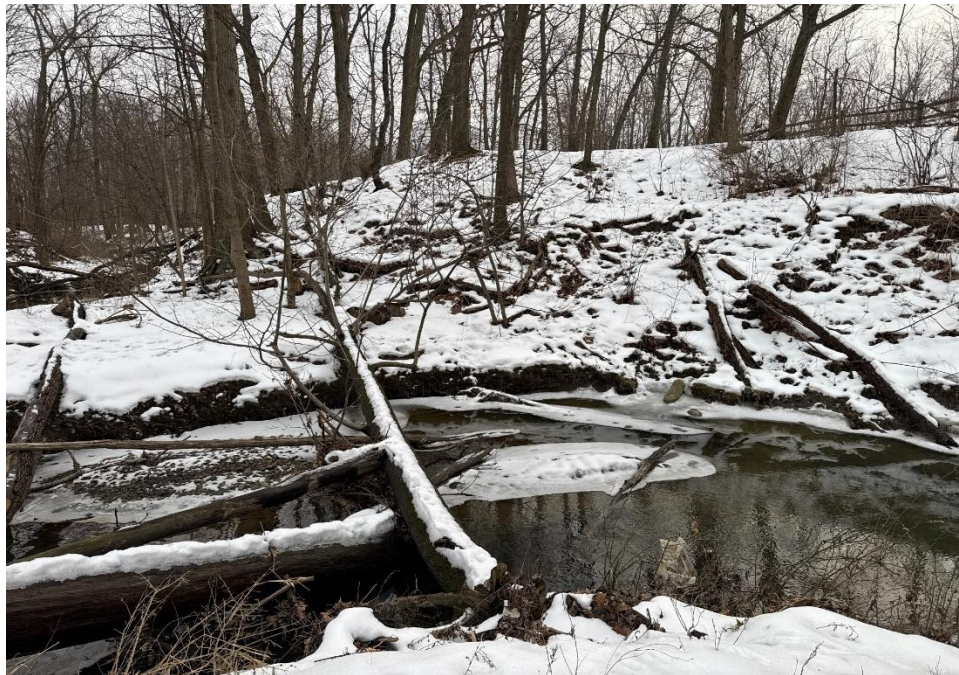
**Photo 10:** This photo shows the slope condition on the west bank, viewed from the east bank looking southwest. The slope grade changes significantly compared to the northwest slopes on the west banks.
