PACP Report with Pipe Run and Incident Snapshots

Surveyed by: DAN		Certificate number: U-716-07004752		Owner:		Customer:		Drainage area:		P/O number:		Sheet number:	
Pipe segment ref.: SMH050A_SMH050				Start date/time: 20220309 13:54		Street: GABLE LN				City: SMITHVILLE			
Location details:				Upstream MH No: SMH050A				Rim to invert:		Grade to invert:		Rim to grade:	
Pipe use: SS		Direction: D		Flow control:		Downstream MH No: SMH050				Rim to invert:		Grade to invert:	
Height: 8 in.		Width:		Shape: C		Material: PVC		Lining method:		Pipe joint length:		Total length: 40.400 ft.	
Length surveyed: 40.400 ft.		Purpose:		Sewer category:		Media label:		PreCleaning: L		Date cleaned:		Weather: 1	
Project name: Sewer Cleaning & CCTV - Project No. 210670				Additional info:

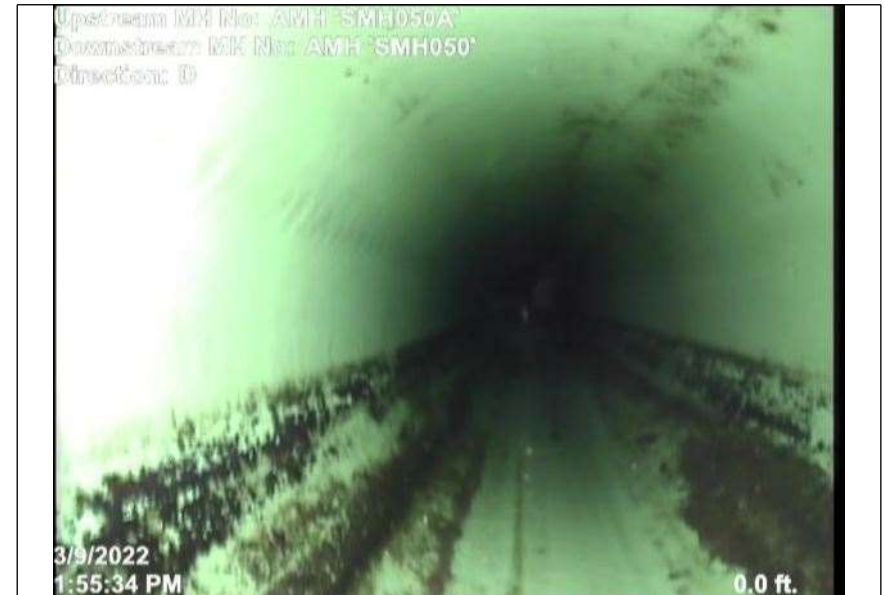
At: 0 ft. MWL - Miscellaneous Water Level
 Joint: No 5 %
