## PACP Report with Pipe Run and Incident Snapshots

Surveyed by: <b>DAN</b>		Certificate number: <b>U-716-07004752</b>		Owner:		Customer:		Drainage area:		P/O number:		Sheet number:	
Pipe segment ref.: <b>SMH050_SMH051</b>				Start date/time: <b>20220309 14:58</b>		Street: <b>W CENTER ST</b>				City: <b>SMITHVILLE</b>			
Location details:				Upstream MH No: <b>SMH050</b>				Rim to invert:		Grade to invert:		Rim to grade:	
Pipe use: <b>SS</b>		Direction: <b>D</b>		Flow control:		Downstream MH No: <b>SMH051</b>				Rim to invert:		Grade to invert:	
Height: <b>10 in.</b>		Width:		Shape: <b>C</b>		Material: <b>VCP</b>		Lining method:		Pipe joint length:		Total length: <b>381.400 ft.</b>	
Length surveyed: <b>381.400 ft.</b>		Purpose:		Sewer category:		Media label:		PreCleaning: <b>L</b>		Date cleaned:		Weather: <b>1</b>	
Project name: <b>Sewer Cleaning &amp; CCTV - Project No. 210670</b>				Additional info:

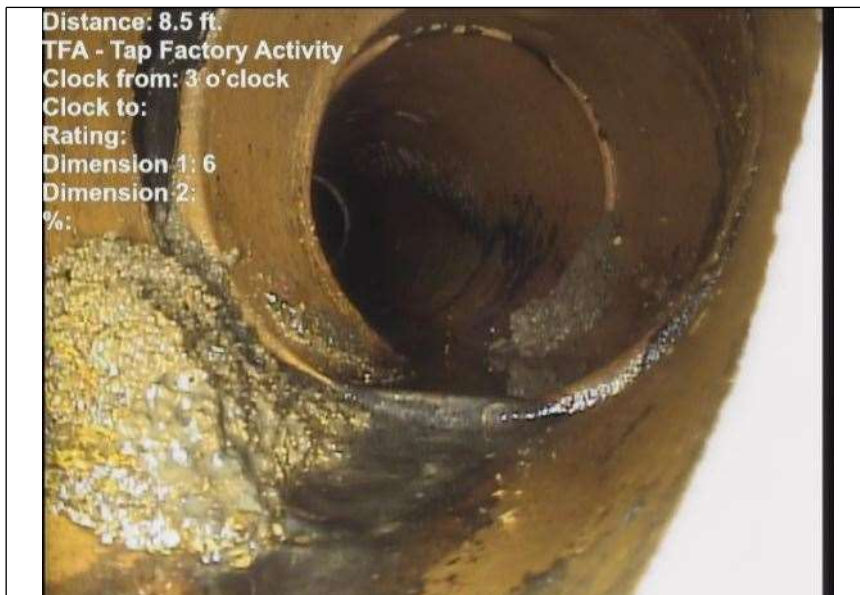
At: 8.5 ft. 3/. TFA - Tap Factory Activity  
 Joint: No

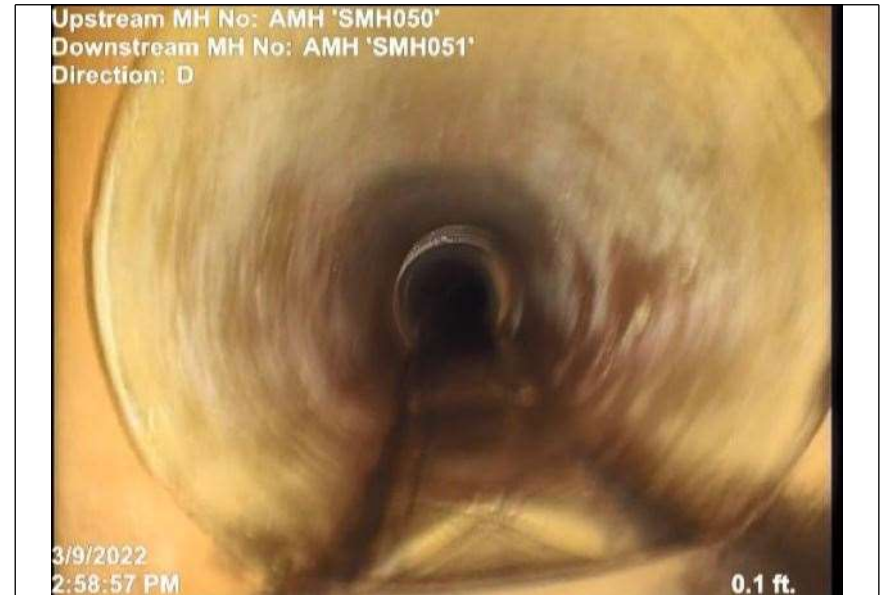
At: 0 ft. MWL - Miscellaneous Water Level  
 Joint: No 5 %

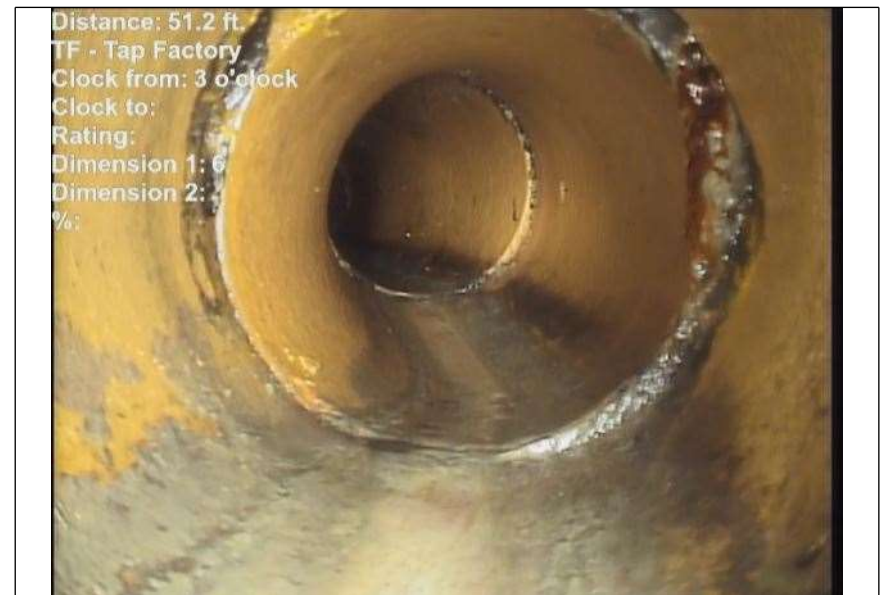
At: 51.2 ft. 3/. TF - Tap Factory  
 Joint: No

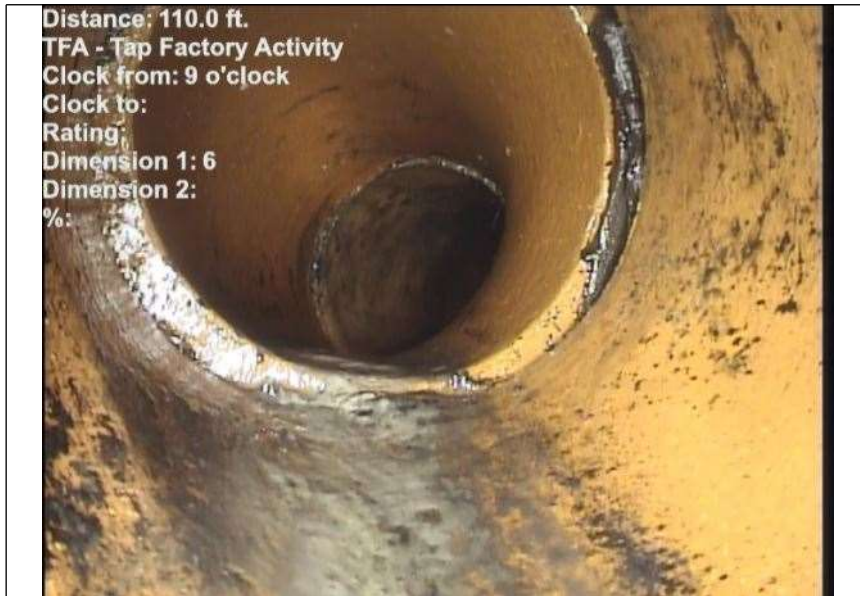
At: 110 ft. 9/. TFA - Tap Factory Activity  
Joint: No

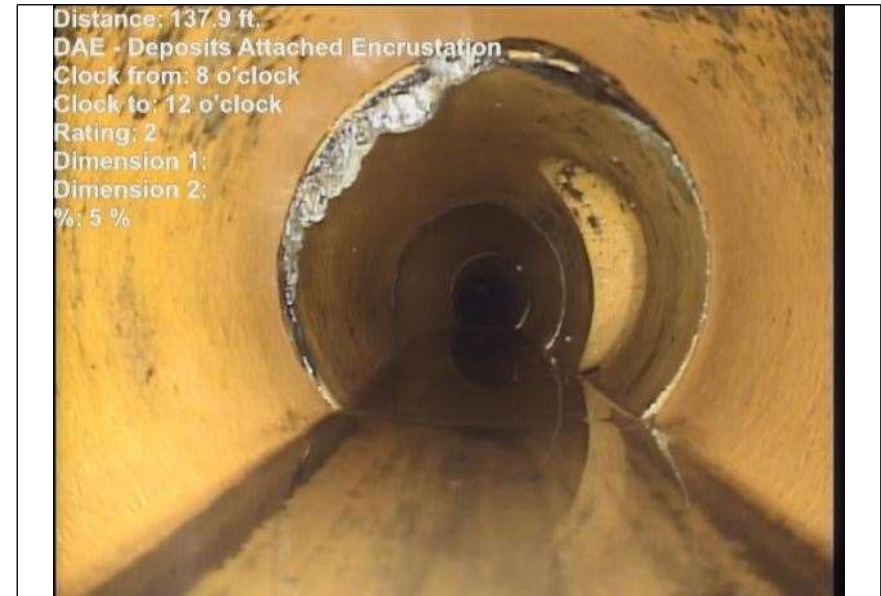
At: 137.9 ft. 8/12 DAE - Deposits Attached Encrustation  
Joint: No 5 %

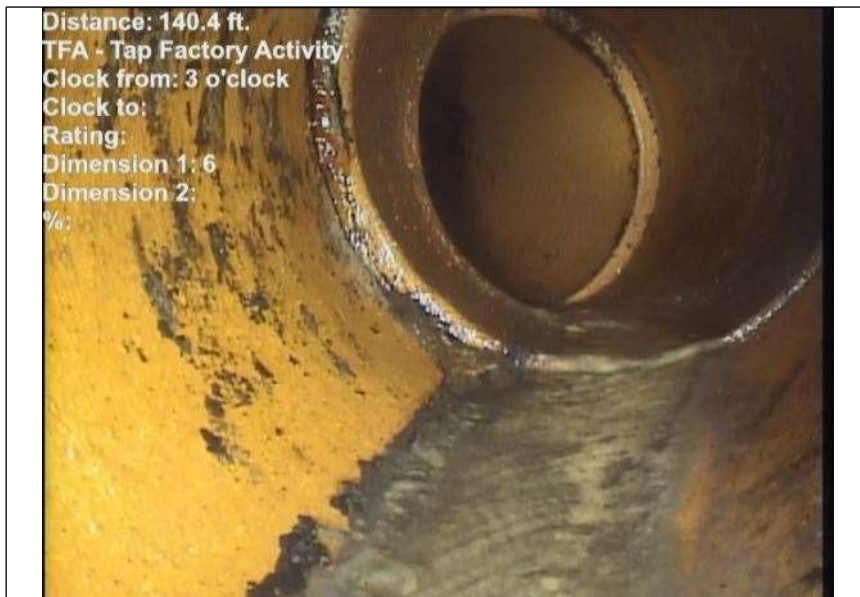
At: 140.4 ft. 3/. TFA - Tap Factory Activity  
Joint: No

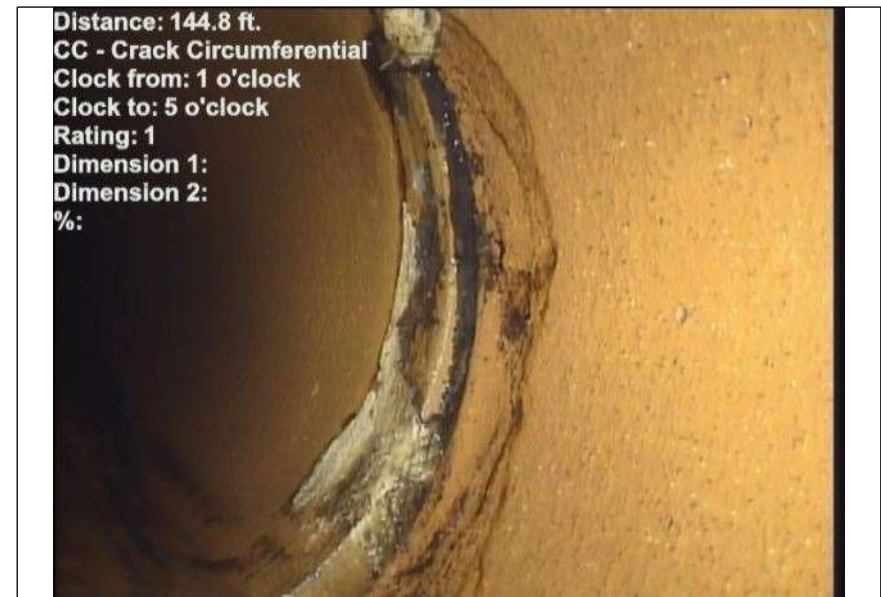
At: 144.8 ft. 1/5 CC - Crack Circumferential  
Joint: No

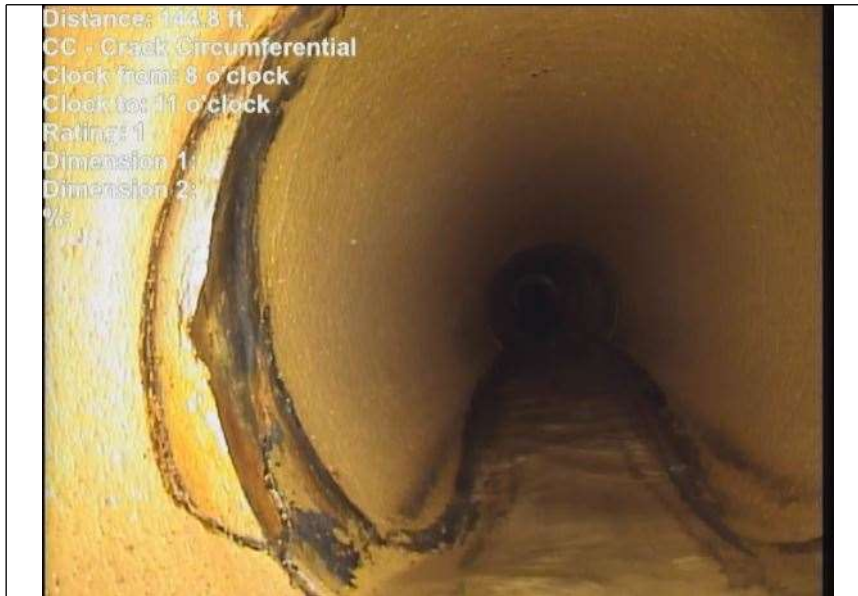
At: 144.8 ft. CC - Crack Circumferential  
8/11

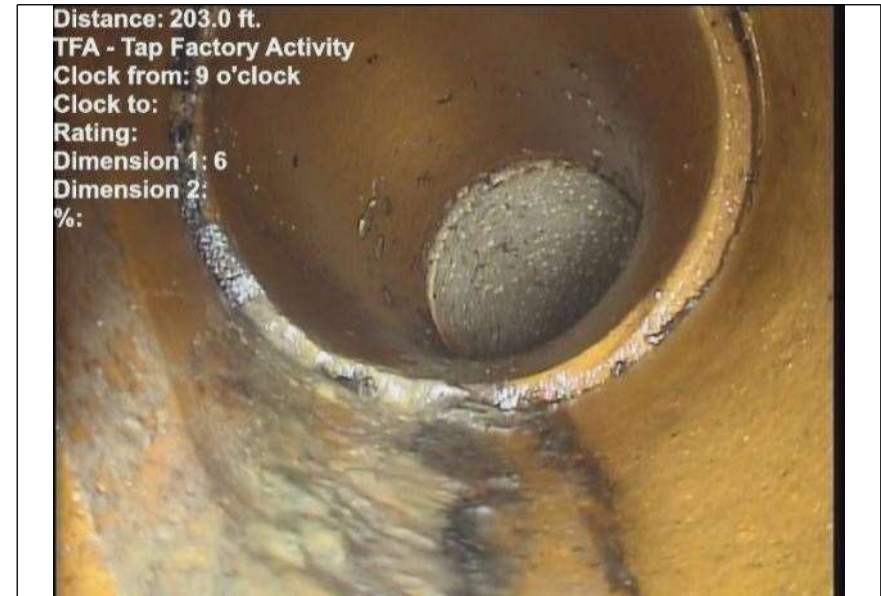
At: 203 ft. 9/. TFA - Tap Factory Activity

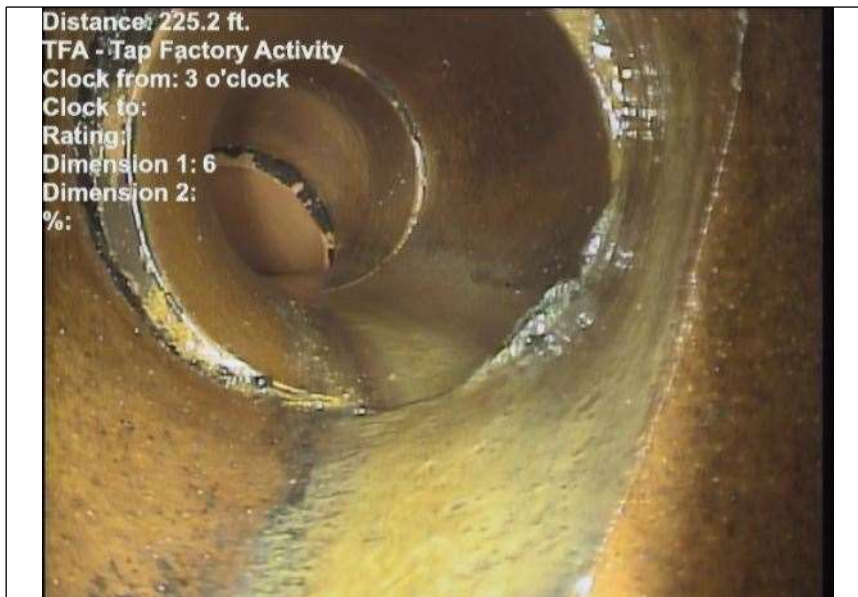
At: 225.2 ft. 3/. TFA - Tap Factory Activity

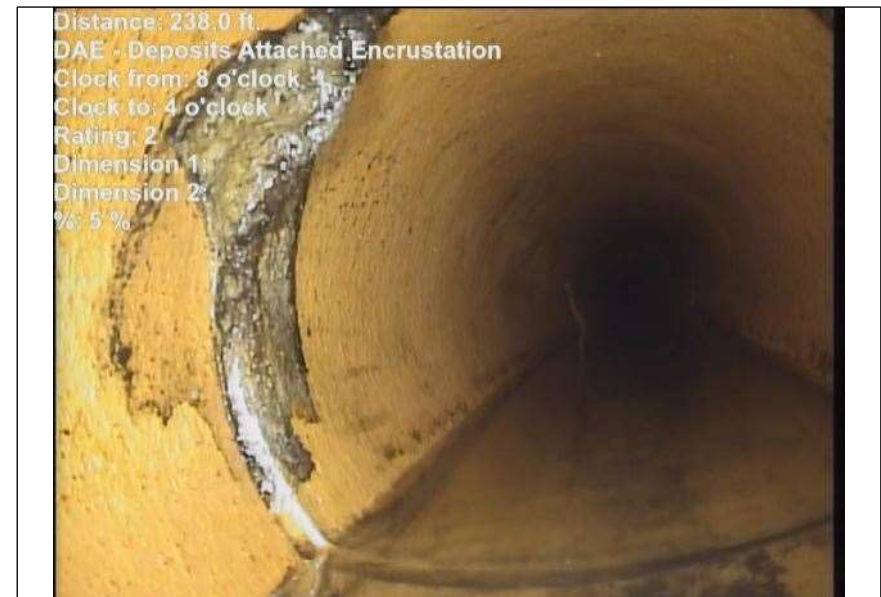
At: 238 ft. 8/4 DAE - Deposits Attached Encrustation

Joint: No 5 %

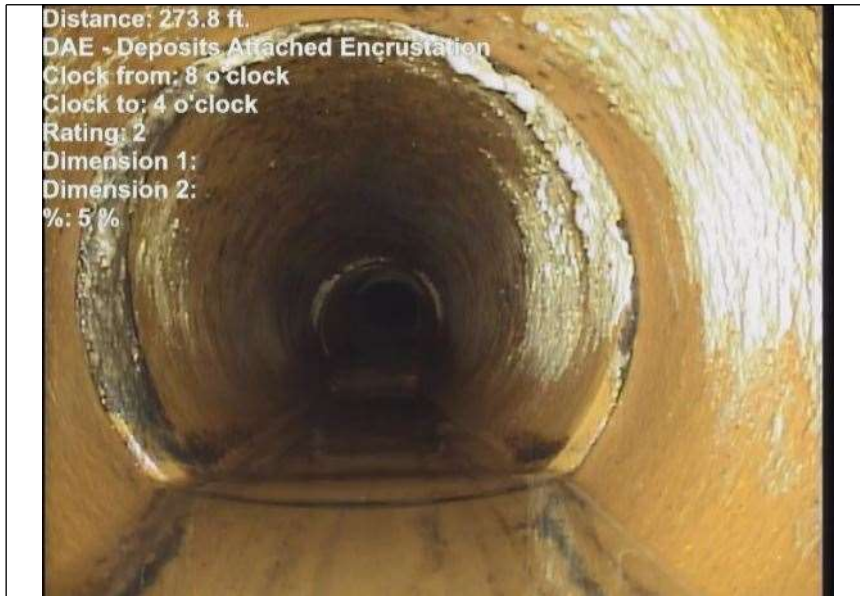
At: 273.8 ft. 8/4 DAE - Deposits Attached Encrustation  
Joint: No 5 %

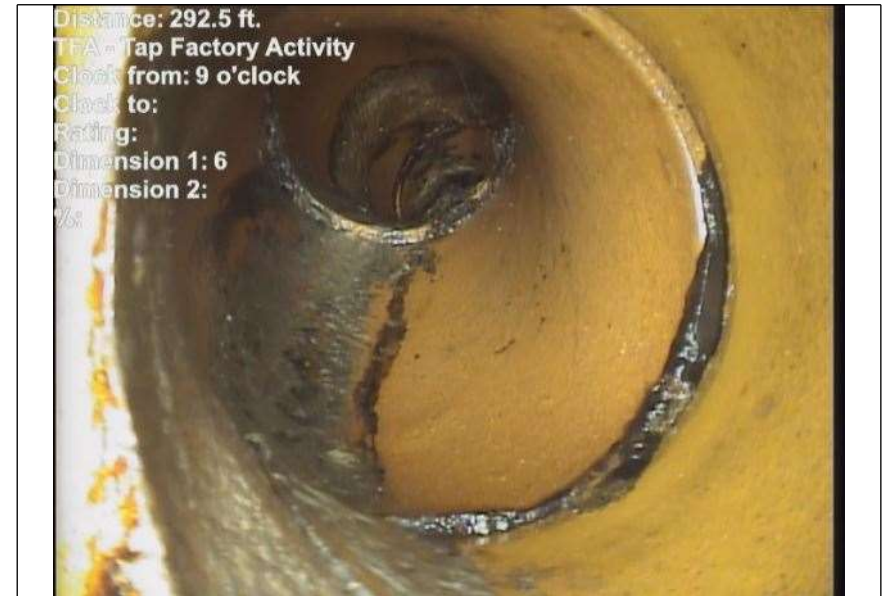
At: 292.5 ft. 9/. TFA - Tap Factory Activity  
Joint: No

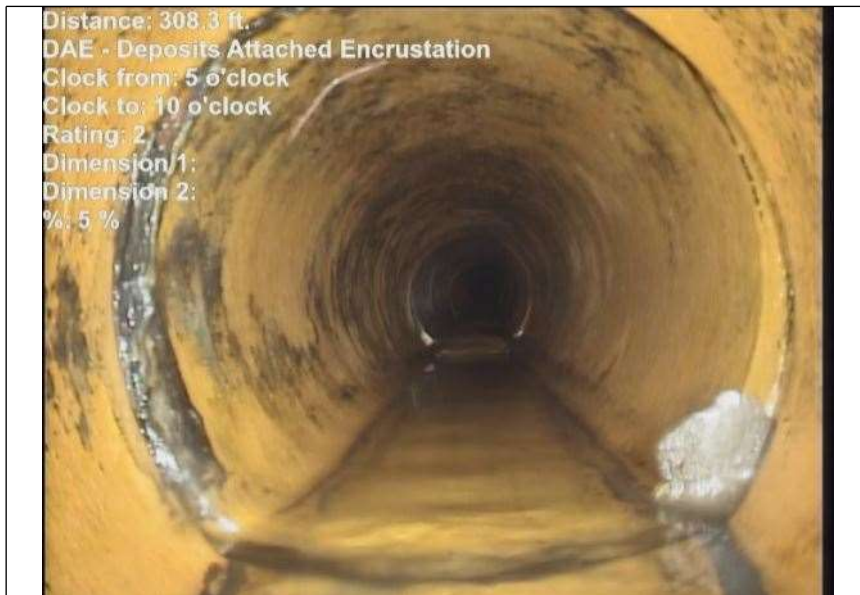
At: 308.3 ft. 7/5 DAE - Deposits Attached Encrustation  
Joint: No 5 %

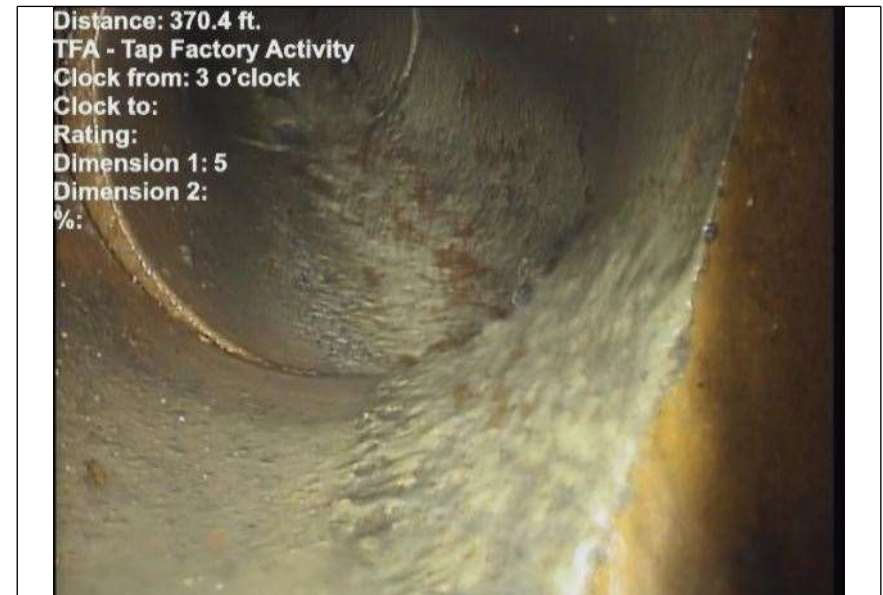
At: 370.4 ft. 3/. TFA - Tap Factory Activity  
Joint: No

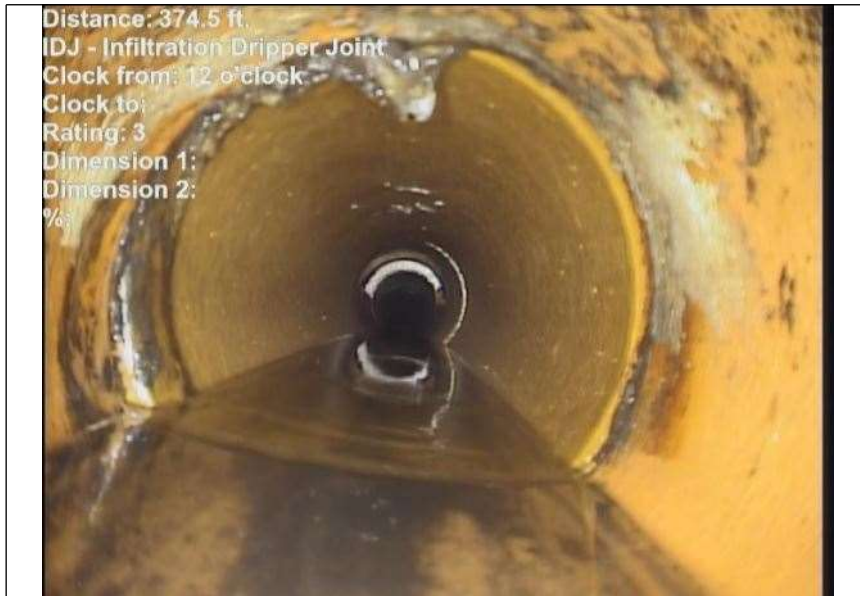
At: 374.5 ft. 12/. IDJ - Infiltration Dripper Joint  
Joint: Yes

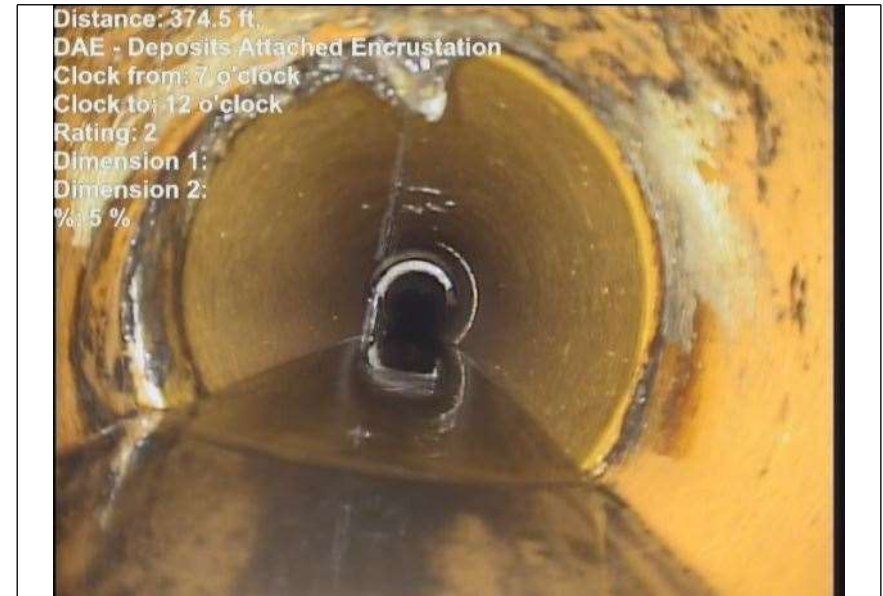
At: 374.5 ft. DAE - Deposits Attached Encrustation  
7/12  
Joint: No 5 %
