PACP Report with Pipe Run and Incident Snapshots

Surveyed by: DAN		Certificate number: U-716-07004752		Owner:		Customer:		Drainage area:		P/O number:		Sheet number:	
Pipe segment ref.: SMH051_SMH052				Start date/time: 20220309 15:22		Street: W CENTER ST				City: SMITHVILLE			
Location details:				Upstream MH No: SMH051				Rim to invert:		Grade to invert:		Rim to grade:	
Pipe use: SS		Direction: D		Flow control:		Downstream MH No: SMH052				Rim to invert:		Grade to invert:	
Height: 10 in.		Width:		Shape: C		Material: VCP		Lining method:		Pipe joint length:		Total length: 161.300 ft.	
Length surveyed: 32.200 ft.		Purpose:		Sewer category:		Media label:		PreCleaning: L		Date cleaned:		Weather: 1	
Project name: Sewer Cleaning & CCTV - Project No. 210670				Additional info:

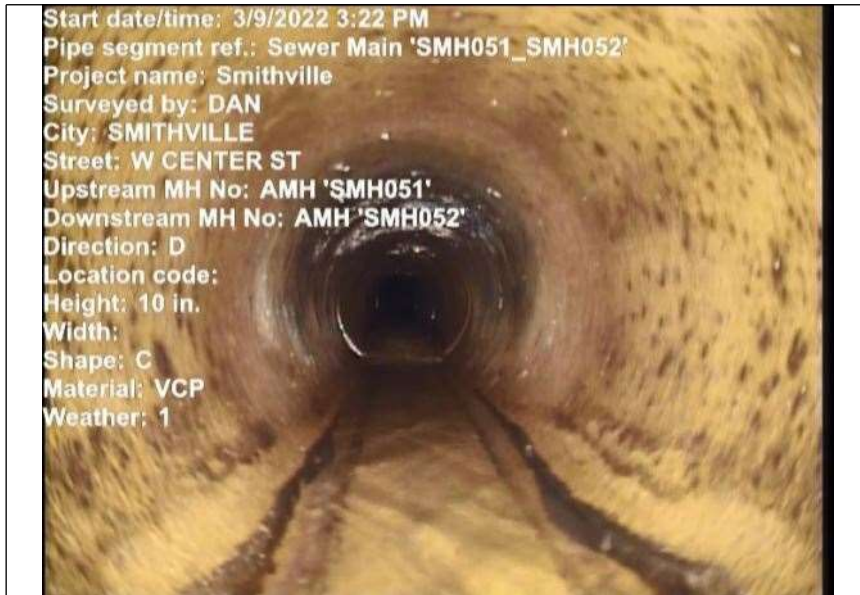
At: 0 ft. AMH - Manhole
 Joint: No SMH051

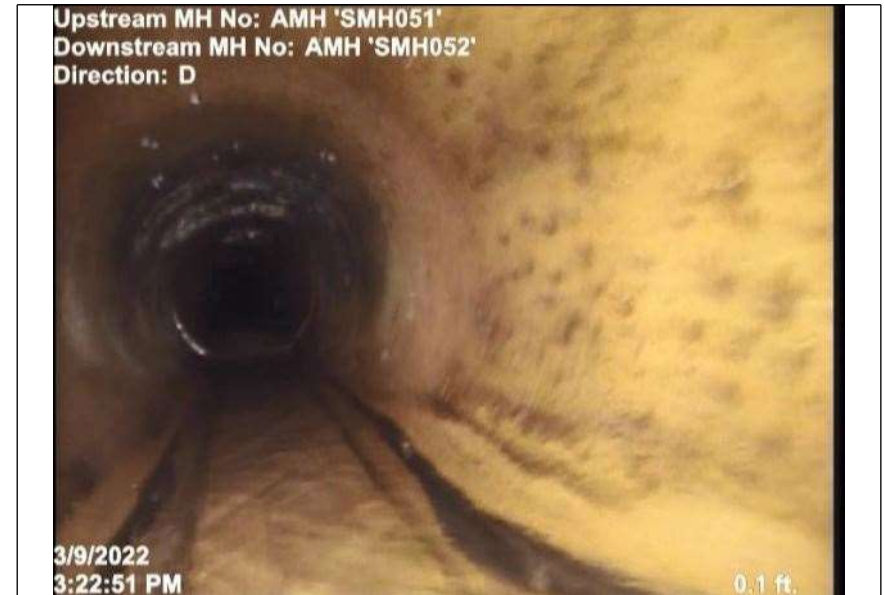
At: 0 ft. MWL - Miscellaneous Water Level
 Joint: No 5 %

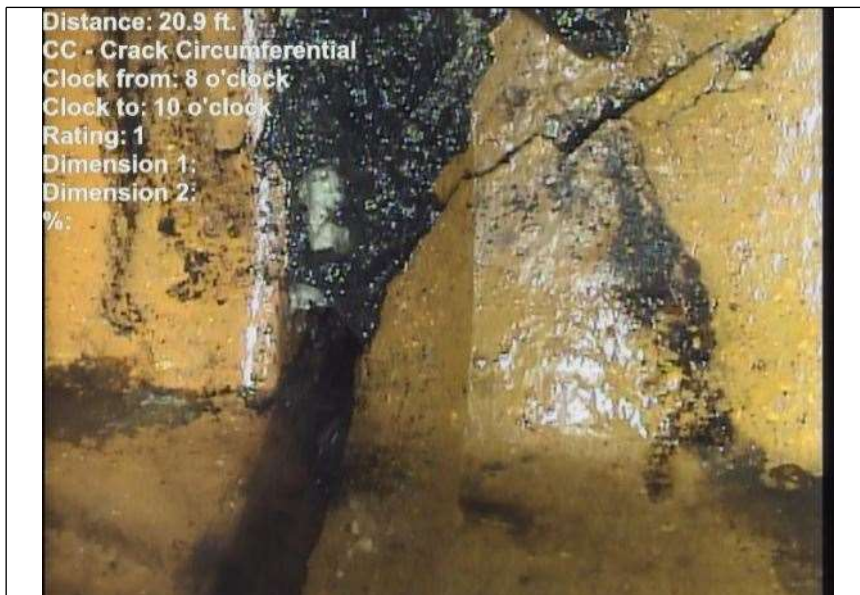
At: 20.9 ft. 8/10 CC - Crack Circumferential
 Joint: No

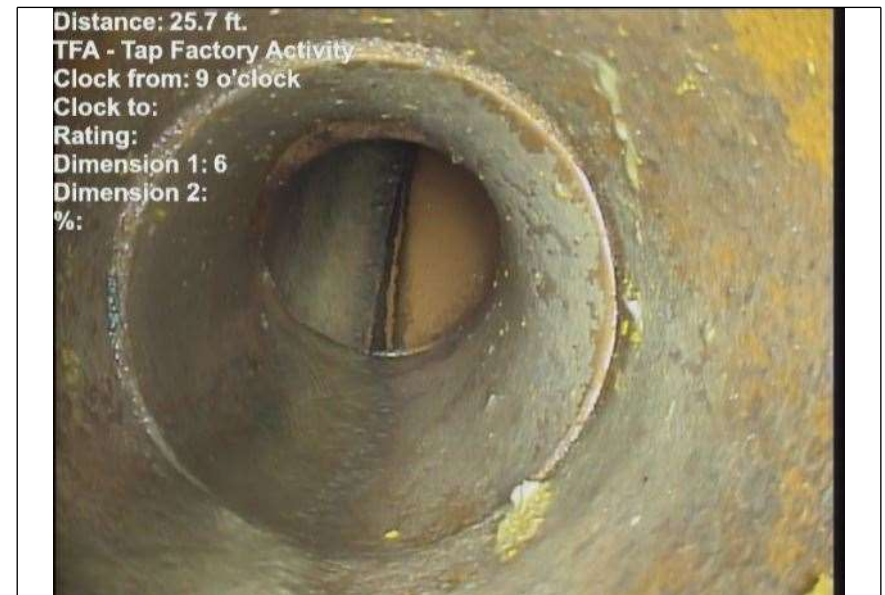
At: 25.7 ft. 9/ TFA - Tap Factory Activity
 Joint: No

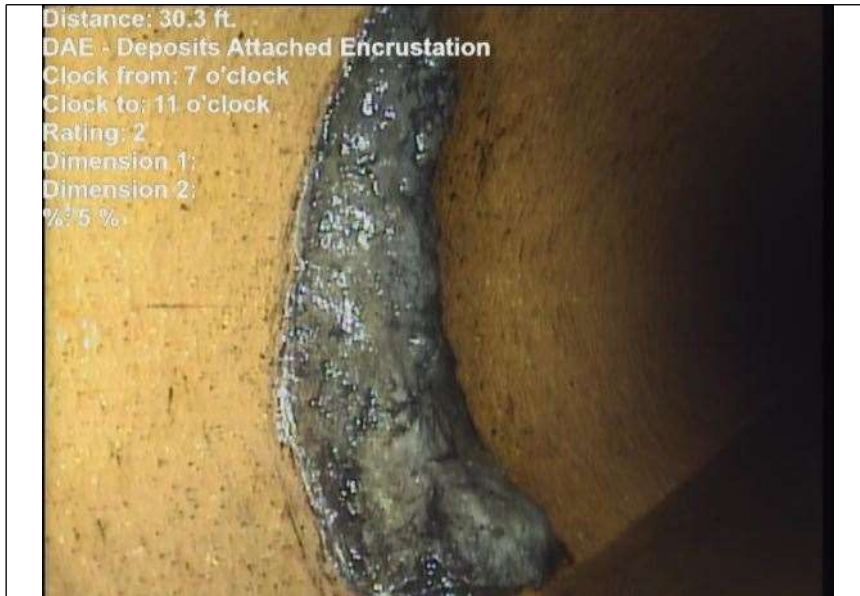
At: 30.3 ft. 7/11 DAE - Deposits Attached Encrustation
Joint: No 5 %

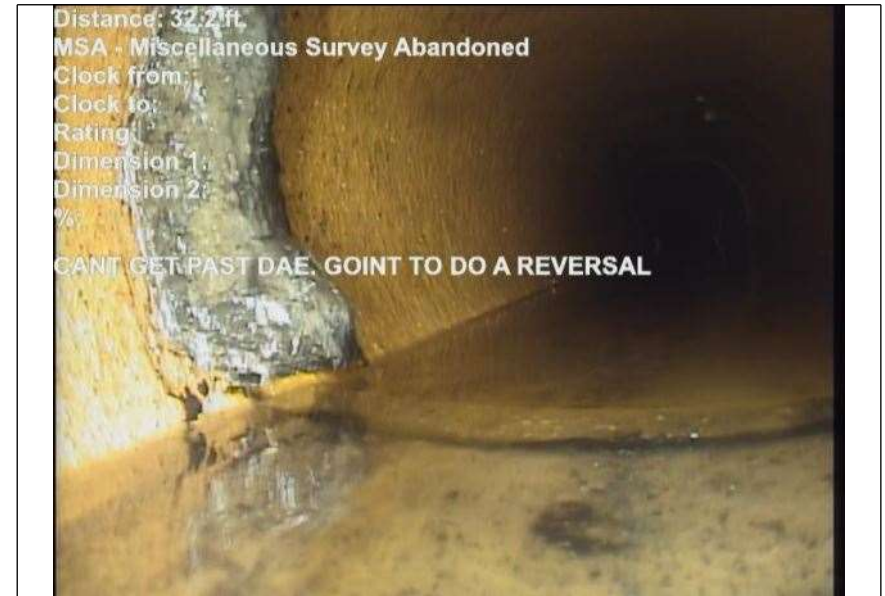
At: 32.2 ft. MSA - Miscellaneous Survey Abandoned
Joint: No CANT GET PAST DAE. GOINT TO DO A REVERSAL
