## PACP Report with Pipe Run and Incident Snapshots

Surveyed by: <b>DAN</b>	Certificate number: <b>U-716-07004752</b>	Owner:	Customer:	Drainage area:	P/O number:	Sheet number:
Pipe segment ref.: <b>SMH051_SMH052.</b>	Start date/time: <b>20220309 16:04</b>	Street: <b>W CENTER ST</b>		City: <b>SMITHVILLE</b>		
Location details:		Upstream MH No: <b>SMH051</b>	Rim to invert:	Grade to invert:	Rim to grade:	
Pipe use: <b>SS</b>	Direction: <b>U</b>	Flow control:	Downstream MH No: <b>SMH052</b>	Rim to invert:	Grade to invert:	Rim to grade:
Height: <b>10 in.</b>	Width:	Shape: <b>C</b>	Material: <b>VCP</b>	Lining method:	Pipe joint length:	Total length: <b>161.300 ft.</b>
Media label:	PreCleaning: <b>L</b>	Date cleaned:	Weather: <b>1</b>	Length surveyed: <b>129.100 ft.</b>	Purpose:	Sewer category:
Project name: <b>Sewer Cleaning &amp; CCTV - Project No. 210670</b>		Additional info:

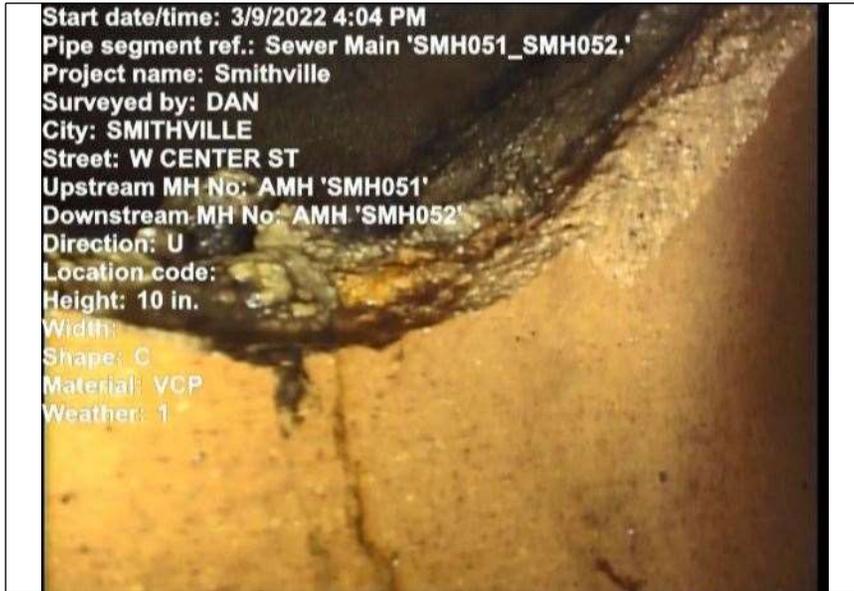
At: 0 ft. AMH - Manhole  
Joint: No SMH052

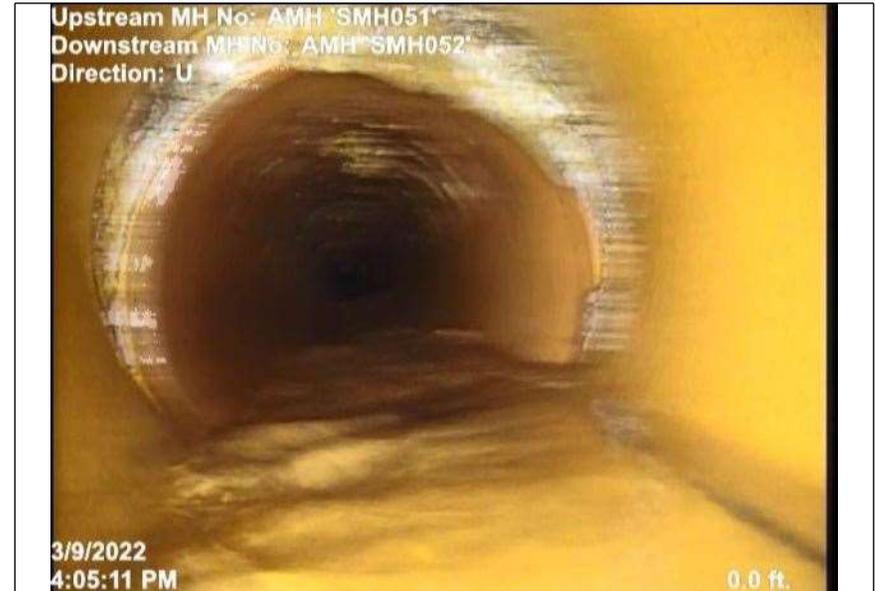
At: 0 ft. MWL - Miscellaneous Water Level  
Joint: No 5%

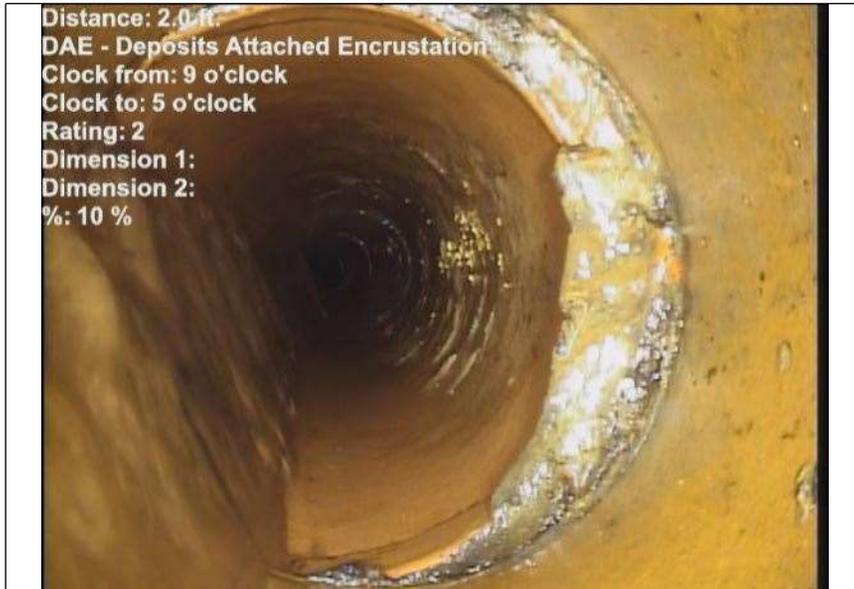
At: 2 ft. 9/5 DAE - Deposits Attached Encrustation  
Joint: No 10%

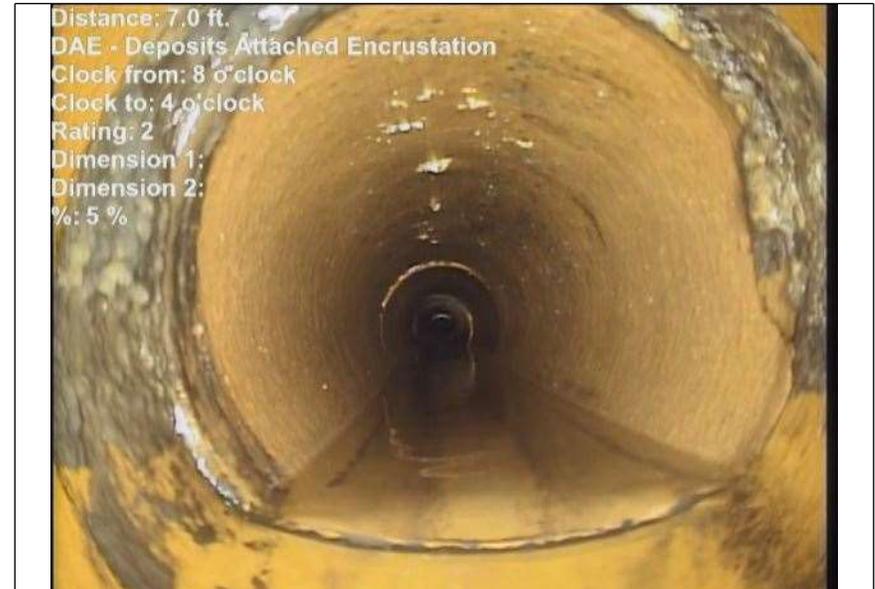
At: 7 ft. 8/4 DAE - Deposits Attached Encrustation  
Joint: No 5%

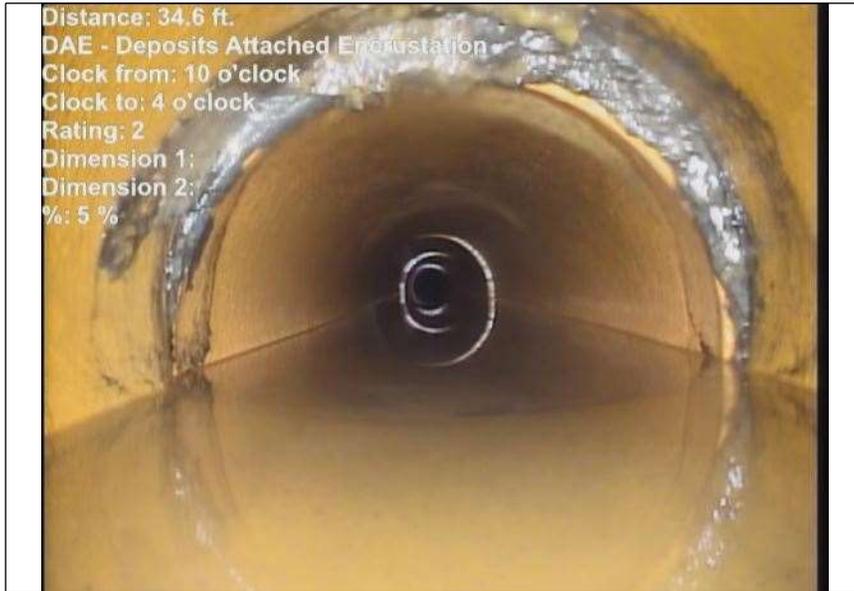
At: 34.6 ft. 10/4 DAE - Deposits Attached Encrustation

Joint: No 5 %

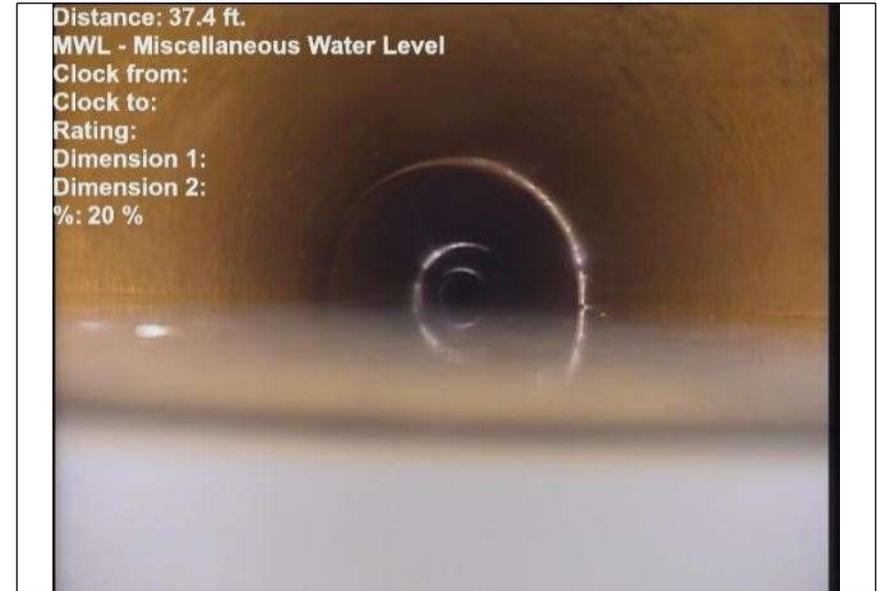
At: 37.4 ft. MWL - Miscellaneous Water Level

Joint: No 20 %

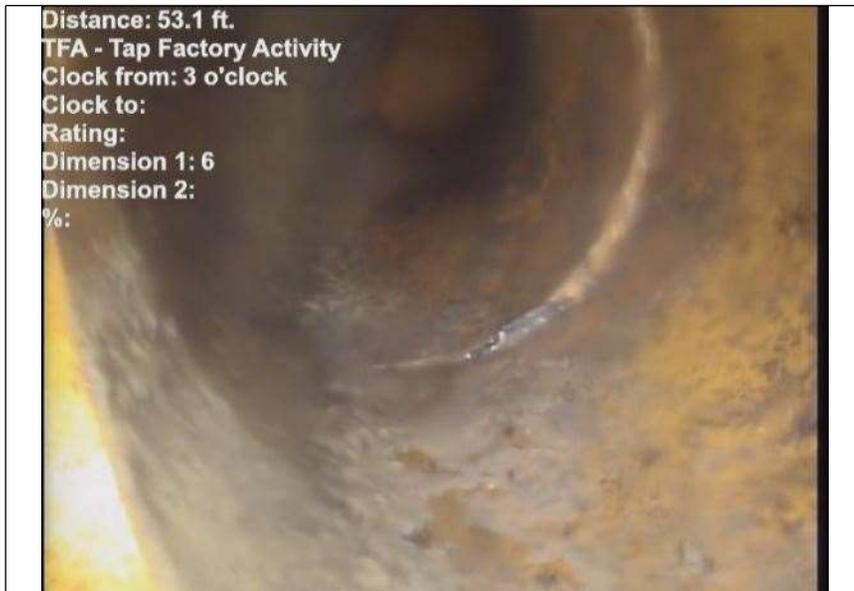
At: 53.1 ft. 3/. TFA - Tap Factory Activity

Joint: No

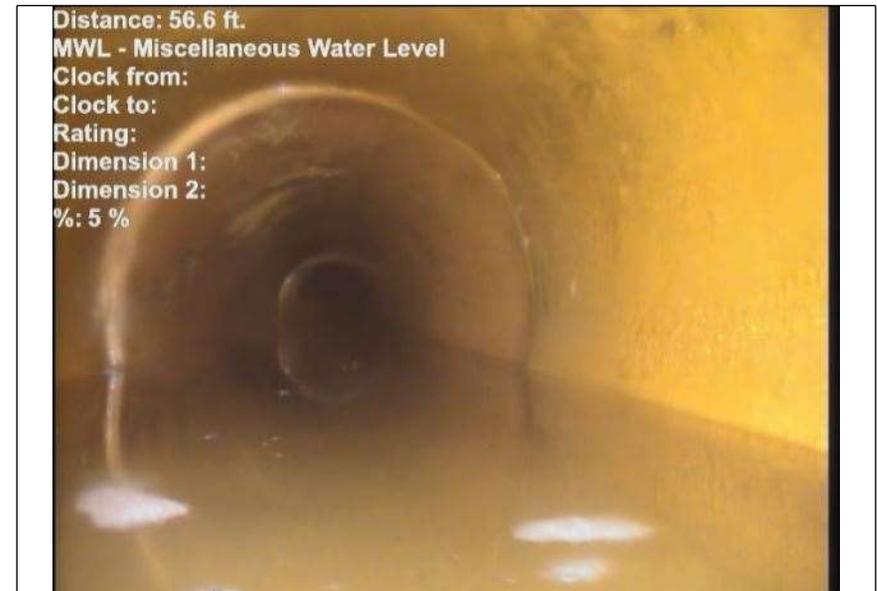
At: 56.6 ft. MWL - Miscellaneous Water Level

Joint: No 5 %

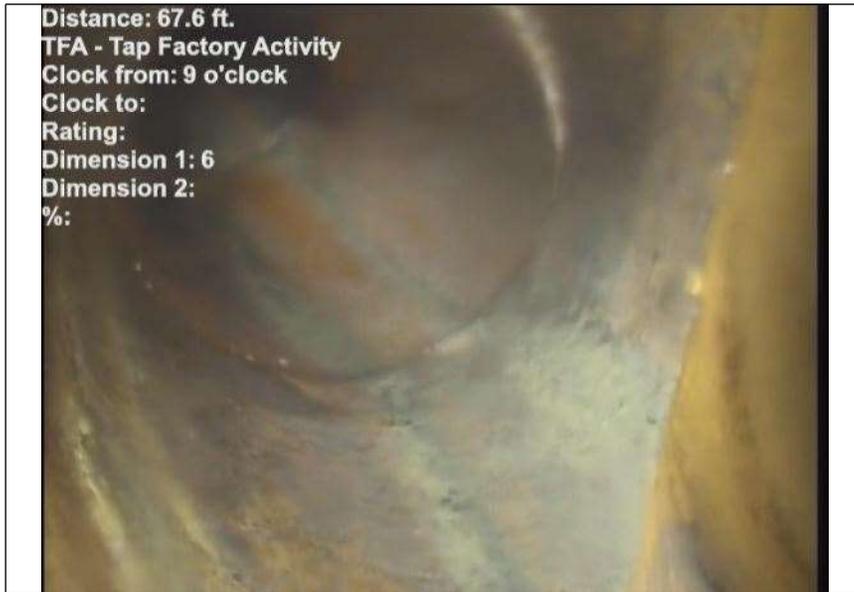
At: 67.6 ft. 9/ TFA - Tap Factory Activity  
Joint: No

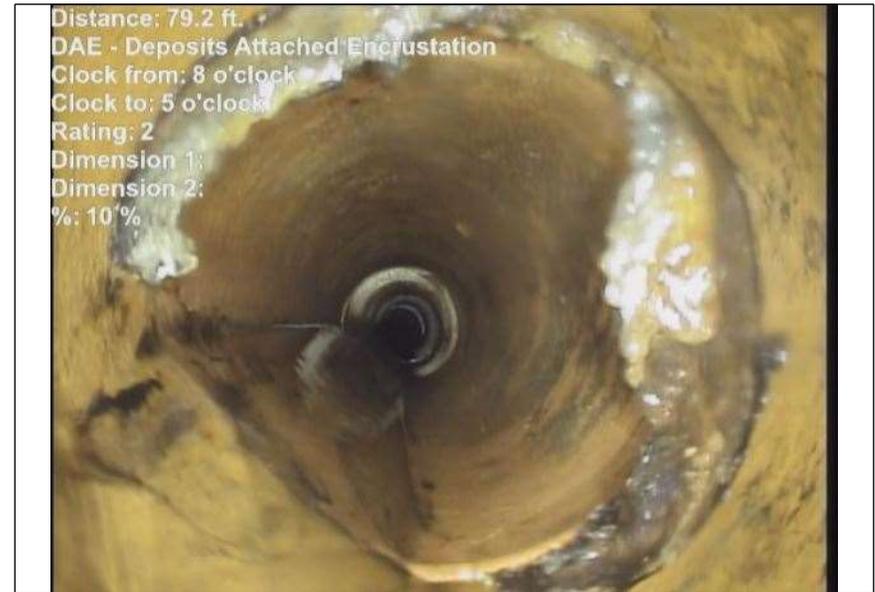
At: 79.2 ft. 8/5 DAE - Deposits Attached Encrustation  
Joint: No 10%

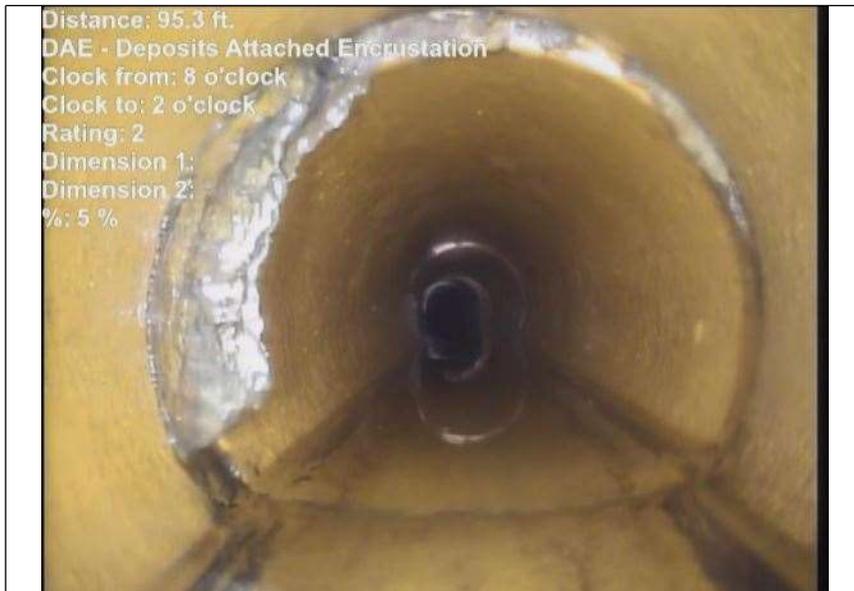
At: 95.3 ft. 8/2 DAE - Deposits Attached Encrustation  
Joint: No 5%

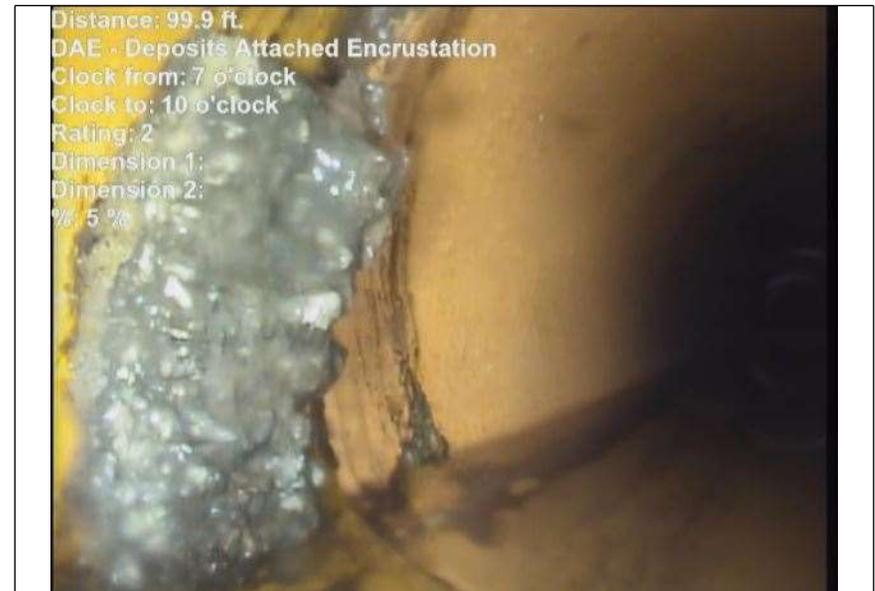
At: 99.9 ft. 7/10 DAE - Deposits Attached Encrustation  
Joint: No 5%

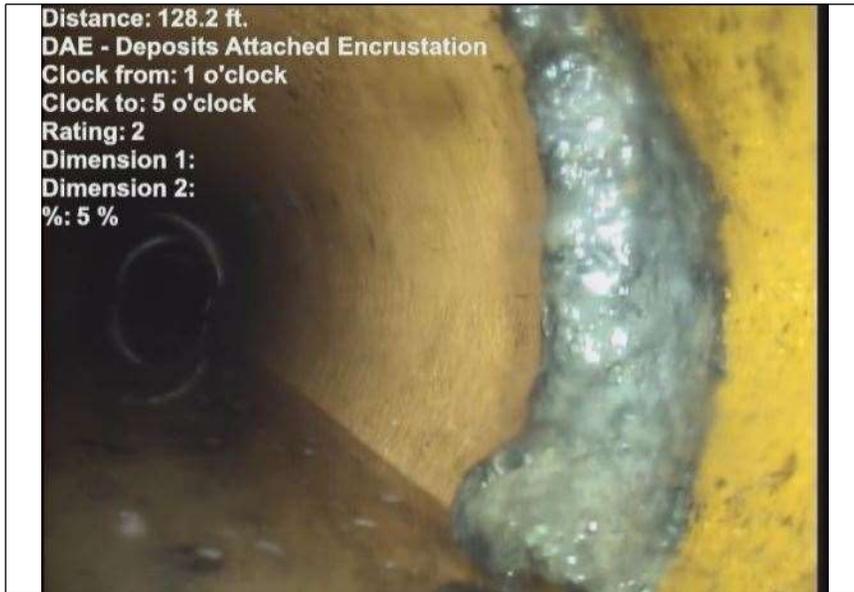
At: 128.2 ft. 1/5 DAE - Deposits Attached Encrustation  
Joint: No 5 %

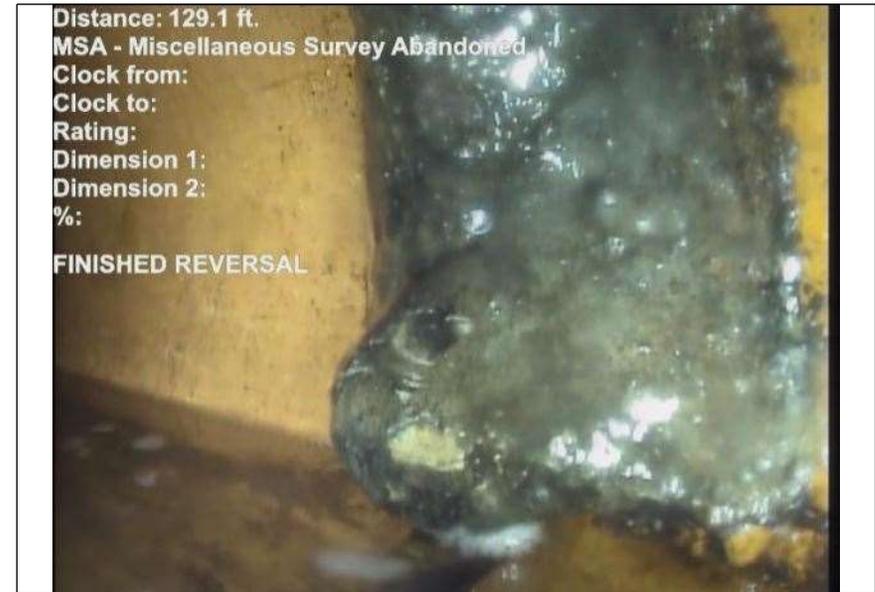
At: 129.1 ft. MSA - Miscellaneous Survey Abandoned  
Joint: No **FINISHED REVERSAL**
