PACP Report with Pipe Run and Incident Snapshots

Surveyed by: Mike Brooks	Certificate number: Mike Brooks	Owner:	Customer:	Drainage area:	P/O number:	Sheet number:
Pipe segment ref.: SMH052_SMH053	Start date/time: 20220317 09:42	Street: W. CENTER ST		City: SMITHVILLE		
Location details: STREET	Upstream MH No: SMH052	Rim to invert:	Grade to invert:	Rim to grade:		
Pipe use: SS	Direction: D	Flow control:	Downstream MH No: SMH053	Rim to invert:	Grade to invert:	Rim to grade:
Height: 8 in.	Width:	Shape: C	Material: VCP	Lining method:	Pipe joint length:	Total length: 182.700 ft.
Length surveyed: 153.800 ft.	Purpose:	Sewer category:				
Media label:	PreCleaning: L	Date cleaned:	Weather: 1	Location code:	Pressure value:	
Project name: Sewer Cleaning & CCTV - Project No. 210670	Additional info:

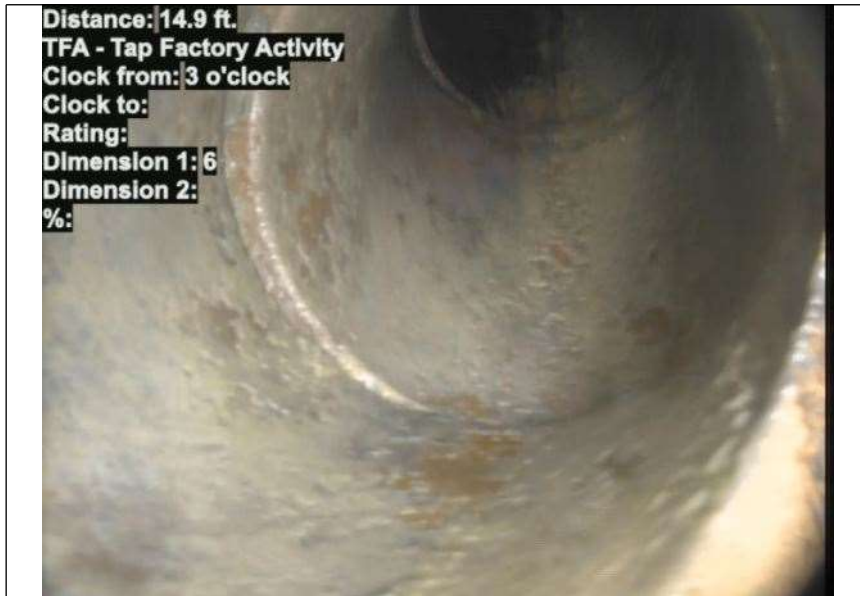
At: 14.9 ft. 3/ TFA - Tap Factory Activity
Joint: No

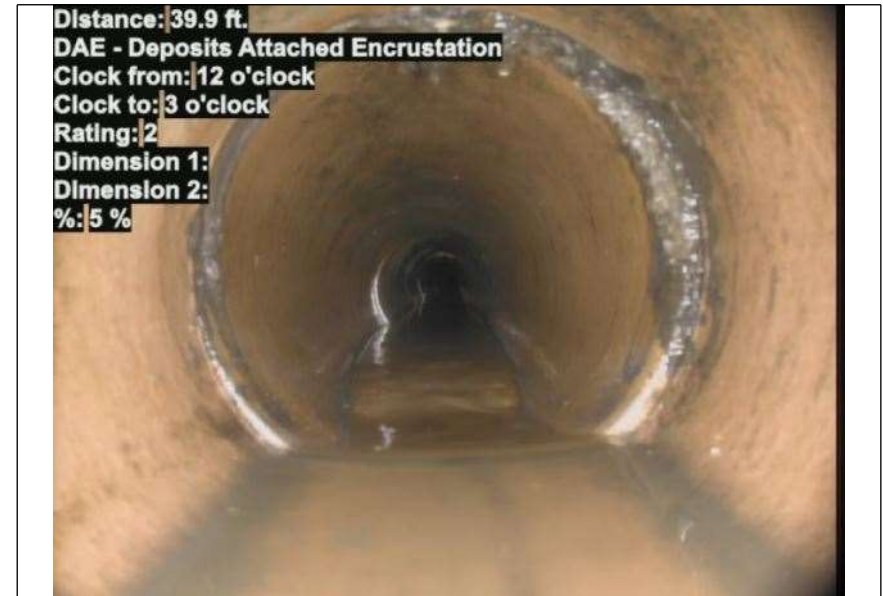
At: 39.9 ft. 12/3 DAE - Deposits Attached Encrustation
Joint: No 5 %

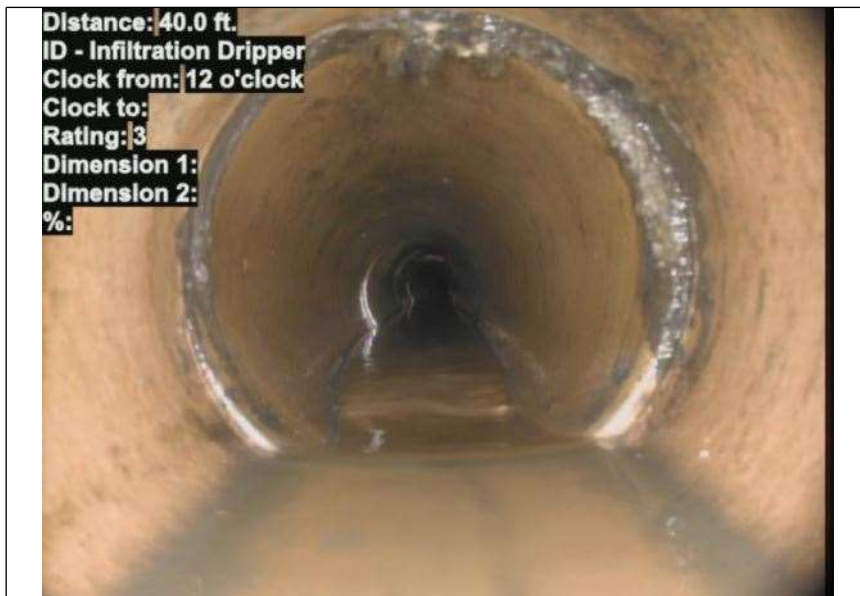
At: 40 ft. 12/ ID - Infiltration Dripper
Joint: No

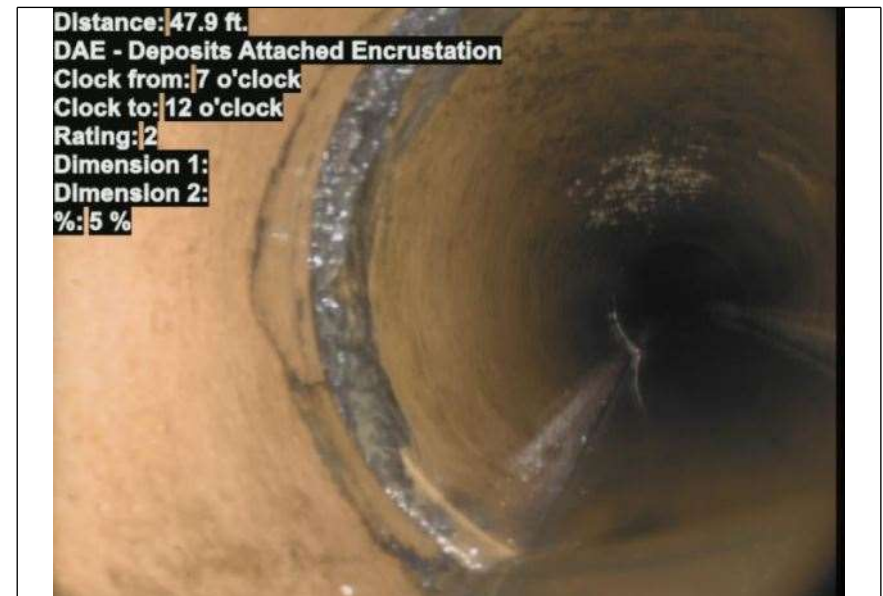
At: 47.9 ft. 7/12 DAE - Deposits Attached Encrustation
Joint: No 5 %

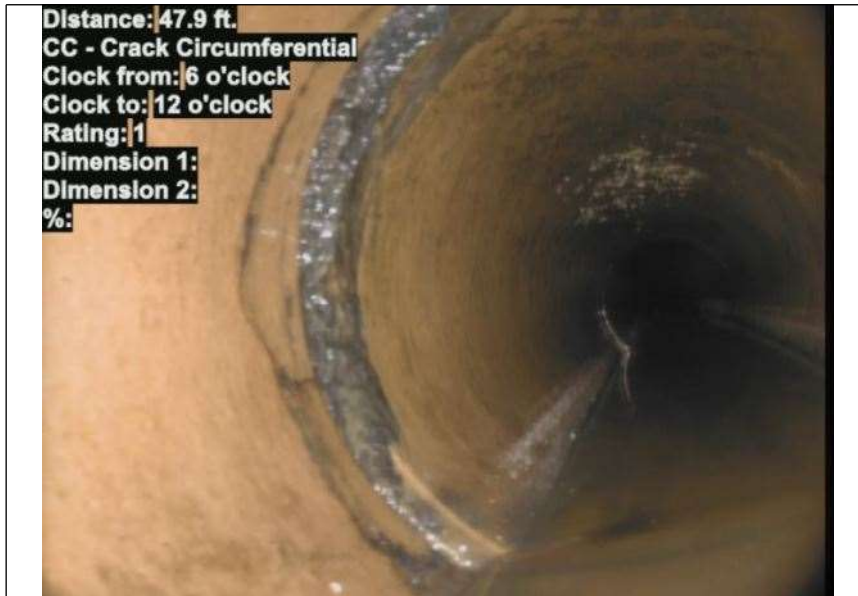
At: 47.9 ft. 6/12 CC - Crack Circumferential
Joint: No

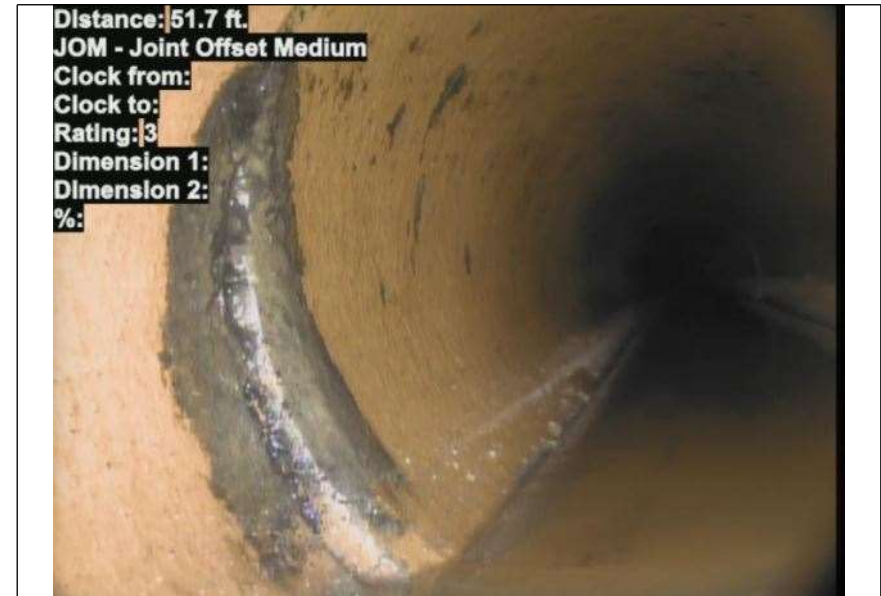
At: 51.7 ft. JOM - Joint Offset Medium
Joint: No

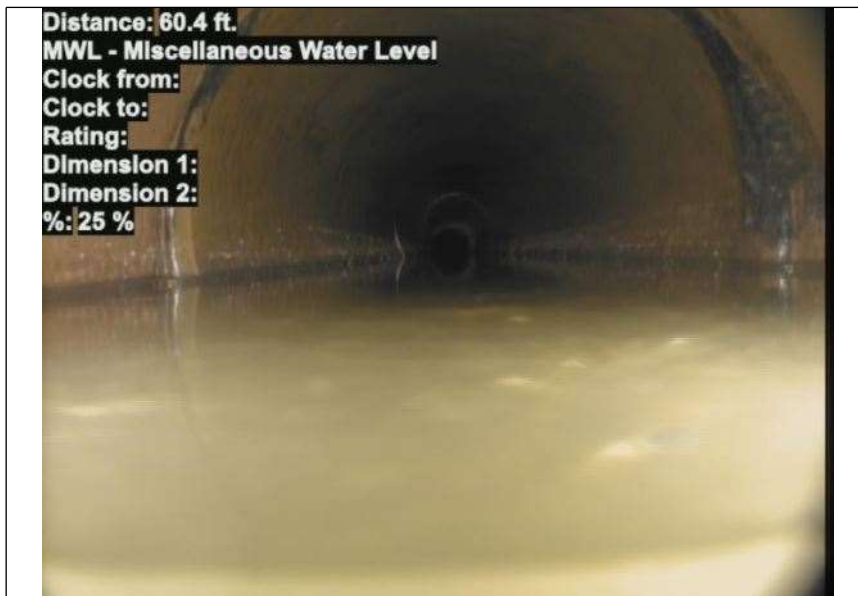
At: 60.4 ft. MWL - Miscellaneous Water Level
Joint: No 25 %

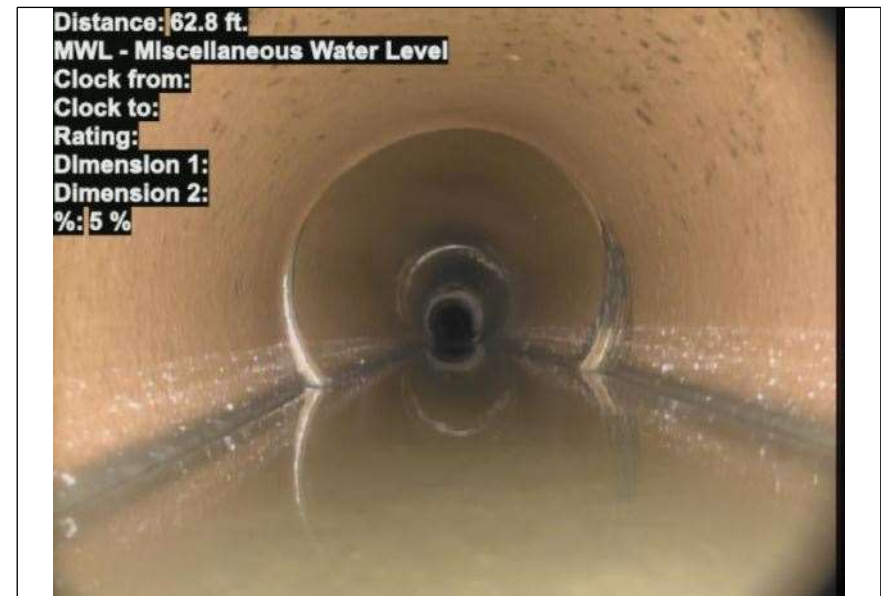
At: 62.8 ft. MWL - Miscellaneous Water Level
Joint: No 5 %

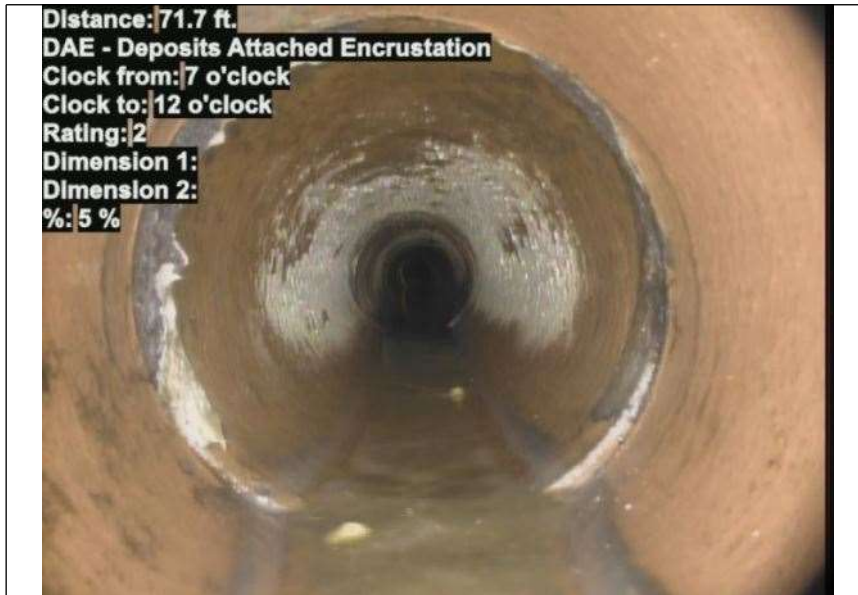
At: 71.7 ft. 7/12 DAE - Deposits Attached Encrustation
Joint: No 5 %

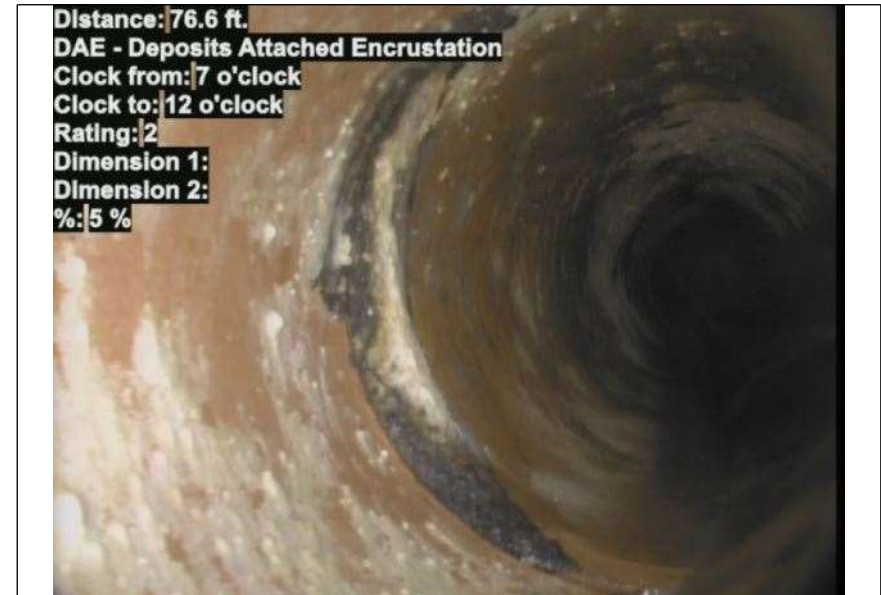
At: 76.6 ft. 7/12 DAE - Deposits Attached Encrustation
Joint: No 5 %

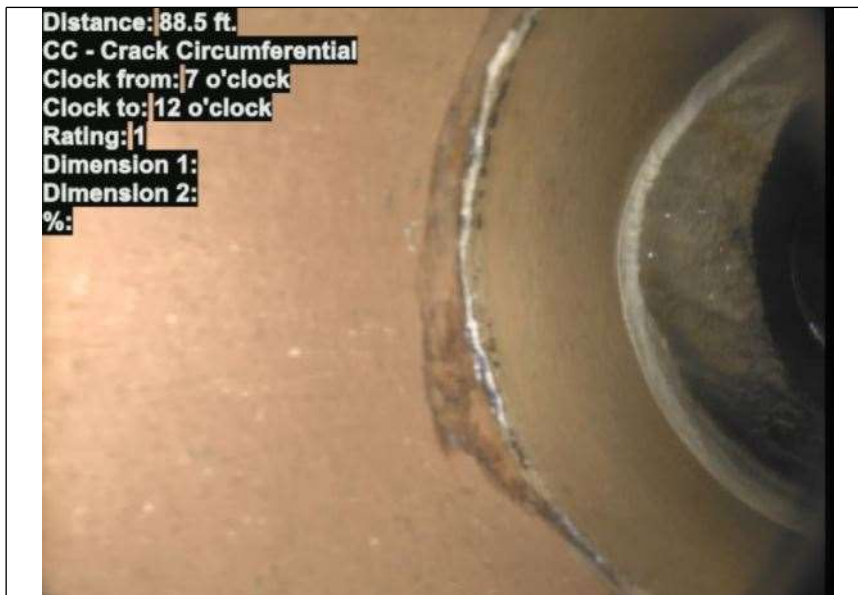
At: 88.5 ft. 7/12 CC - Crack Circumferential
Joint: No

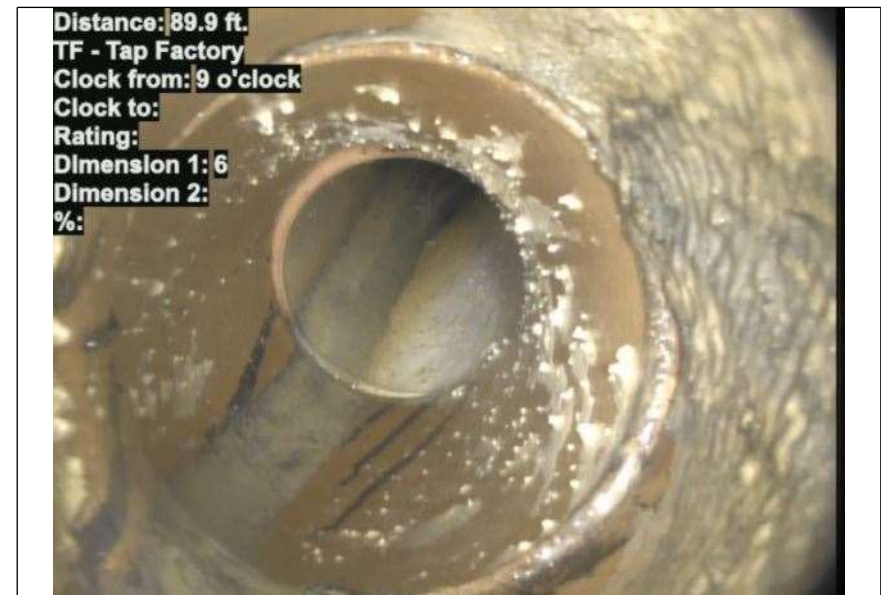
At: 89.9 ft. 9/ TF - Tap Factory
Joint: No

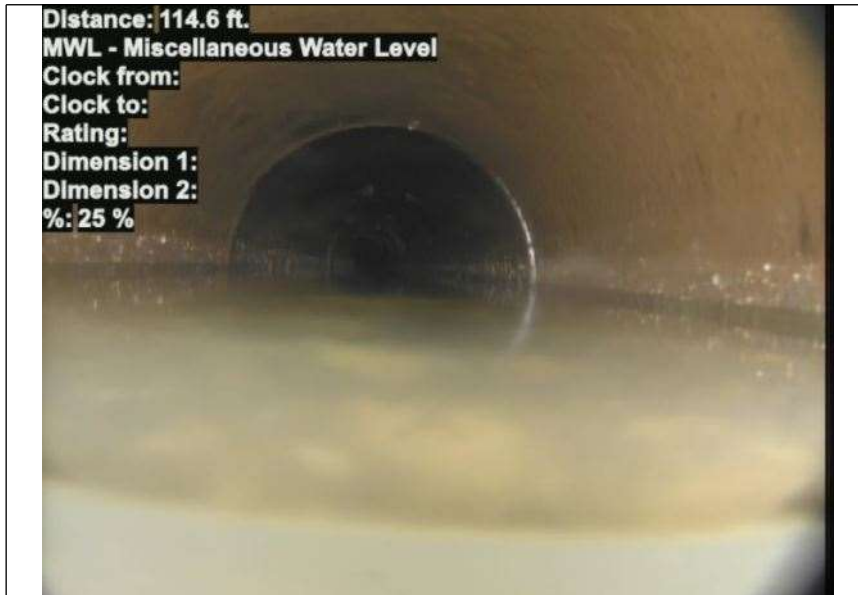
At: 114.6 ft. MWL - Miscellaneous Water Level
Joint: No 25 %

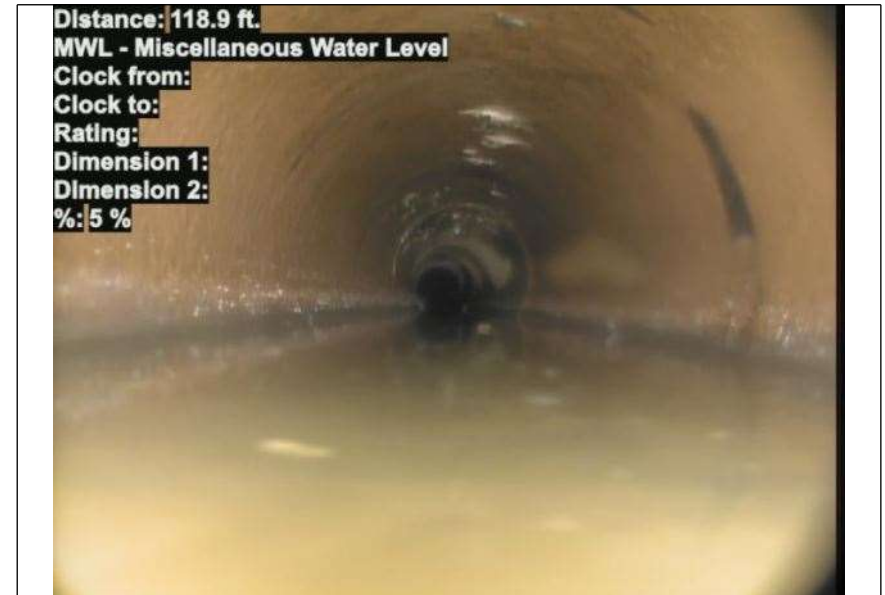
At: 118.9 ft. MWL - Miscellaneous Water Level
Joint: No 5 %

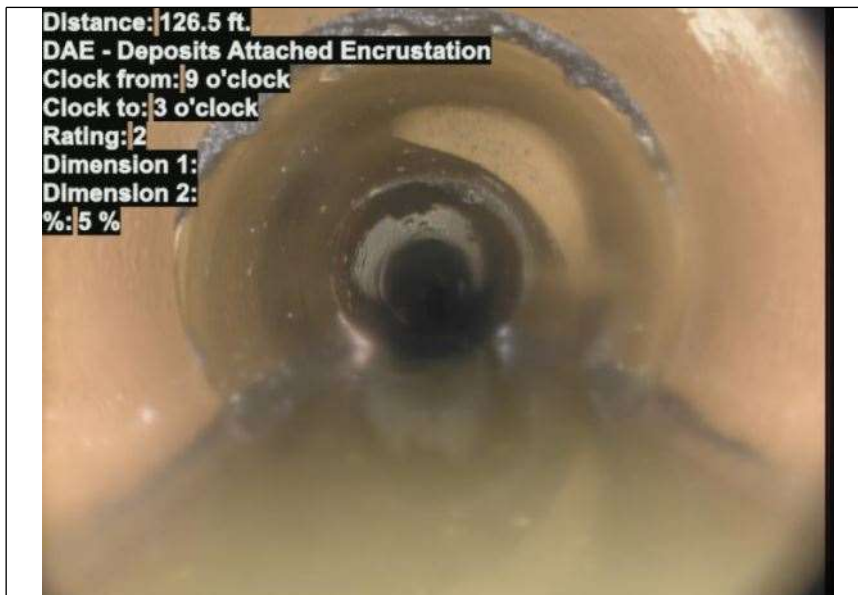
At: 126.5 ft. 9/3 DAE - Deposits Attached Encrustation
Joint: No 5 %

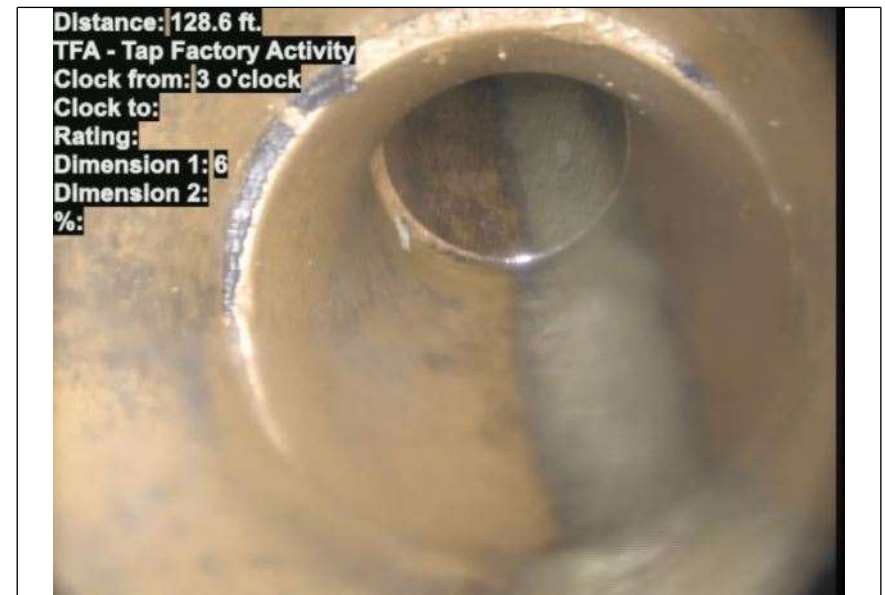
At: 128.6 ft. 3/. TFA - Tap Factory Activity
Joint: No

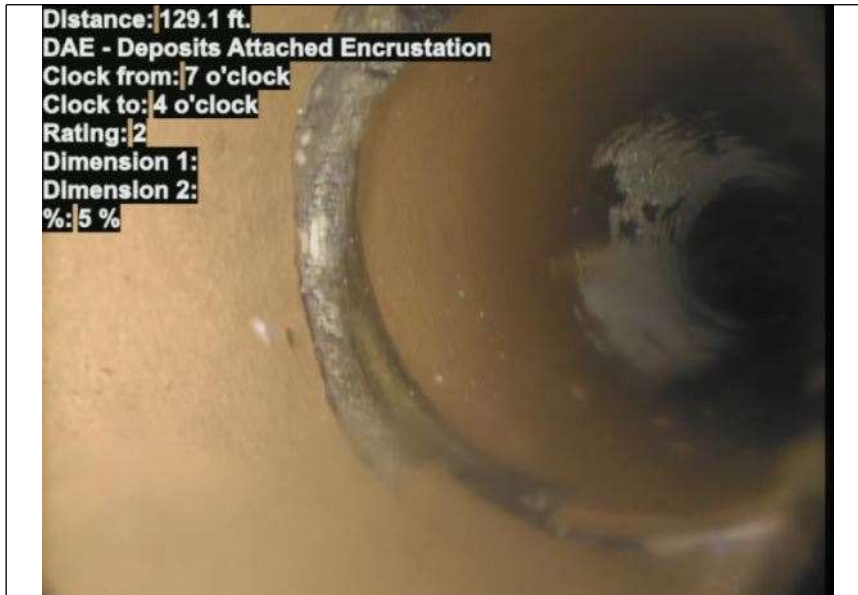
At: 129.1 ft. 7/4 DAE - Deposits Attached Encrustation
Joint: No 5 %

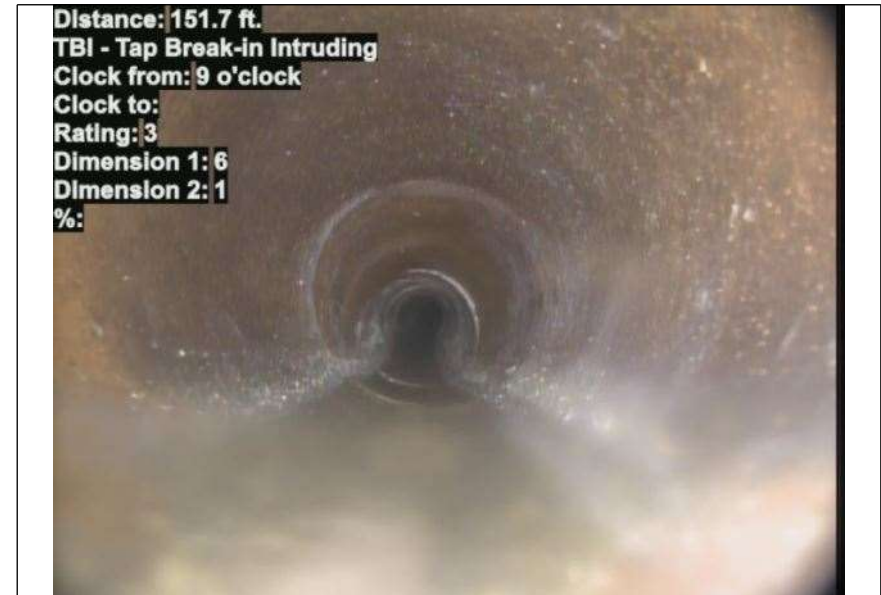
At: 151.7 ft. 9/. TBI - Tap Break-in Intruding
Joint: No

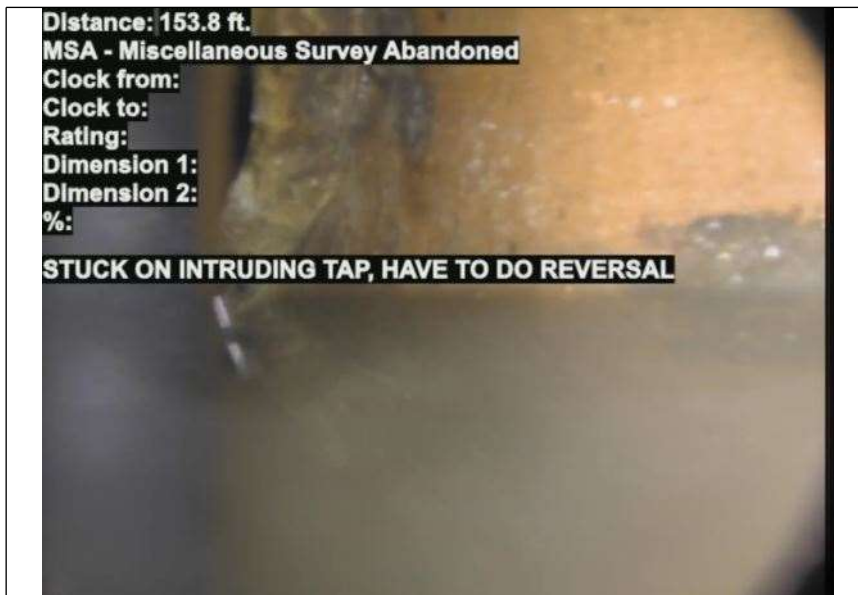
At: 153.8 ft. MSA - Miscellaneous Survey Abandoned
Joint: No STUCK ON INTRUDING TAP, HAVE TO DO REVERSAL
