PACP Report with Pipe Run and Incident Snapshots

Surveyed by: Mike Brooks		Certificate number: Mike Brooks		Owner:		Customer:		Drainage area:		P/O number:		Sheet number:	
Pipe segment ref.: SMH052_SMH053				Start date/time: 20220317 11:08		Street: W. CENTER ST				City: SMITHVILLE			
Location details: STREET				Upstream MH No: SMH052				Rim to invert:		Grade to invert:		Rim to grade:	
Pipe use: SS		Direction: U		Flow control:		Downstream MH No: SMH053				Rim to invert:		Grade to invert:	
Height: 8 in.		Width:		Shape: C		Material: VCP		Lining method:		Pipe joint length:		Total length: 182.700 ft.	
Length surveyed: 28.900 ft.		Purpose: F		Sewer category:		Media label:		PreCleaning: L		Date cleaned:		Weather:	
Location code:		Pressure value:		Project name: Sewer Cleaning & CCTV - Project No. 210670									
Additional info:

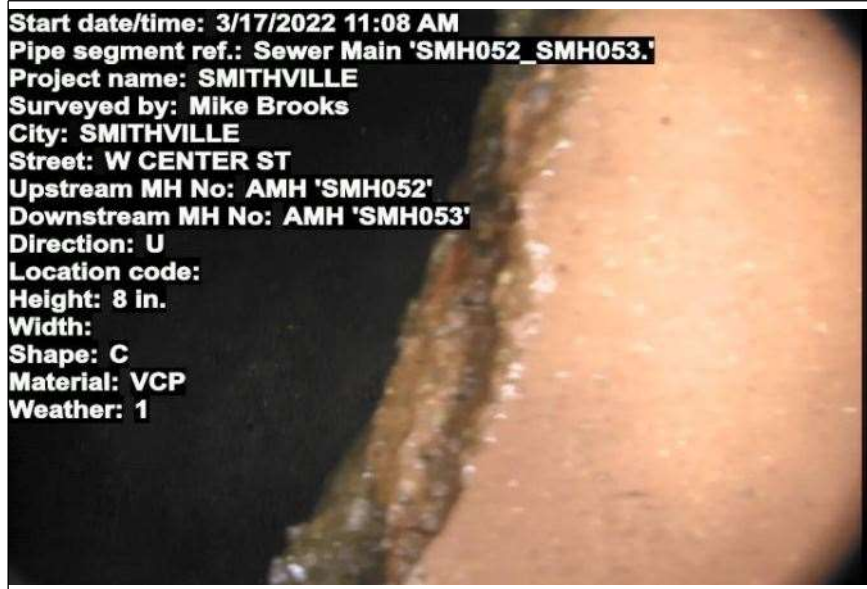
At: 0 ft. AMH - Manhole
 Joint: No SMH053

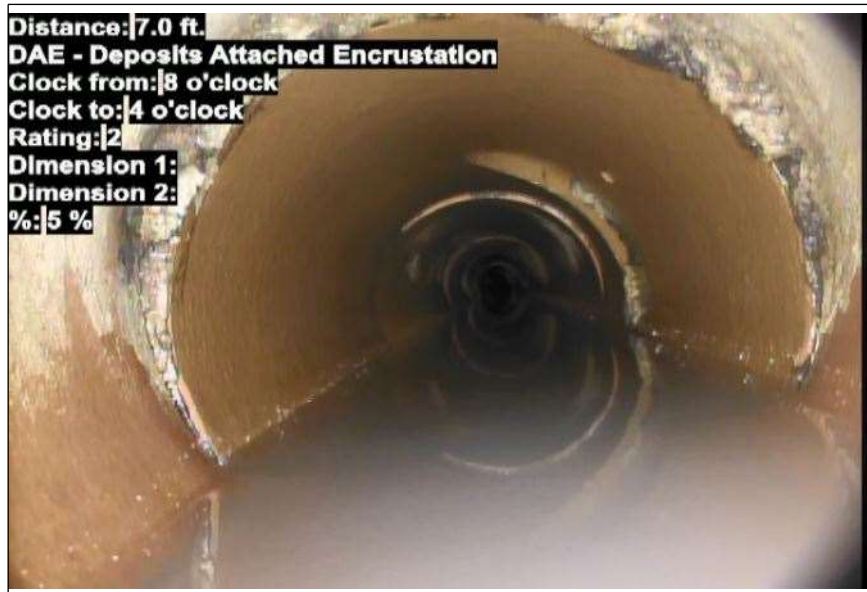
At: 7 ft. 8/4 DAE - Deposits Attached Encrustation
 Joint: No 5 %

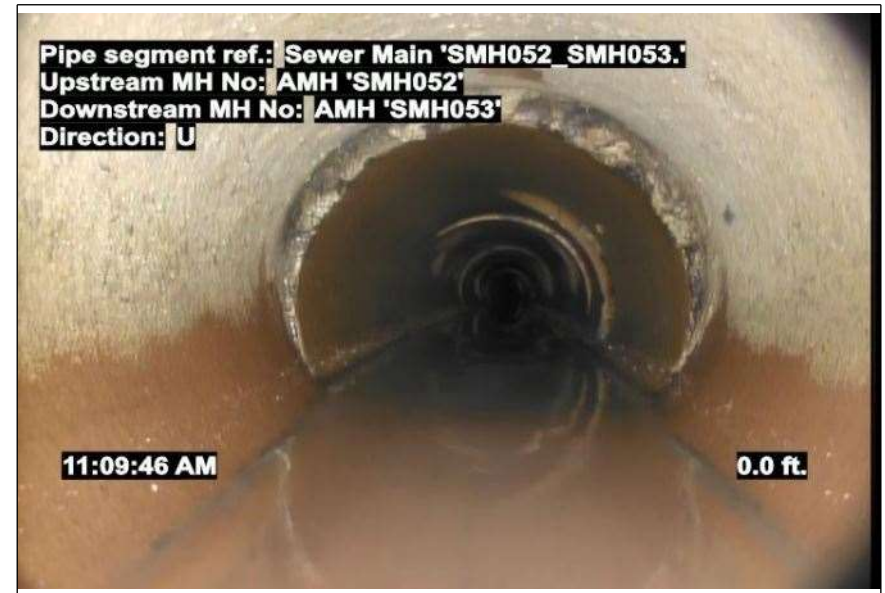
At: 0 ft. MWL - Miscellaneous Water Level
 Joint: No 5 %

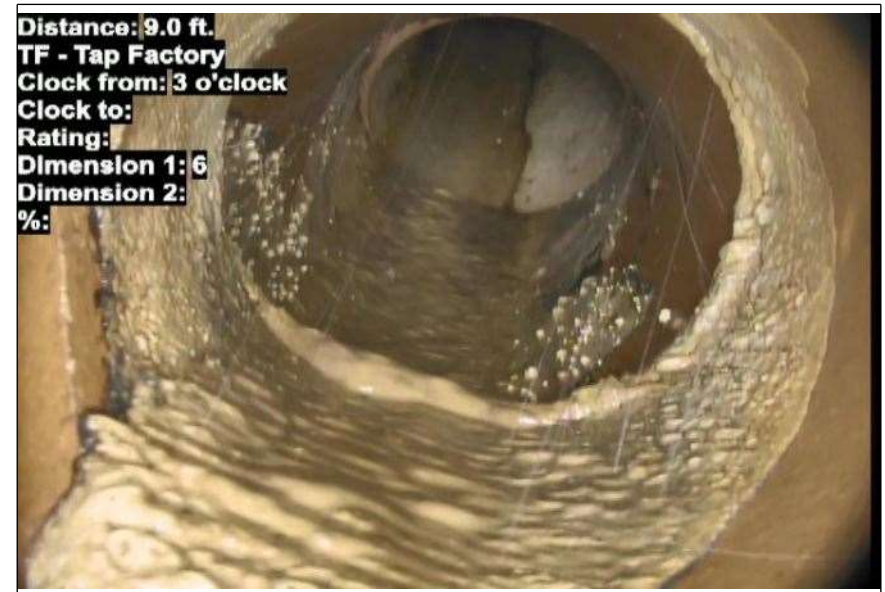
At: 9 ft. 3/. TF - Tap Factory
 Joint: No

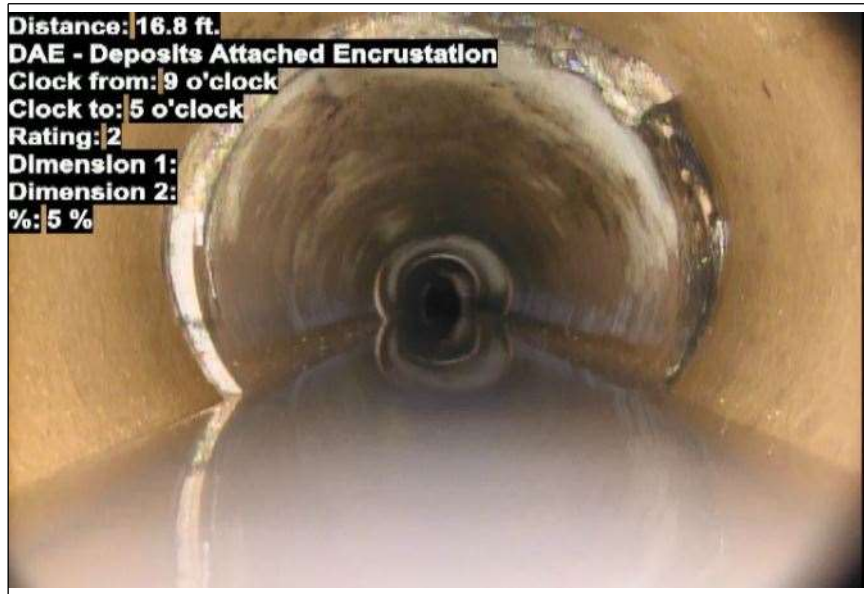
At: 16.8 ft. 9/5 DAE - Deposits Attached Encrustation
Joint: No 5 %

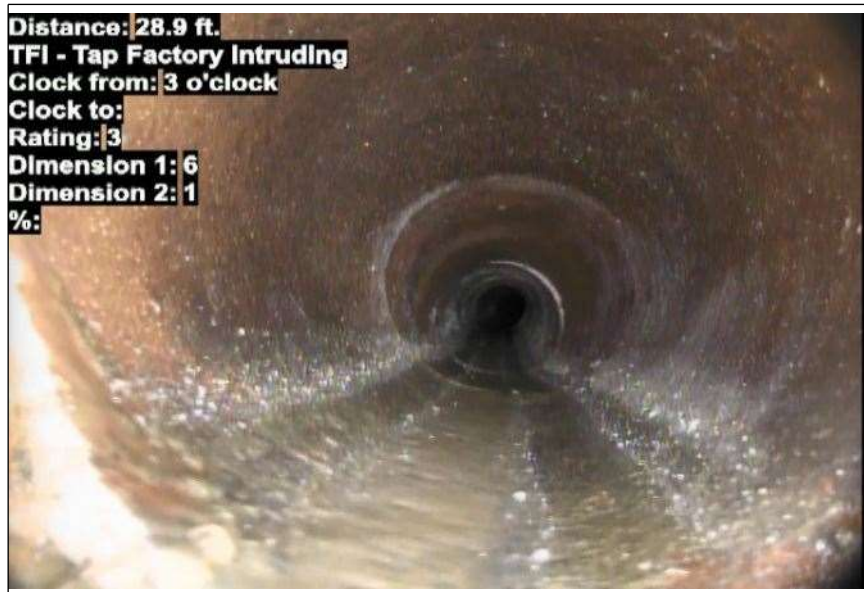
At: 28.9 ft. 3/. TFI - Tap Factory Intruding
Joint: No

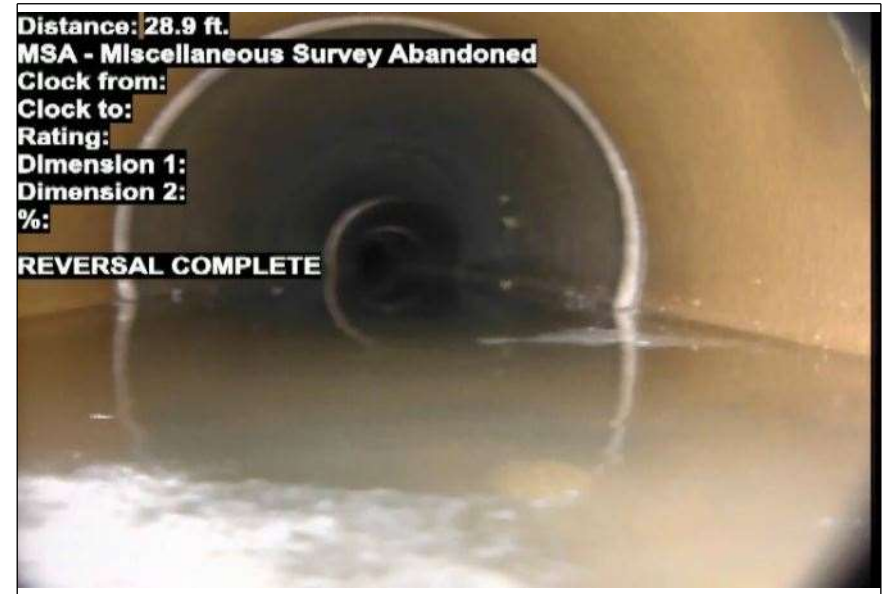
At: 28.9 ft. MSA - Miscellaneous Survey Abandoned
Joint: No REVERSAL COMPLETE
