PACP Report with Pipe Run and Incident Snapshots

Surveyed by: Mike Brooks	Certificate number: Mike Brooks	Owner:	Customer:	Drainage area:	P/O number:	Sheet number:
Pipe segment ref.: SMH053_SMH054	Start date/time: 20220317 11:36	Street: W CENTER ST	City: SMITHVILLE			
Location details: STREET	Upstream MH No: SMH053	Rim to invert:	Grade to invert:	Rim to grade:		
Pipe use: SS	Direction: D	Flow control:	Downstream MH No: SMH054	Rim to invert:	Grade to invert:	Rim to grade:
Height: 8 in.	Width:	Shape: C	Material: VCP	Lining method:	Pipe joint length:	Total length: 358.900 ft.
Length surveyed: 167.400 ft.	Purpose:	Sewer category:				
Media label:	PreCleaning: L	Date cleaned:	Weather: 1	Location code:	Pressure value:	
Project name: Sewer Cleaning & CCTV - Project No. 210670	Additional info:

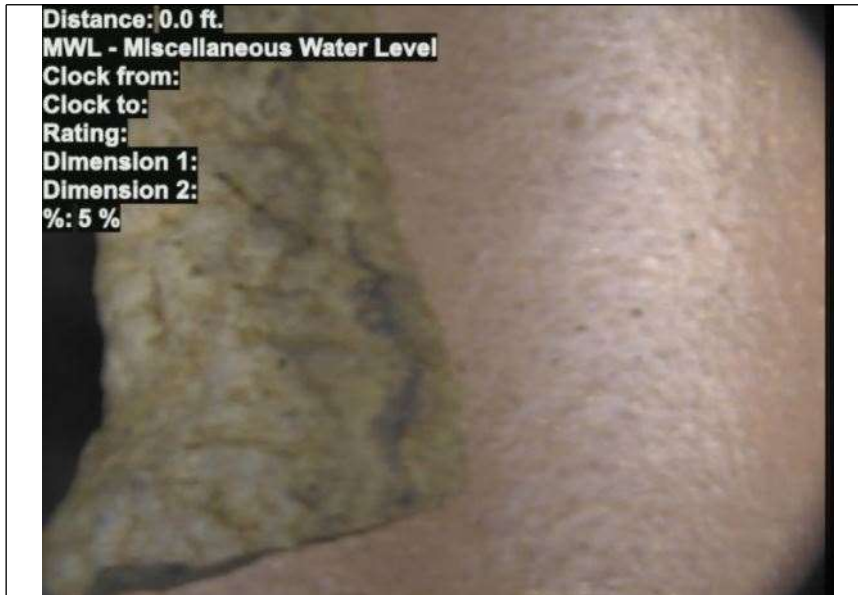
At: 0 ft. MWL - Miscellaneous Water Level
Joint: No 5 %

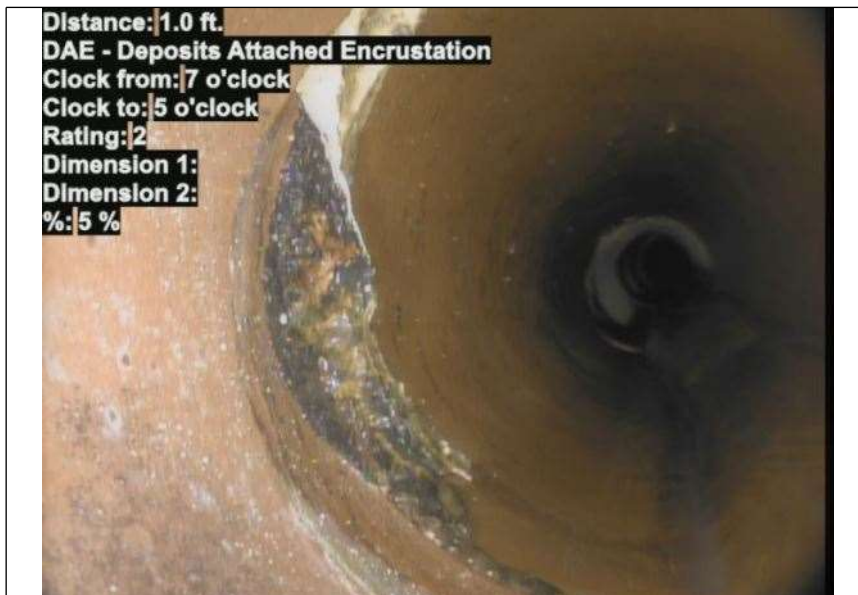
At: 1 ft. 7/5 DAE - Deposits Attached Encrustation
Joint: No 5 %

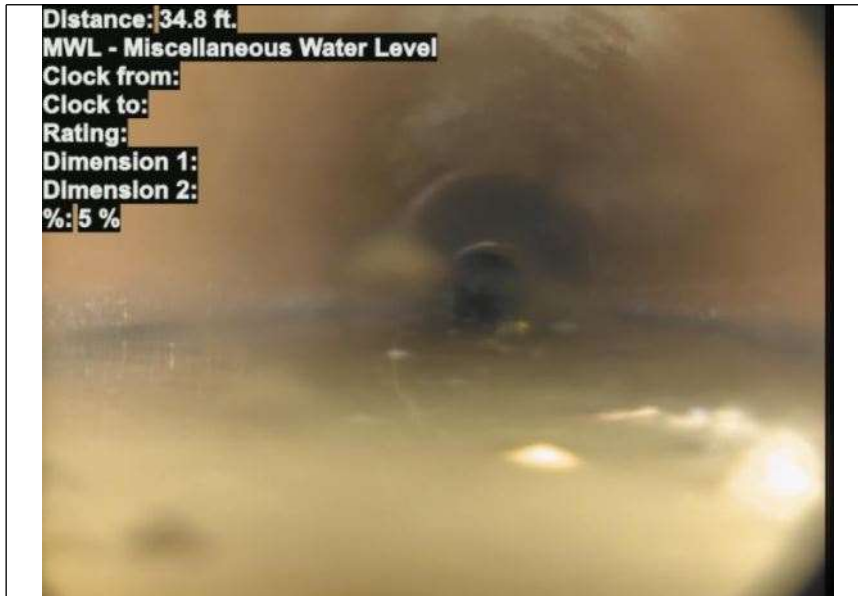
At: 34.8 ft. MWL - Miscellaneous Water Level
 Joint: No 5 %

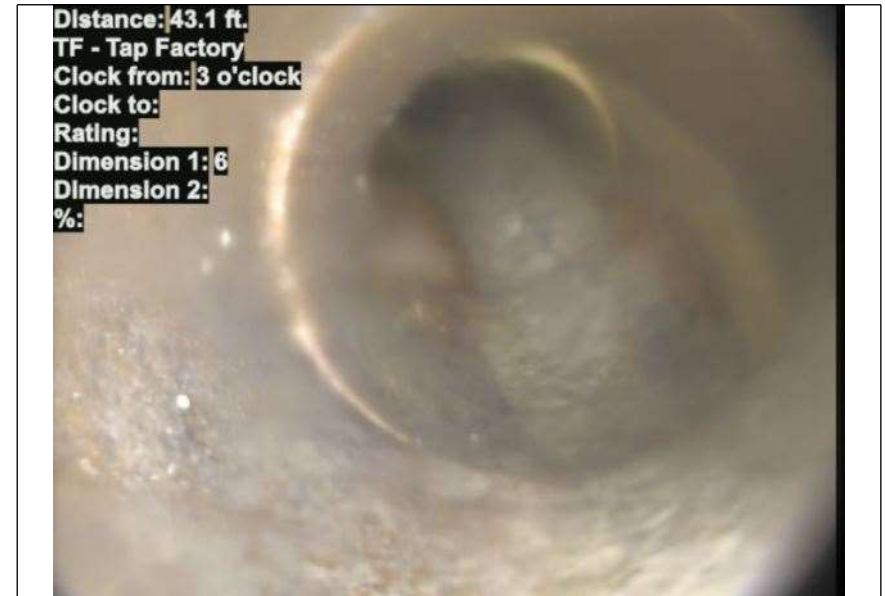
At: 43.1 ft. 3/ TF - Tap Factory
 Joint: No

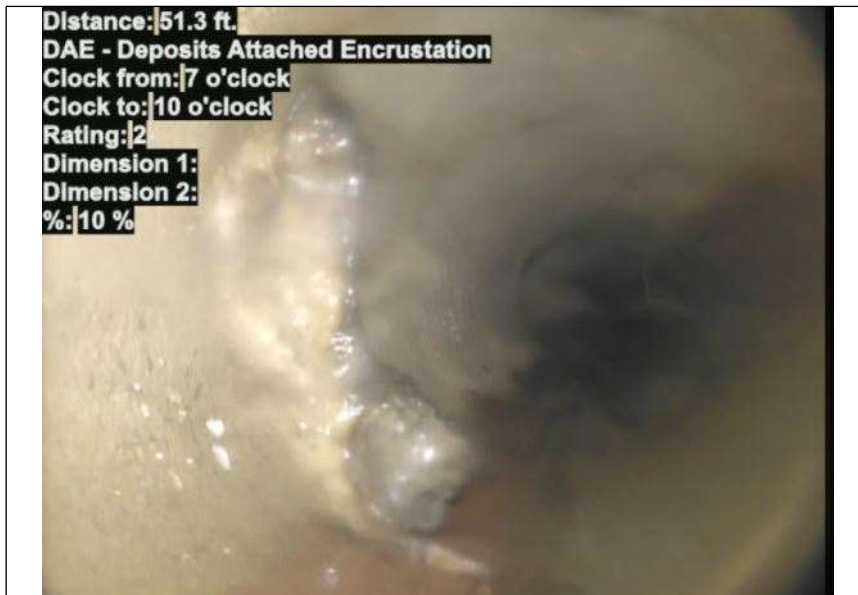
At: 51.3 ft. 7/10 DAE - Deposits Attached Encrustation
 Joint: No 10 %

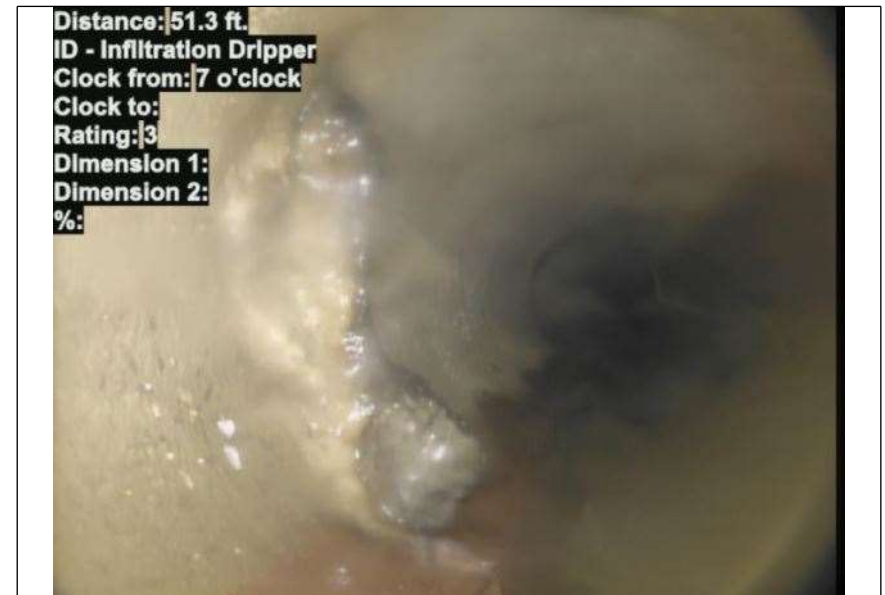
At: 51.3 ft. 7/ ID - Infiltration Dripper
 Joint: No

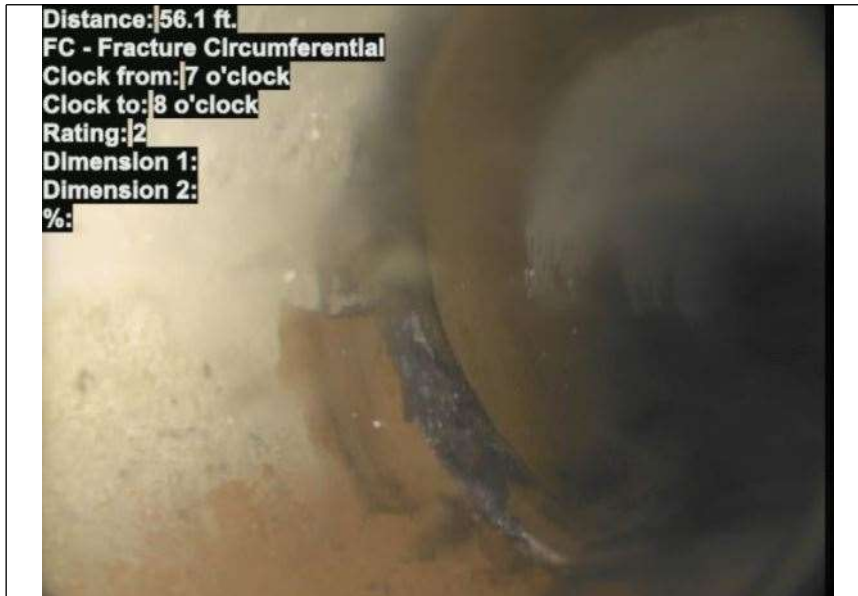
At: 56.1 ft. 7/8 FC - Fracture Circumferential
Joint: No

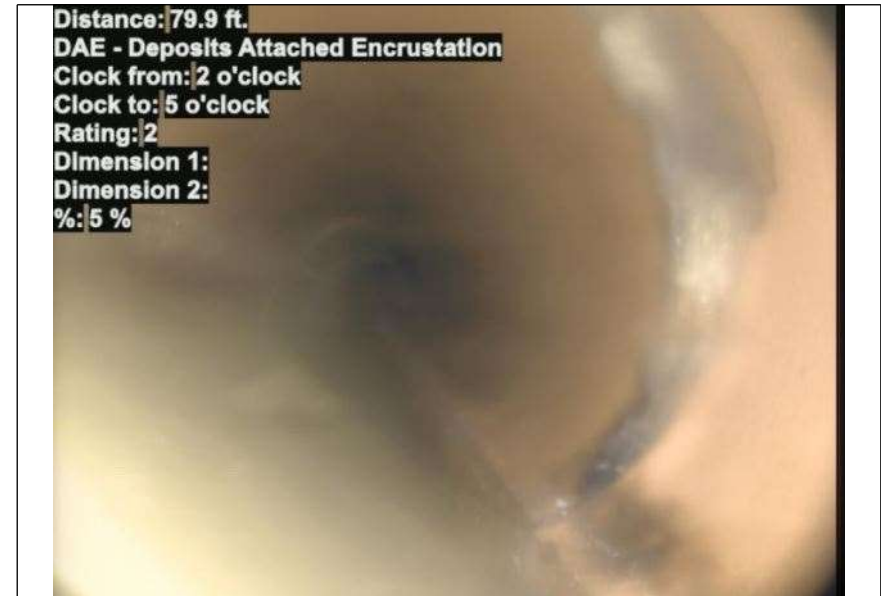
At: 79.9 ft. 2/5 DAE - Deposits Attached Encrustation
Joint: No 5 %

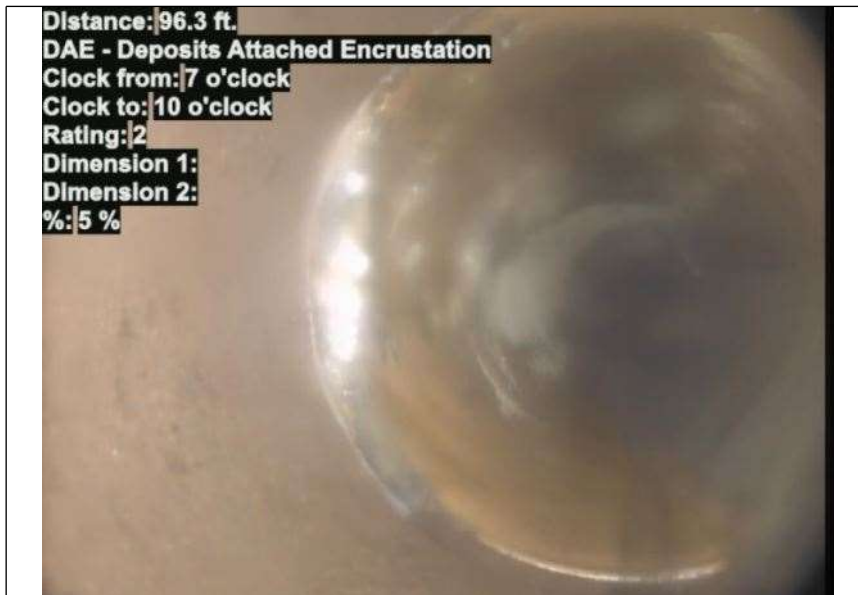
At: 96.3 ft. 7/10 DAE - Deposits Attached Encrustation
Joint: No 5 %

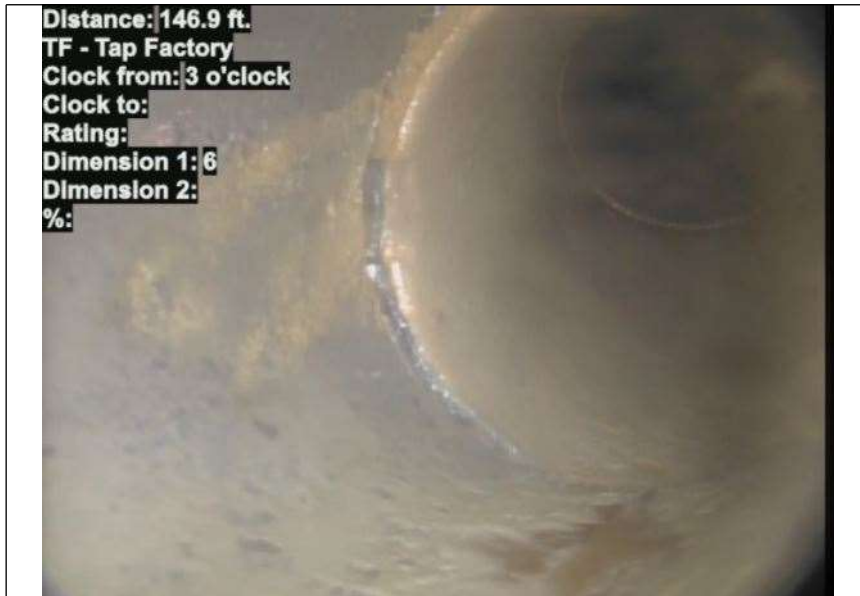
At: 146.9 ft. 3/. TF - Tap Factory
Joint: No

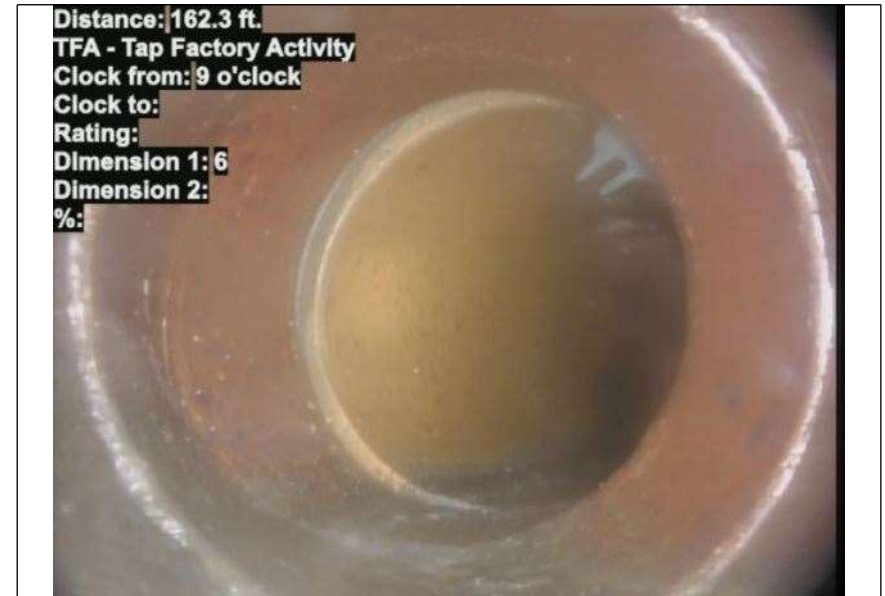
At: 162.3 ft. 9/. TFA - Tap Factory Activity
Joint: No

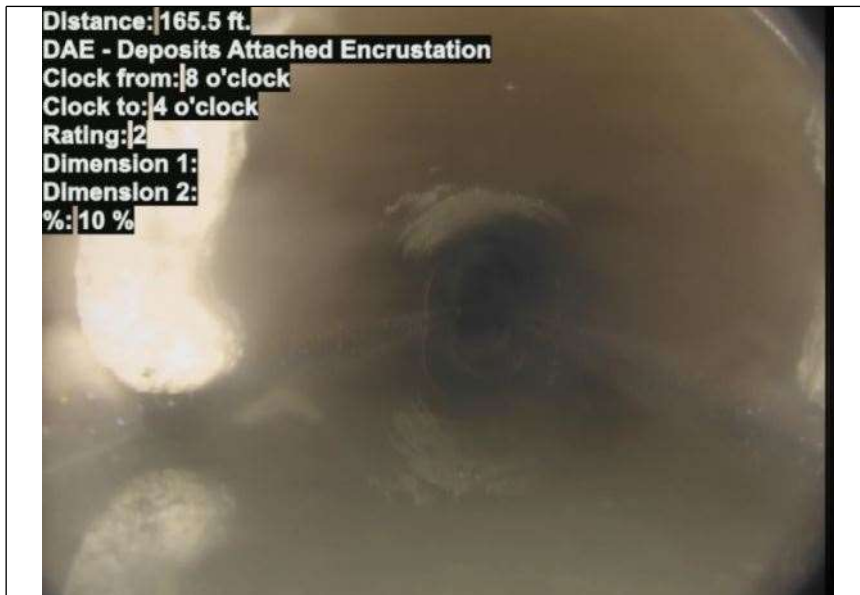
At: 165.5 ft. 8/4 DAE - Deposits Attached Encrustation
Joint: No 10 %

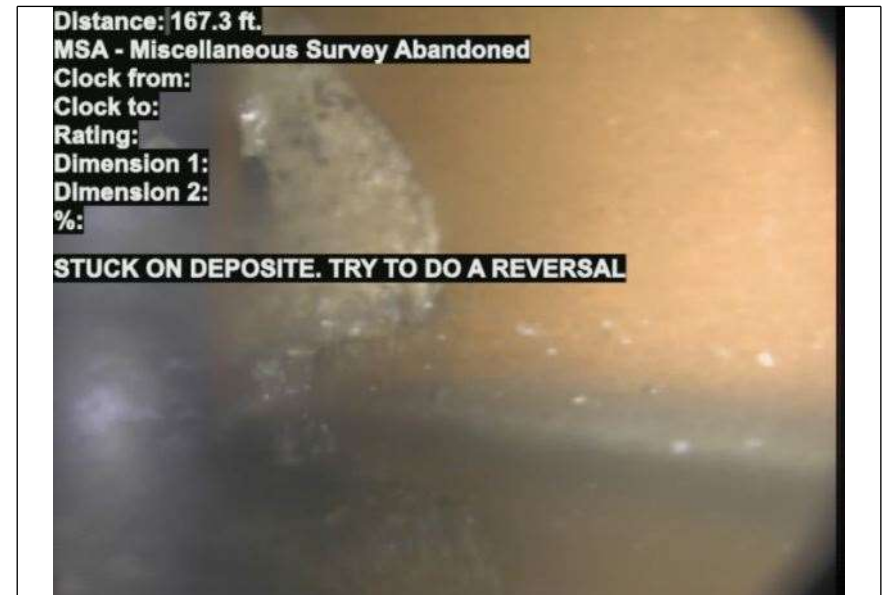
At: 167.4 ft. MSA - Miscellaneous Survey Abandoned
Joint: No **STUCK ON DEPOSITE. TRY TO DO A REVERSAL**
