PACP Report with Pipe Run and Incident Snapshots

Surveyed by: Mike Brooks	Certificate number: Mike Brooks	Owner:	Customer:	Drainage area:	P/O number:	Sheet number:
Pipe segment ref.: SMH053_SMH054	Start date/time: 20220317 12:47	Street: W CENTER ST		City: SMITHVILLE		
Location details: STREET	Upstream MH No: SMH053	Rim to invert:	Grade to invert:	Rim to grade:		
Pipe use: SS	Direction: U	Flow control:	Downstream MH No: SMH054	Rim to invert:	Grade to invert:	Rim to grade:
Height: 8 in.	Width:	Shape: C	Material: VCP	Lining method:	Pipe joint length:	Total length: 358.900 ft.
Length surveyed: 191.500 ft.	Purpose: F	Sewer category:	Media label:	PreCleaning: L	Date cleaned:	Weather:
Location code:	Pressure value:					
Project name: Sewer Cleaning & CCTV - Project No. 210670	Additional info:

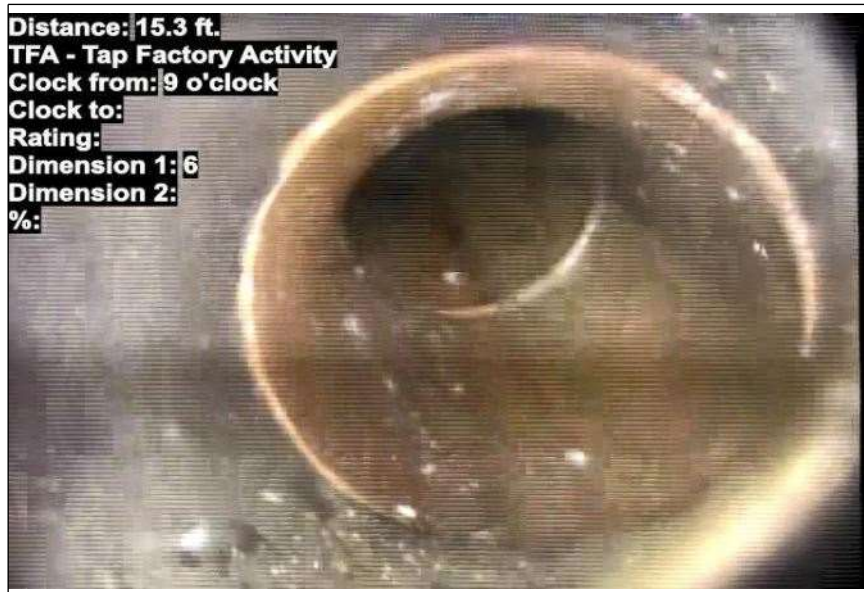
At: 15.3 ft. 9/. TFA - Tap Factory Activity
 Joint: No

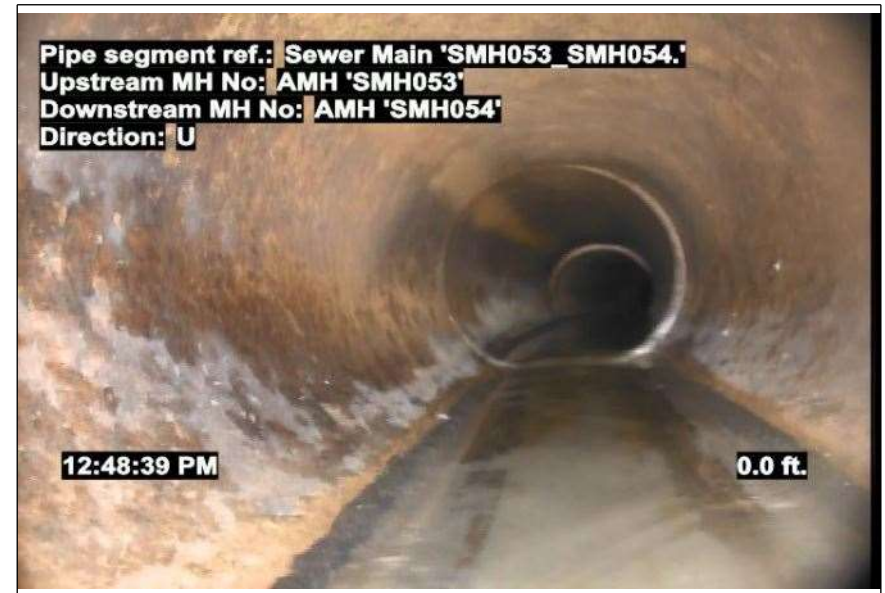
At: 0 ft. MWL - Miscellaneous Water Level
 Joint: No 5 %

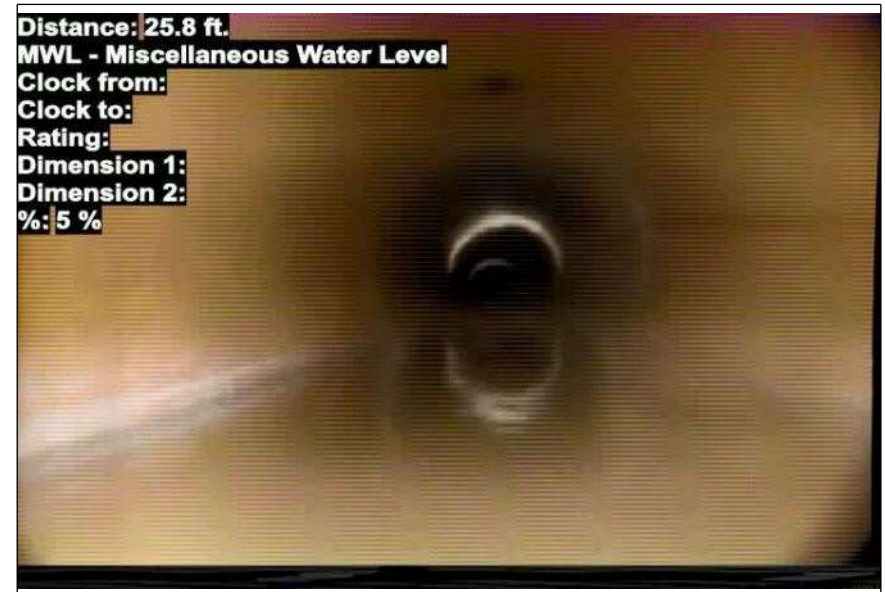
At: 25.8 ft. MWL - Miscellaneous Water Level
 Joint: No 5 %

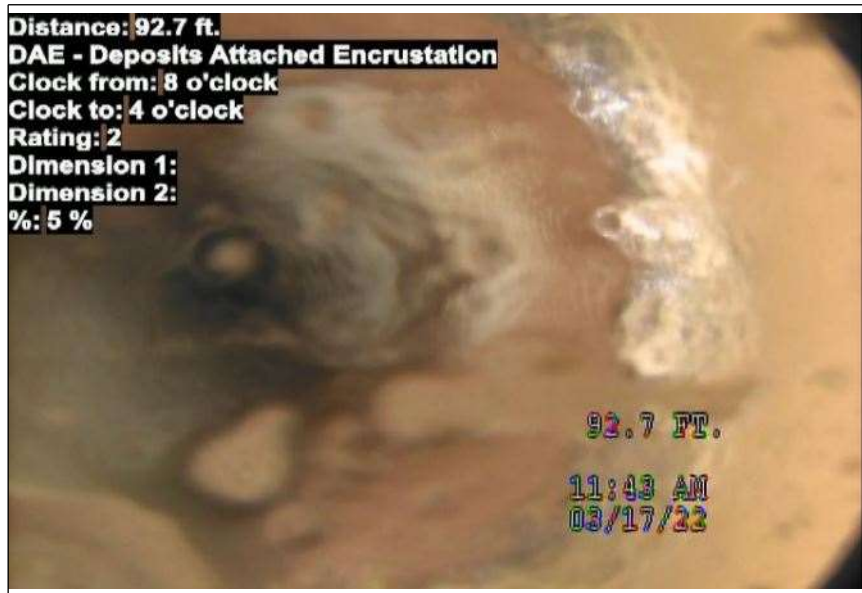
At: 92.7 ft. 8/4 DAE - Deposits Attached Encrustation
Joint: No 5 %

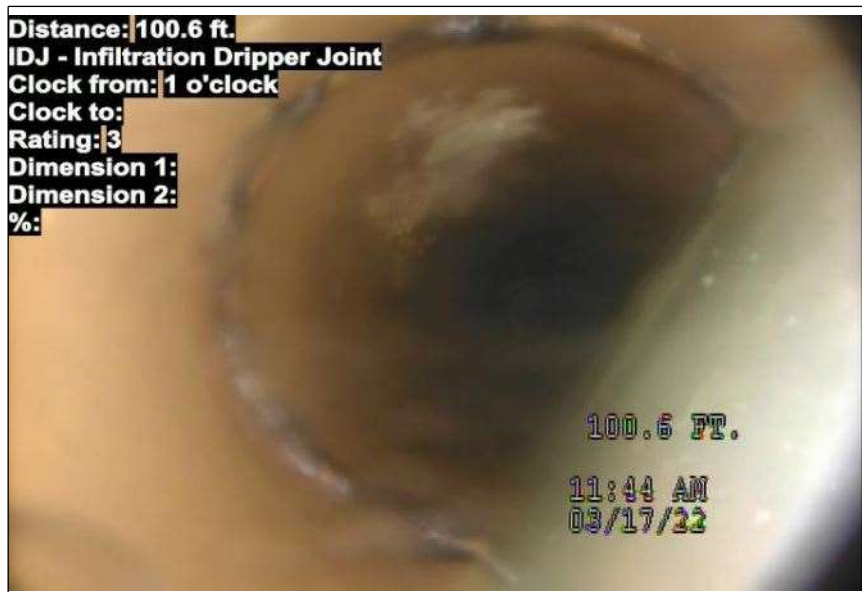
At: 100.6 ft. 1/. IDJ - Infiltration Dripper Joint
Joint: Yes

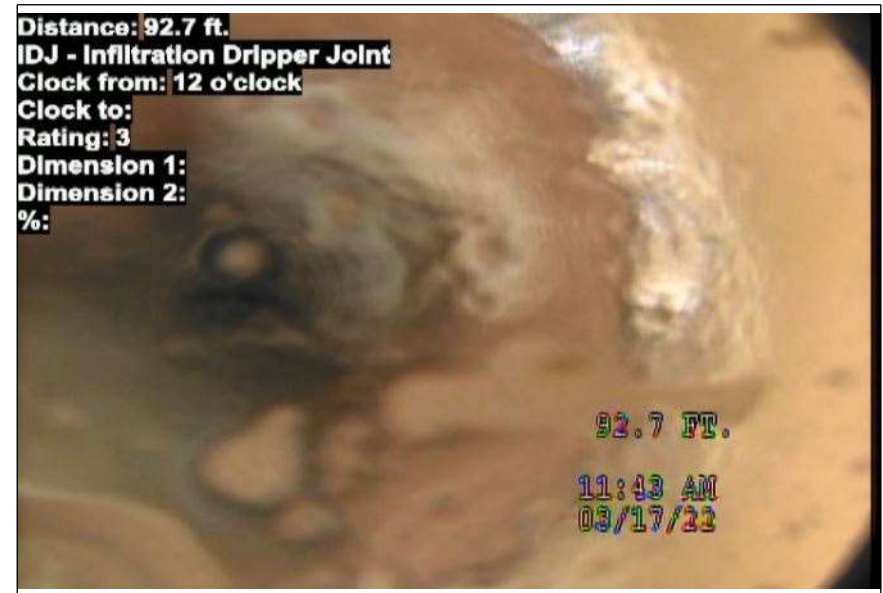
At: 92.7 ft. 12/. IDJ - Infiltration Dripper Joint
Joint: Yes

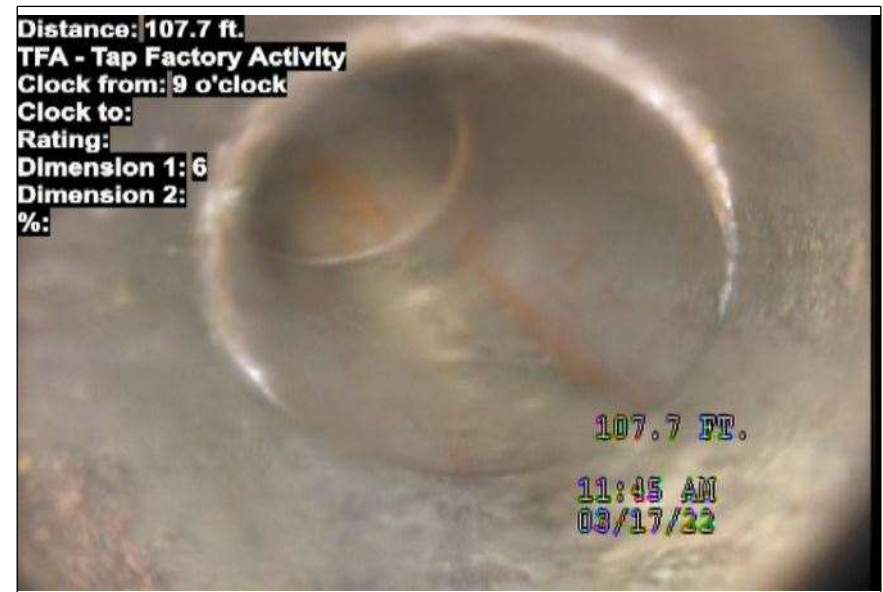
At: 107.7 ft. 9/. TFA - Tap Factory Activity
Joint: No

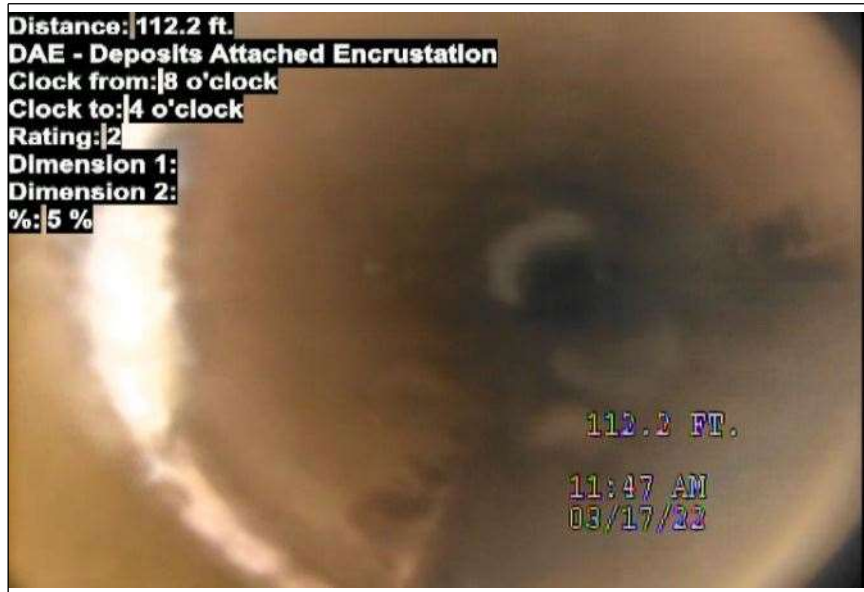
At: 112.2 ft. 8/4 DAE - Deposits Attached Encrustation
Joint: No 5 %

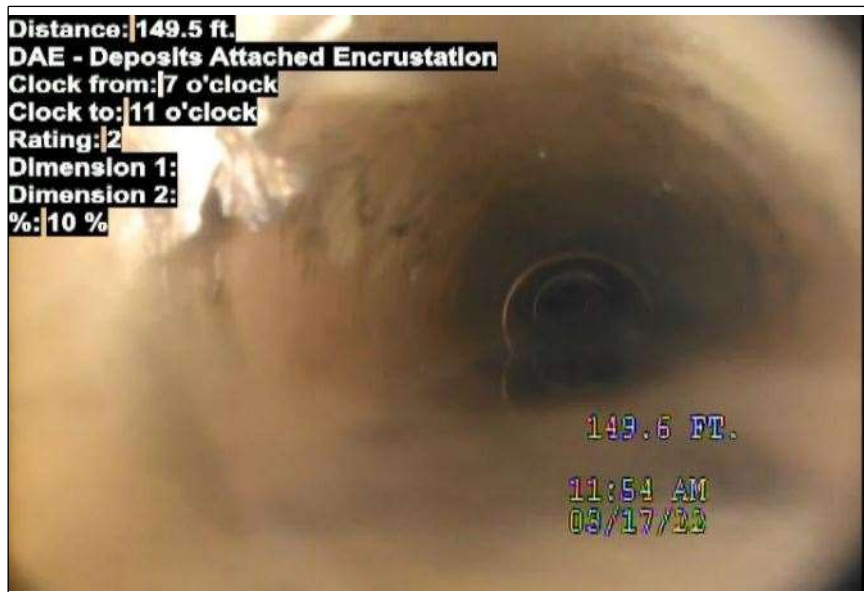
At: 149.5 ft. DAE - Deposits Attached Encrustation
7/11
Joint: No 10 %

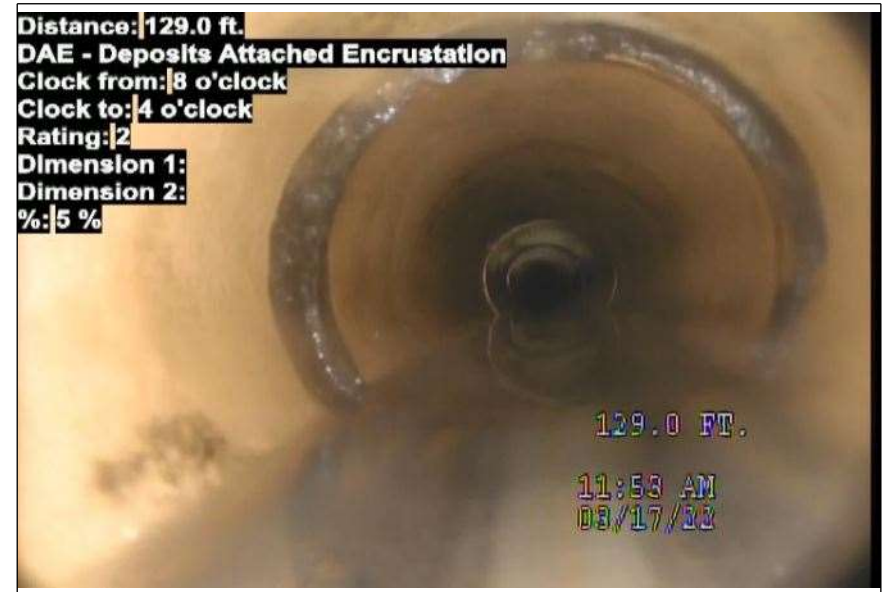
At: 129 ft. 8/4 DAE - Deposits Attached Encrustation
Joint: No 5 %

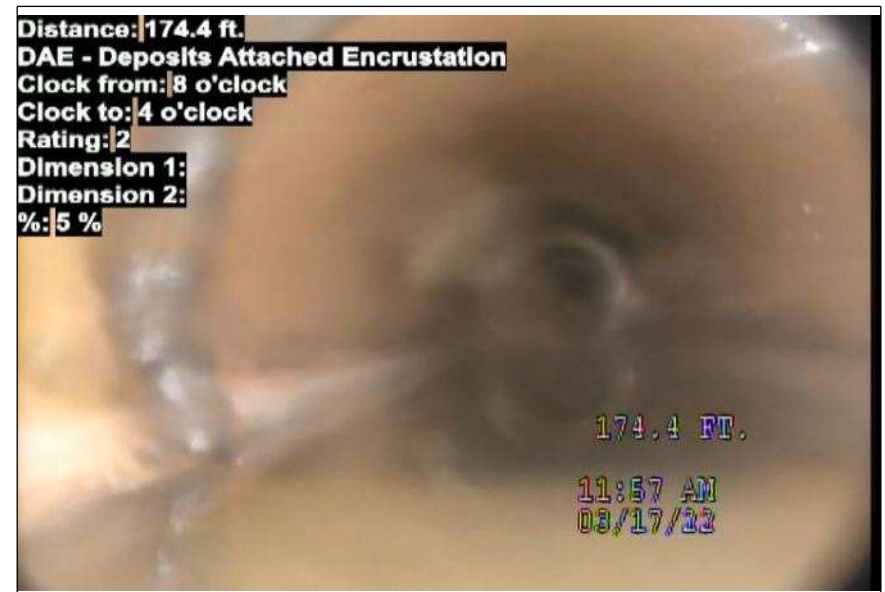
At: 174.4 ft. 8/4 DAE - Deposits Attached Encrustation
Joint: No 5 %

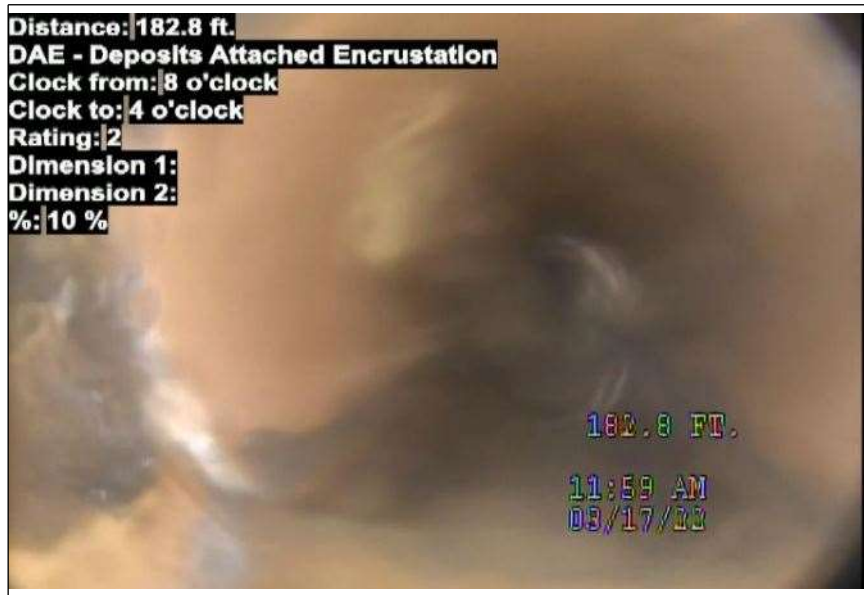
At: 182.8 ft. 8/4 DAE - Deposits Attached Encrustation
Joint: No 10 %

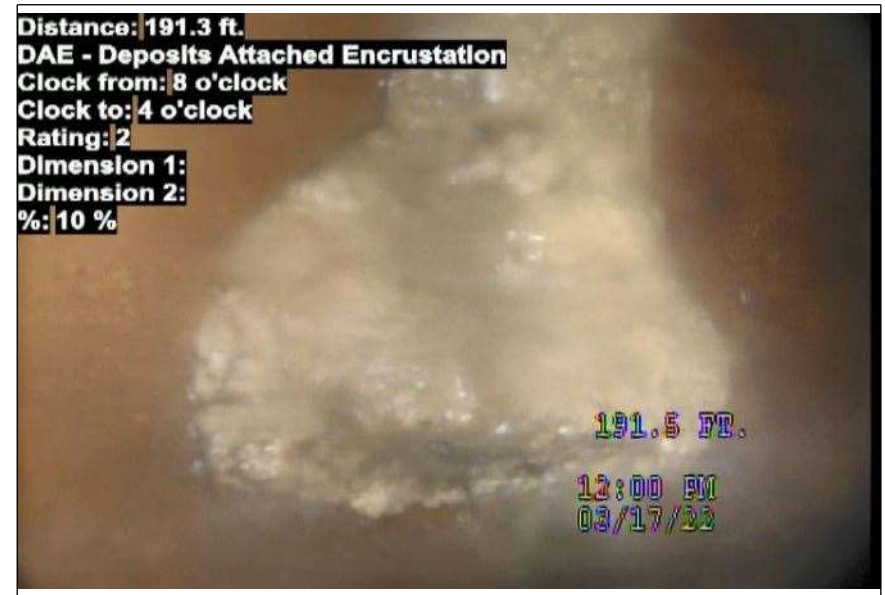
At: 191.3 ft. 8/4 DAE - Deposits Attached Encrustation
Joint: No 5 %
