PACP Report with Pipe Run and Incident Snapshots

Surveyed by: Mike Brooks		Certificate number: Mike Brooks		Owner:		Customer:		Drainage area:		P/O number:		Sheet number:	
Pipe segment ref.: SMH054A_SMH055				Start date/time: 20220318 09:01		Street: W CENTER ST				City: SMITHVILLE			
Location details: STREET				Upstream MH No: SMH054A				Rim to invert:		Grade to invert:		Rim to grade:	
Pipe use: SS		Direction: D		Flow control:		Downstream MH No: SMH055				Rim to invert:		Grade to invert:	
Height: 8 in.		Width:		Shape: C		Material: VCP		Lining method:		Pipe joint length:		Total length: 365.500 ft.	
Length surveyed: 365.500 ft.		Purpose:		Sewer category:		Media label:		PreCleaning: L		Date cleaned:		Weather: 1	
Project name: Sewer Cleaning & CCTV - Project No. 210670				Additional info:

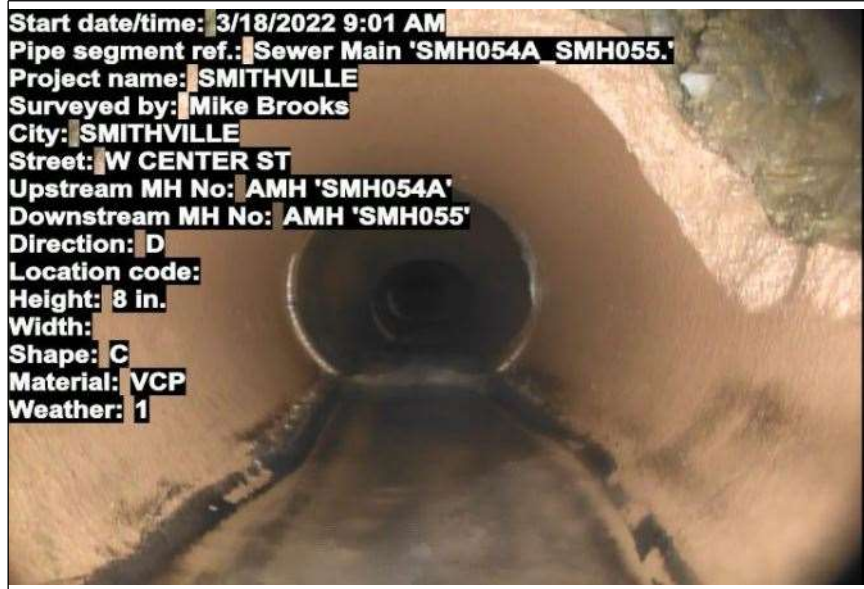
At: 0 ft. AMH - Manhole
 Joint: No SMH054A

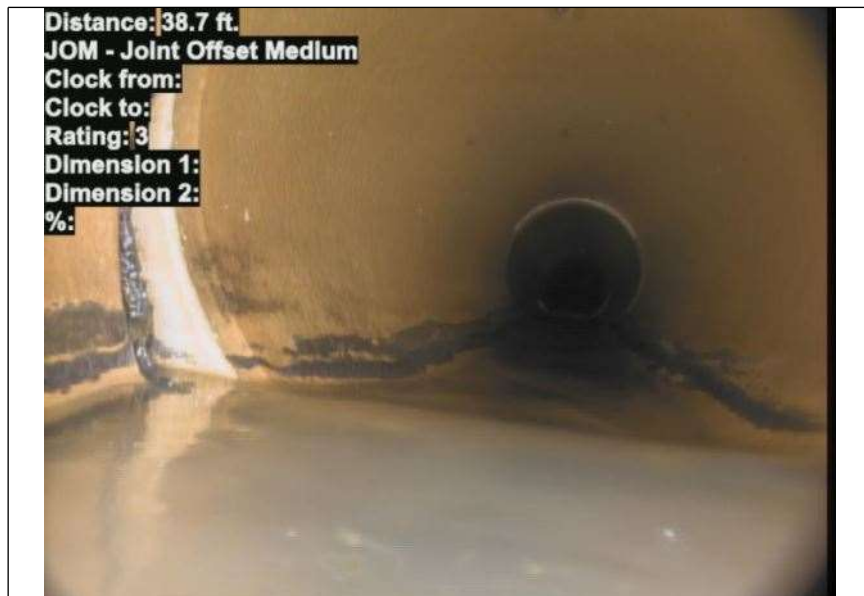
At: 38.7 ft. JOM - Joint Offset Medium
 Joint: No

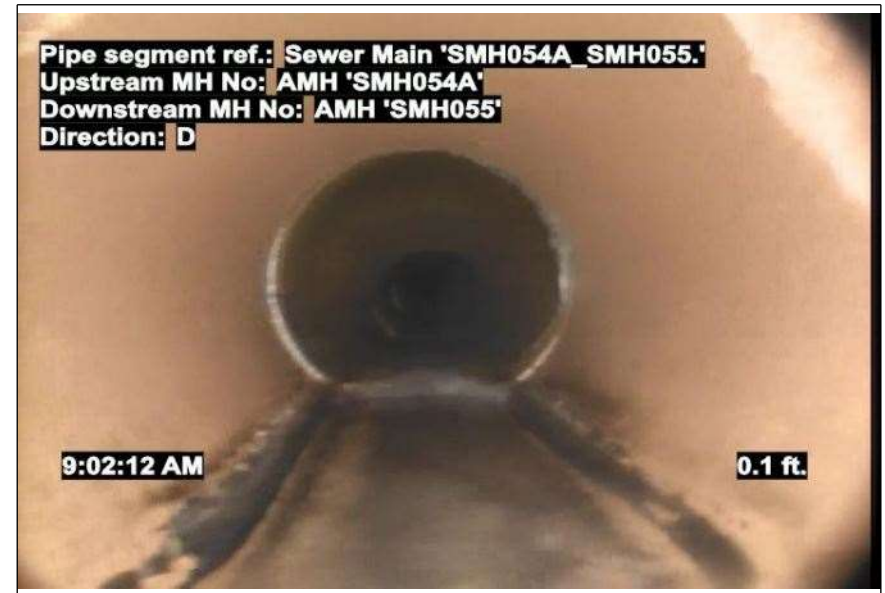
At: 0 ft. MWL - Miscellaneous Water Level
 Joint: No 5 %

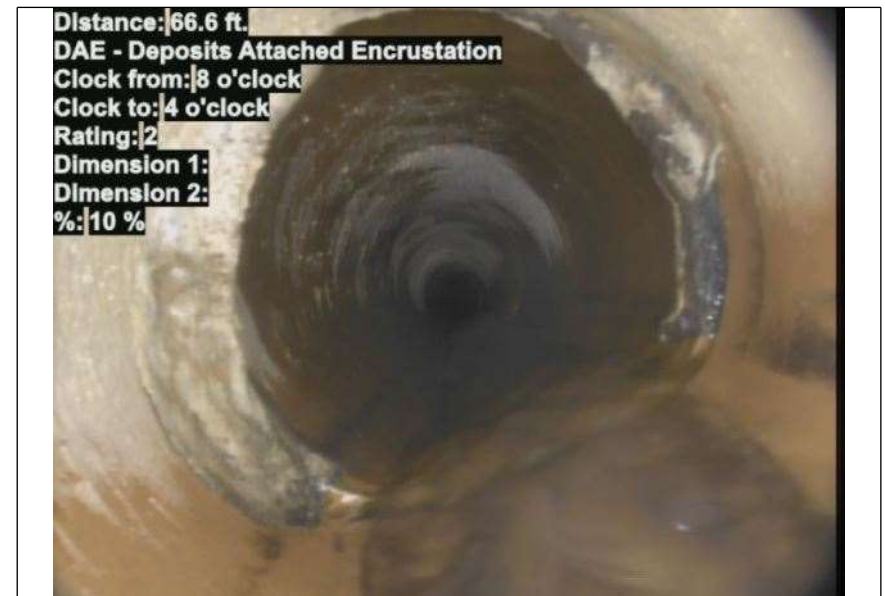
At: 66.6 ft. 8/4 DAE - Deposits Attached Encrustation
 Joint: No 10 %

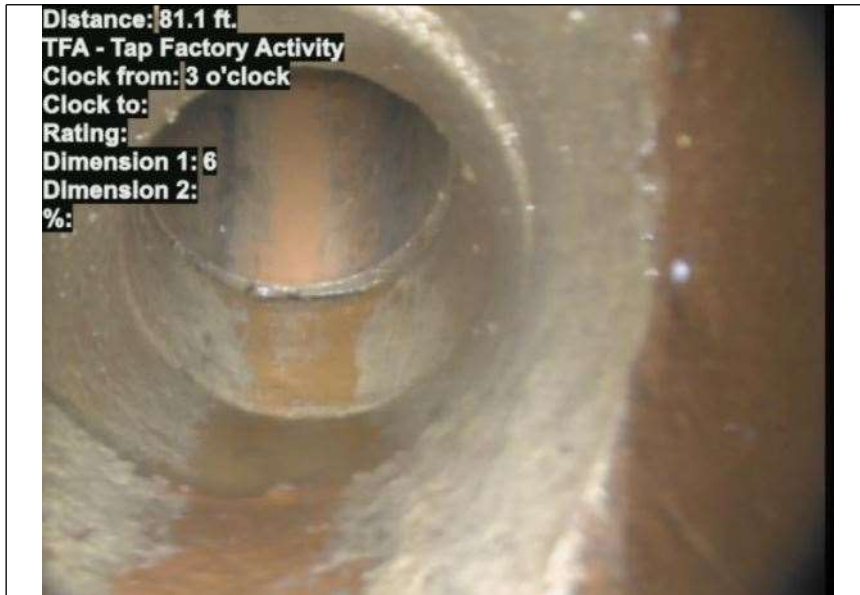
At: 81.1 ft. 3/ TFA - Tap Factory Activity
Joint: No

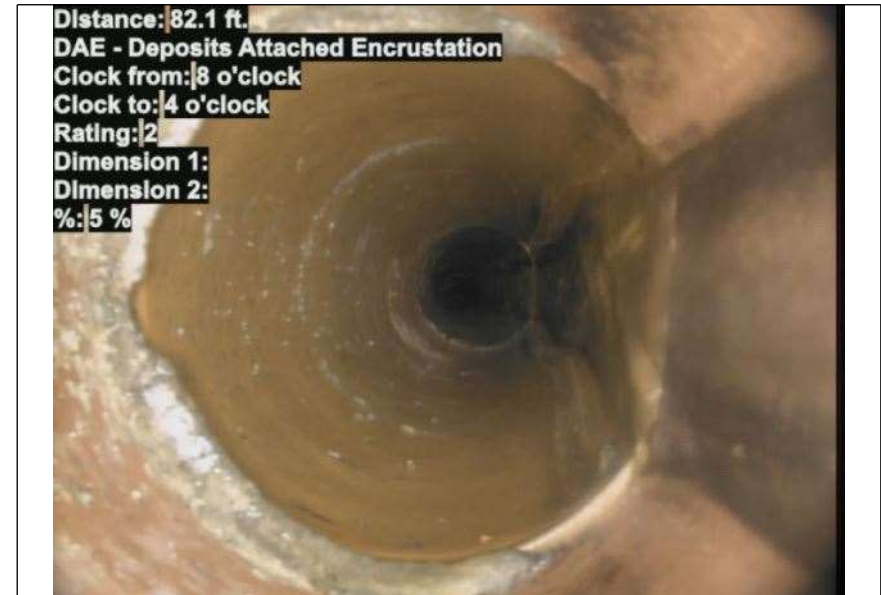
At: 82.1 ft. 8/4 DAE - Deposits Attached Encrustation
Joint: No 5 %

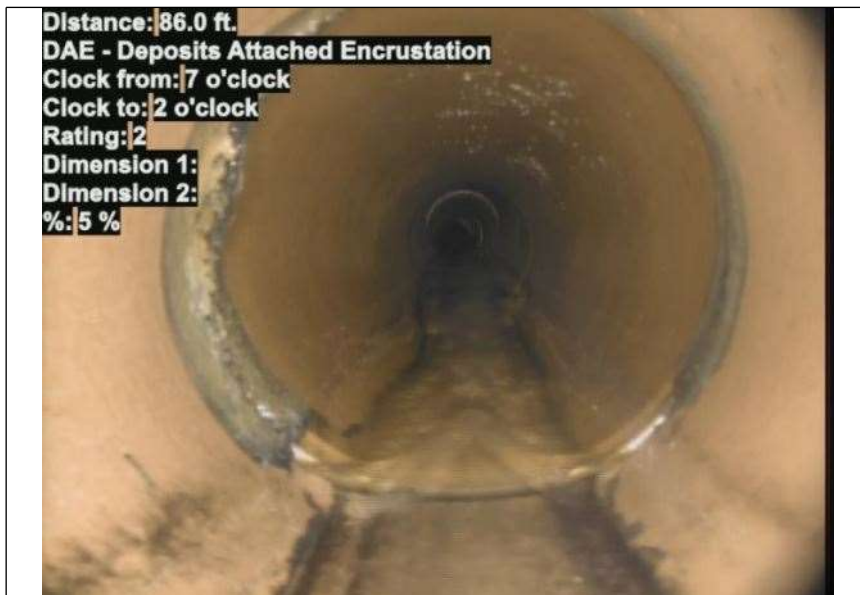
At: 86 ft. 7/2 DAE - Deposits Attached Encrustation
Joint: No 5 %

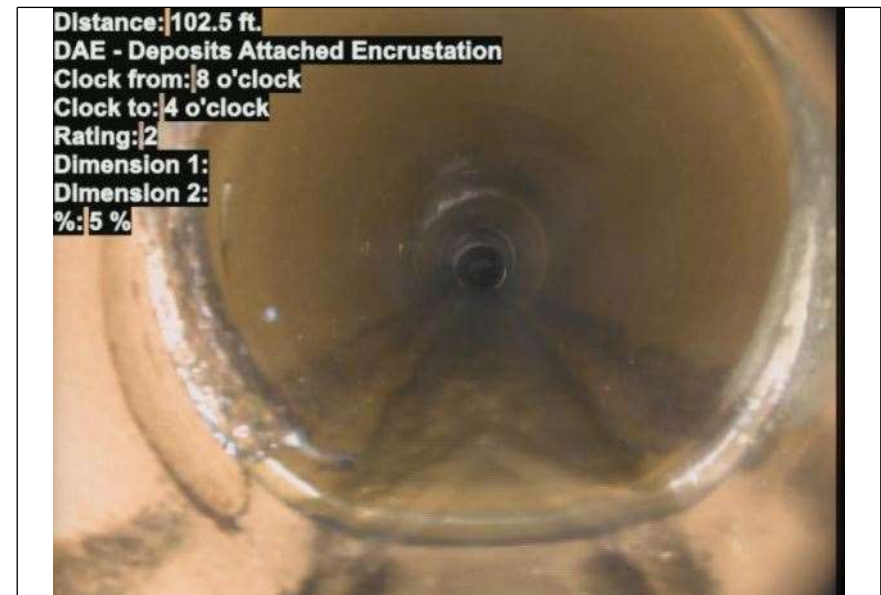
At: 102.5 ft. 8/4 DAE - Deposits Attached Encrustation
Joint: No 5 %

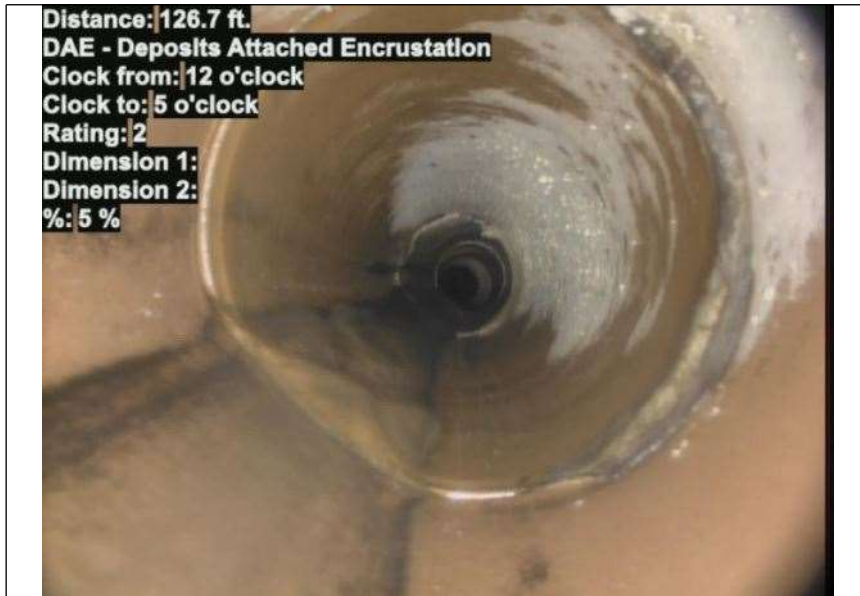
At: 126.7 ft. DAE - Deposits Attached Encrustation
12/5

Joint: No 5 %

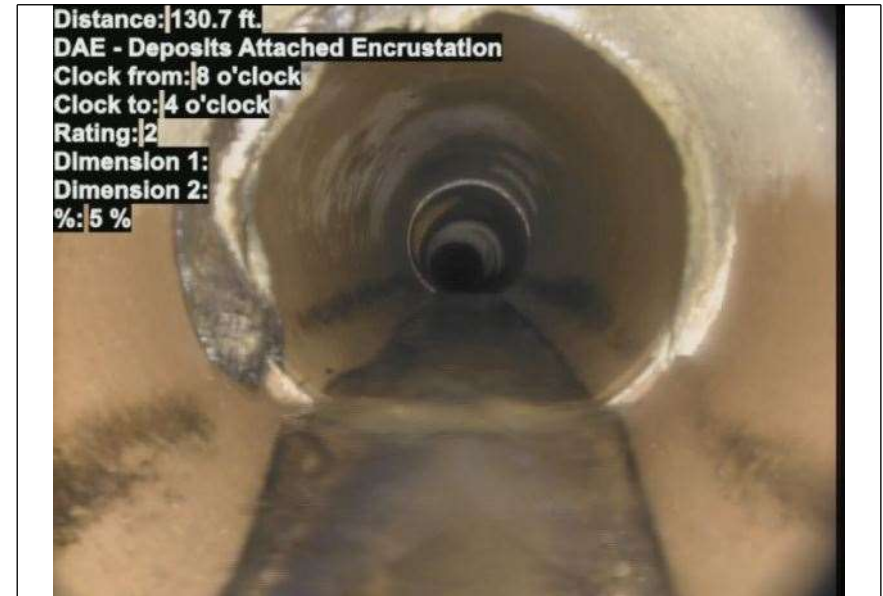
At: 130.7 ft. 8/4 DAE - Deposits Attached Encrustation

Joint: No 5 %

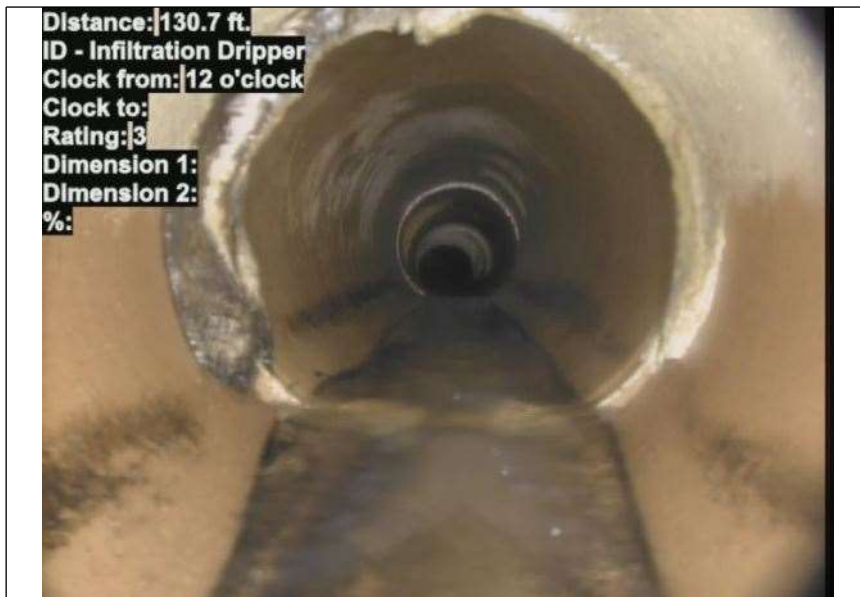
At: 130.7 ft. 12/ ID - Infiltration Dripper

Joint: Yes

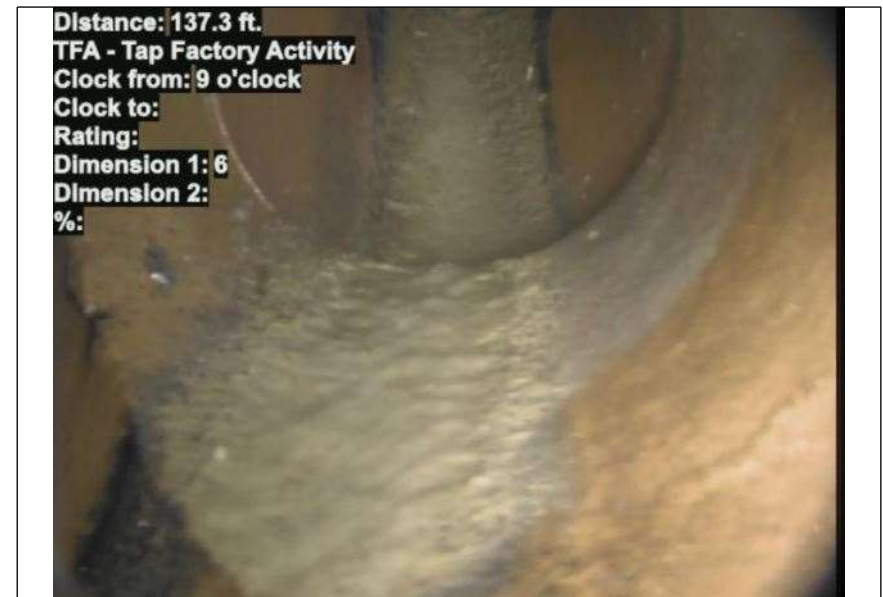
At: 137.3 ft. 9/ TFA - Tap Factory Activity

Joint: No

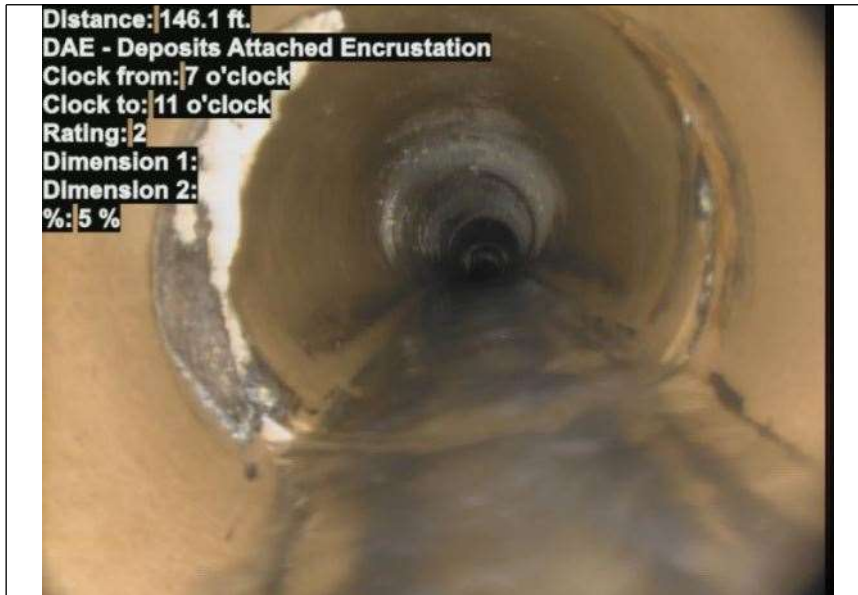
At: 146.1 ft. DAE - Deposits Attached Encrustation
7/11

Joint: No 5 %

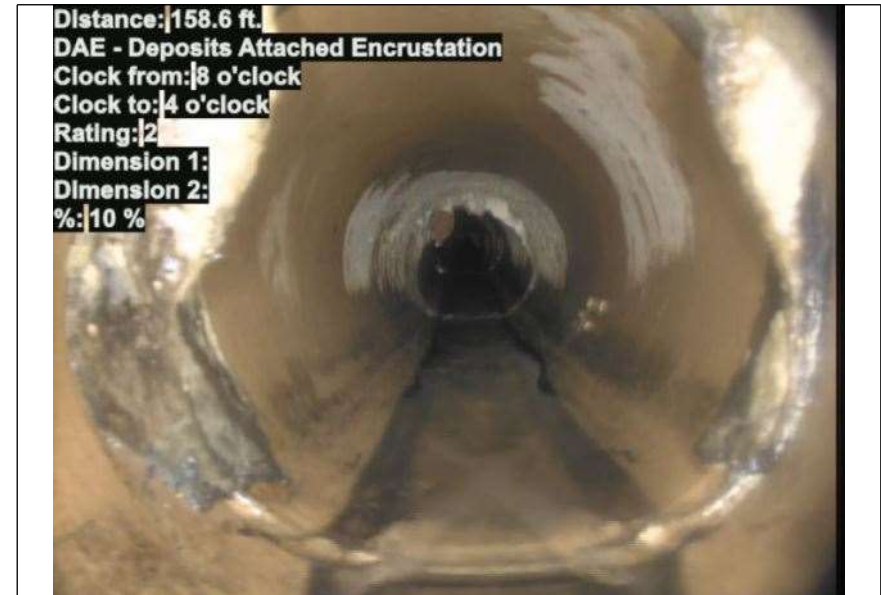
At: 158.6 ft. 8/4 DAE - Deposits Attached Encrustation

Joint: No 10 %

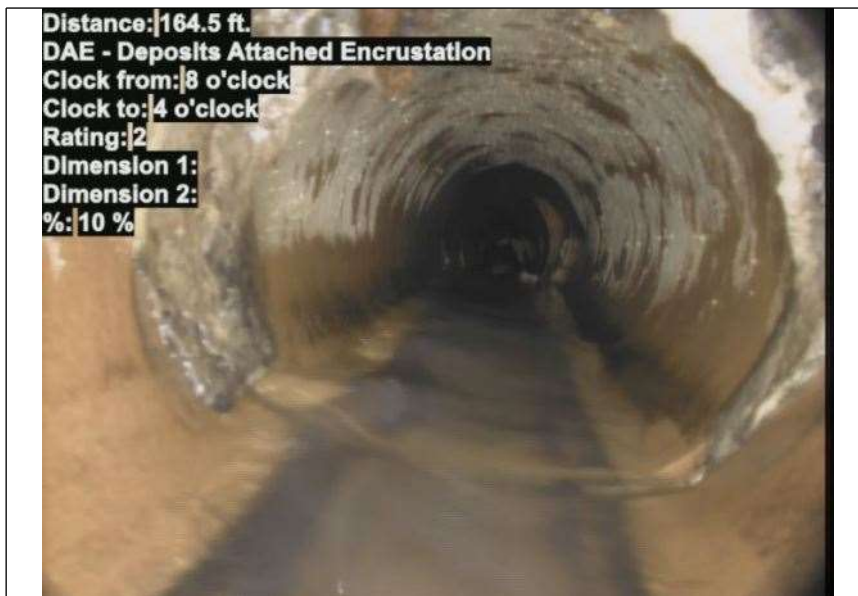
At: 164.5 ft. 8/4 DAE - Deposits Attached Encrustation

Joint: No 10 %

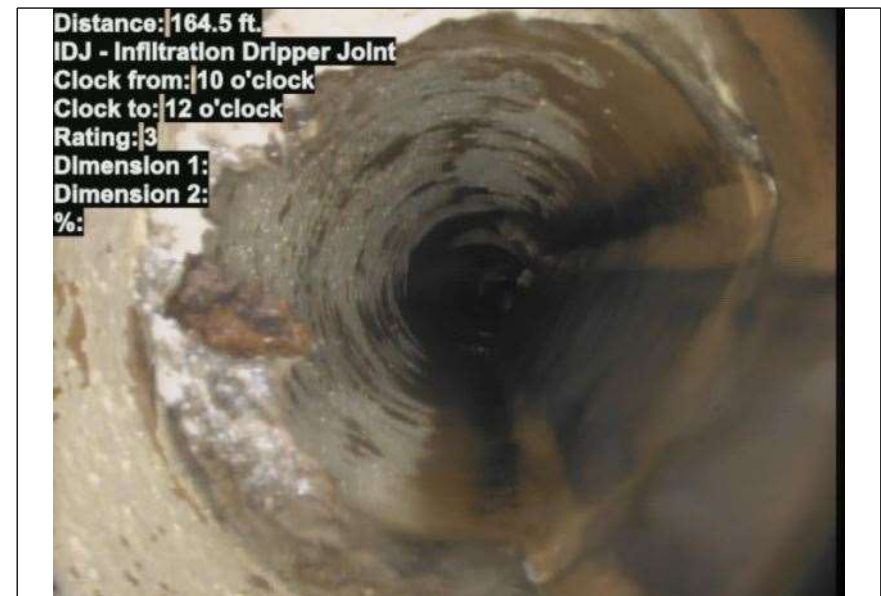
At: 164.5 ft. IDJ - Infiltration Dripper Joint
10/12

Joint: Yes

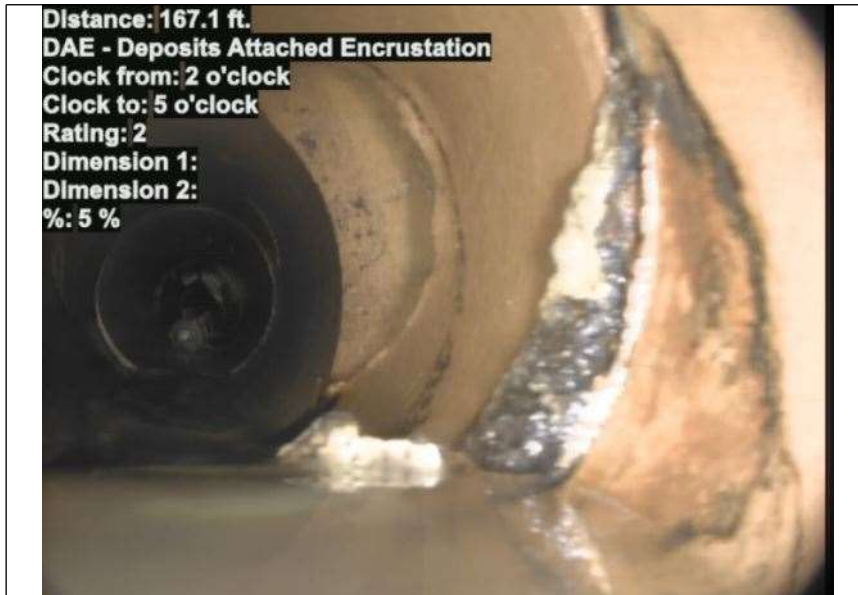
At: 167.1 ft. 2/5 DAE - Deposits Attached Encrustation
Joint: No 5 %

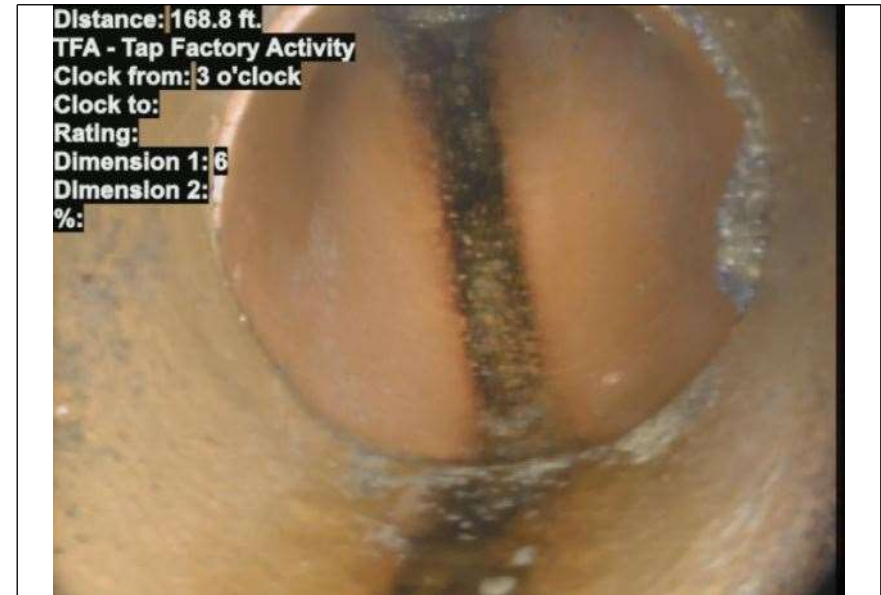
At: 168.8 ft. 3/. TFA - Tap Factory Activity
Joint: No

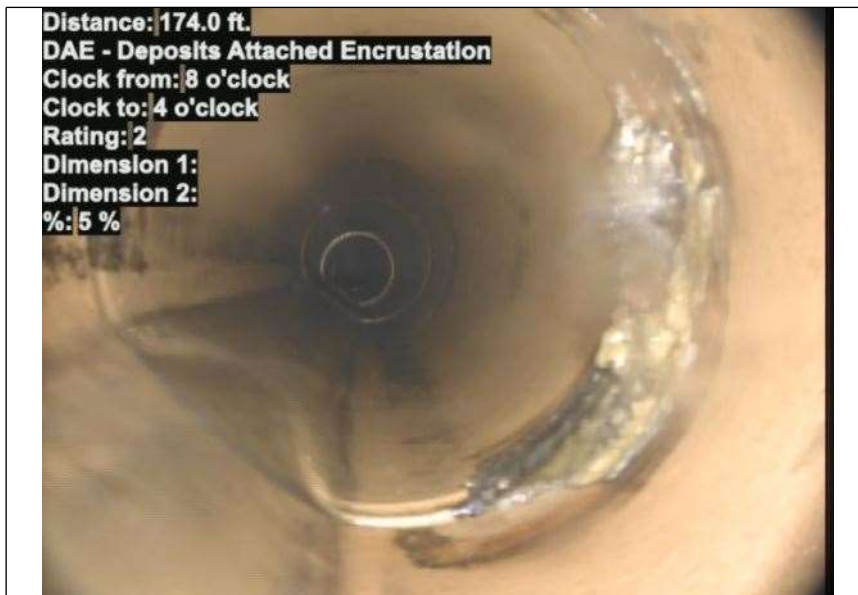
At: 174 ft. 8/4 DAE - Deposits Attached Encrustation
Joint: No 5 %

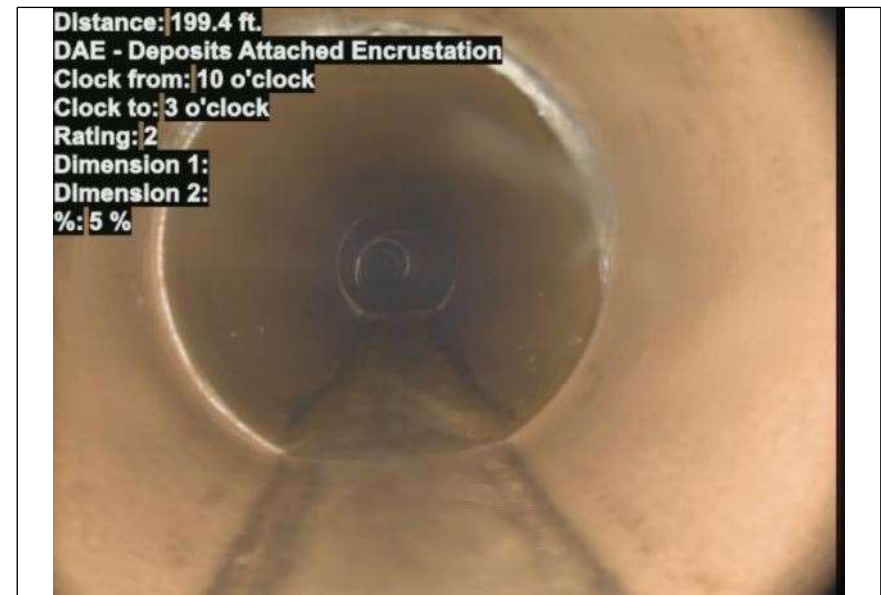
At: 199.4 ft. 10/3 DAE - Deposits Attached Encrustation
Joint: No 5 %

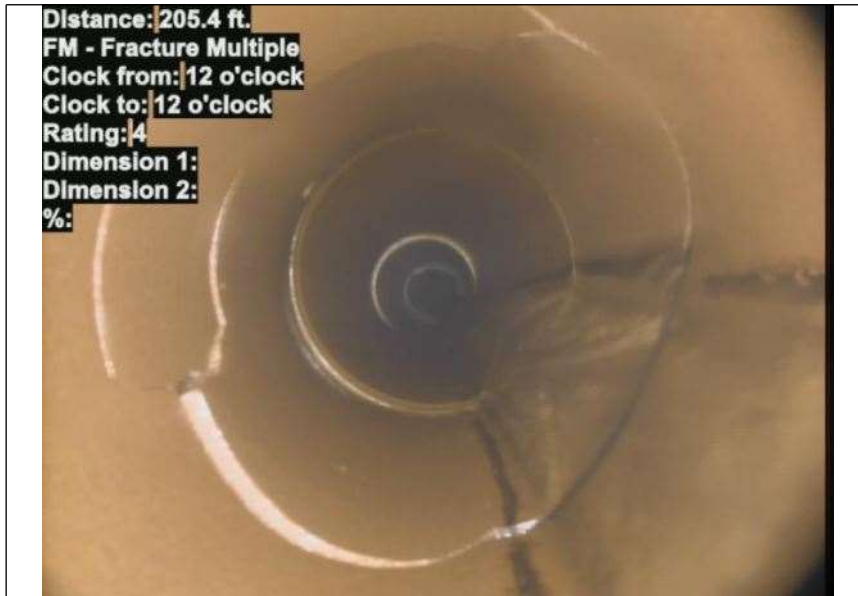
At: 205.4 ft. FM - Fracture Multiple
12/12

Joint: No

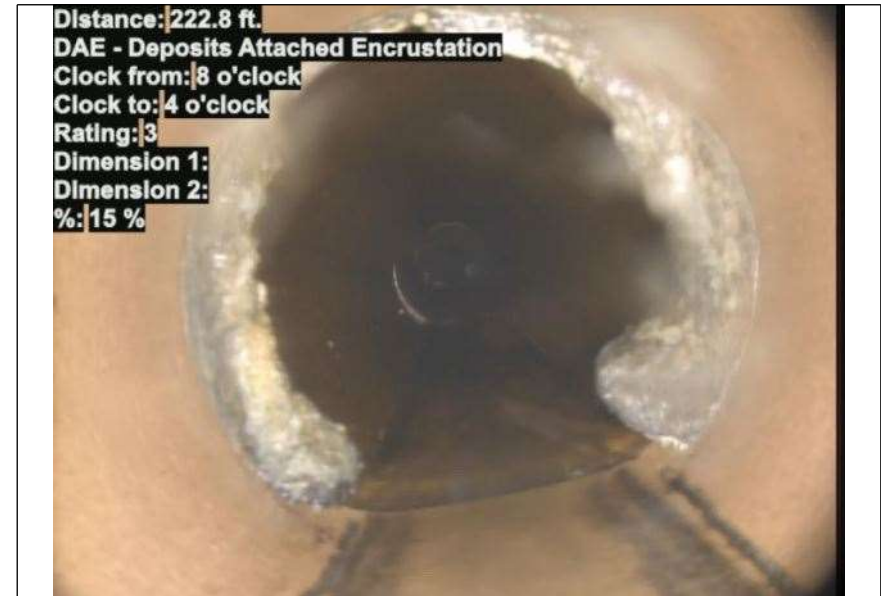
At: 222.8 ft. 8/4 DAE - Deposits Attached Encrustation

Joint: No 15 %

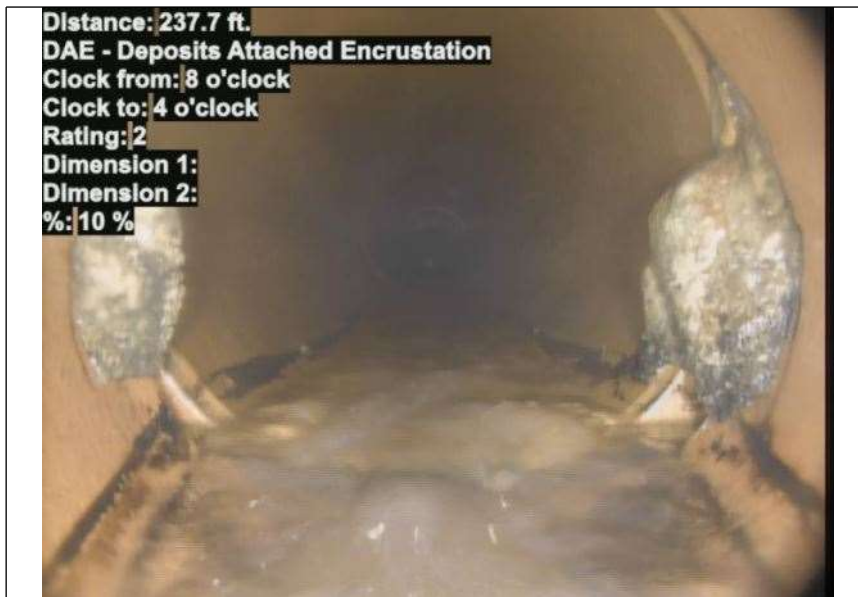
At: 237.7 ft. 8/4 DAE - Deposits Attached Encrustation

Joint: No 10 %

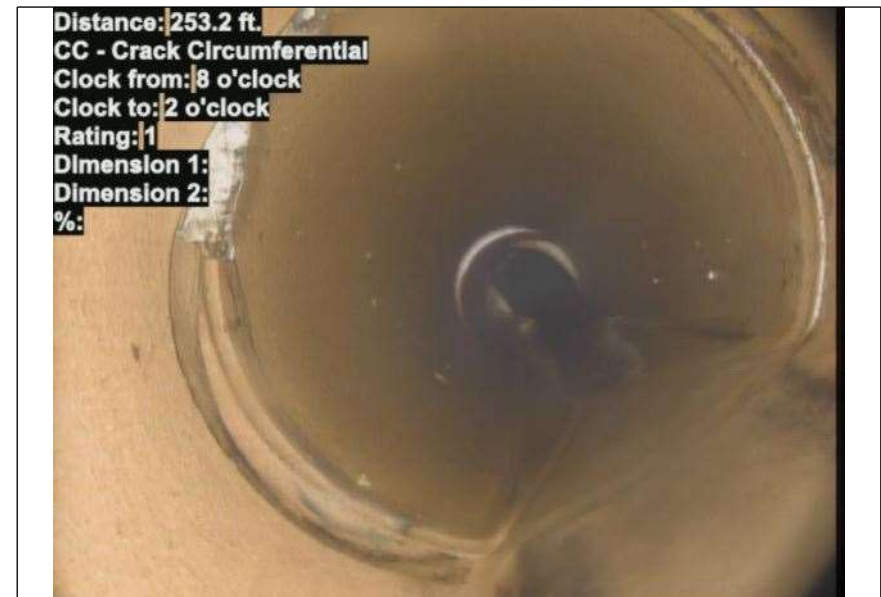
At: 253.2 ft. 8/2 CC - Crack Circumferential

Joint: No

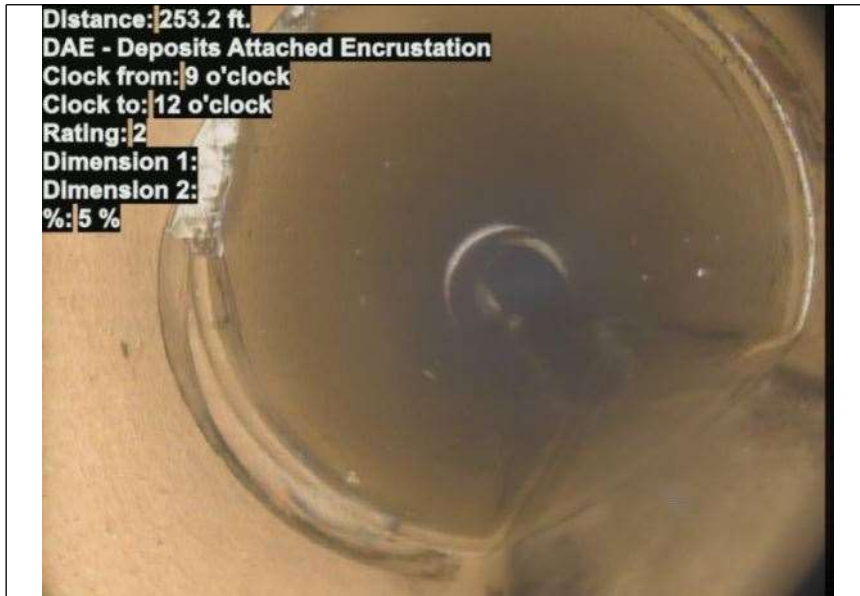
At: 253.2 ft. DAE - Deposits Attached Encrustation
9/12

Joint: No 5 %

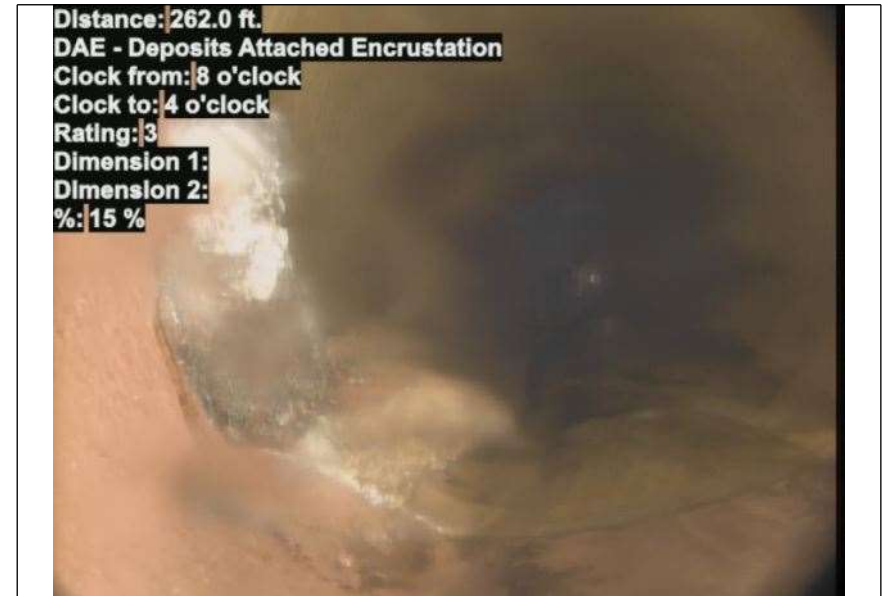
At: 262 ft. 8/4 DAE - Deposits Attached Encrustation

Joint: No 15 %

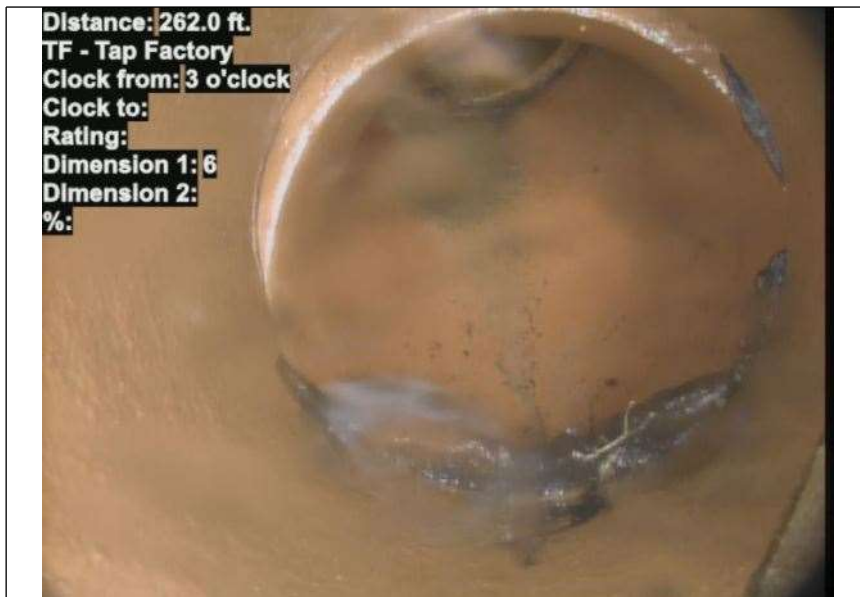
At: 262 ft. 3/. TF - Tap Factory

Joint: No

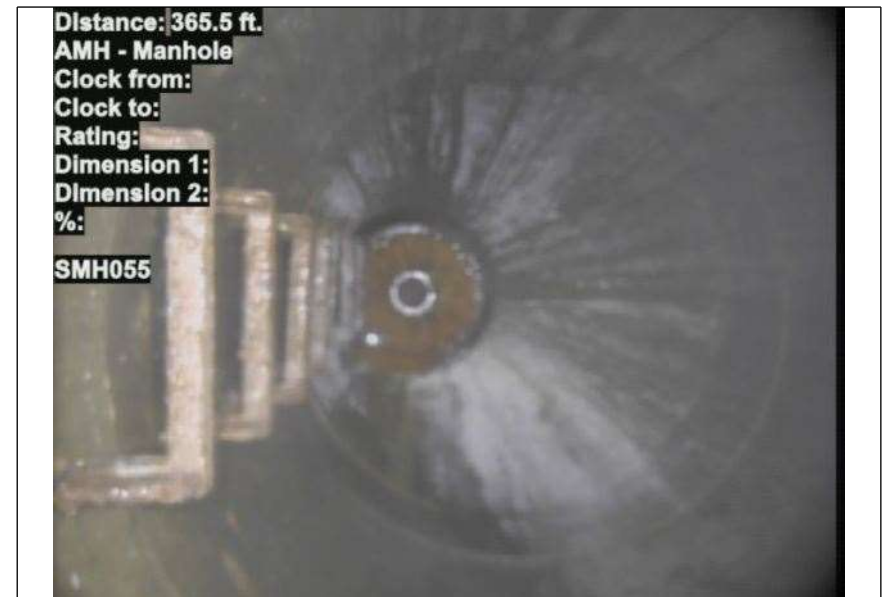
At: 365.5 ft. AMH - Manhole

Joint: No SMH055

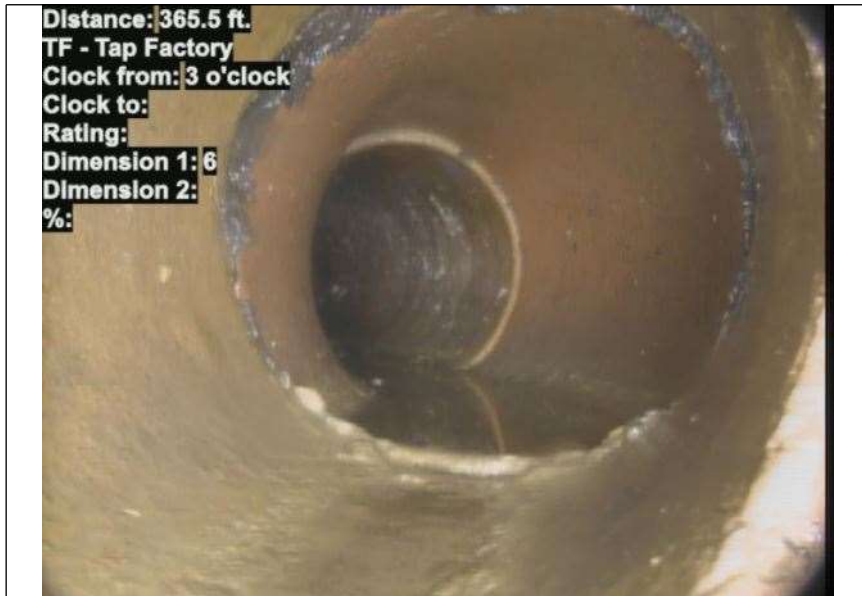
At: 365.5 ft. 3/. TF - Tap Factory

Joint: No
