## PACP Report with Pipe Run and Incident Snapshots

Surveyed by: <b>Mike Brooks</b>	Certificate number: <b>Mike Brooks</b>	Owner:	Customer:	Drainage area:	P/O number:	Sheet number:
Pipe segment ref.: <b>SMH054_SMH054A</b>	Start date/time: <b>20220317 13:34</b>	Street: <b>W CENTER ST</b>	City: <b>SMITHVILLE</b>			
Location details: <b>STREET</b>	Upstream MH No: <b>SMH054</b>	Rim to invert:	Grade to invert:	Rim to grade:		
Pipe use: <b>SS</b>	Direction: <b>D</b>	Flow control:	Downstream MH No: <b>SMH054A</b>	Rim to invert:	Grade to invert:	Rim to grade:
Height: <b>8 in.</b>	Width:	Shape: <b>C</b>	Material: <b>VCP</b>	Lining method:	Pipe joint length:	Total length: <b>300.900 ft.</b>
Media label:	PreCleaning: <b>L</b>	Date cleaned:	Weather: <b>1</b>	Length surveyed: <b>300.900 ft.</b>	Purpose:	Sewer category:
Project name: <b>Sewer Cleaning &amp; CCTV - Project No. 210670</b>	Additional info:

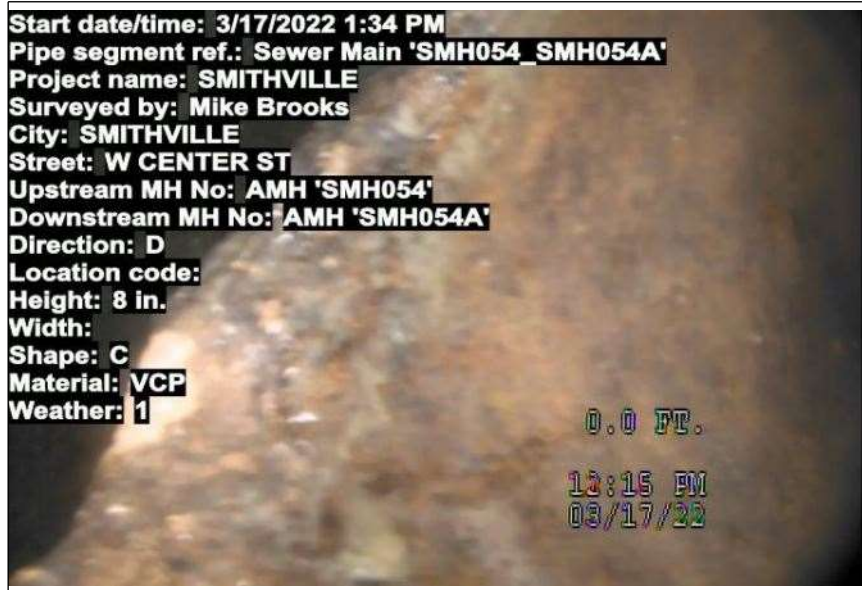
At: 0 ft. AMH - Manhole  
 Joint: No SMH054

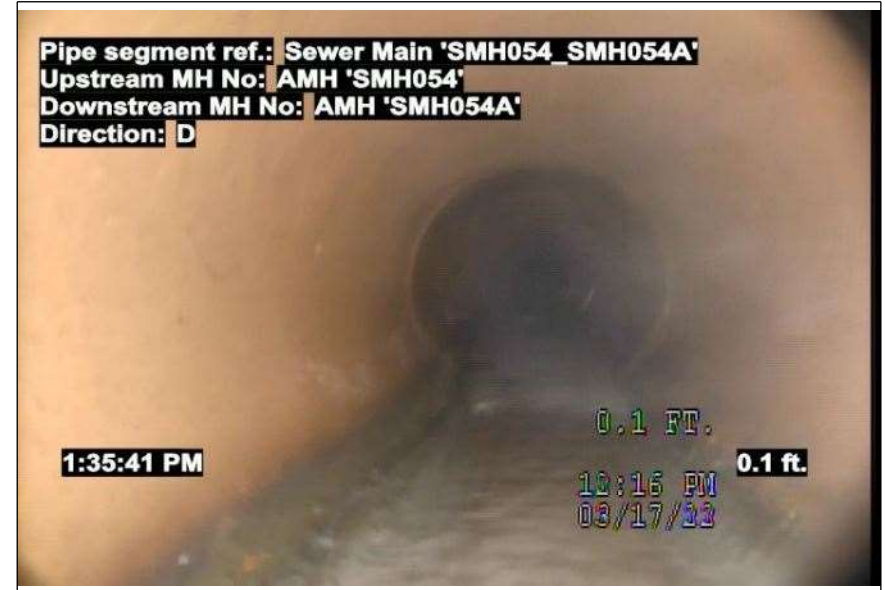
At: 0 ft. MWL - Miscellaneous Water Level  
 Joint: No 5 %

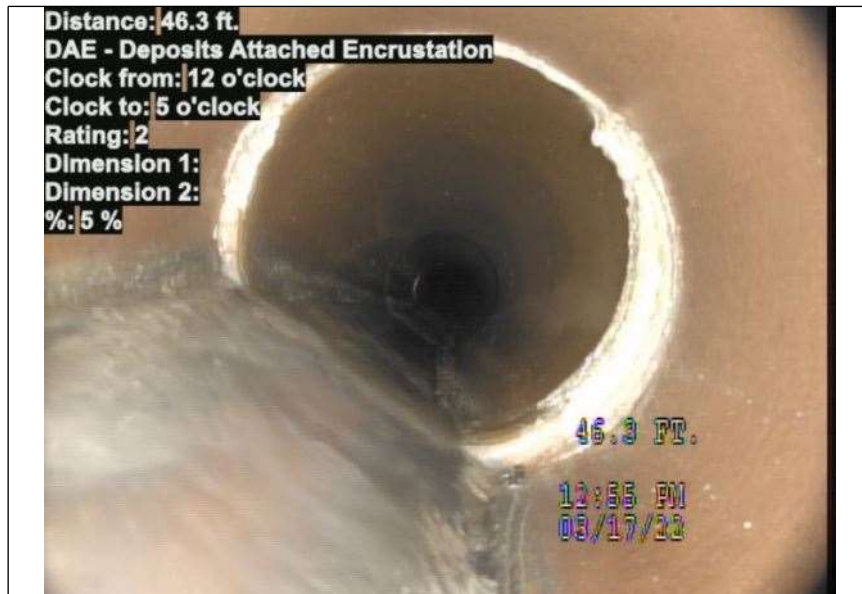
At: 46.3 ft. 12/5 DAE - Deposits Attached Encrustation  
 Joint: No 5 %

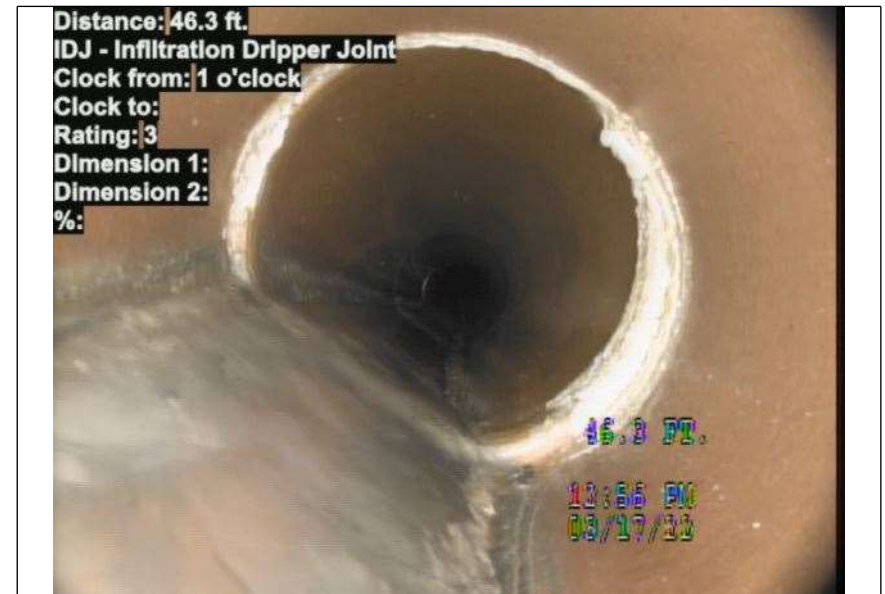
At: 46.3 ft. 1/ IDJ - Infiltration Dripper Joint  
 Joint: Yes

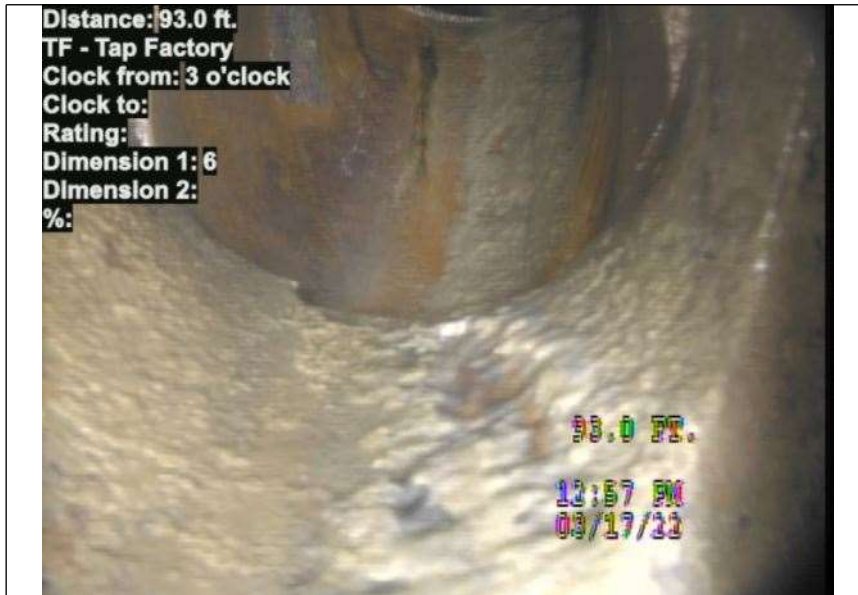
At: 93 ft. 3/. TF - Tap Factory  
 Joint: No

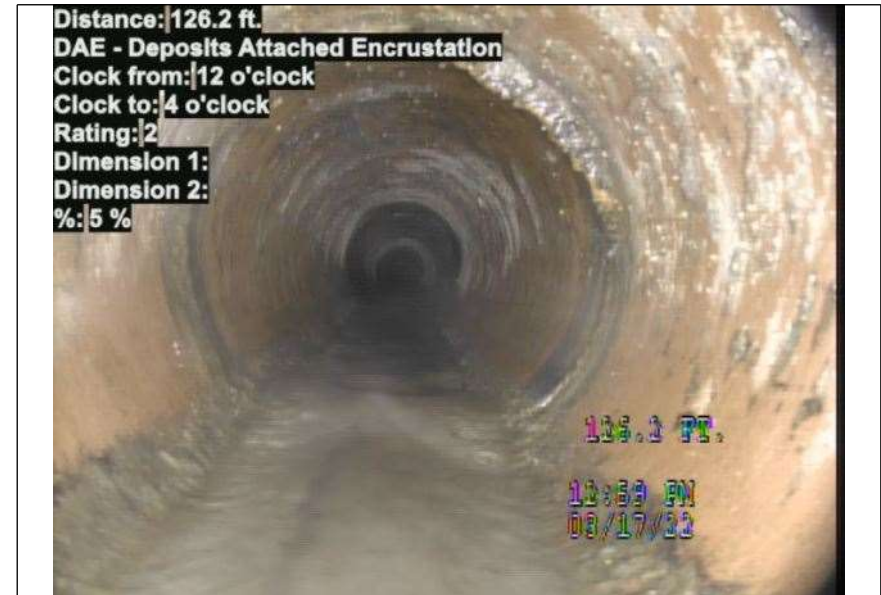
At: 126.2 ft. DAE - Deposits Attached Encrustation  
 12/4  
 Joint: No 5 %

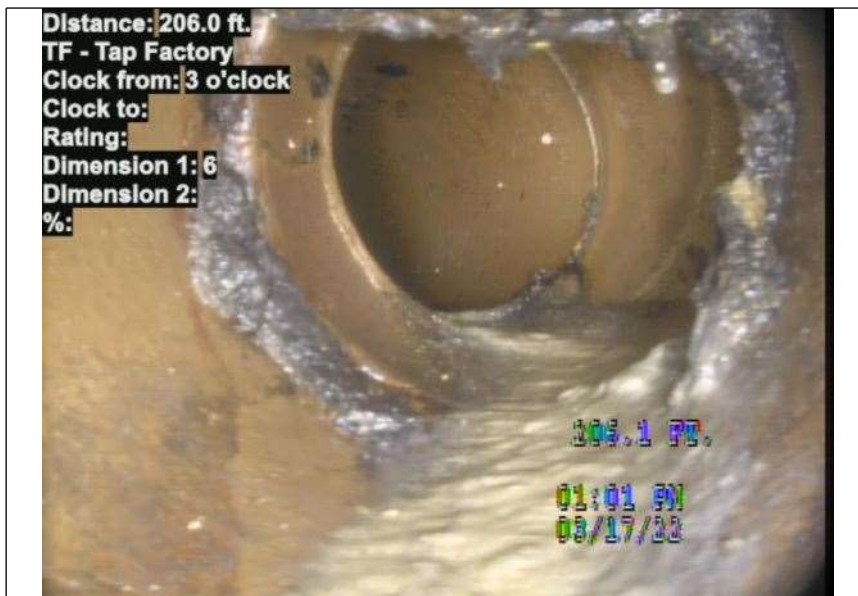
At: 206 ft. 3/. TF - Tap Factory  
 Joint: No

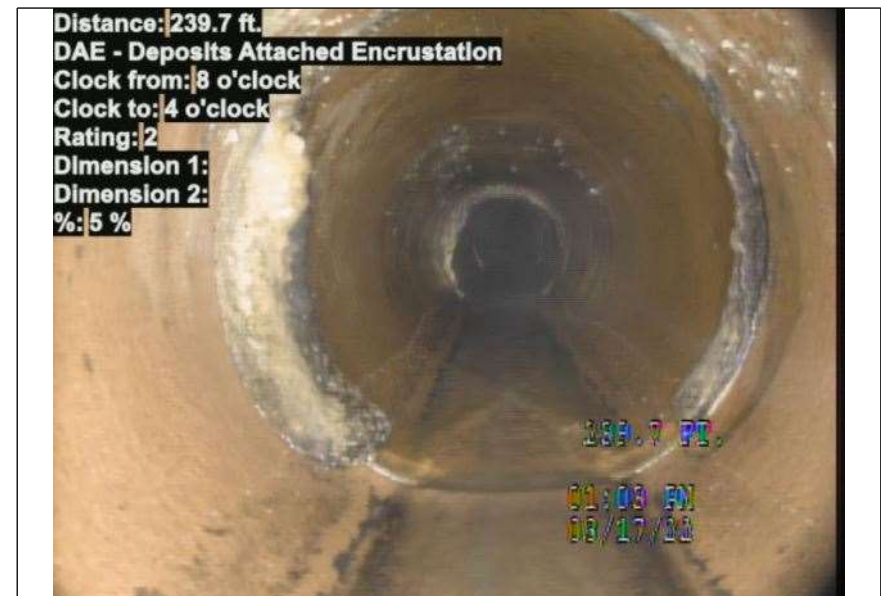
At: 239.7 ft. 8/4 DAE - Deposits Attached Encrustation  
 Joint: No 5 %

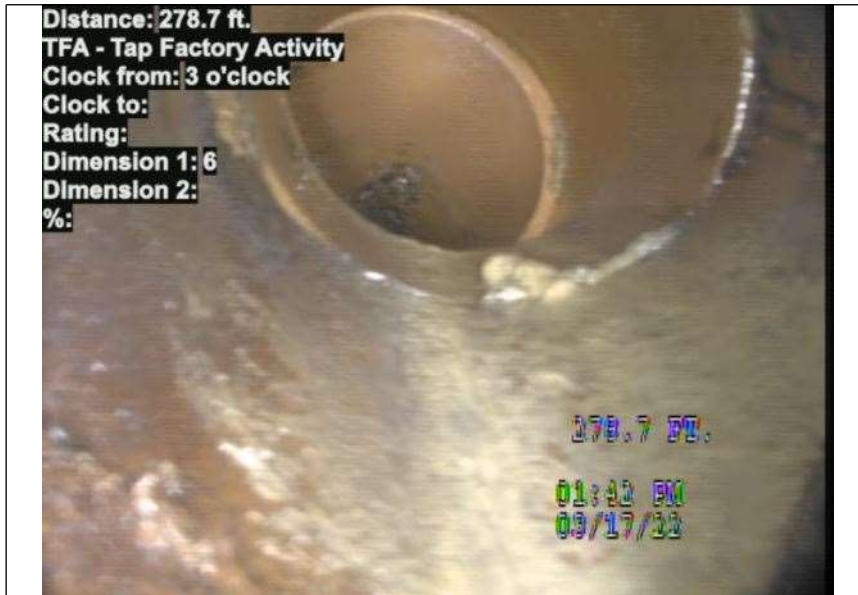
At: 278.7 ft. 3/. TFA - Tap Factory Activity  
Joint: No

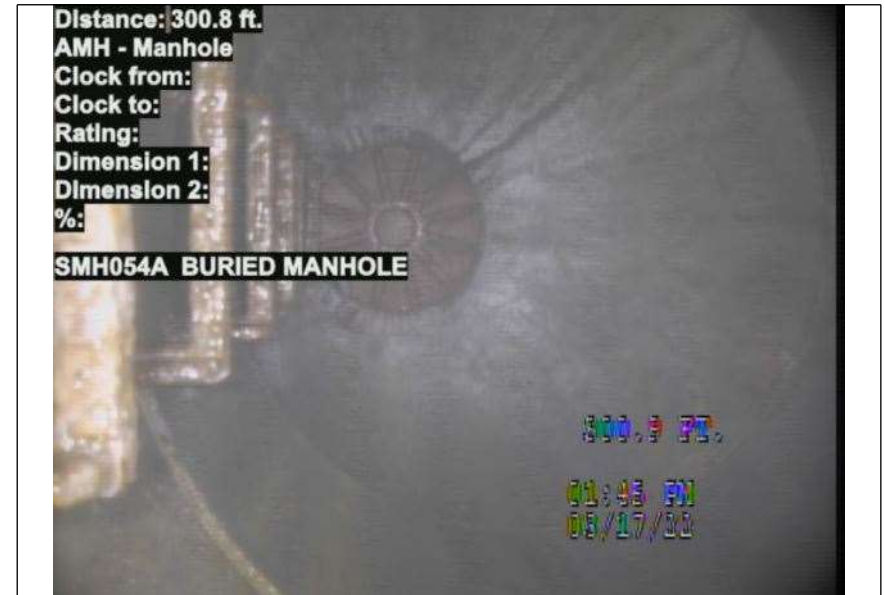
At: 300.9 ft. AMH - Manhole  
Joint: No SMH054A BURIED MANHOLE
