PACP Report with Pipe Run and Incident Snapshots

Surveyed by: Mike Brooks		Certificate number: Mike Brooks		Owner:		Customer:		Drainage area:		P/O number:		Sheet number:	
Pipe segment ref.: SMH055_SMH056				Start date/time: 20220318 11:39		Street: E CENTER ST				City: SMITHVILLE			
Location details: STREET				Upstream MH No: SMH055				Rim to invert:		Grade to invert:		Rim to grade:	
Pipe use: SS		Direction: D		Flow control:		Downstream MH No: SMH056				Rim to invert:		Grade to invert:	
Height: 8 in.		Width:		Shape: C		Material: VCP		Lining method:		Pipe joint length:		Total length: 359.800 ft.	
Length surveyed: 359.800 ft.		Purpose:		Sewer category:		Media label:		PreCleaning: L		Date cleaned:		Weather: 1	
Project name: Sewer Cleaning & CCTV - Project No. 210670				Additional info:

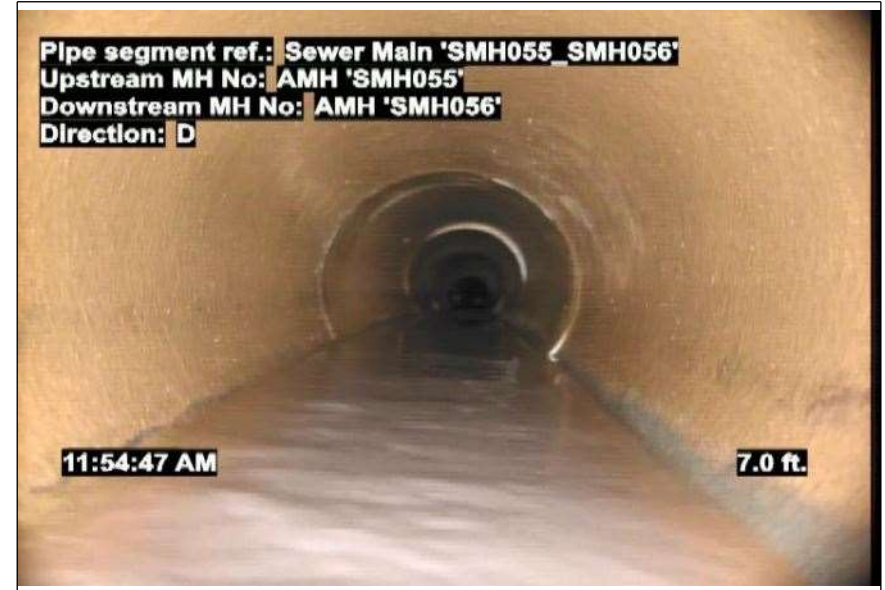
At: 0 ft. MWL - Miscellaneous Water Level
 Joint: No 5 %

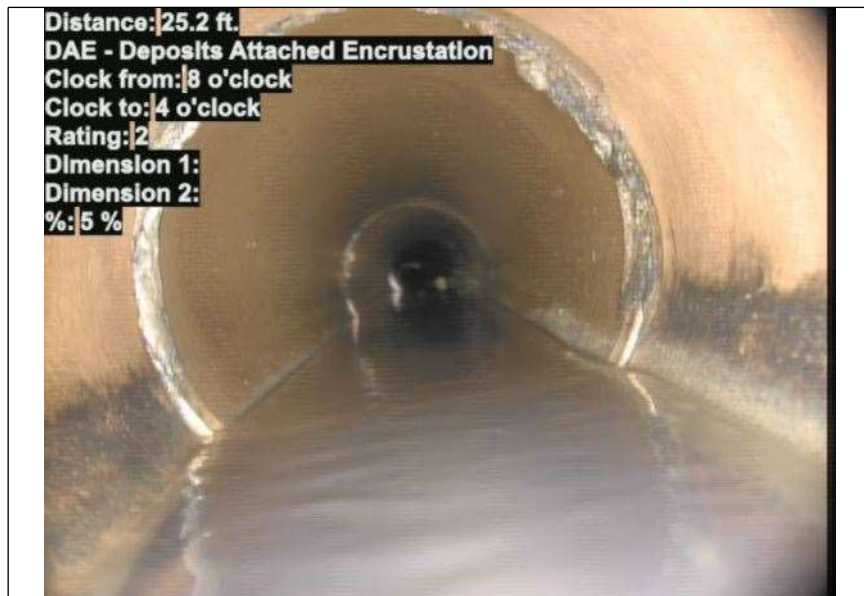
At: 25.2 ft. 8/4 DAE - Deposits Attached Encrustation
 Joint: No 5 %

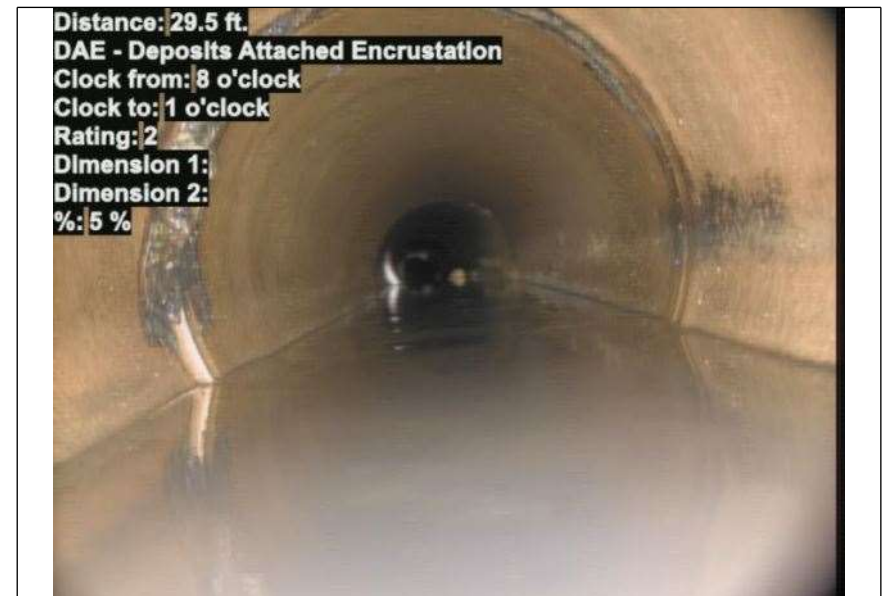
At: 29.5 ft. 8/1 DAE - Deposits Attached Encrustation
 Joint: No 5 %

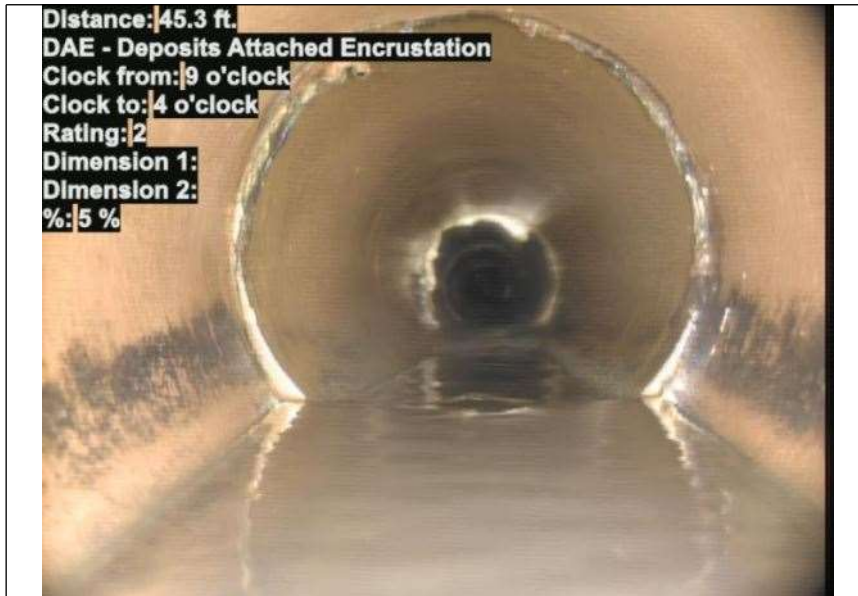
At: 45.3 ft. 9/4 DAE - Deposits Attached Encrustation
Joint: No 5 %

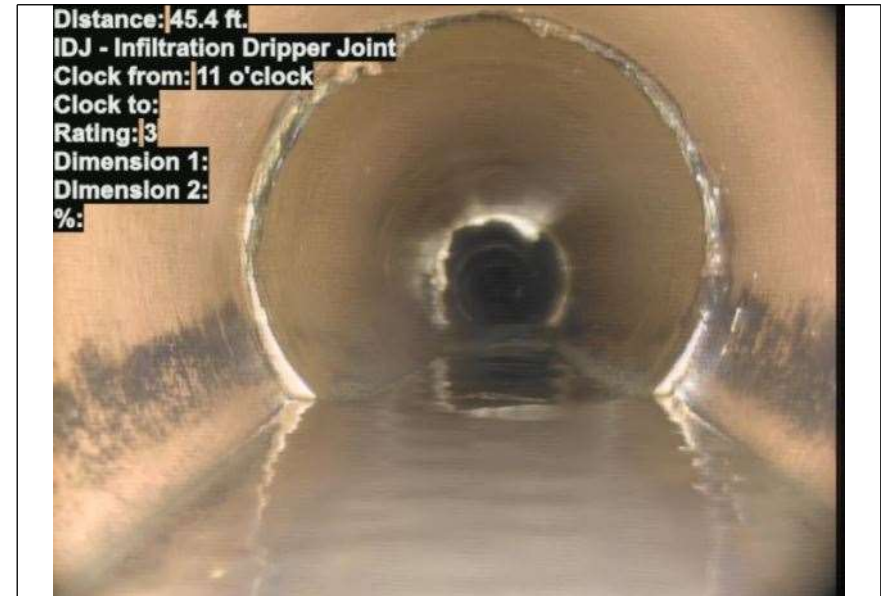
At: 45.4 ft. 11/ IDJ - Infiltration Dripper Joint
Joint: Yes

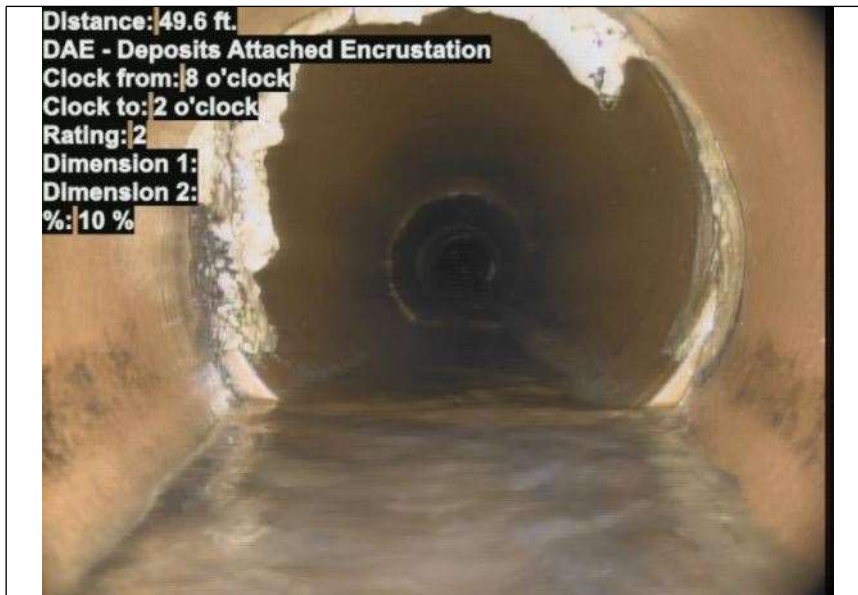
At: 49.6 ft. 8/2 DAE - Deposits Attached Encrustation
Joint: No 10 %

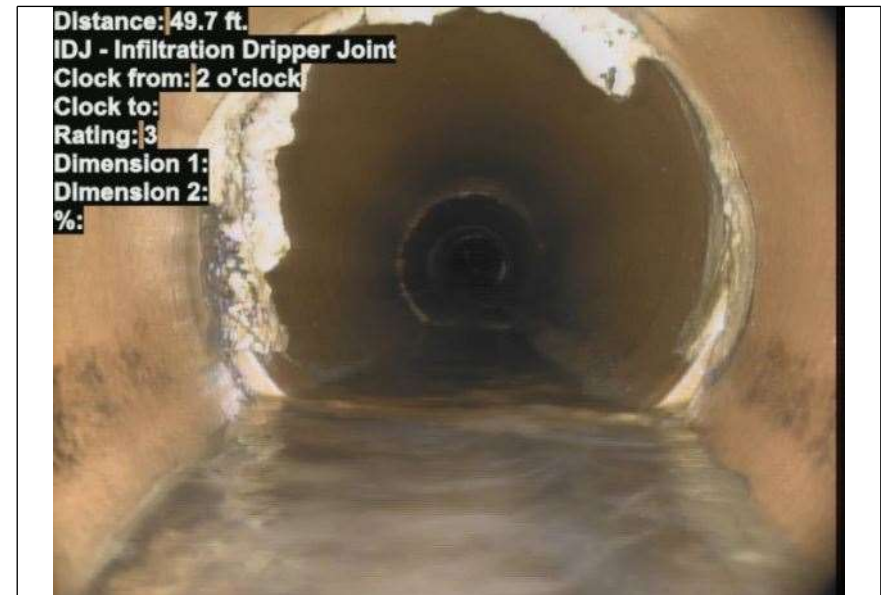
At: 49.7 ft. 2/ IDJ - Infiltration Dripper Joint
Joint: Yes

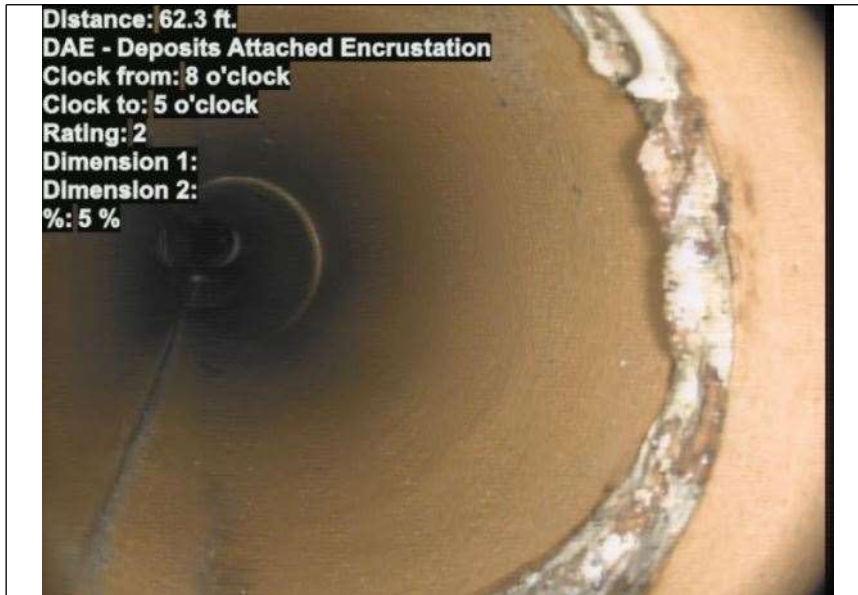
At: 62.3 ft. 8/5 DAE - Deposits Attached Encrustation
 Joint: No 5 %

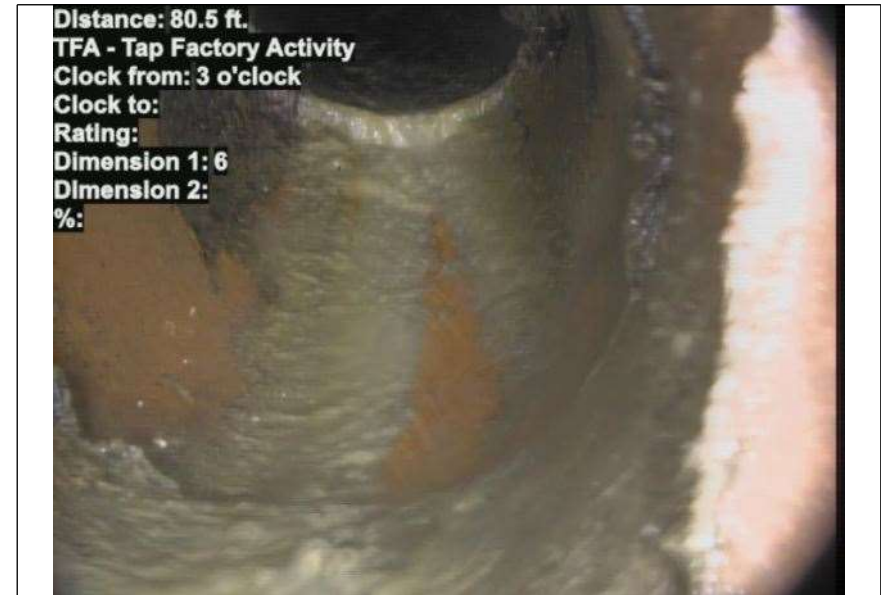
At: 80.5 ft. 3/ TFA - Tap Factory Activity
 Joint: No

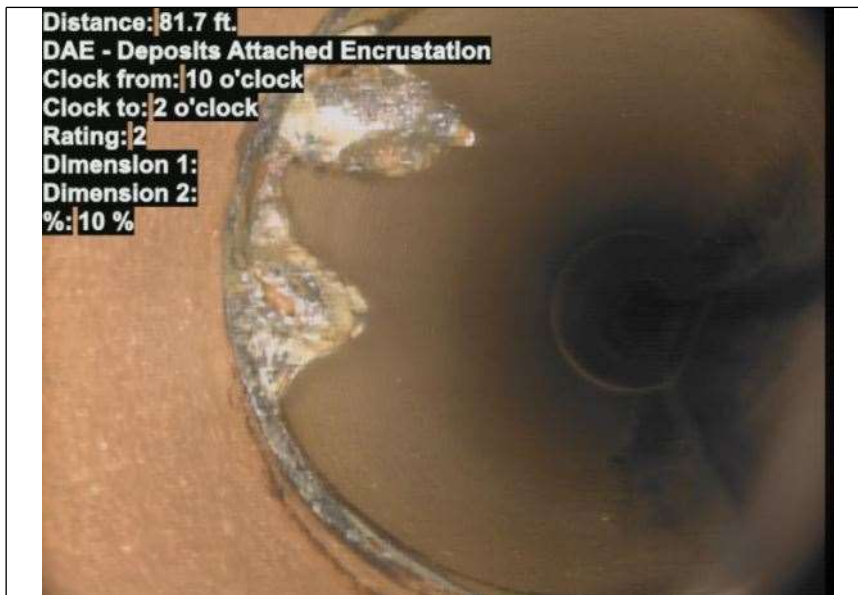
At: 81.7 ft. 10/2 DAE - Deposits Attached Encrustation
 Joint: No 10 %

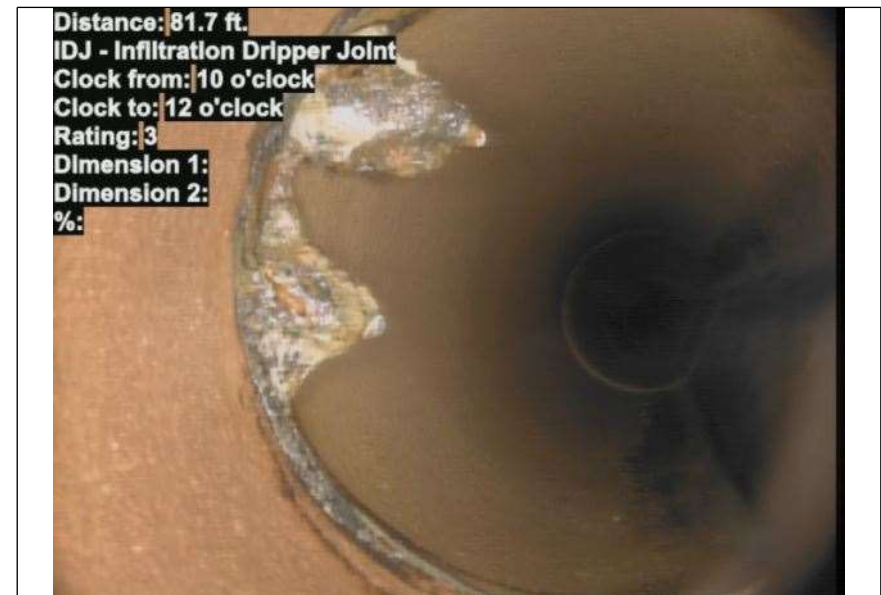
At: 81.7 ft. 10/12 IDJ - Infiltration Dripper Joint
 Joint: Yes

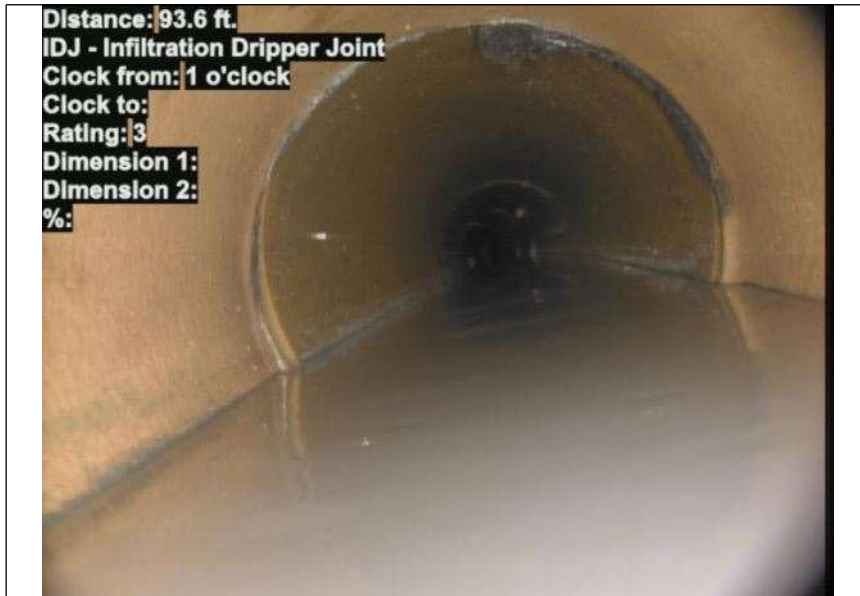
At: 93.6 ft. 1/ IDJ - Infiltration Dripper Joint
Joint: Yes

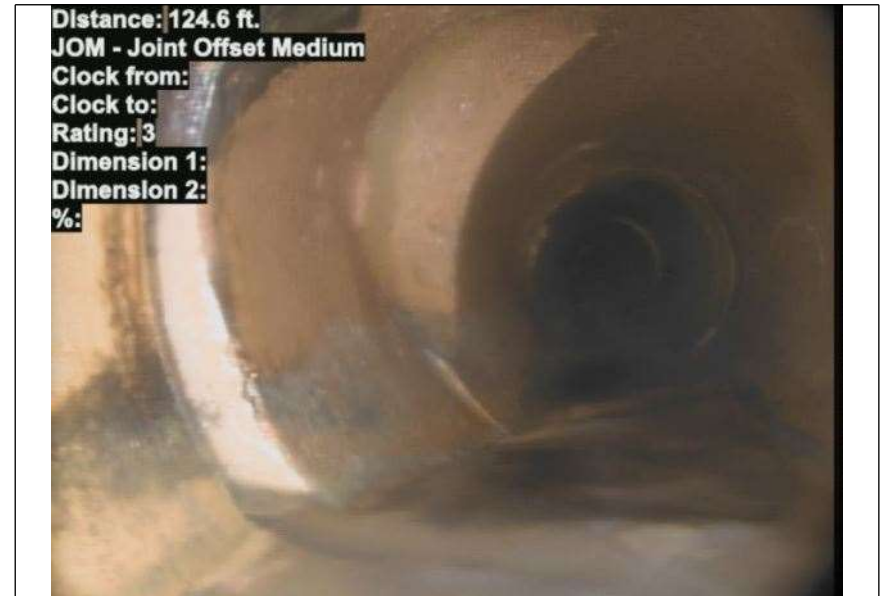
At: 124.6 ft. JOM - Joint Offset Medium
Joint: No

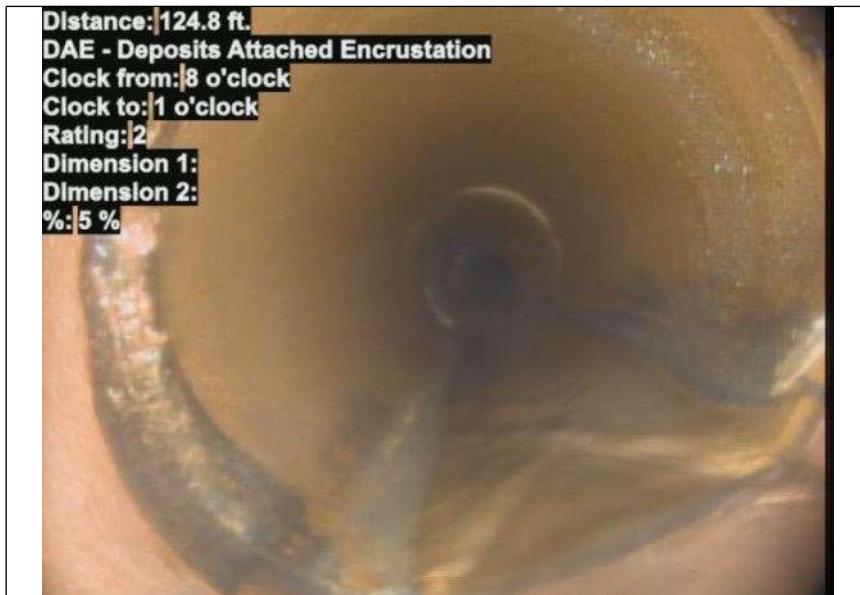
At: 124.8 ft. 8/1 DAE - Deposits Attached Encrustation
Joint: No 5 %

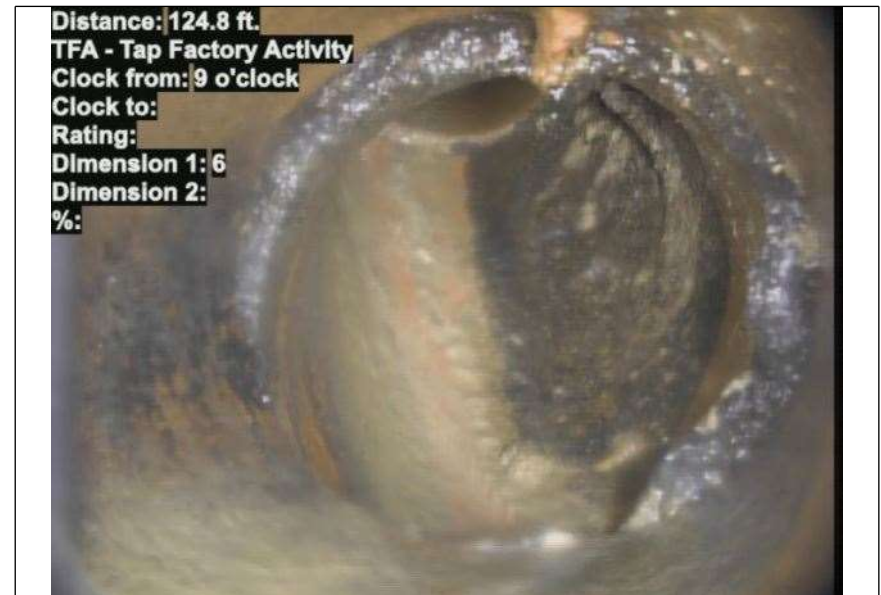
At: 124.8 ft. 9/ TFA - Tap Factory Activity
Joint: No

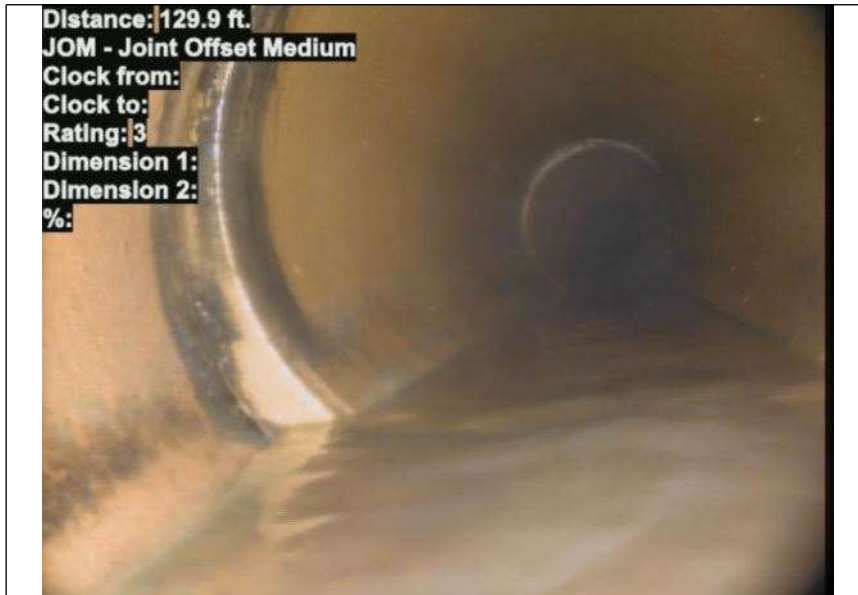
At: 129.9 ft. JOM - Joint Offset Medium
Joint: No

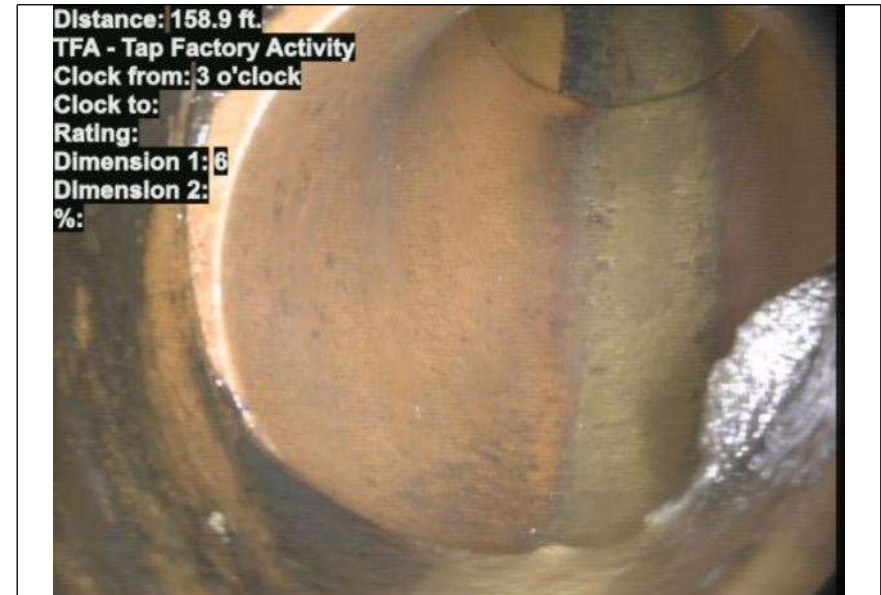
At: 158.9 ft. 3/. TFA - Tap Factory Activity
Joint: No

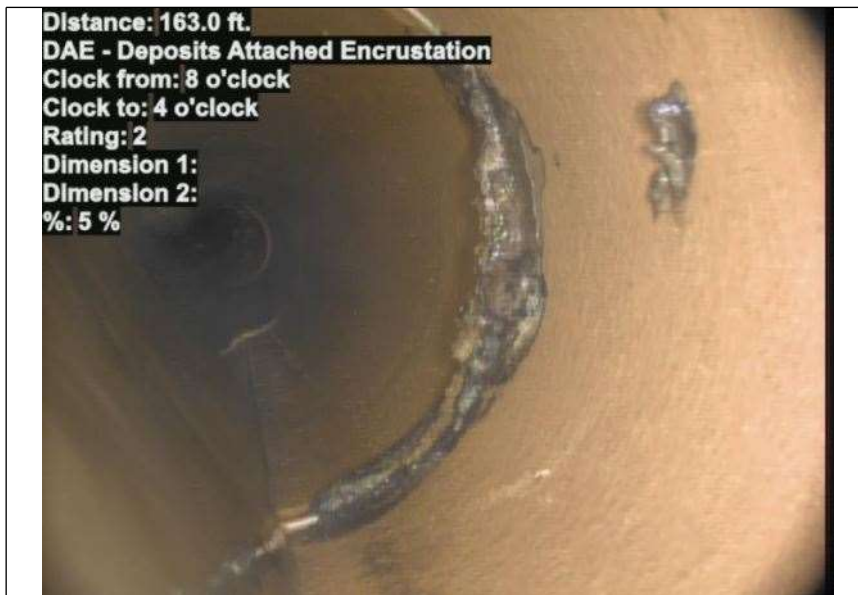
At: 163 ft. 8/4 DAE - Deposits Attached Encrustation
Joint: No 5 %

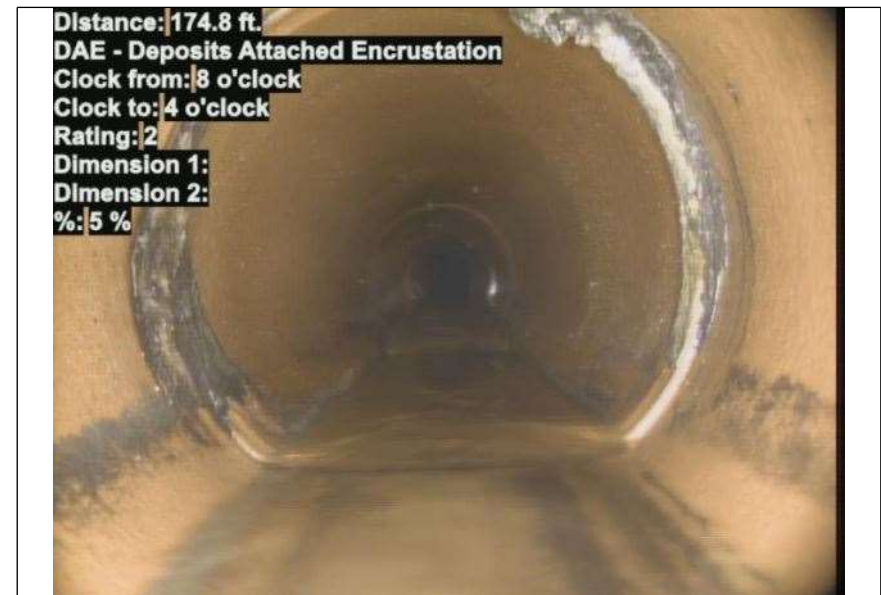
At: 174.8 ft. 8/4 DAE - Deposits Attached Encrustation
Joint: No 5 %

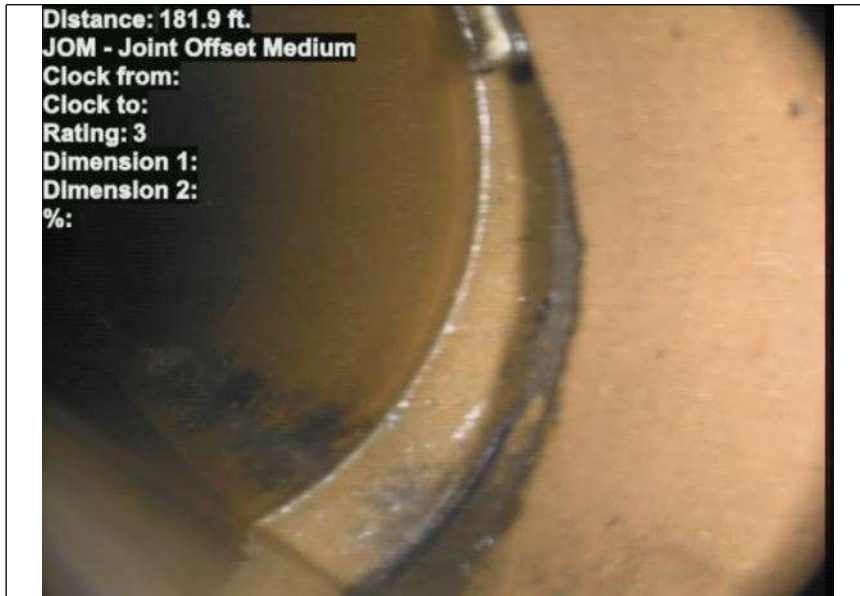
At: 181.9 ft. JOM - Joint Offset Medium
Joint: No

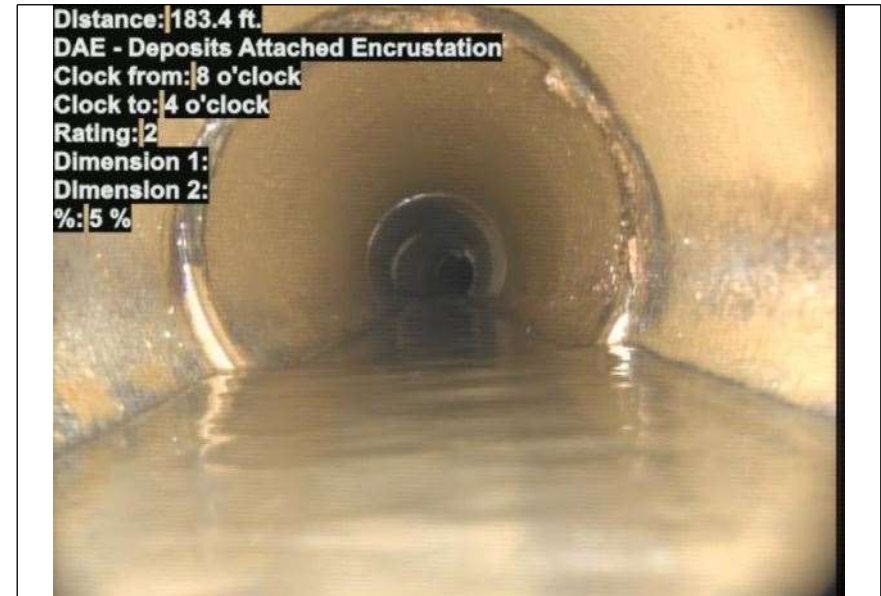
At: 183.4 ft. 8/4 DAE - Deposits Attached Encrustation
Joint: No 5 %

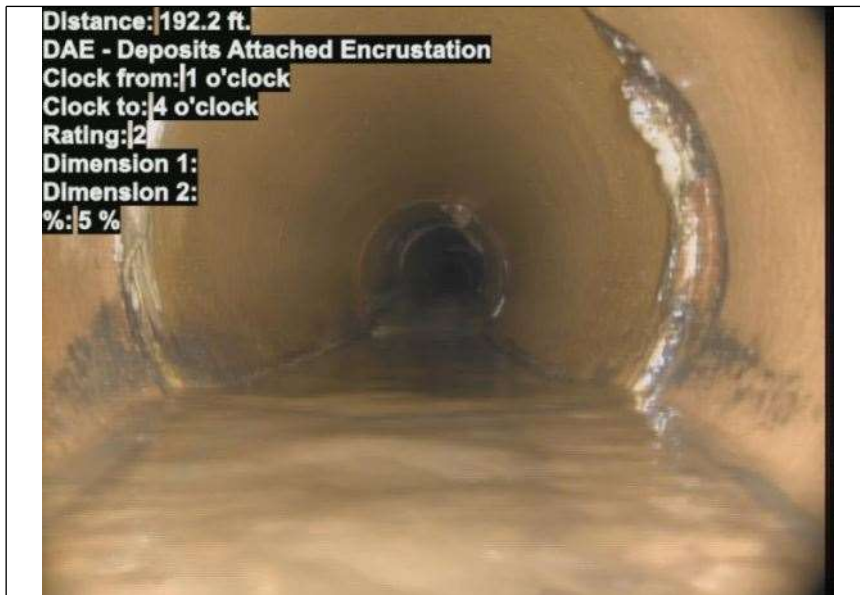
At: 192.2 ft. 1/4 DAE - Deposits Attached Encrustation
Joint: No 5 %

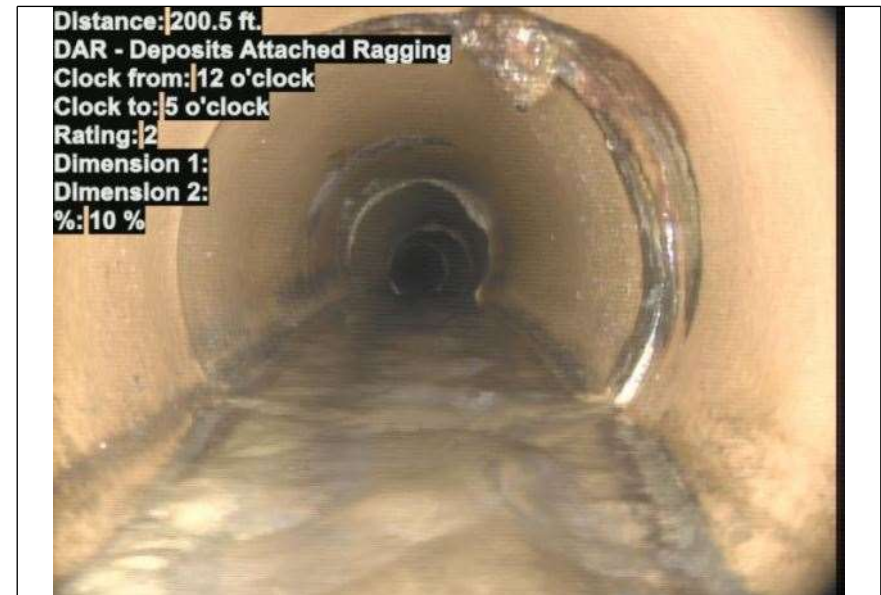
At: 200.5 ft. 12/5 DAR - Deposits Attached Ragging
Joint: No 10 %

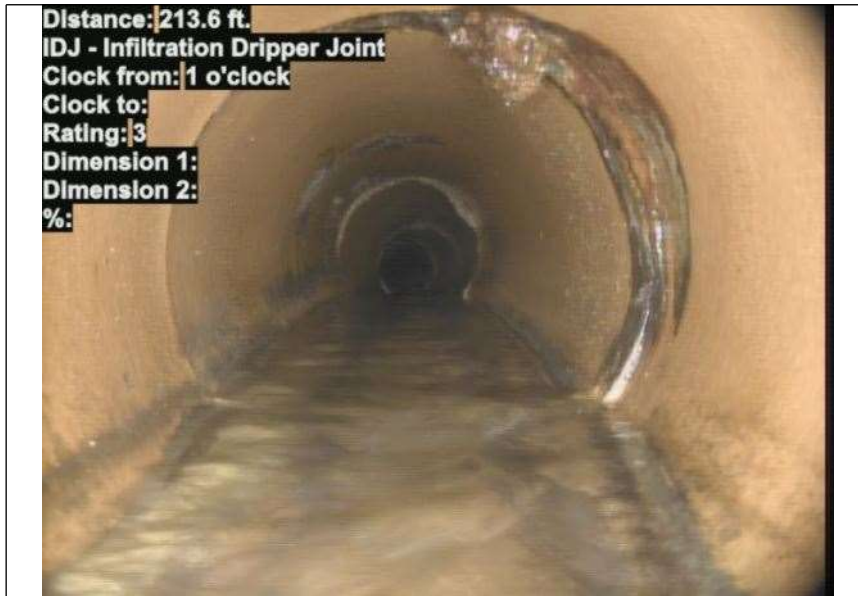
At: 213.6 ft. 1/. IDJ - Infiltration Dripper Joint
Joint: Yes

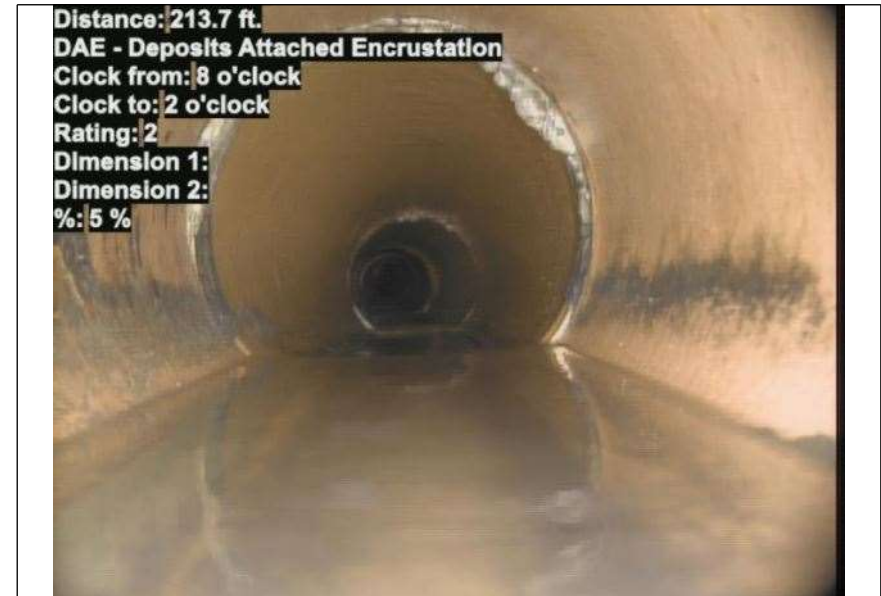
At: 213.7 ft. 8/2 DAE - Deposits Attached Encrustation
Joint: No 5 %

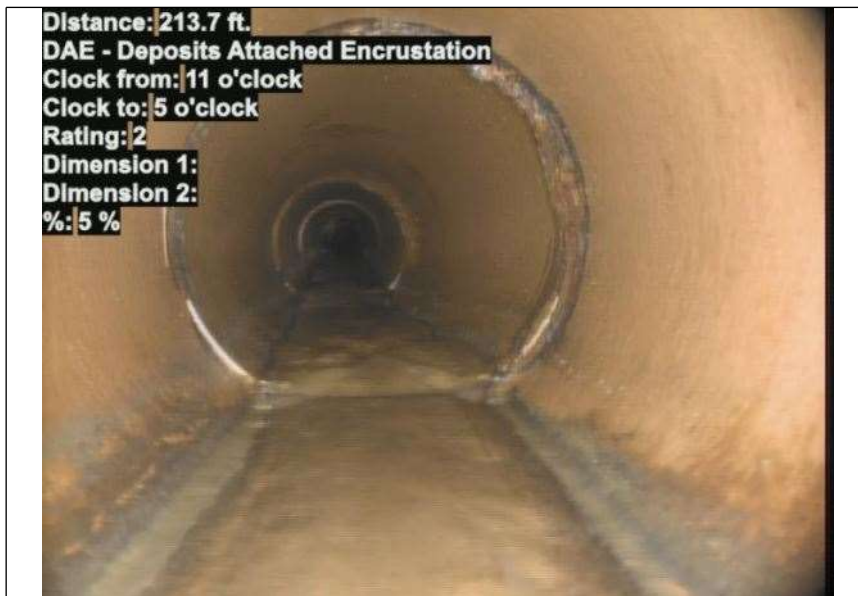
At: 213.7 ft. 11/5 DAE - Deposits Attached Encrustation
Joint: No 5 %

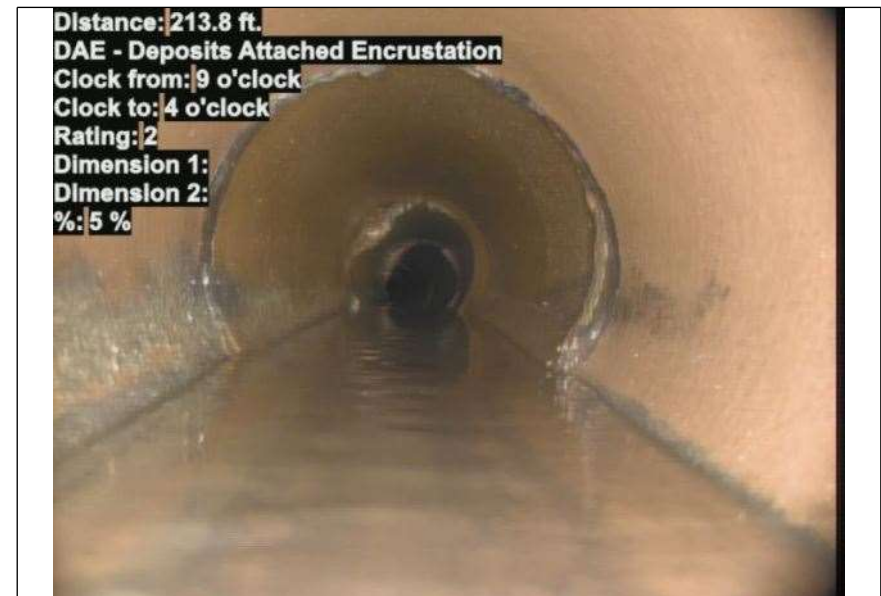
At: 213.8 ft. 9/4 DAE - Deposits Attached Encrustation
Joint: No 5 %

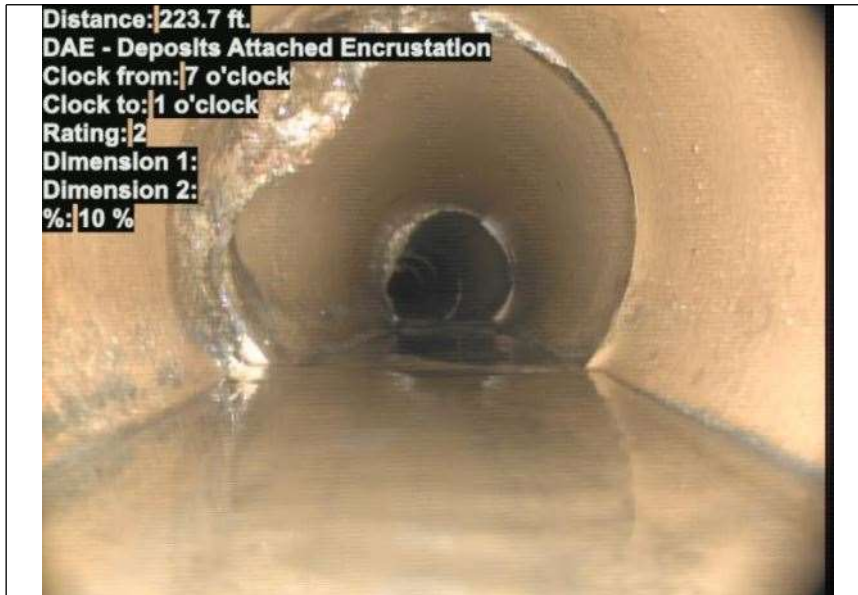
At: 223.7 ft. 7/1 DAE - Deposits Attached Encrustation
Joint: No 10 %

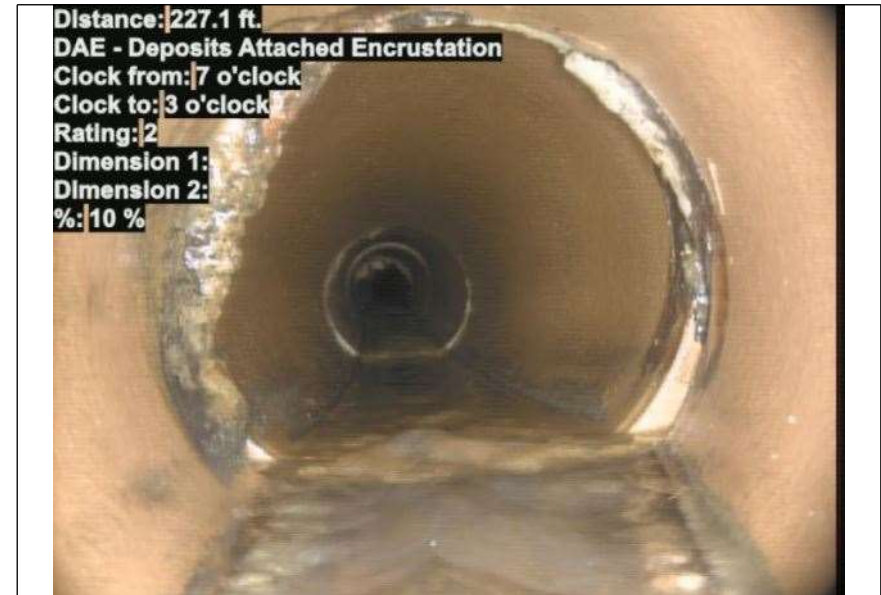
At: 227.1 ft. 7/3 DAE - Deposits Attached Encrustation
Joint: No 10 %

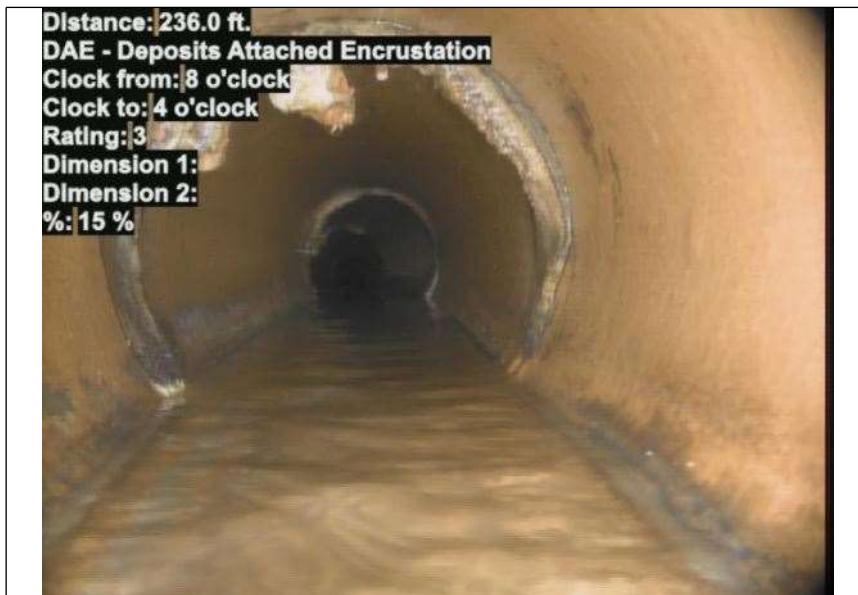
At: 236 ft. 8/4 DAE - Deposits Attached Encrustation
Joint: No 15 %

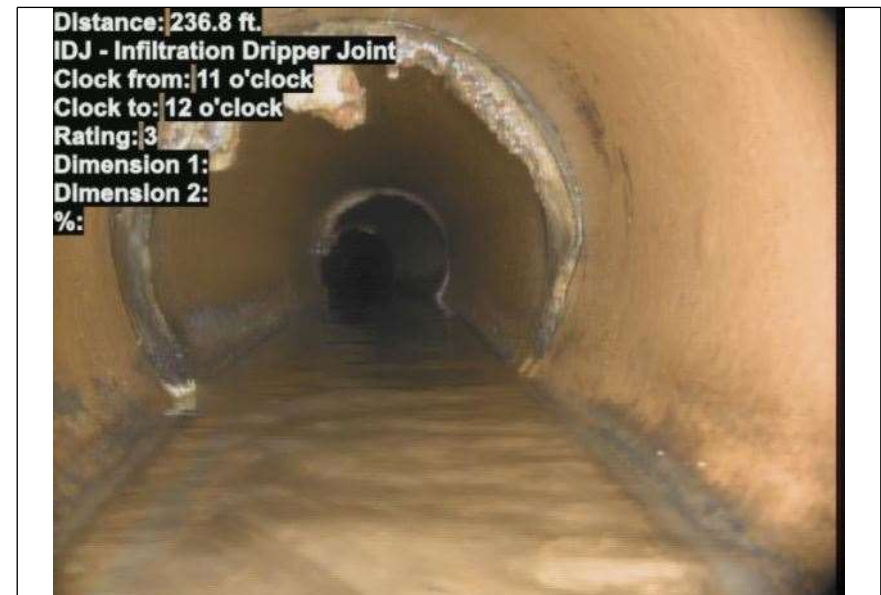
At: 236.8 ft. IDJ - Infiltration Dripper Joint
11/12
Joint: Yes

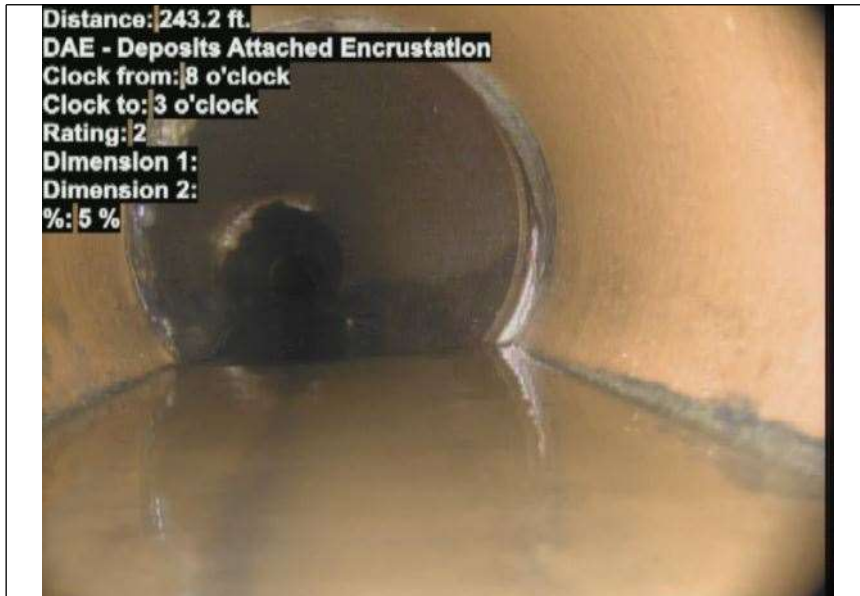
At: 243.2 ft. 8/3 DAE - Deposits Attached Encrustation
Joint: No 5 %

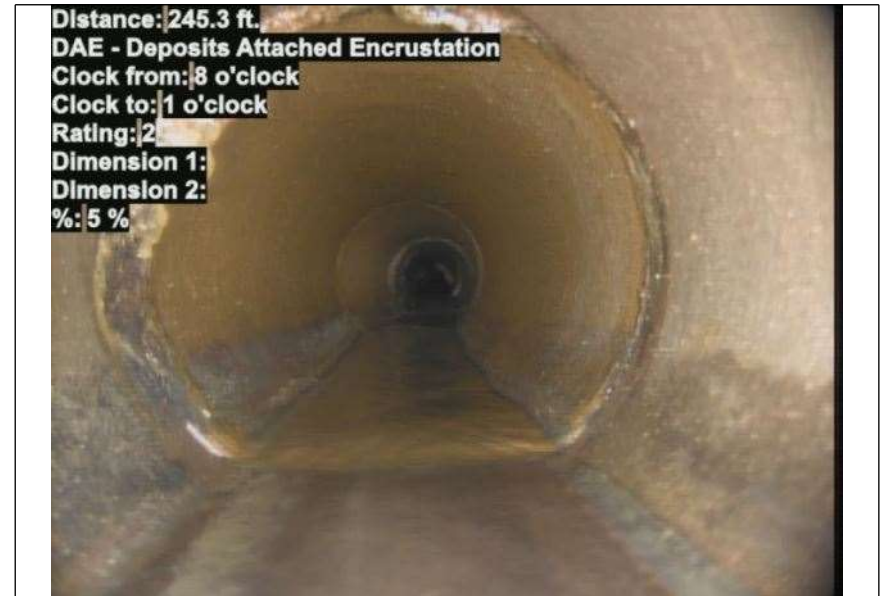
At: 245.3 ft. 8/1 DAE - Deposits Attached Encrustation
Joint: No 5 %

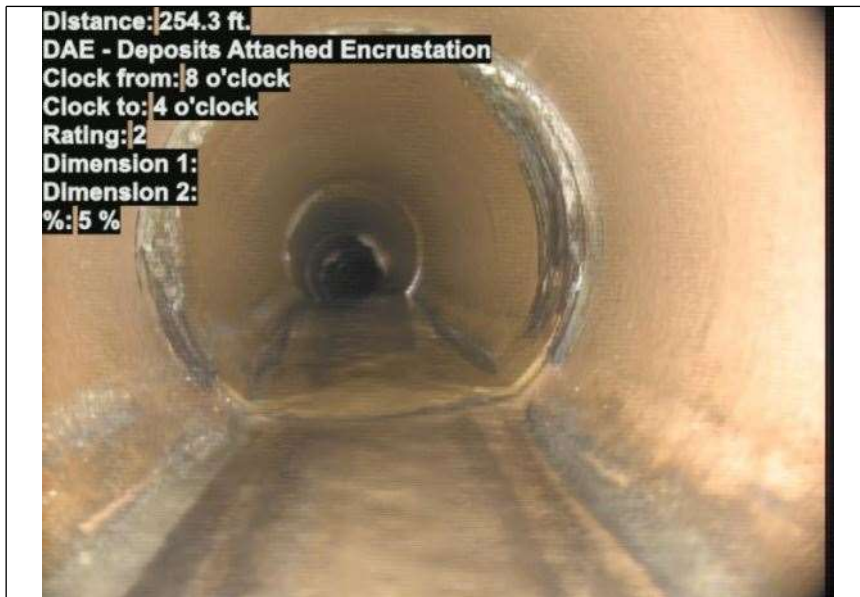
At: 254.3 ft. 8/4 DAE - Deposits Attached Encrustation
Joint: No 5 %

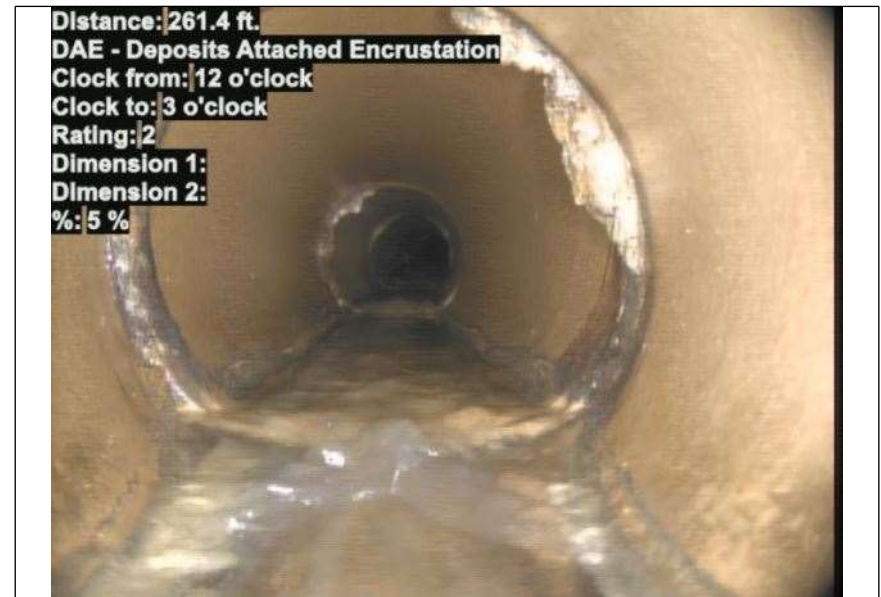
At: 261.4 ft. 12/3 DAE - Deposits Attached Encrustation
Joint: No 5 %

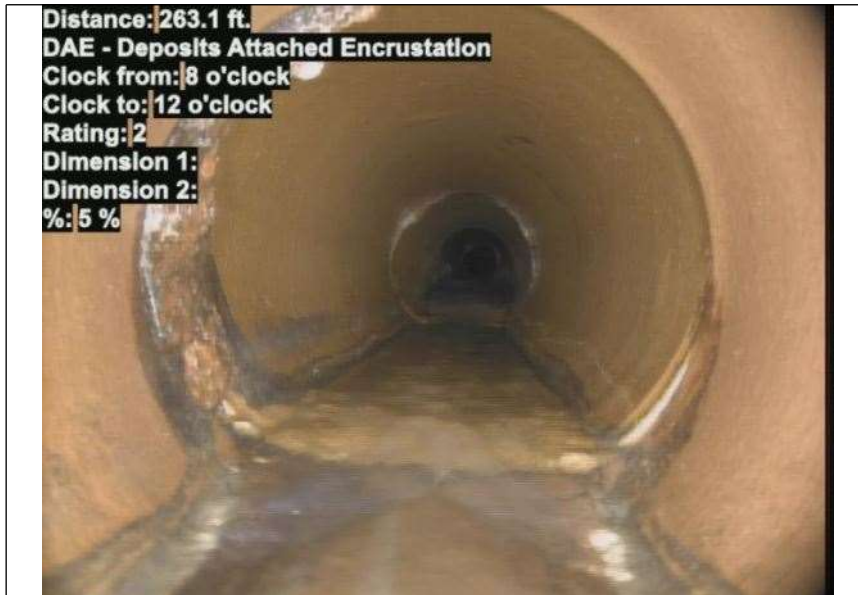
At: 263.1 ft. DAE - Deposits Attached Encrustation
8/12

Joint: No 5 %

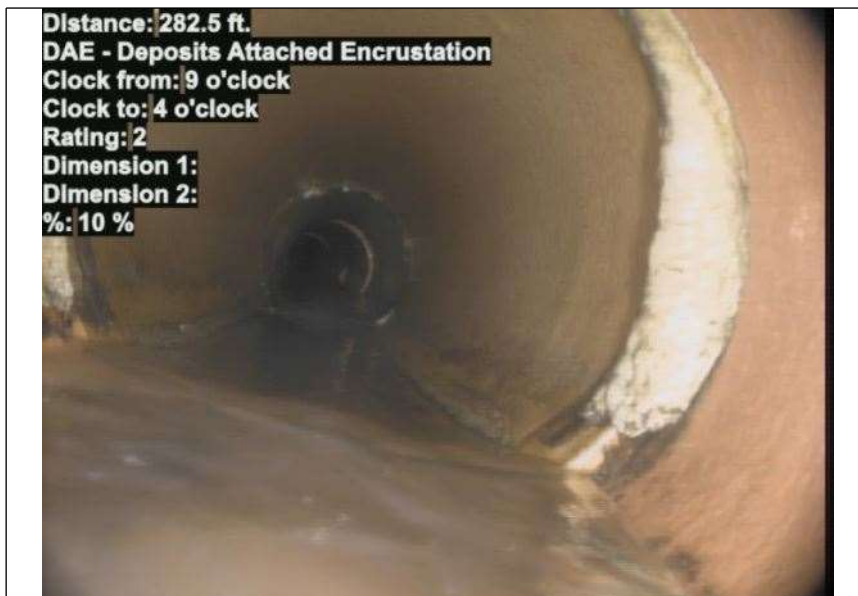
At: 282.5 ft. 9/4 DAE - Deposits Attached Encrustation

Joint: No 10 %

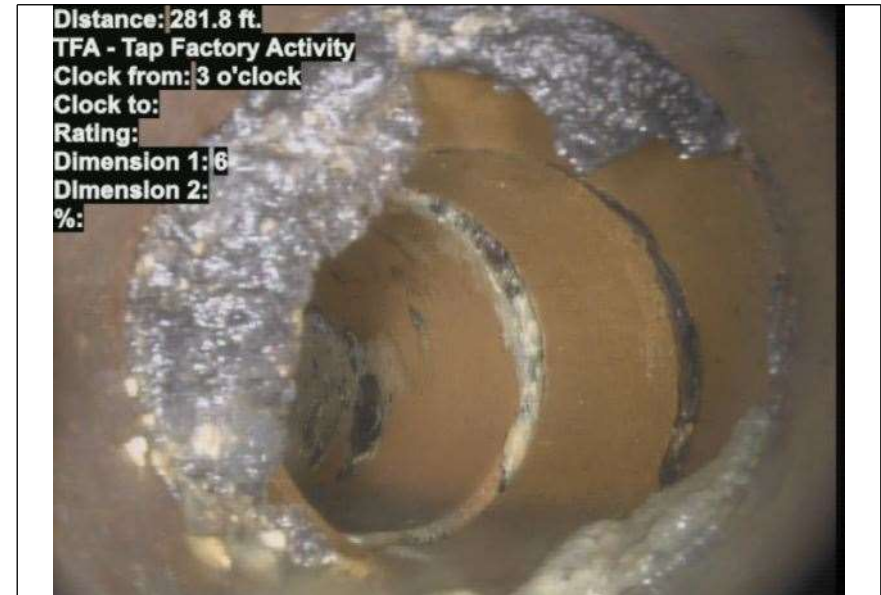
At: 281.8 ft. 3/ TFA - Tap Factory Activity

Joint: No

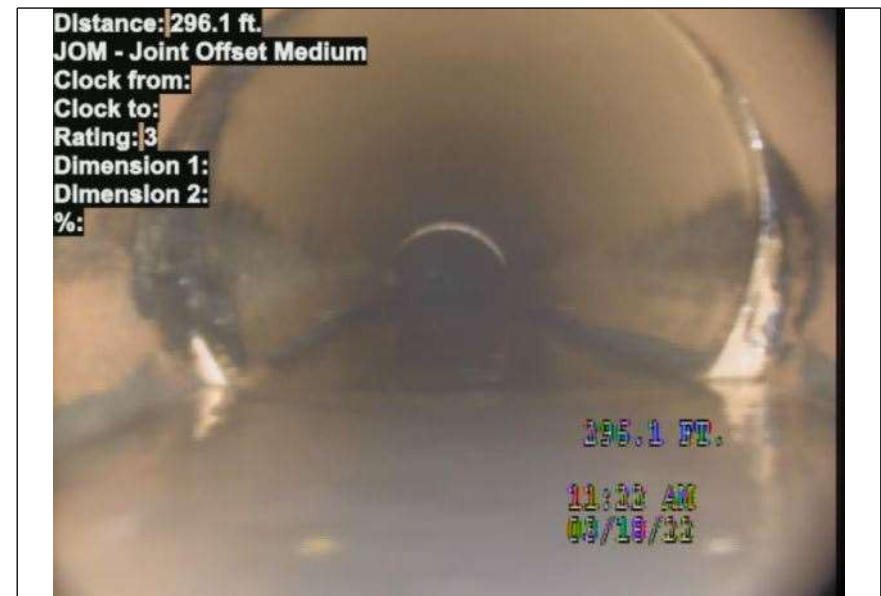
At: 296.1 ft. JOM - Joint Offset Medium

Joint: No

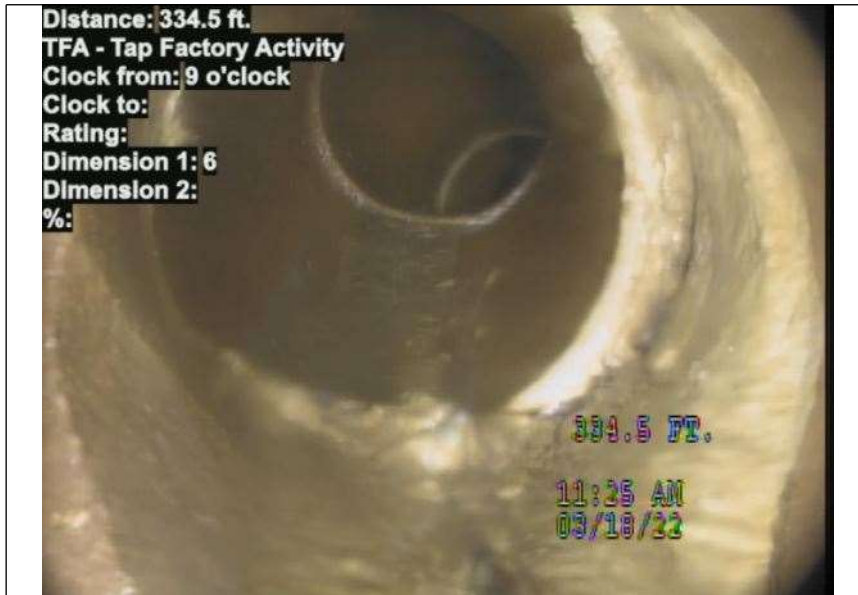
At: 334.5 ft. 9/. TFA - Tap Factory Activity
Joint: No
