## PACP Report with Pipe Run and Incident Snapshots

Surveyed by: <b>Mike Brooks</b>	Certificate number: <b>Mike Brooks</b>	Owner:	Customer:	Drainage area:	P/O number:	Sheet number:
Pipe segment ref.: <b>SMH056_SMH057</b>	Start date/time: <b>20220318 12:51</b>	Street: <b>E CENTER ST</b>	City: <b>SMITHVILLE</b>			
Location details: <b>STREET</b>	Upstream MH No: <b>SMH056</b>	Rim to invert:	Grade to invert:	Rim to grade:		
Pipe use: <b>SS</b>	Direction: <b>D</b>	Flow control:	Downstream MH No: <b>SMH057</b>	Rim to invert:	Grade to invert:	Rim to grade:
Height: <b>8 in.</b>	Width:	Shape: <b>C</b>	Material: <b>VCP</b>	Lining method:	Pipe joint length:	Total length: <b>327.500 ft.</b>
Length surveyed: <b>267.000 ft.</b>	Purpose:	Sewer category:				
Media label:	PreCleaning: <b>L</b>	Date cleaned:	Weather: <b>1</b>	Location code:	Pressure value:	
Project name: <b>Sewer Cleaning &amp; CCTV - Project No. 210670</b>	Additional info:

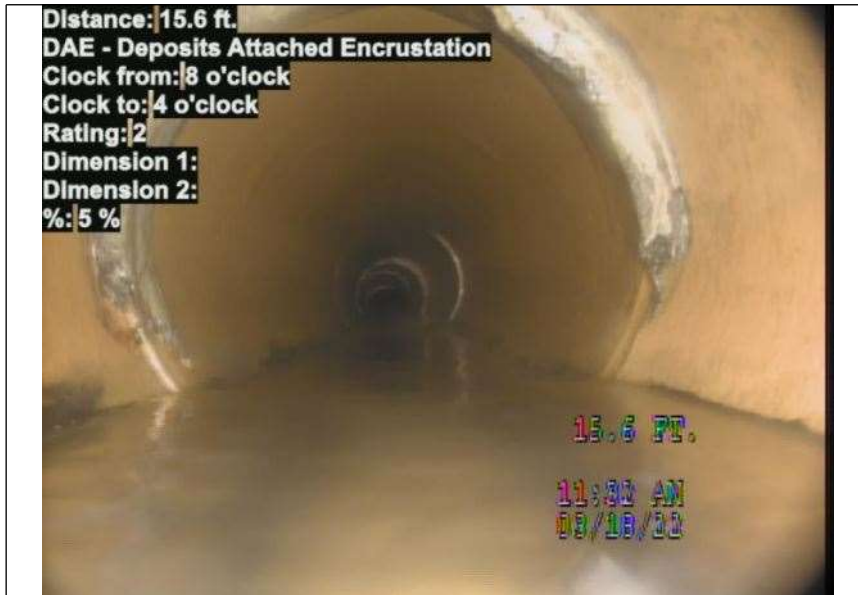
At: 15.6 ft. 8/4 DAE - Deposits Attached Encrustation  
Joint: No 5 %

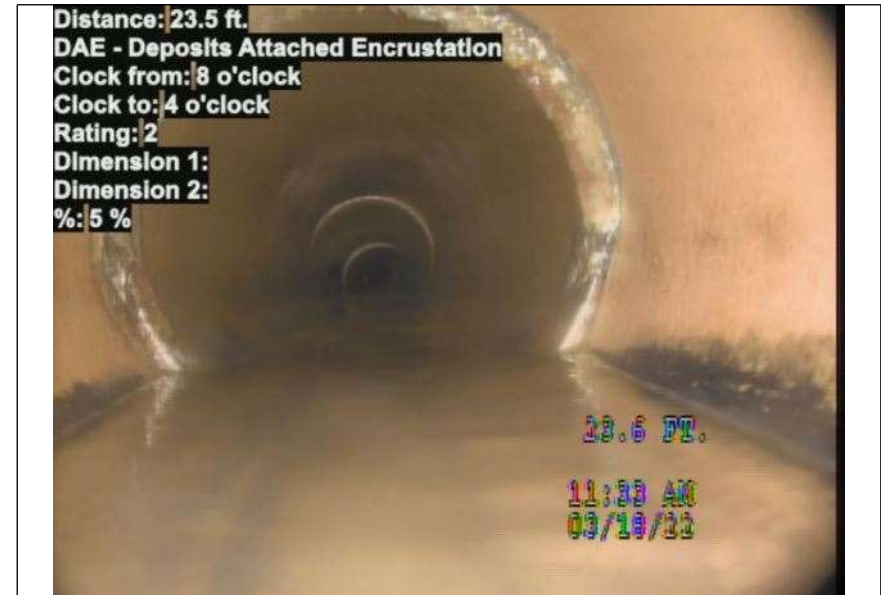
At: 23.5 ft. 8/4 DAE - Deposits Attached Encrustation  
Joint: No 5 %

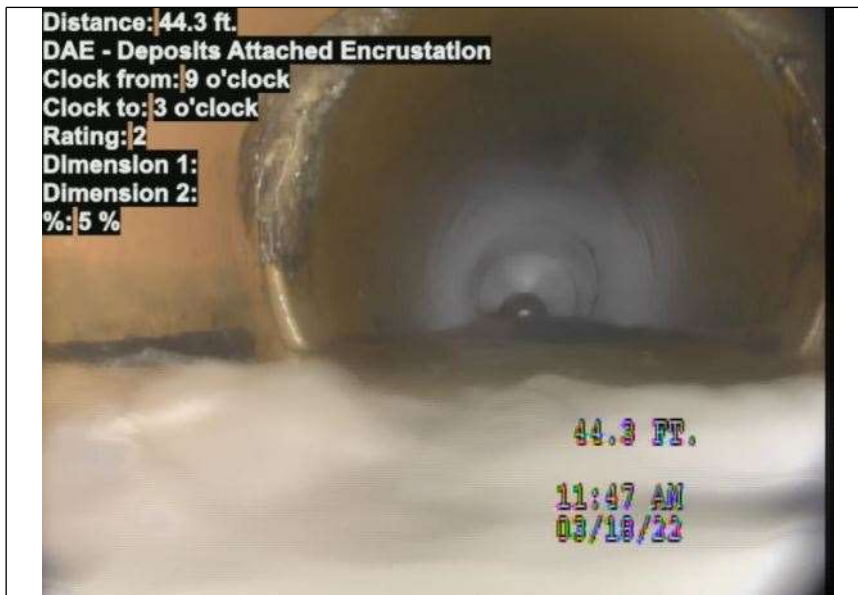
At: 44.3 ft. 9/3 DAE - Deposits Attached Encrustation  
Joint: No 5 %

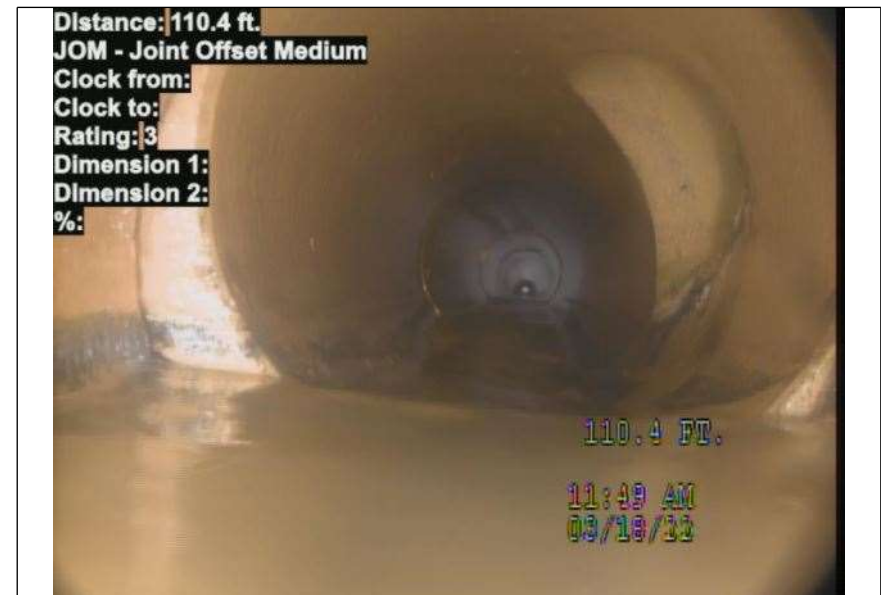
At: 110.4 ft. JOM - Joint Offset Medium  
Joint: No

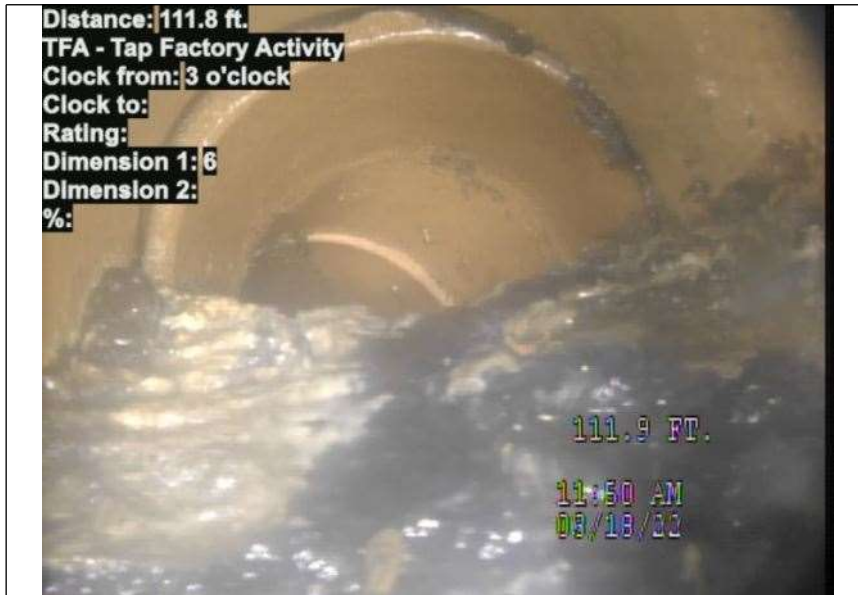
At: 111.8 ft. 3/. TFA - Tap Factory Activity  
Joint: No DAE

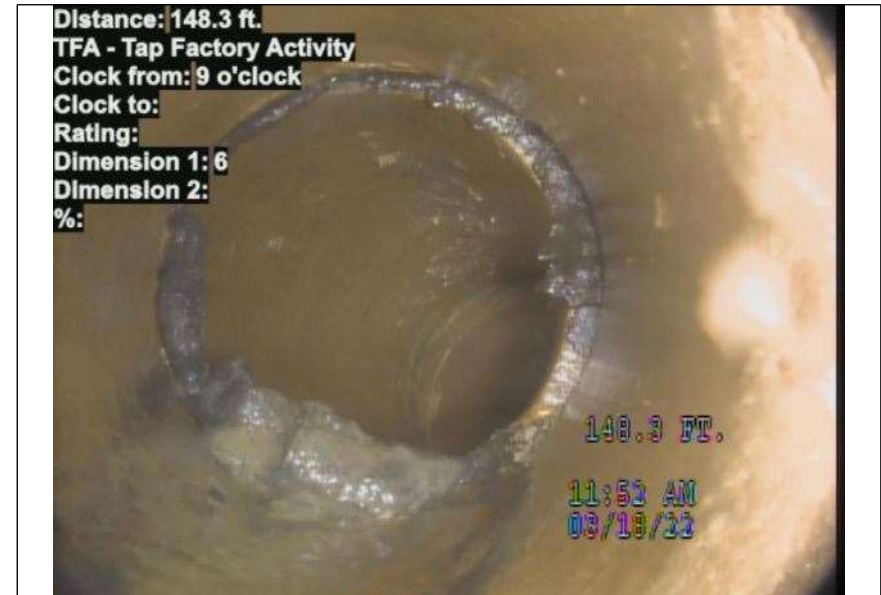
At: 148.3 ft. 9/. TFA - Tap Factory Activity  
Joint: No

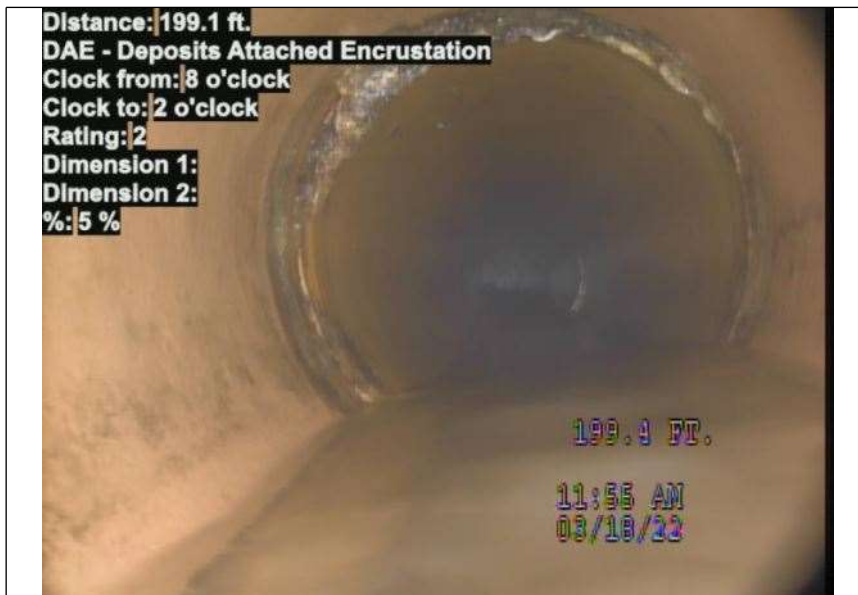
At: 199.1 ft. 8/2 DAE - Deposits Attached Encrustation  
Joint: No 5 %

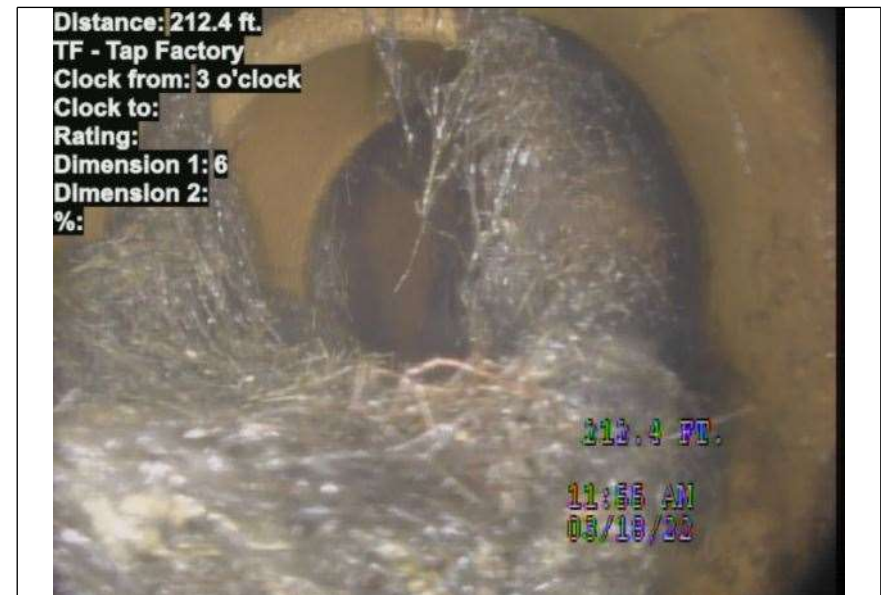
At: 212.4 ft. 3/. TF - Tap Factory  
Joint: No RFL

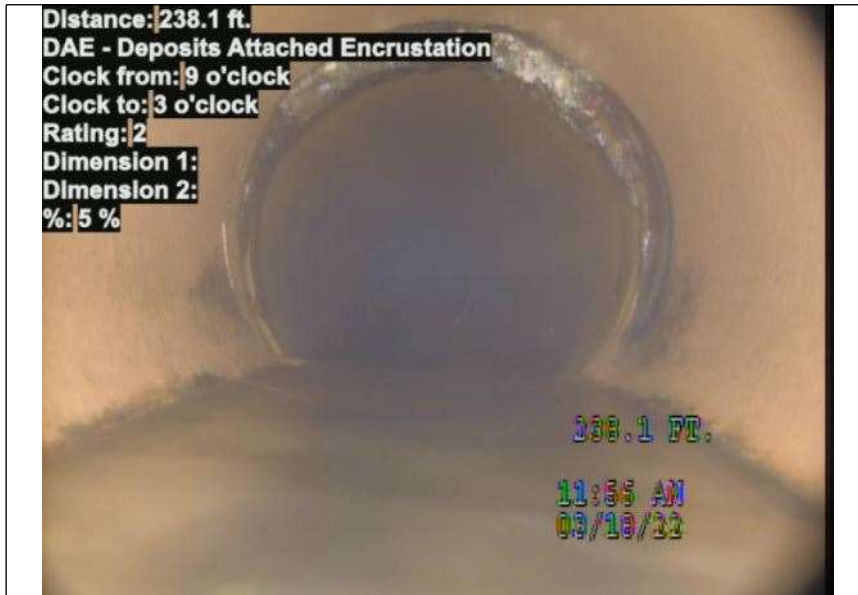
At: 238.1 ft. 9/3 DAE - Deposits Attached Encrustation  
Joint: No 5 %

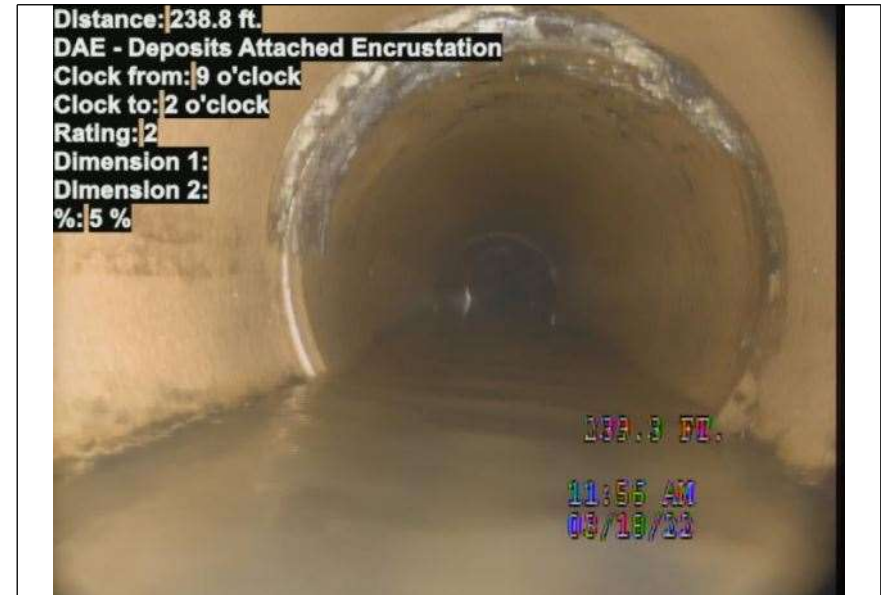
At: 238.8 ft. 9/2 DAE - Deposits Attached Encrustation  
Joint: No 5 %

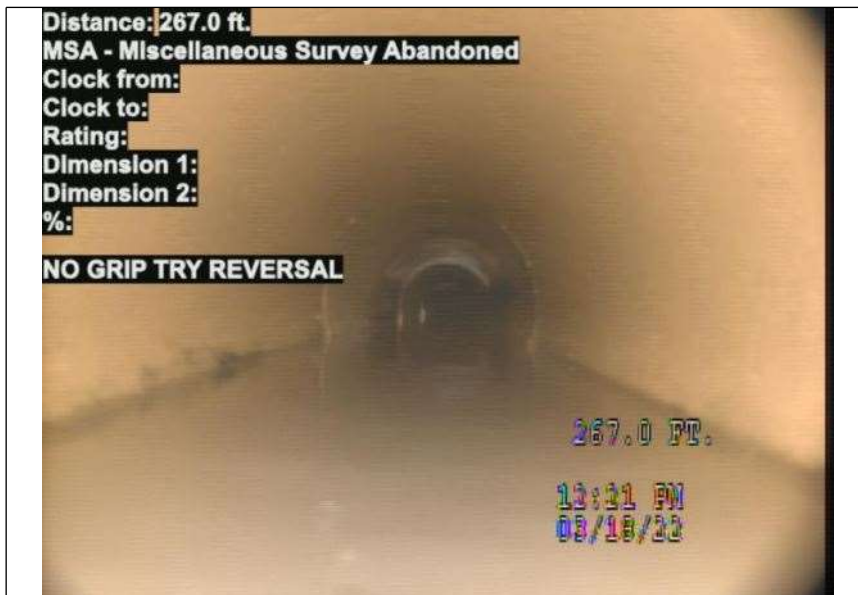
At: 267 ft. MSA - Miscellaneous Survey Abandoned  
Joint: No NO GRIP TRY REVERSAL
