PACP Report with Pipe Run and Incident Snapshots

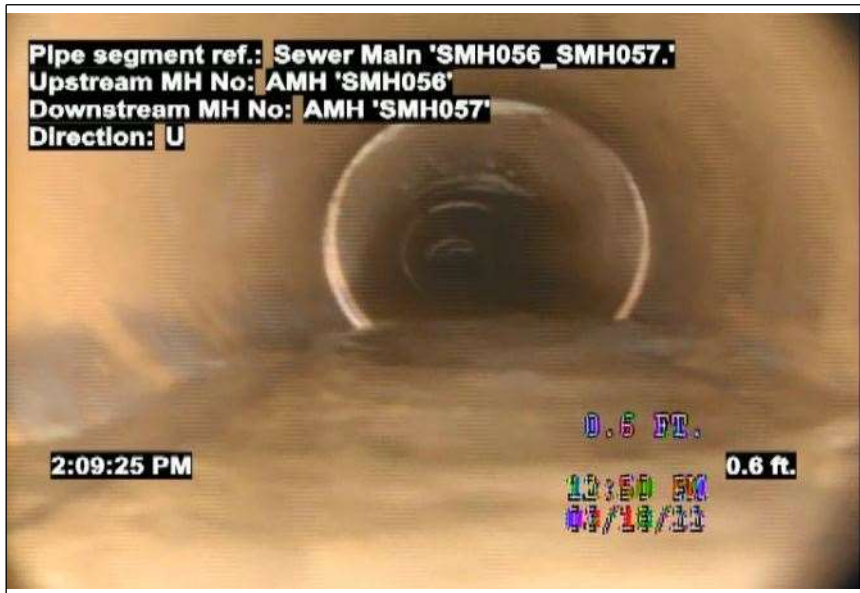
At: 0 ft. MWL - Miscellaneous Water Level
 Joint: No 5 %

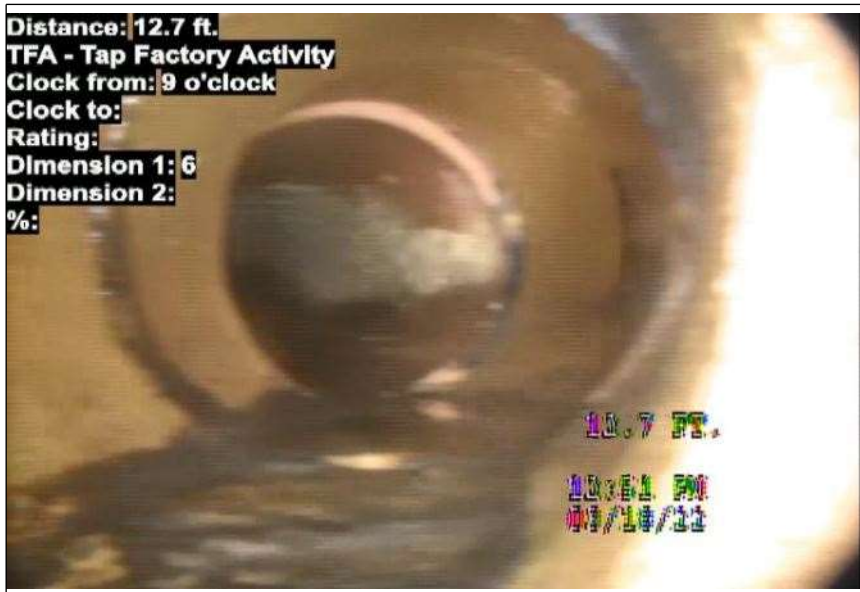
At: 12.7 ft. 9/. TFA - Tap Factory Activity
 Joint: No

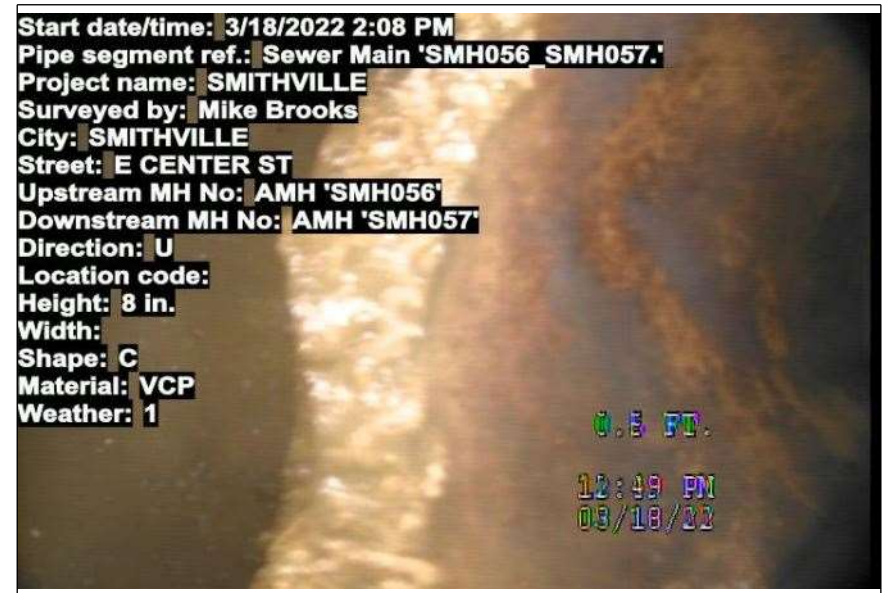
At: 0 ft. AMH - Manhole
 Joint: No SMH057

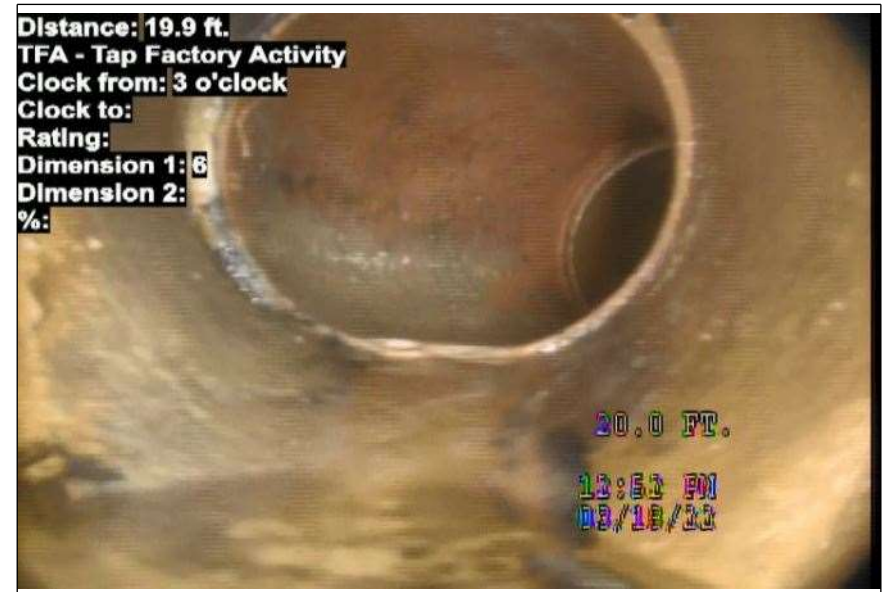
At: 19.9 ft. 3/. TFA - Tap Factory Activity
 Joint: No

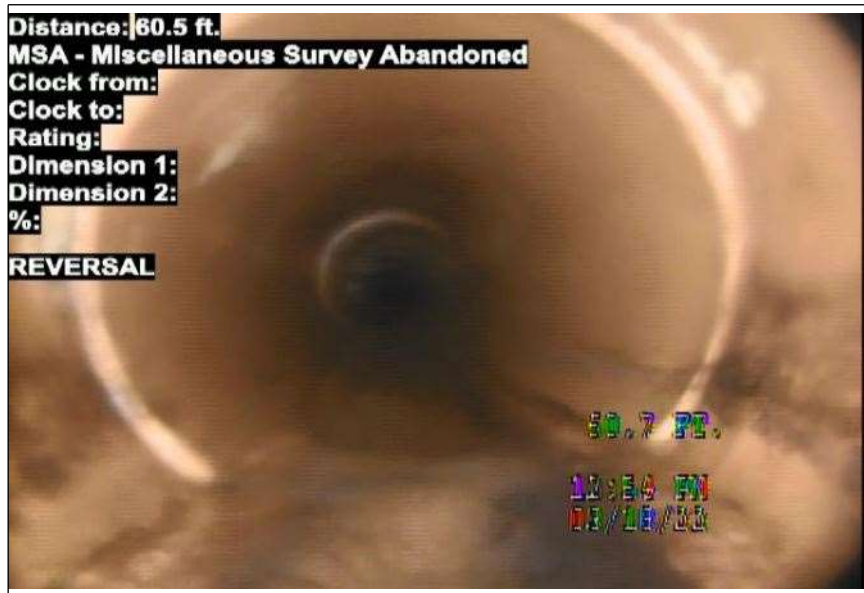
At: 60.5 ft. MSA - Miscellaneous Survey Abandoned
Joint: No REVERSAL COMPLETE
