PACP Report with Pipe Run and Incident Snapshots

Surveyed by: Mike Brooks	Certificate number: Mike Brooks	Owner:	Customer:	Drainage area:	P/O number:	Sheet number:
Pipe segment ref.: SMH057_SMH057A	Start date/time: 20220318 14:28	Street: E CENTER ST		City: SMITHVILLE		
Location details: STREET	Upstream MH No: SMH057	Rim to invert:	Grade to invert:	Rim to grade:		
Pipe use: SS	Direction: D	Flow control:	Downstream MH No: SMH057A	Rim to invert:	Grade to invert:	Rim to grade:
Height: 8 in.	Width:	Shape: C	Material: VCP	Lining method:	Pipe joint length:	Total length: 391.400 ft.
Media label:	PreCleaning: L	Date cleaned:	Weather: 1	Purpose:	Sewer category:	
Project name: Sewer Cleaning & CCTV - Project No. 210670	Additional info:

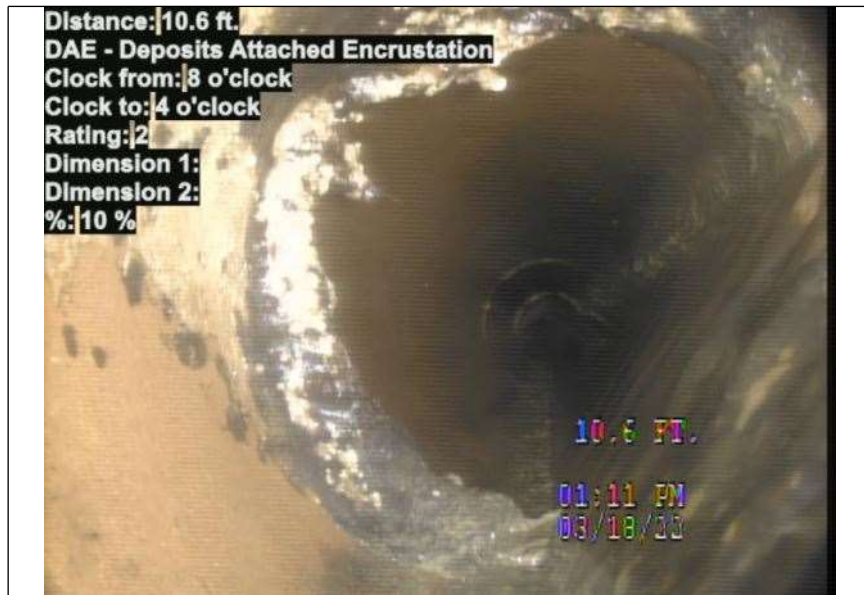
At: 10.6 ft. 8/4 DAE - Deposits Attached Encrustation
 Joint: No 10 %

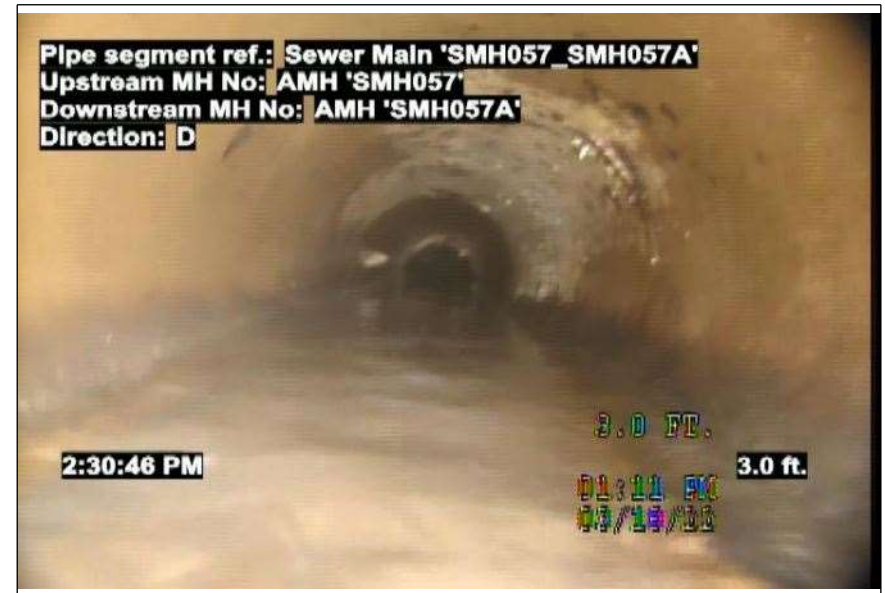
At: 0 ft. MWL - Miscellaneous Water Level
 Joint: No 5 %

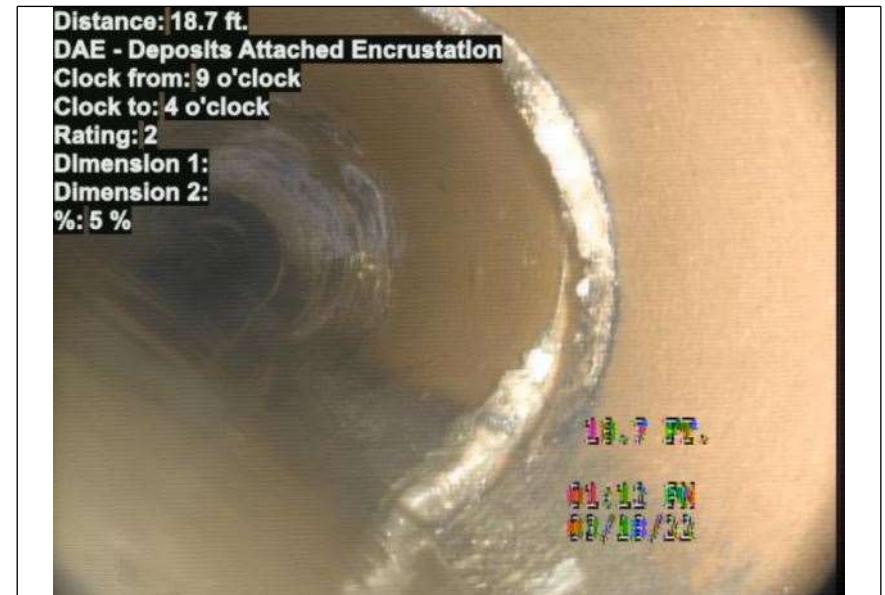
At: 18.7 ft. 9/4 DAE - Deposits Attached Encrustation
 Joint: No 5 %

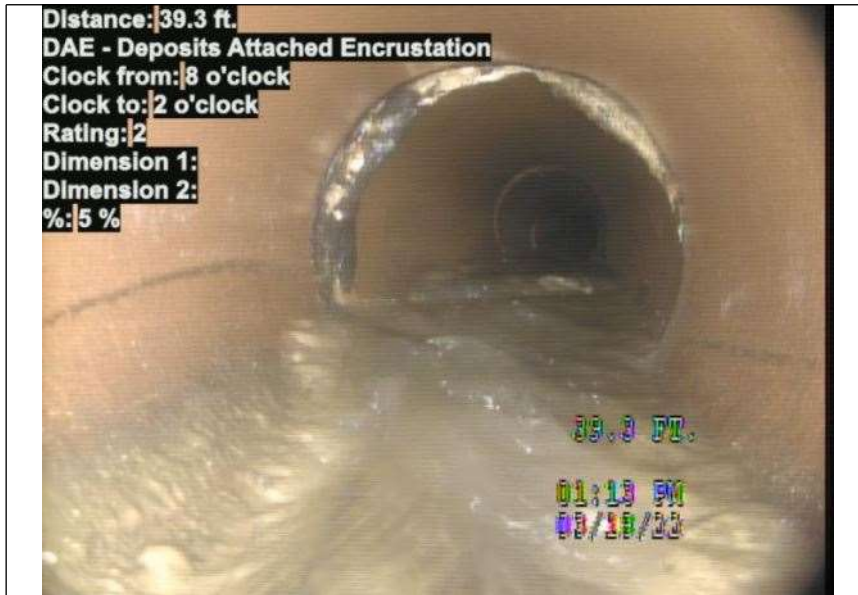
At: 39.3 ft. 8/2 DAE - Deposits Attached Encrustation
Joint: No 5 %

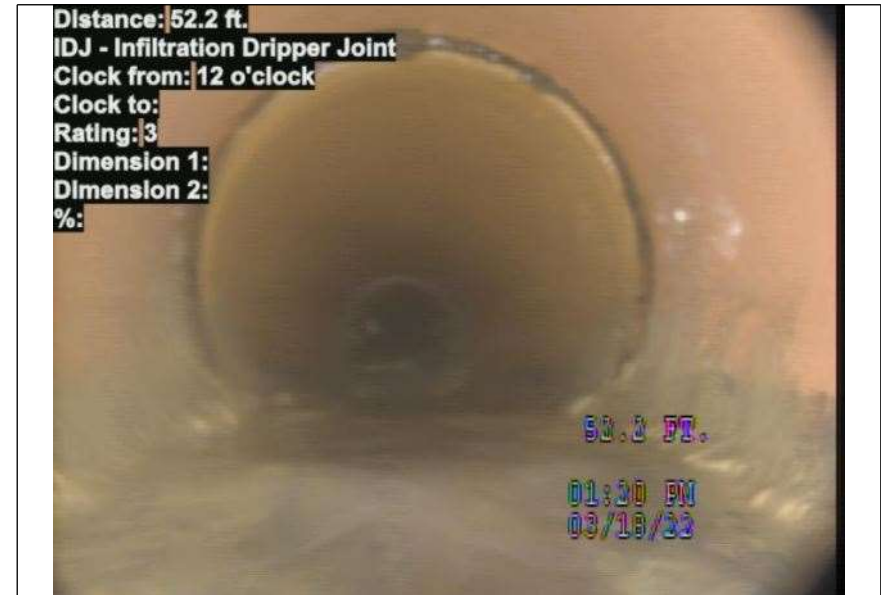
At: 52.2 ft. 12/ IDJ - Infiltration Dripper Joint
Joint: Yes

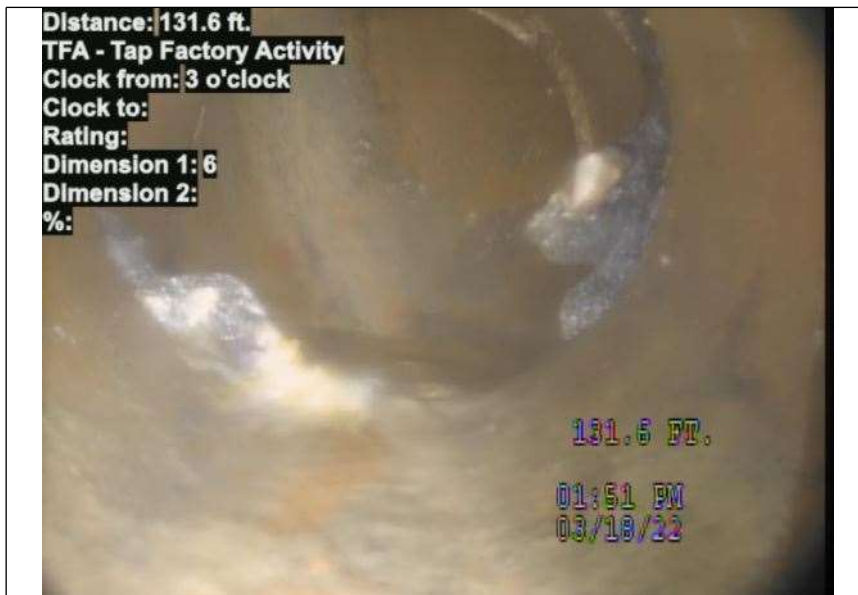
At: 131.6 ft. 3/ TFA - Tap Factory Activity
Joint: No

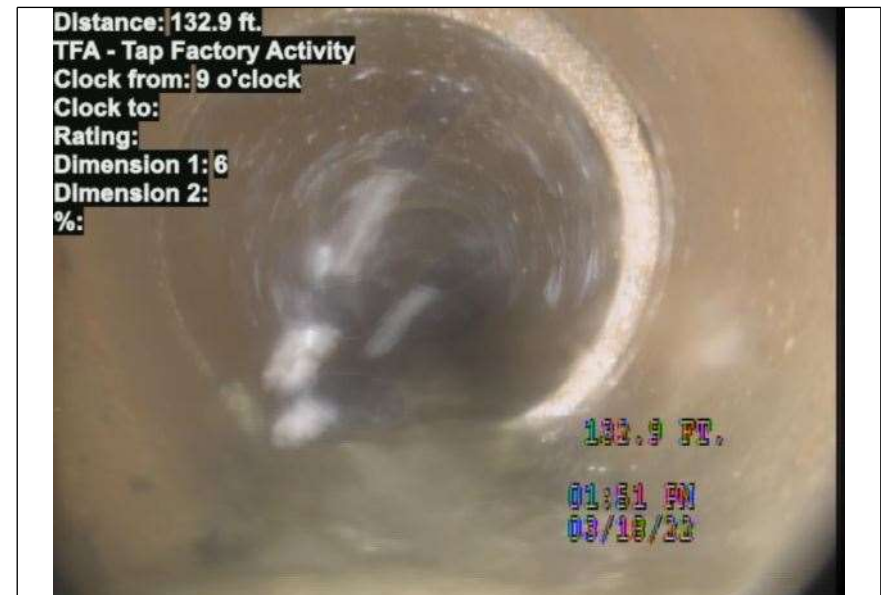
At: 132.9 ft. 9/ TFA - Tap Factory Activity
Joint: No

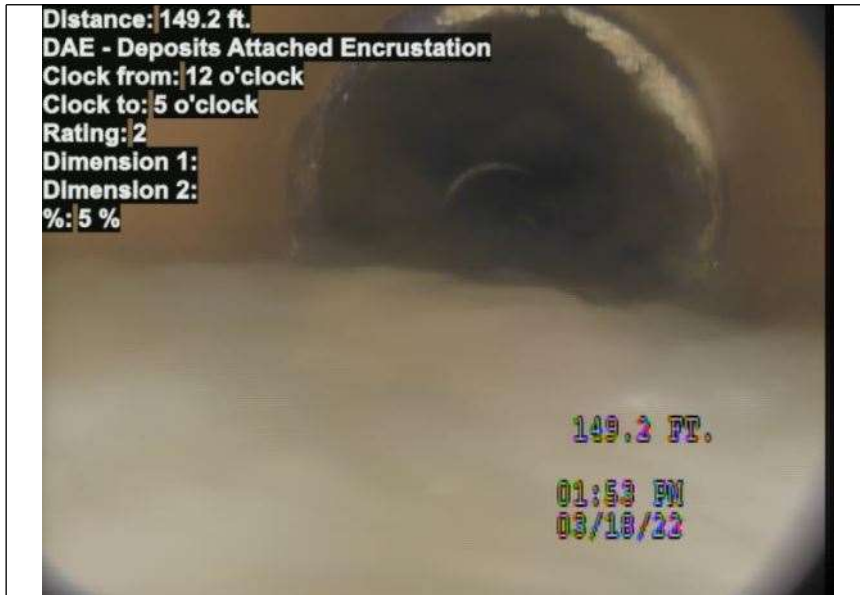
At: 149.2 ft. DAE - Deposits Attached Encrustation
12/5

Joint: No 5 %

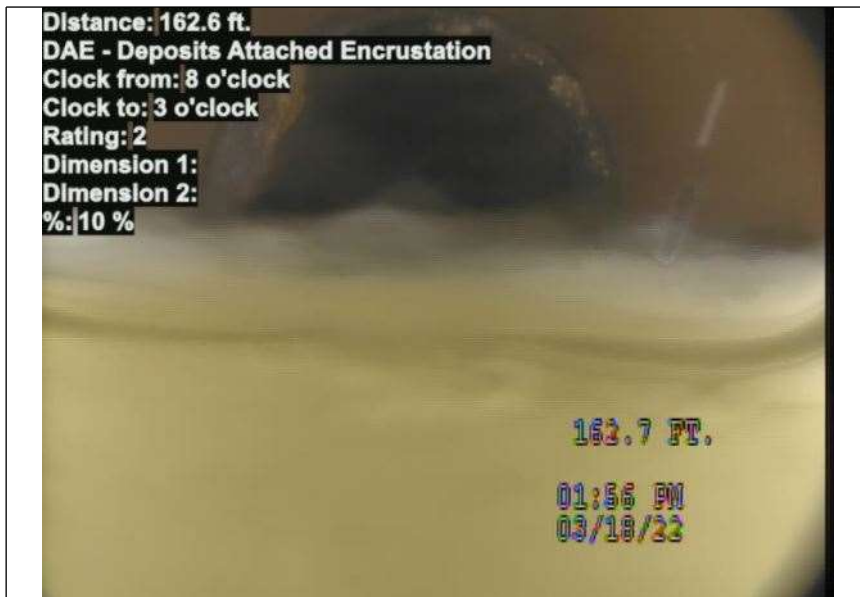
At: 162.6 ft. 8/3 DAE - Deposits Attached Encrustation

Joint: No 10 %

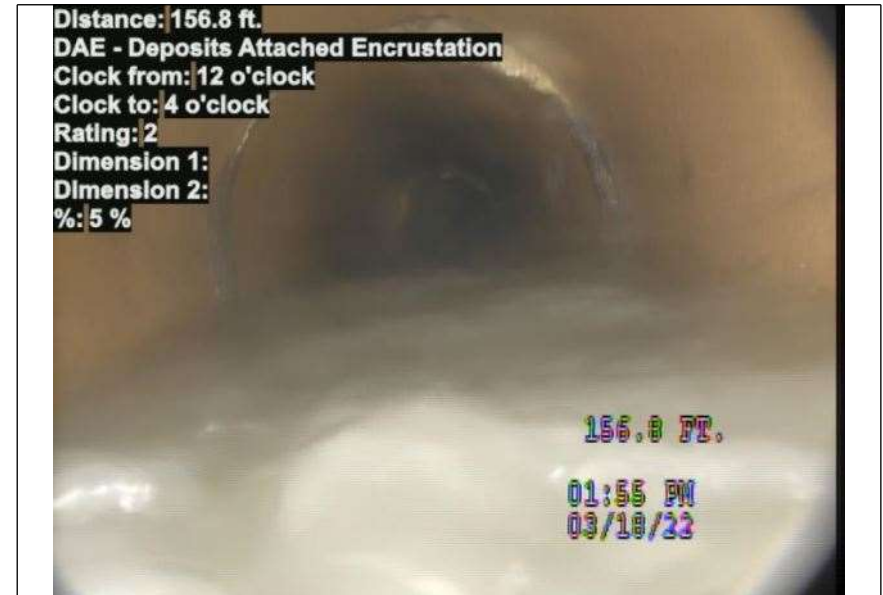
At: 156.8 ft. DAE - Deposits Attached Encrustation
12/4

Joint: No 5 %

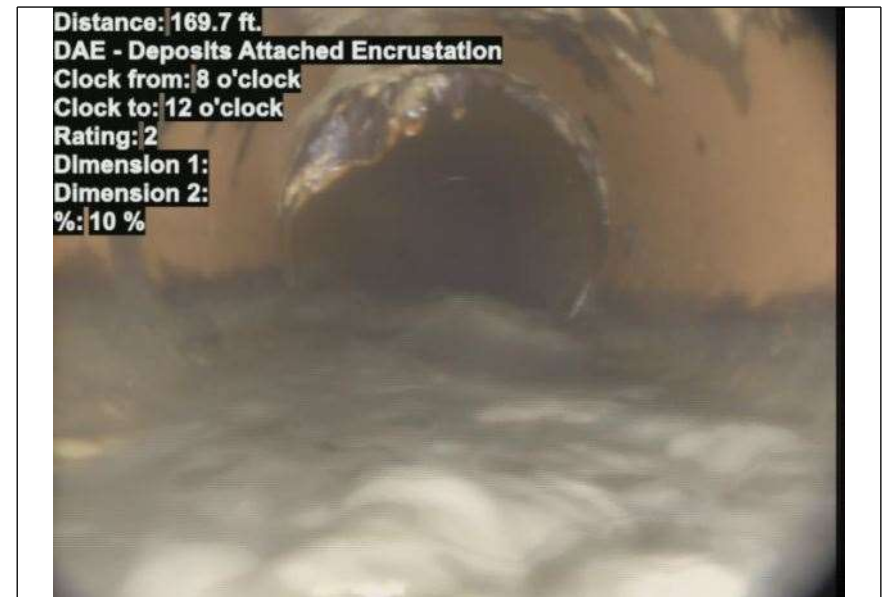
At: 169.7 ft. DAE - Deposits Attached Encrustation
8/12

Joint: No 10 %

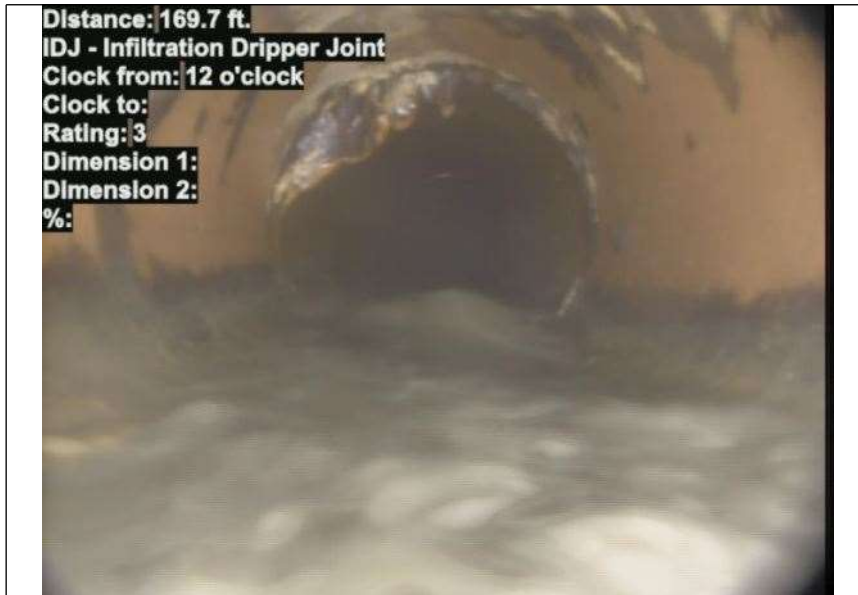
At: 169.7 ft. 12/. IDJ - Infiltration Dripper Joint
Joint: Yes

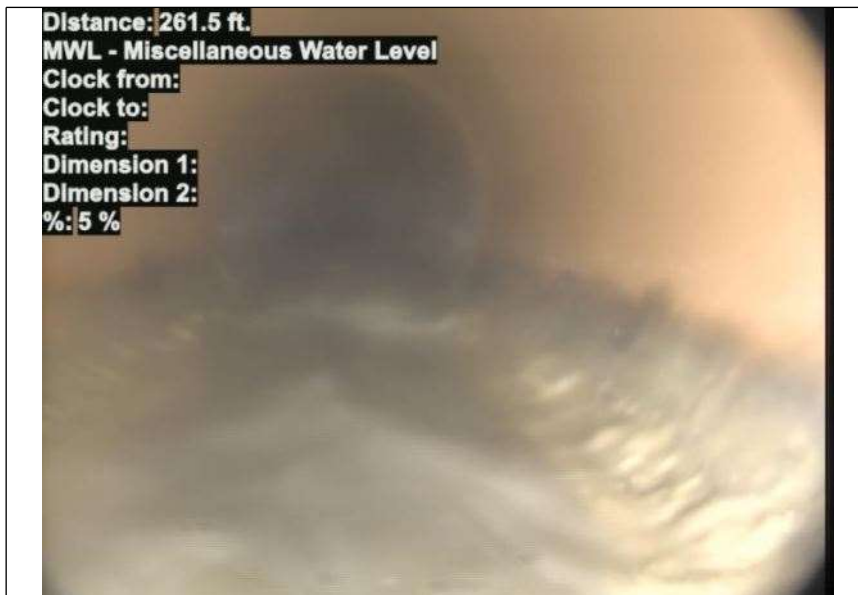
At: 261.5 ft. MWL - Miscellaneous Water Level
Joint: No 5 %

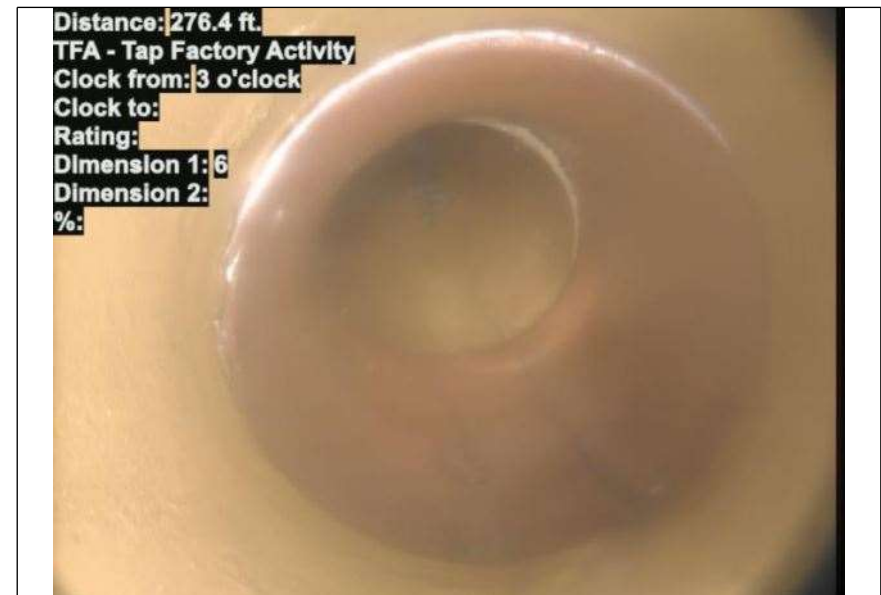
At: 276.4 ft. 3/. TFA - Tap Factory Activity
Joint: No

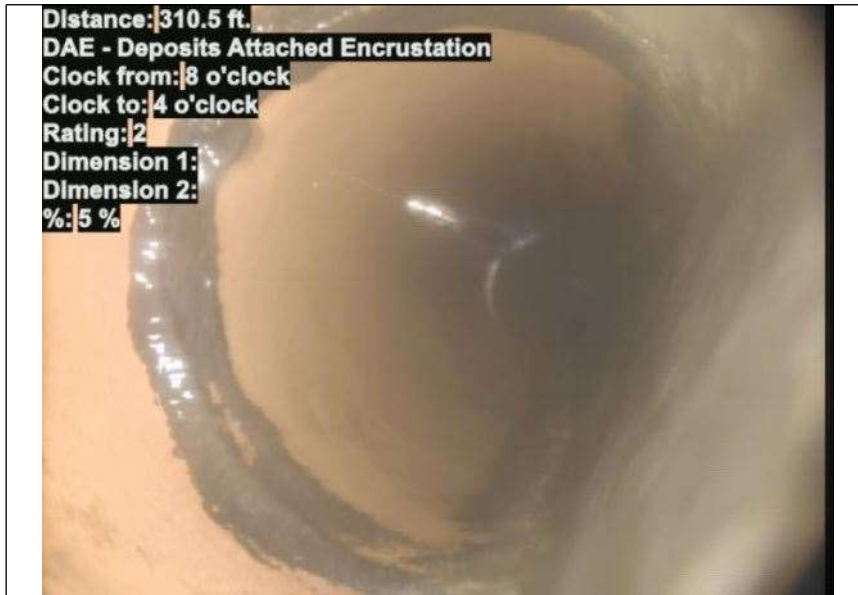
At: 310.5 ft. 8/4 DAE - Deposits Attached Encrustation
Joint: No 5 %

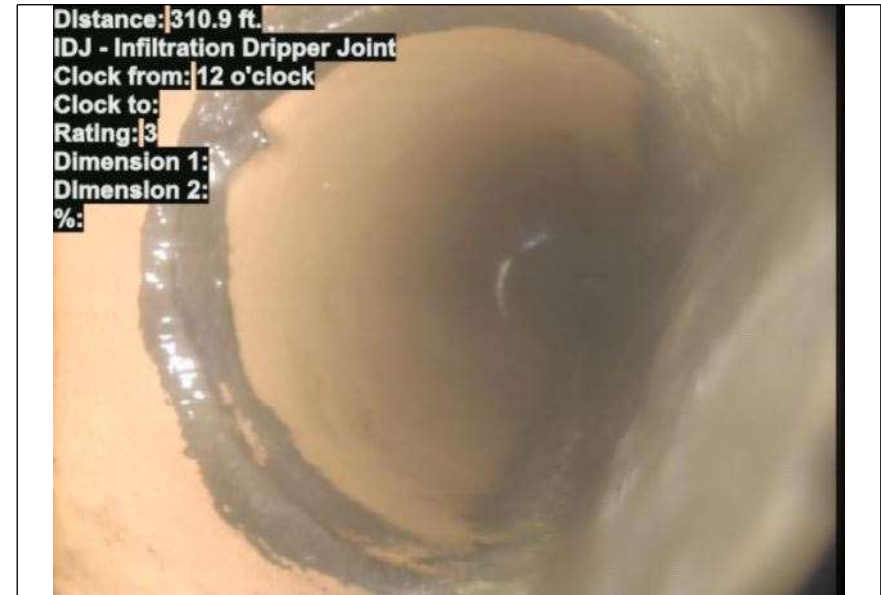
At: 310.9 ft. 12/. IDJ - Infiltration Dripper Joint
Joint: Yes

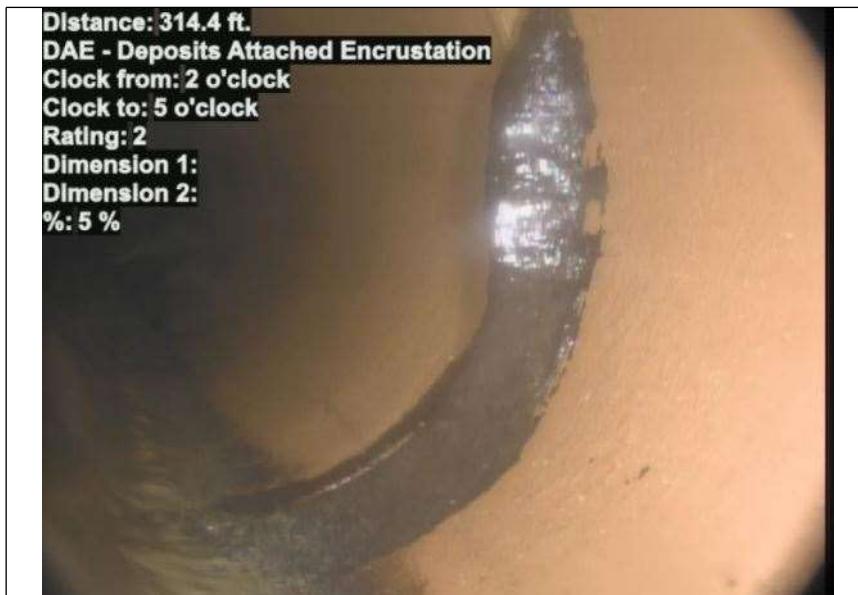
At: 314.4 ft. 2/5 DAE - Deposits Attached Encrustation
Joint: No 5 %

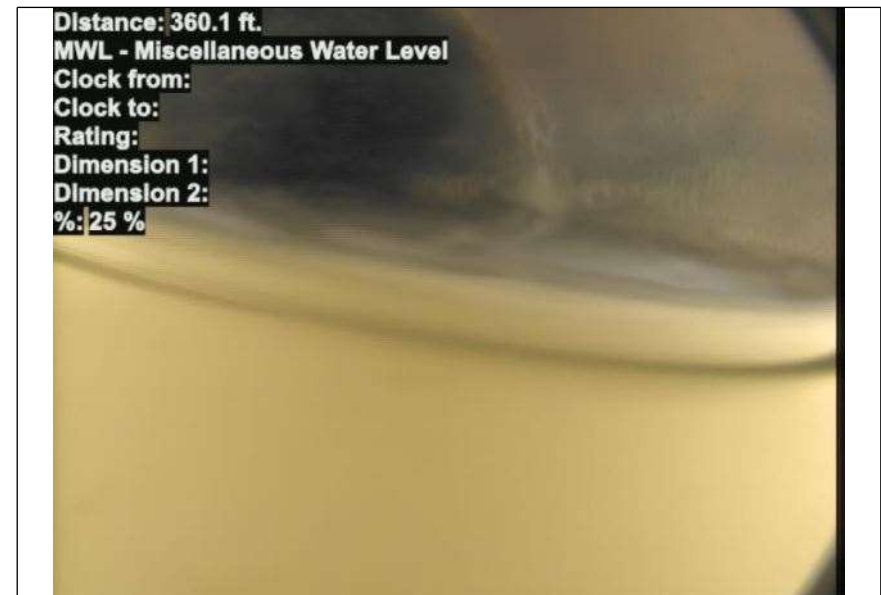
At: 360.1 ft. MWL - Miscellaneous Water Level
Joint: No 25 %

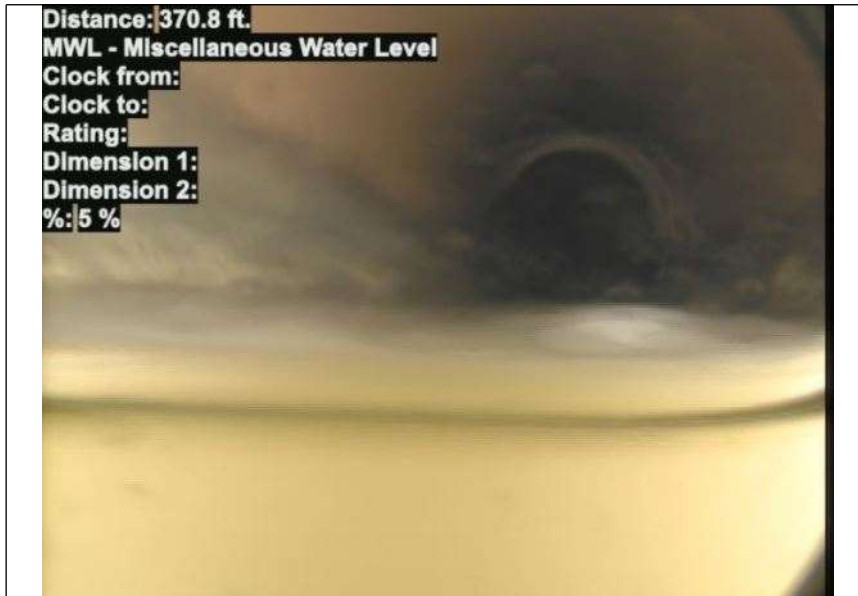
At: 370.8 ft. MWL - Miscellaneous Water Level
Joint: No 5 %

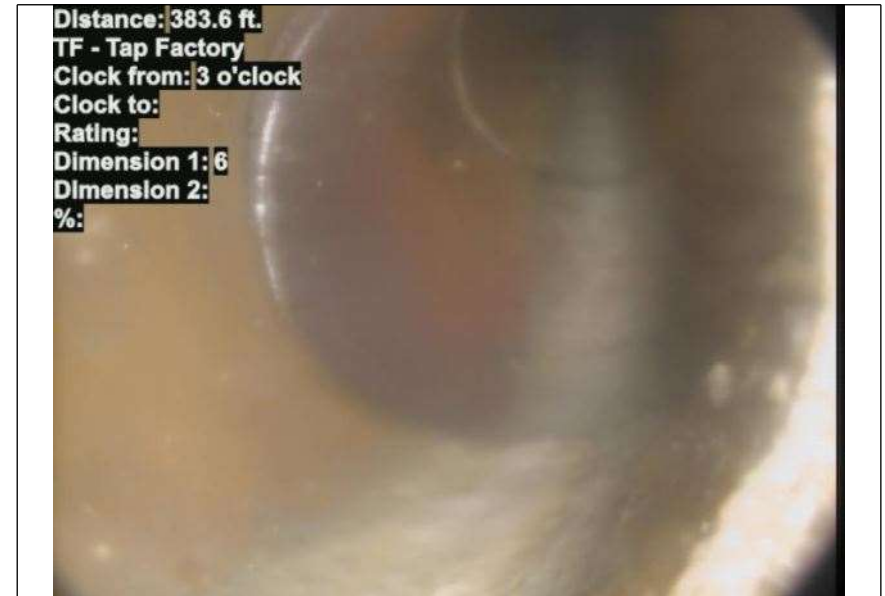
At: 383.6 ft. 3/. TF - Tap Factory
Joint: No
