## PACP Report with Pipe Run and Incident Snapshots

Surveyed by: <b>Mike Brooks</b>	Certificate number: <b>Mike Brooks</b>	Owner:	Customer:	Drainage area:	P/O number:	Sheet number:
Pipe segment ref.: <b>SMH066_SMH067</b>	Start date/time: <b>20220321 14:19</b>	Street: <b>PARKVIEW DR</b>	City: <b>SMITHVILLE</b>			
Location details: <b>STREET</b>	Upstream MH No: <b>SMH066</b>	Rim to invert:	Grade to invert:	Rim to grade:		
Pipe use: <b>SS</b>	Direction: <b>D</b>	Flow control:	Downstream MH No: <b>SMH067</b>	Rim to invert:	Grade to invert:	Rim to grade:
Height: <b>8 in.</b>	Width:	Shape: <b>C</b>	Material: <b>VCP</b>	Lining method:	Pipe joint length:	Total length: <b>379.900 ft.</b>
Length surveyed: <b>379.900 ft.</b>	Purpose:	Sewer category:				
Media label:	PreCleaning: <b>L</b>	Date cleaned:	Weather: <b>1</b>	Location code:	Pressure value:	
Project name: <b>Sewer Cleaning &amp; CCTV - Project No. 210670</b>	Additional info:

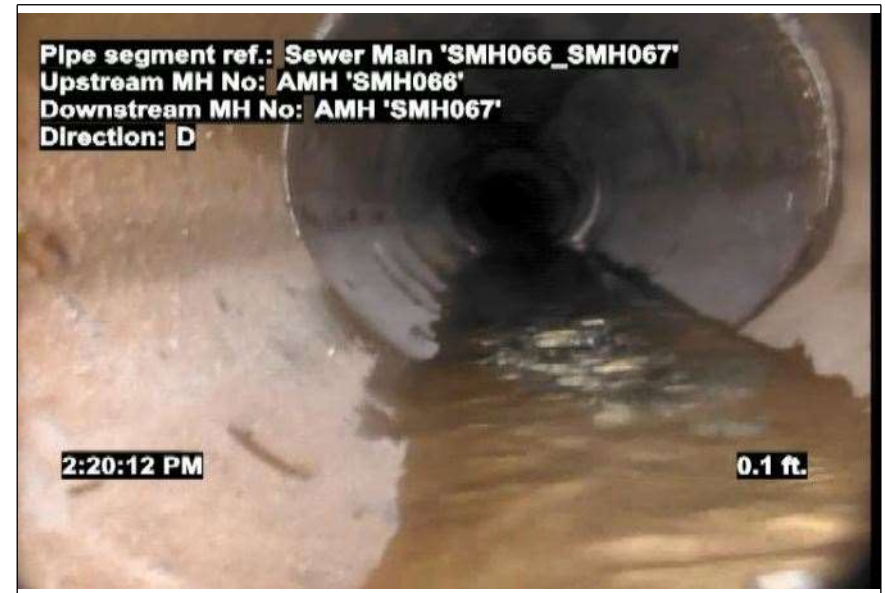
At: 0 ft. MWL - Miscellaneous Water Level  
 Joint: No 5 %

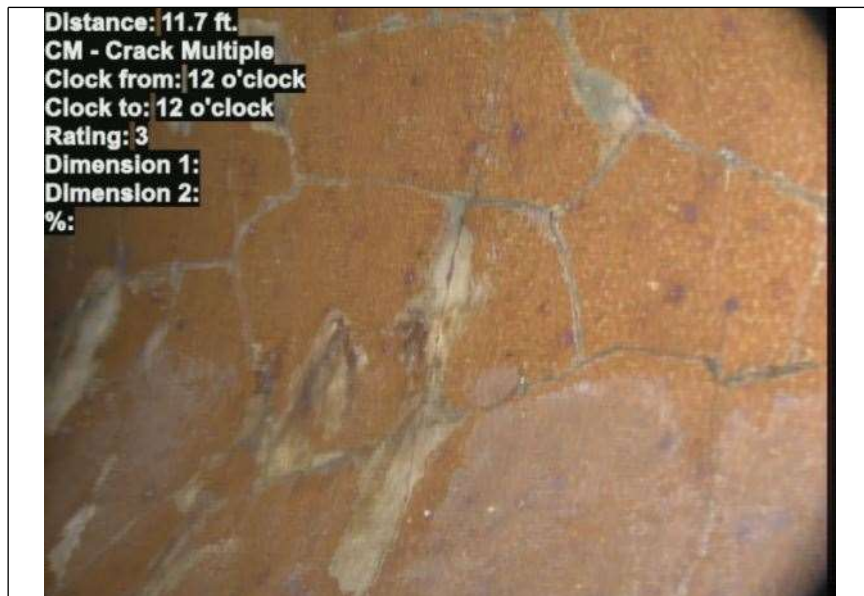
At: 11.7 ft. CM - Crack Multiple  
 12/12  
 Joint: No

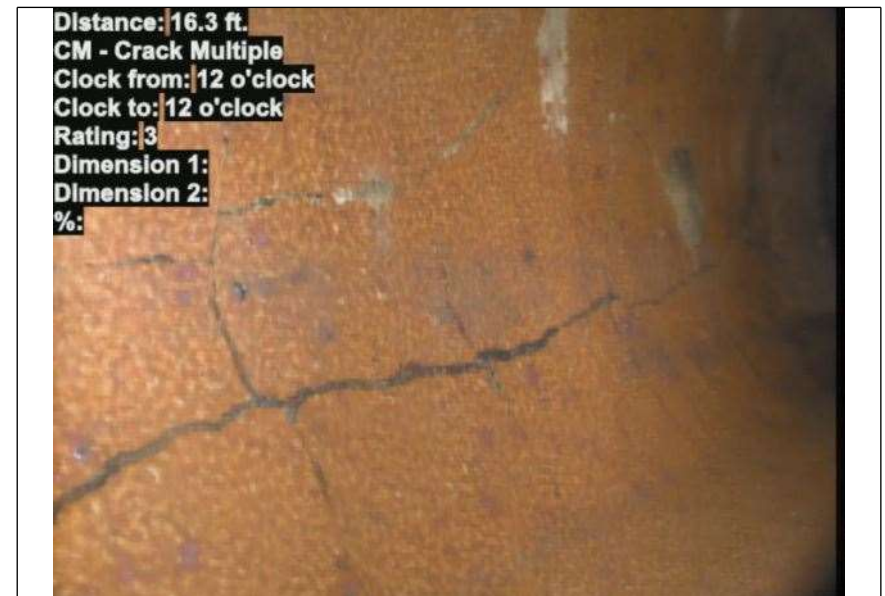
At: 16.3 ft. CM - Crack Multiple  
 12/12  
 Joint: No

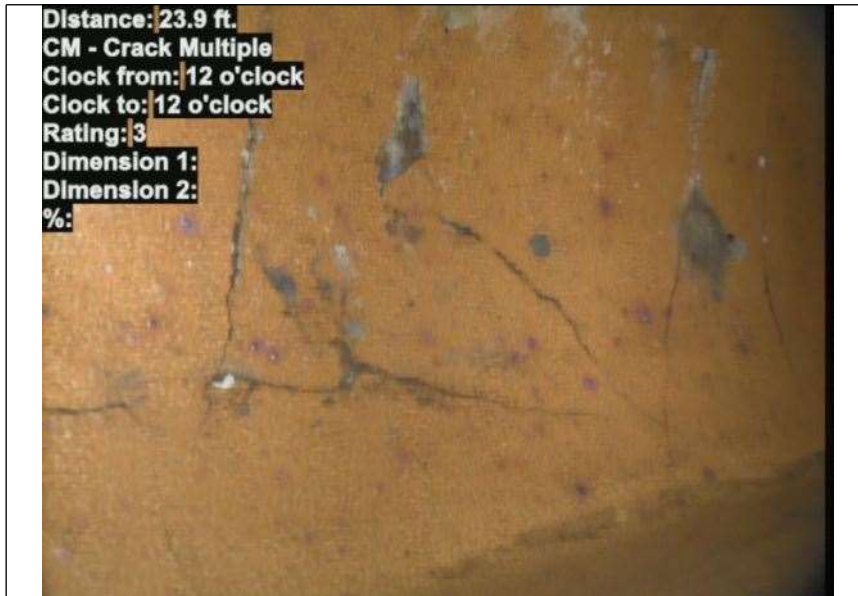
At: 23.9 ft. CM - Crack Multiple  
 12/12

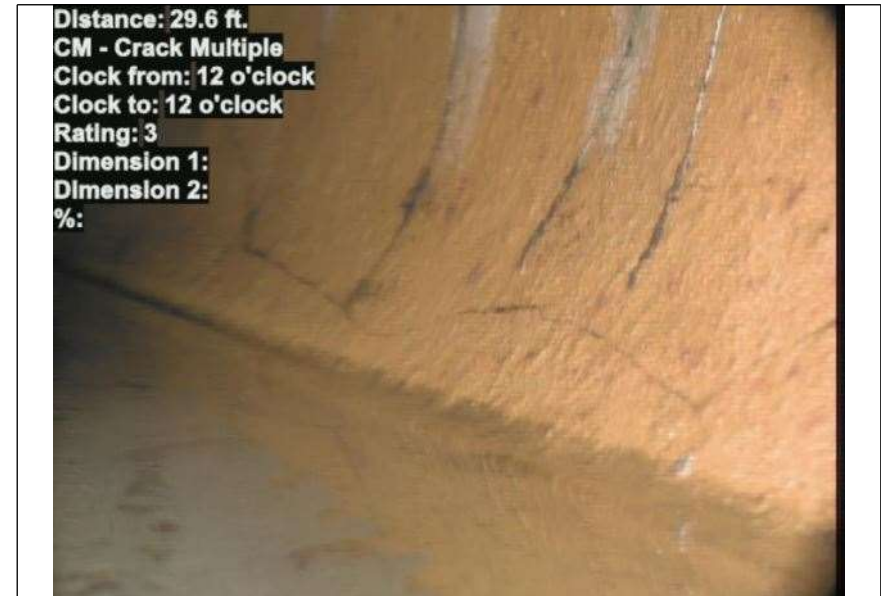
At: 29.6 ft. CM - Crack Multiple  
 12/12

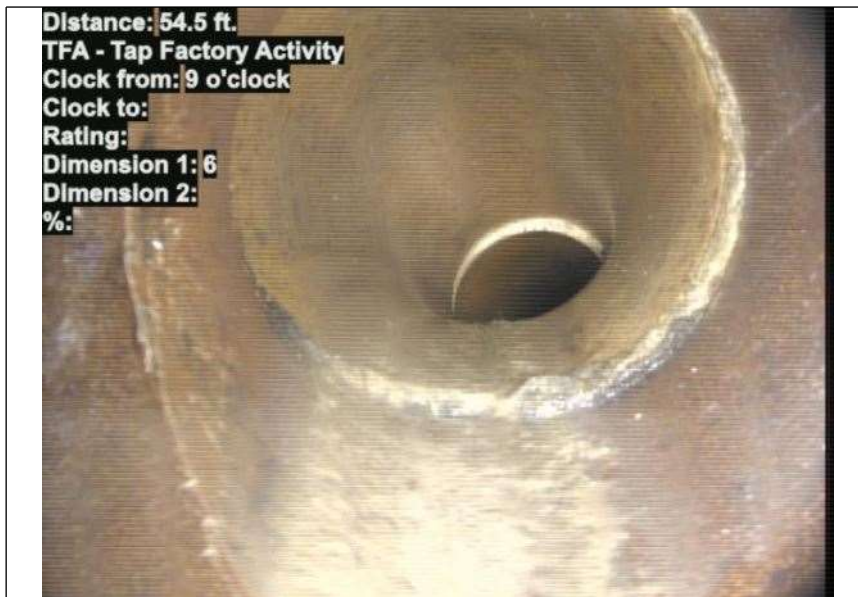
At: 54.5 ft. 9/. TFA - Tap Factory Activity

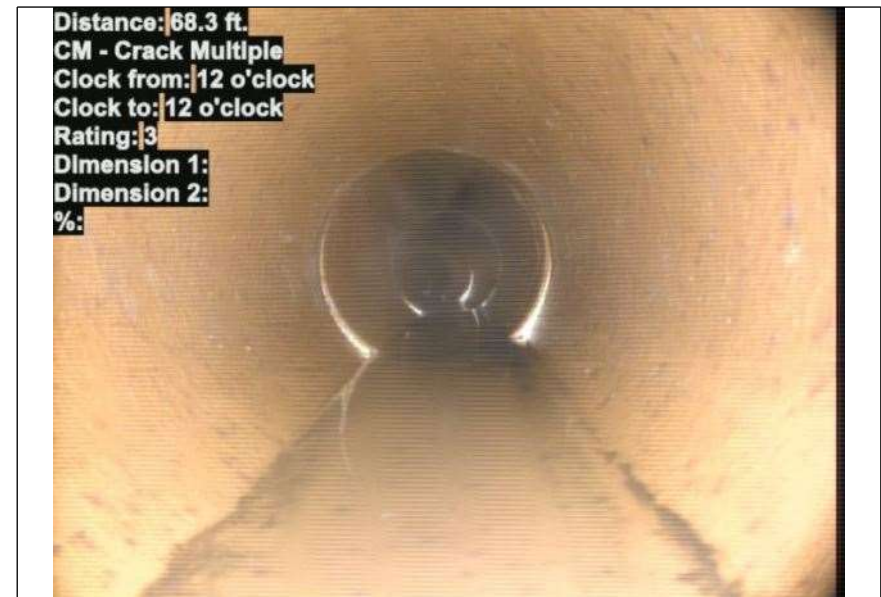
At: 68.3 ft. CM - Crack Multiple

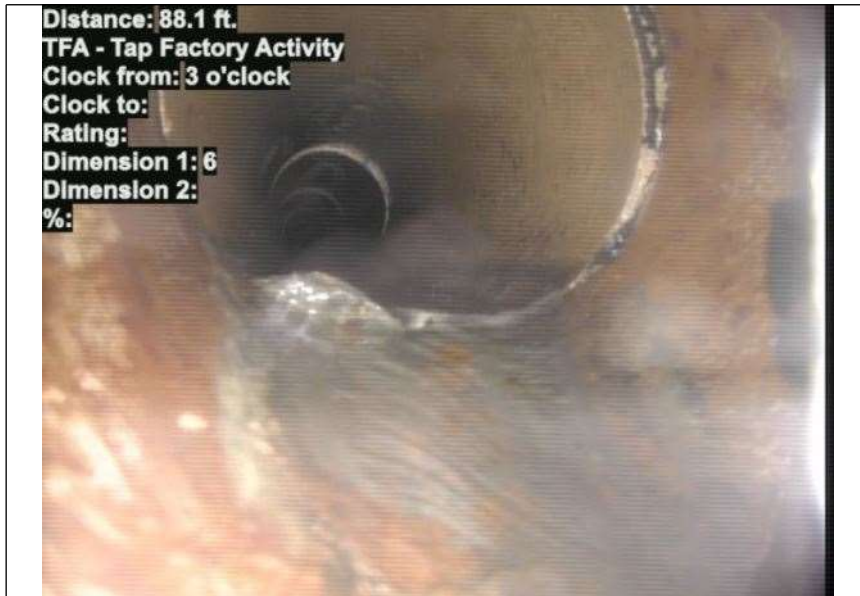
At: 88.1 ft. 3/. TFA - Tap Factory Activity  
Joint: No

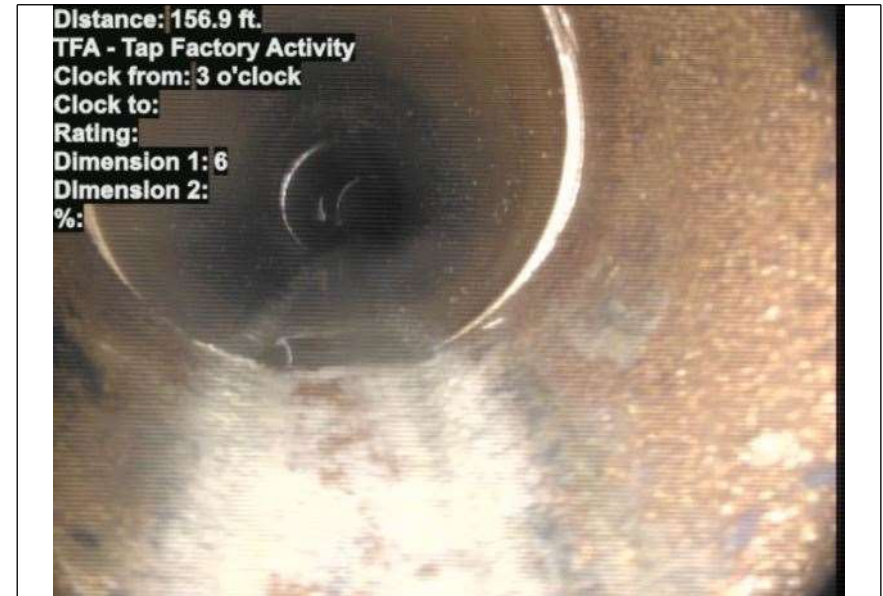
At: 156.9 ft. 3/. TFA - Tap Factory Activity  
Joint: No

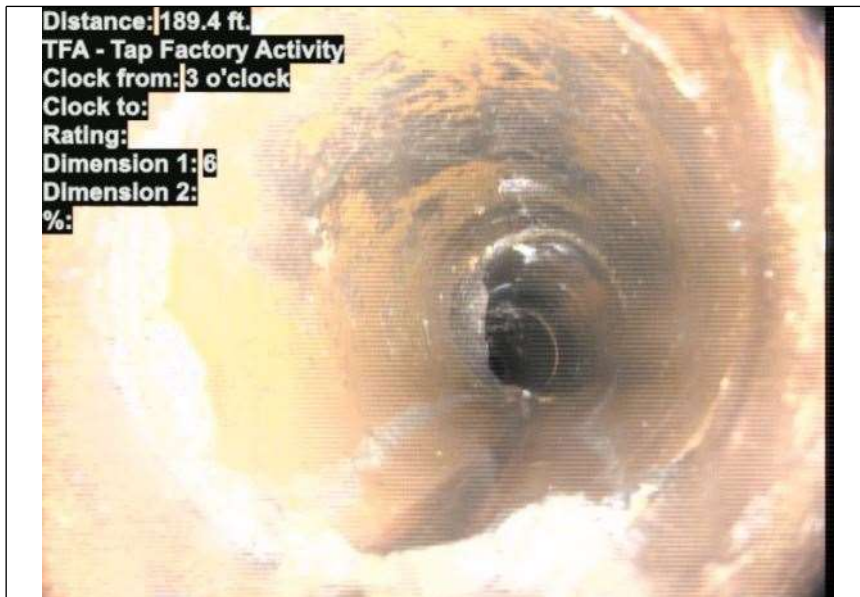
At: 189.4 ft. 3/. TFA - Tap Factory Activity  
Joint: No

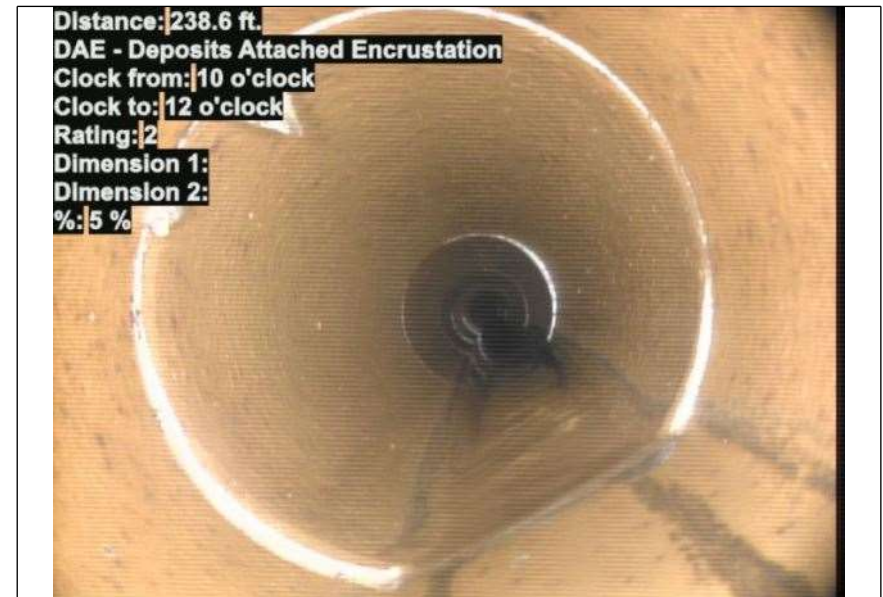
At: 238.6 ft. 10/12 DAE - Deposits Attached Encrustation  
Joint: No 5 %

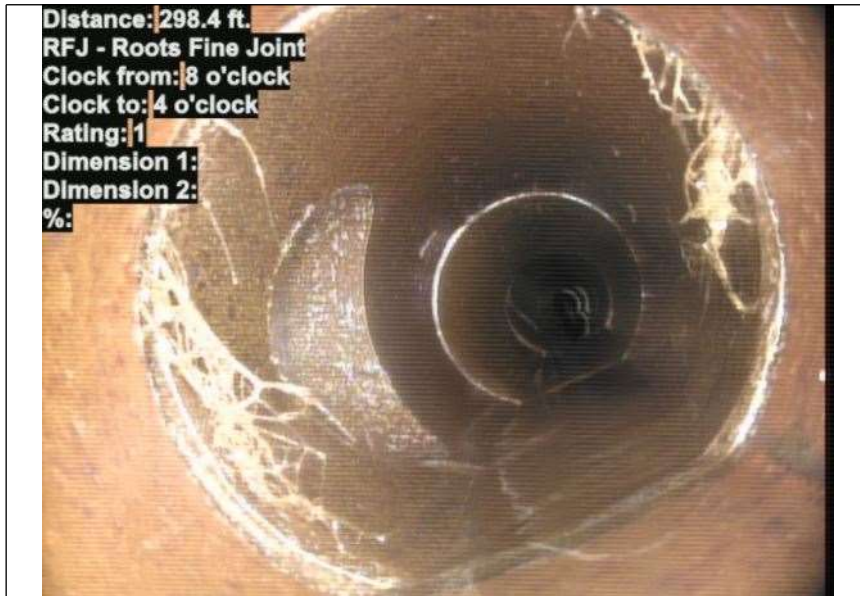
At: 298.4 ft. 8/4 RFJ - Roots Fine Joint  
 Joint: Yes

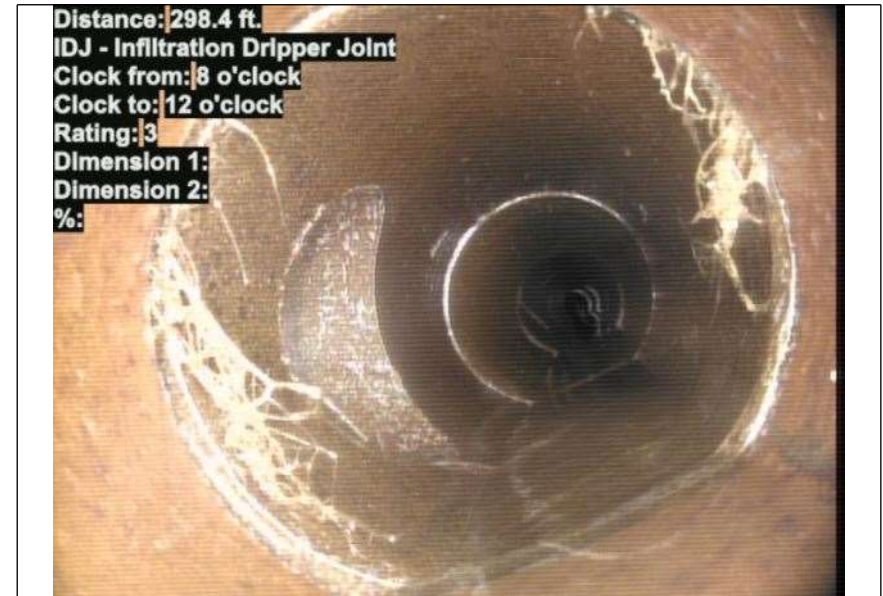
At: 298.4 ft. 8/12 IDJ - Infiltration Dripper Joint  
 Joint: Yes

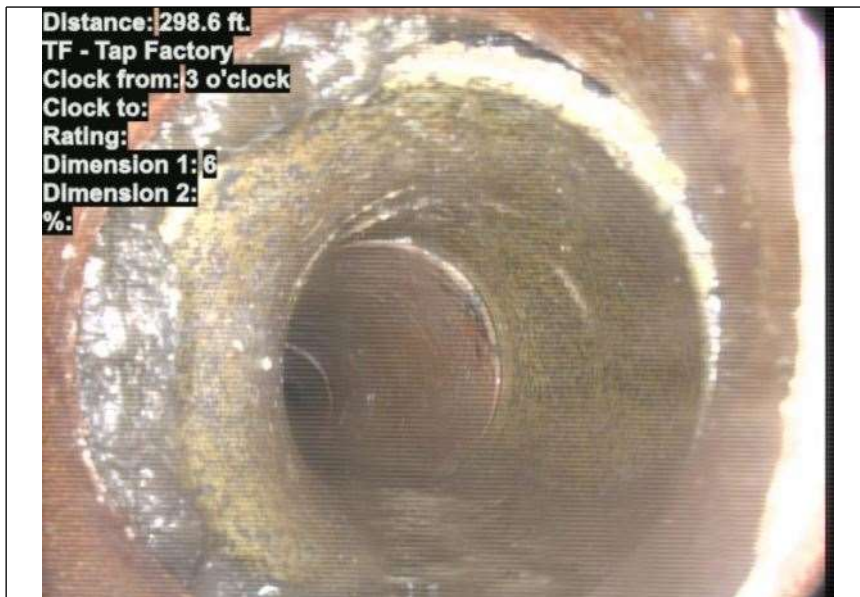
At: 298.6 ft. 3/. TF - Tap Factory  
 Joint: No

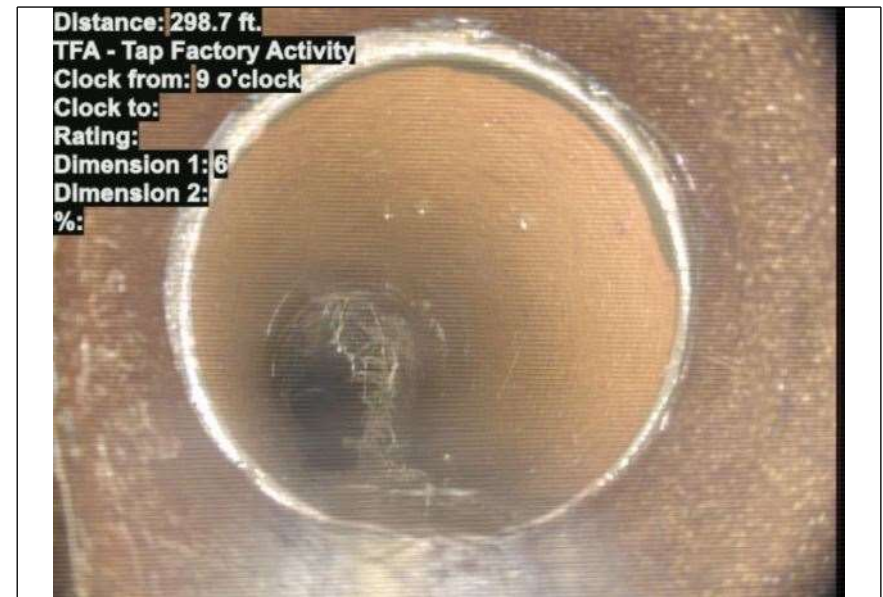
At: 298.7 ft. 9/. TFA - Tap Factory Activity  
 Joint: No

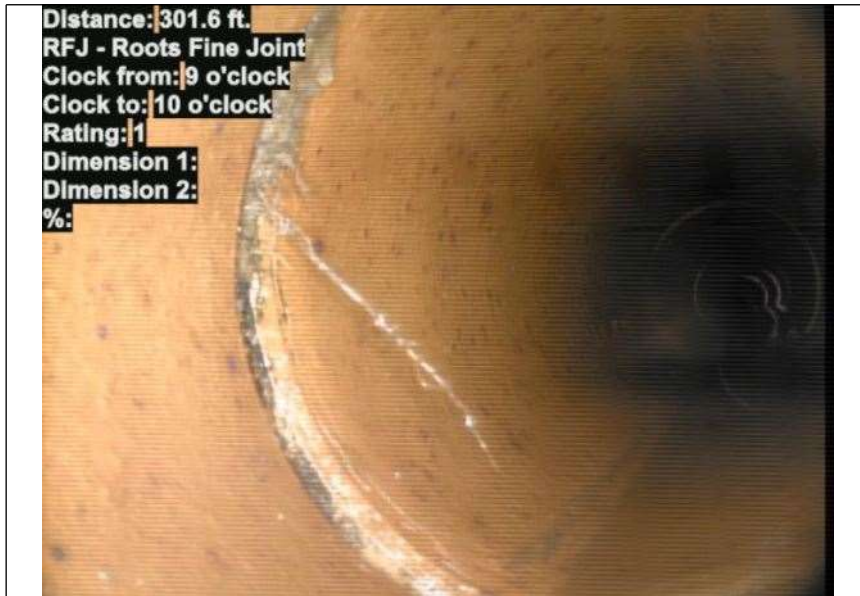
At: 301.6 ft. RFJ - Roots Fine Joint  
9/10

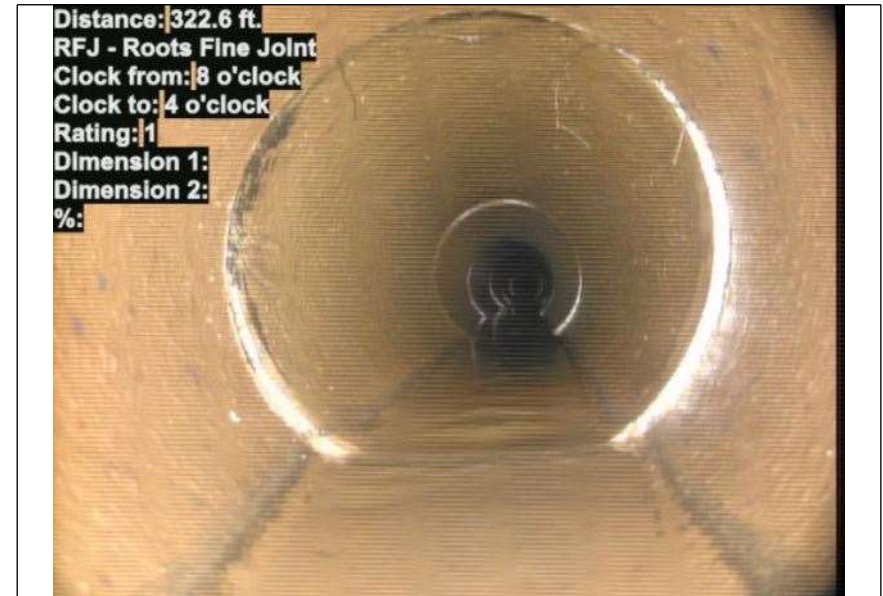
At: 322.6 ft. 8/4 RFJ - Roots Fine Joint

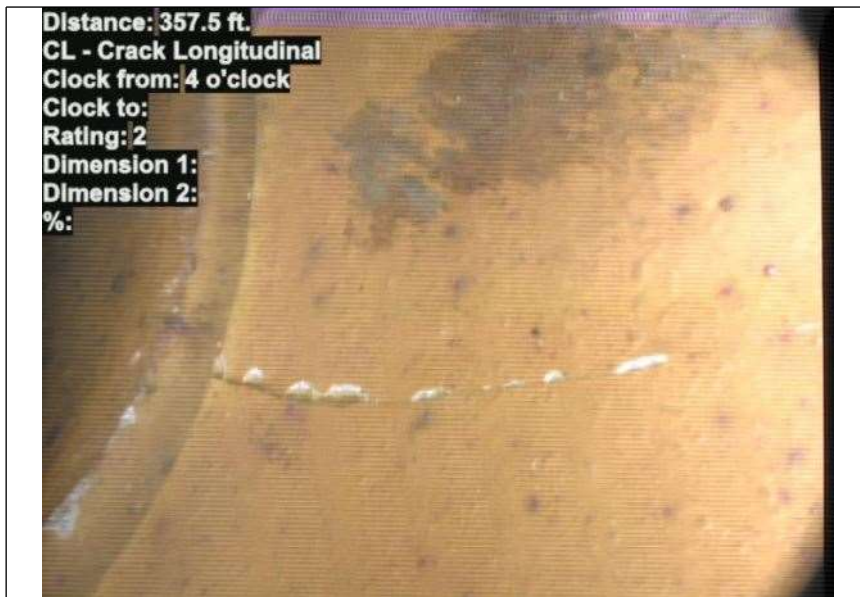
At: 357.5 ft. 4/. CL - Crack Longitudinal

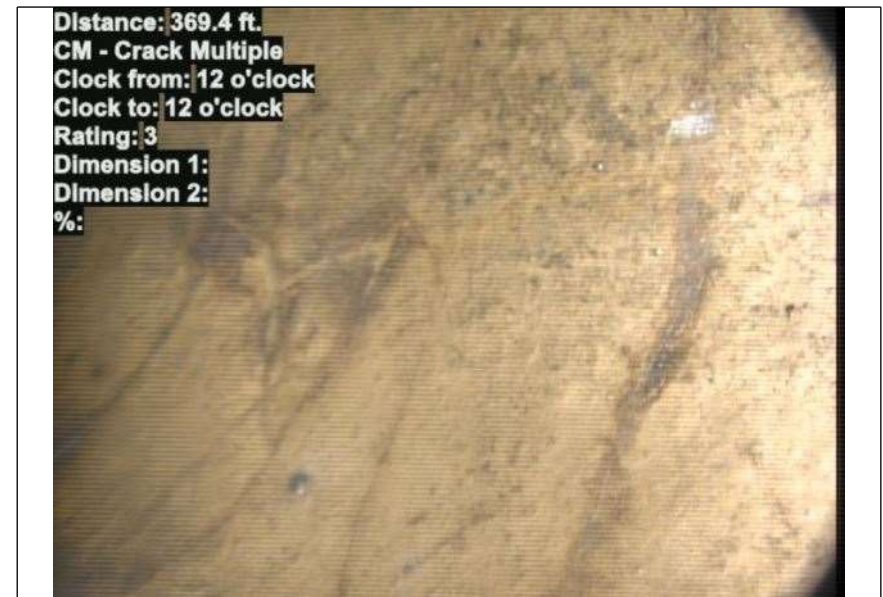
At: 369.4 ft. CM - Crack Multiple
