PACP Report with Pipe Run and Incident Snapshots

Surveyed by: Mike Brooks	Certificate number: Mike Brooks	Owner:	Customer:	Drainage area:	P/O number:	Sheet number:
Pipe segment ref.: SMH067_SMH068	Start date/time: 20220321 15:00	Street: PARKVIEW DR	City: SMITHVILLE			
Location details: STREET	Upstream MH No: SMH067	Rim to invert:	Grade to invert:	Rim to grade:		
Pipe use: SS	Direction: D	Flow control:	Downstream MH No: SMH068	Rim to invert:	Grade to invert:	Rim to grade:
Height: 8 in.	Width:	Shape: C	Material: VCP	Lining method:	Pipe joint length:	Total length: 299.700 ft.
Length surveyed: 257.700 ft.	Purpose:	Sewer category:				
Media label:	PreCleaning: L	Date cleaned:	Weather: 1	Location code:	Pressure value:	
Project name: Sewer Cleaning & CCTV - Project No. 210670	Additional info:

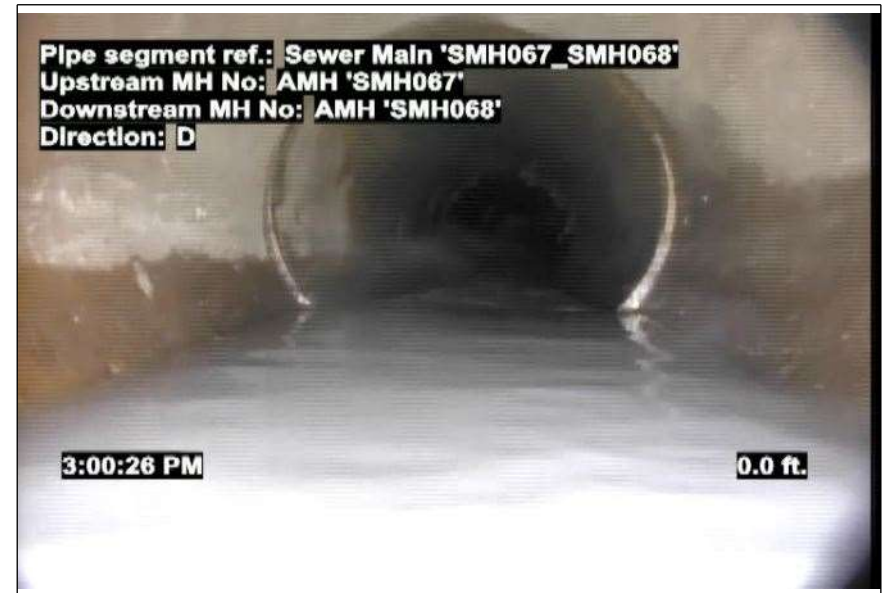
At: 0 ft. MWL - Miscellaneous Water Level
 Joint: No 5 %

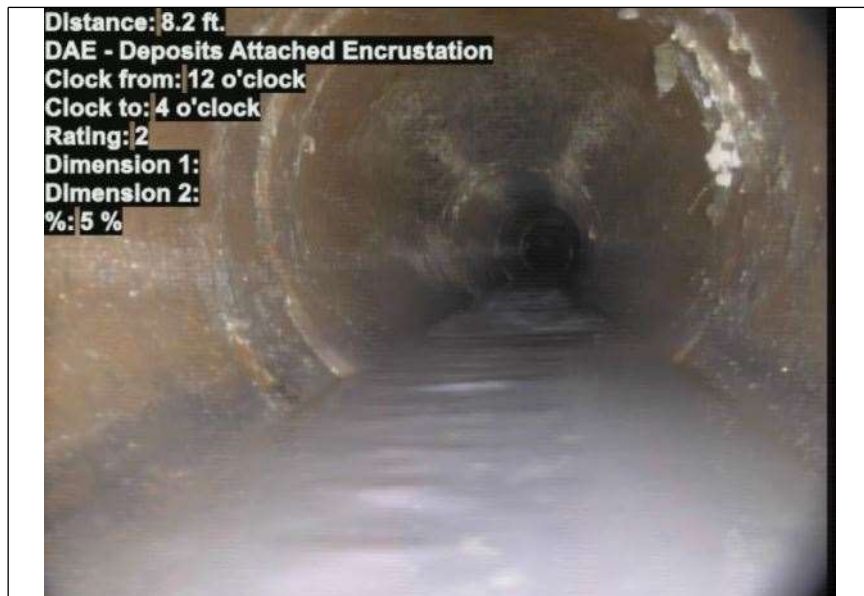
At: 8.2 ft. 12/4 DAE - Deposits Attached Encrustation
 Joint: No 5 %

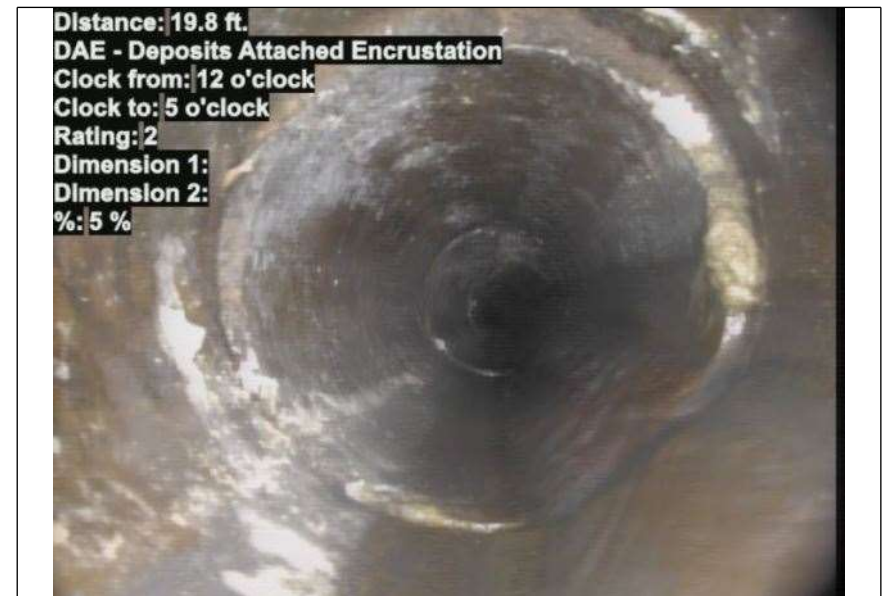
At: 19.8 ft. 12/5 DAE - Deposits Attached Encrustation
 Joint: No 5 %

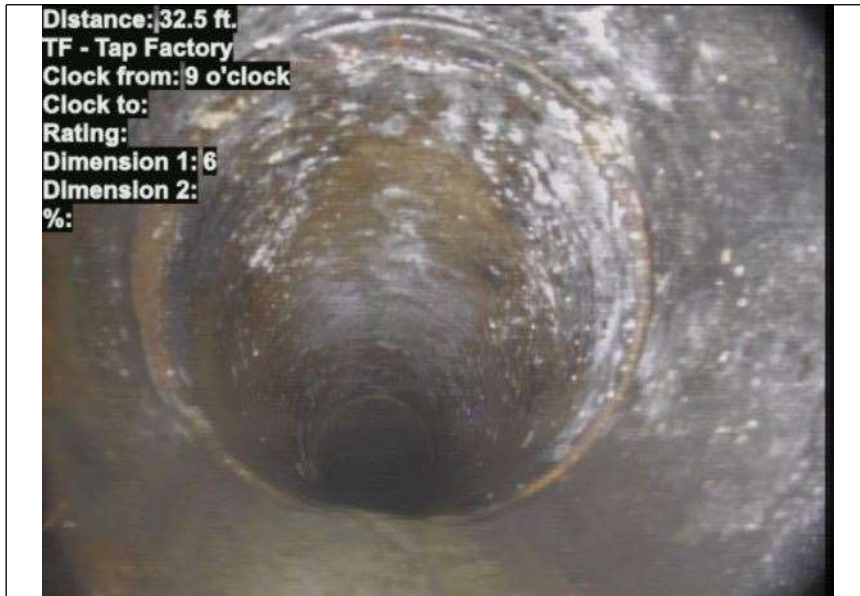
At: 32.5 ft. 9/ TF - Tap Factory
Joint: No

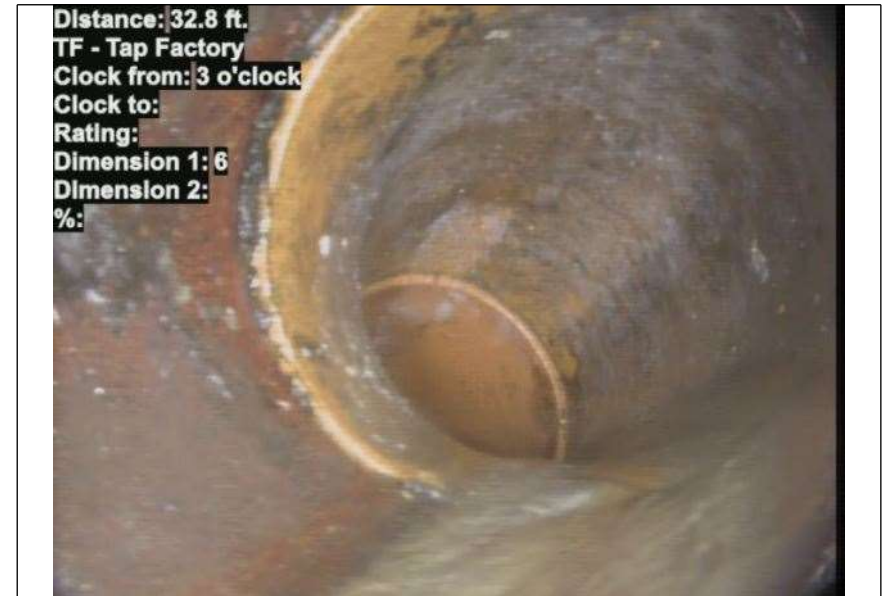
At: 32.8 ft. 3/ TF - Tap Factory
Joint: No

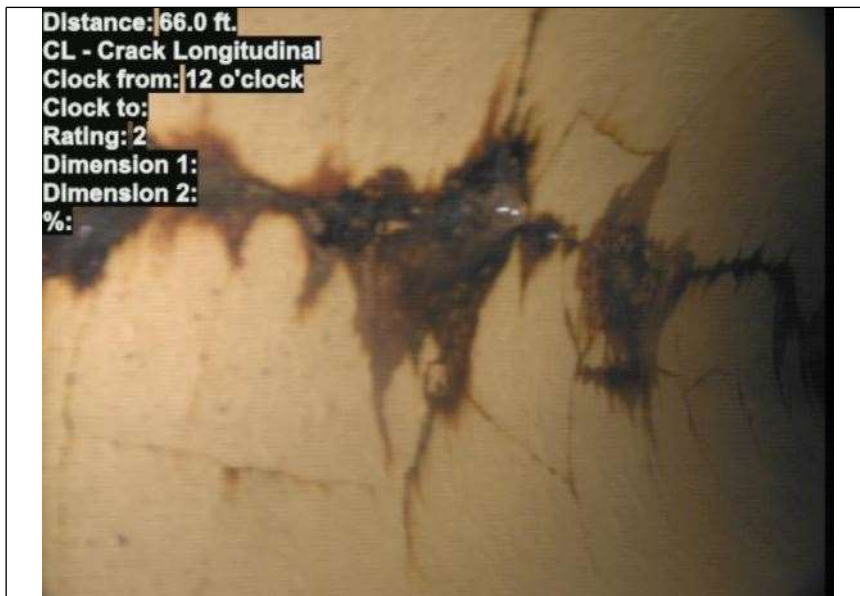
At: 66 ft. 12/ CL - Crack Longitudinal
Joint: No

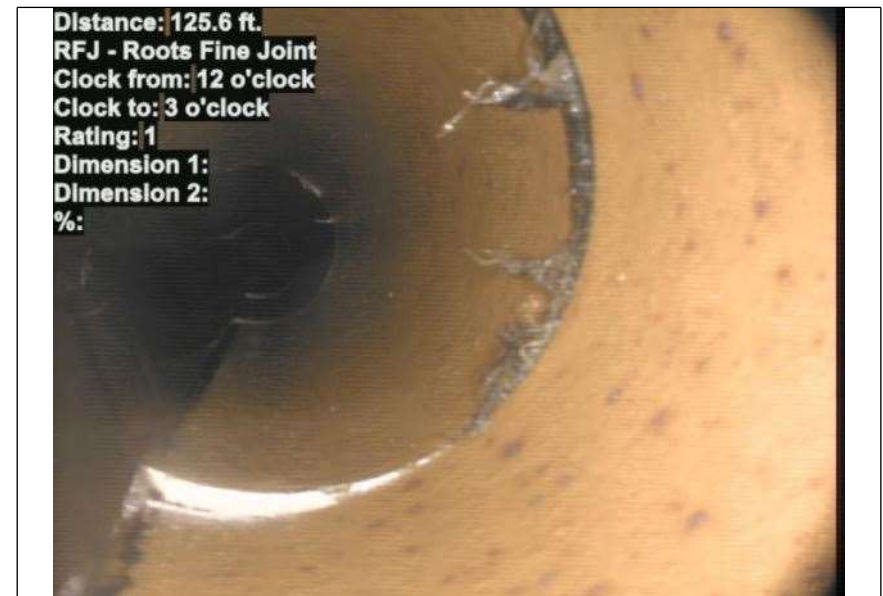
At: 125.6 ft. RFJ - Roots Fine Joint
12/3
Joint: Yes

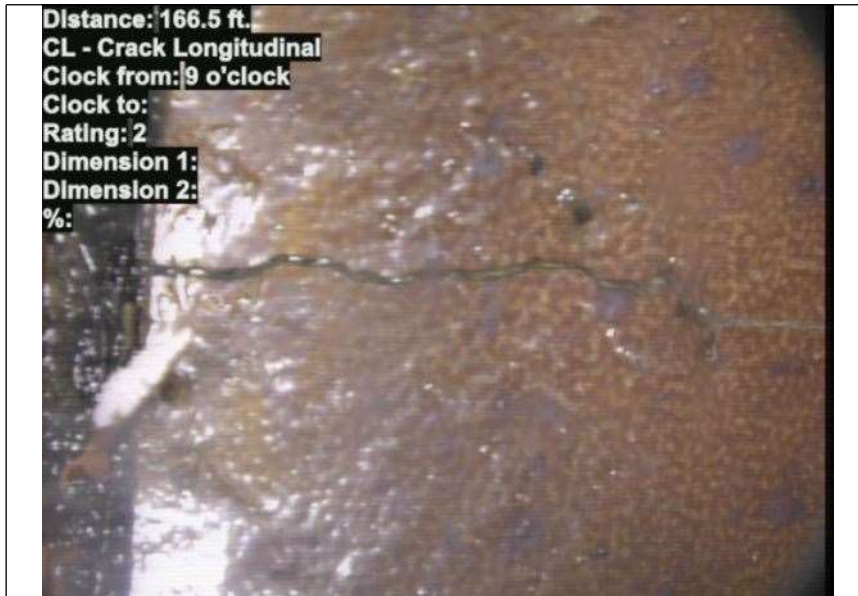
At: 166.5 ft. 9/. CL - Crack Longitudinal
Joint: No

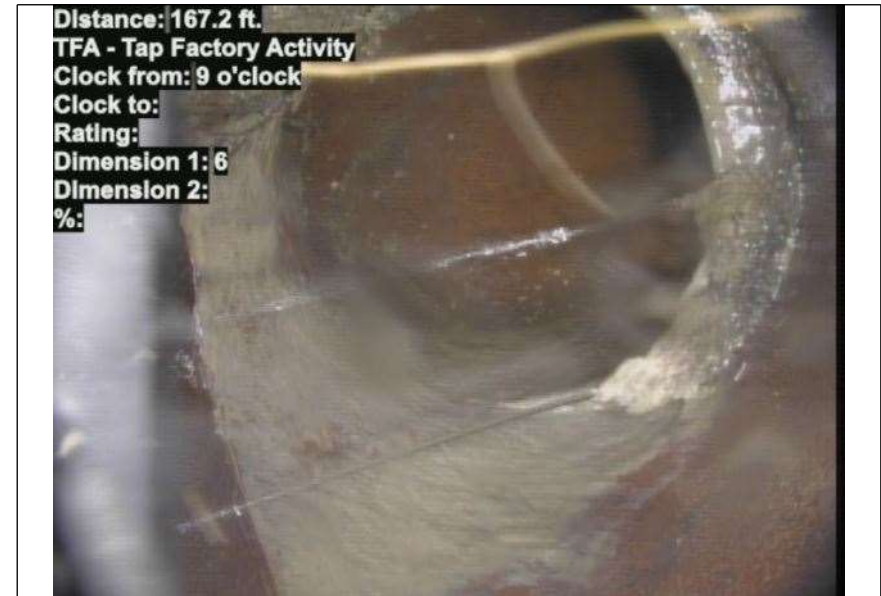
At: 167.2 ft. 9/. TFA - Tap Factory Activity
Joint: No

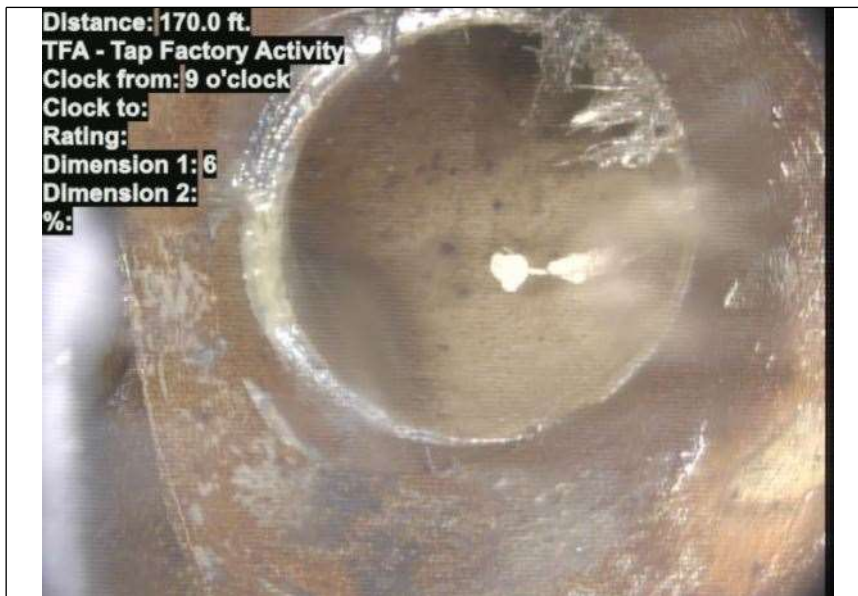
At: 170 ft. 9/. TFA - Tap Factory Activity
Joint: No

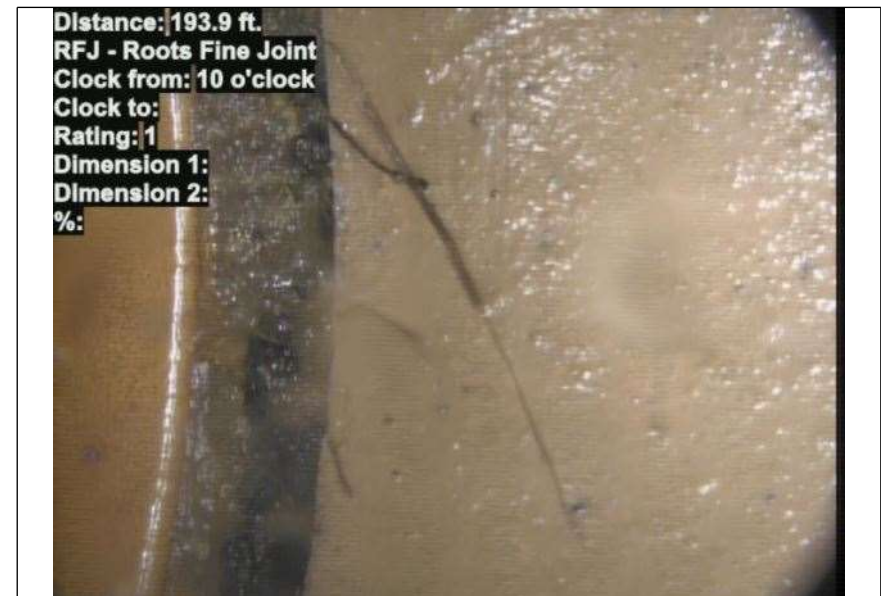
At: 193.9 ft. 10/. RFJ - Roots Fine Joint
Joint: Yes

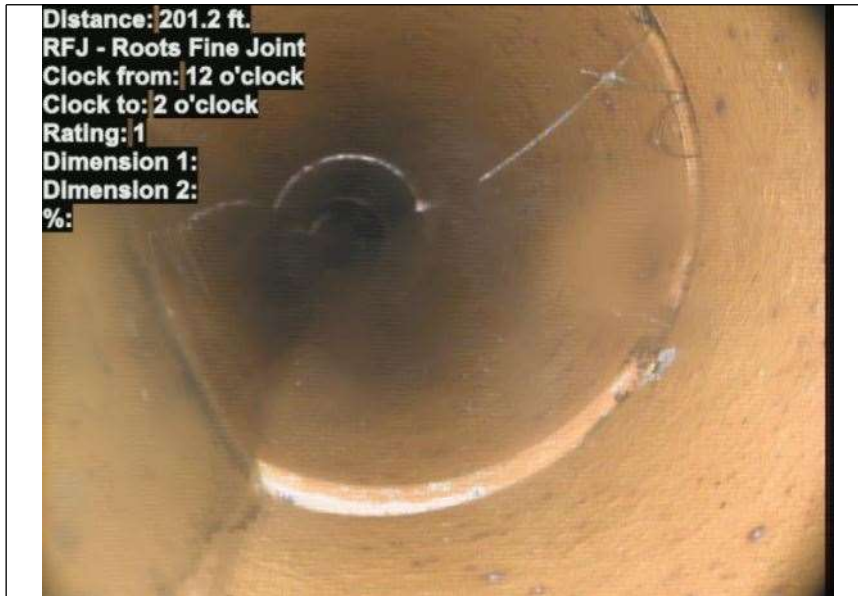
At: 201.2 ft. RFJ - Roots Fine Joint
12/2

Joint: Yes

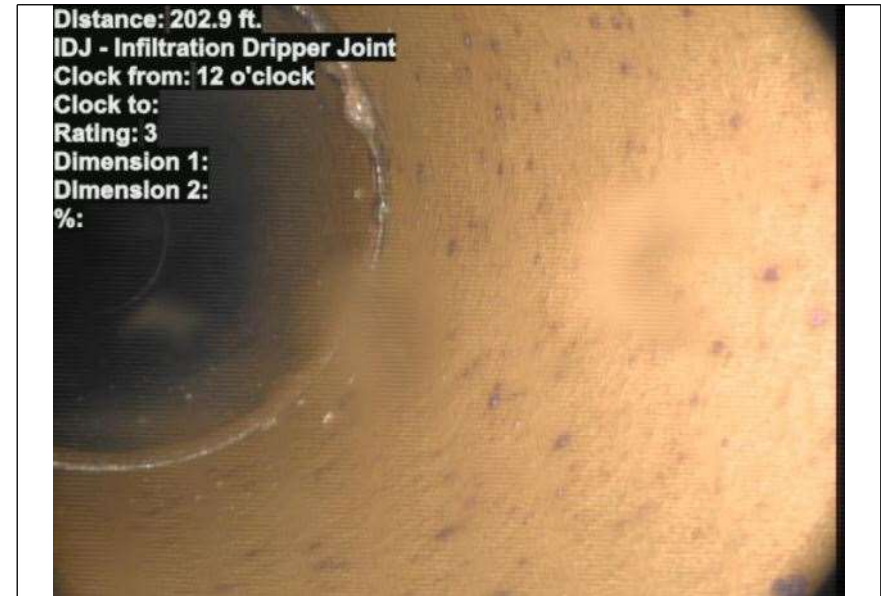
At: 202.9 ft. 12/ IDJ - Infiltration Dripper Joint

Joint: Yes

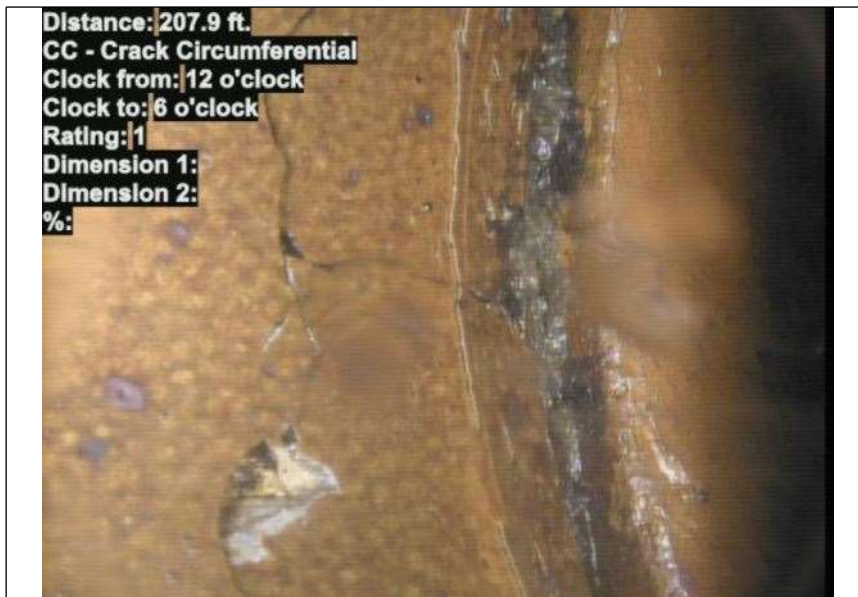
At: 207.9 ft. CC - Crack Circumferential
12/6

Joint: No

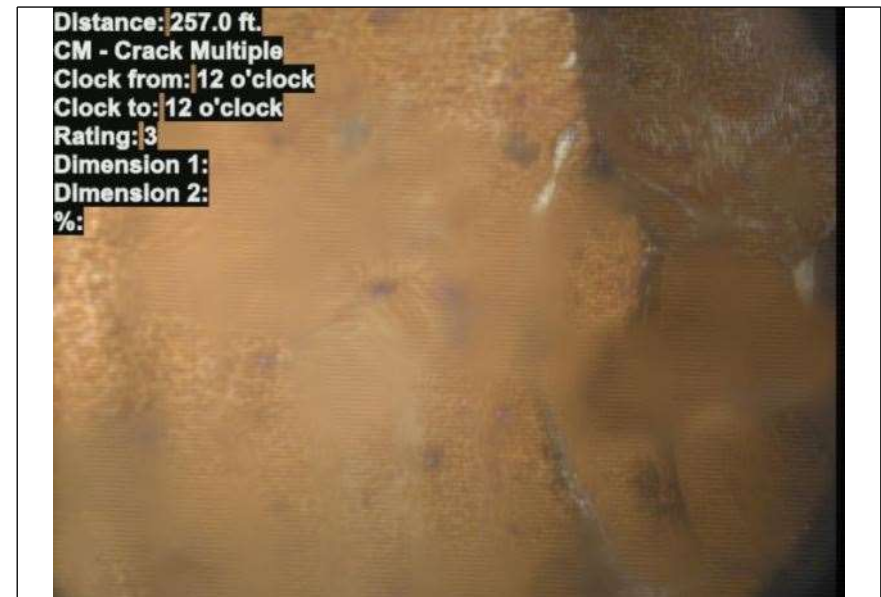
At: 257 ft. 12/12 CM - Crack Multiple

Joint: No

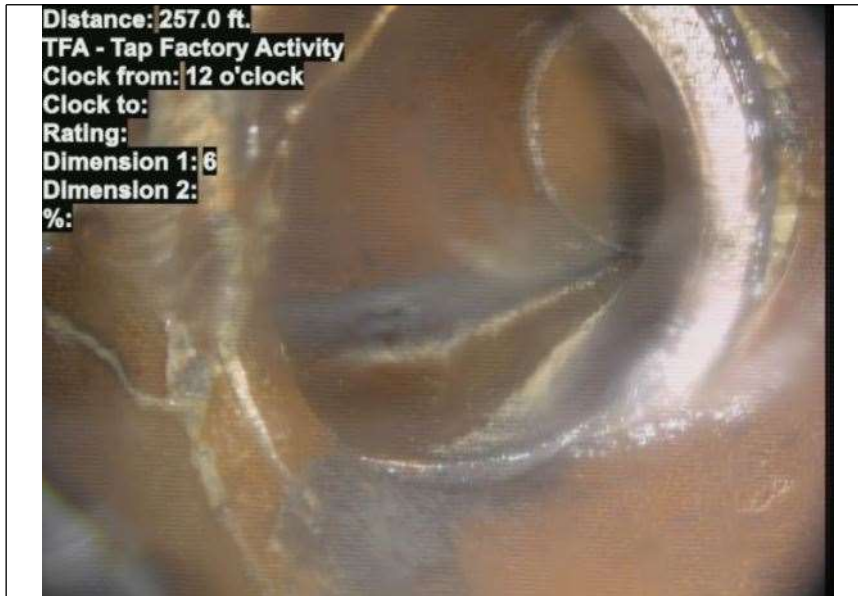
At: 257 ft. 12/. TFA - Tap Factory Activity
Joint: No

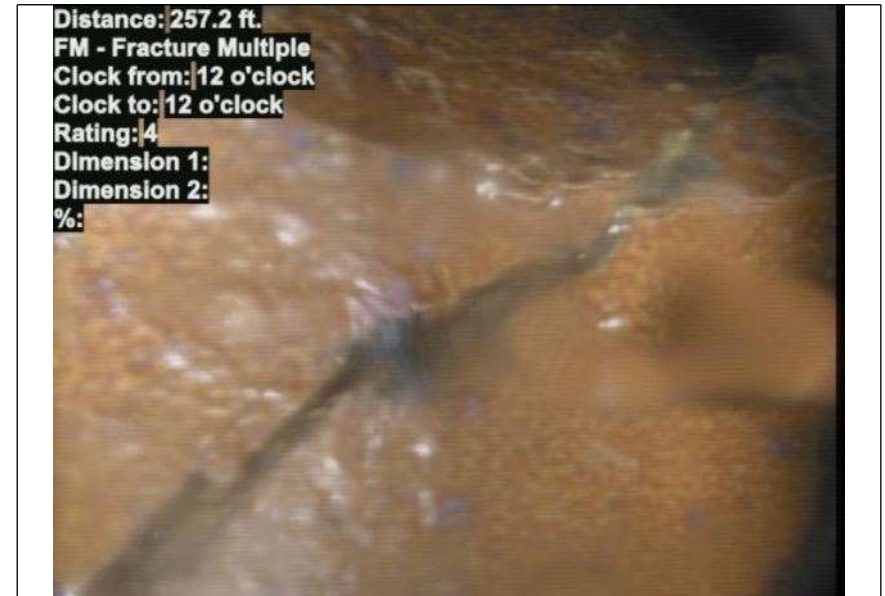
At: 257.2 ft. 12/12 FM - Fracture Multiple
Joint: No

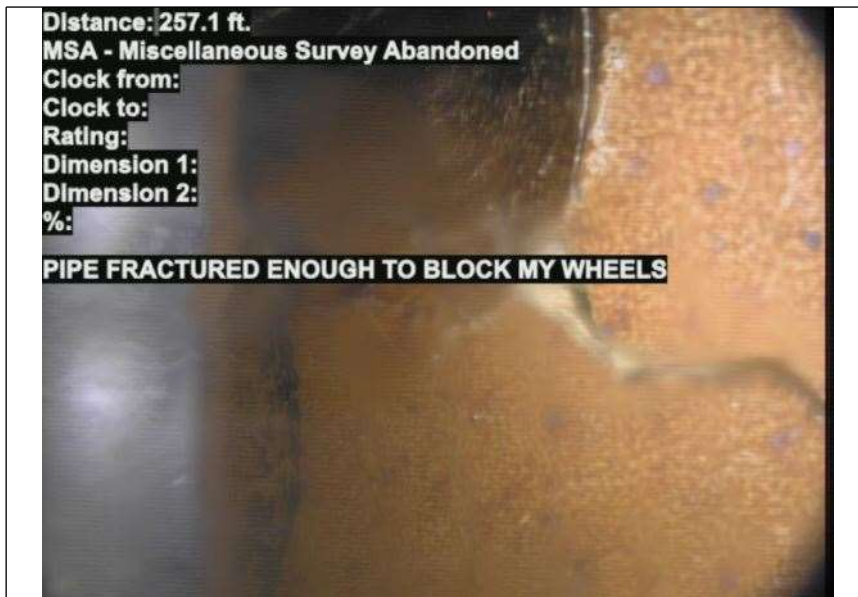
At: 257.7 ft. MSA - Miscellaneous Survey Abandoned
Joint: No PIPE FRACTURED ENOUGH TO BLOCK MY WHEELS
