PACP Report with Pipe Run and Incident Snapshots

Surveyed by: Mike Brooks	Certificate number: Mike Brooks	Owner:	Customer:	Drainage area:	P/O number:	Sheet number:
Pipe segment ref.: SMH068_SMH056	Start date/time: 20220322 09:56	Street: HOOLEY DR	City: SMITHVILLE			
Location details: STREET	Upstream MH No: SMH068	Rim to invert:	Grade to invert:	Rim to grade:		
Pipe use: SS	Direction: D	Flow control:	Downstream MH No: SMH056	Rim to invert:	Grade to invert:	Rim to grade:
Height: 8 in.	Width:	Shape: C	Material: VCP	Lining method:	Pipe joint length:	Total length: 108.600 ft.
Length surveyed: 108.600 ft.	Purpose:	Sewer category:				
Media label:	PreCleaning: L	Date cleaned:	Weather: 1	Location code:	Pressure value:	
Project name: Sewer Cleaning & CCTV - Project No. 210670	Additional info:

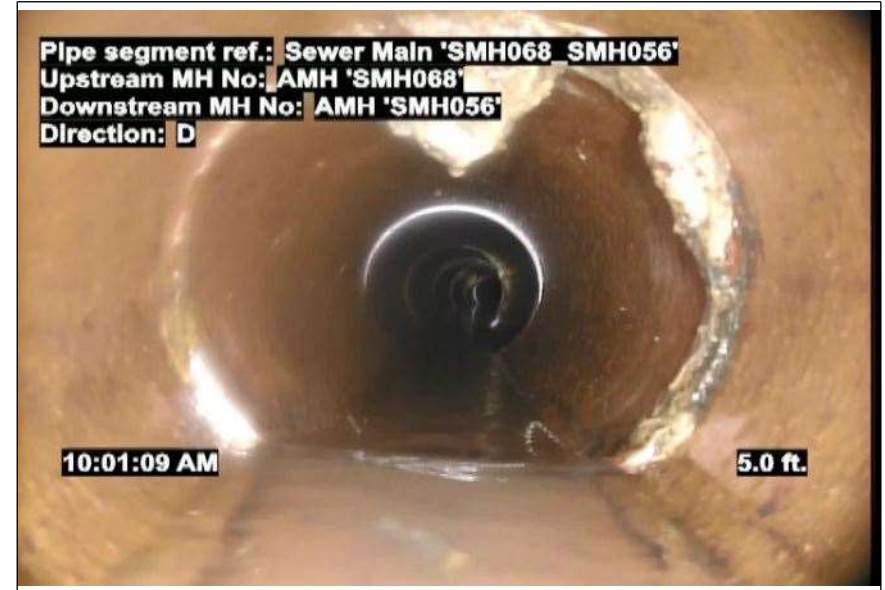
At: 0 ft. MWL - Miscellaneous Water Level
 Joint: No 5 %

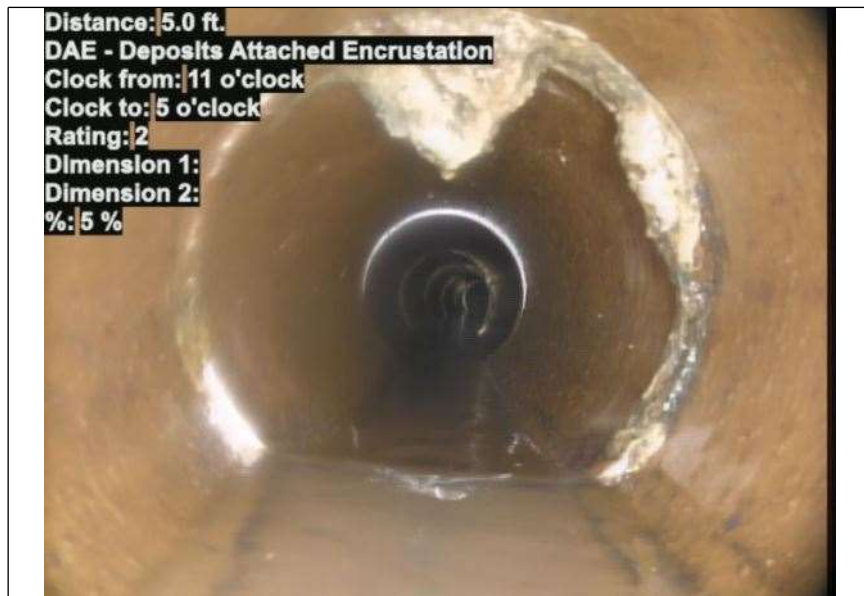
At: 5 ft. 11/5 DAE - Deposits Attached Encrustation
 Joint: No 5 %

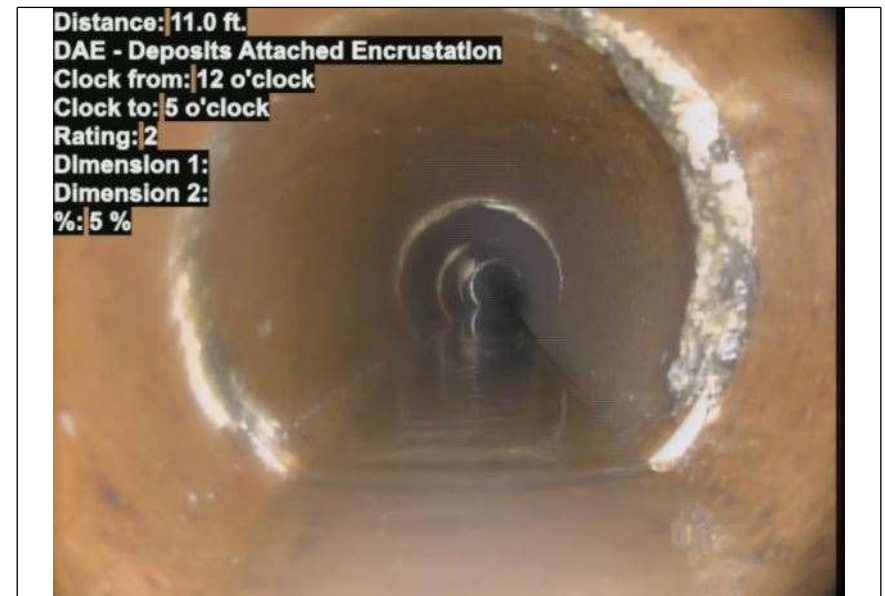
At: 11 ft. 12/5 DAE - Deposits Attached Encrustation
 Joint: No 5 %

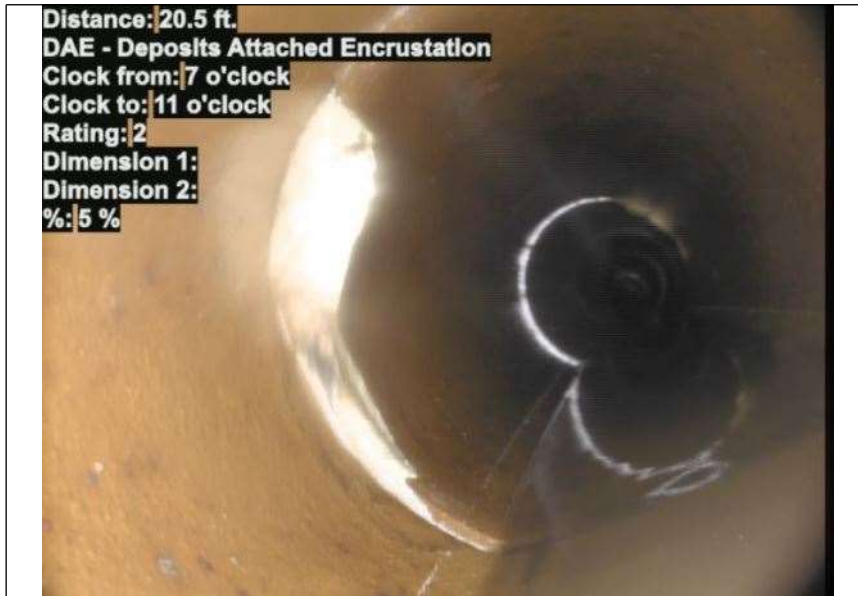
At: 20.5 ft. 7/11 DAE - Deposits Attached Encrustation
Joint: No 5 %

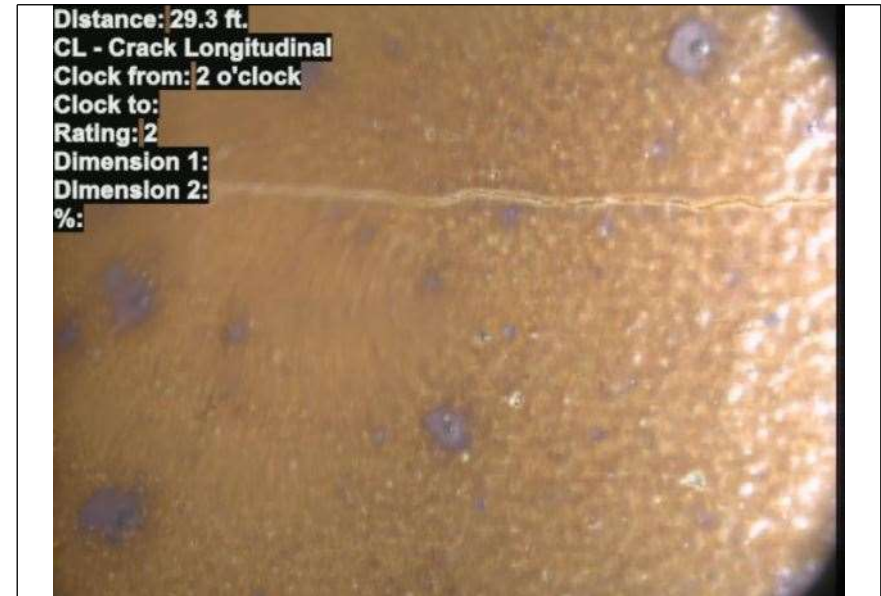
At: 29.3 ft. 2/ CL - Crack Longitudinal
Joint: No

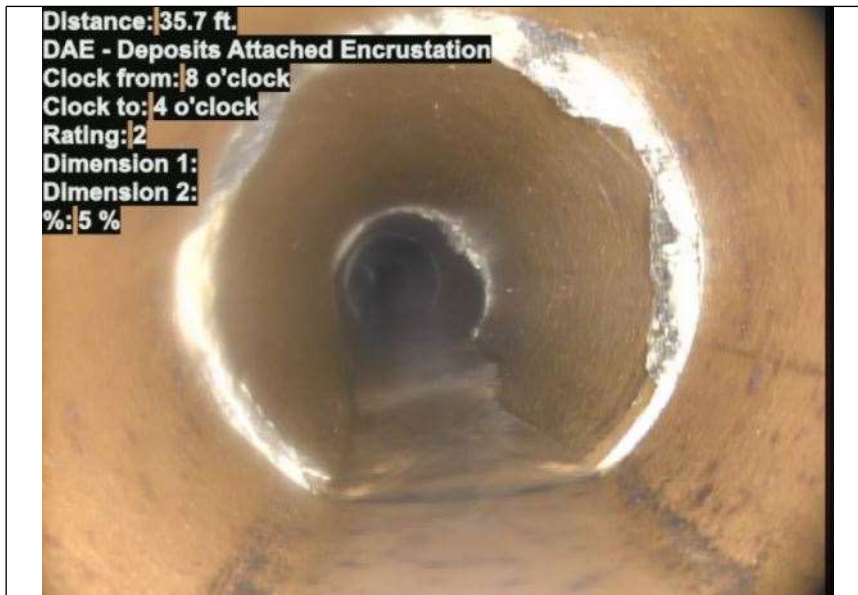
At: 35.7 ft. 8/4 DAE - Deposits Attached Encrustation
Joint: No 5 %

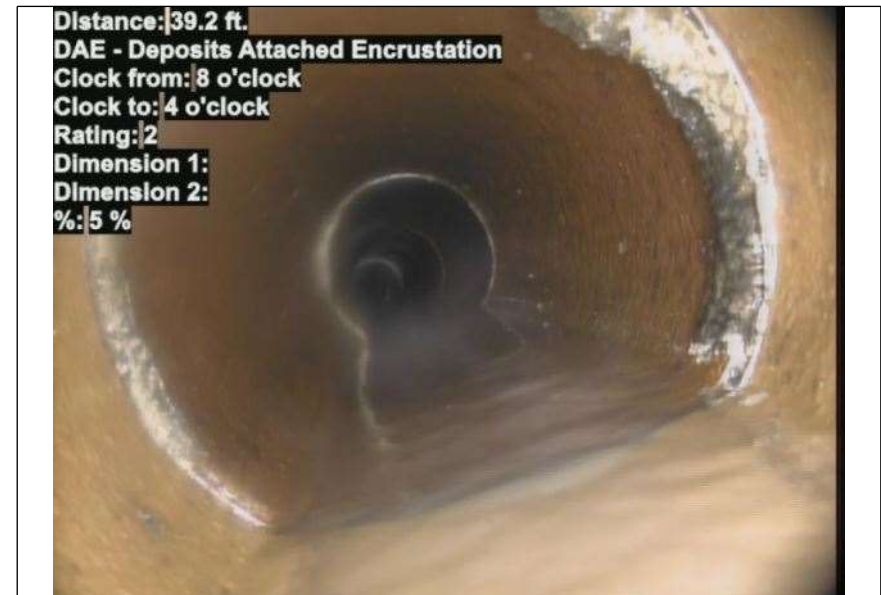
At: 39.2 ft. 8/4 DAE - Deposits Attached Encrustation
Joint: No 5 %
