**BURGESS & NIPLE****Dye Testing Form**

Resident Name: ED REHO  
 Project Name: F.P. IT  
 Project Job #: \_\_\_\_\_  
 Testing Crew: L.C.S.  
 B&N Field Rep: RRH  
 Others Present: \_\_\_\_\_

Street Address: 403 EAST  
 Arrive Time: 8:00  
 Depart Time: 12:16  
 Testing Date: 10/3/16  
 Sanitary Main Size: 8 Inch  
 Downstream MH: \_\_\_\_\_  
 Upstream MH: \_\_\_\_\_  
 Flowmeter Area: \_\_\_\_\_

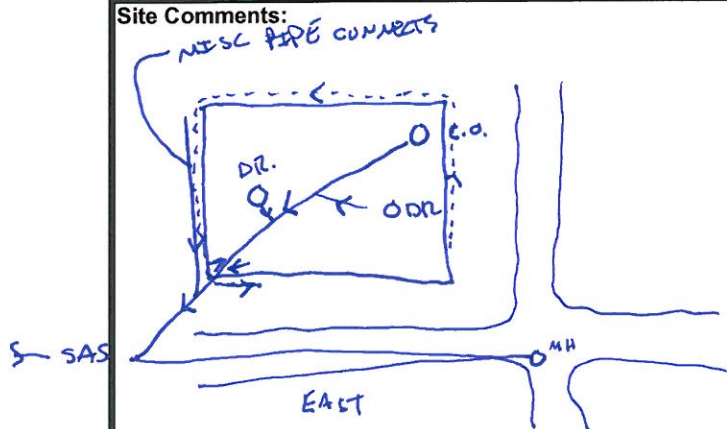
- + FLOOR DRAINS CONNECTED AS SHOULD BE
- + 2-MINERAL DEPOSITS @ JOINTS.
- + INTRODUCED GREEN DYE, AFTER 5 MIN WATER WAS IN LATERAL. (SOUTH WALL)
- + INTRODUCED RED DYE AGAINST HOUSE ON NORTH WALL. CONFIRMED FOOTER DRAIN TIE INTO LATERAL. (20-MIN)
- + NO HITS ON I/I OVER AREA OF LATERAL.

+ NUMEROUS INTRODUCTORY TAPS IN MAIN LINE. MAIN LINE IN GOOD CONDITION.

+ DOWN SPOUTS ALL SPLASH..

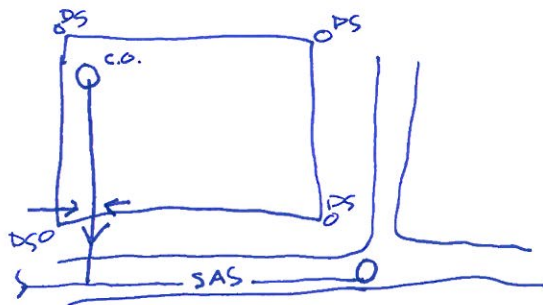
+ PUSH CAM SHOWS TEE CONN. 12'  
FROM C.O. IN BASEMENT.

+ HEAVY ROOTS IN LATERAL. (20' FROM MAIN)

+ UNABLE TO COMPLETE LATERAL. HARD  
DEPOSITS AND ROOTS. (10'-CAP OF MASSIVE PIPE)

+ TEST ALL D.S. AND ALL SAS ARE  
PIPED AND RUN TO SIDEWALK.

+ DOWNSPOUT DISCHARGES NEAR LATERAL LOCATION (POSSIBLE I-I SOURCE)

+ 75'-U.S. MAINLINE GUSHED I-I.

+ 144'-BROKEN CONW. SEPC VISIBLE.

+ RESIDENT SAYS MH OPEN, HAS 3'  
OF WATER PURCH. STORM.

+ CONFIRM RED DYE THROUGH S.W. CRACK  
INTO FOOTER DRAIN AND INTO SAN. LATERAL.

+ NO DYE THROUGH I-I OVER LATERAL.

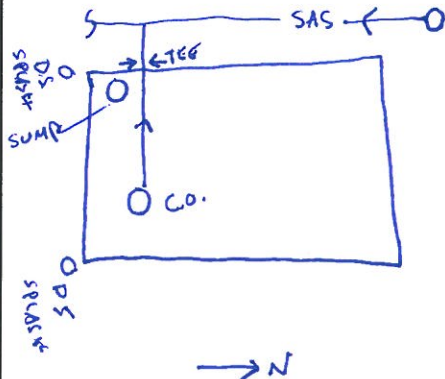
+ 5' UP LATERAL, DEPOSITS ON INVERT 50% UNABLE TO PASS W/ LATERAL LAUNCHER. (MINERALS? W/ SLIGHT OFFSET JOINT)

+ 11' - TEE CONNECTION 3:00-9:00

+ 28' CONNECTION @ 12:00 IN YARD.

+ AFTER 7-MIN OF TESTING, GREEN DYE CONFIRMED IN LATERAL THROUGH FOOTER DRAIN.

+ GREEN DYE ALSO IN SUMP.

+ WATER GOING FROM S.W. DOWN FOUNDATION THROUGH CRACKS IN FLOOR INTO FLOOR DRAIN AND

INTO SANITARY LATERAL.

+ 17' FROM MH 6099 - LARGE HOLE S.V. (GRADE 5)  
 + 73' TO LATERAL FROM MH.

+ I-I THROUGH JOINTS IN LAT.

+ LATERAL IN GOOD SHAPE STRUCTURALLY WISE.

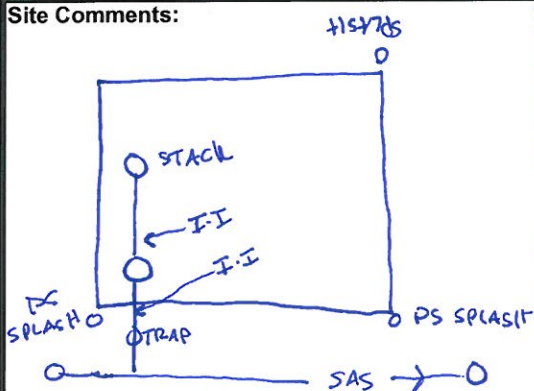
+ 16' - BROKEN PIPE @ CROWN IN LATERAL (FROM MAIN)  
 + 20' - TRAP IN YARD. WILL REVERSE FROM HSE.  
 + 27' FROM HSE CO., SMALL MINERAL DEPOSITS. @ TWO JOINTS.  
 + 39' FROM HSE CO., REACHED OVERLAP.  
 + NO TEE CONNECTION OBSERVED IN LATERAL.  
 + GREEN DYE IN LATERAL AFTER 9-MINS OF FOUNDATION TESTING. PORTION IN FROM SEP. JOINT LOCATED UNDER SLAB. MEDIUM HEAVY FLOW.

+ MAIN LOOKED GOOD @ 153' TO LATERAL FROM INTERSECTION.

+ RED DYE @ 4' AT JOINT. I-I (NOT DIRECT INFLOW)  
 + HEAVY I-I @ TWO JOINTS

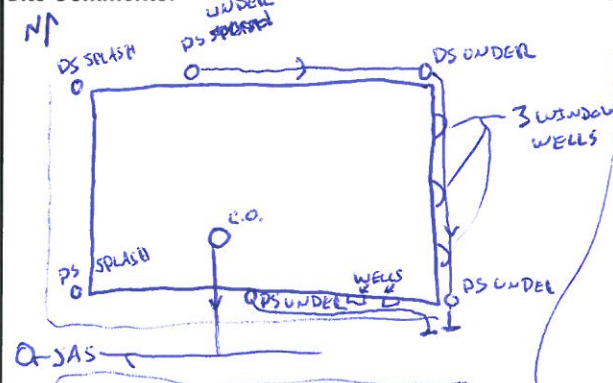
- + ALL UNDERGROUND DS. DISCHARGE TO TWO PIPES IN CORNER OF YARD TO GROUND.
- + I-I @ JOINT @ 68' (FLOODING RIGHT FRONT WINDOW WELL)
- + AFTER 50 MINS, RED DYE IN LATERAL.
- + ENTERED GREEN DYE AND CONFIRMED FOUNDATION DRAINS LOOKED TO BE TIED IN
- + RESIDENT STATED THAT DS. WERE WORKING ON FEW YEARS AGO BEFORE SHE MOVED IN, APPEARS THEY WERE DISCONNECTED FROM SAN LAT.

+ LATERAL @ 82'.

+ LATERAL HAS MULTIPLE CONNECTIONS (2 BREAK IN CONNECTIONS.)

DUE TO BASEMENT FLOODING ISSUES.

+ PROBBED AROUND FOUNDATION LOOKING FOR OLD SIS PIPE TIEING IN. NONE FOUND.

+ TESTED SMALL SINK HOLE IN TREE CAWN, NO DYE VISIBLE.

\* POSSIBLE WM BREAK.  
HEAVY I.I IN MAIN

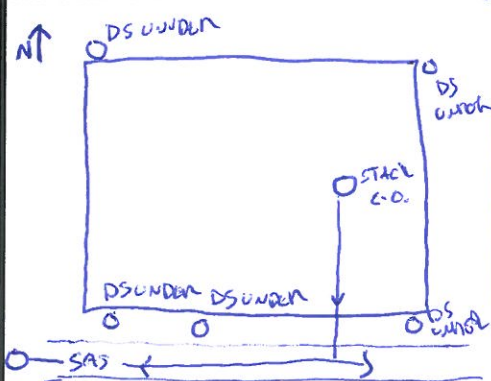
+10.4 - SEP JOINT IN LATERAL, SOFT VISIBLE.  
 +4.6 - MINERAL & JOINT LSE  
 +7.1 - 12:00 CONN, CAPPED (WAS C.O.)  
 +7.9 - "  
 +8.5 - 3:00 @ 9:00 CONNECTION.  
 +10.1 - 3:00 CONNECTION  
 +10.4 - END OF RUN. - PIPE ENTERS IN LATERAL (LAUNDRY RUN)  
 + RED DYE IN SUMP AFTER 30 MINUS OF TESTING.

+9.0 - HEAVY INFILTRATION OF  
 CLEAN WATER @ JOINT. (CUSHIONS)  
 +12.5 - "  
 +13.0 - "  
 +15.1 - "  
 +18.0 - "  
 +20.0 - CONNECTION FOUND.

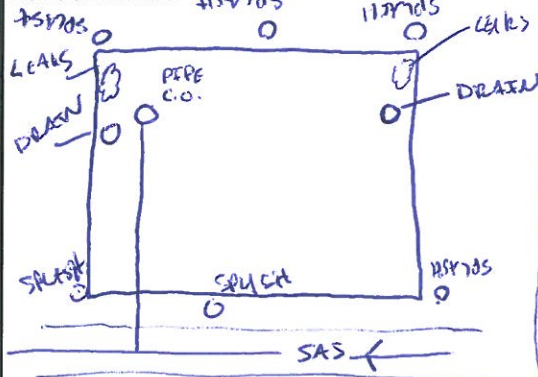
+ AFTER 5 MINS OF DYE TESTING, WATER POURING INTO BASEMENT THROUGH CRACKS IN FLOOR AND RUNNING TO FLOOR DRAIN THAT GOES TO SAN. LAT  
 + APPEARS FLOOR DRAIN (IF PRESENT) ARE BROKEN OR CLOGGED.  
 + OLD DOWNSPOUT CONNECTIONS IN GARAGE PRESENT. PROPERLY GROUTED, UNABLE TO GET WATER IN.  
 + BOTH SIDES OF BASEMENT WALLS LEAK HEAVY IT INTO BASEMENT.

+ 13' - LAT @ 12:00

31'-36' → + 31' - ROOTS & CROWN IN LATERAL (50%)  
47'

+ SLIGHT

+ 86'-3:00' ROOTS CONNECTION, BOTH W/ROOTS

+ 100' CONN. @ 9:00

+ I/I IN NUMEROUS SCENTS IN LATERAL AFTER 20 MINS OF DYE TESTING. AT ROOF AND MINERALS.

+ WAS ABLE TO GET SLIGHT DYE OUT OF OLD CAPPED DOWNSPOUT. DOWNSPOUTS WERE CONNECTED AT ONE POINT.

+ HAD CROWN SNAKE LINE IN SPRING. HAS SNAKE LINE HIMSELF.

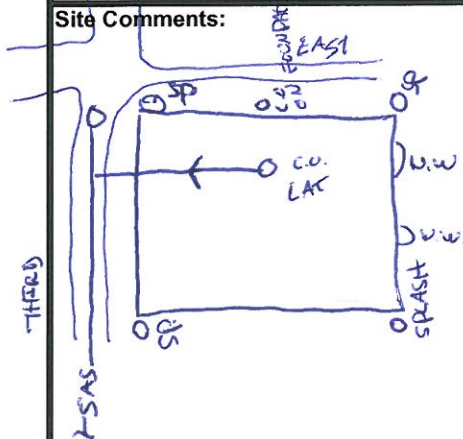
+ DYE TESTING C.O. ON EAST SIDE OF HOUSE - AFTER 40 MINS NO CONFIRMATION ON WHERE IT GOES. NO SUMP, NO SANITARY, NO STORM.

+ PUSH CAM IN FRONT C.O. SHOW PERFORATED PIPE. LINE BENDS TWICE TO GO AROUND FRONT PORCH AND UNABLE TO GET PUSH CAM AROUND THEM. MM EVENTUALLY GO TO OLD FOOTER DRAINS.

+ HOUSE WAS WATERPROOFED EARLIER IN YEAR W/

+ LATERAL LOCATED 25' FROM DOWNSTREAM. THIS NEW PIPE PUT IN FOR ADDITION (OHIO STATE WATER PROOFING).

+ ROOT BALL @ FEW INCHES.

+ HEAVY DEBRIS IN BOTTOM OF PIPE.

+ 88' - BREAK IN @ 12:00

+ 90' - 3:00-9:00 CONNECTION

+ NO CLEAN OUT IN YARD - NO TRAIL AND CLEAN.

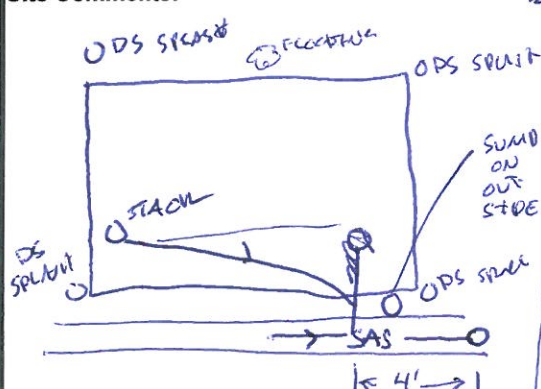
+ SUMP PUMP TEST LOCATED IN FRONT YARD  
UP AGAINST HOUSE - RAN RED DYE FOR  
APPROX 20 MINS. RED DYE WAS STREAMING  
INTO LATERAL WHERE PIPE CHANGED SIZE  
AND MATERIAL TO PVC. LOOKS LIKE SUMP  
COULD BE PIPED INTO SAME TRENCH AND  
BAY CONNECTION.

- + LATERAL CONNECTION 3' FAN MH.
- + 2' TN - BROKEN @ JOINT - SMALL
- + 22' - TRANSITION TO PVC
- + 58' - 3:00 - 9:00 CONNECTION

+ AFTER 10 MINS OF FLOODING OVER LATERAL GREEN DYE CONTIN IN WHERE PIPE CHANGES TO PVC. ALSO INTRODUCES RED DYE, TOOK 5 MIN TO LEAK IN.

+ RESIDENT STATED WOULD DISCONNECT SUMM INT. CAT.  
AND DISCHARGE TO YARD.

+ Looks like they need to dig lateral up

2 TRANSITION AND PROPERLY SEAL. MIGHT HAVE REPLACED LATERAL UP TO SWAZI
