**Sanitary & Storm Sewers
Inflow & Infiltration Investigation
Lake County Department of Utilities**

Village of Fairport Harbor

June 2017

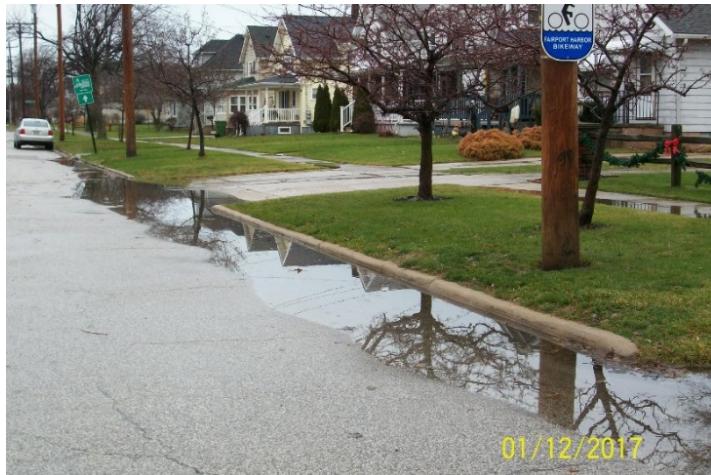
*Roadway Drainage Deficiency
Second St.
January 12, 2017*

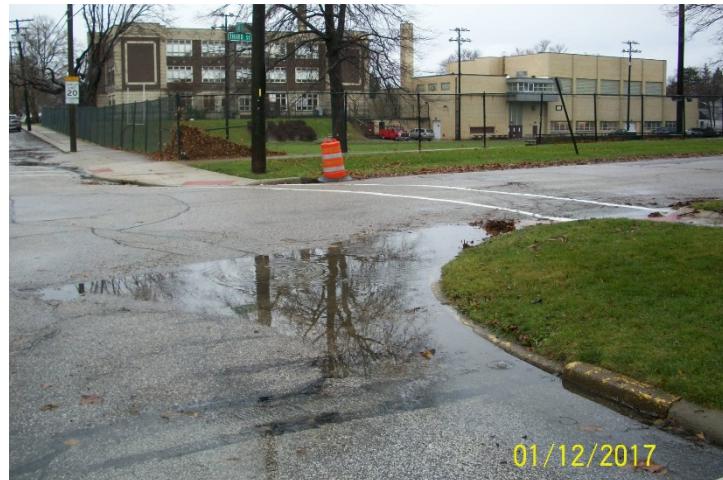
Roadway Drainage Deficiency
Vine St. and Third St.
January 12, 2017

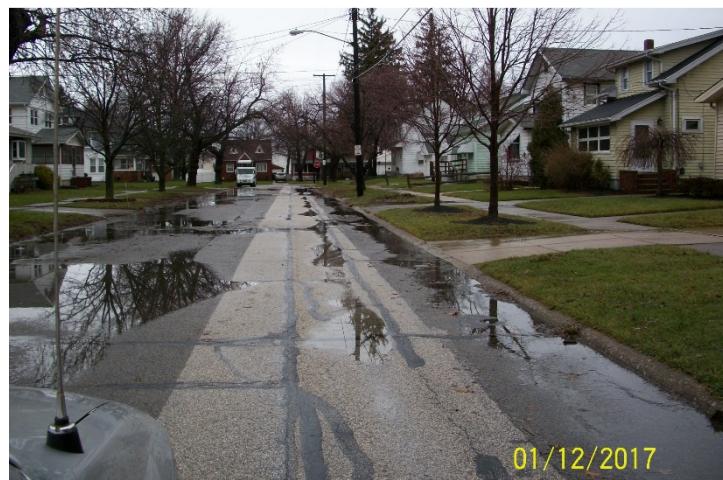
Roadway Drainage Deficiency
Chestnut St.
January 12, 2017

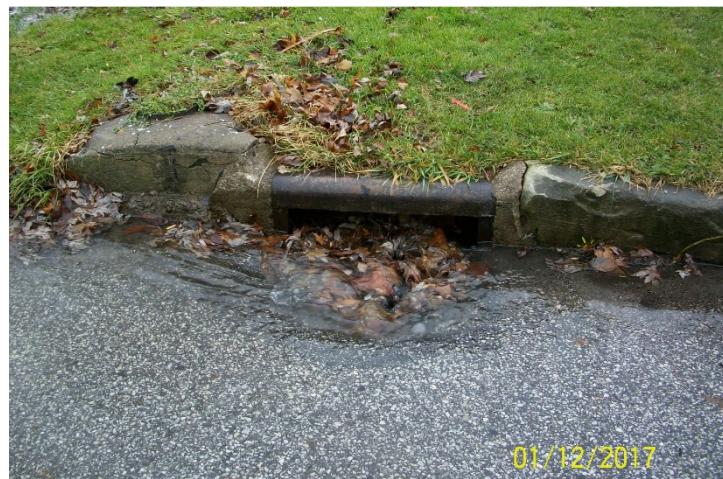
Clogged Catch Basin
East St.
January 12, 2017

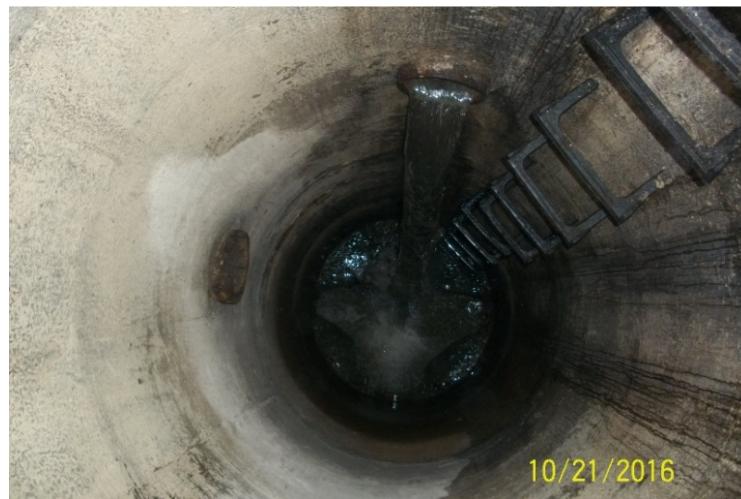
- Third St. and East St. – I/I from the south pipe
- Third St. and Vine St. – I/I from north and east pipe
- Fifth St. and Chestnut St. – I/I from north pipe

***Sanitary Manhole at Third St. and Vine St.
During Wet Weather Flow***

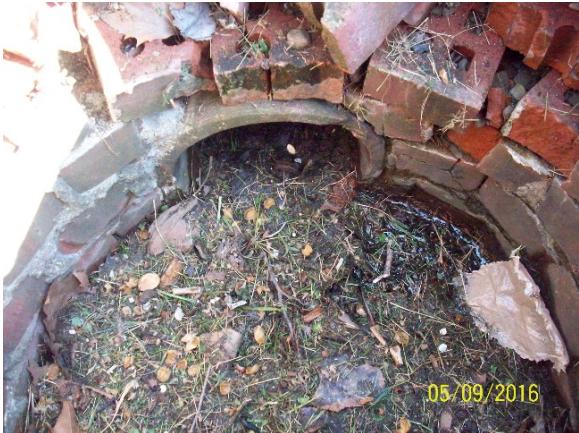
***Catch Basin Located on York St.
Loose Bricks and Full of Debris***

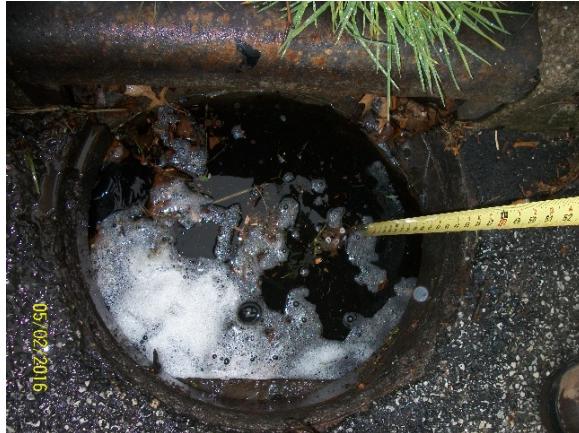
***Catch Basin Located on Second St.
Clogged With Debris, Water Backed Up***

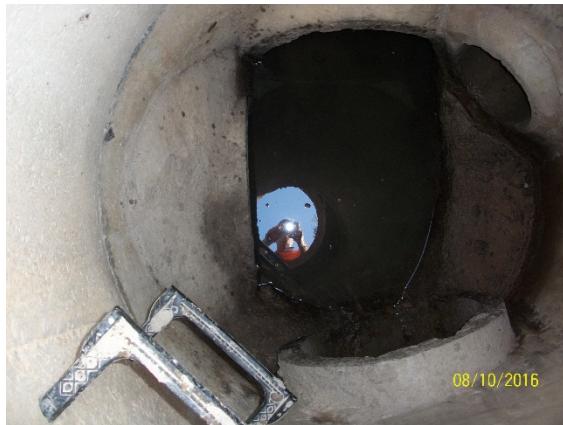
Storm Manhole Asset ID 100056
Standing Water in Invert

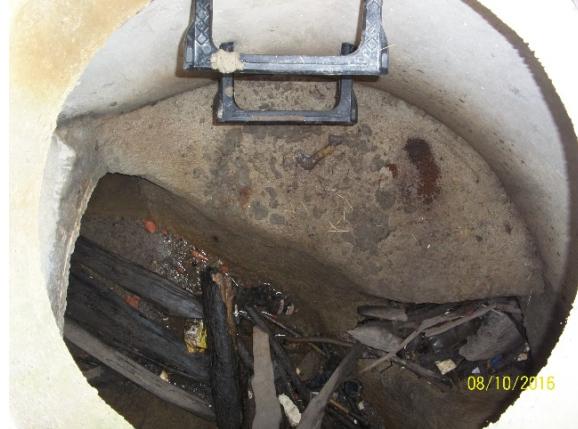
Storm Manhole Asset ID 100127
Large Amounts of Wood Debris

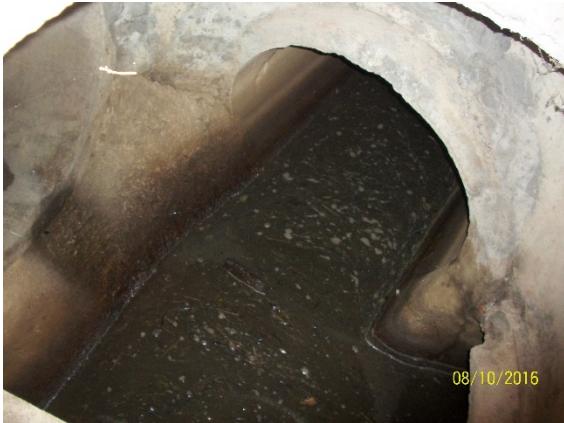
Storm Manhole ID 100128
Standing Water Invert

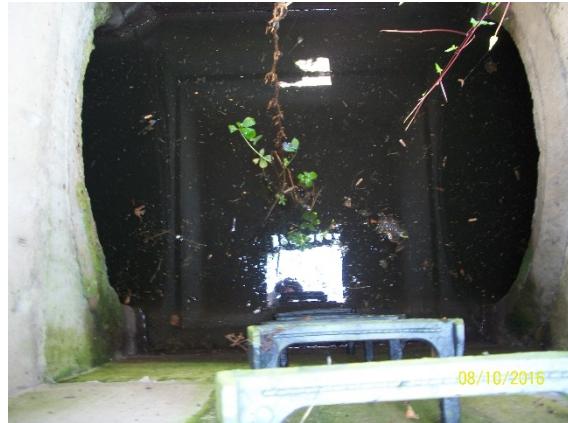
Storm Manhole ID 100098
Standing Water Invert

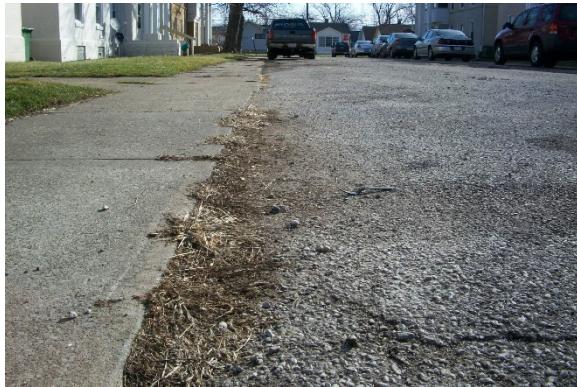
Paradise Ct.
No Curb For Stormwater Conveyance

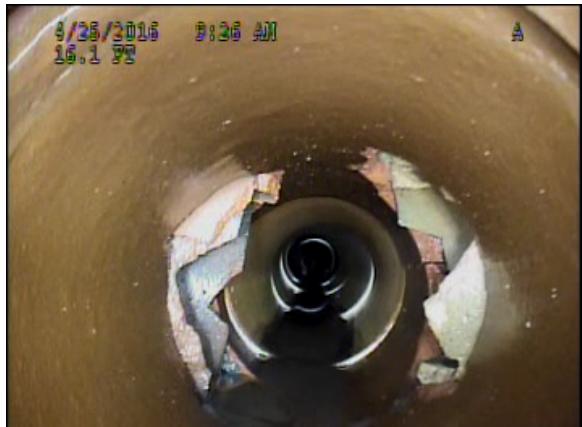
SAS - York St. - Double Intruding Lateral

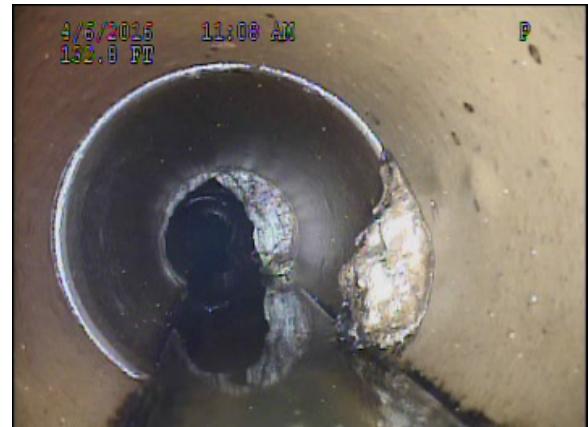
SAS - Joughin St. – Mineral Deposits at Joints

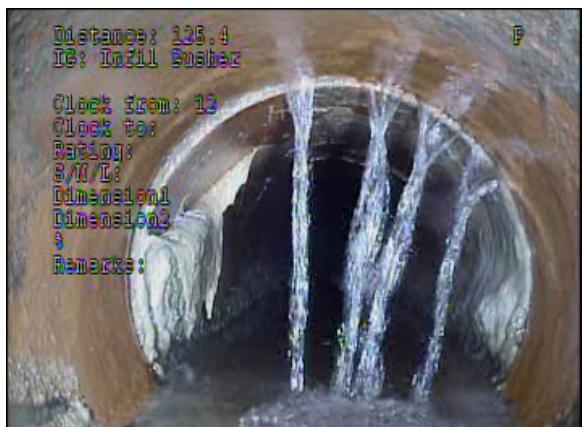
SAS - Third St. – Heavy Infiltration

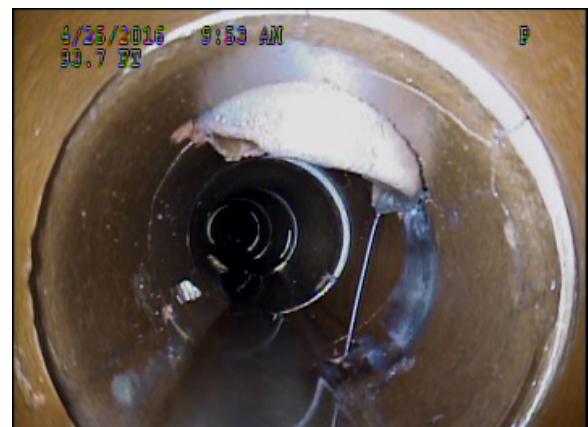
SAS - East St. – Intruding Lateral

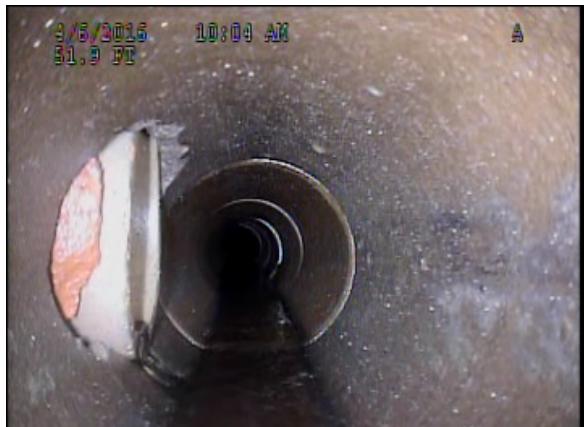
SAS - East St. – Intruding Lateral

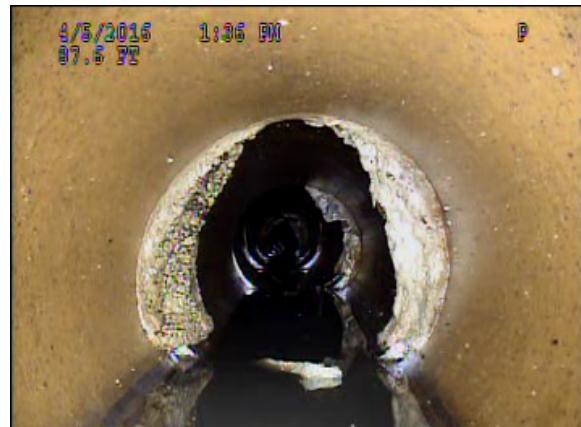
SAS - New Fourth St. – Mineral Deposits at Joints

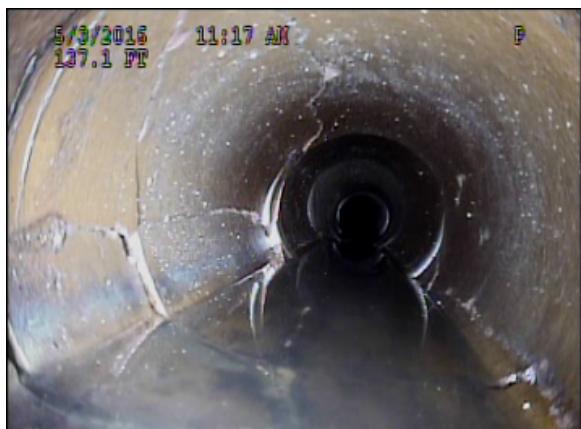
SAS - East St. – Multiple Fractures

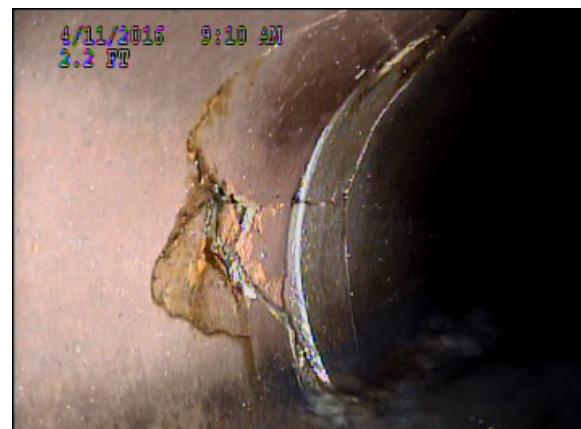
SAS - Fifth St. – Hole, Multiple Fractures

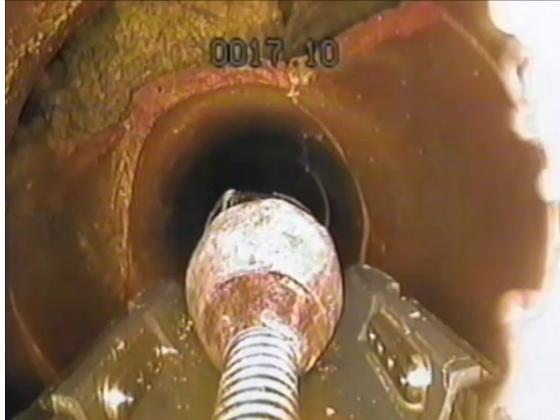
*SAS - East St.
Large Hole at Crow; Soil Visible*

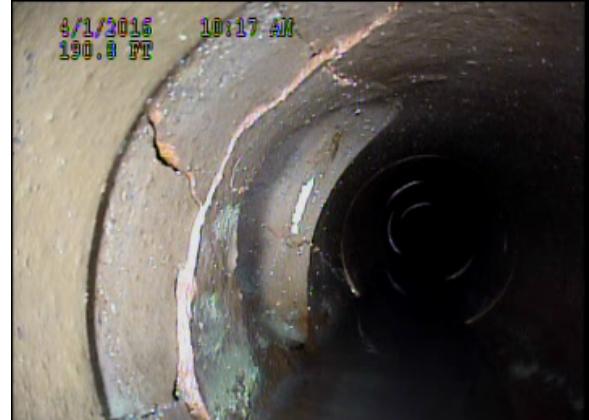
SAS - Chestnut St. – Multiple Fractures

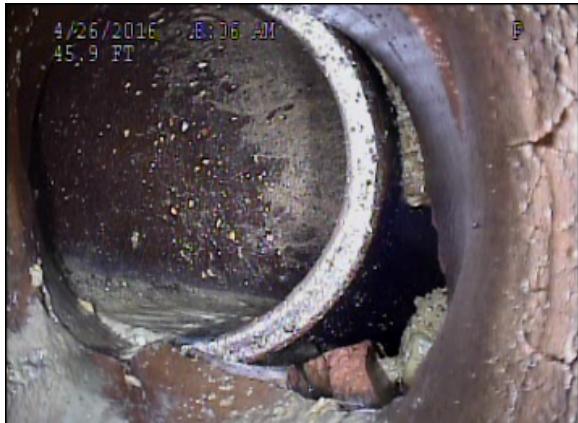
SAS - Second St. – Broken Tee Connection

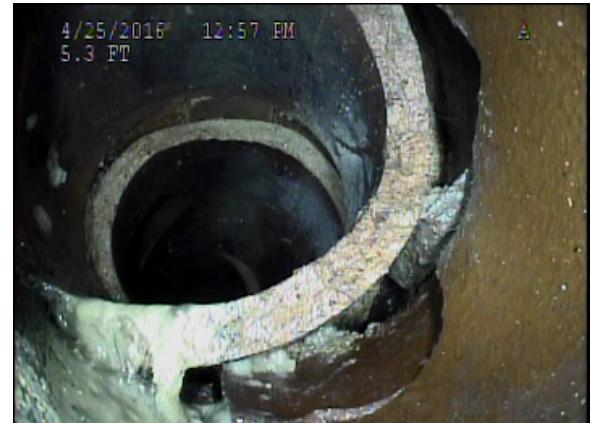
SAS - Second St. – Broken Tee Connection

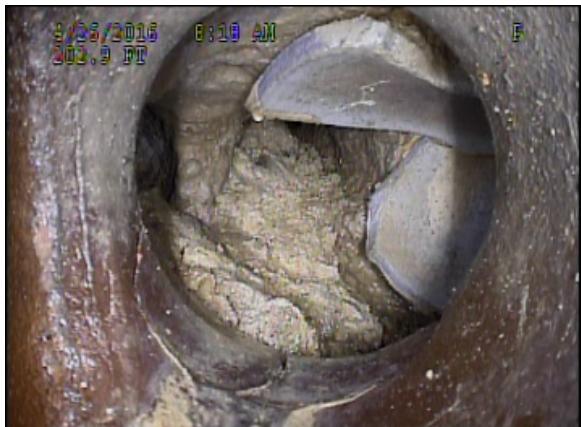
SAS - Second St. – Lateral with Heavy Debris

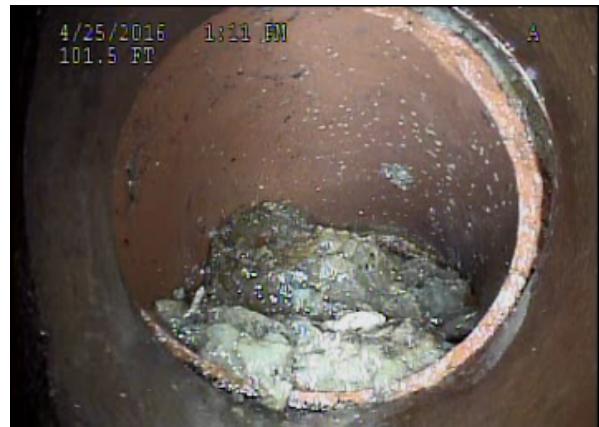
SAS - Second St. – Lateral with Heavy Debris

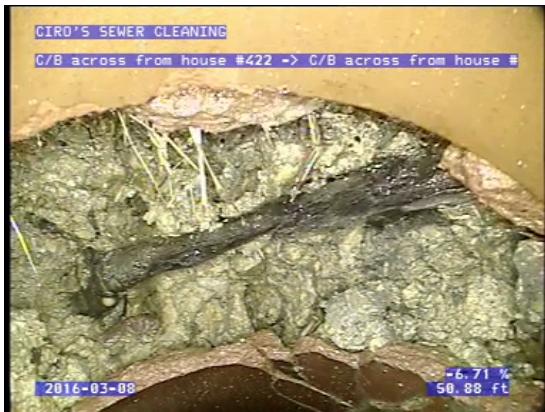
STS - New Fourth St. – Hole in Crown; Soil Visible

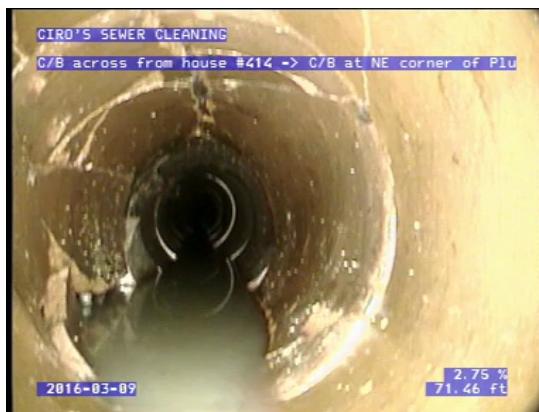
STS - New Fourth St. – Fractures/Broken Pipe

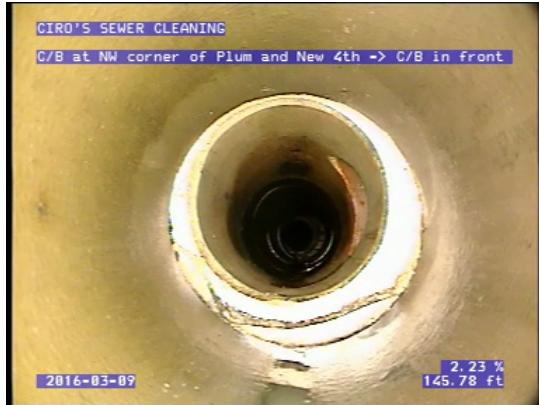
STS - New Fourth St. – Repair with Smaller Pipe

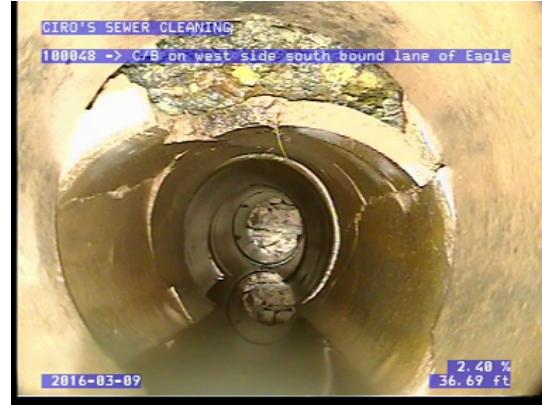
STS - New Fourth St. – Large Hole; Soil Visible

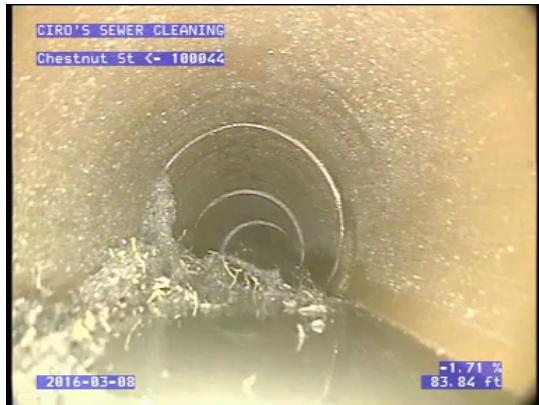
STS - New Fourth St. – Roots

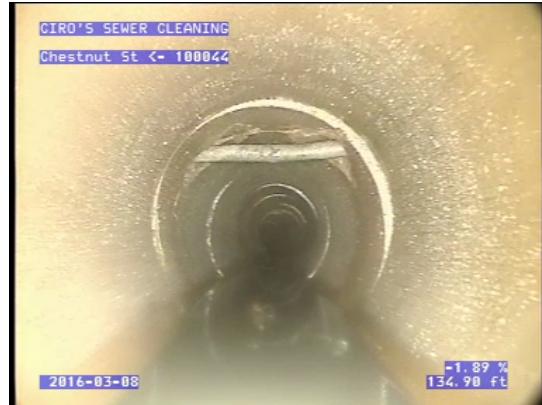
STS - New Fourth St. – Utility Through Crown of Storm Sewer

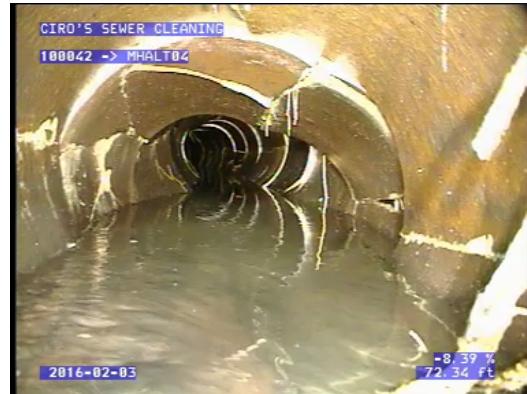
STS - Harding School- Fractured, Deformed Pipe

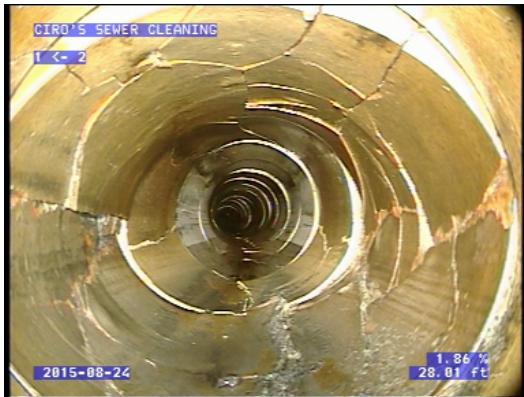
STS - "The Gully" - Multiple Fractures,

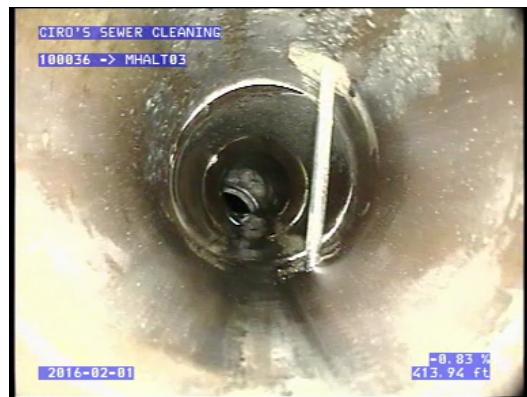
STS - Third St. - Utility Bored Through Storm Sewer

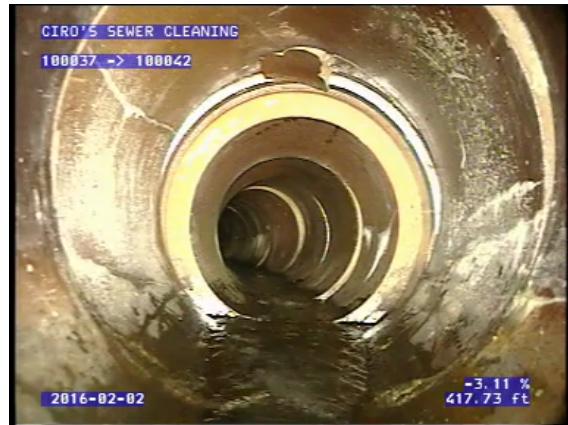
STS - Harding School – Repair with Smaller Pipe

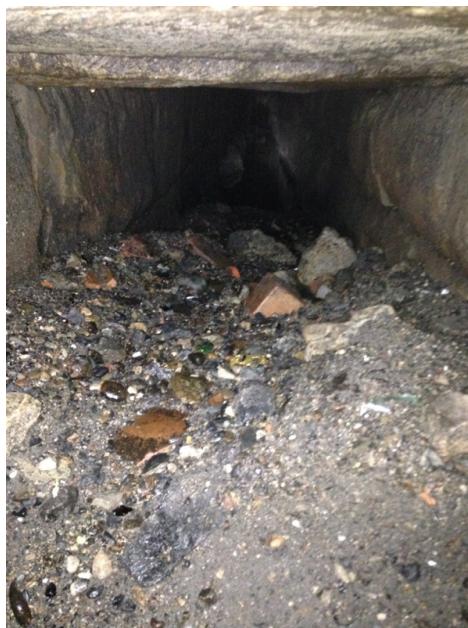
One public storm sewer segment that had significant debris levels restricting flow is the stone box culvert that crosses High St. which was found to be approximately two-thirds full of sediment and debris. The culvert is attached to the downstream end of the 24-inch trunk sewer that runs from Third St. and through the Harding School property. This box culvert is approximately 3 feet wide by 3 feet tall. The sewer inspection contractor spent several days cleaning out debris from the box culvert. The restored capacity of the culvert will allow it to convey stormwater much more efficiently.

STS - High St. – Box Culvert Before Cleaning

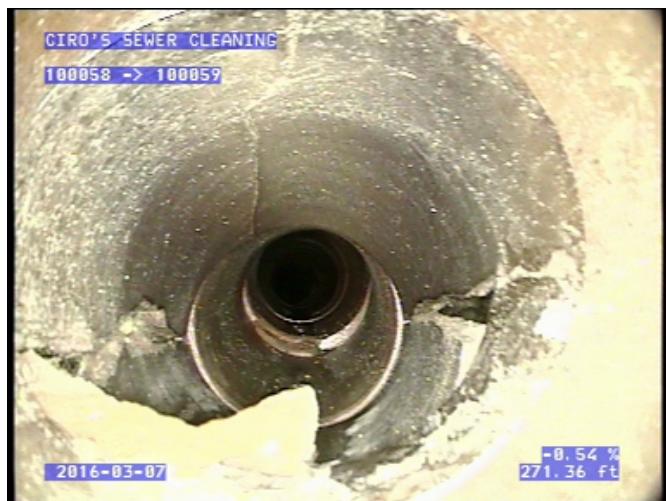
STS - East St. – Broken Pipe Looking Downstream

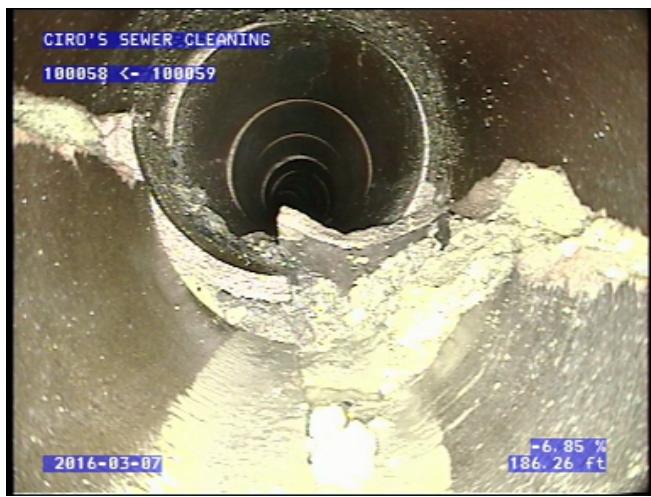
STS - East St. – Broken Pipe Looking Upstream

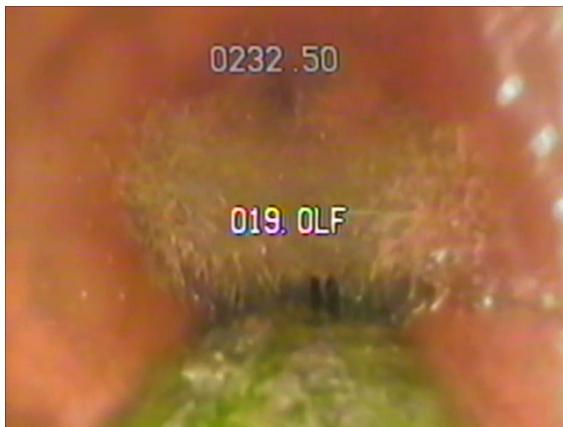
*517 Fifth St. – Large Root Ball
(Camera in SAS Lateral Looking Towards House)*

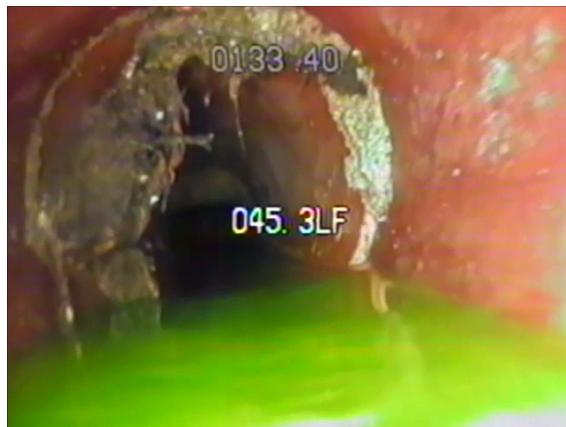
*533 Third St. – Medium Root Ball
(Camera in SAS Lateral Looking Towards House)*

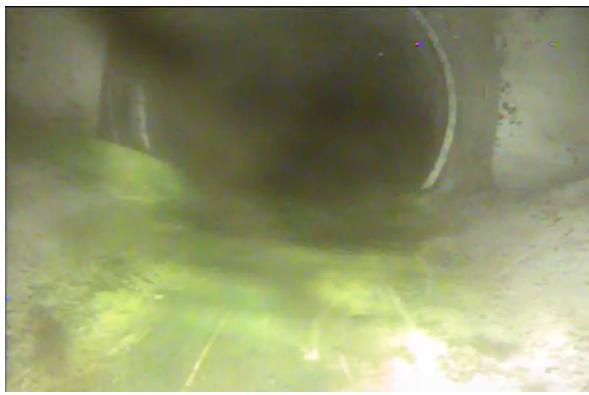
*600 Third St. – 3:00 and 9:00 Tee Connection on Lateral
With Dyed Water Entering
(Camera in SAS Lateral Looking Towards Sanitary Main)*

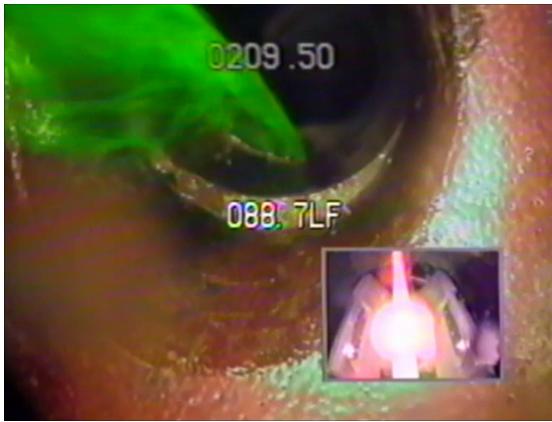
*225 East St. – Connection 12:00 on Lateral
With Dye Water Entering
(Camera in SAS Lateral Looking Towards
House, Tilted up to 12:00 Position)*
