AAA Advanced Plumbing and Drain  
7277 Bessemer Avenue • Cleveland, Ohio 44127  
440-331-5555 voice • 216-341-6681 fax  
www.advancedplumber.com

Upstream MH NEW FOURTH 1 STM	Downstream MH 401 NEW FOURTH STM	Size 10	Material Polyethylene	Total Length 88	City FAIRPORT HARBOR
Surveyor's Name M.Crawford	Certificate Number U735286	Street Address NEW FOURTH	Location Details		
Direction Upstream	Purpose Routine Assessment	Weather Dry	Date 8/11/2026	Time 1:59 AM	Length Surveyed 88
Additional Information 10"

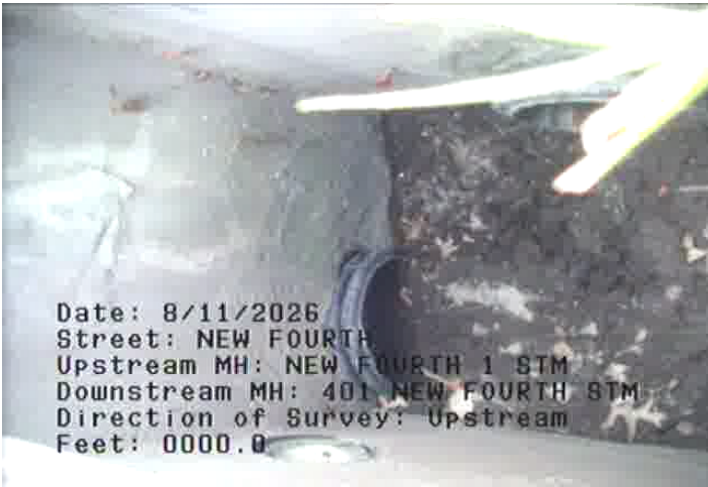
AMH - Access Point - Manhole @ 0.0 ft.  
Starting Manhole: 401 NEW FOURTH STM

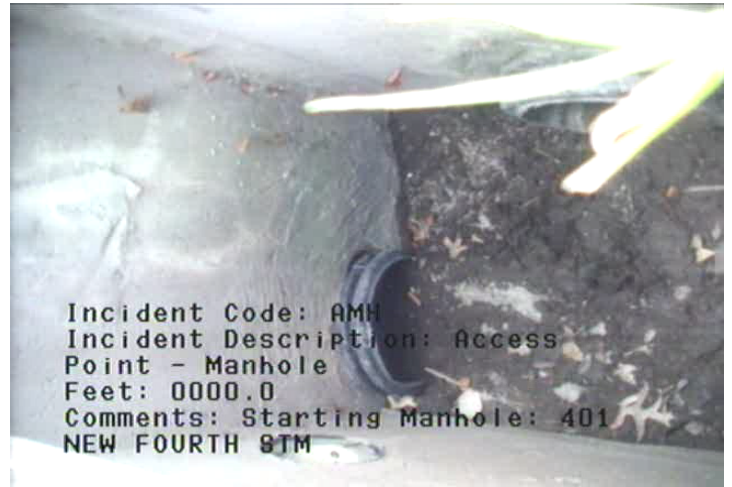
MWL - Water Level @ 0.0 ft.

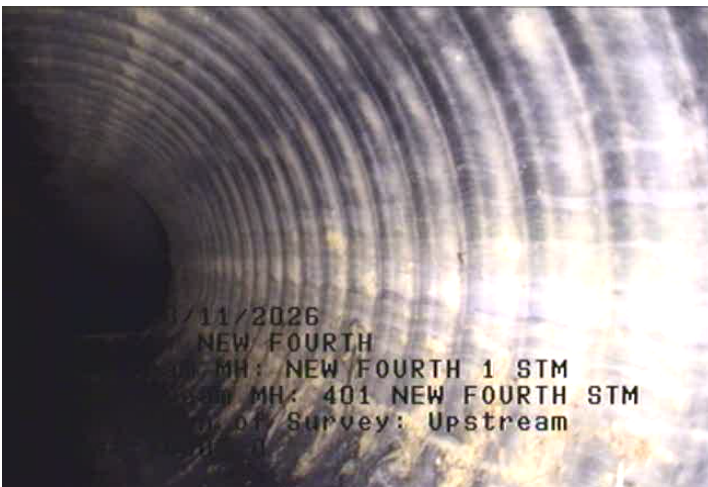
DSGV - Deposits Settled: Gravel @ 1.0 ft.

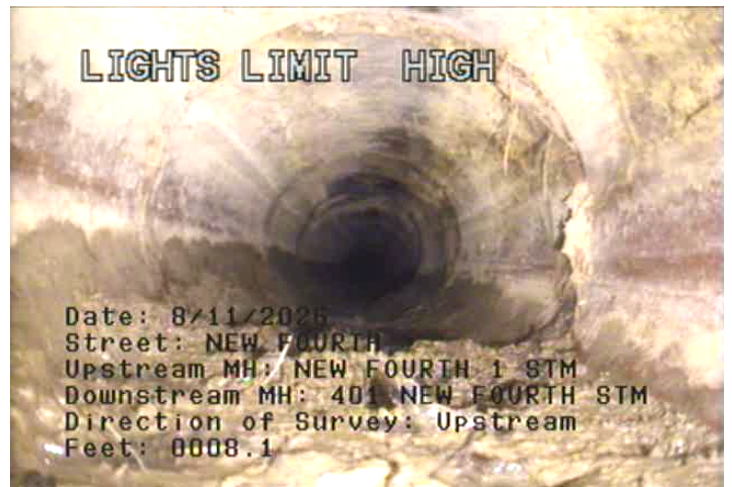
JOL - Joint Offset (displaced): Large @ 8.1 ft.

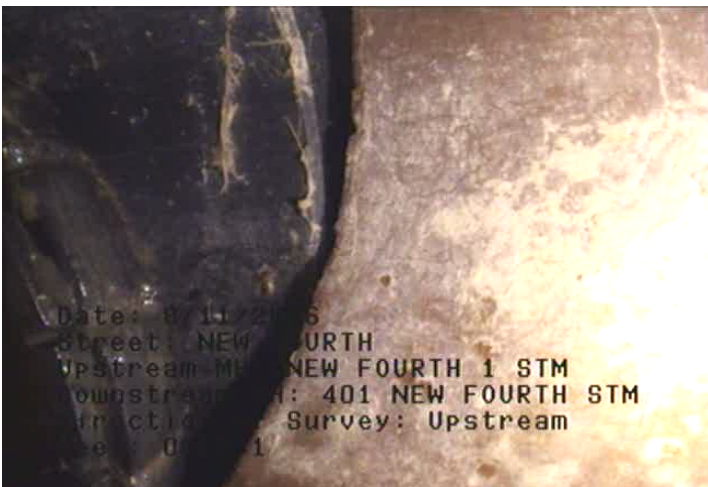
MMC - Material Change @ 8.1 ft. VCP

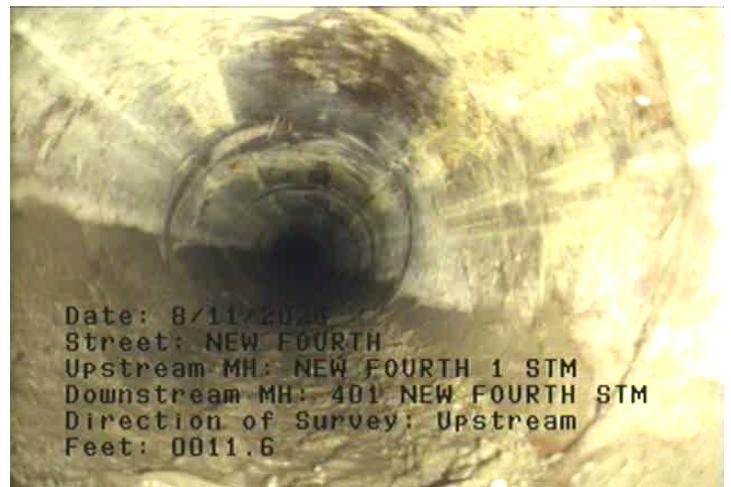
RFJ - Roots, Fine: Joint @ 11.6 ft.

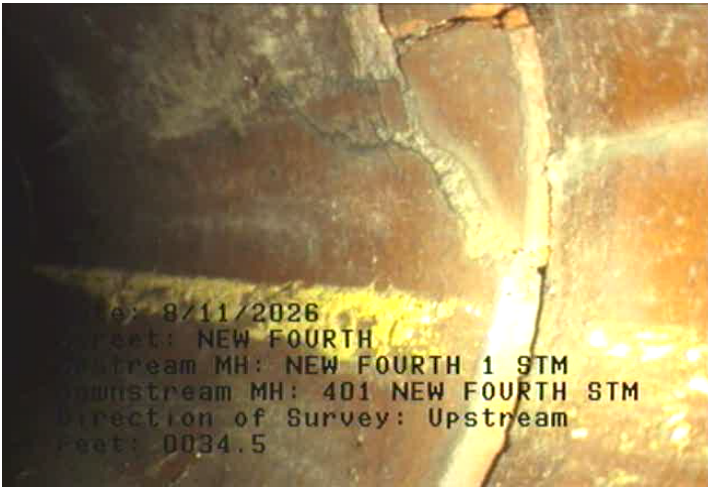
FM - Fracture Multiple @ 34.5 ft.

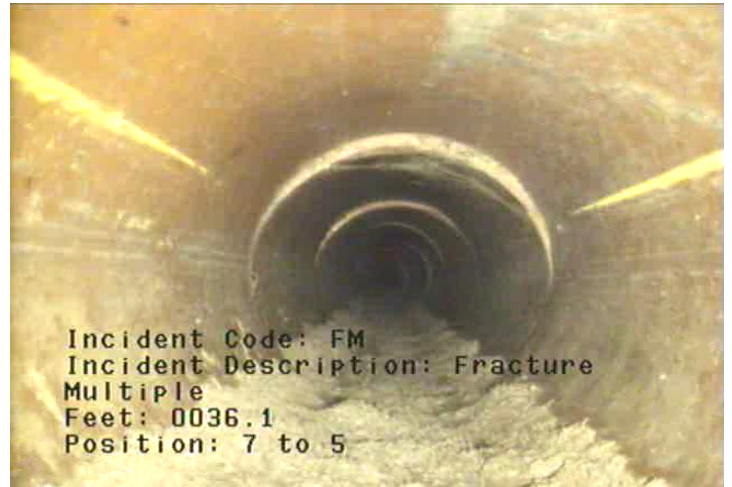
FM - Fracture Multiple @ 36.1 ft.

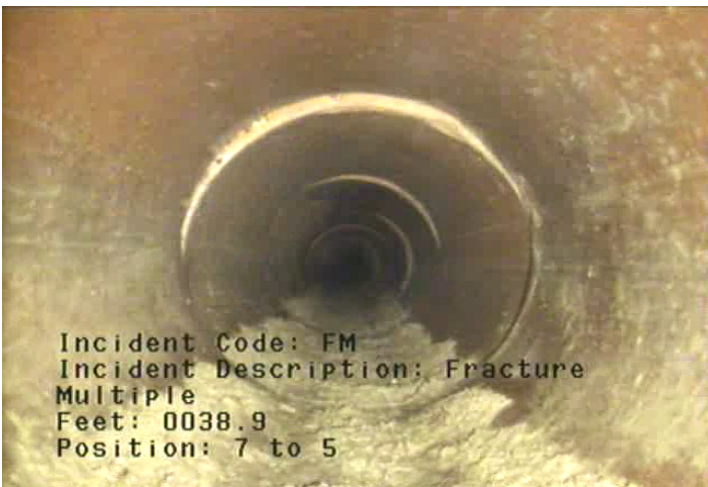
FM - Fracture Multiple @ 38.9 ft.

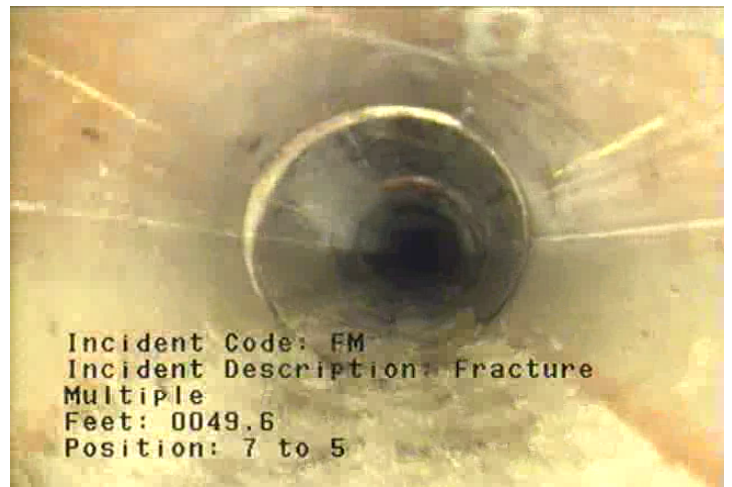
FM - Fracture Multiple @ 49.6 ft.

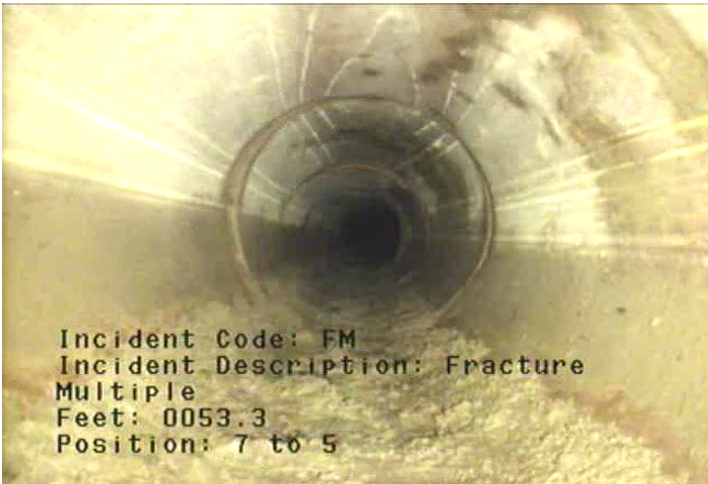
FM - Fracture Multiple @ 53.3 ft.

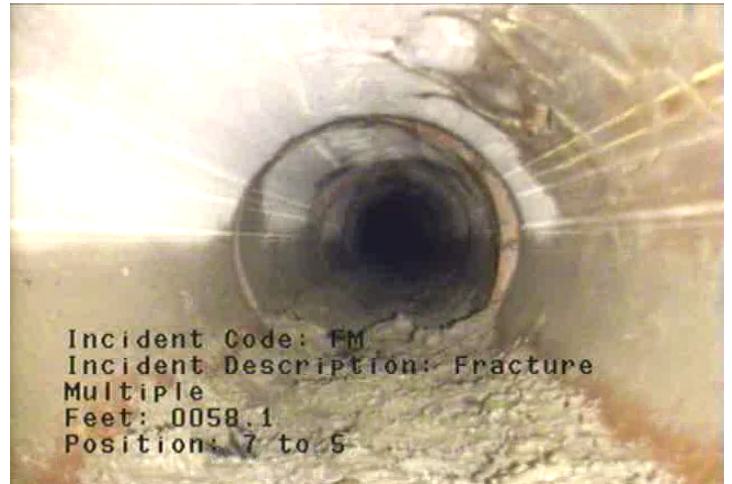
FM - Fracture Multiple @ 58.1 ft.

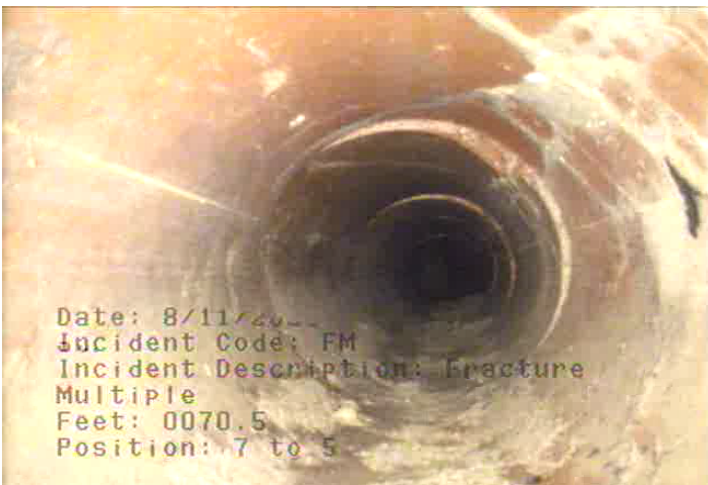
FM - Fracture Multiple @ 70.5 ft.

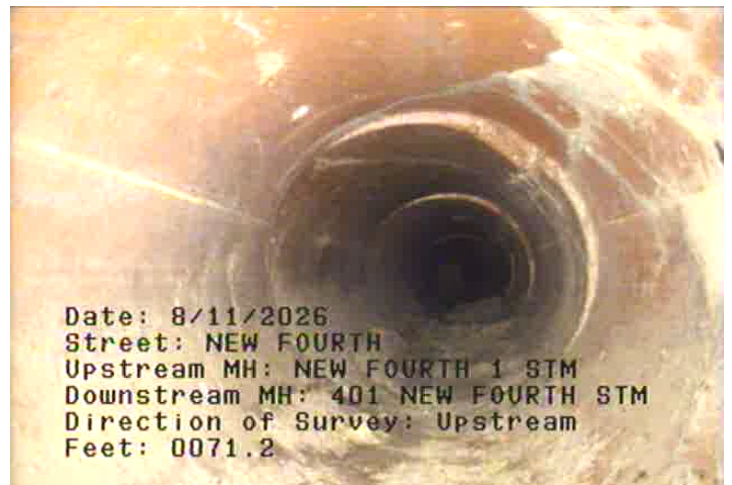
CM - Crack Multiple @ 71.2 ft.

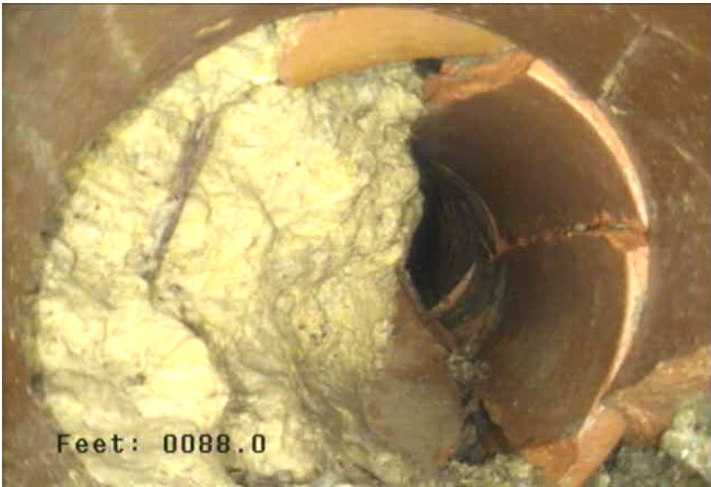
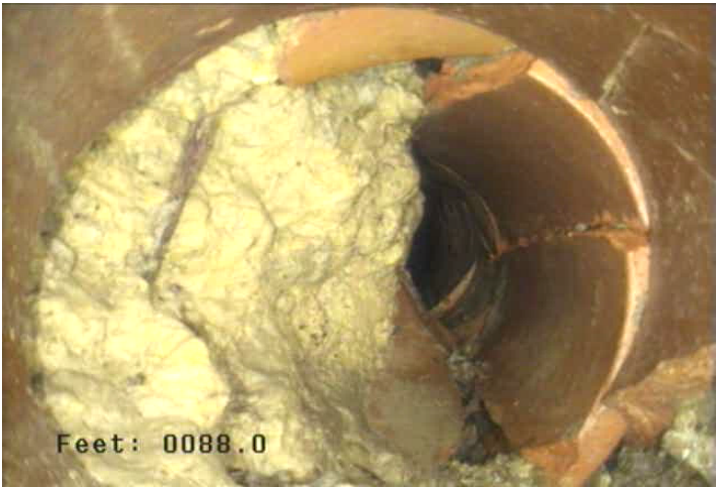
DSGV - Deposits Settled: Gravel @ 88.0 ft. FM - Fracture Multiple @ 88.0 ft.

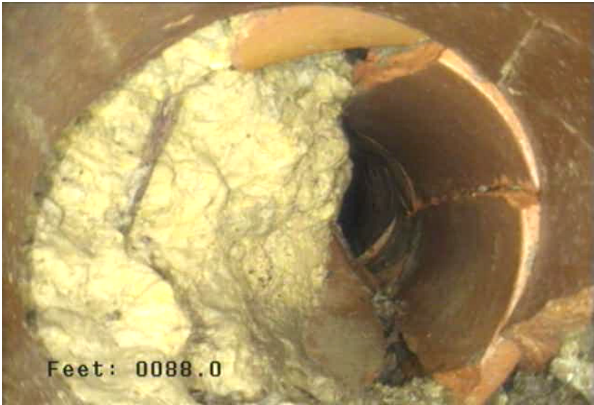
XP - Pipe Collapsed @ 88.0 ft. UNABLE TO GET PASS COLLAPSE. ALL OTHEWR ACCESS POINTS COVERED BY CONSTRUCTION

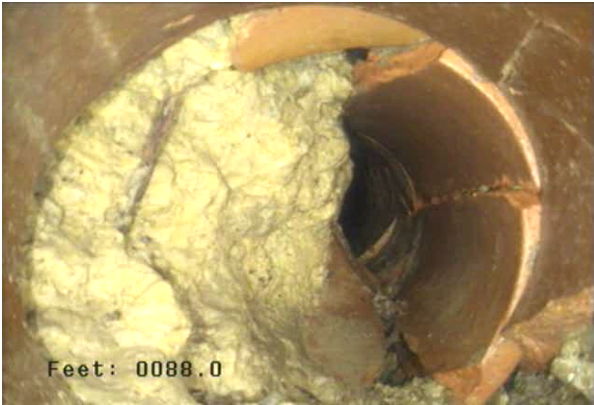
MSA - Survey Abandoned @ 88.0 ft. UNABLE TO GET PASS COLLAPSE. ALL OTHEWR ACCESS POINTS COVERED BY CONSTRUCTION
