Coring Report

Erskine Ave. Crossing Improvements

PREPARED FOR
ABC Water and Stormwater District

Verdantas Project No. 39498
February 13, 2026

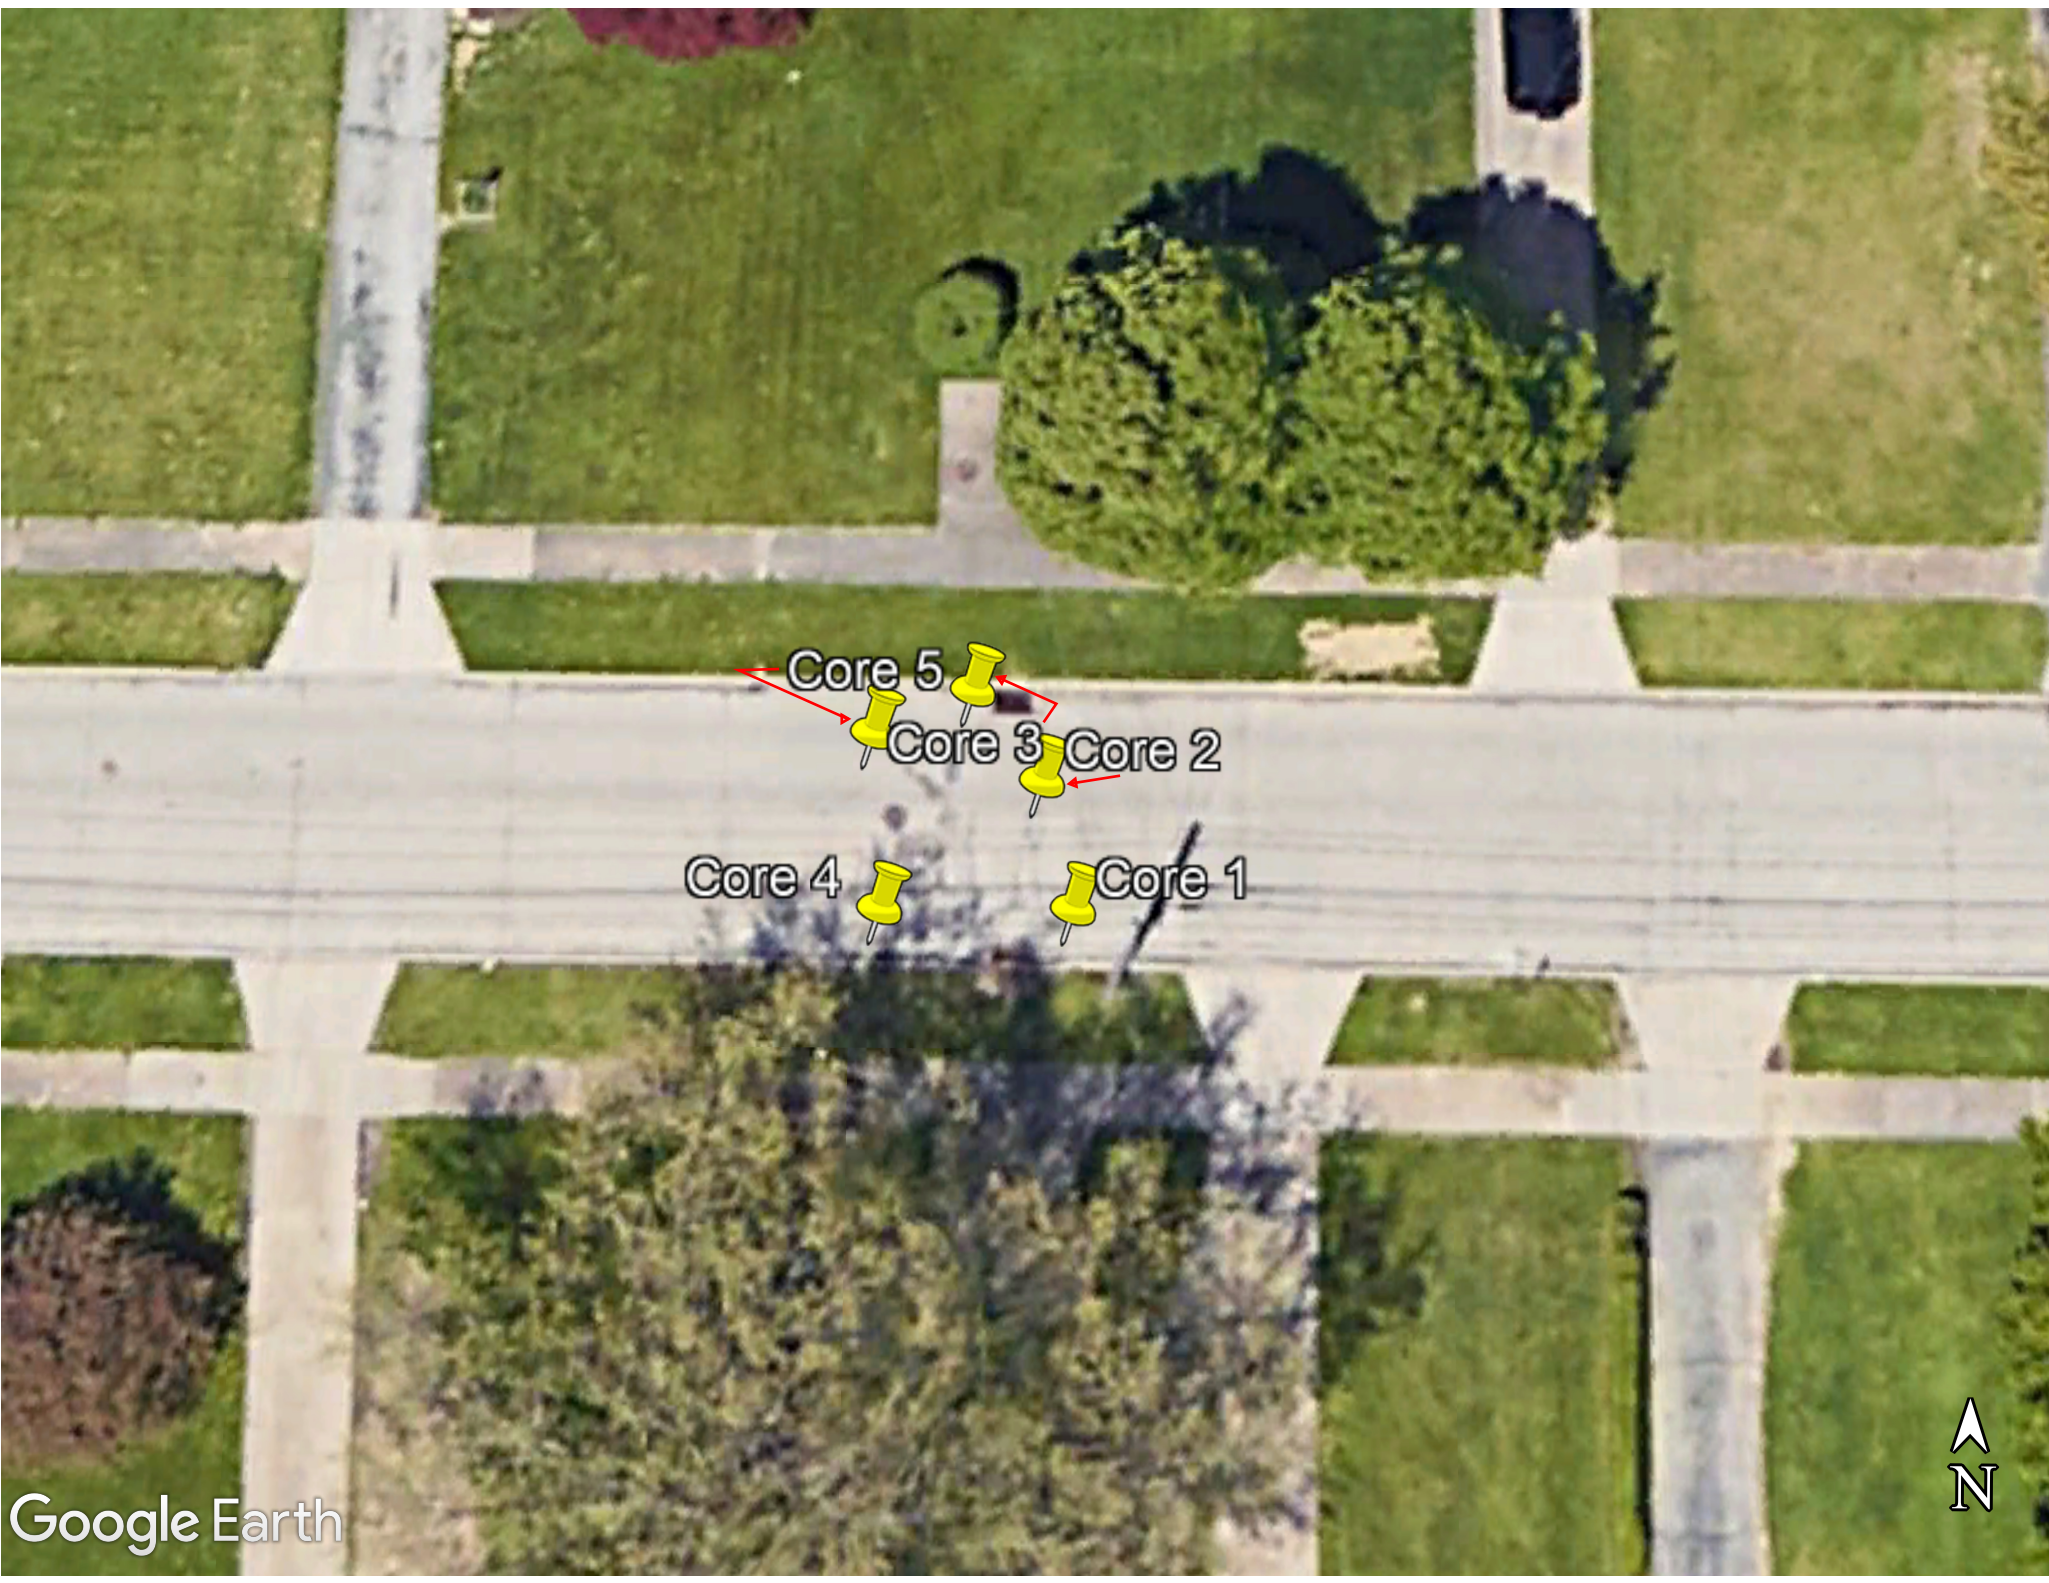
Core 5
Core 3
Core 2
Core 4
Core 1

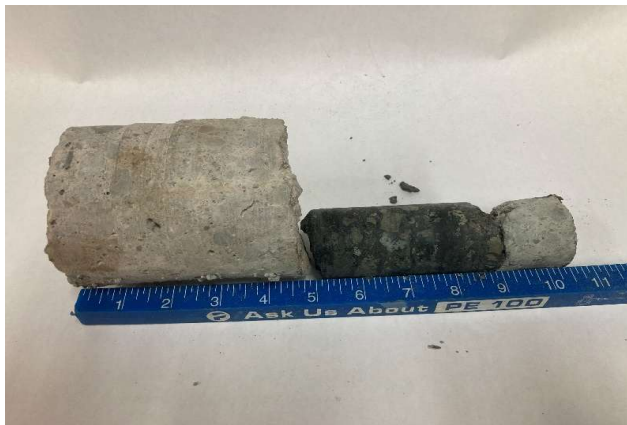
CORE SAMPLE

See core log page for actual thickness of concrete layers.

No base material.
Core taken over concrete culvert.

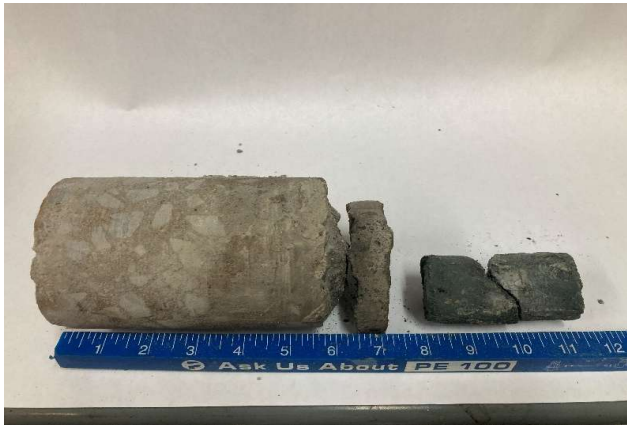
CORE SAMPLE

See core log page for actual thickness of concrete layers.

No base material.
Core taken over concrete culvert.

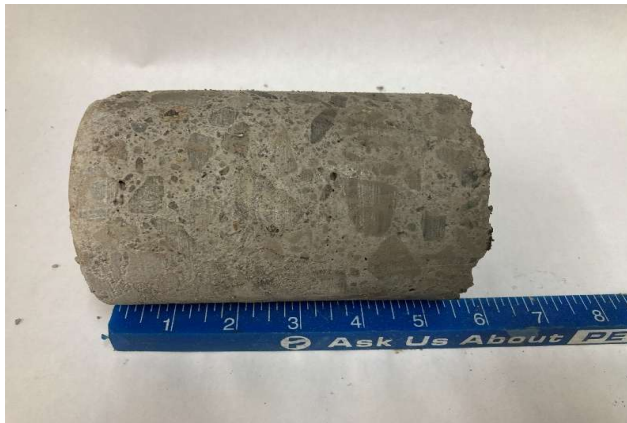
CORE SAMPLE

See core log page for actual thickness of concrete layers.
See log for actual thickness of concrete layers.

No base material.
Core taken over concrete culvert.

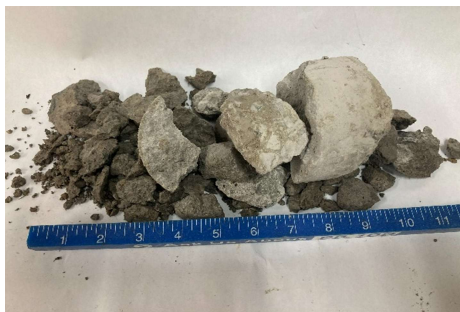
CORE SAMPLE

See core log page for actual thickness of concrete layers.

Core bit stuck in concrete. Hammered bit out of core. Drilled through pavement with 3/4" hammer drill bit and measured to bottom of pavement.
