## PACP Report with Pipe Run and Incident Snapshots

| Pipe segment ref.:<br><b>SMH061_SMH054A</b> | Start date/time:<br><b>20220322 12:23</b> | Street:<br><b>S MILTON ST</b> | | City:<br><b>SMITHVILLE</b> | | |
| Project name:<br><b>Sewer Cleaning &amp; CCTV - Project No. 210670</b> | Additional info: | | | | | |

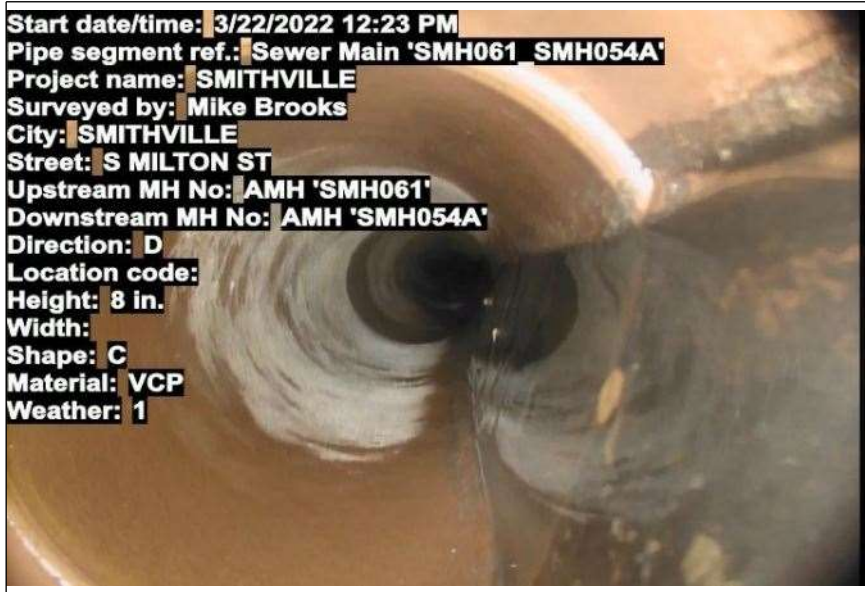
At: 0 ft. AMH - Manhole  
 Joint: No SMH061

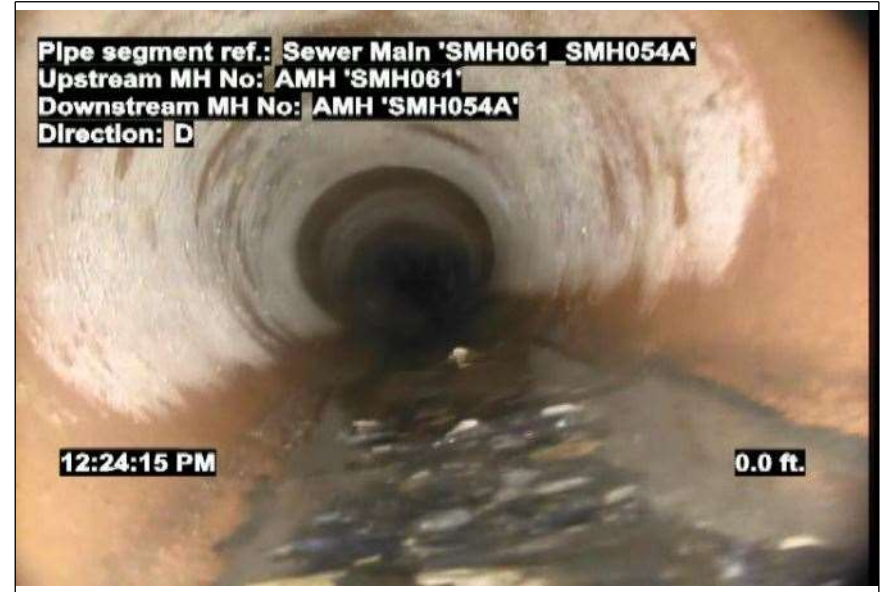
At: 0 ft. MWL - Miscellaneous Water Level  
 Joint: No 5 %

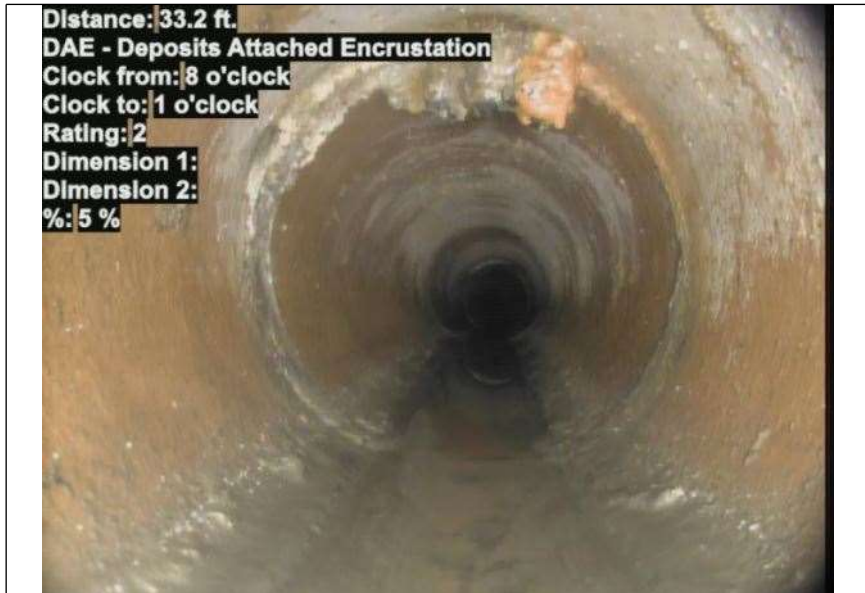
| Distance | Video Ref. | PACP Code | Continuous | S/M/L | Value Inches (mm) | | % | Joint | Circumferential Location | | Rating | Image Ref. | Remarks |
|---|---|---|---|---|---|---|---|---|---|---|---|---|---|
| 33.2 ft. | 00:02:14 | DAE | | | | | 5 | <input type="checkbox"/> | 8 / 1 | | 2 | SMH061_SMH054A_D<br>AE_33.2 ft.JPG | |

At: 33.2 ft. 8/1 DAE - Deposits Attached Encrustation  
 Joint: No 5 %

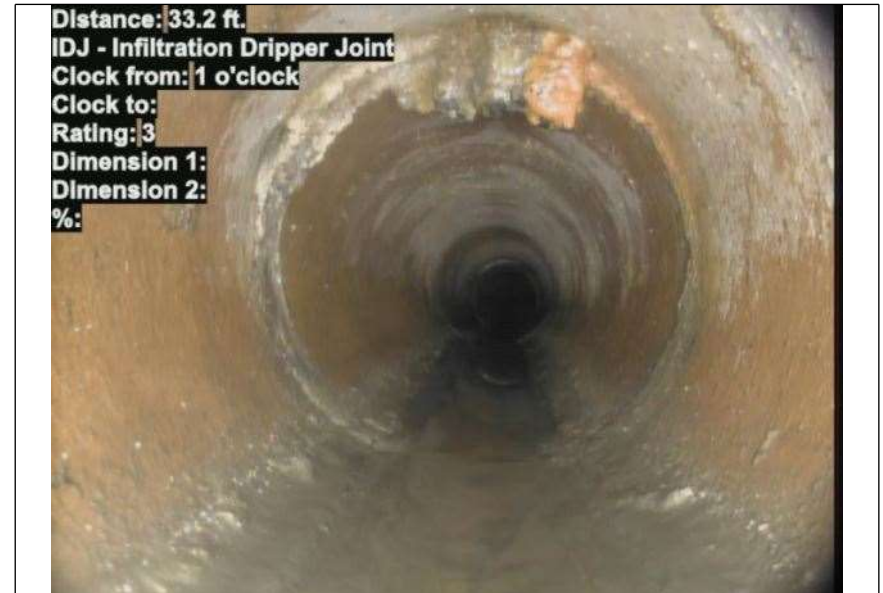
| Distance | Video Ref. | PACP Code | Continuous | S/M/L | Value Inches (mm) | | % | Joint | Circumferential Location | | Rating | Image Ref. | Remarks |
|---|---|---|---|---|---|---|---|---|---|---|---|---|---|
| 33.2 ft. | 00:02:31 | IDJ | | | | | | <input checked="" type="checkbox"/> | 1 / | | 3 | SMH061_SMH054A_I<br>DJ_33.2 ft.JPG | |

At: 33.2 ft. 1/. IDJ - Infiltration Dripper Joint  
 Joint: Yes

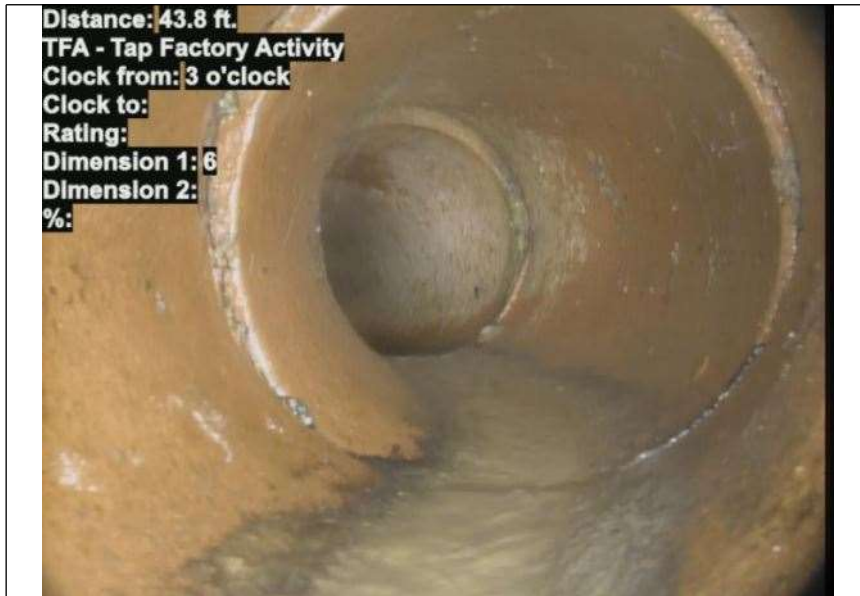
At: 43.8 ft. 3/ TFA - Tap Factory Activity  
Joint: No

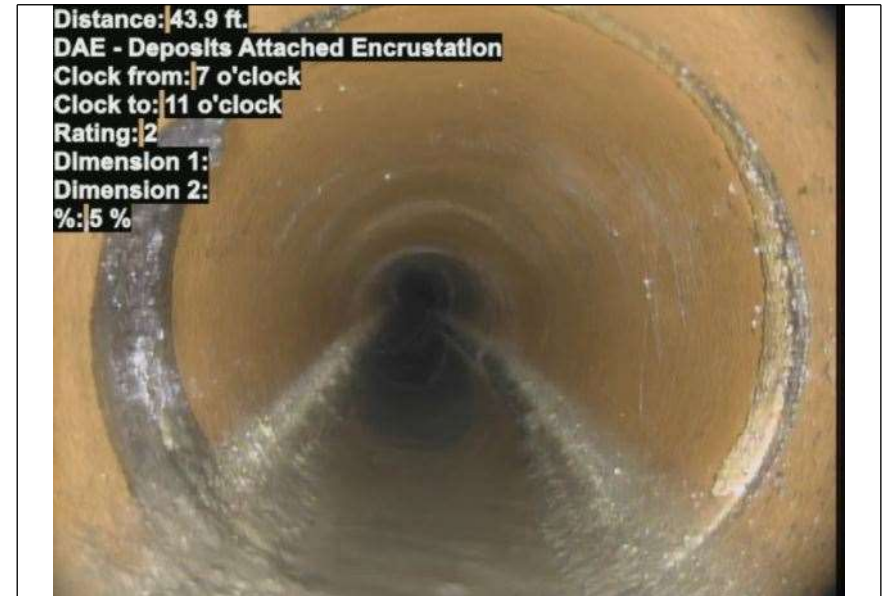
| Distance | Video Ref. | PACP Code | Continuous | S/M/L | Value Inches (mm) | | % | Joint | Circumferential Location | | Rating | Image Ref. | Remarks |
|---|---|---|---|---|---|---|---|---|---|---|---|---|---|
| 43.9 ft. | 00:03:51 | DAE | | | | | 5 | <input type="checkbox"/> | 7 / 11 | | 2 | SMH061_SMH054A_D<br>AE_43.9 ft.JPG | |

At: 43.9 ft. 7/11 DAE - Deposits Attached Encrustation  
Joint: No 5 %

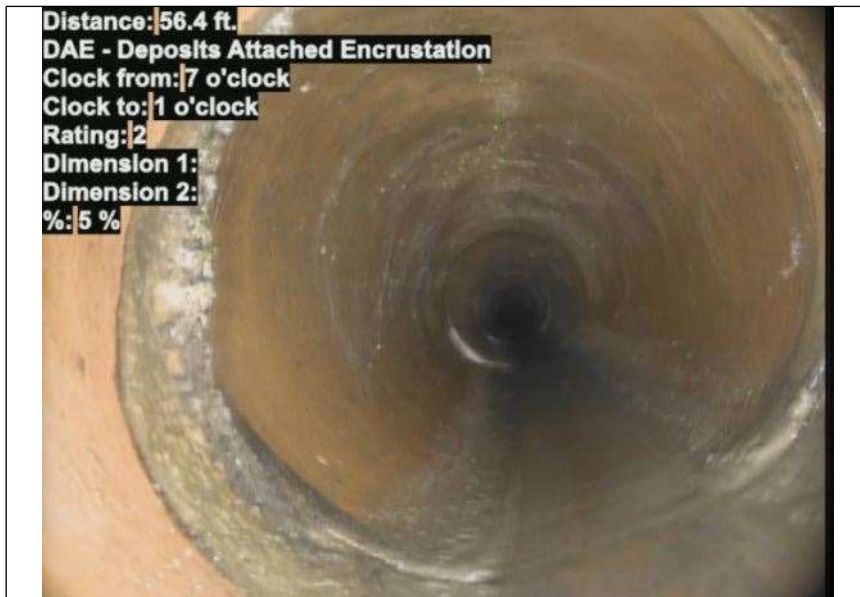
| Distance | Video Ref. | PACP Code | Continuous | S/M/L | Value Inches (mm) | | % | Joint | Circumferential Location | | Rating | Image Ref. | Remarks |
|---|---|---|---|---|---|---|---|---|---|---|---|---|---|
| 56.4 ft. | 00:04:42 | DAE | | | | | 5 | <input type="checkbox"/> | 7 / 1 | | 2 | SMH061_SMH054A_D<br>AE_56.4 ft.JPG | |

At: 56.4 ft. 7/1 DAE - Deposits Attached Encrustation  
Joint: No 5 %

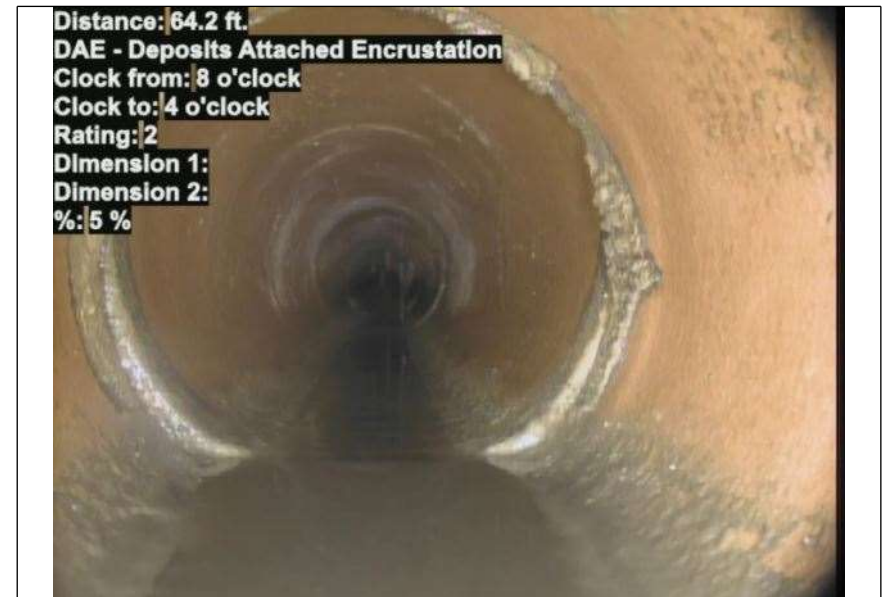
| Distance | Video Ref. | PACP Code | Continuous | S/M/L | Value Inches (mm) | | % | Joint | Circumferential Location | | Rating | Image Ref. | Remarks |
|---|---|---|---|---|---|---|---|---|---|---|---|---|---|
| 64.2 ft. | 00:06:30 | DAE | | | | | 5 | <input type="checkbox"/> | 8 / 4 | | 2 | SMH061_SMH054A_D<br>AE_64.2 ft.JPG | |

At: 64.2 ft. 8/4 DAE - Deposits Attached Encrustation  
Joint: No 5 %

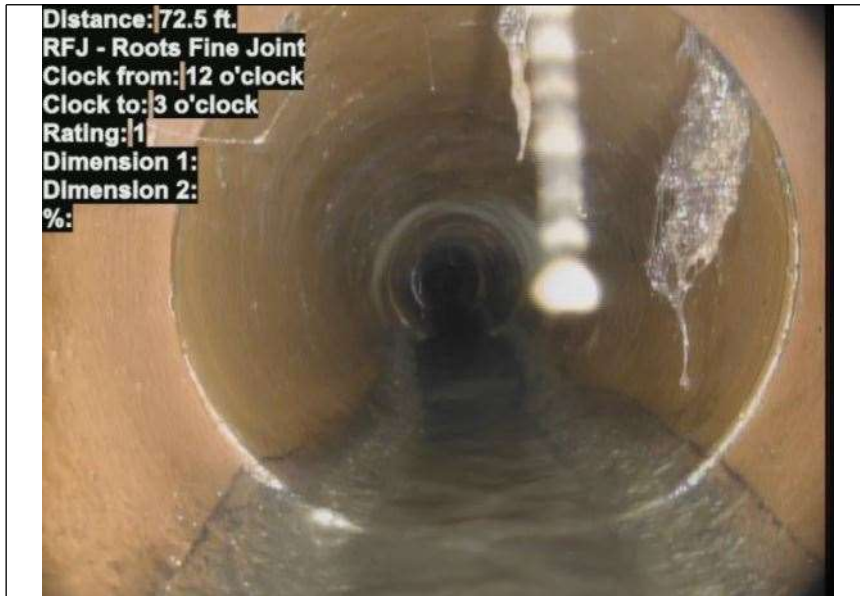
| Distance | Video Ref. | PACP Code | Continuous | S/M/L | Value Inches (mm) | | % | Joint | Circumferential Location | | Rating | Image Ref. | Remarks |
|---|---|---|---|---|---|---|---|---|---|---|---|---|---|
| 72.5 ft. | 00:07:01 | RFJ | | | | | | <input checked="" type="checkbox"/> | 12 / 3 | | 1 | SMH061_SMH054A_R<br>FJ_72.5 ft.JPG | |

At: 72.5 ft. 12/3 RFJ - Roots Fine Joint  
Joint: Yes

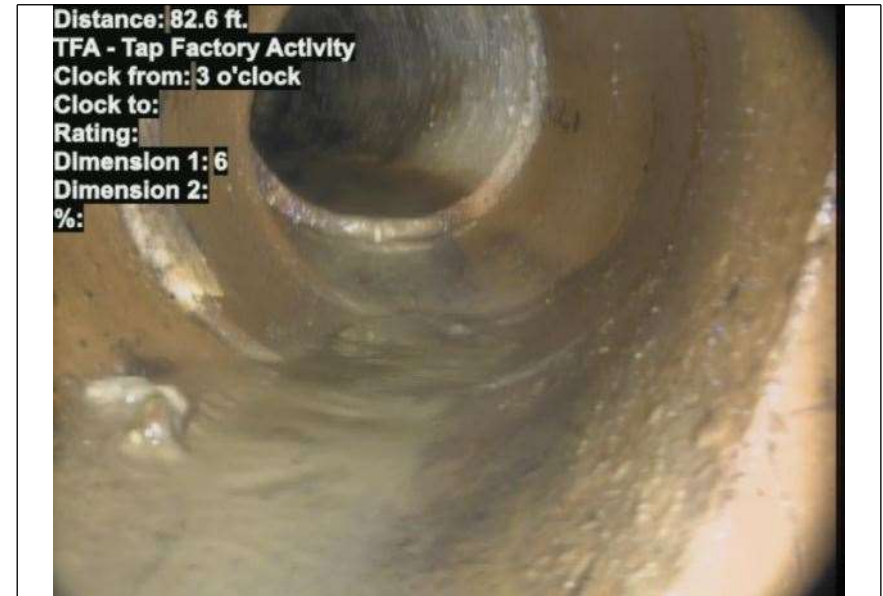
At: 82.6 ft. 3/ TFA - Tap Factory Activity  
Joint: No

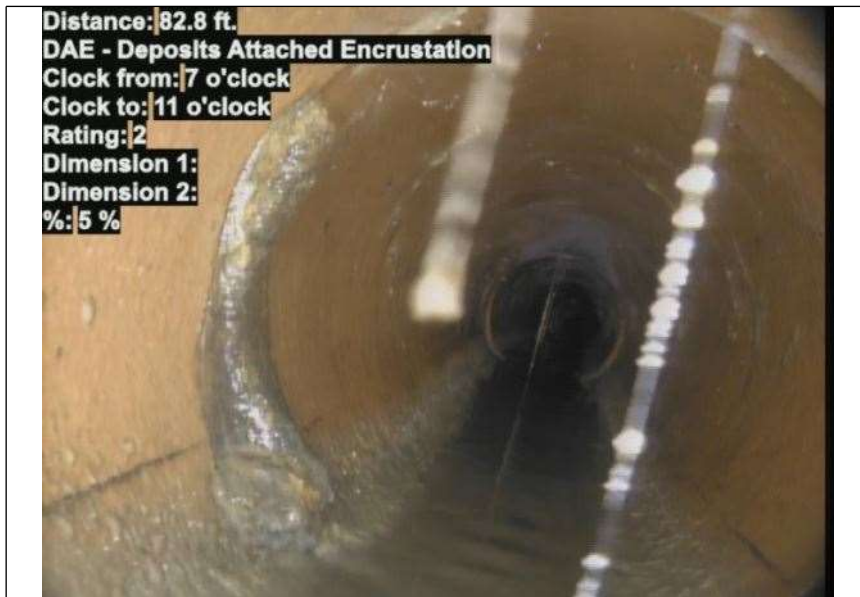
| Distance | Video Ref. | PACP Code | Continuous | S/M/L | Value Inches (mm) | | % | Joint | Circumferential Location | | Rating | Image Ref. | Remarks |
|---|---|---|---|---|---|---|---|---|---|---|---|---|---|
| 82.8 ft. | 00:08:30 | DAE | | | | | 5 | <input type="checkbox"/> | 7 / 11 | | 2 | SMH061_SMH054A_D<br>AE_82.8 ft.JPG | |

At: 82.8 ft. 7/11 DAE - Deposits Attached Encrustation  
Joint: No 5 %

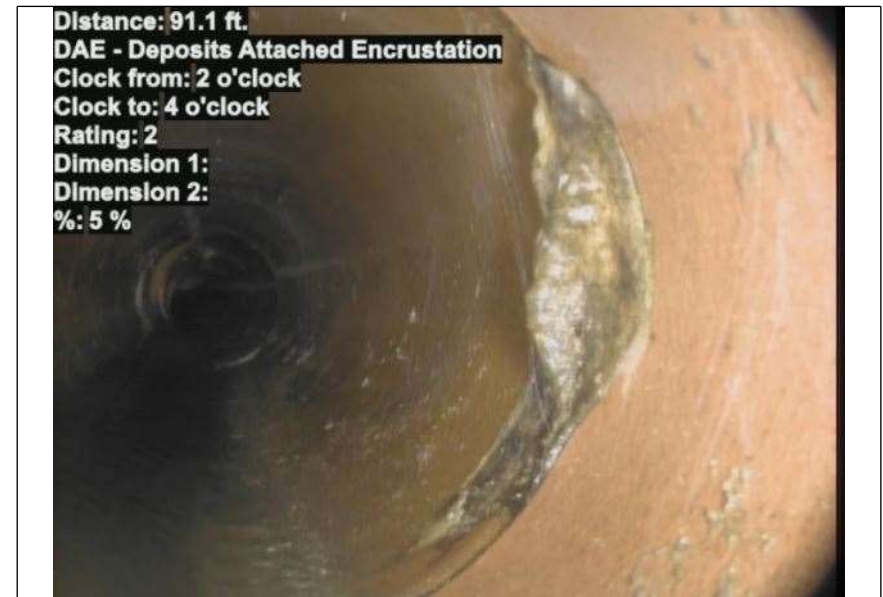
| Distance | Video Ref. | PACP Code | Continuous | S/M/L | Value Inches (mm) | | % | Joint | Circumferential Location | | Rating | Image Ref. | Remarks |
|---|---|---|---|---|---|---|---|---|---|---|---|---|---|
| 91.1 ft. | 00:09:03 | DAE | | | | | 5 | <input type="checkbox"/> | 2 / 4 | | 2 | SMH061_SMH054A_D<br>AE_91.1 ft.JPG | |

At: 91.1 ft. 2/4 DAE - Deposits Attached Encrustation  
Joint: No 5 %

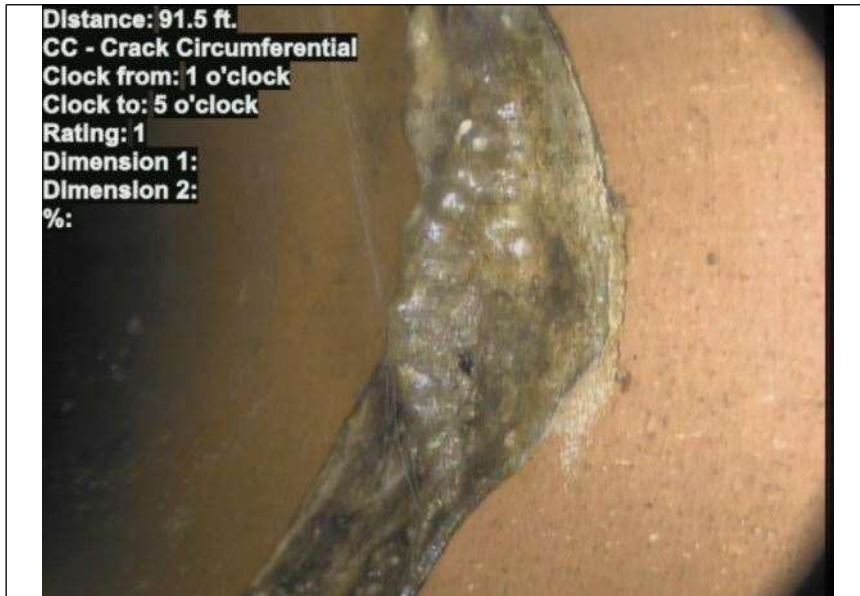
| Distance | Video Ref. | PACP Code | Continuous | S/M/L | Value Inches (mm) | | % | Joint | Circumferential Location | | Rating | Image Ref. | Remarks |
|---|---|---|---|---|---|---|---|---|---|---|---|---|---|
| 91.5 ft. | 00:09:52 | CC | | | | | | <input type="checkbox"/> | 1 / 5 | | 1 | SMH061_SMH054A_C<br>C_91.5 ft.JPG | |

At: 91.5 ft. 1/5 CC - Crack Circumferential  
Joint: No

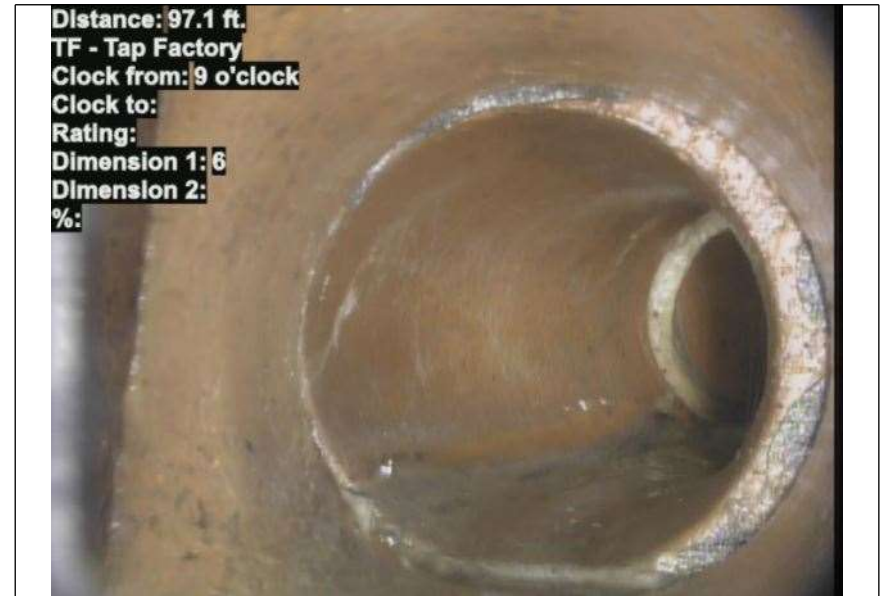
At: 97.1 ft. 9/ TF - Tap Factory  
Joint: No

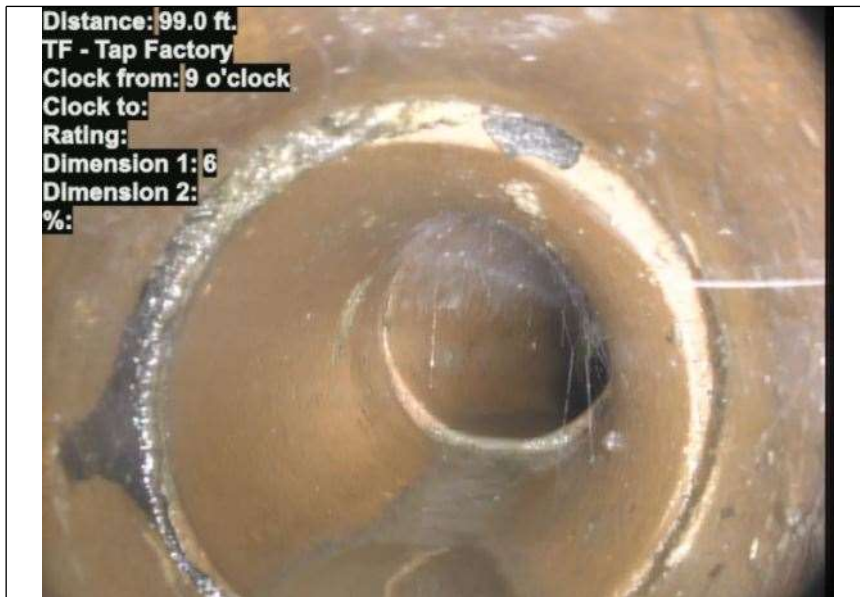
At: 99 ft. 9/ TF - Tap Factory  
Joint: No

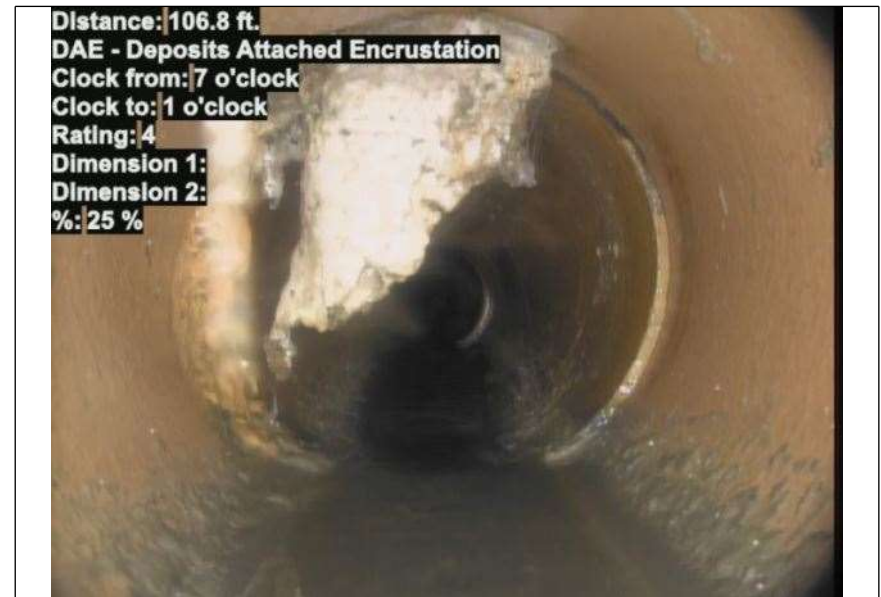
| Distance | Video Ref. | PACP Code | Continuous | S/M/L | Value Inches (mm) | | % | Joint | Circumferential Location | | Rating | Image Ref. | Remarks |
|---|---|---|---|---|---|---|---|---|---|---|---|---|---|
| 106.8 ft. | 00:11:26 | DAE | | | | | 25 | <input type="checkbox"/> | 7 / 1 | | 4 | SMH061_SMH054A_D<br>AE_106.8 ft.JPG | |

At: 106.8 ft. 7/1 DAE - Deposits Attached Encrustation  
Joint: No 25 %

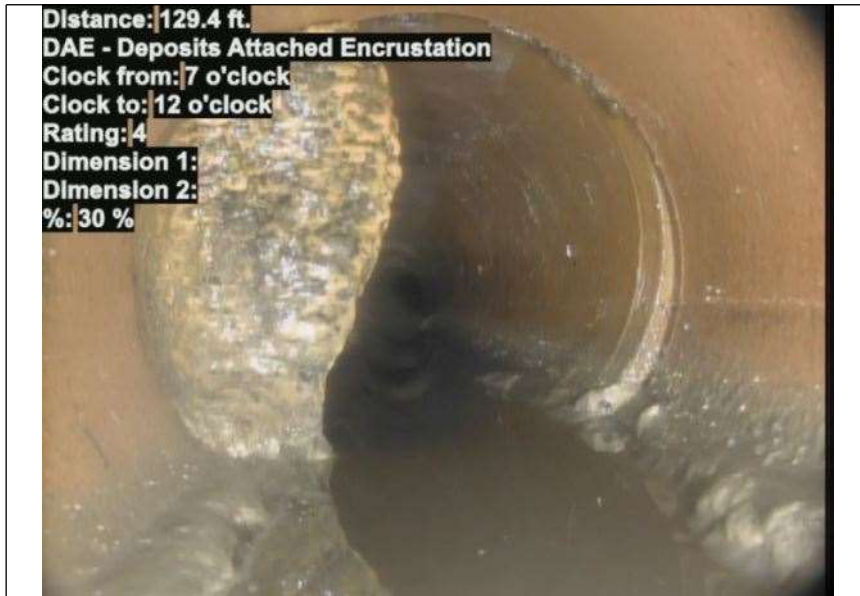
| Distance | Video Ref. | PACP Code | Continuous | S/M/L | Value Inches (mm) | | % | Joint | Circumferential Location | | Rating | Image Ref. | Remarks |
|---|---|---|---|---|---|---|---|---|---|---|---|---|---|
| 129.4 ft. | 00:00:05 | DAE | | | | | 30 | <input type="checkbox"/> | 7 / 12 | | 4 | SMH061_SMH054A_D<br>AE_129.4 ft.JPG | |

At: 129.4 ft. DAE - Deposits Attached Encrustation  
7/12

Joint: No 30 %

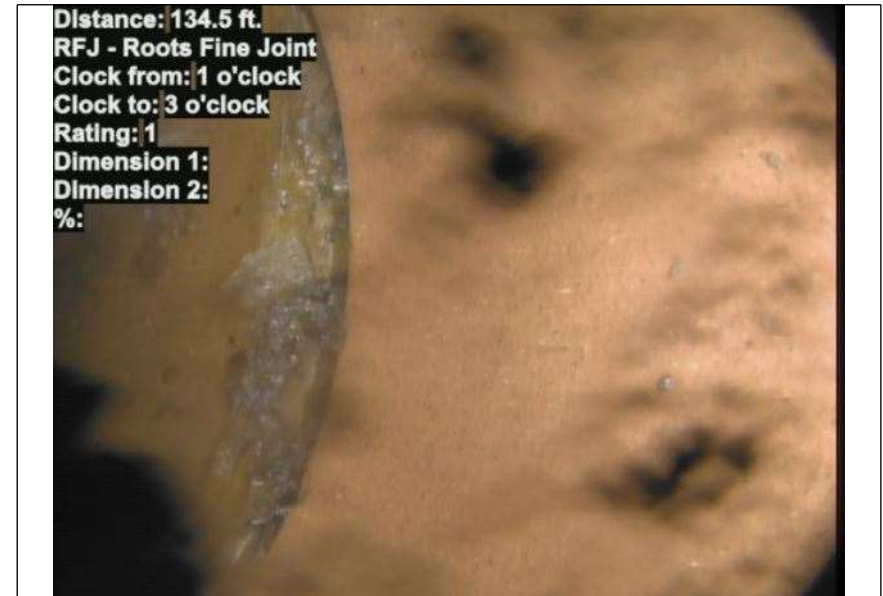
| Distance | Video Ref. | PACP Code | Continuous | S/M/L | Value Inches (mm) | | % | Joint | Circumferential Location | | Rating | Image Ref. | Remarks |
|---|---|---|---|---|---|---|---|---|---|---|---|---|---|
| 134.5 ft. | 00:05:28 | RFJ | | | | | | <input checked="" type="checkbox"/> | 1 / 3 | | 1 | SMH061_SMH054A_R<br>FJ_134.5 ft.JPG | |

At: 134.5 ft. 1/3 RFJ - Roots Fine Joint

Joint: Yes

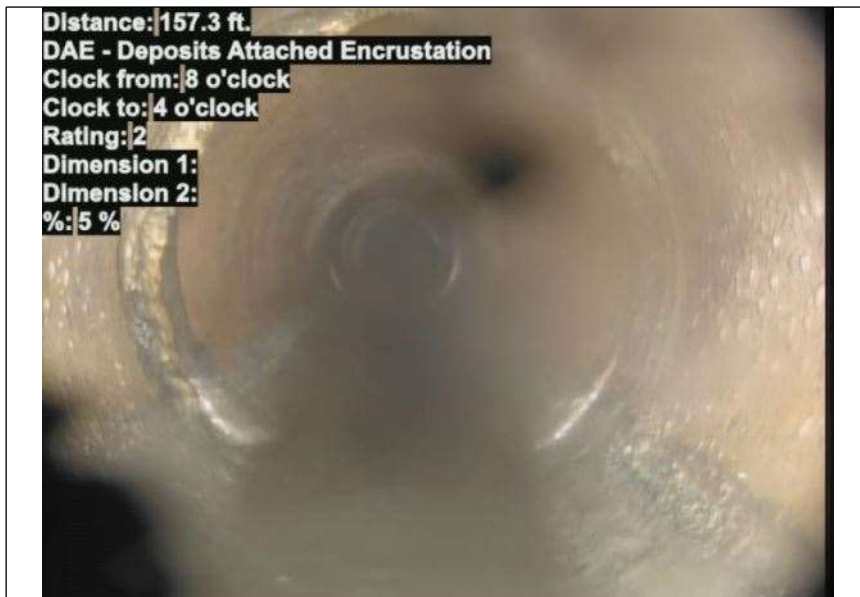
| Distance | Video Ref. | PACP Code | Continuous | S/M/L | Value Inches (mm) | | % | Joint | Circumferential Location | | Rating | Image Ref. | Remarks |
|---|---|---|---|---|---|---|---|---|---|---|---|---|---|
| 157.3 ft. | 00:07:02 | DAE | | | | | 5 | <input type="checkbox"/> | 8 / 4 | | 2 | SMH061_SMH054A_D<br>AE_157.3 ft.JPG | |

At: 157.3 ft. 8/4 DAE - Deposits Attached Encrustation

Joint: No 5 %

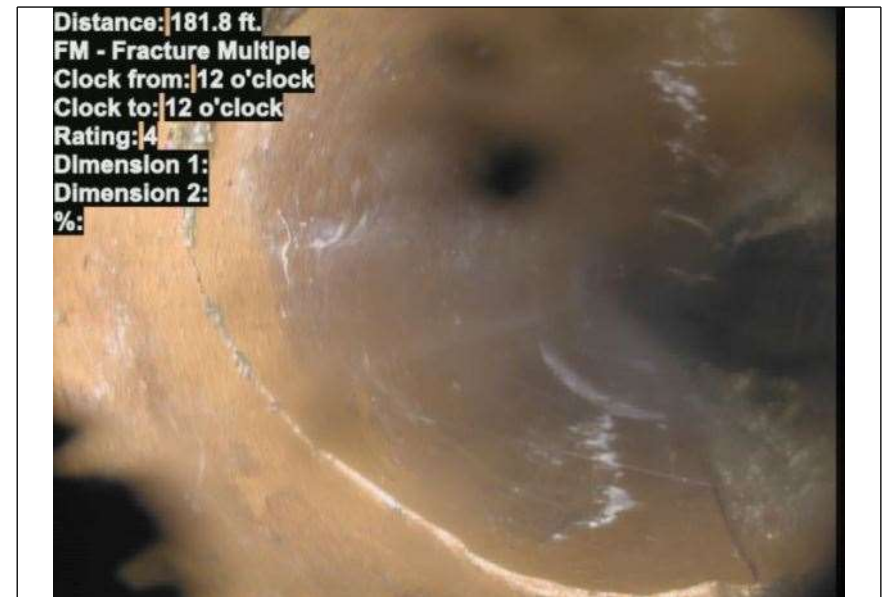
| Distance | Video Ref. | PACP Code | Continuous | S/M/L | Value Inches (mm) | | % | Joint | Circumferential Location | | Rating | Image Ref. | Remarks |
|---|---|---|---|---|---|---|---|---|---|---|---|---|---|
| 181.8 ft. | 00:08:45 | FM | | | | | | <input type="checkbox"/> | 12 / 12 | | 4 | SMH061_SMH054A_F<br>M_181.8 ft.JPG | |

At: 181.8 ft. FM - Fracture Multiple  
12/12

Joint: No

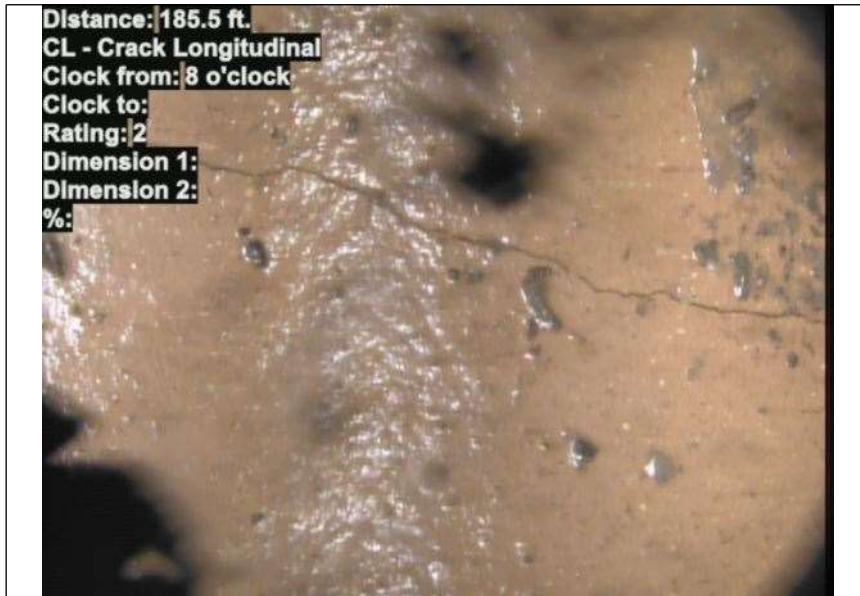
| Distance | Video Ref. | PACP Code | Continuous | S/M/L | Value Inches (mm) | | % | Joint | Circumferential Location | | Rating | Image Ref. | Remarks |
|---|---|---|---|---|---|---|---|---|---|---|---|---|---|
| 185.5 ft. | 00:09:32 | CL | | | | | | <input type="checkbox"/> | 8 / | | 2 | SMH061_SMH054A_C<br>L_185.5 ft.JPG | |

Distance: 185.5 ft.  
CL - Crack Longitudinal  
Clock from: 8 o'clock  
Clock to:  
Rating: 2  
Dimension 1:  
Dimension 2:  
%:

At: 185.5 ft. 8/. CL - Crack Longitudinal  
Joint: No

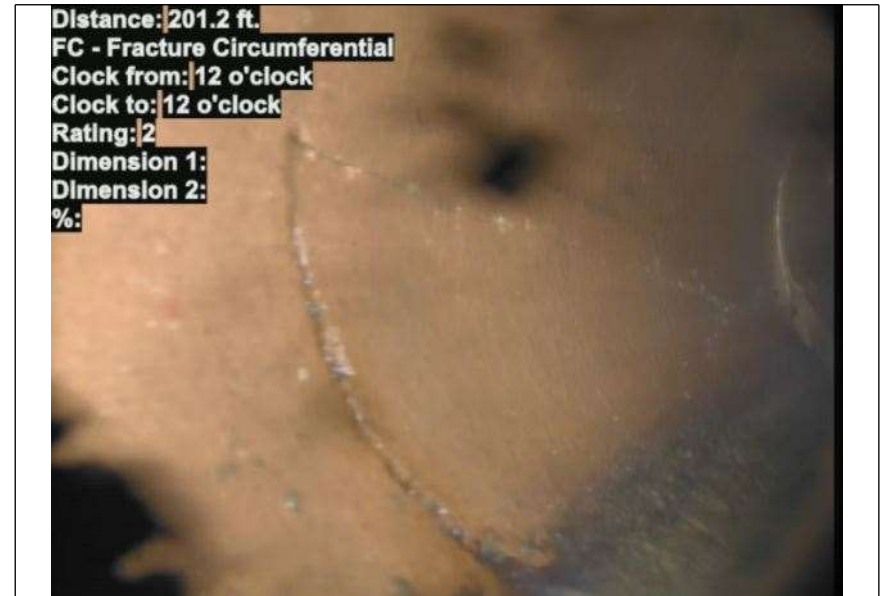
| Distance | Video Ref. | PACP Code | Continuous | S/M/L | Value Inches (mm) | | % | Joint | Circumferential Location | | Rating | Image Ref. | Remarks |
|---|---|---|---|---|---|---|---|---|---|---|---|---|---|
| 201.2 ft. | 00:11:50 | FC | | | | | | <input type="checkbox"/> | 12 / 12 | | 2 | SMH061_SMH054A_F<br>C_201.2 ft.JPG | |

Distance: 201.2 ft.  
FC - Fracture Circumferential  
Clock from: 12 o'clock  
Clock to: 12 o'clock  
Rating: 2  
Dimension 1:  
Dimension 2:  
%:

At: 201.2 ft. FC - Fracture Circumferential  
12/12  
Joint: No

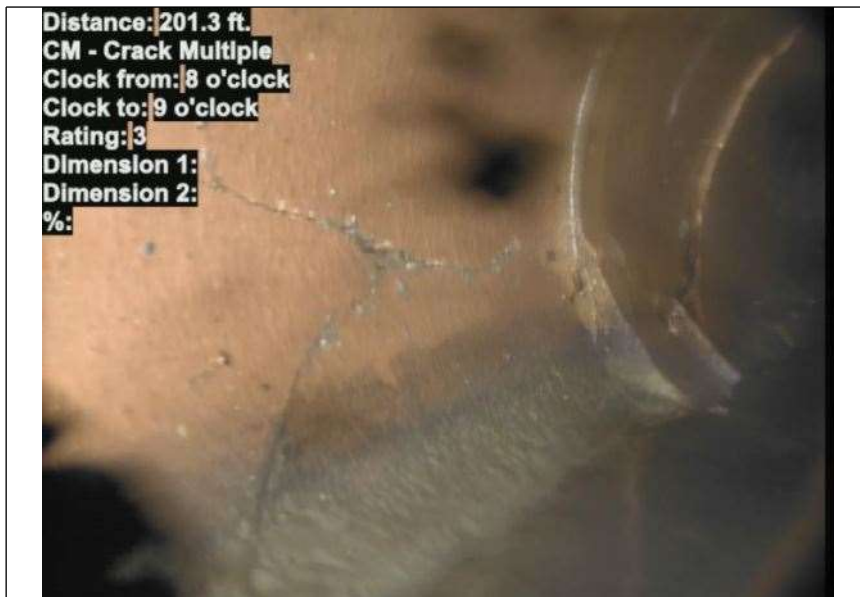
| Distance | Video Ref. | PACP Code | Continuous | S/M/L | Value Inches (mm) | | % | Joint | Circumferential Location | | Rating | Image Ref. | Remarks |
|---|---|---|---|---|---|---|---|---|---|---|---|---|---|
| 201.3 ft. | 00:12:20 | CM | | | | | | <input type="checkbox"/> | 8 / 9 | | 3 | SMH061_SMH054A_C<br>M_201.3 ft.JPG | |

Distance: 201.3 ft.  
CM - Crack Multiple  
Clock from: 8 o'clock  
Clock to: 9 o'clock  
Rating: 3  
Dimension 1:  
Dimension 2:  
%:

At: 201.3 ft. 8/9 CM - Crack Multiple  
Joint: No

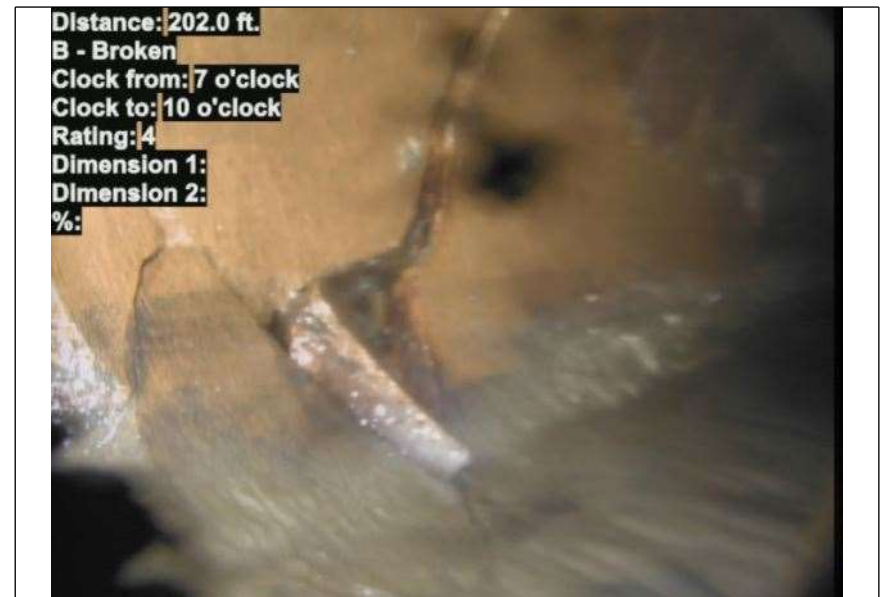
| Distance | Video Ref. | PACP Code | Continuous | S/M/L | Value Inches (mm) | | % | Joint | Circumferential Location | | Rating | Image Ref. | Remarks |
|---|---|---|---|---|---|---|---|---|---|---|---|---|---|
| 202.0 ft. | 00:00:54 | B | | | | | | <input type="checkbox"/> | 7 / 10 | | 4 | SMH061_SMH054A_B<br>_202.0 ft.JPG | |

Distance: 202.0 ft.  
B - Broken  
Clock from: 7 o'clock  
Clock to: 10 o'clock  
Rating: 4  
Dimension 1:  
Dimension 2:  
%:

At: 202 ft. 7/10 B - Broken  
Joint: No

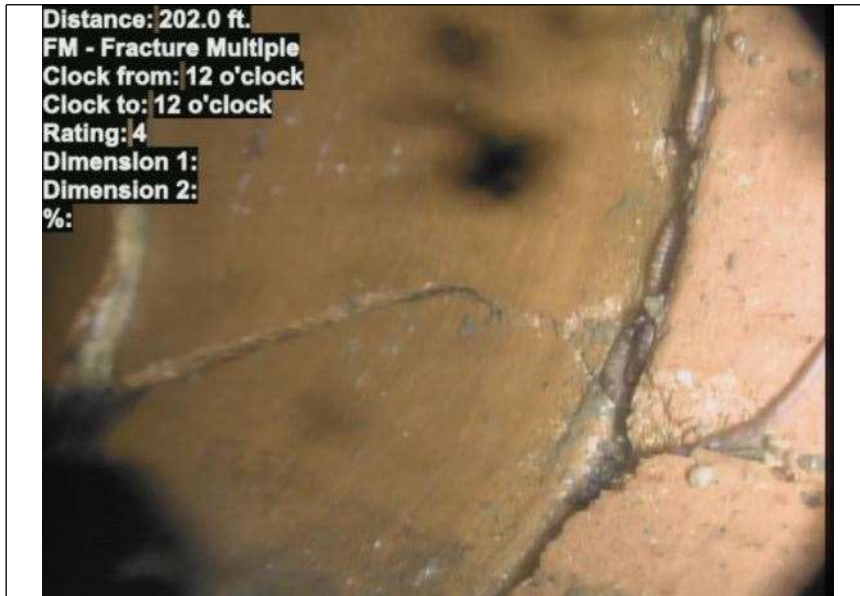
| Distance | Video Ref. | PACP Code | Continuous | S/M/L | Value Inches (mm) | | % | Joint | Circumferential Location | | Rating | Image Ref. | Remarks |
|---|---|---|---|---|---|---|---|---|---|---|---|---|---|
| 202.0 ft. | 00:02:04 | FM | | | | | | <input type="checkbox"/> | 12 / 12 | | 4 | SMH061_SMH054A_F<br>M_202.0 ft.JPG | |

At: 202 ft. 12/12 FM - Fracture Multiple

Joint: No

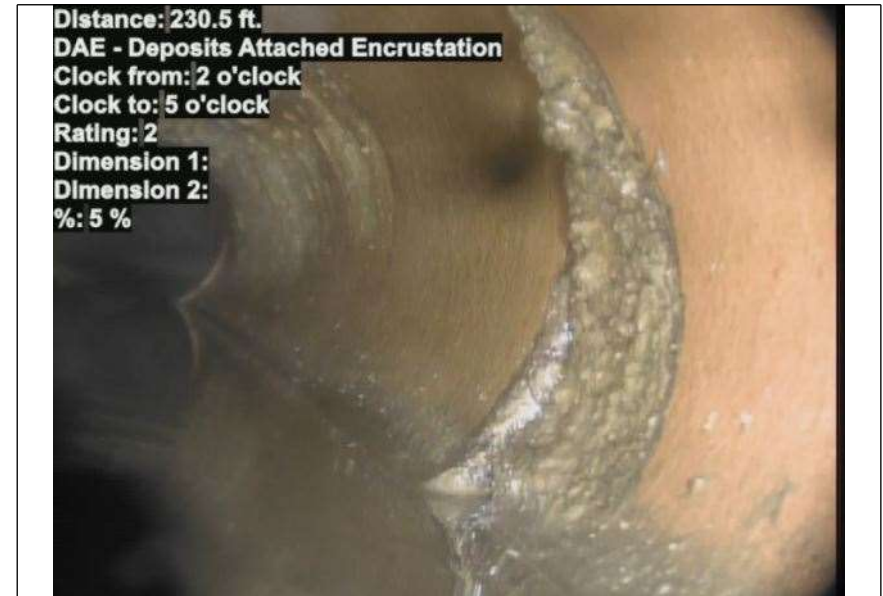
| Distance | Video Ref. | PACP Code | Continuous | S/M/L | Value Inches (mm) | | % | Joint | Circumferential Location | | Rating | Image Ref. | Remarks |
|---|---|---|---|---|---|---|---|---|---|---|---|---|---|
| 230.5 ft. | 00:04:17 | DAE | | | | | 5 | <input type="checkbox"/> | 2 / 5 | | 2 | SMH061_SMH054A_D<br>AE_230.5 ft.JPG | |

At: 230.5 ft. 2/5 DAE - Deposits Attached Encrustation

Joint: No 5 %

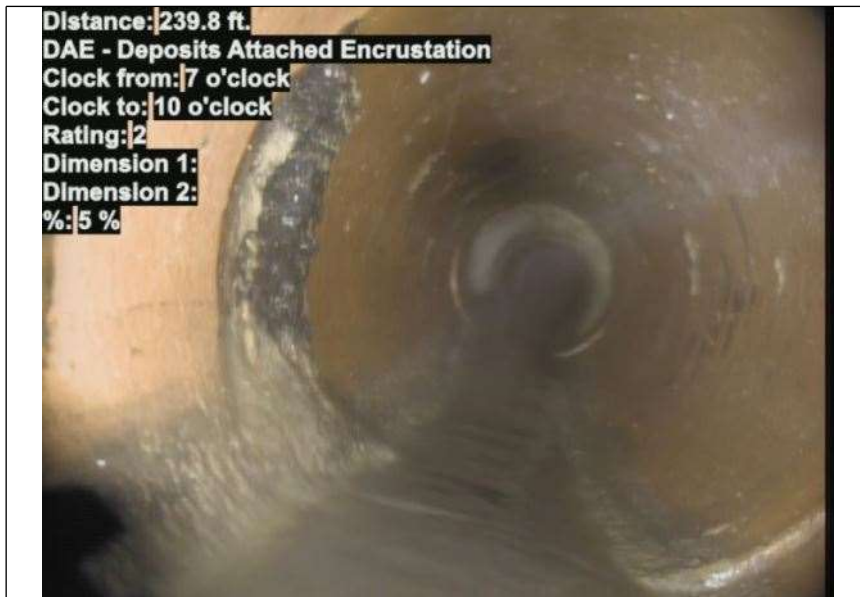
| Distance | Video Ref. | PACP Code | Continuous | S/M/L | Value Inches (mm) | | % | Joint | Circumferential Location | | Rating | Image Ref. | Remarks |
|---|---|---|---|---|---|---|---|---|---|---|---|---|---|
| 239.8 ft. | 00:05:03 | DAE | | | | | 5 | <input type="checkbox"/> | 7 / 10 | | 2 | SMH061_SMH054A_D<br>AE_239.8 ft.JPG | |

At: 239.8 ft. DAE - Deposits Attached Encrustation

7/10  
Joint: No 5 %

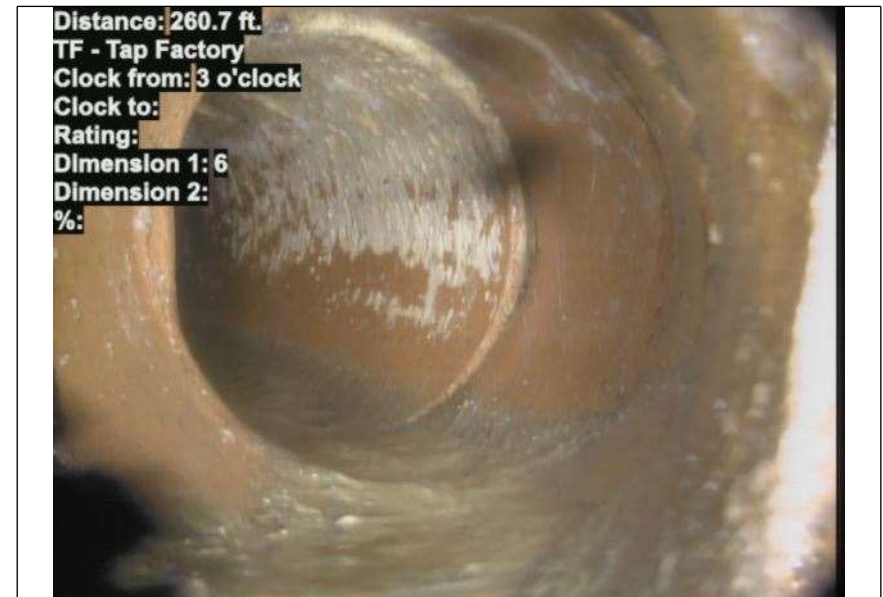
At: 260.7 ft. 3/ TF - Tap Factory

Joint: No

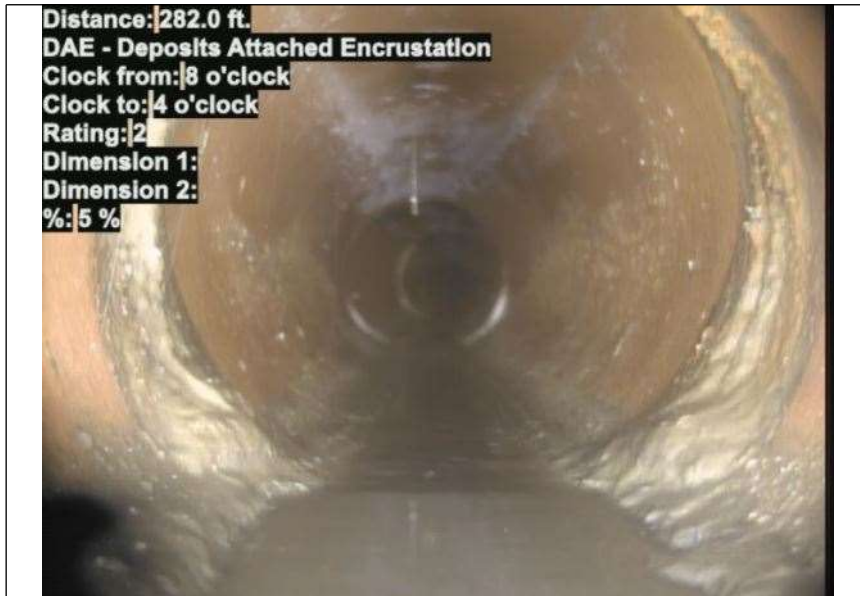
| Distance | Video Ref. | PACP Code | Continuous | S/M/L | Value Inches (mm) | | % | Joint | Circumferential Location | | Rating | Image Ref. | Remarks |
|---|---|---|---|---|---|---|---|---|---|---|---|---|---|
| 282.0 ft. | 00:06:49 | DAE | | | | | 5 | <input type="checkbox"/> | 8 / 4 | | 2 | SMH061_SMH054A_D<br>AE_282.0 ft.JPG | |

At: 282 ft. 8/4 DAE - Deposits Attached Encrustation  
Joint: No 5 %

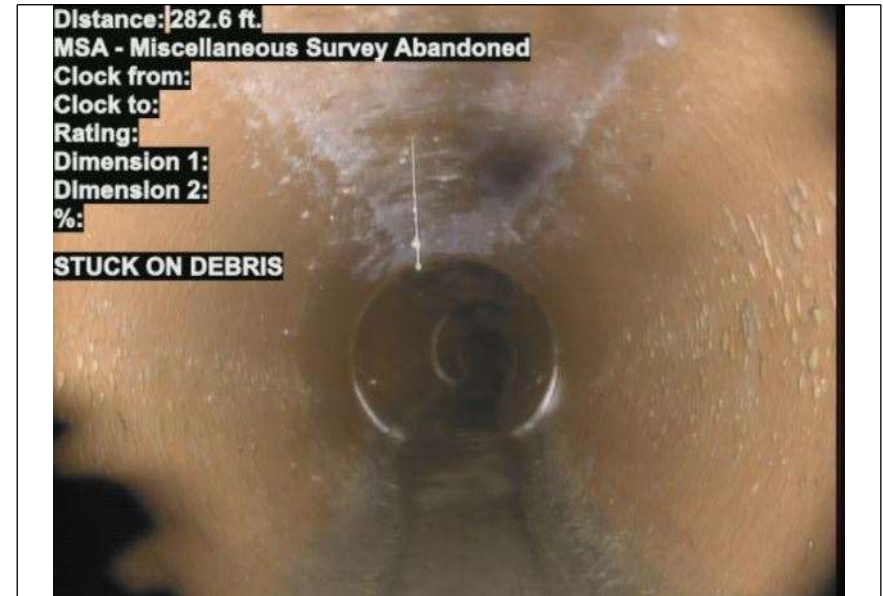
| Distance | Video Ref. | PACP Code | Continuous | S/M/L | Value Inches (mm) | | % | Joint | Circumferential Location | | Rating | Image Ref. | Remarks |
|---|---|---|---|---|---|---|---|---|---|---|---|---|---|
| 282.6 ft. | 00:06:24 | MSA | | | | | | <input type="checkbox"/> | / | | | SMH061_SMH054A_M<br>SA_282.6 ft.JPG | STUCK ON DEBRIS |

At: 282.6 ft. MSA - Miscellaneous Survey Abandoned  
Joint: No STUCK ON DEBRIS
