## PACP Report with Pipe Run and Incident Snapshots

Surveyed by: <b>Mike Brooks</b>	Certificate number: <b>Mike Brooks</b>	Owner:	Customer:	Drainage area:	P/O number:	Sheet number:
Pipe segment ref.: <b>SMH062A_SMH062</b>	Start date/time: <b>20220321 08:49</b>	Street: <b>PARKVIEW DR</b>		City: <b>SMITHVILLE</b>		
Location details: <b>STREET</b>		Upstream MH No: <b>SMH062A</b>	Rim to invert:	Grade to invert:	Rim to grade:	
Pipe use: <b>SS</b>	Direction: <b>U</b>	Flow control:	Downstream MH No: <b>SMH062</b>	Rim to invert:	Grade to invert:	Rim to grade:
Height: <b>8 in.</b>	Width:	Shape: <b>C</b>	Material: <b>VCP</b>	Lining method:	Pipe joint length:	Total length: <b>157.900 ft.</b>
Media label:	PreCleaning: <b>L</b>	Date cleaned:	Weather: <b>1</b>	Length surveyed: <b>157.900 ft.</b>	Purpose:	Sewer category:
Project name: <b>Sewer Cleaning &amp; CCTV - Project No. 210670</b>		Additional info:

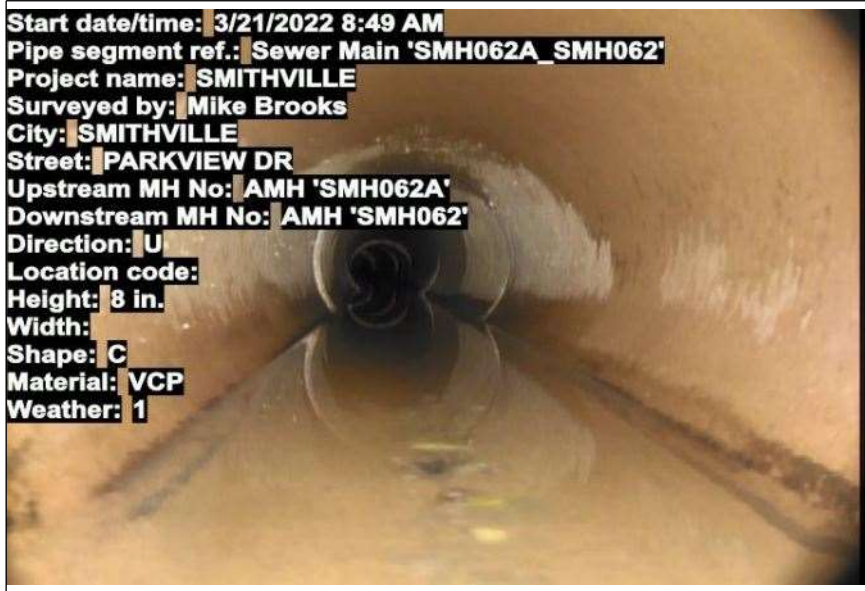
At: 0 ft. AMH - Manhole  
Joint: No SMH062

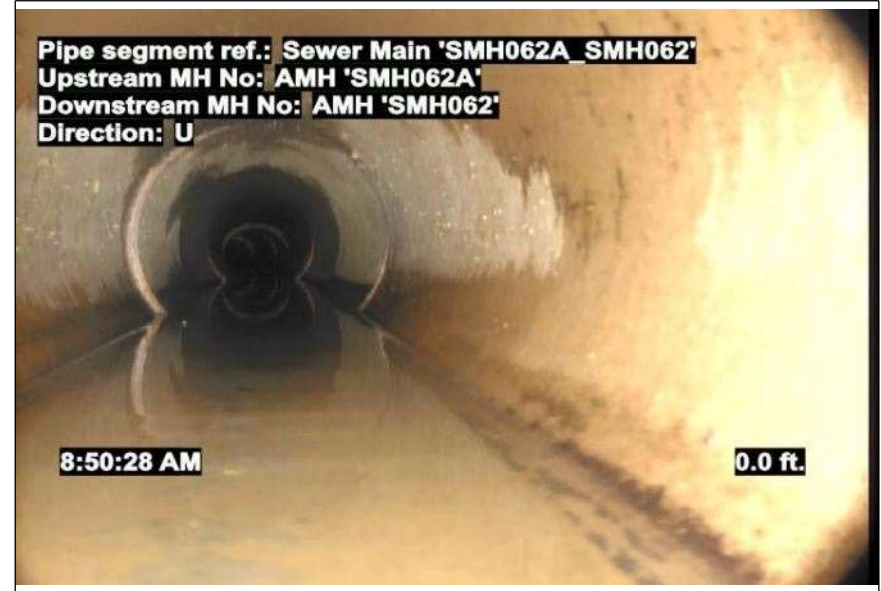
At: 0 ft. MWL - Miscellaneous Water Level  
Joint: No 5 %

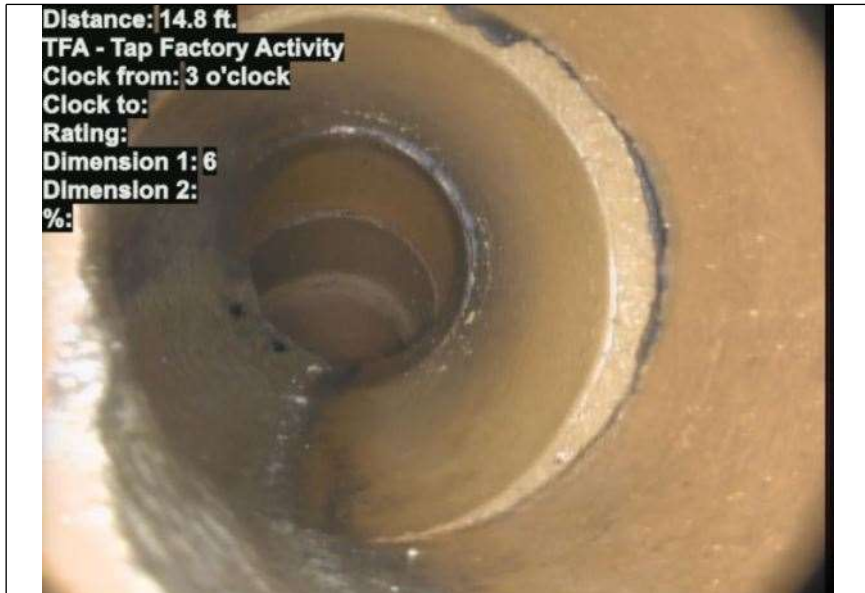
At: 14.8 ft. 3/. TFA - Tap Factory Activity  
Joint: No

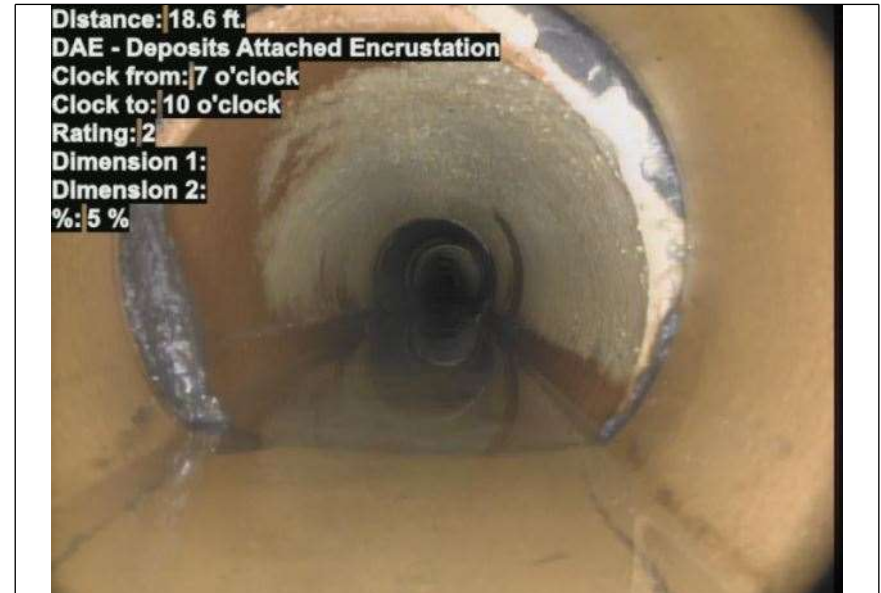
At: 18.6 ft. 7/10 DAE - Deposits Attached Encrustation  
Joint: No 5 %

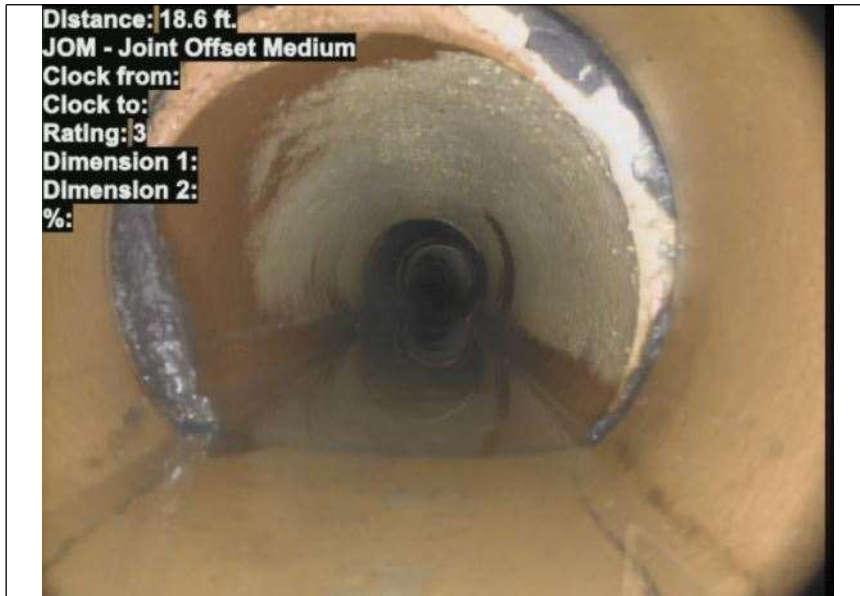
At: 18.6 ft. JOM - Joint Offset Medium  
Joint: No

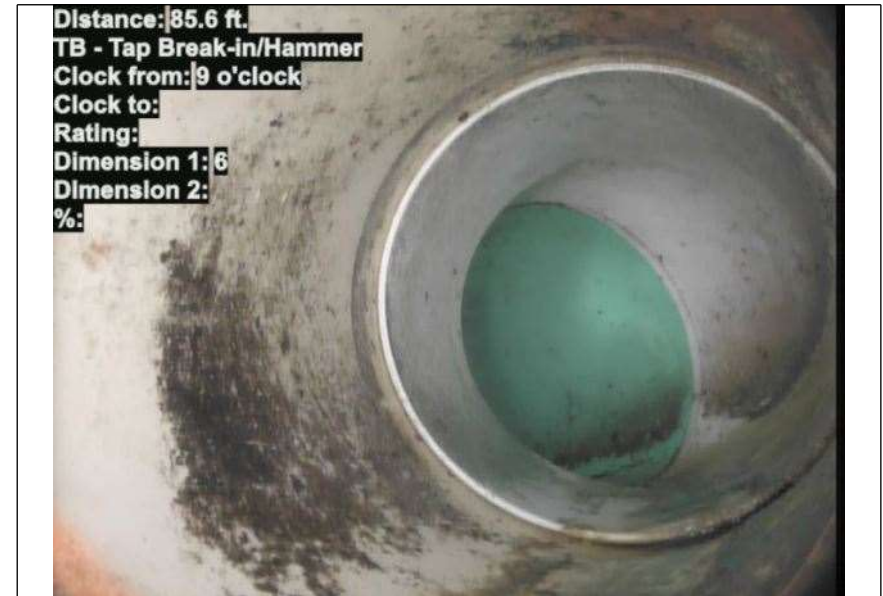
At: 85.6 ft. 9/ TB - Tap Break-in/Hammer  
Joint: No

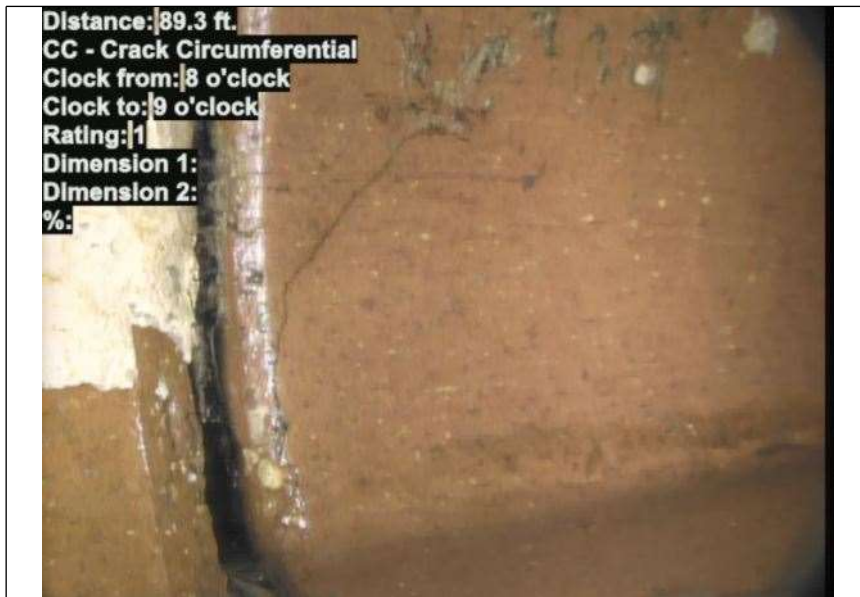
At: 89.3 ft. 8/9 CC - Crack Circumferential  
Joint: No

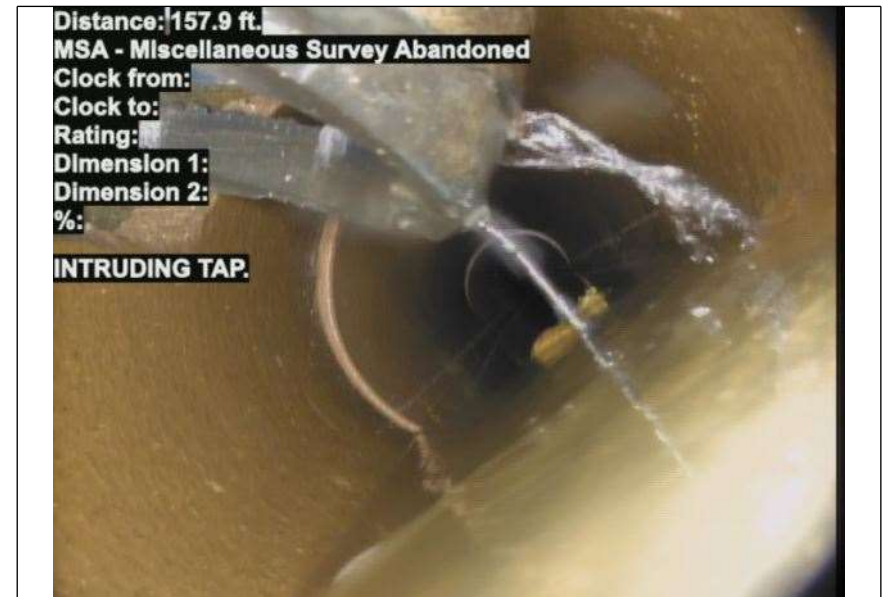
At: 157.9 ft. MSA - Miscellaneous Survey Abandoned  
Joint: No INTRUDING TAP.

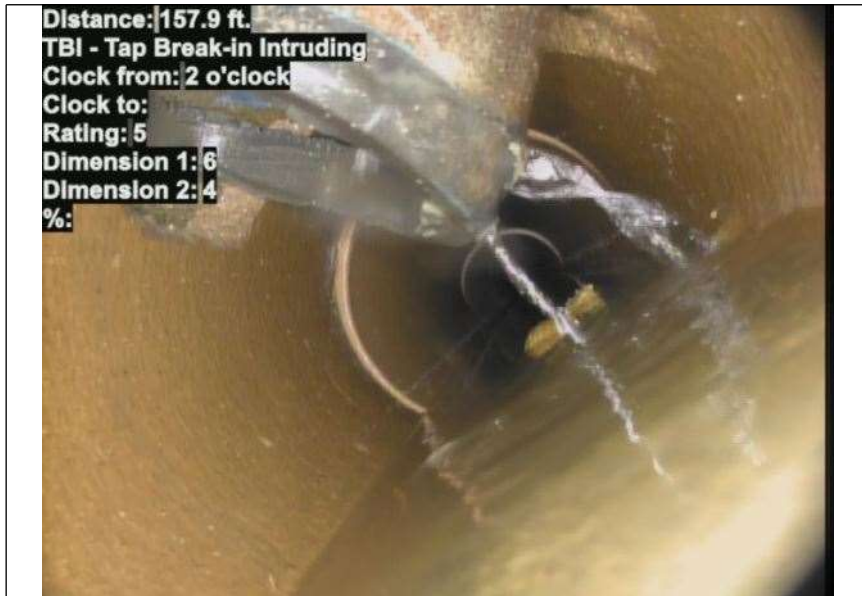
At: 157.9 ft. 2/. TBI - Tap Break-in Intruding

Joint: No
