PACP Report with Pipe Run and Incident Snapshots

| Pipe segment ref.: SMH062_SMH063 | Start date/time: 20220321 09:26 | Street: PARKVIEW DR | | City: SMITHVILLE | | |
| Project name: Sewer Cleaning & CCTV - Project No. 210670 | | Additional info: | | | | |

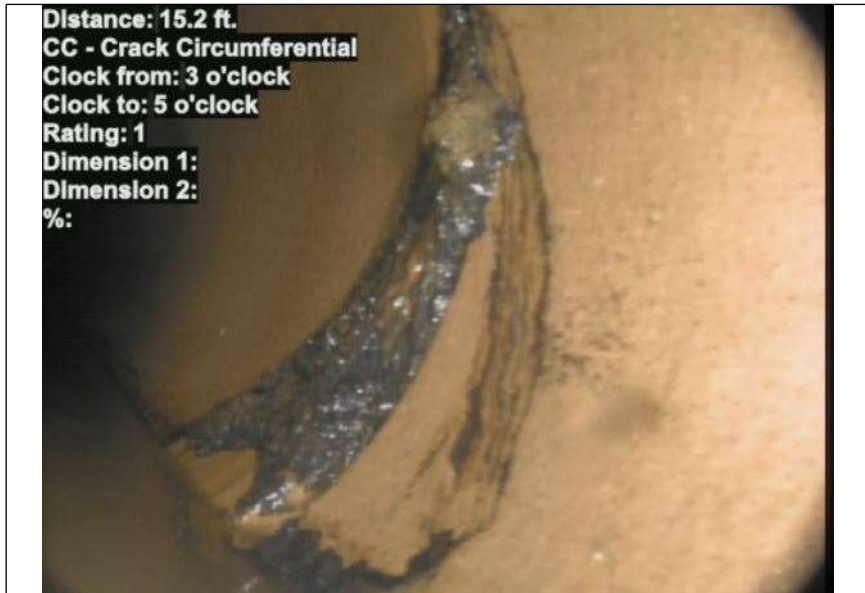
| Distance | Video Ref. | PACP Code | Continuous | S/M/L | Value Inches (mm) | | % | Joint | Circumferential Location | | Rating | Image Ref. | Remarks |
|---|---|---|---|---|---|---|---|---|---|---|---|---|---|
| 15.2 ft. | 00:01:46 | CC | | | | | | <input type="checkbox"/> | 3 / 5 | | 1 | SMH062_SMH063_CC _15.2 ft.JPG | |

At: 15.2 ft. 3/5 CC - Crack Circumferential
Joint: No

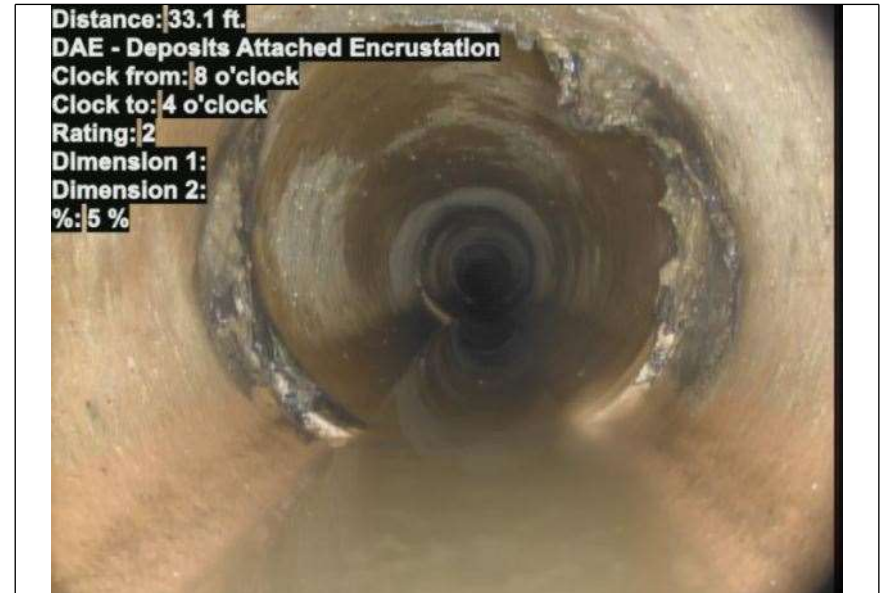
| Distance | Video Ref. | PACP Code | Continuous | S/M/L | Value Inches (mm) | | % | Joint | Circumferential Location | | Rating | Image Ref. | Remarks |
|---|---|---|---|---|---|---|---|---|---|---|---|---|---|
| 33.1 ft. | 00:03:00 | DAE | | | | | 5 | <input type="checkbox"/> | 8 / 4 | | 2 | SMH062_SMH063_DA E_33.1 ft.JPG | |

At: 33.1 ft. 8/4 DAE - Deposits Attached Encrustation
Joint: No 5 %

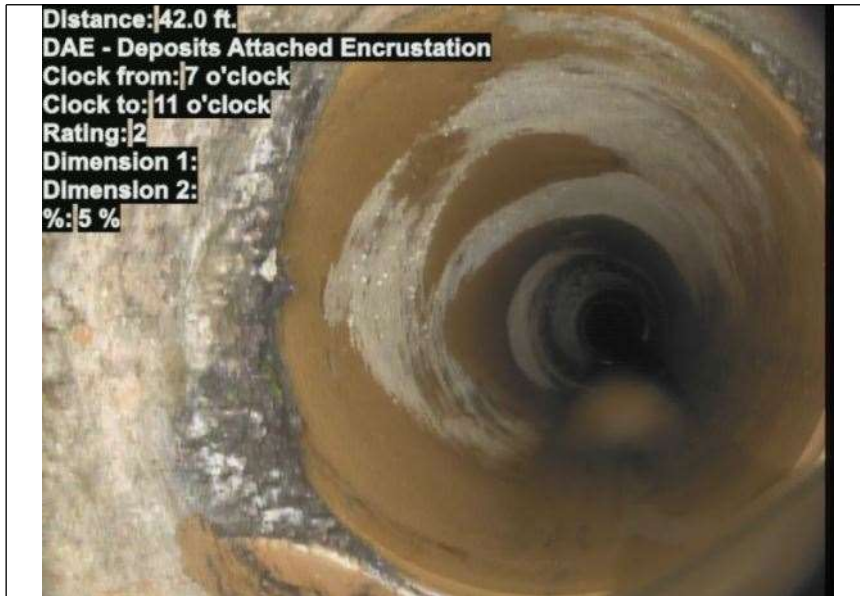
| Distance | Video Ref. | PACP Code | Continuous | S/M/L | Value Inches (mm) | | % | Joint | Circumferential Location | | Rating | Image Ref. | Remarks |
|---|---|---|---|---|---|---|---|---|---|---|---|---|---|
| 42.0 ft. | 00:04:01 | DAE | | | | | 5 | <input type="checkbox"/> | 7 / 11 | | 2 | SMH062_SMH063_DA E_42.0 ft.JPG | |

At: 42 ft. 7/11 DAE - Deposits Attached Encrustation
Joint: No 5 %

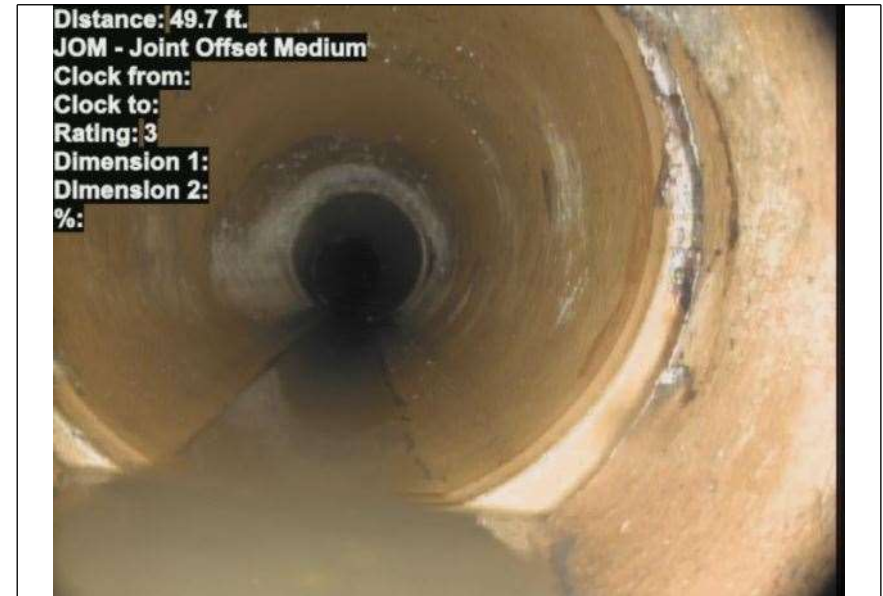
| Distance | Video Ref. | PACP Code | Continuous | S/M/L | Value Inches (mm) | | % | Joint | Circumferential Location | | Rating | Image Ref. | Remarks |
|---|---|---|---|---|---|---|---|---|---|---|---|---|---|
| 49.7 ft. | 00:04:42 | JOM | | M | | | | <input type="checkbox"/> | / | | 3 | SMH062_SMH063_JO M_49.7 ft.JPG | |

At: 49.7 ft. JOM - Joint Offset Medium
Joint: No

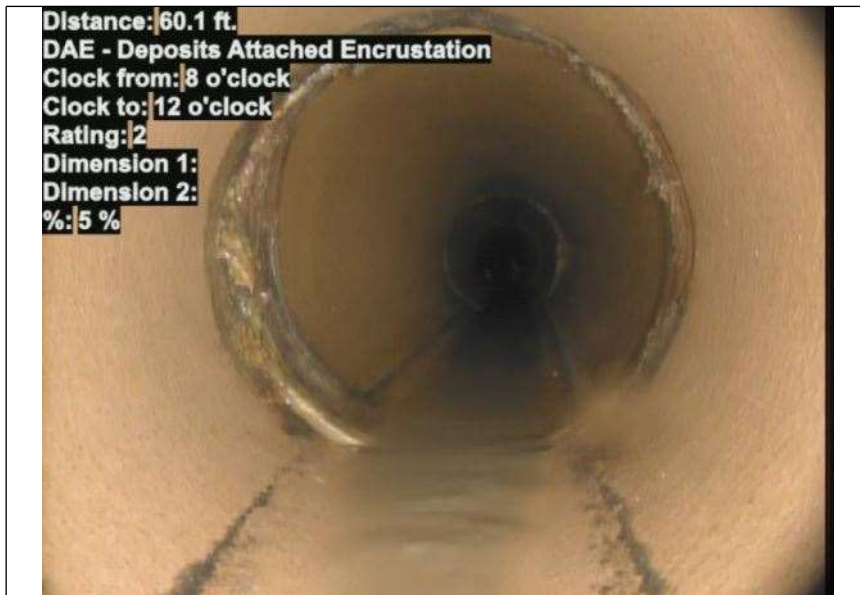
| Distance | Video Ref. | PACP Code | Continuous | S/M/L | Value Inches (mm) | | % | Joint | Circumferential Location | | Rating | Image Ref. | Remarks |
|---|---|---|---|---|---|---|---|---|---|---|---|---|---|
| 60.1 ft. | 00:05:09 | DAE | | | | | 5 | <input type="checkbox"/> | 8 / 12 | | 2 | SMH062_SMH063_DA E_60.1 ft.JPG | |

At: 60.1 ft. 8/12 DAE - Deposits Attached Encrustation
Joint: No 5 %

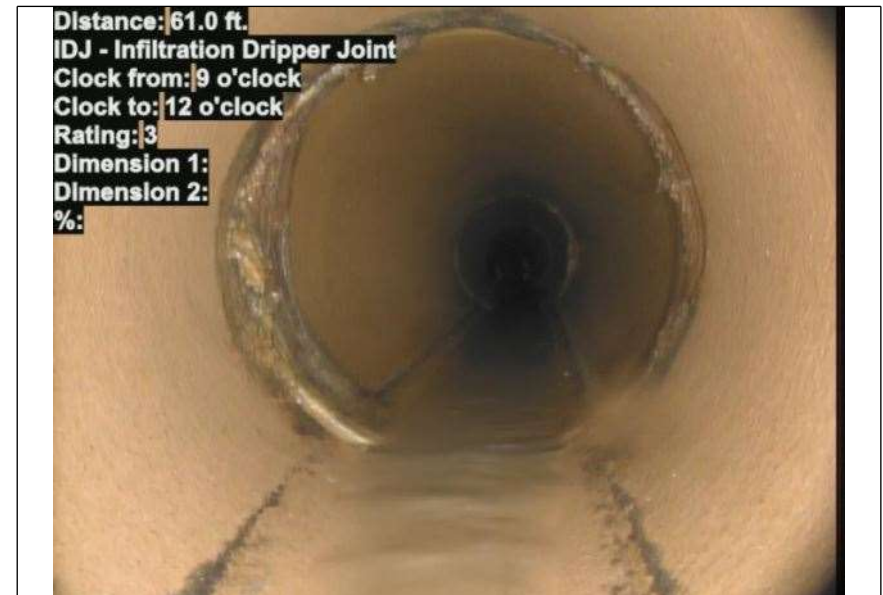
| Distance | Video Ref. | PACP Code | Continuous | S/M/L | Value Inches (mm) | | % | Joint | Circumferential Location | | Rating | Image Ref. | Remarks |
|---|---|---|---|---|---|---|---|---|---|---|---|---|---|
| 61.0 ft. | 00:05:29 | IDJ | | | | | | <input checked="" type="checkbox"/> | 9 / 12 | | 3 | SMH062_SMH063_IDJ _61.0 ft.JPG | |

At: 61 ft. 9/12 IDJ - Infiltration Drifter Joint
Joint: Yes

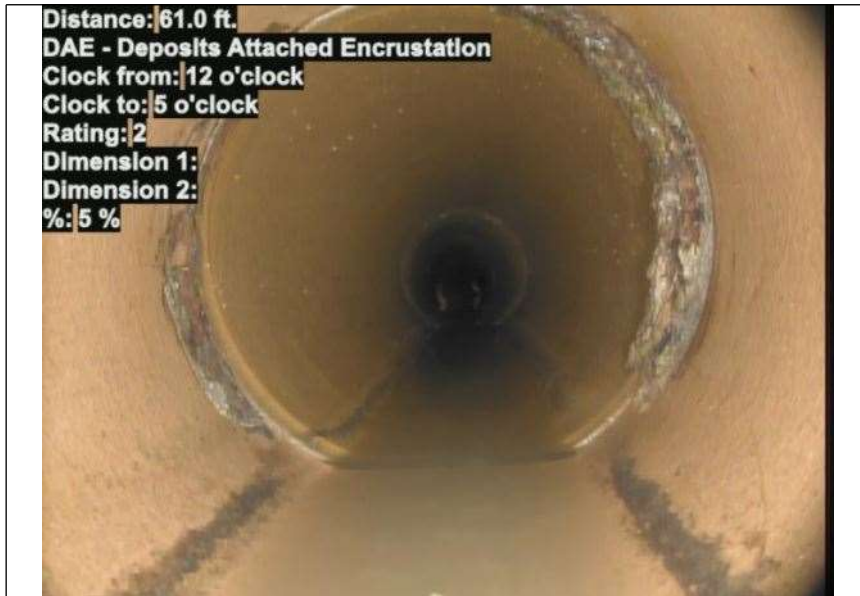
| Distance | Video Ref. | PACP Code | Continuous | S/M/L | Value Inches (mm) | | % | Joint | Circumferential Location | | Rating | Image Ref. | Remarks |
|---|---|---|---|---|---|---|---|---|---|---|---|---|---|
| 61.0 ft. | 00:05:53 | DAE | | | | | 5 | <input type="checkbox"/> | 12 / 5 | | 2 | SMH062_SMH063_DA E_61.0 ft.JPG | |

At: 61 ft. 12/5 DAE - Deposits Attached Encrustation
Joint: No 5 %

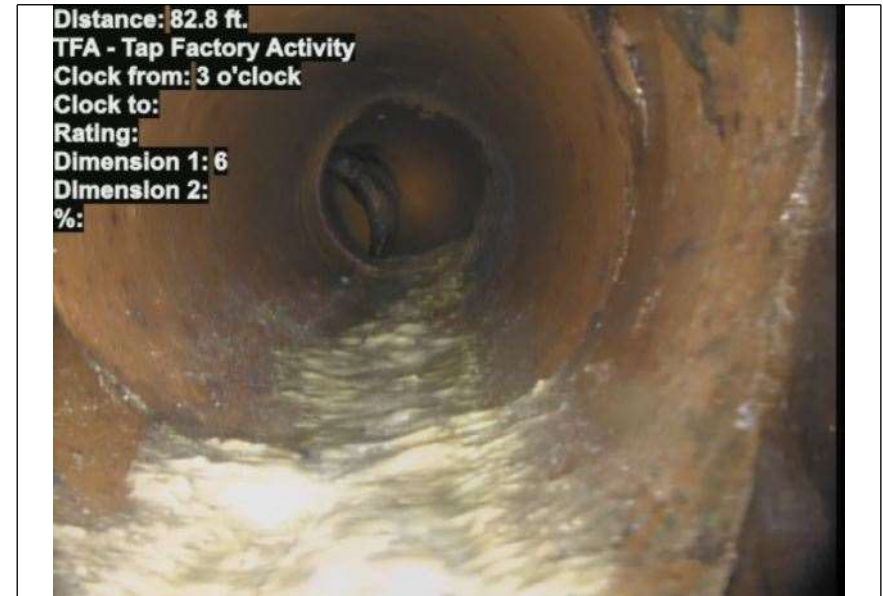
At: 82.8 ft. 3/ TFA - Tap Factory Activity
Joint: No

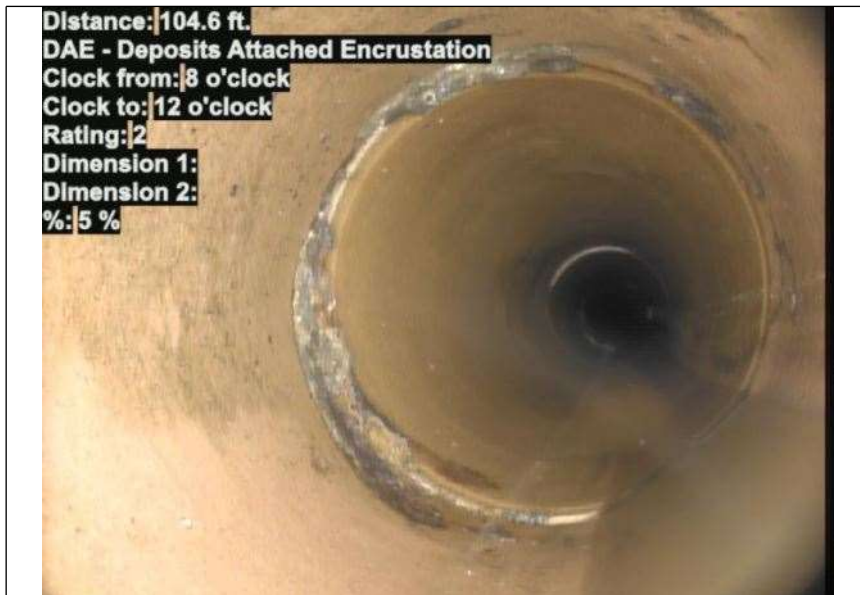
| Distance | Video Ref. | PACP Code | Continuous | S/M/L | Value Inches (mm) | | % | Joint | Circumferential Location | | Rating | Image Ref. | Remarks |
|---|---|---|---|---|---|---|---|---|---|---|---|---|---|
| 104.6 ft. | 00:08:04 | DAE | | | | | 5 | <input type="checkbox"/> | 8 / 12 | | 2 | SMH062_SMH063_DA E_104.6 ft.JPG | |

At: 104.6 ft. 8/12 DAE - Deposits Attached Encrustation
Joint: No 5 %

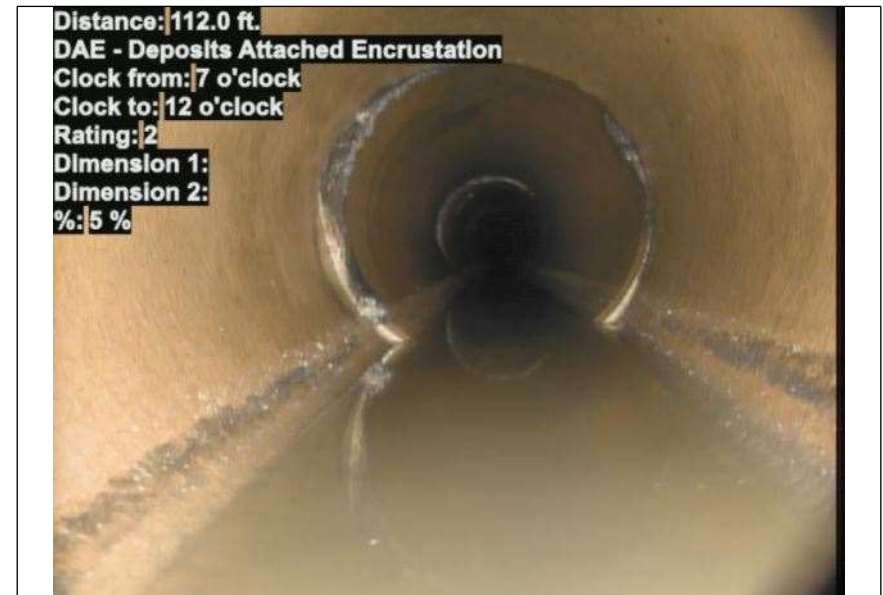
| Distance | Video Ref. | PACP Code | Continuous | S/M/L | Value Inches (mm) | | % | Joint | Circumferential Location | | Rating | Image Ref. | Remarks |
|---|---|---|---|---|---|---|---|---|---|---|---|---|---|
| 112.0 ft. | 00:09:07 | DAE | | | | | 5 | <input type="checkbox"/> | 7 / 12 | | 2 | SMH062_SMH063_DA E_112.0 ft.JPG | |

At: 112 ft. 7/12 DAE - Deposits Attached Encrustation
Joint: No 5 %

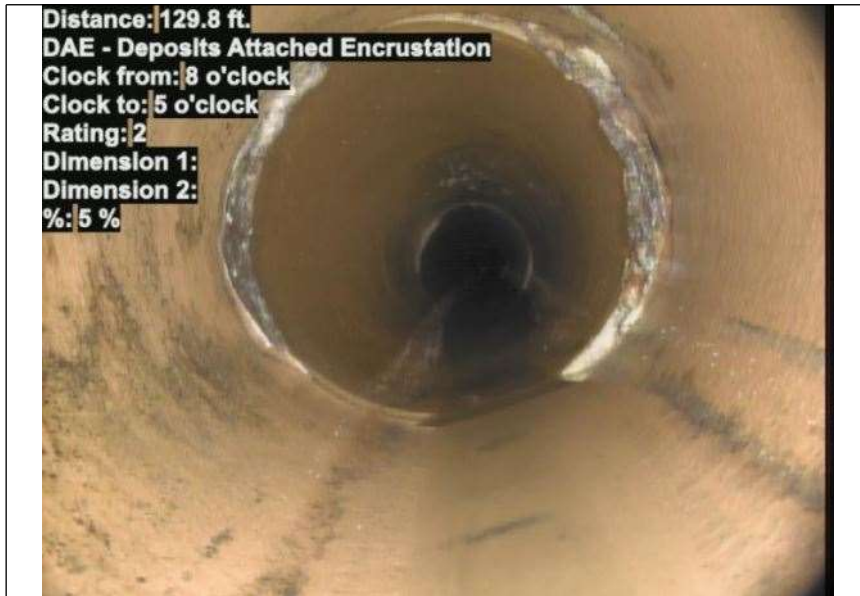
| Distance | Video Ref. | PACP Code | Continuous | S/M/L | Value Inches (mm) | | % | Joint | Circumferential Location | | Rating | Image Ref. | Remarks |
|---|---|---|---|---|---|---|---|---|---|---|---|---|---|
| 129.8 ft. | 00:10:07 | DAE | | | | | 5 | <input type="checkbox"/> | 8 / 5 | | 2 | SMH062_SMH063_DA E_129.8 ft.JPG | |

At: 129.8 ft. 8/5 DAE - Deposits Attached Encrustation
Joint: No 5 %

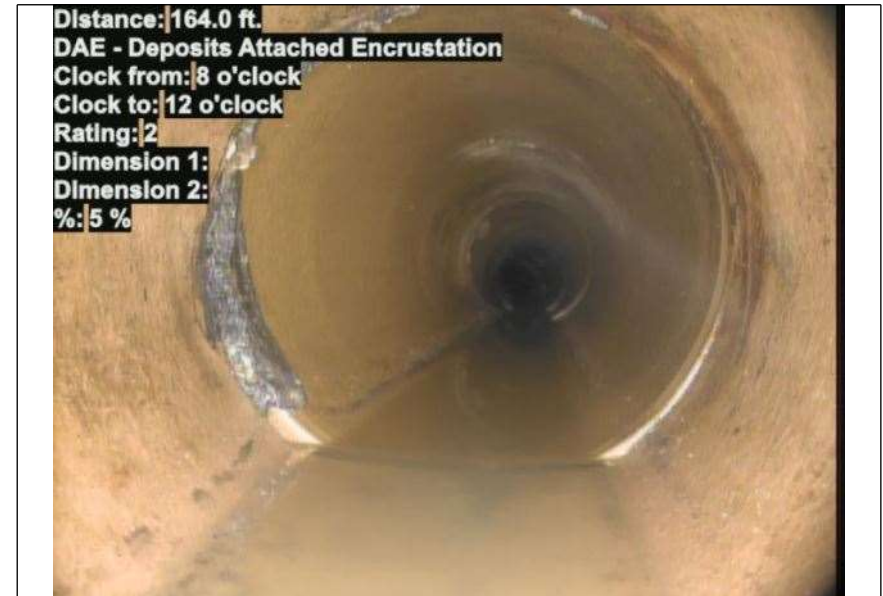
| Distance | Video Ref. | PACP Code | Continuous | S/M/L | Value Inches (mm) | | % | Joint | Circumferential Location | | Rating | Image Ref. | Remarks |
|---|---|---|---|---|---|---|---|---|---|---|---|---|---|
| 164.0 ft. | 00:10:58 | DAE | | | | | 5 | <input type="checkbox"/> | 8 / 12 | | 2 | SMH062_SMH063_DA E_164.0 ft.JPG | |

At: 164 ft. 8/12 DAE - Deposits Attached Encrustation
Joint: No 5 %

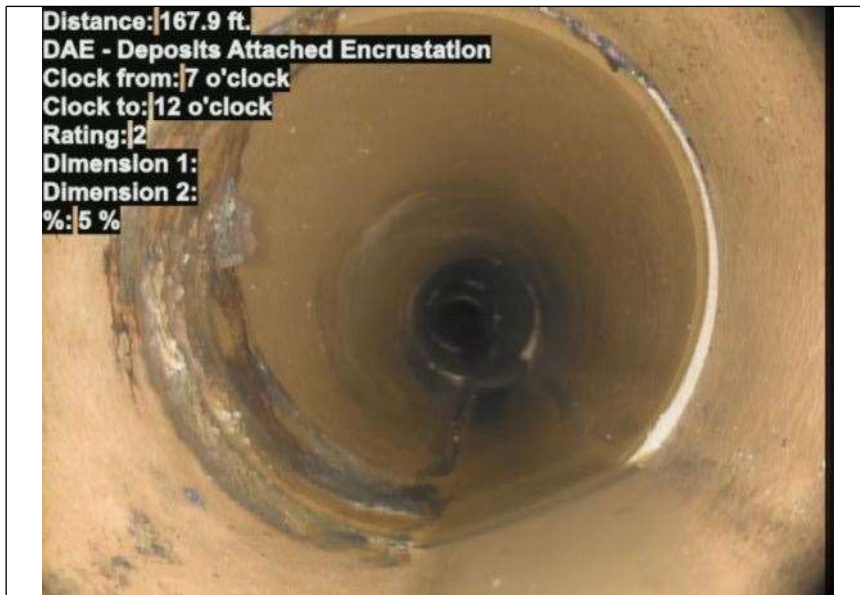
| Distance | Video Ref. | PACP Code | Continuous | S/M/L | Value Inches (mm) | | % | Joint | Circumferential Location | | Rating | Image Ref. | Remarks |
|---|---|---|---|---|---|---|---|---|---|---|---|---|---|
| 167.9 ft. | 00:11:49 | DAE | | | | | 5 | <input type="checkbox"/> | 7 / 12 | | 2 | SMH062_SMH063_DA E_167.9 ft.JPG | |

At: 167.9 ft. DAE - Deposits Attached Encrustation
7/12
Joint: No 5 %

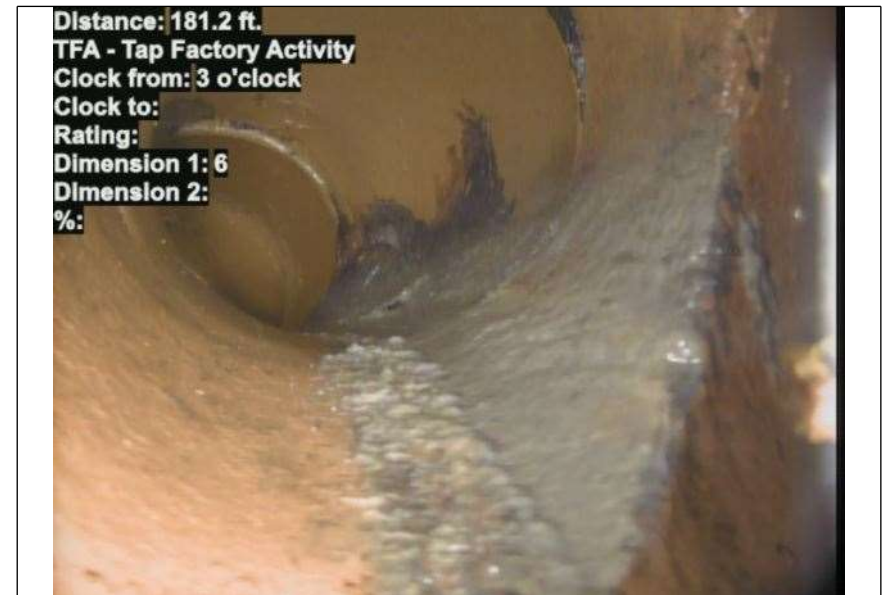
At: 181.2 ft. 3/. TFA - Tap Factory Activity
Joint: No

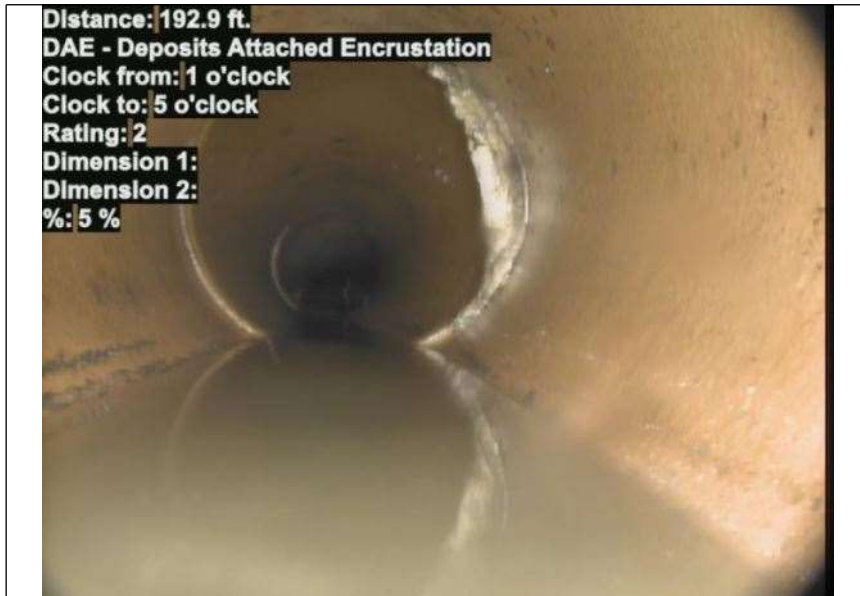
| Distance | Video Ref. | PACP Code | Continuous | S/M/L | Value Inches (mm) | | % | Joint | Circumferential Location | | Rating | Image Ref. | Remarks |
|---|---|---|---|---|---|---|---|---|---|---|---|---|---|
| 192.9 ft. | 00:02:49 | DAE | | | | | 5 | <input type="checkbox"/> | 1 / 5 | 2 | | SMH062_SMH063_DAE_192.9 ft.JPG | |

At: 192.9 ft. 1/5 DAE - Deposits Attached Encrustation
Joint: No 5 %

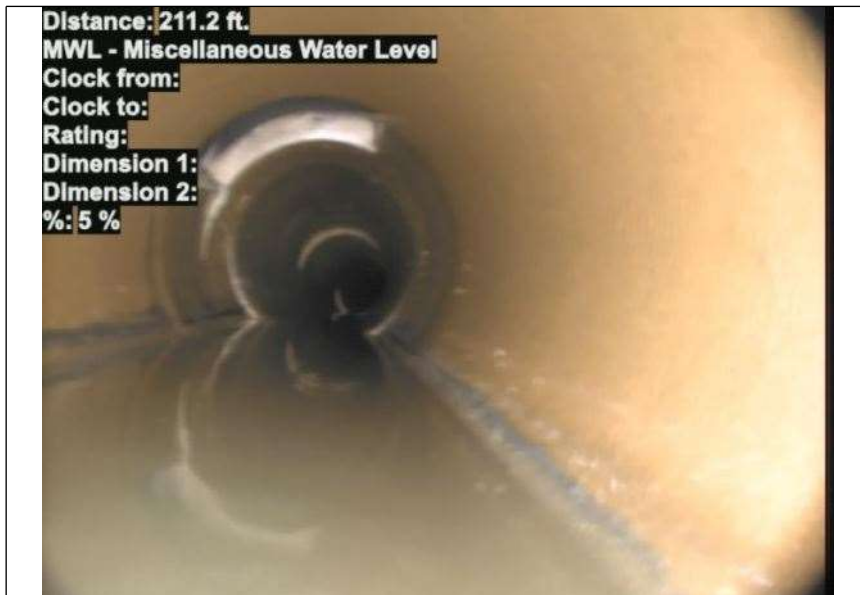
At: 211.2 ft. MWL - Miscellaneous Water Level
Joint: No 5 %

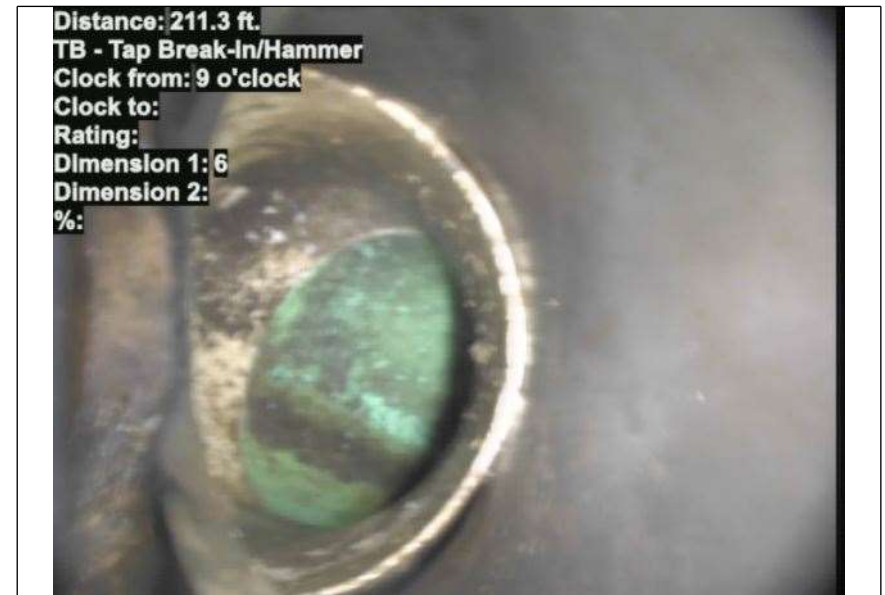
At: 211.3 ft. 9/. TB - Tap Break-in/Hammer
Joint: No

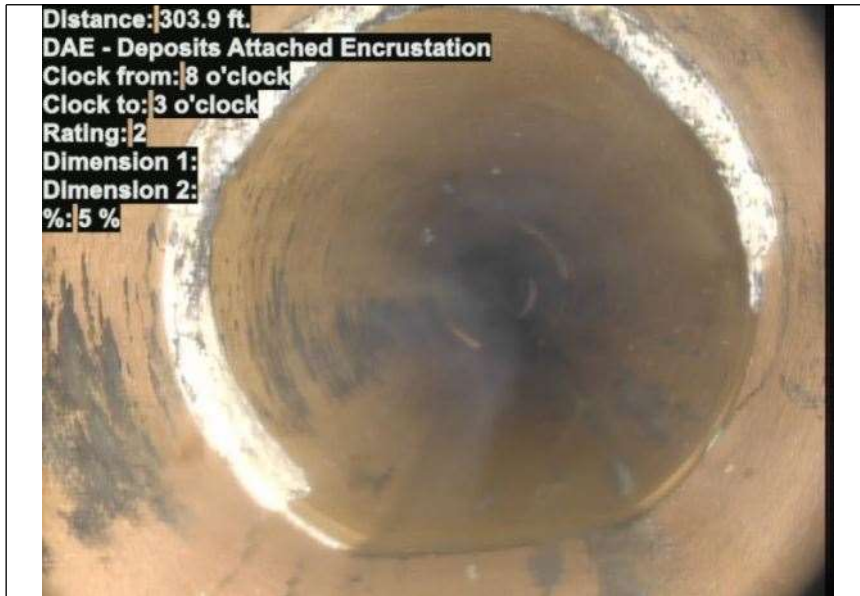
| Distance | Video Ref. | PACP Code | Continuous | S/M/L | Value Inches (mm) | | % | Joint | Circumferential Location | | Rating | Image Ref. | Remarks |
|---|---|---|---|---|---|---|---|---|---|---|---|---|---|
| 303.9 ft. | 00:08:04 | DAE | | | | | 5 | <input type="checkbox"/> | 8 / 3 | 2 | | SMH062_SMH063_DAE_303.9 ft.JPG | |

At: 303.9 ft. 8/3 DAE - Deposits Attached Encrustation
Joint: No 5 %

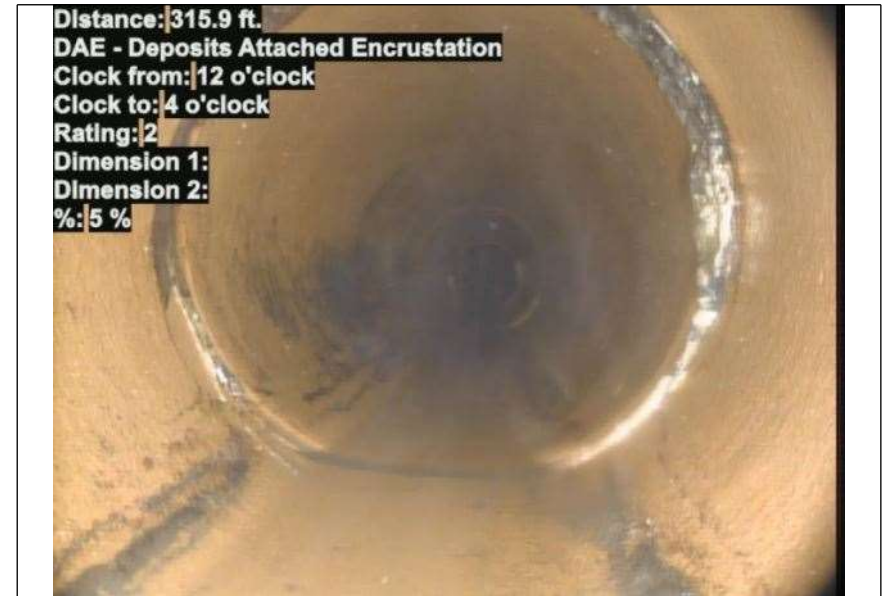
| Distance | Video Ref. | PACP Code | Continuous | S/M/L | Value Inches (mm) | | % | Joint | Circumferential Location | | Rating | Image Ref. | Remarks |
|---|---|---|---|---|---|---|---|---|---|---|---|---|---|
| 315.9 ft. | 00:09:20 | DAE | | | | | 5 | <input type="checkbox"/> | 12 / 4 | 2 | | SMH062_SMH063_DAE_315.9 ft.JPG | |

At: 315.9 ft. 12/4 DAE - Deposits Attached Encrustation
Joint: No 5 %

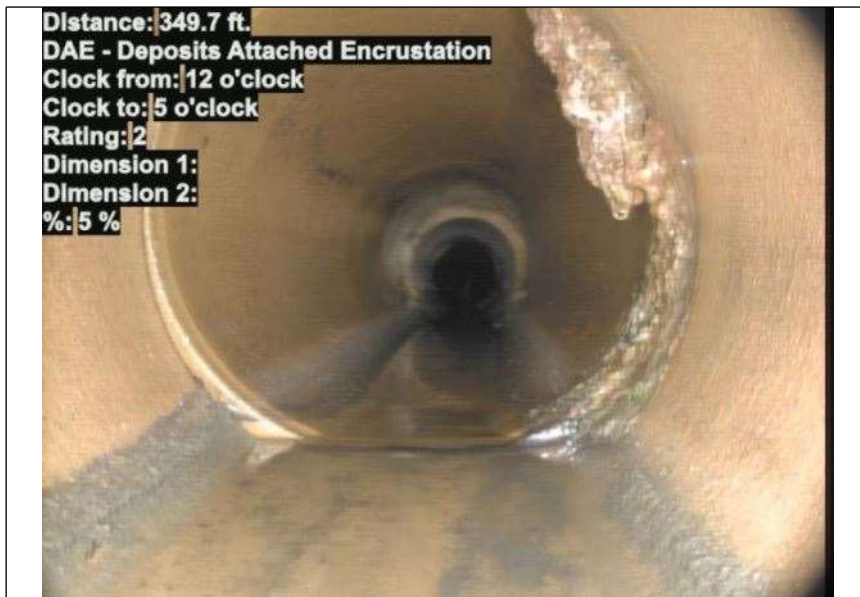
| Distance | Video Ref. | PACP Code | Continuous | S/M/L | Value Inches (mm) | | % | Joint | Circumferential Location | | Rating | Image Ref. | Remarks |
|---|---|---|---|---|---|---|---|---|---|---|---|---|---|
| 349.7 ft. | 00:10:50 | DAE | | | | | 5 | <input checked="" type="checkbox"/> | 12 / 5 | 2 | | SMH062_SMH063_DAE_349.7 ft.JPG | |

At: 349.7 ft. 12/5 DAE - Deposits Attached Encrustation
Joint: Yes 5 %

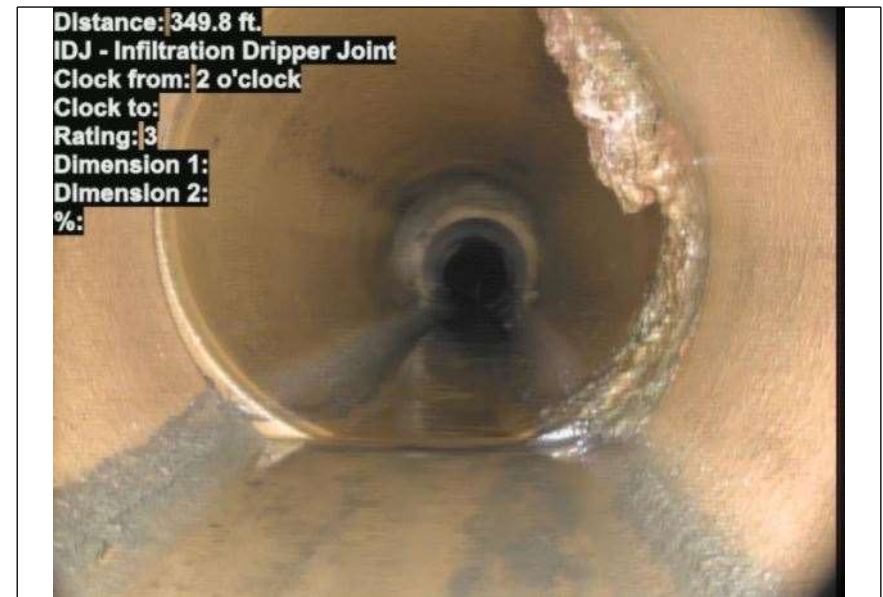
| Distance | Video Ref. | PACP Code | Continuous | S/M/L | Value Inches (mm) | | % | Joint | Circumferential Location | | Rating | Image Ref. | Remarks |
|---|---|---|---|---|---|---|---|---|---|---|---|---|---|
| 349.8 ft. | 00:11:12 | IDJ | | | | | | <input checked="" type="checkbox"/> | 2 / | 3 | | SMH062_SMH063_IDJ_349.8 ft.JPG | |

At: 349.8 ft. 2/ IDJ - Infiltration Dripper Joint
Joint: Yes
