PACP Report with Pipe Run and Incident Snapshots

Surveyed by: Mike Brooks	Certificate number: Mike Brooks	Owner:	Customer:	Drainage area:	P/O number:	Sheet number:
Pipe segment ref.: SMH063_SMH064	Start date/time: 20220321 10:02	Street: PARKVIEW DR		City: SMITHVILLE		
Location details: STREET		Upstream MH No: SMH063	Rim to invert:	Grade to invert:	Rim to grade:	
Pipe use: SS	Direction: D	Flow control:	Downstream MH No: SMH064	Rim to invert:	Grade to invert:	Rim to grade:
Height: 8 in.	Width:	Shape: C	Material: VCP	Lining method:	Pipe joint length:	Total length: 326.300 ft.
Media label:	PreCleaning: L	Date cleaned:	Weather: 1	Length surveyed: 326.300 ft.	Purpose:	Sewer category:
Project name: Sewer Cleaning & CCTV - Project No. 210670			Additional info:

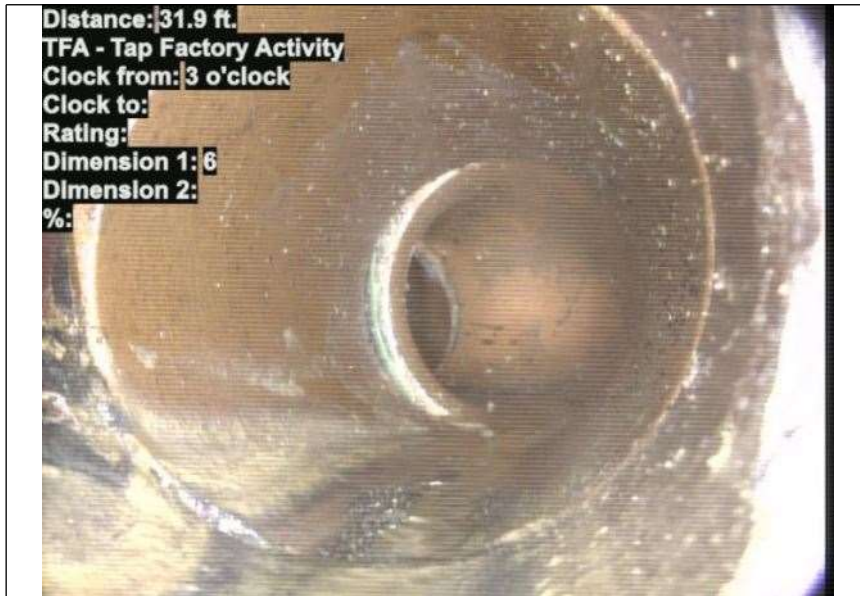
At: 31.9 ft. 3/. TFA - Tap Factory Activity
Joint: No

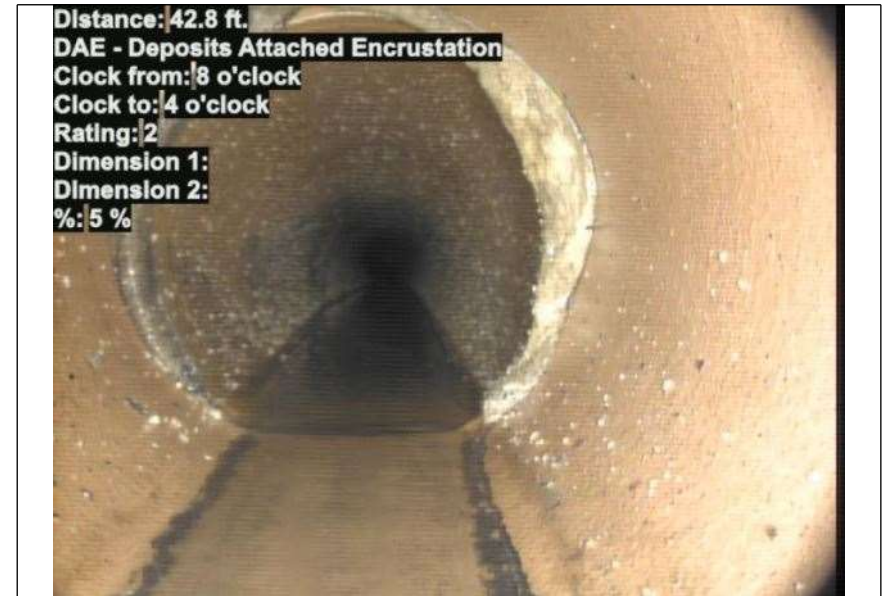
At: 42.8 ft. 8/4 DAE - Deposits Attached Encrustation
Joint: No 5 %

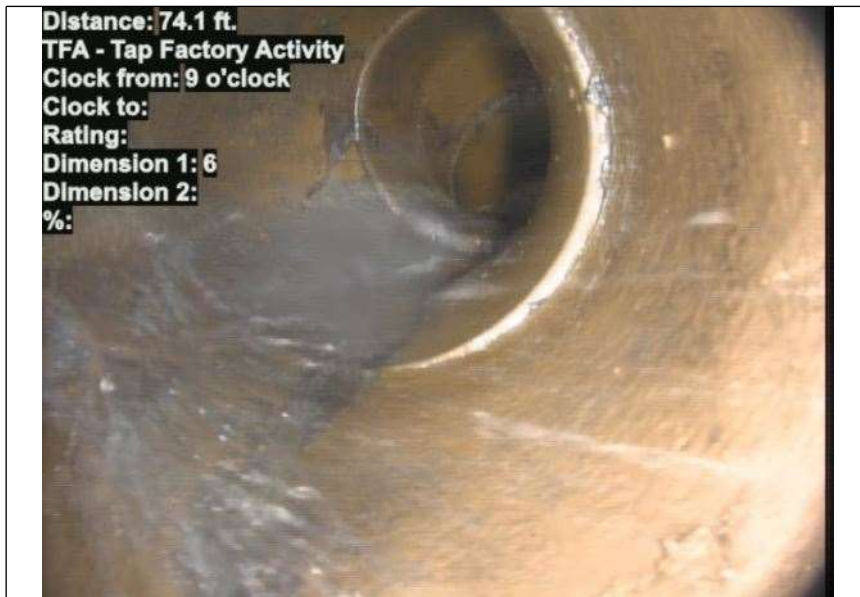
At: 74.1 ft. 9/. TFA - Tap Factory Activity
Joint: No

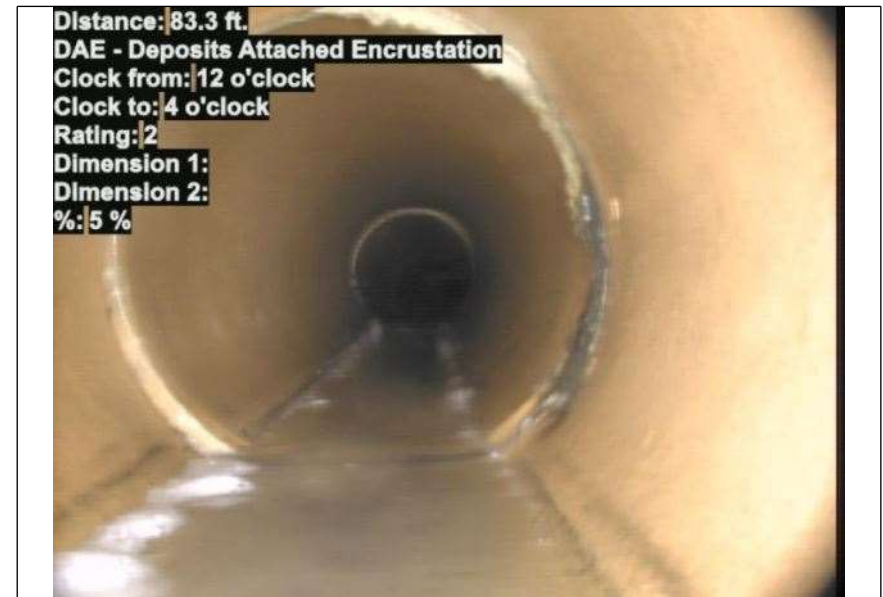
At: 83.3 ft. 12/4 DAE - Deposits Attached Encrustation
Joint: No 5 %

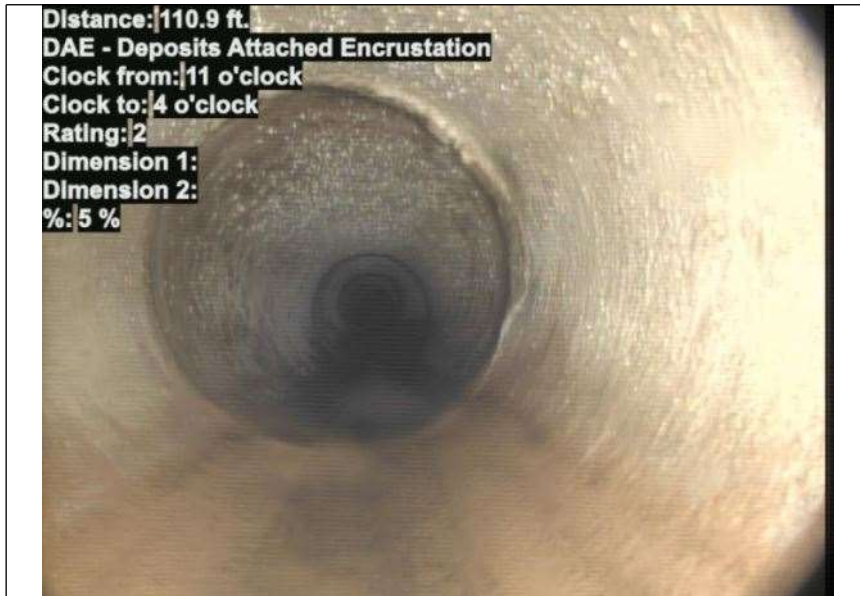
At: 110.9 ft. DAE - Deposits Attached Encrustation
11/4

Joint: No 5 %

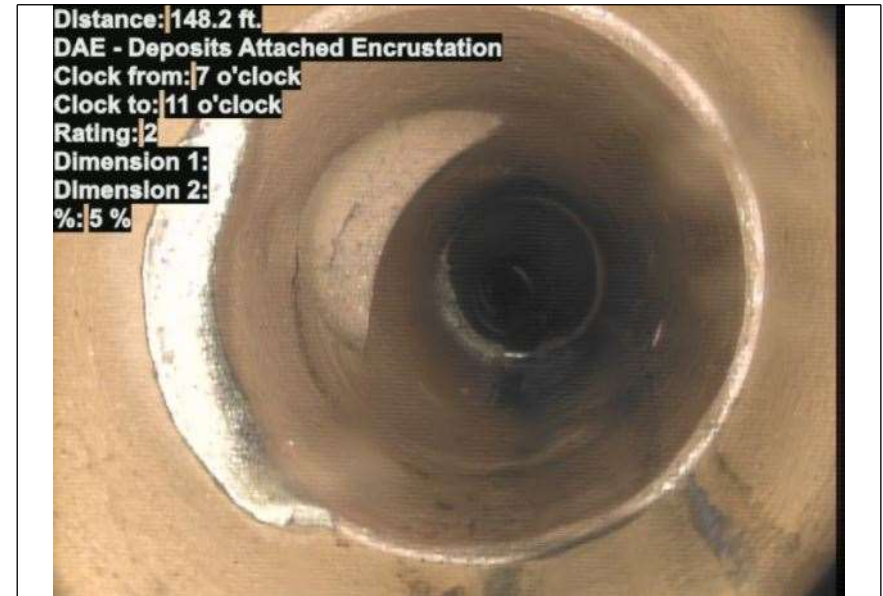
At: 148.2 ft. DAE - Deposits Attached Encrustation
7/11

Joint: No 5 %

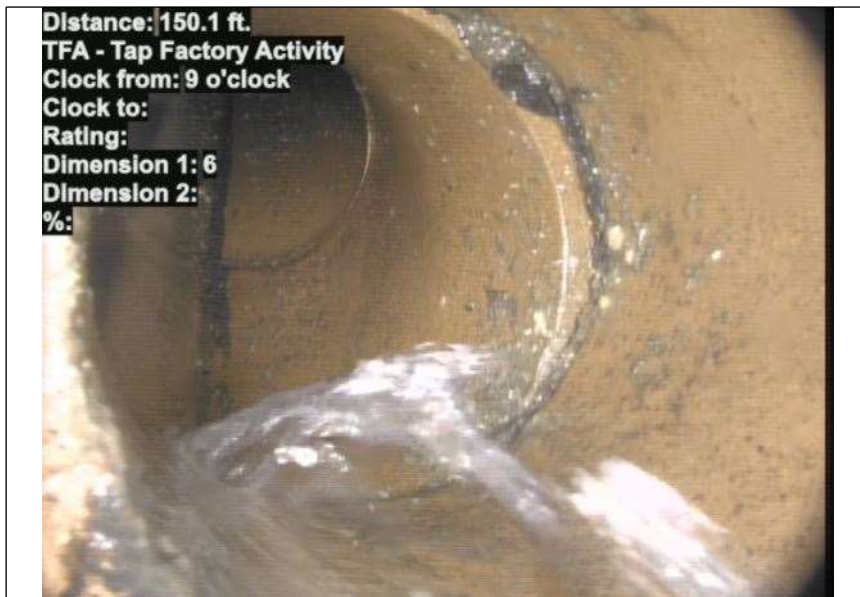
At: 150.1 ft. 9/. TFA - Tap Factory Activity

Joint: No

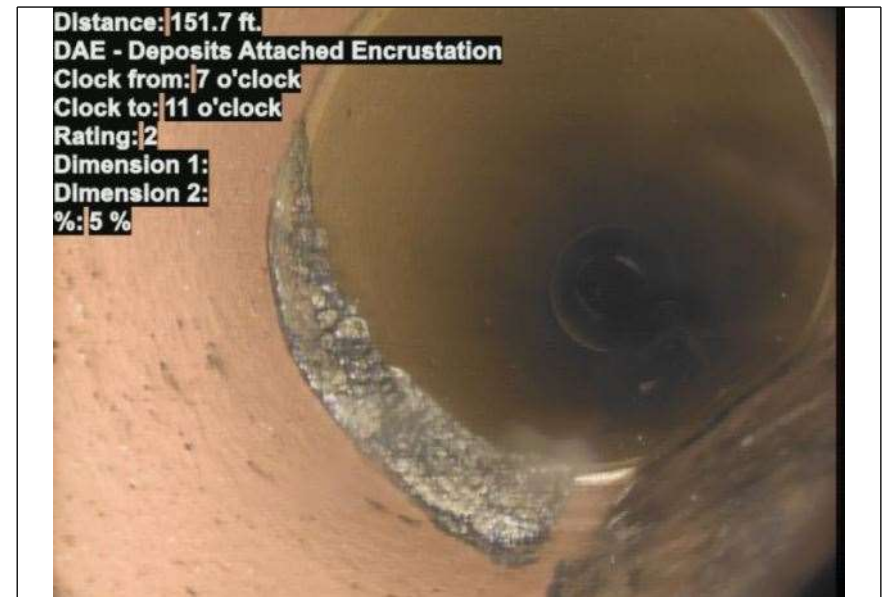
At: 151.7 ft. DAE - Deposits Attached Encrustation
7/11

Joint: No 5 %

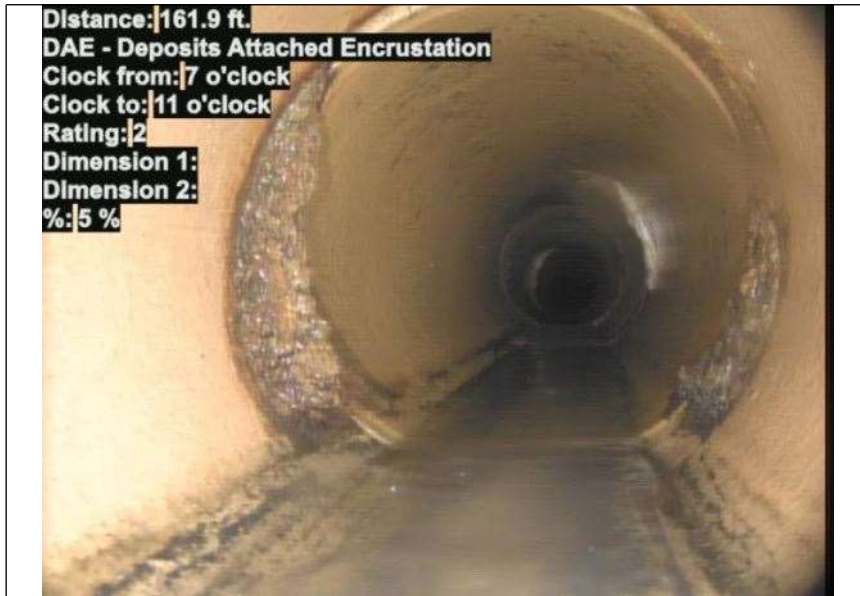
At: 161.9 ft. DAE - Deposits Attached Encrustation
7/11

Joint: No 5 %

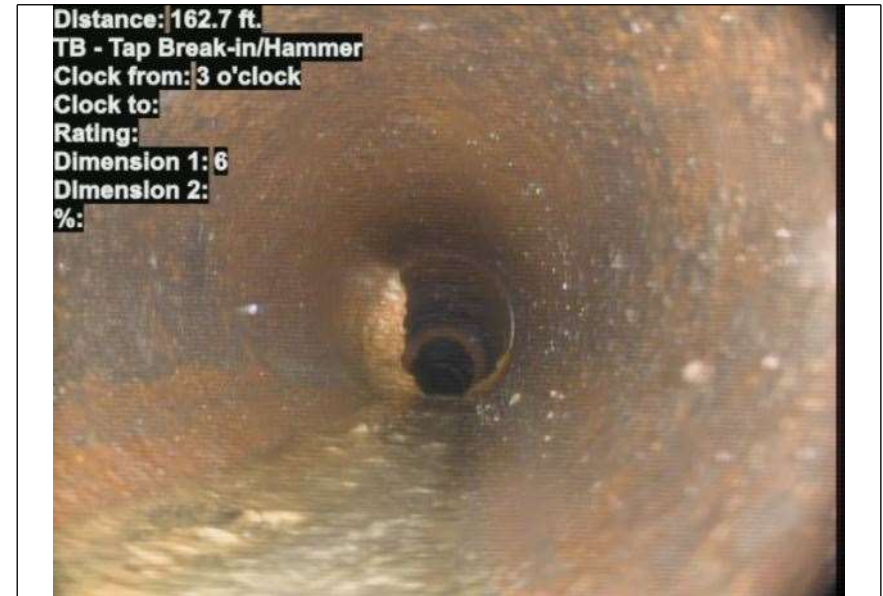
At: 162.7 ft. 3/ TB - Tap Break-in/Hammer

Joint: No

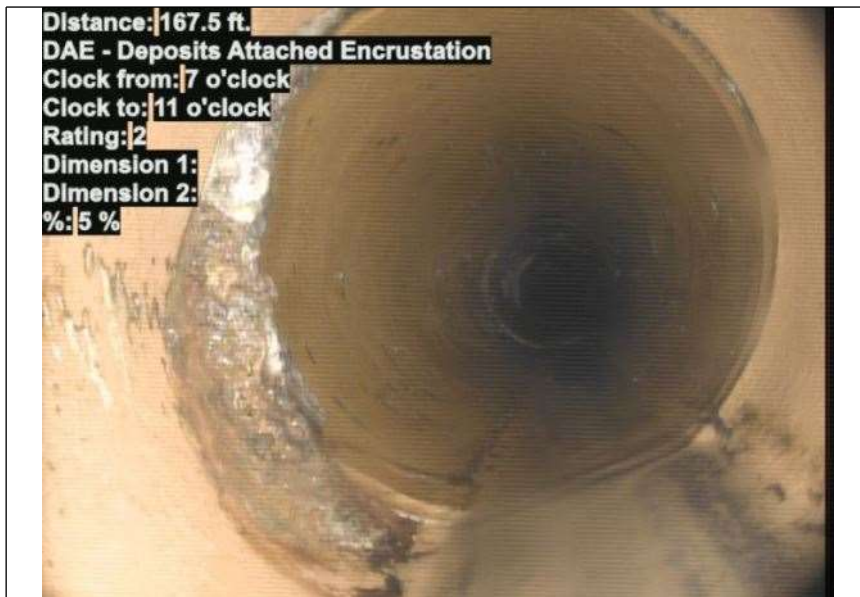
At: 167.5 ft. DAE - Deposits Attached Encrustation
7/11

Joint: No 5 %

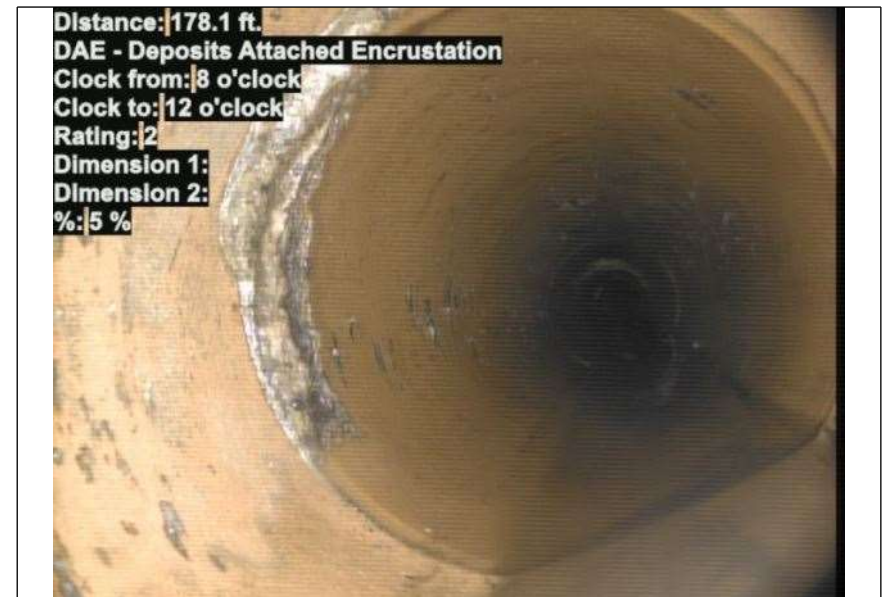
At: 178.1 ft. DAE - Deposits Attached Encrustation
8/12

Joint: No 5 %

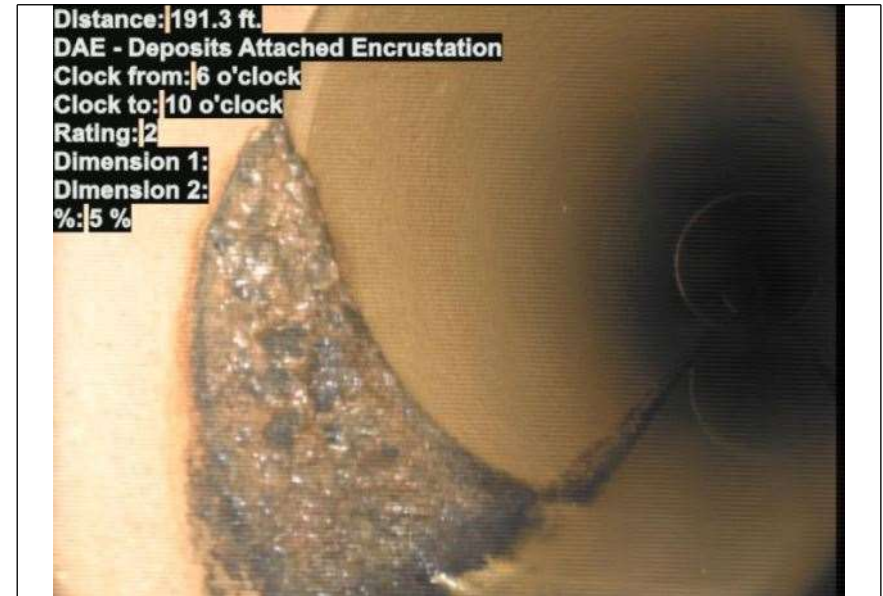
At: 191.3 ft. DAE - Deposits Attached Encrustation
6/10
Joint: No 5 %

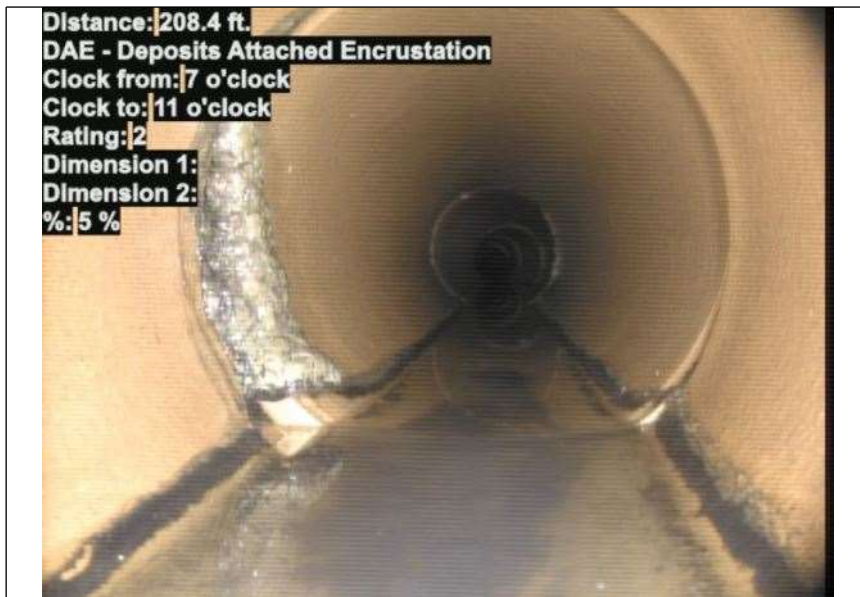
At: 208.4 ft. DAE - Deposits Attached Encrustation
7/11
Joint: No 5 %

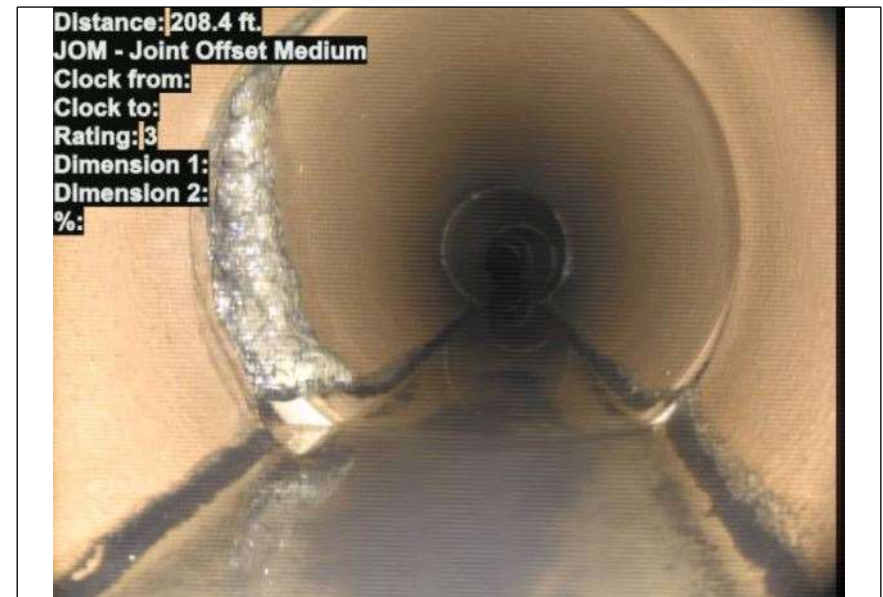
At: 208.4 ft. JOM - Joint Offset Medium
Joint: No

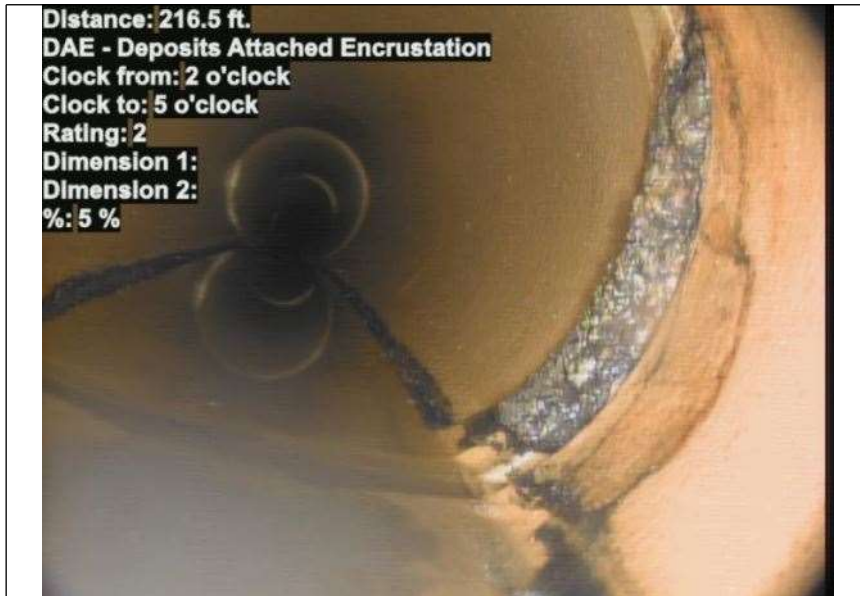
At: 216.5 ft. 2/5 DAE - Deposits Attached Encrustation
Joint: No 5 %

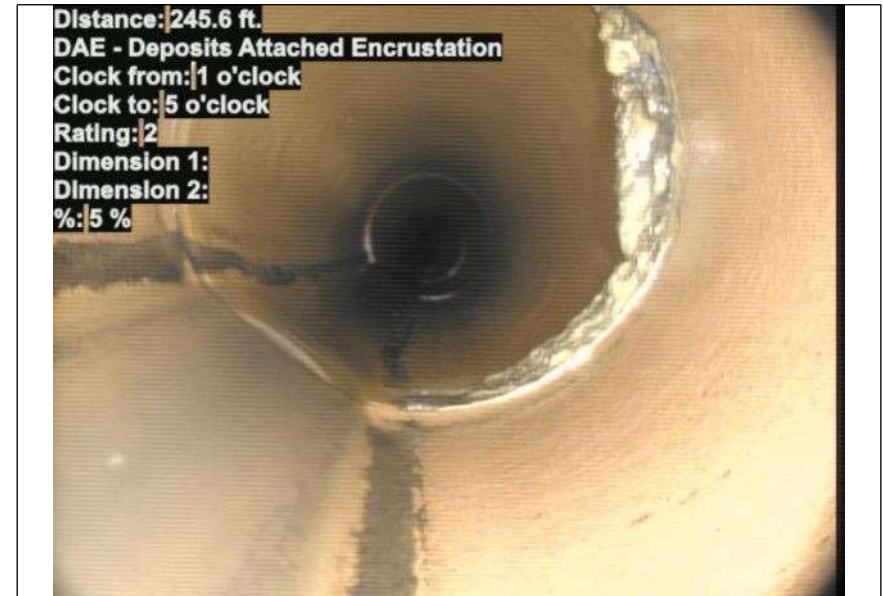
At: 245.6 ft. 1/5 DAE - Deposits Attached Encrustation
Joint: No 5 %

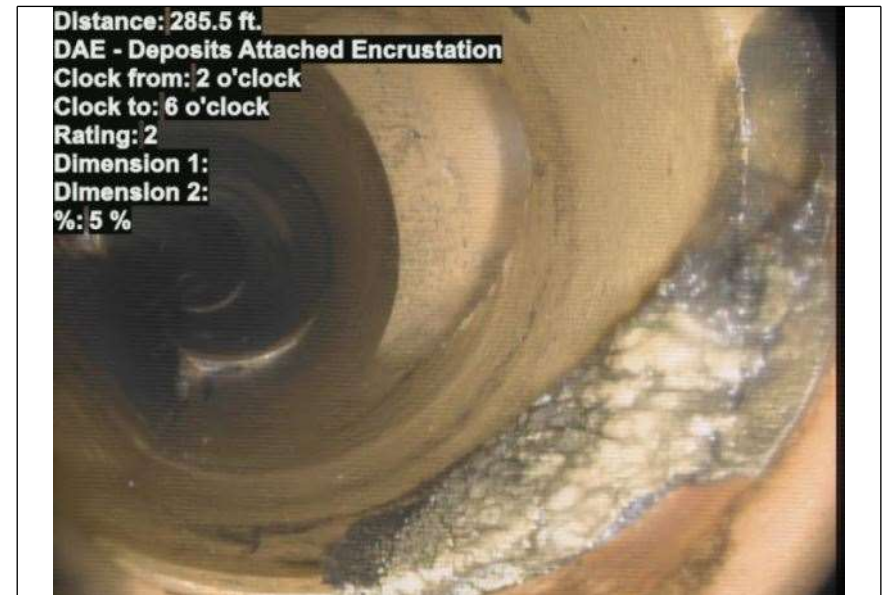
At: 285.5 ft. 2/6 DAE - Deposits Attached Encrustation
Joint: No 5 %

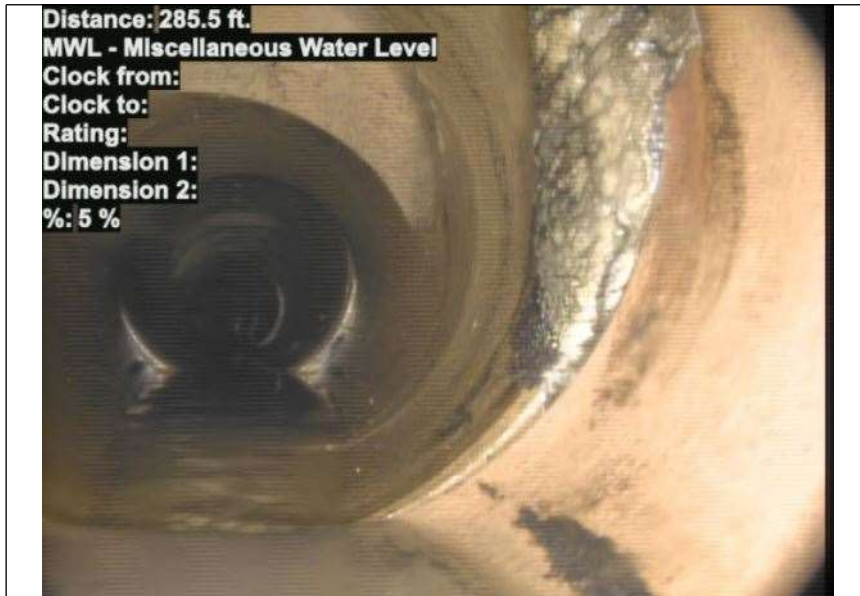
At: 285.5 ft. MWL - Miscellaneous Water Level
Joint: No 5 %

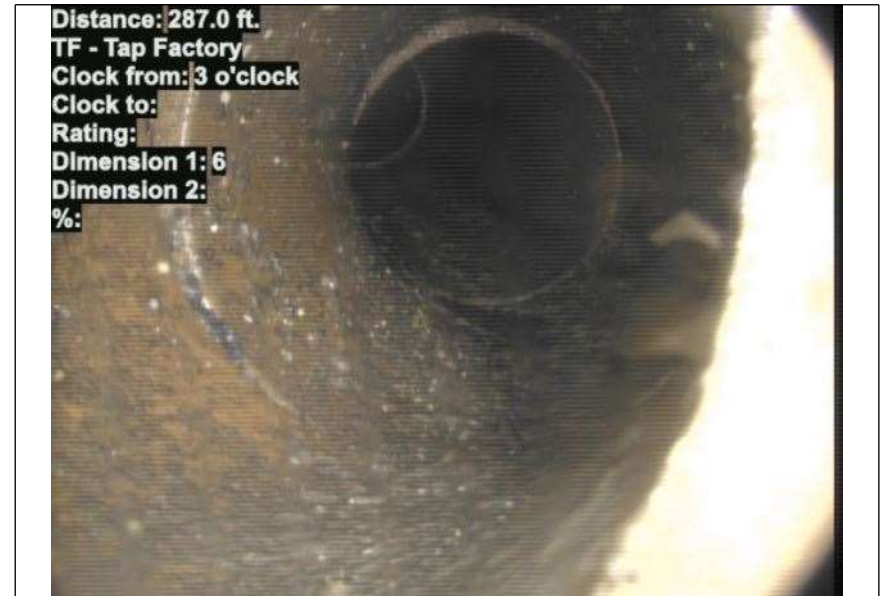
At: 287 ft. 3/. TF - Tap Factory
Joint: No

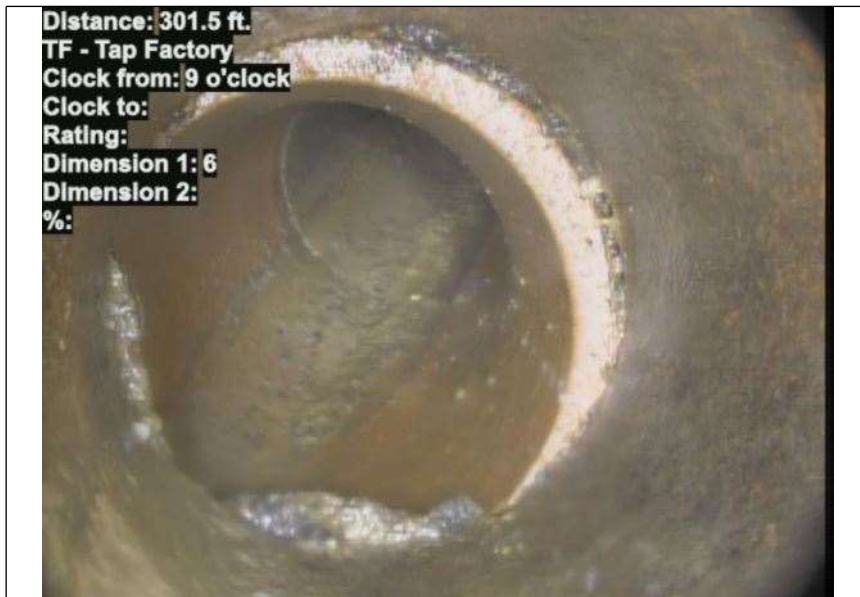
At: 301.5 ft. 9/. TF - Tap Factory
Joint: No

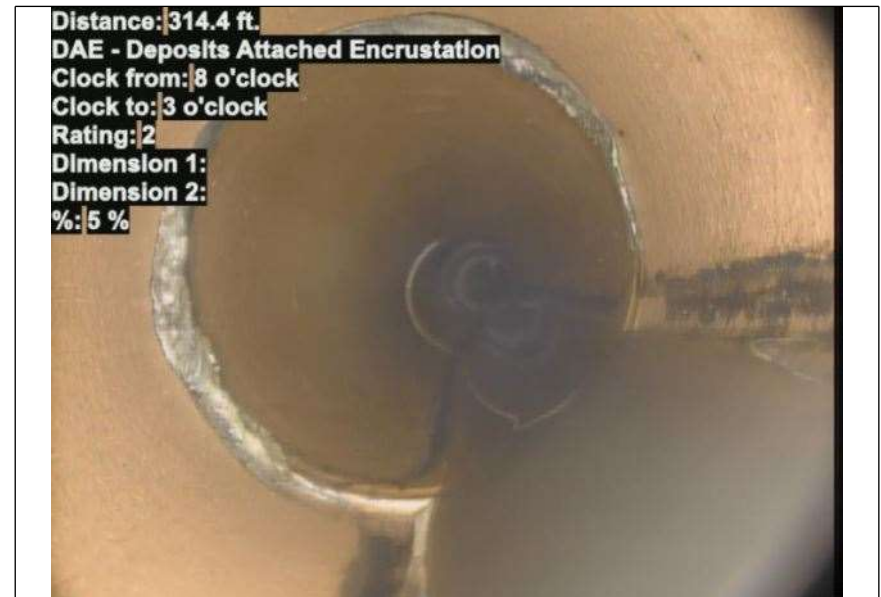
At: 314.4 ft. 8/3 DAE - Deposits Attached Encrustation
Joint: No 5 %

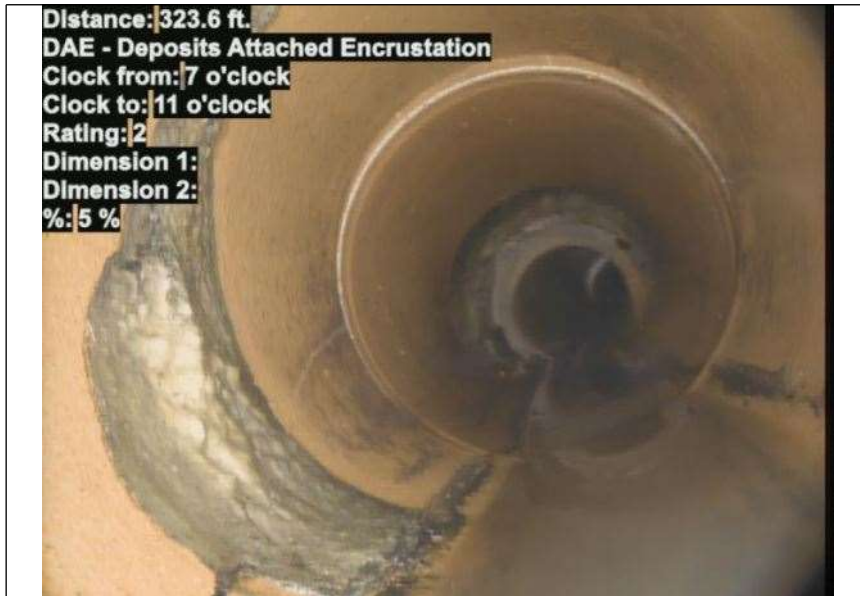
At: 323.6 ft. DAE - Deposits Attached Encrustation
7/11
Joint: No 5 %

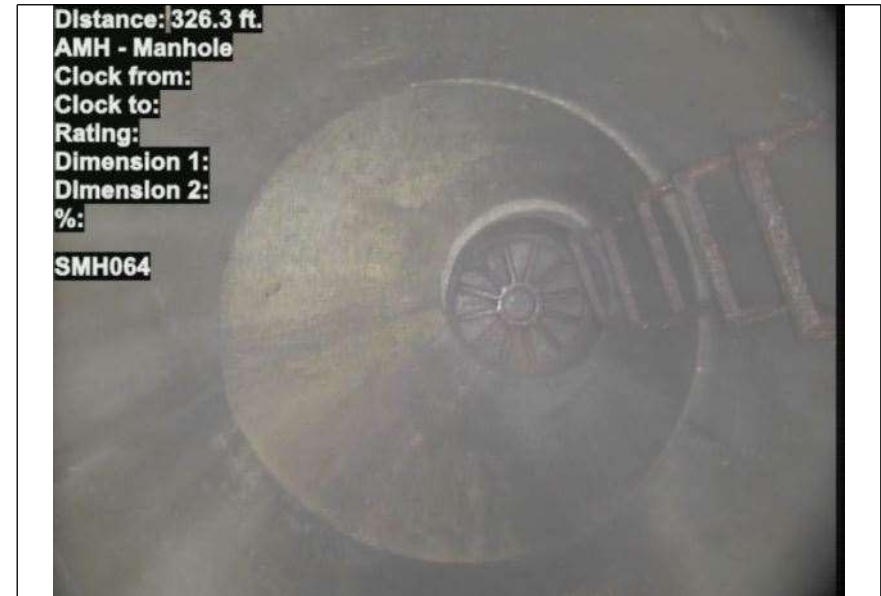
At: 326.3 ft. AMH - Manhole
Joint: No SMH064
