PACP Report with Pipe Run and Incident Snapshots

Surveyed by: Mike Brooks	Certificate number: Mike Brooks	Owner:	Customer:	Drainage area:	P/O number:	Sheet number:
Pipe segment ref.: SMH064_SMH065	Start date/time: 20220321 12:24	Street: PARKVIEW DR		City: SMITHVILLE		
Location details: STREET		Upstream MH No: SMH064	Rim to invert:	Grade to invert:	Rim to grade:	
Pipe use: SS	Direction: U	Flow control:	Downstream MH No: SMH065	Rim to invert:	Grade to invert:	Rim to grade:
Height: 8 in.	Width:	Shape: C	Material: VCP	Lining method:	Pipe joint length:	Total length: 121.400 ft.
Media label:	PreCleaning: L	Date cleaned:	Weather: 1	Length surveyed: 121.400 ft.	Purpose:	Sewer category:
Project name: Sewer Cleaning & CCTV - Project No. 210670		Additional info:

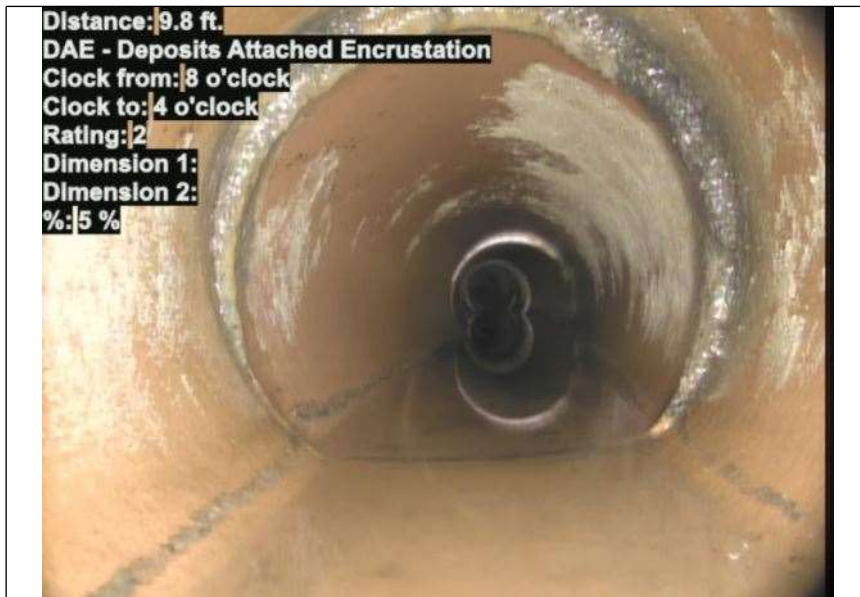
At: 9.8 ft. 8/4 DAE - Deposits Attached Encrustation
Joint: No 5 %

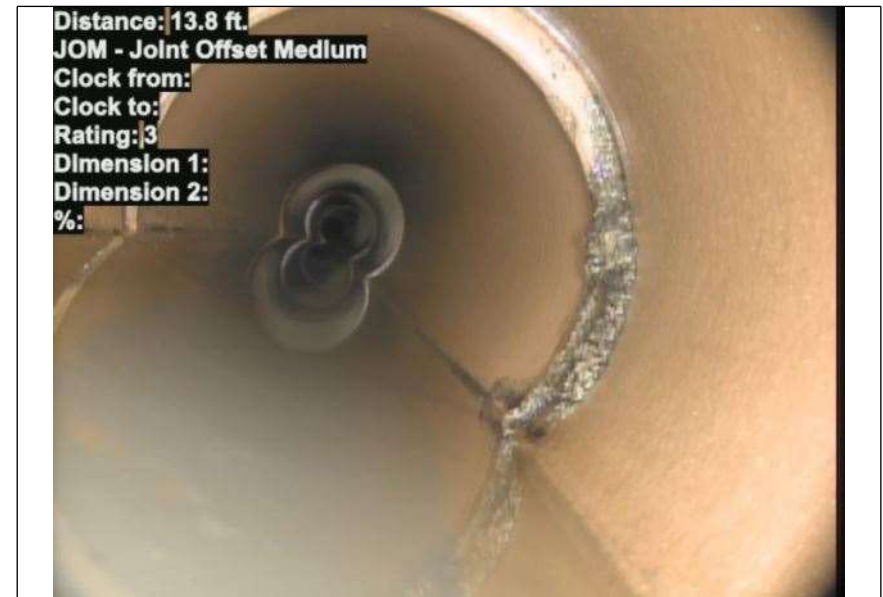
At: 13.8 ft. JOM - Joint Offset Medium
Joint: No

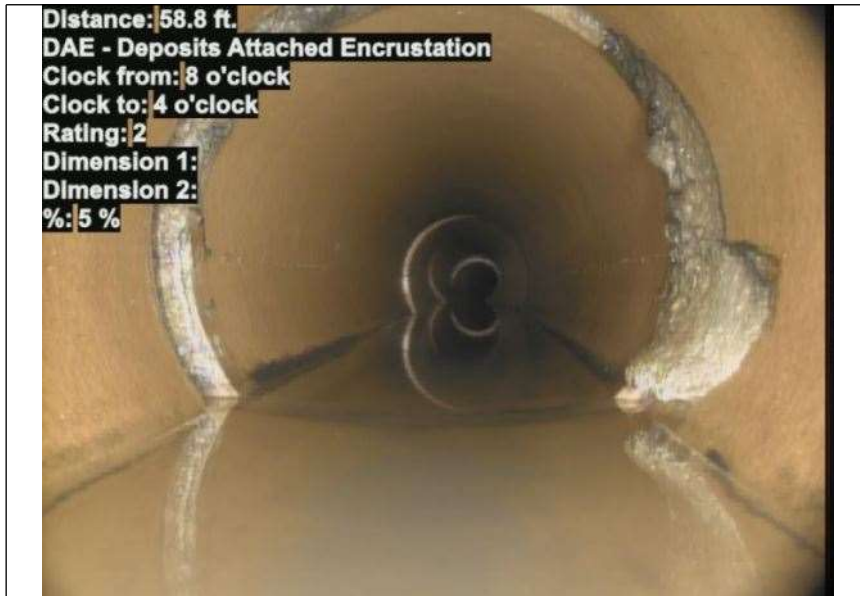
At: 58.8 ft. 8/4 DAE - Deposits Attached Encrustation
Joint: No 5 %

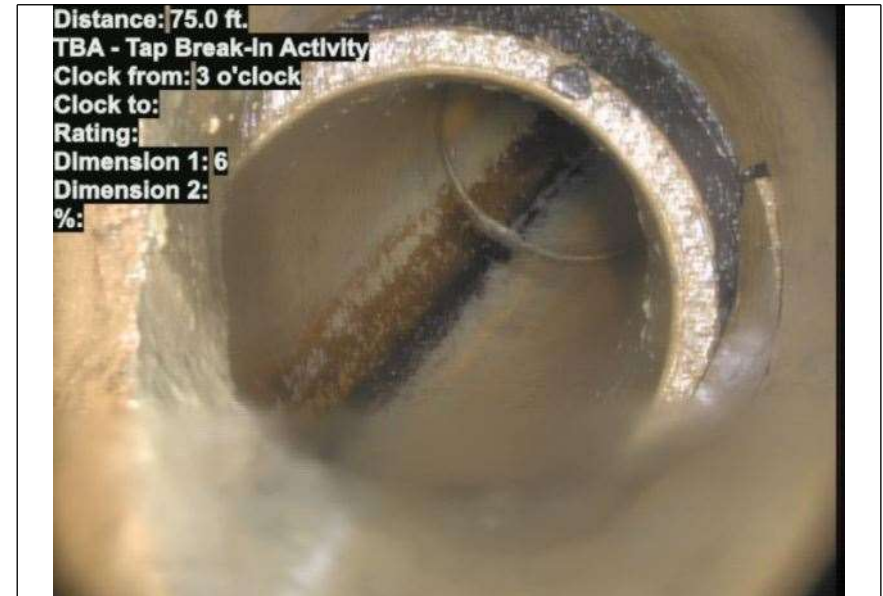
At: 75 ft. 3/. TBA - Tap Break-in Activity
Joint: No

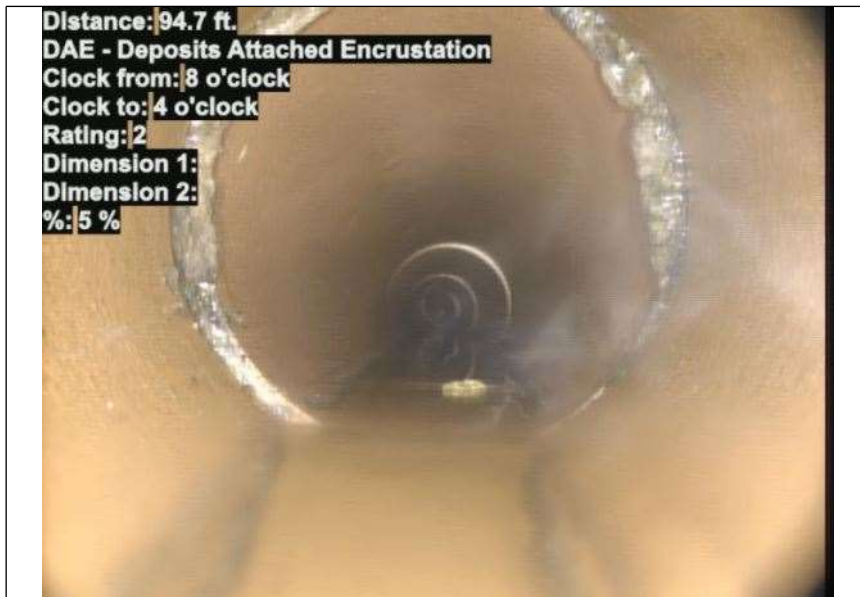
At: 94.7 ft. 8/4 DAE - Deposits Attached Encrustation
Joint: No 5 %

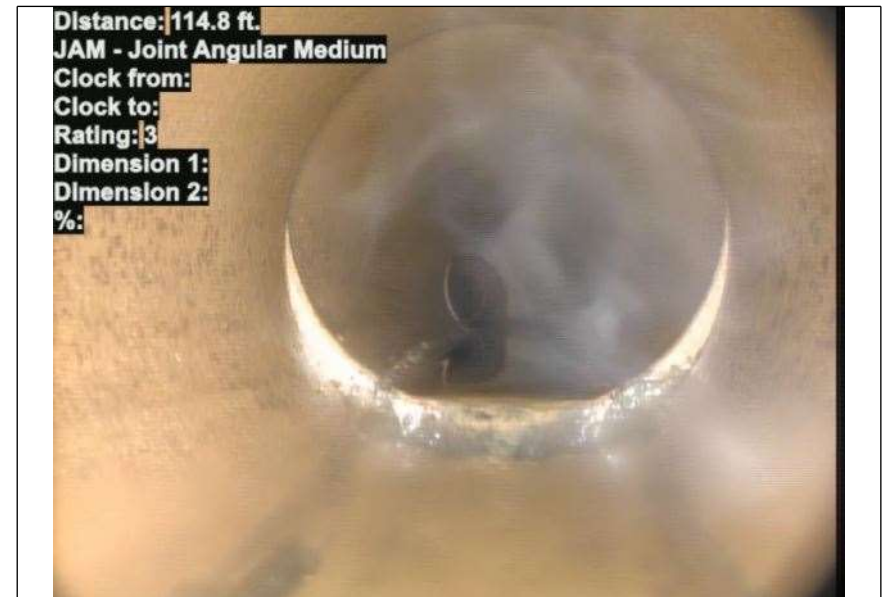
At: 114.8 ft. JAM - Joint Angular Medium
Joint: No

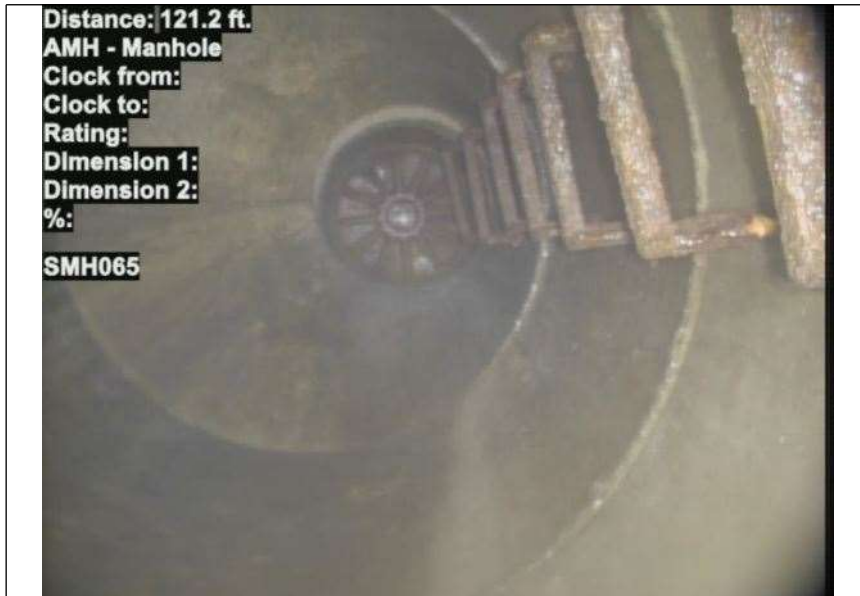
At: 121.4 ft. AMH - Manhole
Joint: No SMH065
