PACP Report with Pipe Run and Incident Snapshots

Surveyed by: Mike Brooks	Certificate number: Mike Brooks	Owner:	Customer:	Drainage area:	P/O number:	Sheet number:
Pipe segment ref.: SMH065_SMH055	Start date/time: 20220322 08:42	Street: PARKVIEW DR		City: SMITHVILLE		
Location details: STREET		Upstream MH No: SMH065	Rim to invert:	Grade to invert:	Rim to grade:	
Pipe use: SS	Direction: D	Flow control:	Downstream MH No: SMH055	Rim to invert:	Grade to invert:	Rim to grade:
Height: 8 in.	Width:	Shape: C	Material: VCP	Lining method:	Pipe joint length:	Total length: 262.900 ft.
Media label:	PreCleaning: L	Date cleaned:	Weather: 1	Length surveyed: 262.900 ft.	Purpose:	Sewer category:
Project name: Sewer Cleaning & CCTV - Project No. 210670		Additional info:

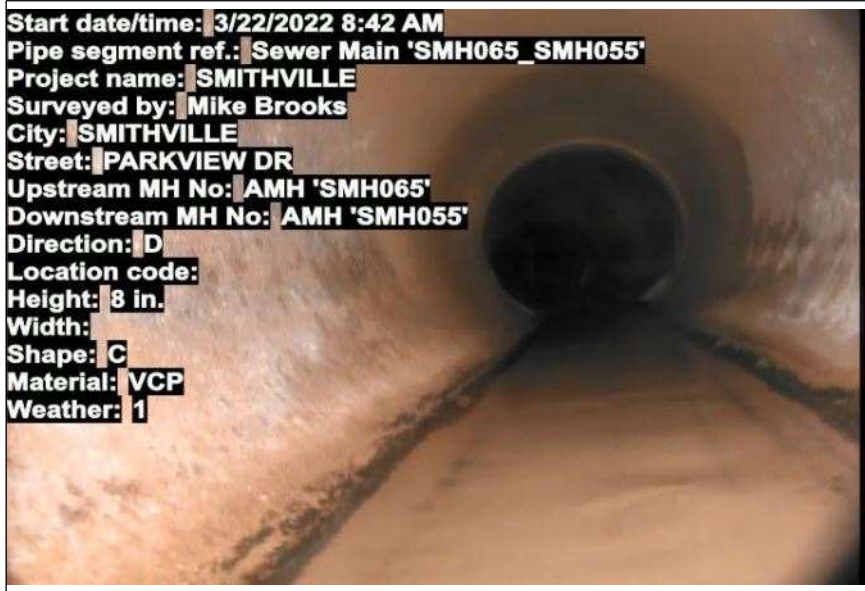
At: 0 ft. AMH - Manhole
Joint: No SMH065

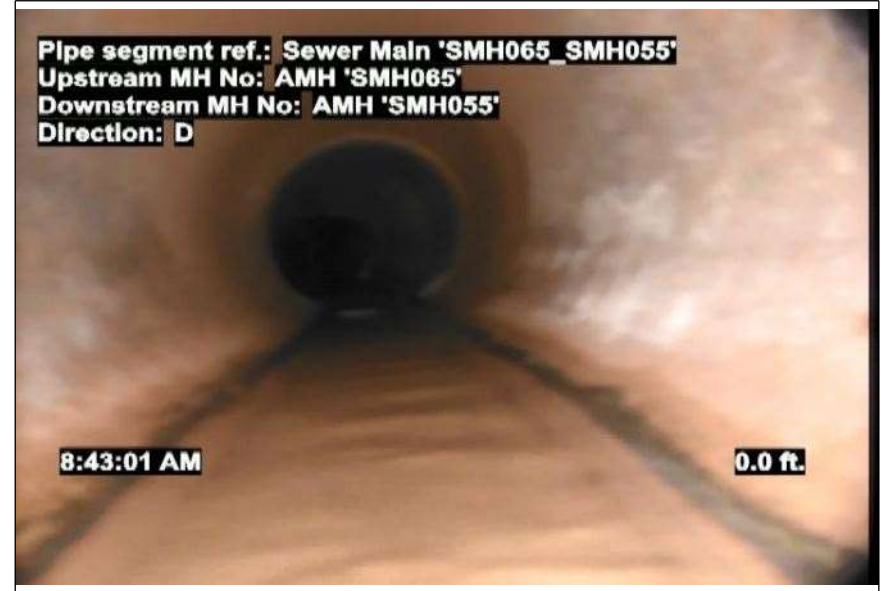
At: 0 ft. MWL - Miscellaneous Water Level
Joint: No 5 %

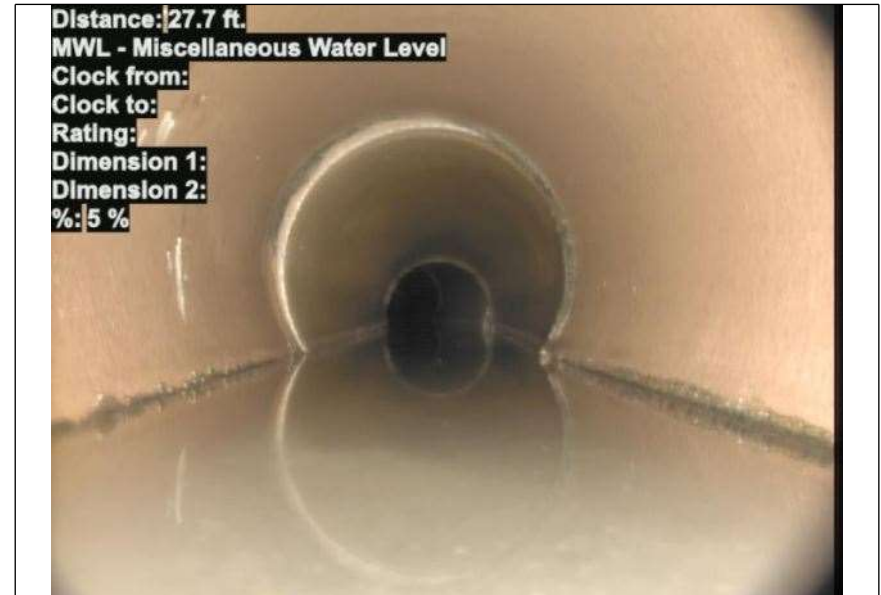
At: 27.7 ft. MWL - Miscellaneous Water Level
Joint: No 5 %

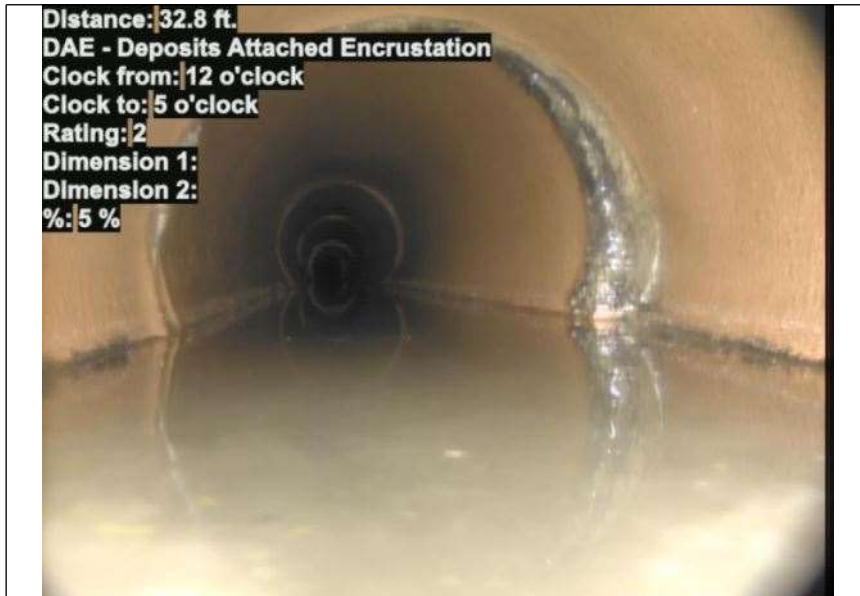
At: 32.8 ft. 12/5 DAE - Deposits Attached Encrustation
Joint: No 5 %

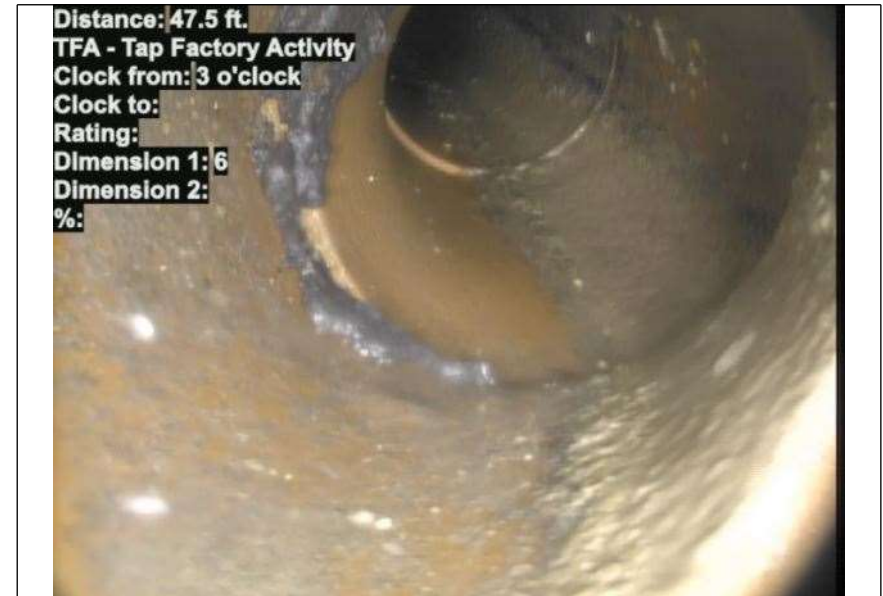
At: 47.5 ft. 3/ TFA - Tap Factory Activity
Joint: No

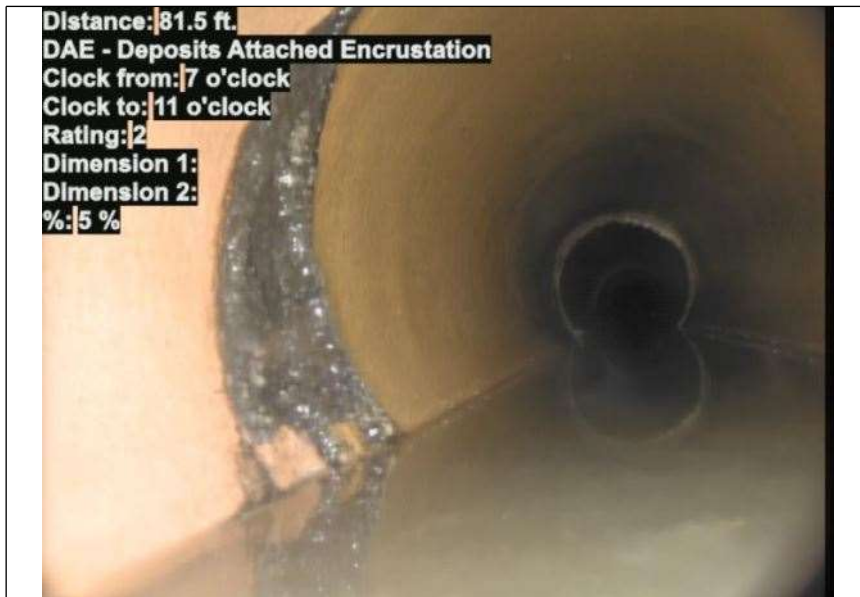
At: 81.5 ft. 7/11 DAE - Deposits Attached Encrustation
Joint: No 5 %

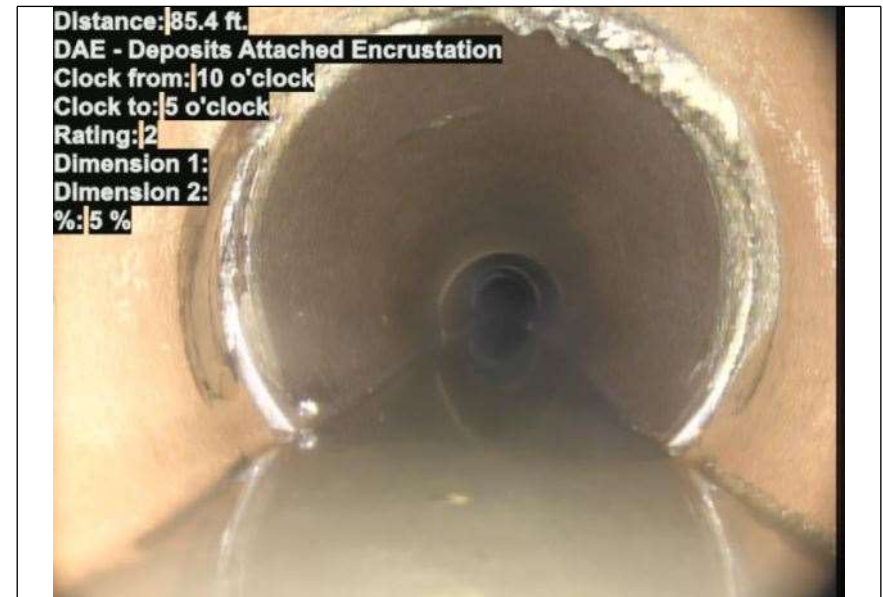
At: 85.4 ft. 10/5 DAE - Deposits Attached Encrustation
Joint: No 5 %

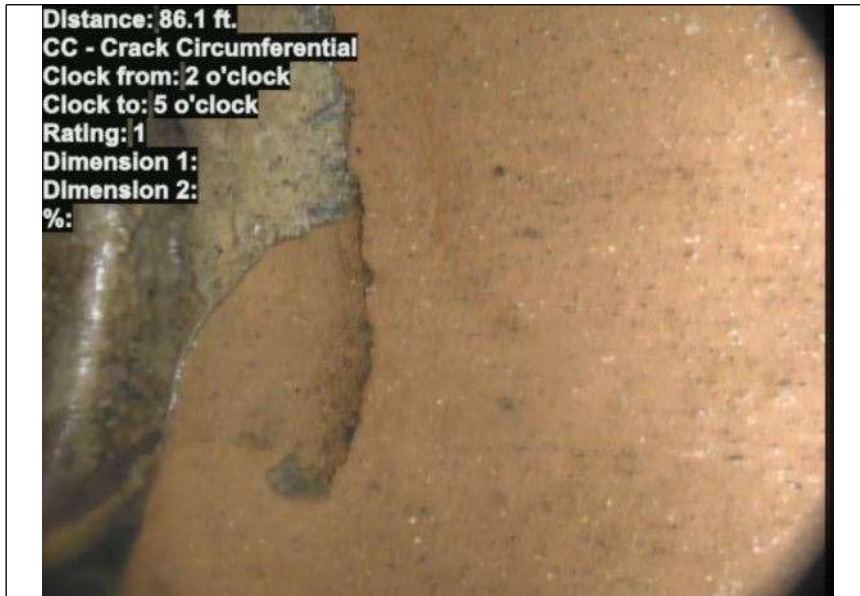
At: 86.1 ft. 2/5 CC - Crack Circumferential
Joint: No

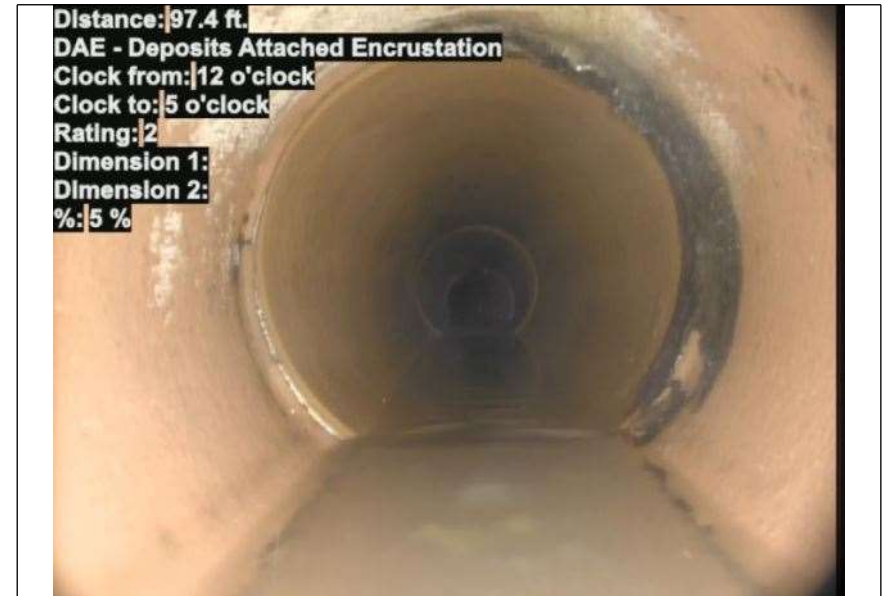
At: 97.4 ft. 12/5 DAE - Deposits Attached Encrustation
Joint: No 5 %

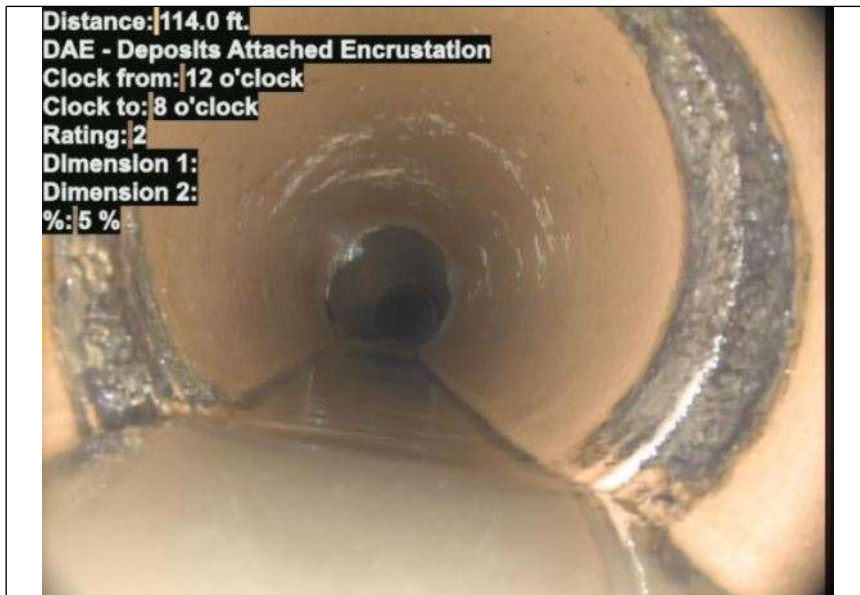
At: 114 ft. 12/8 DAE - Deposits Attached Encrustation
Joint: No 5 %

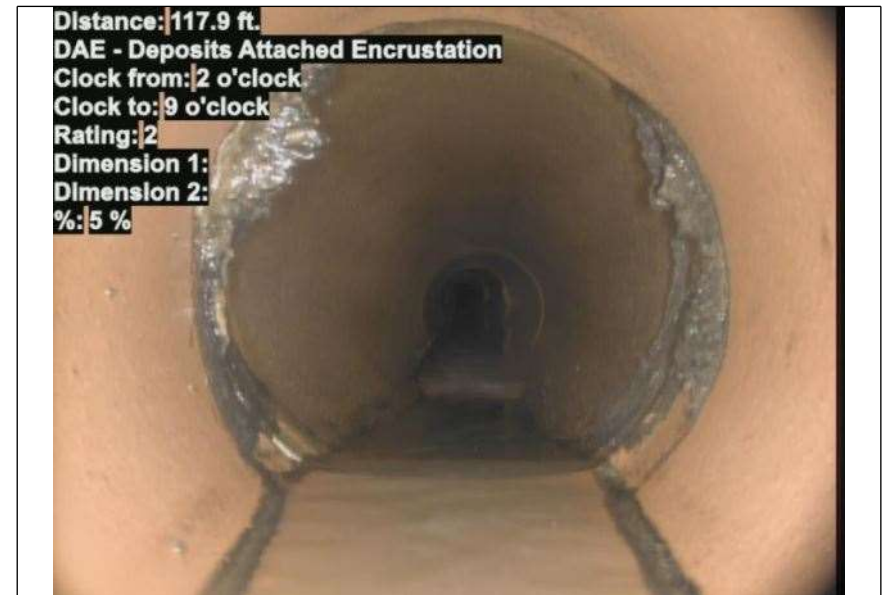
At: 117.9 ft. 2/9 DAE - Deposits Attached Encrustation
Joint: No 5 %

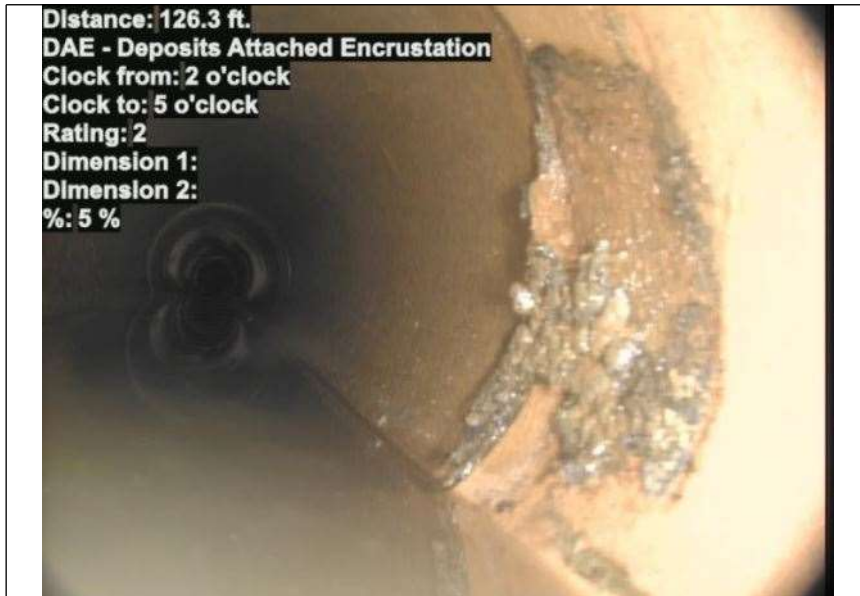
At: 126.3 ft. 2/5 DAE - Deposits Attached Encrustation
Joint: No 5 %

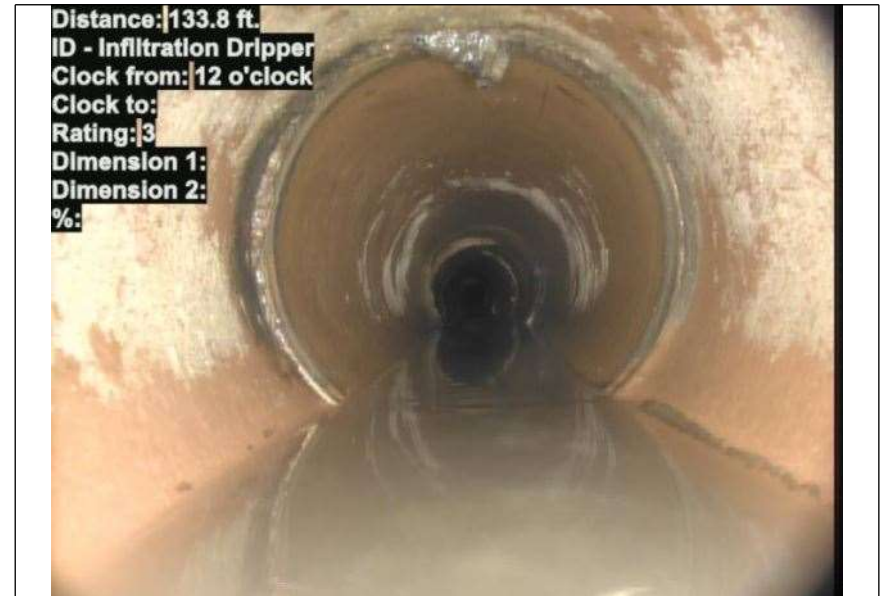
At: 133.8 ft. 12/ ID - Infiltration Dripper
Joint: No

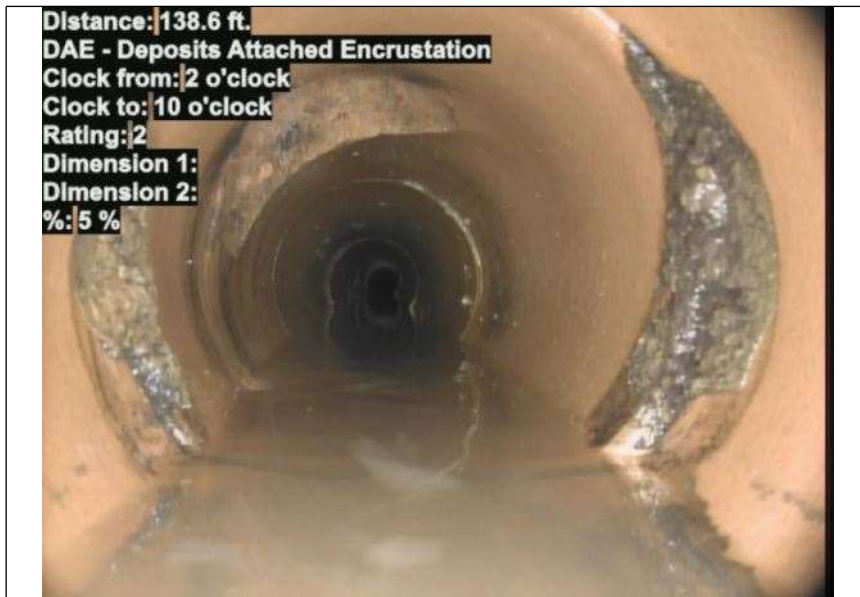
At: 138.6 ft. 2/10 DAE - Deposits Attached Encrustation
Joint: No 5 %

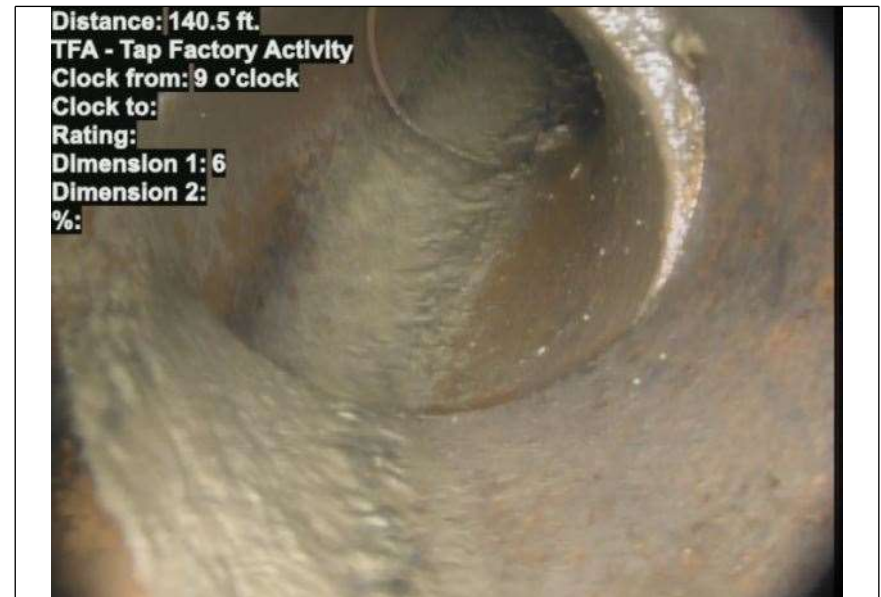
At: 140.5 ft. 9/ TFA - Tap Factory Activity
Joint: No

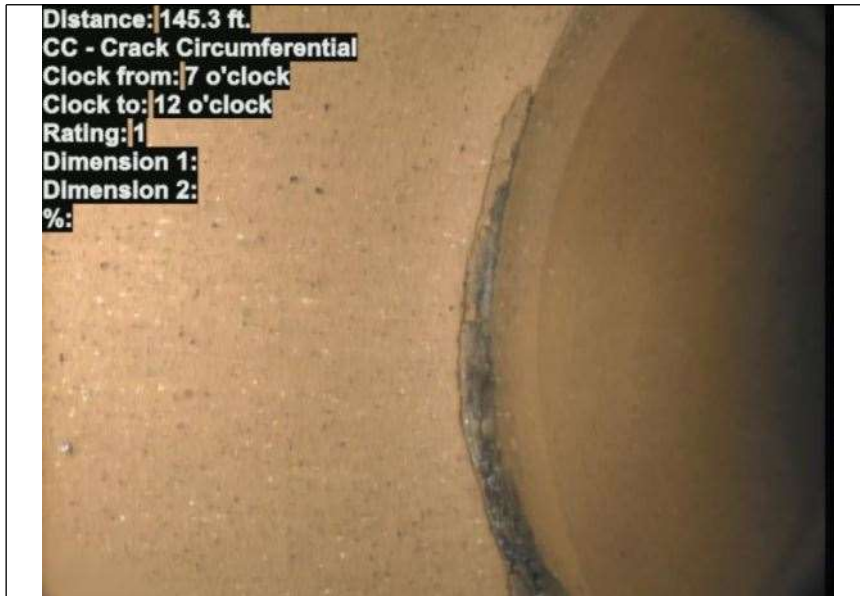
At: 145.3 ft. CC - Crack Circumferential
7/12

Joint: No

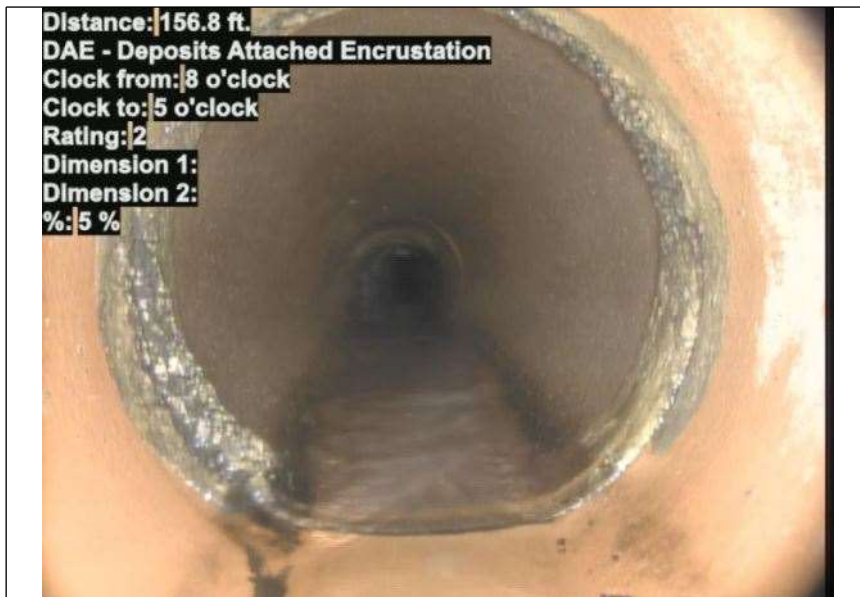
At: 156.8 ft. 8/5 DAE - Deposits Attached Encrustation

Joint: No 5 %

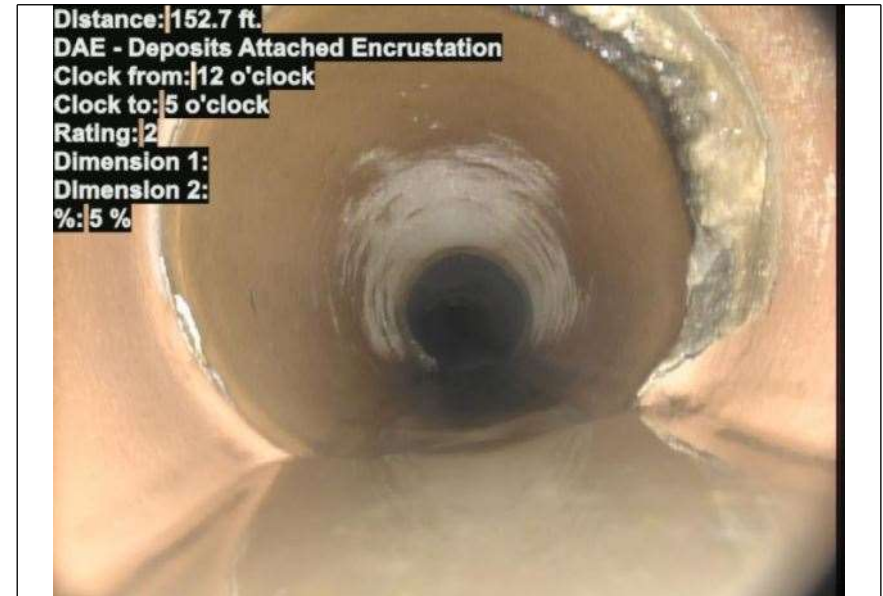
At: 152.7 ft. DAE - Deposits Attached Encrustation
12/5

Joint: No 5 %

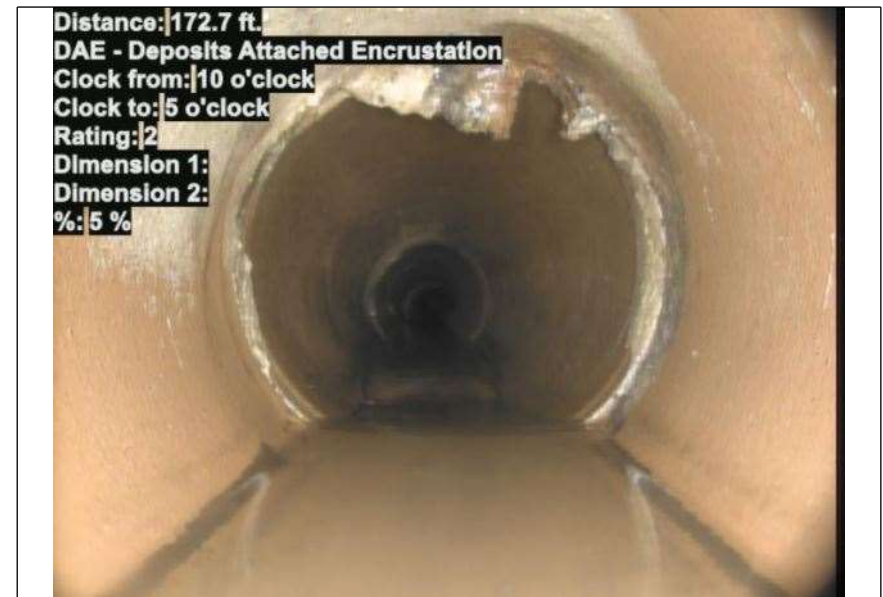
At: 172.7 ft. DAE - Deposits Attached Encrustation
10/5

Joint: No 5 %

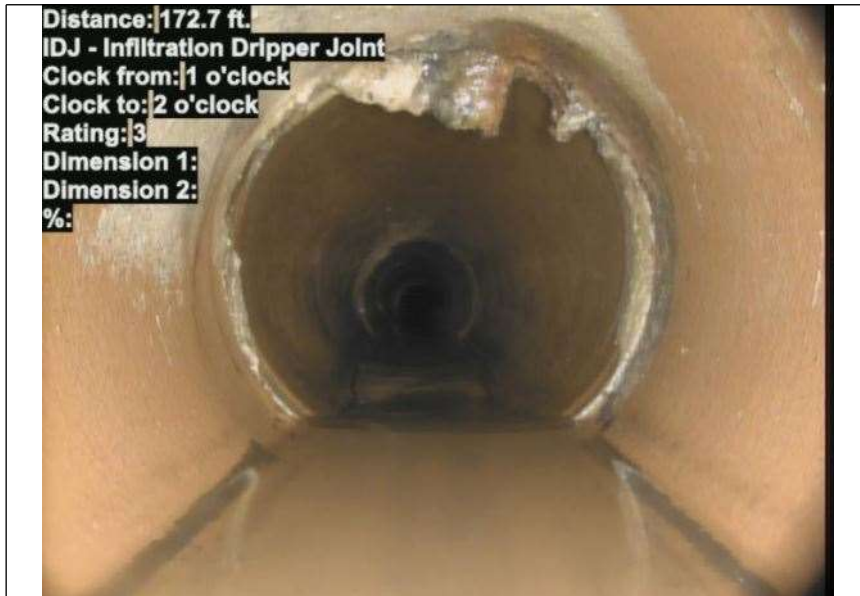
At: 172.7 ft. 1/2 IDJ - Infiltration Dripper Joint
Joint: Yes

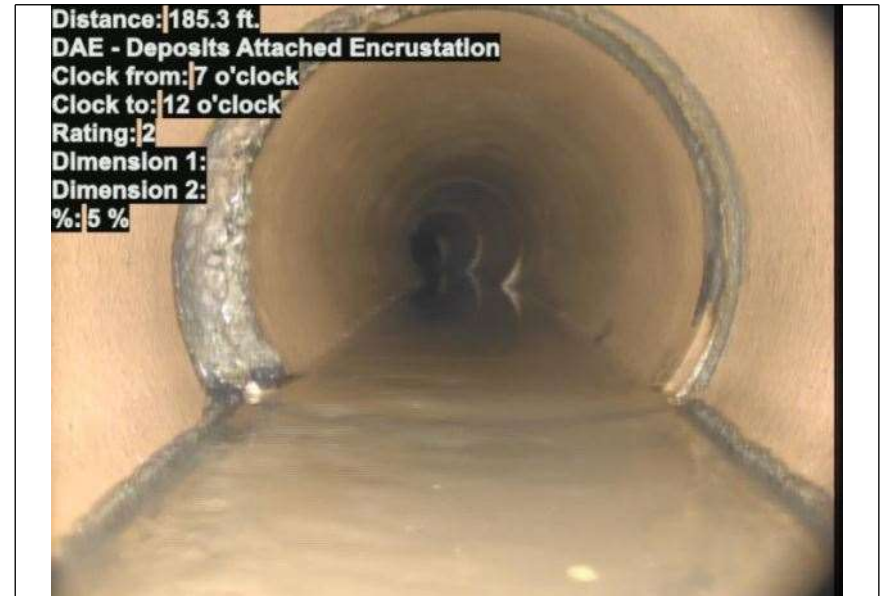
At: 185.3 ft. DAE - Deposits Attached Encrustation
7/12
Joint: No 5 %

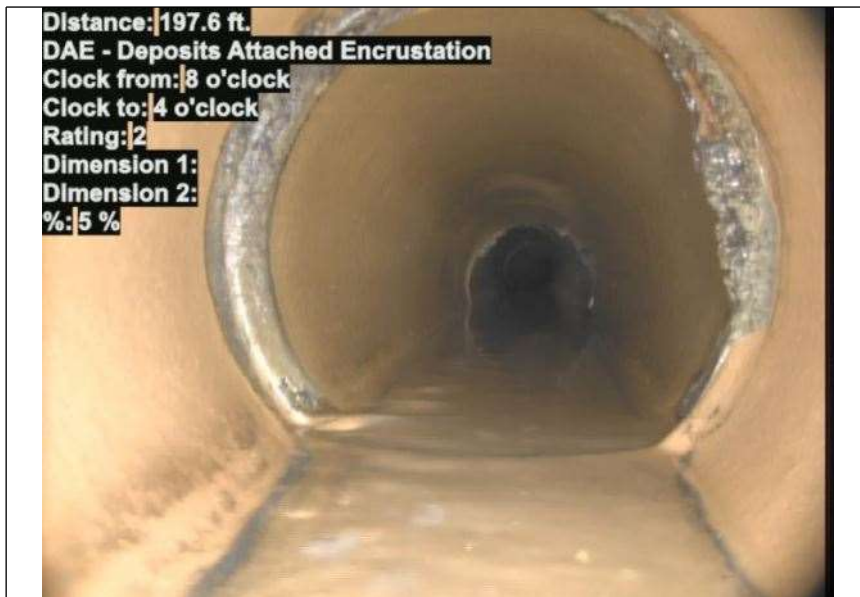
At: 197.6 ft. 8/4 DAE - Deposits Attached Encrustation
Joint: No 5 %

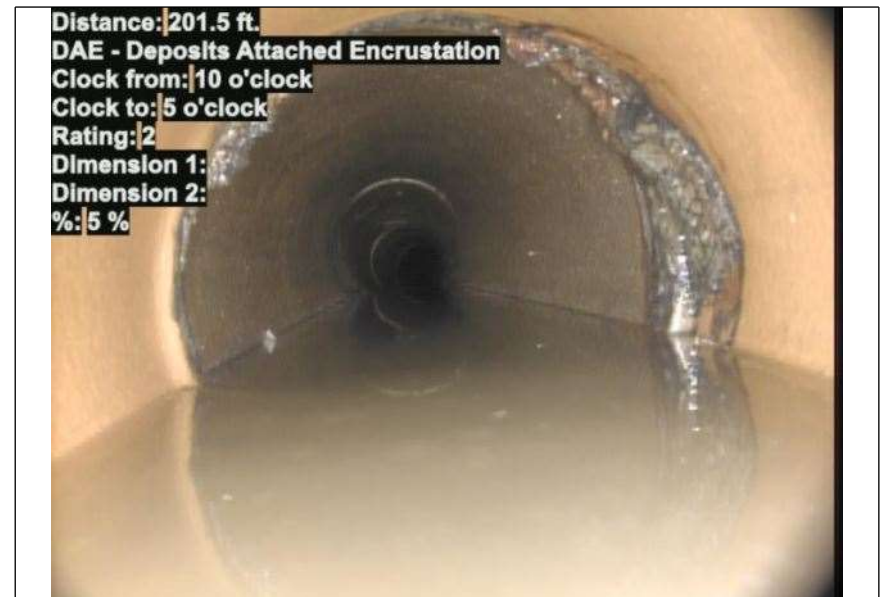
At: 201.5 ft. DAE - Deposits Attached Encrustation
10/5
Joint: No 5 %

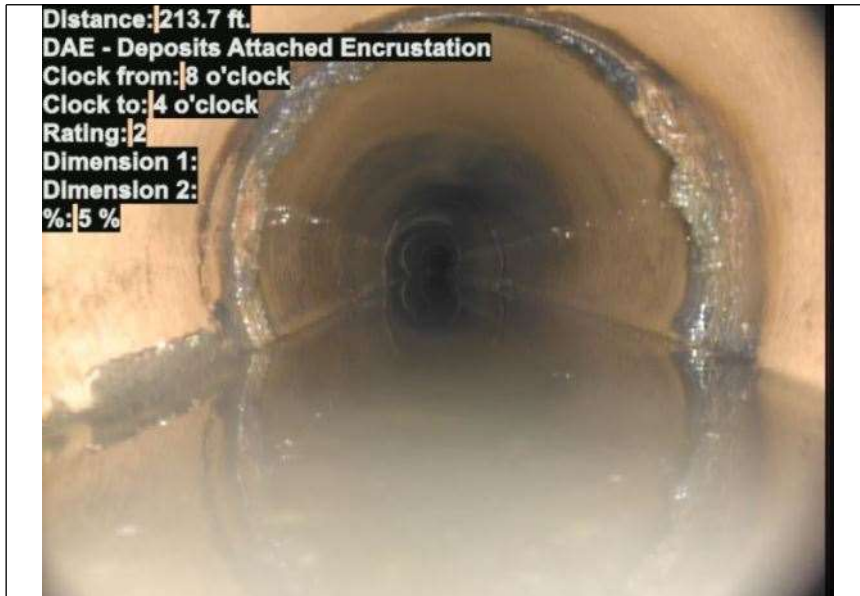
At: 213.7 ft. 8/4 DAE - Deposits Attached Encrustation
Joint: No 5 %

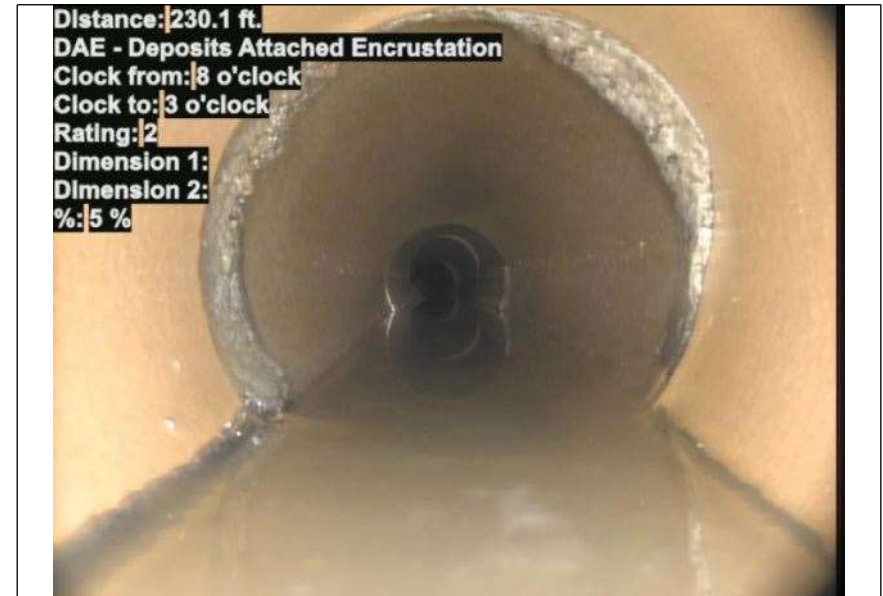
At: 230.1 ft. 8/3 DAE - Deposits Attached Encrustation
Joint: No 5 %

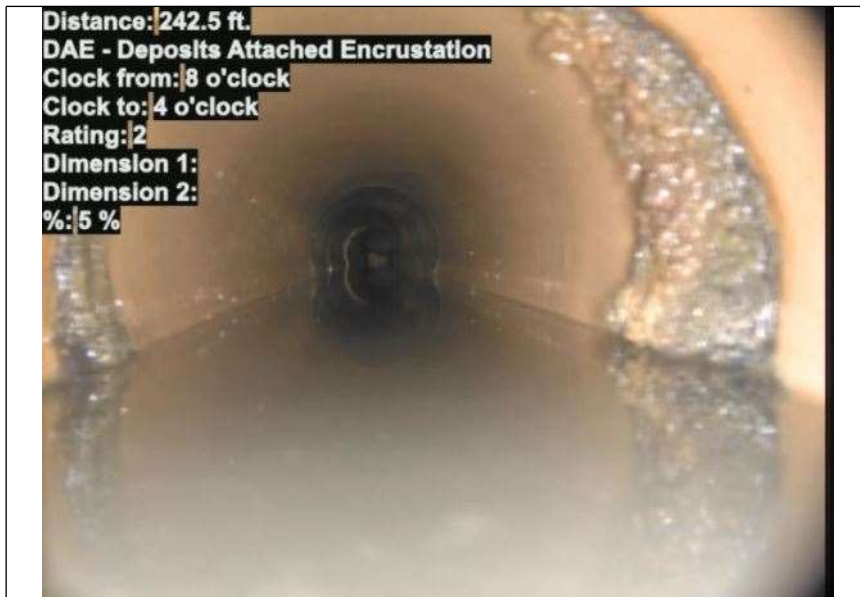
At: 242.5 ft. 8/4 DAE - Deposits Attached Encrustation
Joint: No 5 %

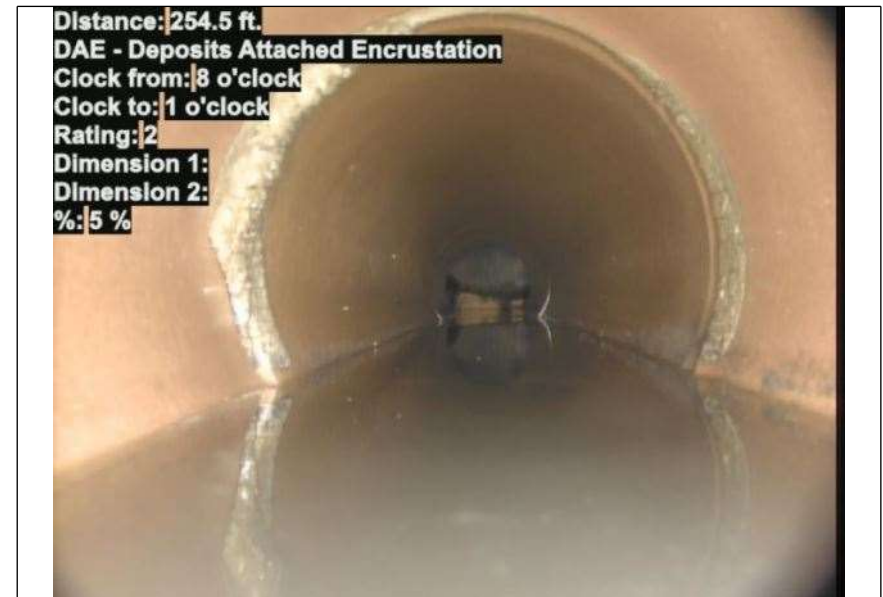
At: 254.5 ft. 8/1 DAE - Deposits Attached Encrustation
Joint: No 5 %

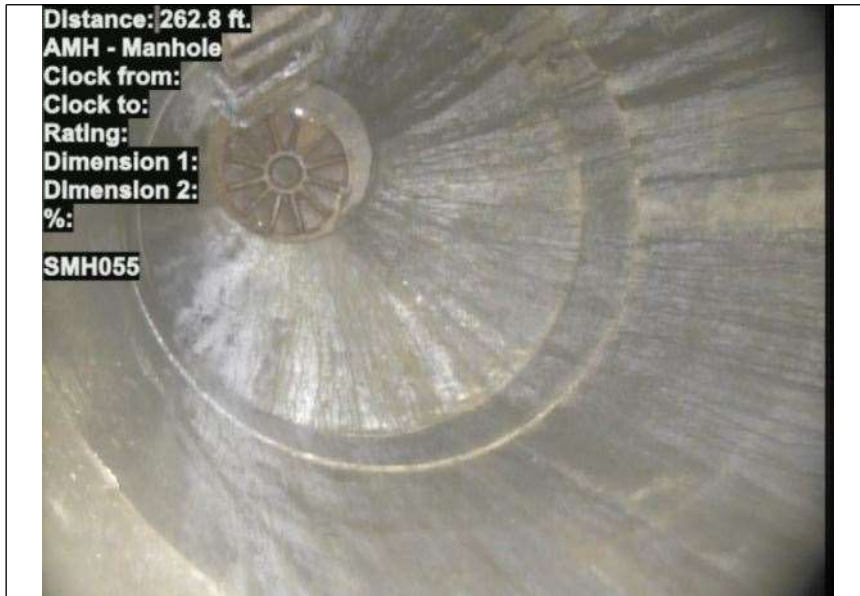
At: 262.9 ft. AMH - Manhole
Joint: No SMH055
