PACP Report with Pipe Run and Incident Snapshots

Surveyed by: Mike Brooks	Certificate number: Mike Brooks	Owner:	Customer:	Drainage area:	P/O number:	Sheet number:			
Pipe segment ref.: SMH120_SMH121	Start date/time: 20220414 08:24	Street: W MAIN ST	City: SMITHVILLE						
Location details: STREET	Upstream MH No: SMH120	Rim to invert:	Grade to invert:	Rim to grade:					
Pipe use: SS	Direction: U	Flow control:	Downstream MH No: SMH121	Rim to invert:	Grade to invert:	Rim to grade:			
Height: 8 in.	Width:	Shape: C	Material: VCP	Lining method:	Pipe joint length:	Total length: 386.900 ft.	Length surveyed: 386.900 ft.	Purpose:	Sewer category:
Media label:	PreCleaning: L	Date cleaned:	Weather: 3	Location code:	Pressure value:				
Project name: Sewer Cleaning & CCTV - Project No. 210670	Additional info:

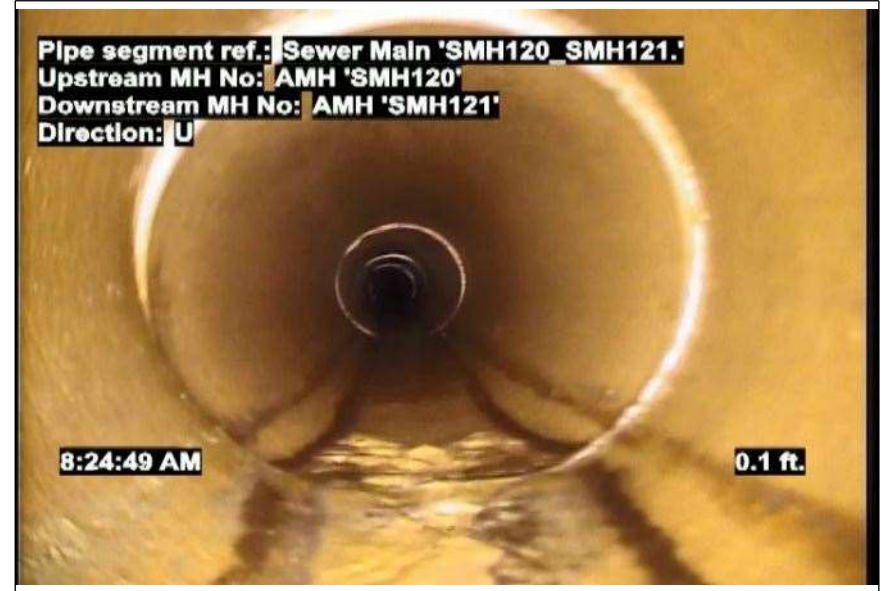
At: 0 ft. MWL - Miscellaneous Water Level
Joint: No 5 %

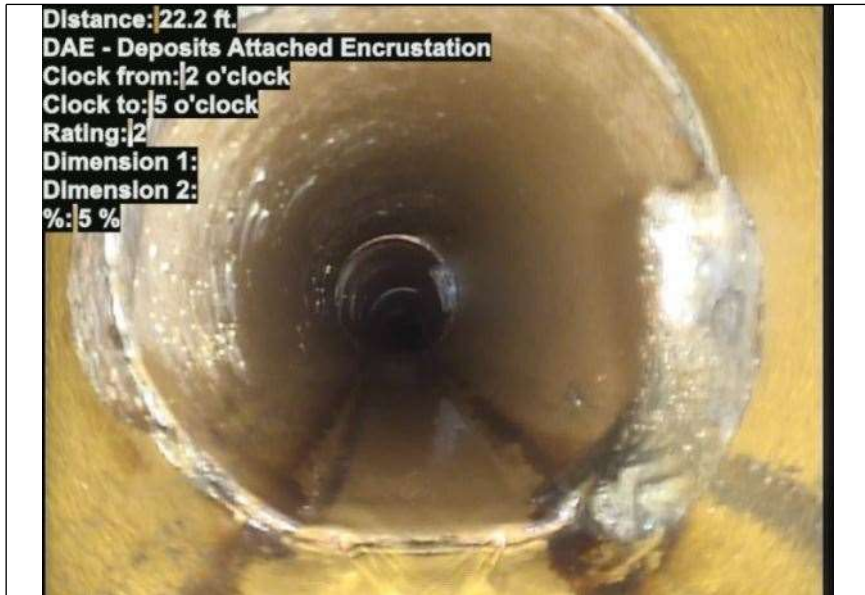
At: 22.2 ft. 2/5 DAE - Deposits Attached Encrustation
Joint: No 5 %

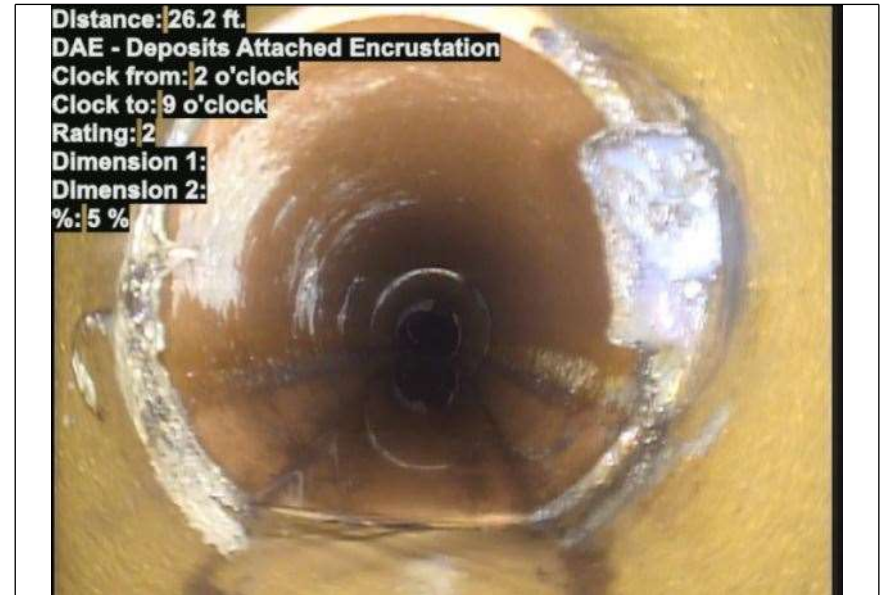
At: 26.2 ft. 2/9 DAE - Deposits Attached Encrustation
Joint: No 5 %

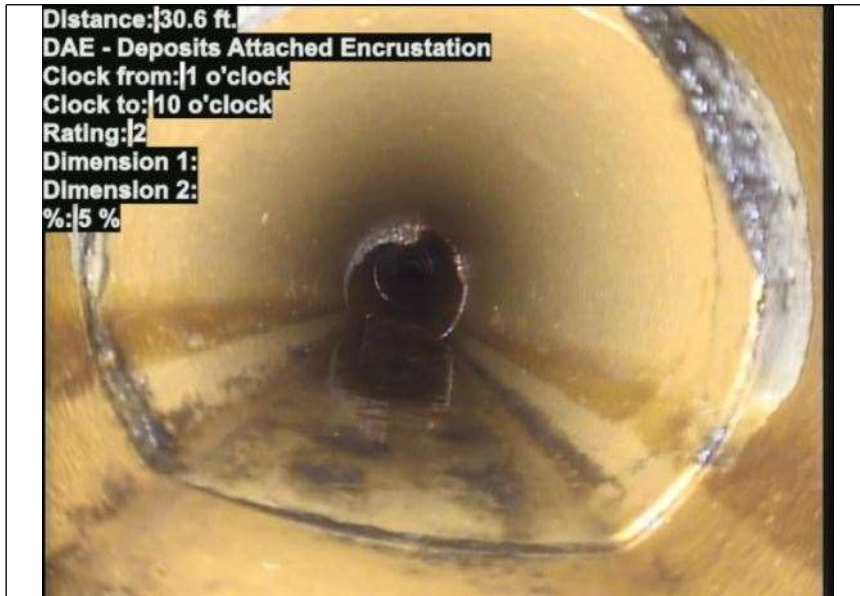
At: 30.6 ft. 1/10 DAE - Deposits Attached Encrustation
Joint: No 5 %

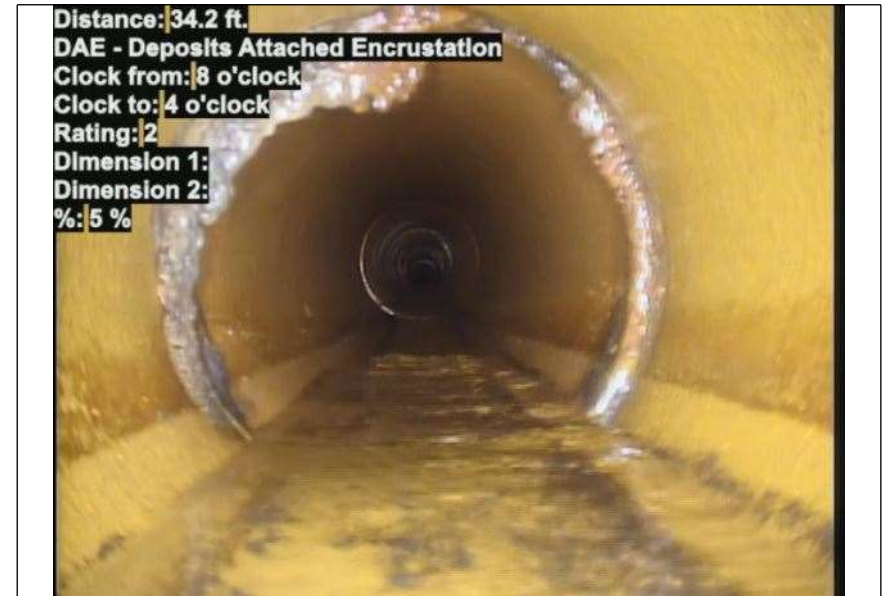
At: 34.2 ft. 8/4 DAE - Deposits Attached Encrustation
Joint: No 5 %

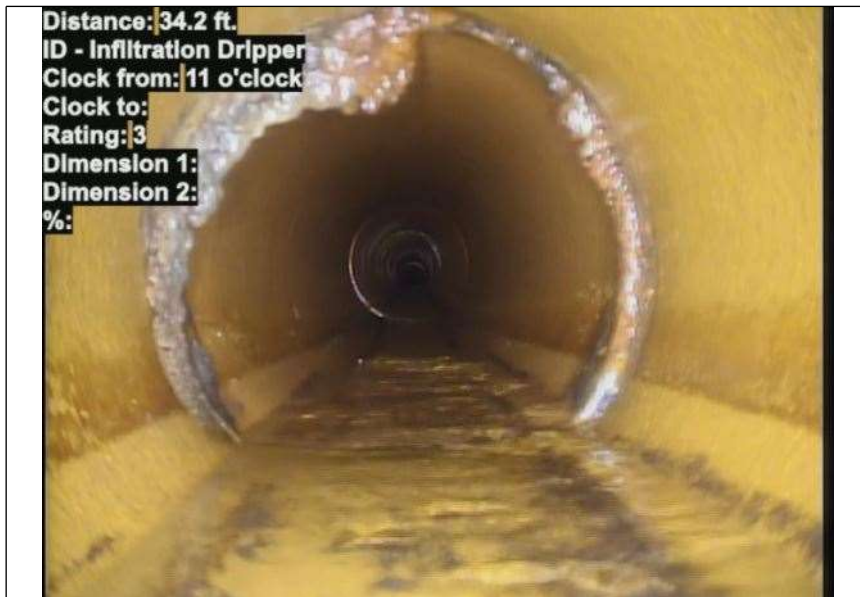
At: 34.2 ft. 11/. ID - Infiltration Dripper
Joint: No

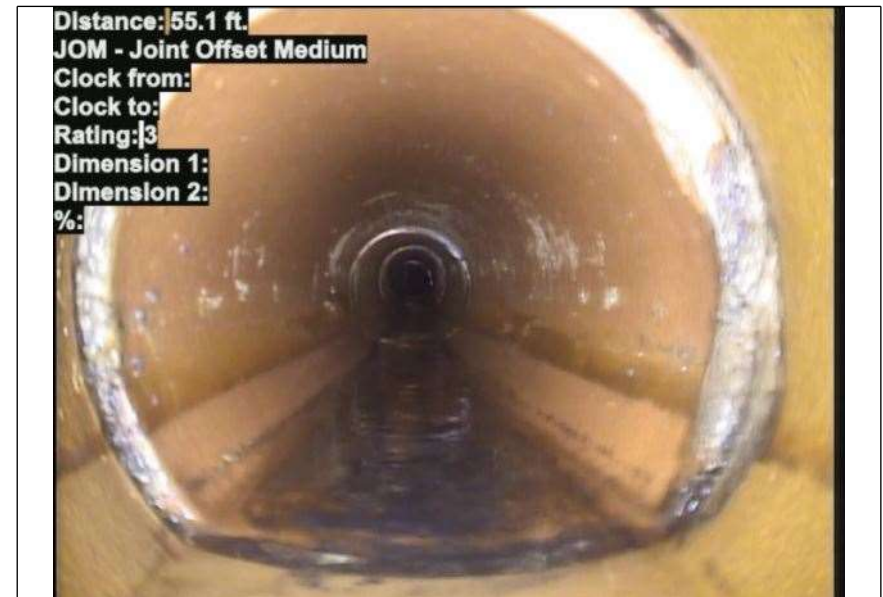
At: 55.1 ft. JOM - Joint Offset Medium
Joint: No

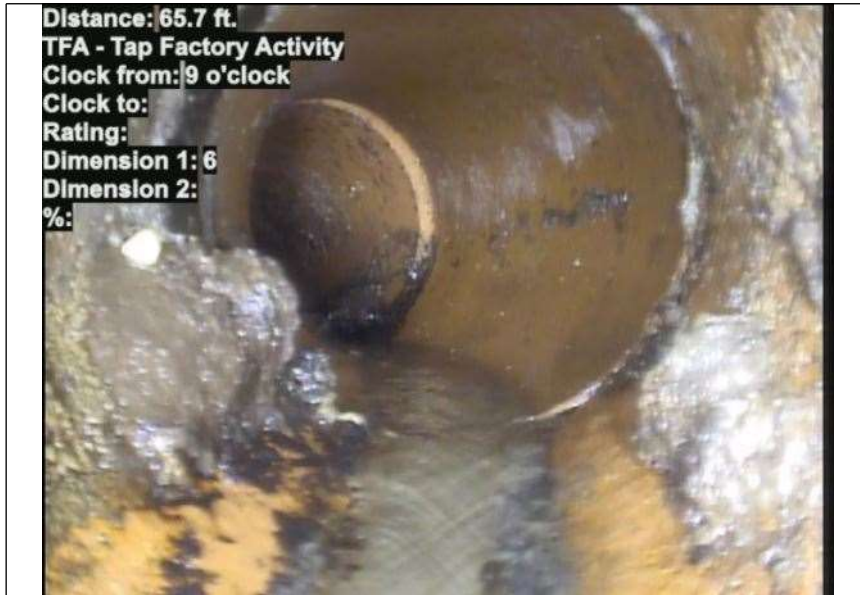
At: 65.7 ft. 9/ TFA - Tap Factory Activity
Joint: No

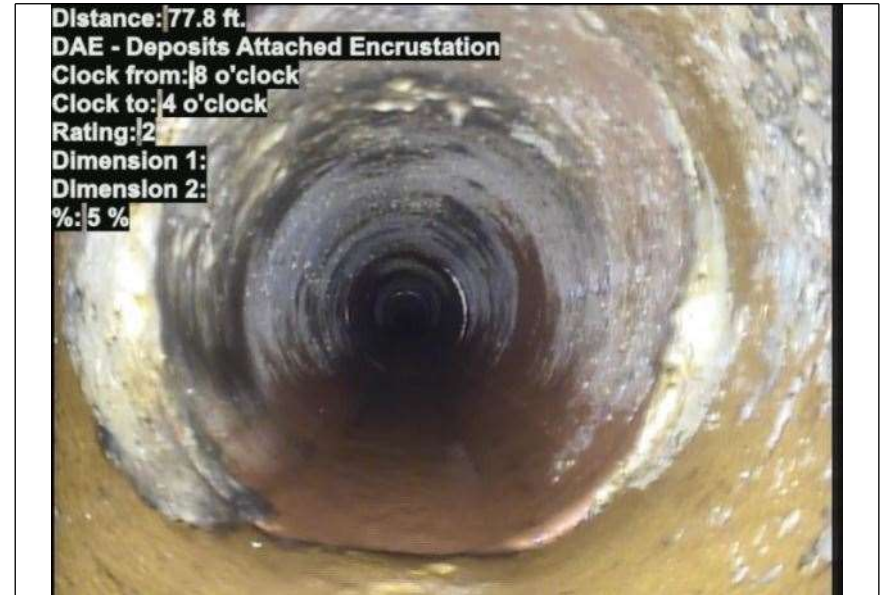
At: 77.8 ft. 8/4 DAE - Deposits Attached Encrustation
Joint: No 5 %

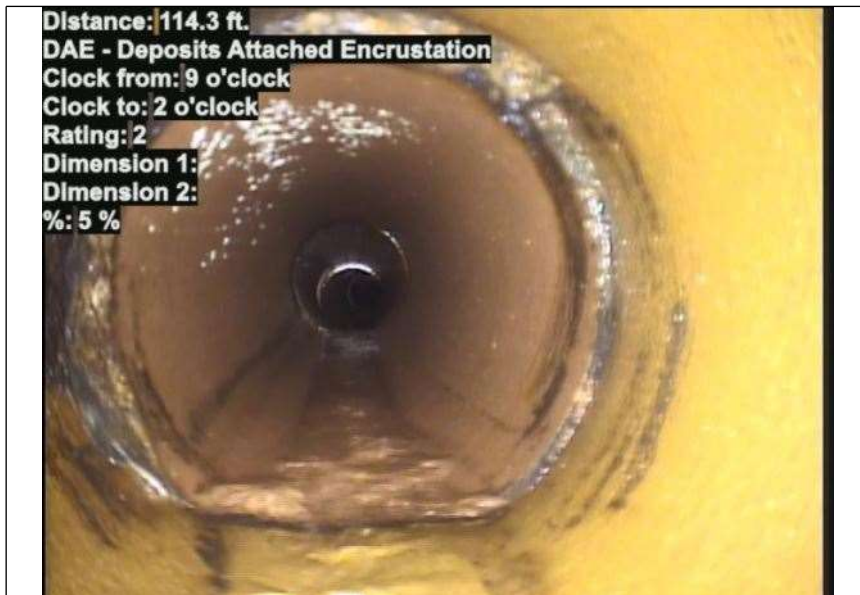
At: 114.3 ft. 9/2 DAE - Deposits Attached Encrustation
Joint: No 5 %

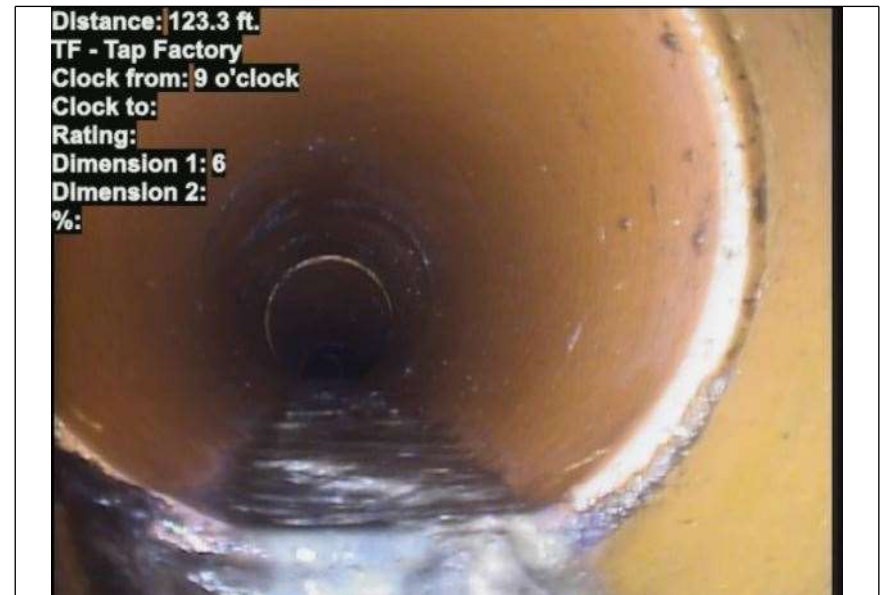
At: 123.3 ft. 9/ TF - Tap Factory
Joint: No

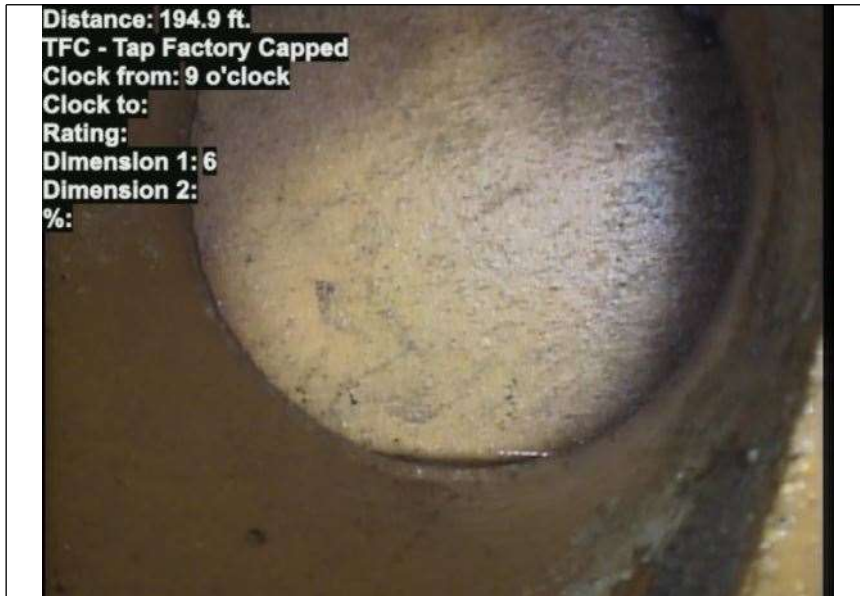
At: 194.9 ft. 9/. TFC - Tap Factory Capped
Joint: No

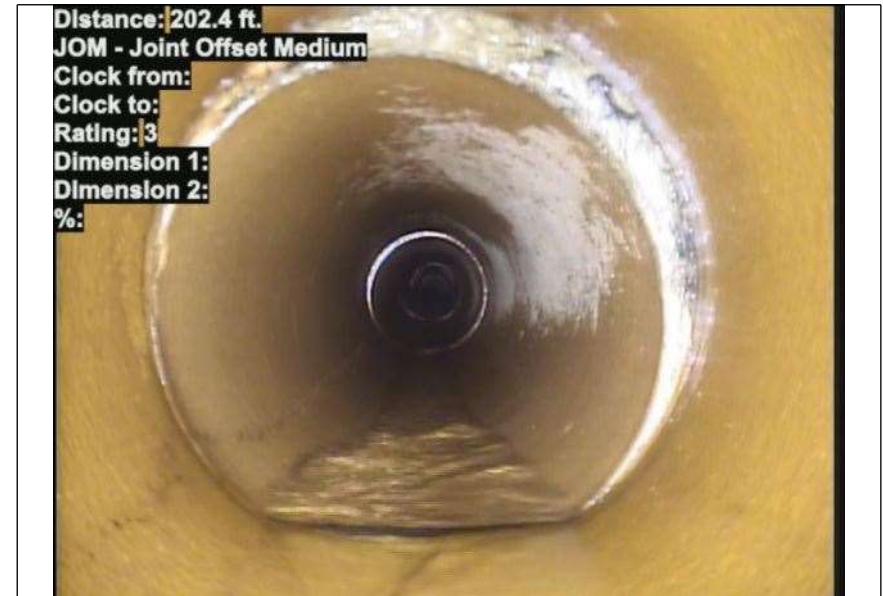
At: 202.4 ft. JOM - Joint Offset Medium
Joint: No

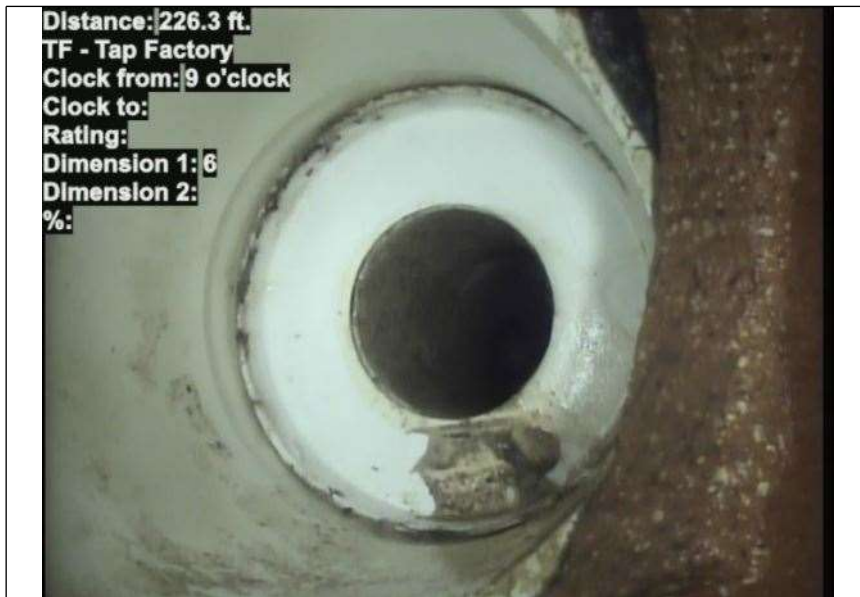
At: 226.3 ft. 9/. TF - Tap Factory
Joint: No

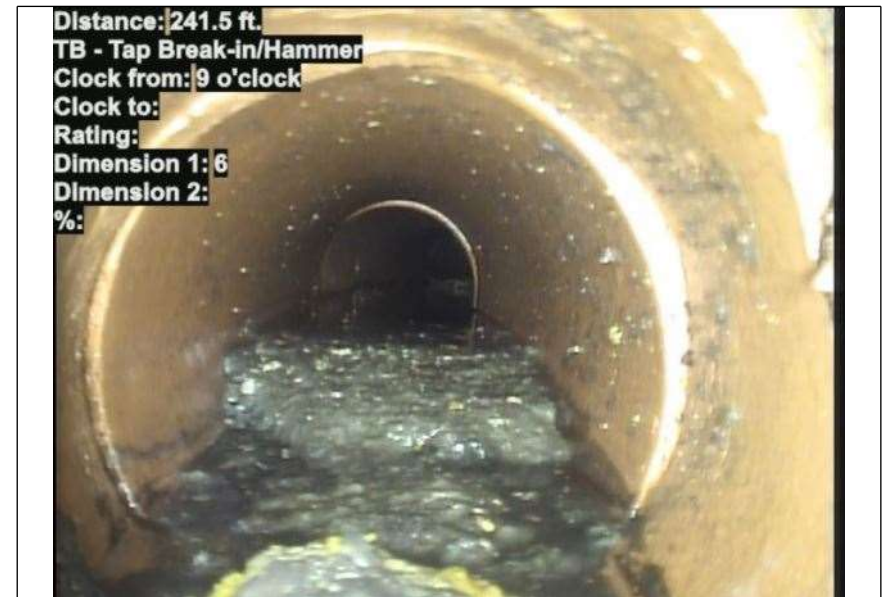
At: 241.5 ft. 9/. TB - Tap Break-in/Hammer
Joint: No

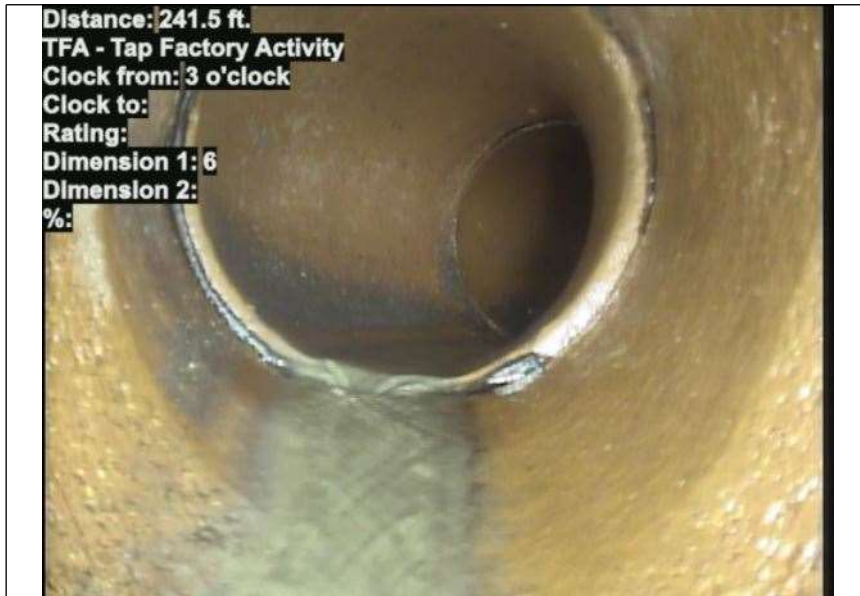
At: 241.5 ft. 3/. TFA - Tap Factory Activity
Joint: No

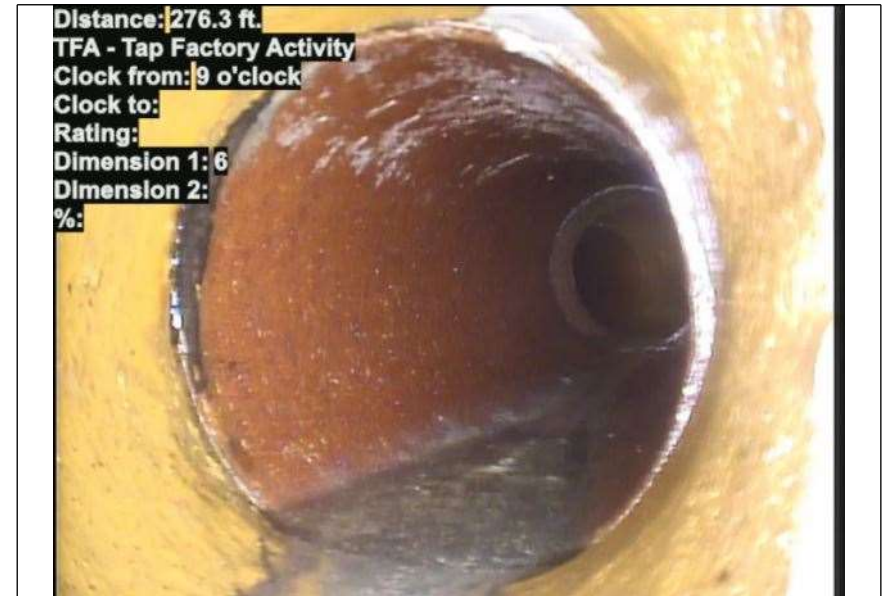
At: 276.3 ft. 9/. TFA - Tap Factory Activity
Joint: No

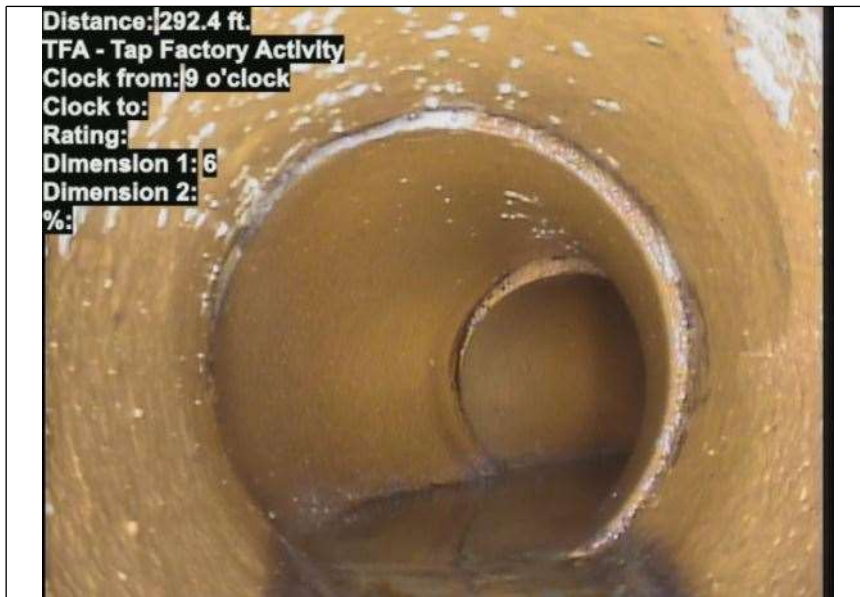
At: 292.4 ft. 9/. TFA - Tap Factory Activity
Joint: No

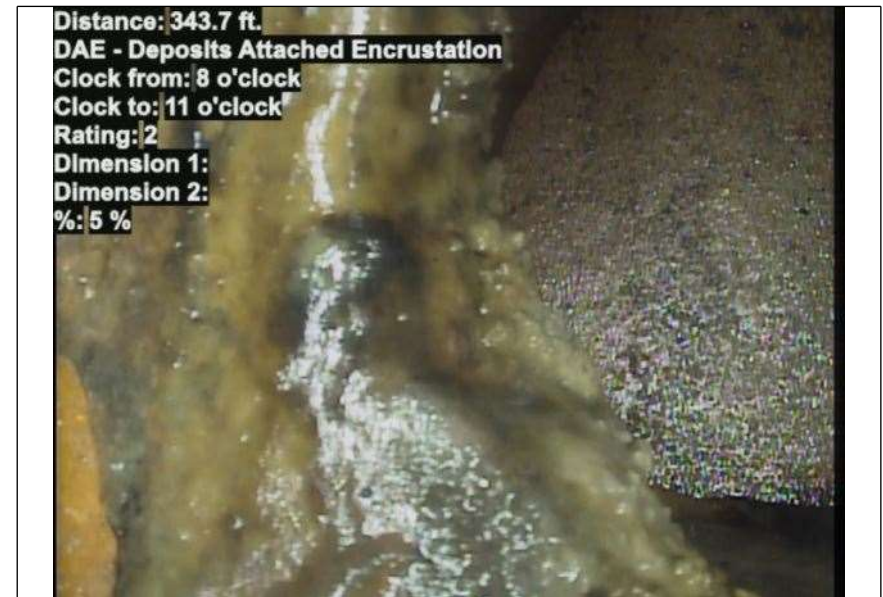
At: 343.7 ft. 8/11 DAE - Deposits Attached Encrustation
Joint: No 5 %

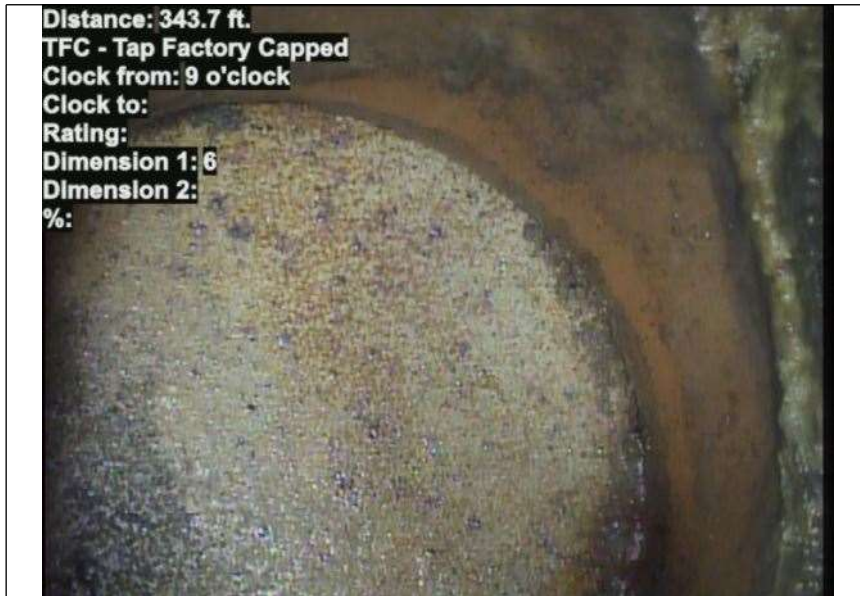
At: 343.7 ft. 9/. TFC - Tap Factory Capped
Joint: No

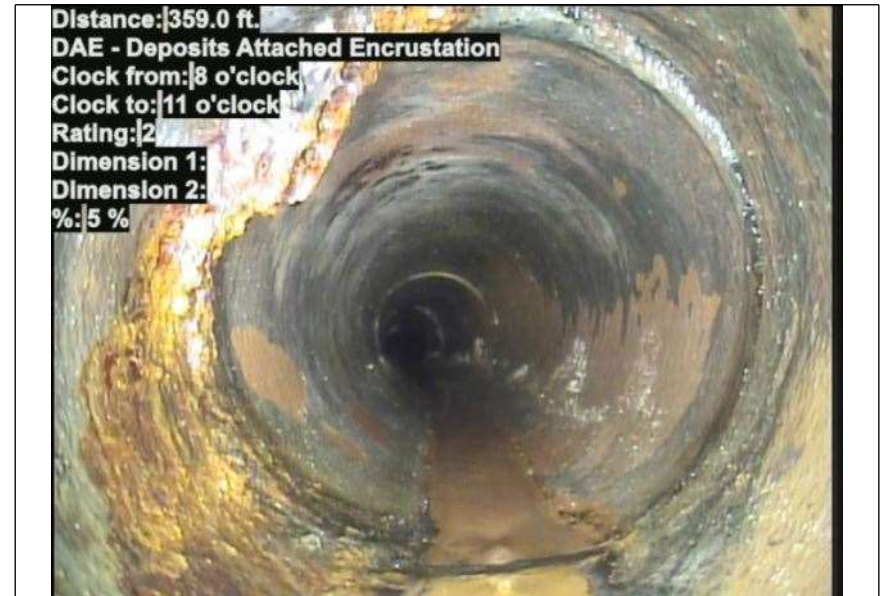
At: 359 ft. 8/11 DAE - Deposits Attached Encrustation
Joint: No 5 %

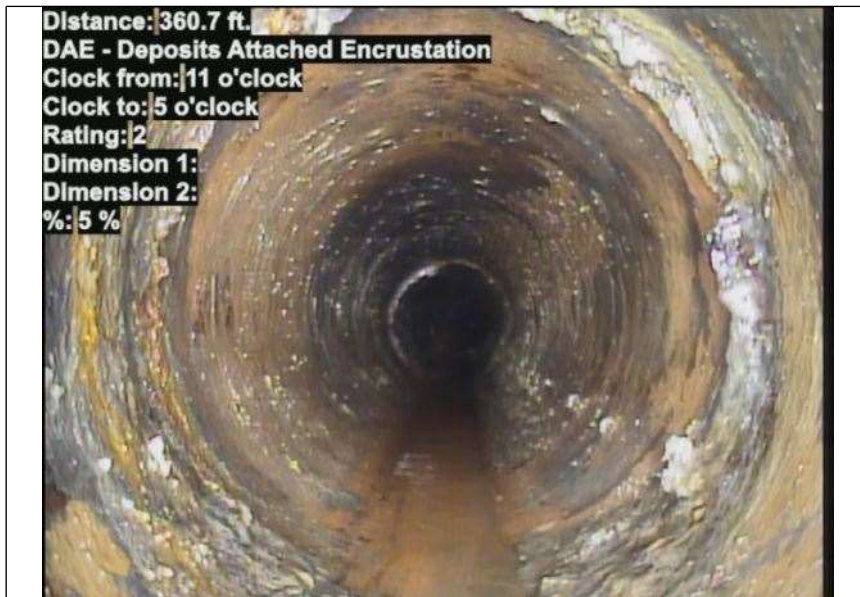
At: 360.7 ft. DAE - Deposits Attached Encrustation
11/5
Joint: No 5 %

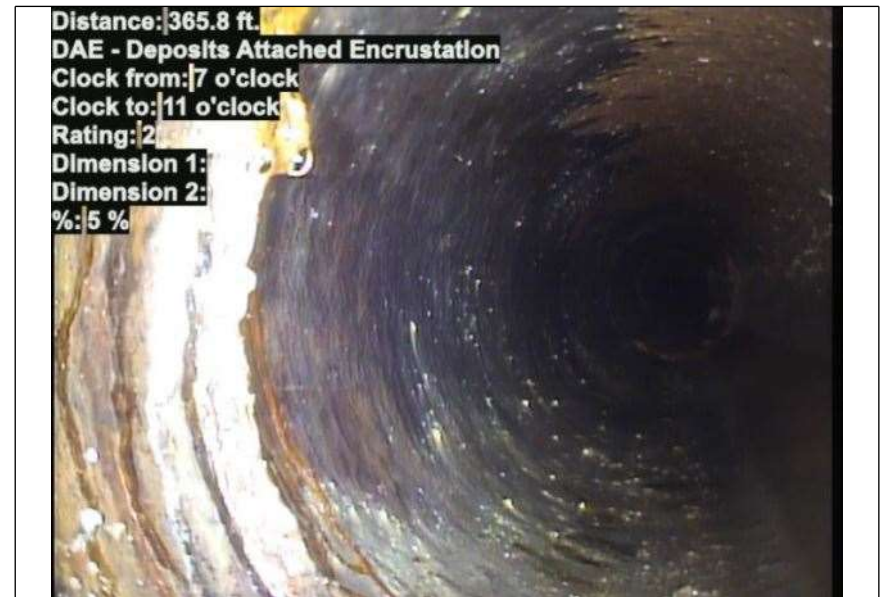
At: 365.8 ft. DAE - Deposits Attached Encrustation
7/11
Joint: No 5 %

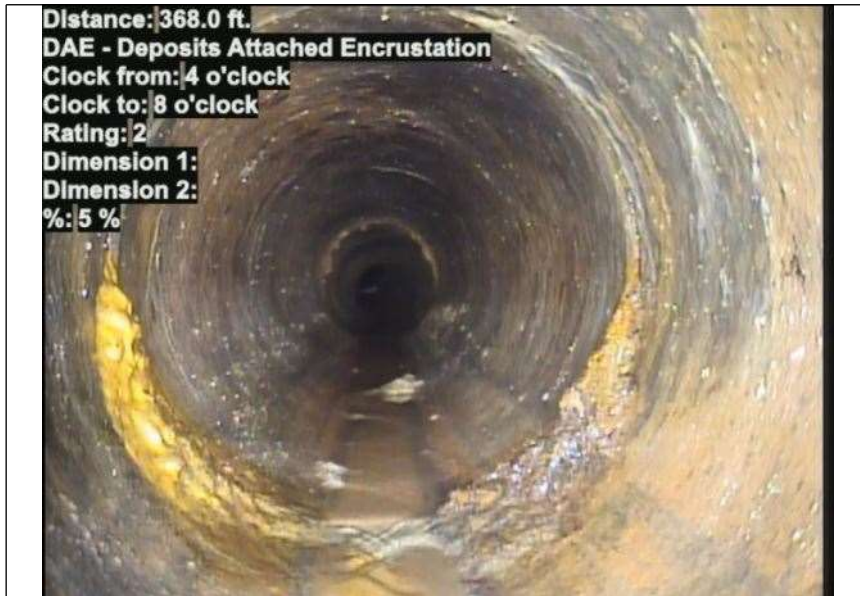
At: 368 ft. 4/8 DAE - Deposits Attached Encrustation
Joint: No 5 %

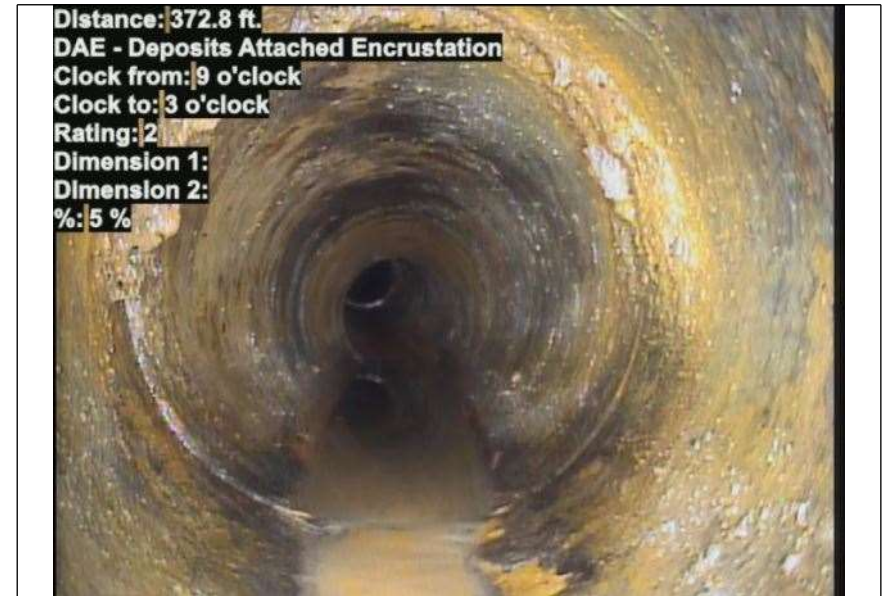
At: 372.8 ft. 9/3 DAE - Deposits Attached Encrustation
Joint: No 5 %
