PACP Report with Pipe Run and Incident Snapshots

Surveyed by: Mike Brooks	Certificate number: Mike Brooks	Owner:	Customer:	Drainage area:	P/O number:	Sheet number:
Pipe segment ref.: SMH121_SMH122	Start date/time: 20220413 13:57	Street: W MAIN ST		City: SMITHVILLE		
Location details: STREET		Upstream MH No: SMH121	Rim to invert:	Grade to invert:	Rim to grade:	
Pipe use: SS	Direction: U	Flow control:	Downstream MH No: SMH122	Rim to invert:	Grade to invert:	Rim to grade:
Height: 8 in.	Width:	Shape: C	Material: VCP	Lining method:	Pipe joint length:	Total length: 352.400 ft.
Media label:	PreCleaning: L	Date cleaned:	Weather: 1	Length surveyed: 352.400 ft.	Purpose:	Sewer category:
Project name: Sewer Cleaning & CCTV - Project No. 210670		Additional info:

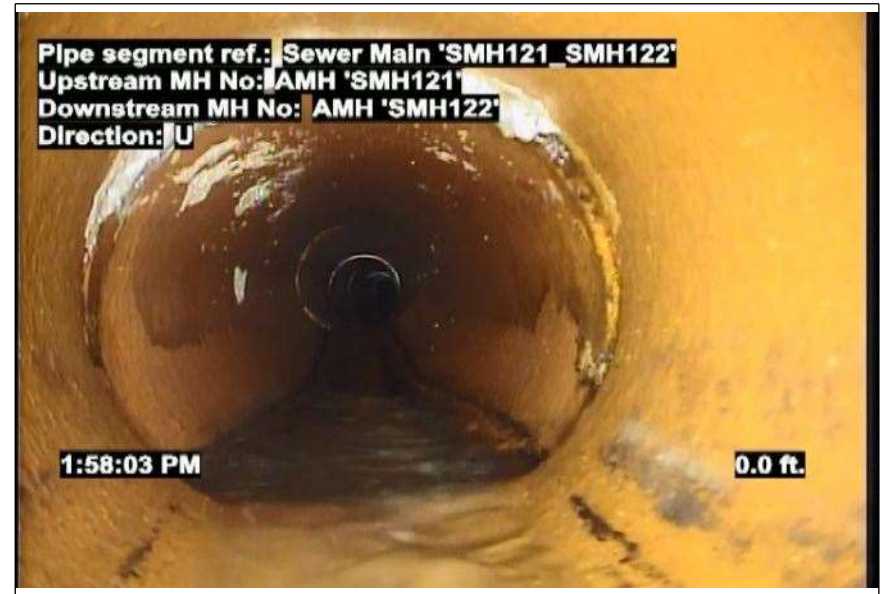
At: 0 ft. MWL - Miscellaneous Water Level
Joint: No 5 %

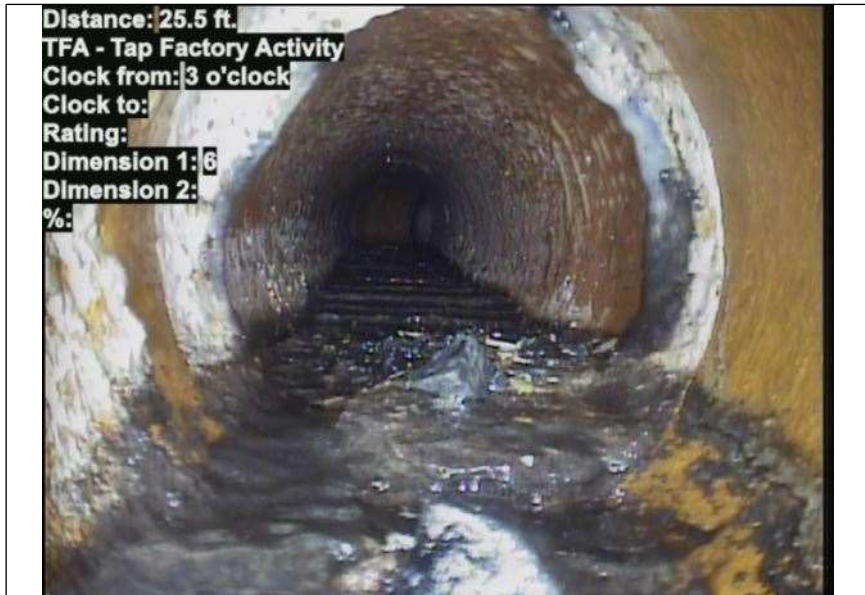
At: 25.5 ft. 3/. TFA - Tap Factory Activity
Joint: No

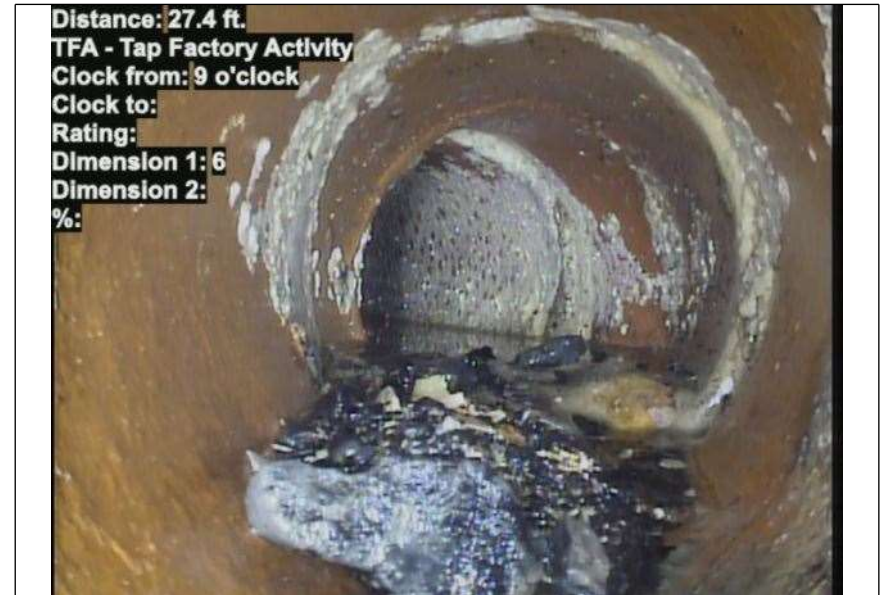
At: 27.4 ft. 9/. TFA - Tap Factory Activity
Joint: No

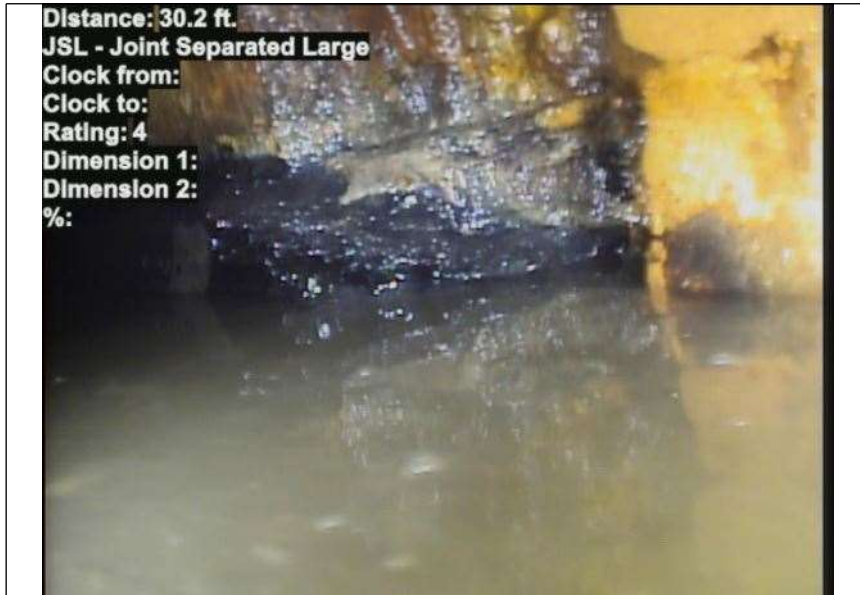
At: 30.2 ft. JSL - Joint Separated Large
Joint: No

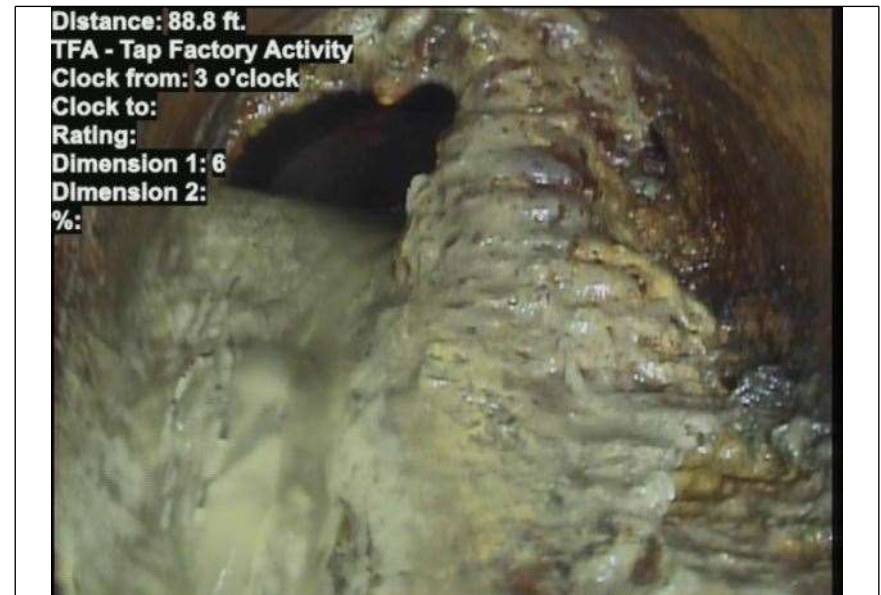
At: 88.8 ft. 3/. TFD - Tap Factory Defective
Joint: No DAE

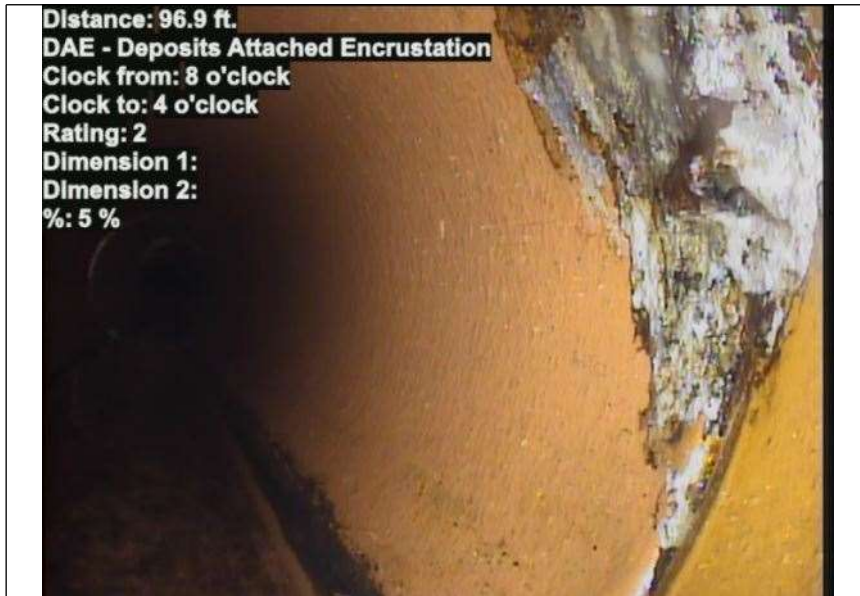
At: 96.9 ft. 8/4 DAE - Deposits Attached Encrustation
Joint: No 5 %

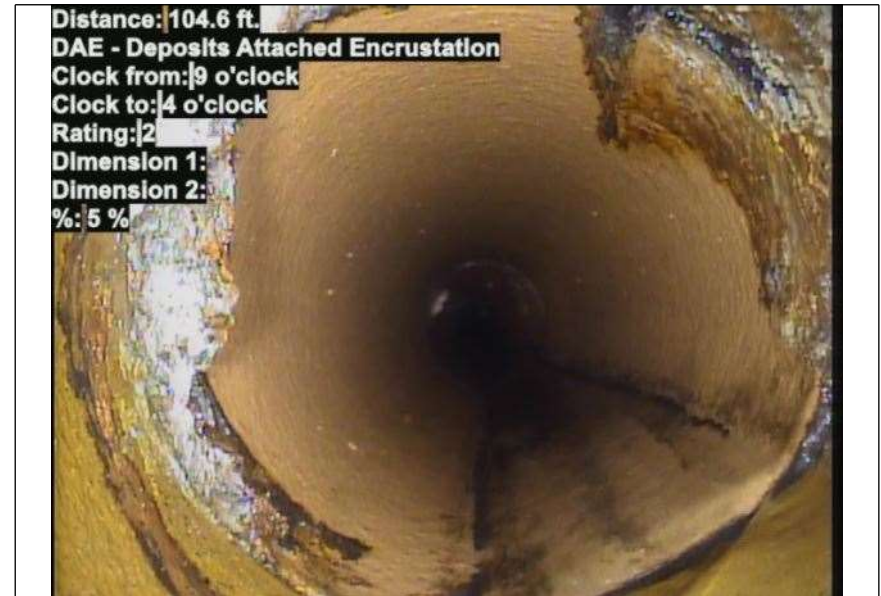
At: 104.6 ft. 9/4 DAE - Deposits Attached Encrustation
Joint: No 5 %

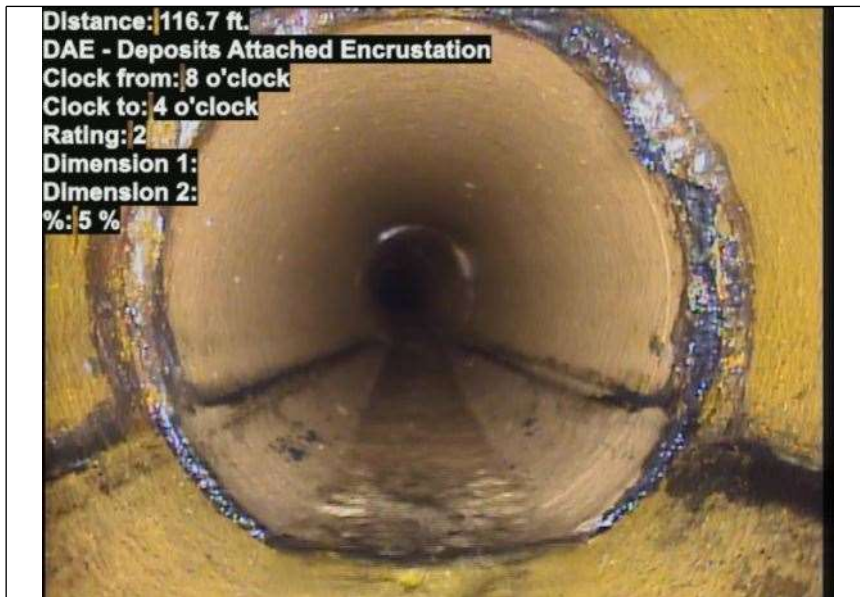
At: 116.7 ft. 8/4 DAE - Deposits Attached Encrustation
Joint: No 5 %

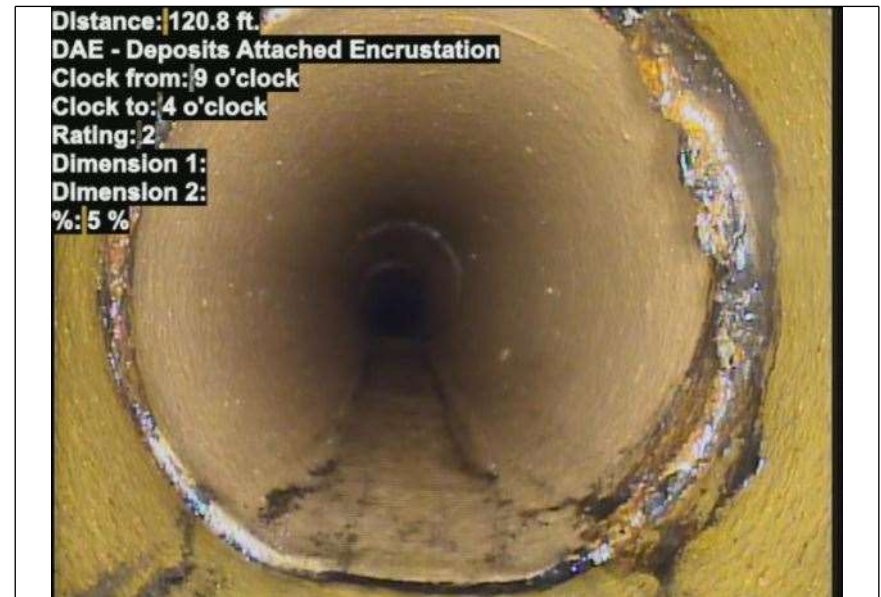
At: 120.8 ft. 9/4 DAE - Deposits Attached Encrustation
Joint: No 5 %

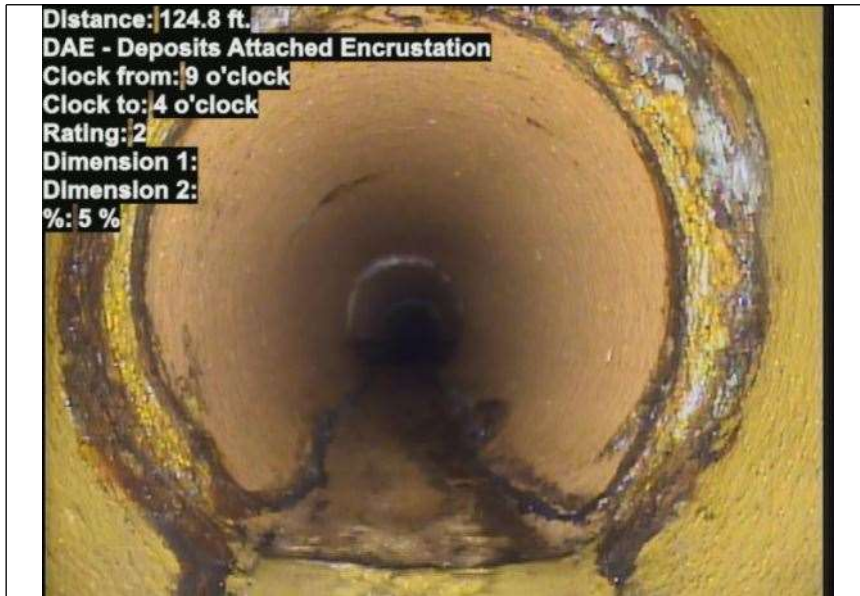
At: 124.8 ft. 9/4 DAE - Deposits Attached Encrustation
Joint: No 5 %

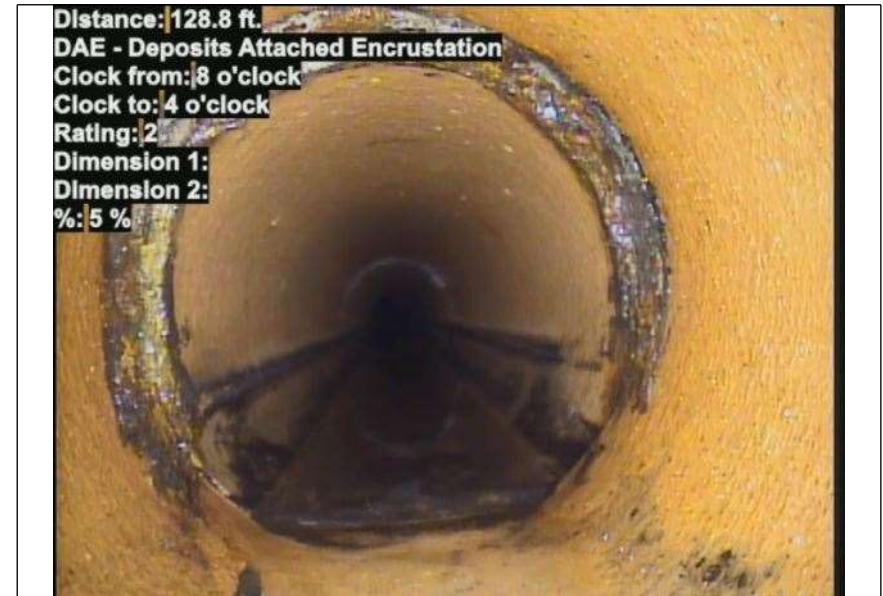
At: 128.8 ft. 8/4 DAE - Deposits Attached Encrustation
Joint: No 5 %

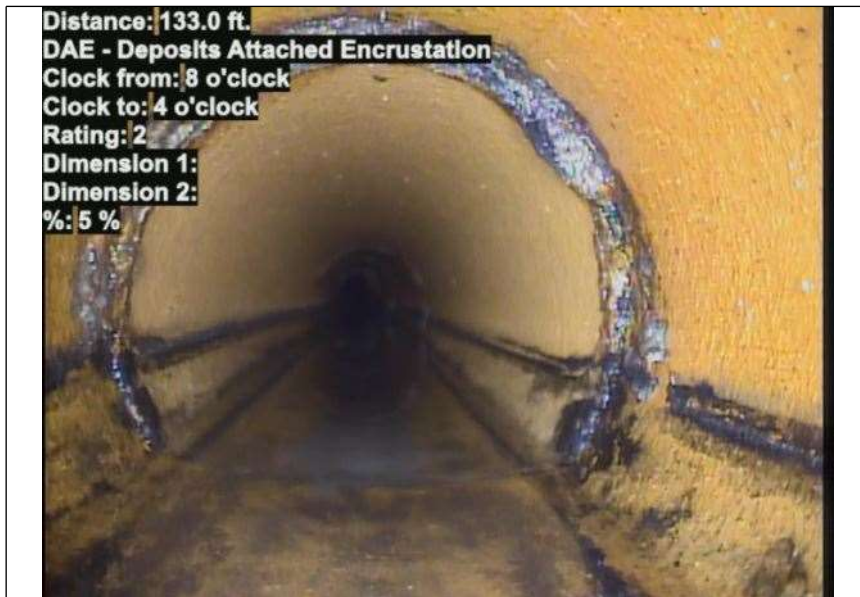
At: 133 ft. 8/4 DAE - Deposits Attached Encrustation
Joint: No 5 %

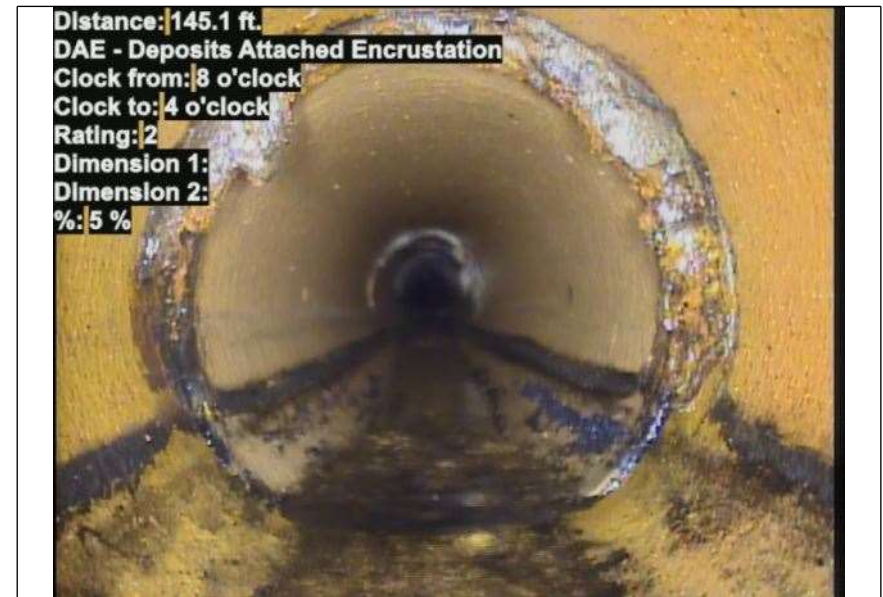
At: 145.1 ft. 8/4 DAE - Deposits Attached Encrustation
Joint: No 5 %

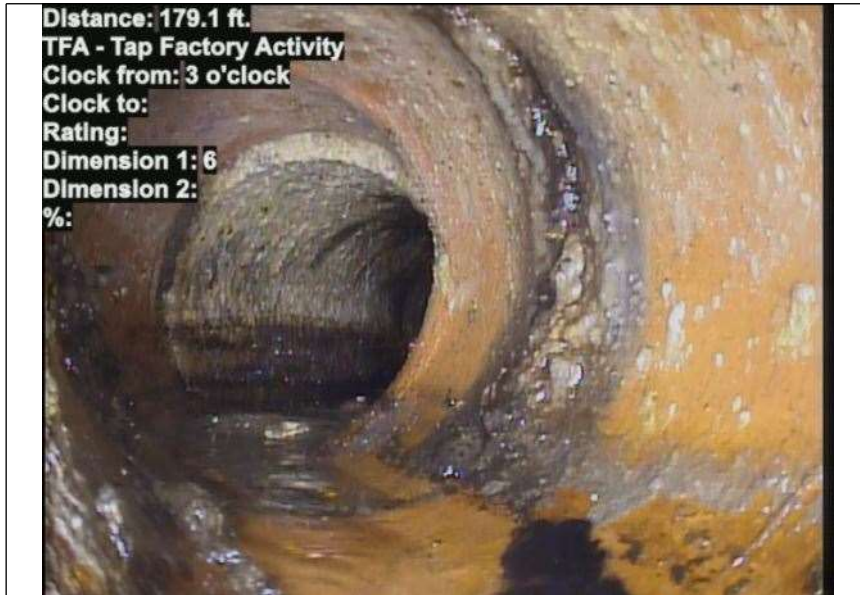
At: 179.1 ft. 3/. TFA - Tap Factory Activity
Joint: No

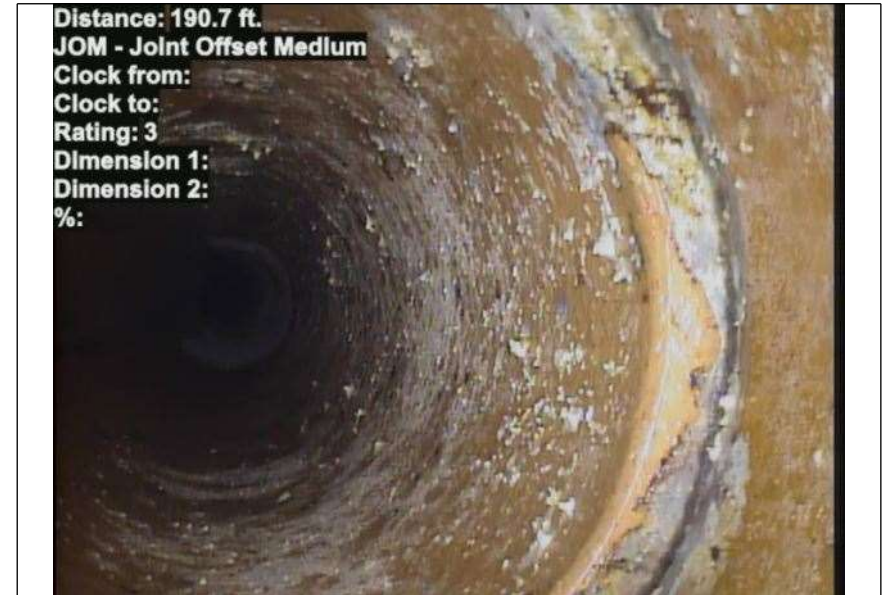
At: 190.7 ft. JOM - Joint Offset Medium
Joint: No

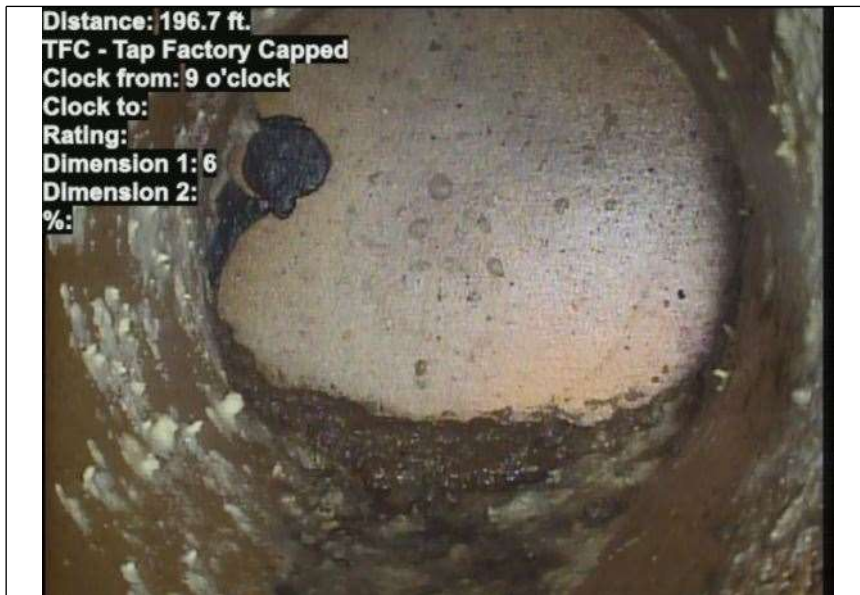
At: 196.7 ft. 9/. TFC - Tap Factory Capped
Joint: No

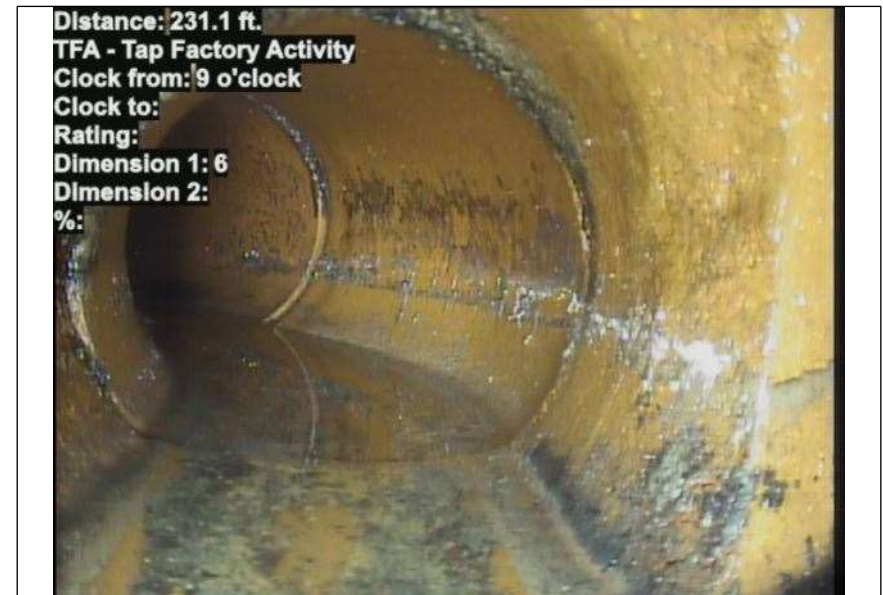
At: 231.1 ft. 9/. TFA - Tap Factory Activity
Joint: No

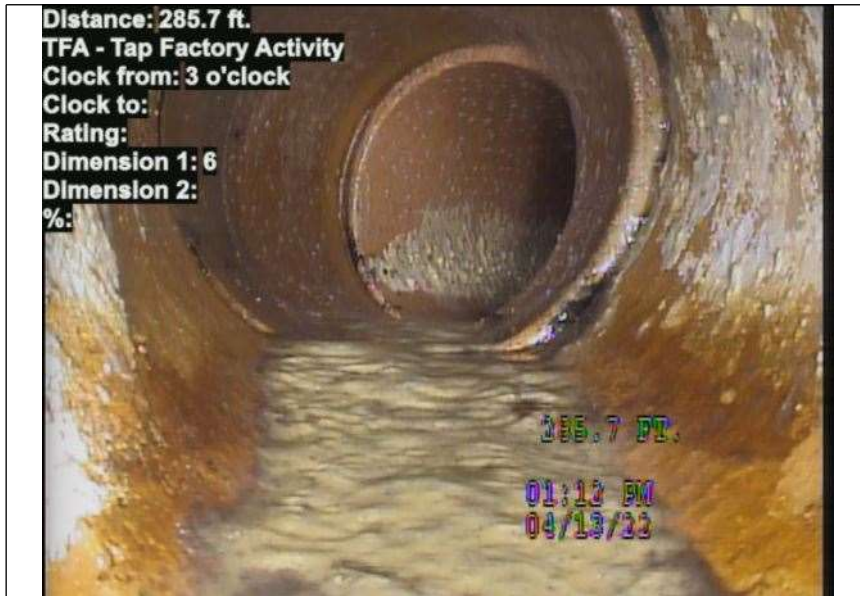
At: 285.7 ft. 3/. TFA - Tap Factory Activity
Joint: No

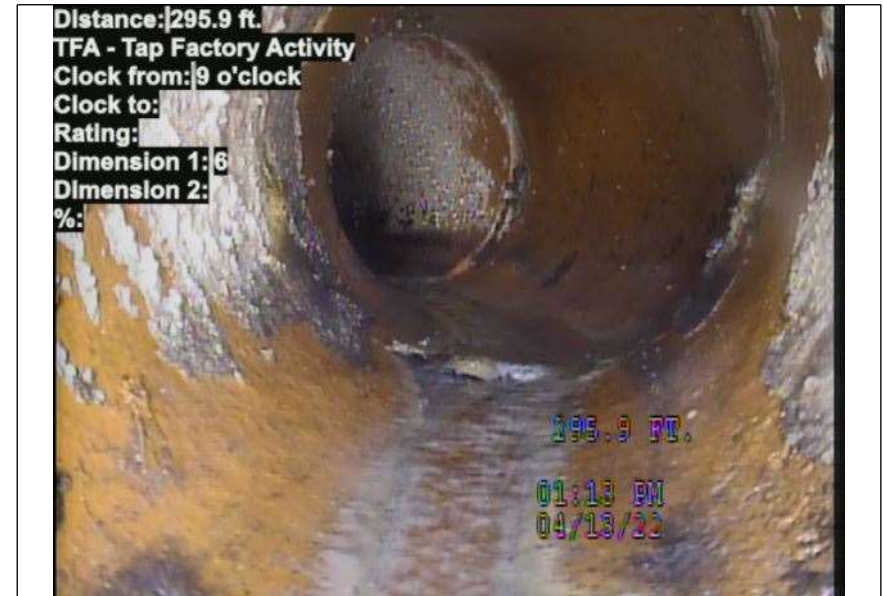
At: 295.9 ft. 9/. TFA - Tap Factory Activity
Joint: No

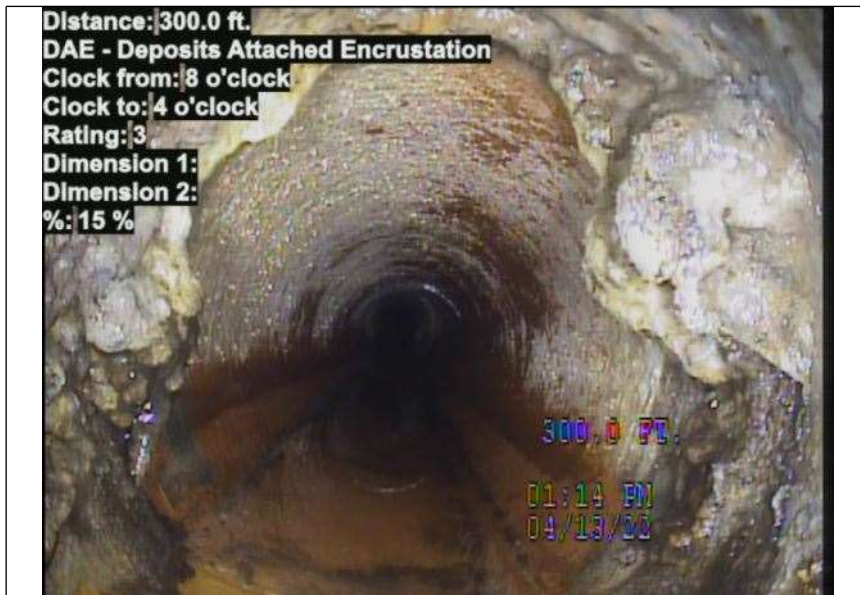
At: 300 ft. 8/4 DAE - Deposits Attached Encrustation
Joint: No 15 %

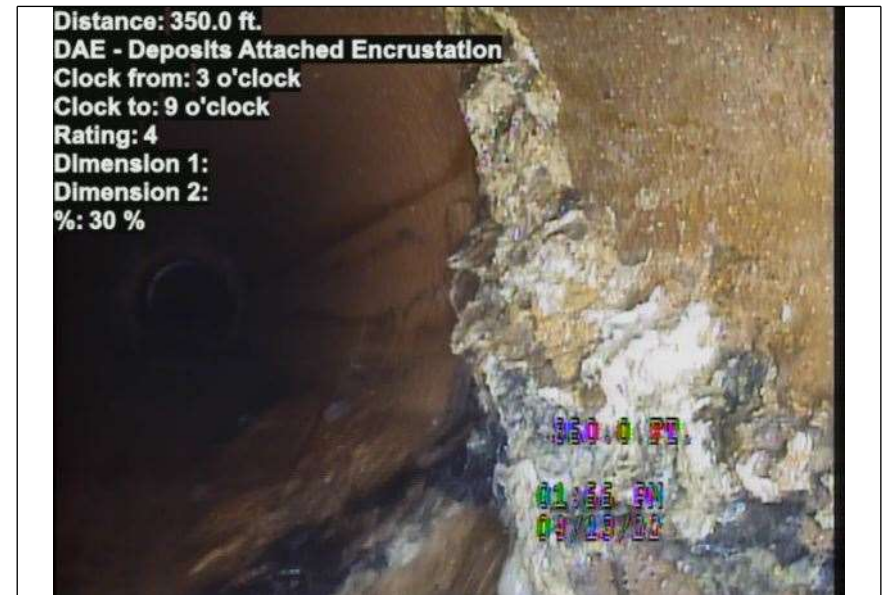
At: 350 ft. 3/9 DAE - Deposits Attached Encrustation
Joint: No 30 %

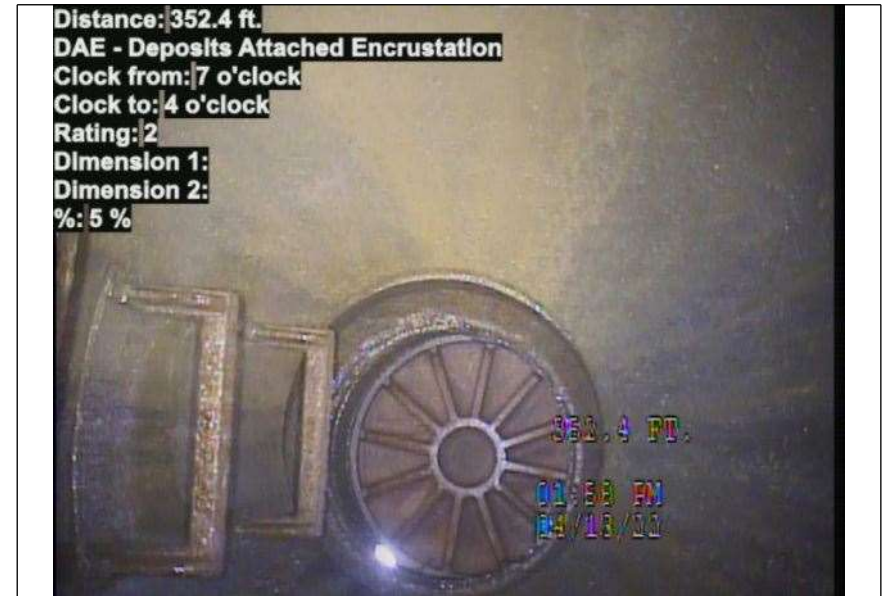
At: 352.4 ft. 7/4 DAE - Deposits Attached Encrustation
Joint: No 5 %
