PACP Report with Pipe Run and Incident Snapshots

Surveyed by: Mike Brooks	Certificate number: Mike Brooks	Owner:	Customer:	Drainage area:	P/O number:	Sheet number:
Pipe segment ref.: SMH122_SMH123	Start date/time: 20220414 09:19	Street: W MAIN ST		City: SMITHVILLE		
Location details: STREET		Upstream MH No: SMH122	Rim to invert:	Grade to invert:	Rim to grade:	
Pipe use: SS	Direction: D	Flow control:	Downstream MH No: SMH123	Rim to invert:	Grade to invert:	Rim to grade:
Height: 8 in.	Width:	Shape: C	Material: VCP	Lining method:	Pipe joint length:	Total length: 405.100 ft.
Media label:	PreCleaning: L	Date cleaned:	Weather: 3	Length surveyed: 405.100 ft.	Purpose:	Sewer category:
Project name: Sewer Cleaning & CCTV - Project No. 210670		Additional info:

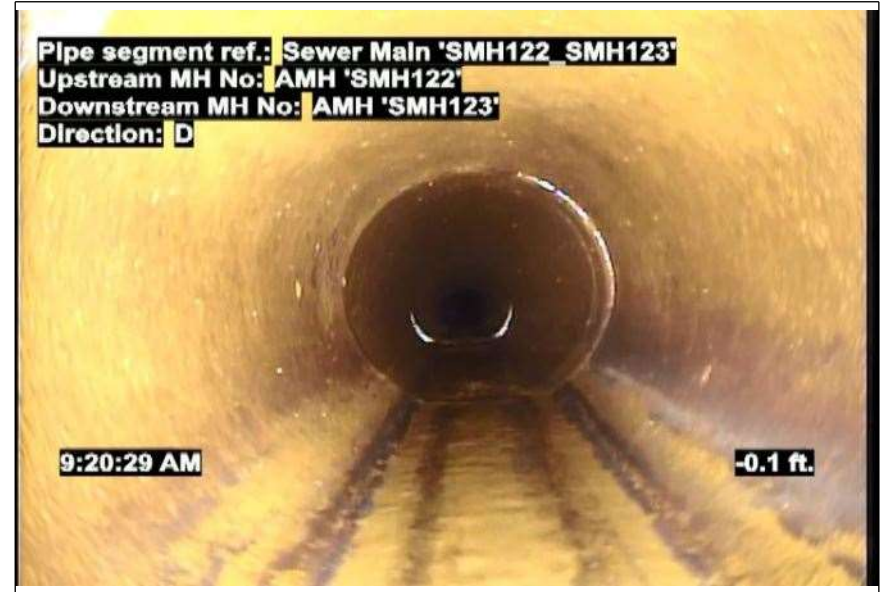
At: 0 ft. MWL - Miscellaneous Water Level
Joint: No 5%

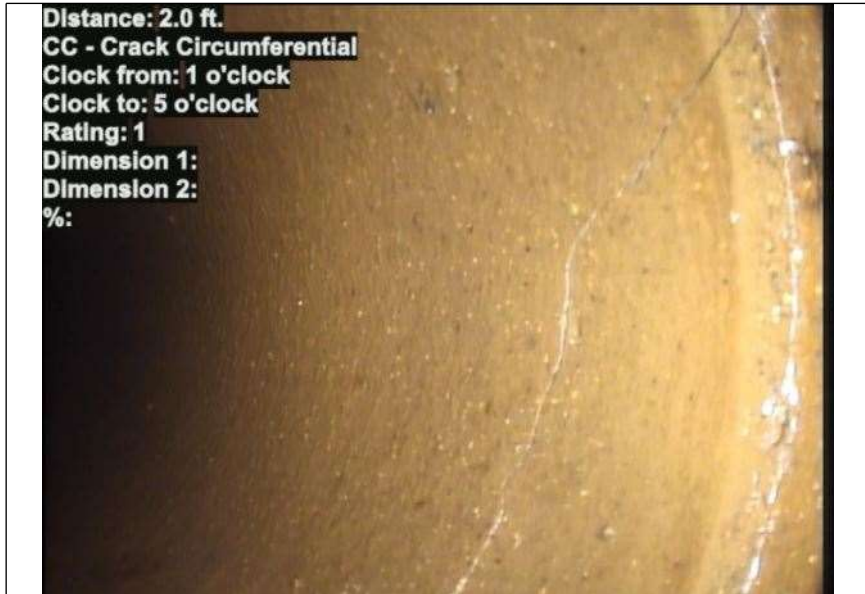
2.0 ft.	00:00:31	CC						<input type="checkbox"/>	1 / 5		1	SMH122_SMH123_CC _2.0 ft.JPG	
36.1 ft.	00:06:05	TF			6.000			<input type="checkbox"/>	9 /			SMH122_SMH123_TF _36.1 ft.JPG

At: 2 ft. 1/5 CC - Crack Circumferential
Joint: No

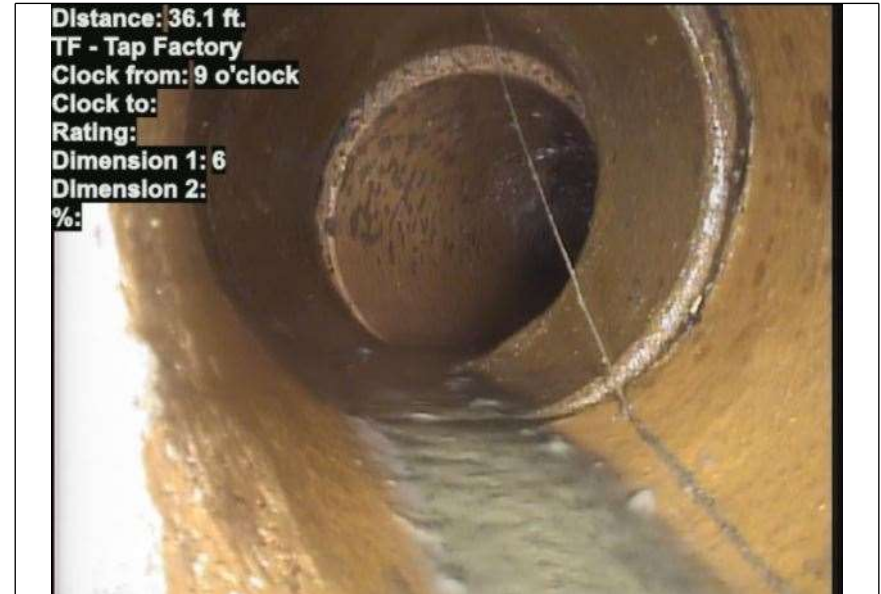
At: 36.1 ft. 9/ TF - Tap Factory
Joint: No

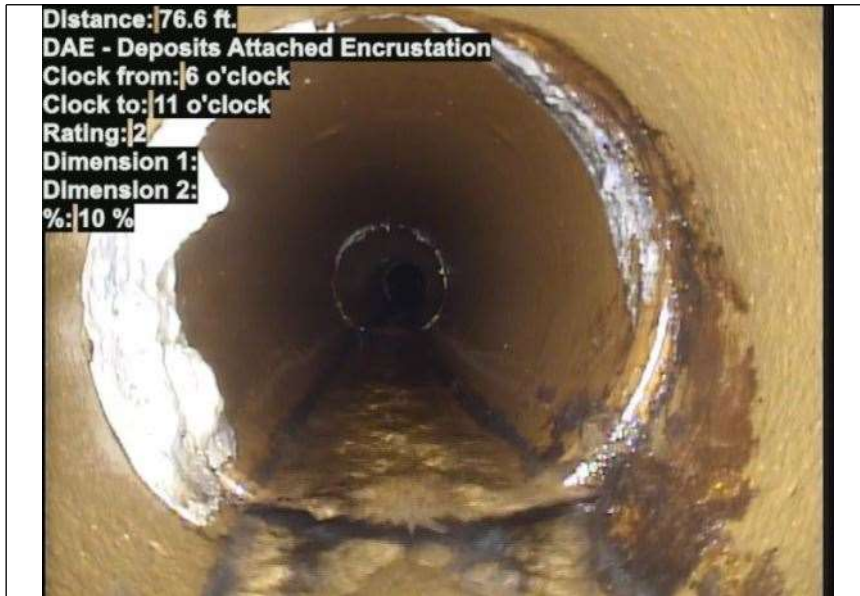
76.6 ft.	00:09:25	DAE					10	<input type="checkbox"/>	6 / 11		2	SMH122_SMH123_DA E_76.6 ft.JPG	
80.5 ft.	00:09:50	DAE					5	<input type="checkbox"/>	8 / 4		2	SMH122_SMH123_DA E_80.5 ft.JPG

At: 76.6 ft. 6/11 DAE - Deposits Attached Encrustation
Joint: No 10 %

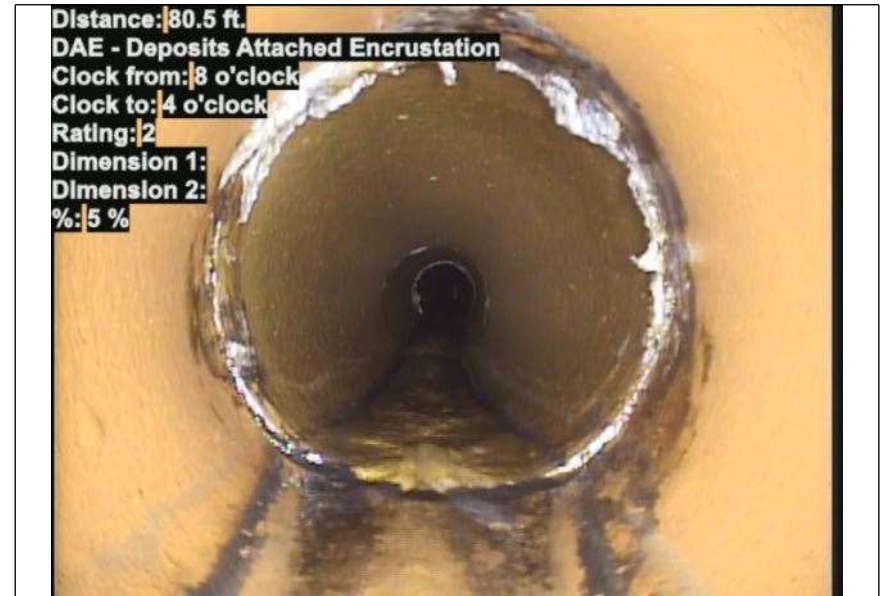
At: 80.5 ft. 8/4 DAE - Deposits Attached Encrustation
Joint: No 5 %

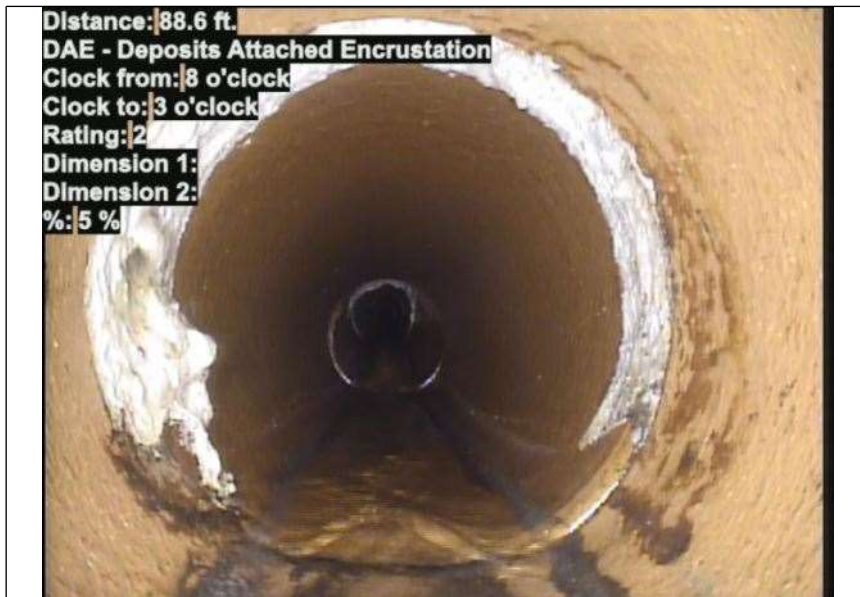
88.6 ft.	00:10:28	DAE					5	<input type="checkbox"/>	8 / 3		2	SMH122_SMH123_DA E_88.6 ft.JPG	
104.7 ft.	00:11:14	DAE					5	<input type="checkbox"/>	10 / 4		2	SMH122_SMH123_DA E_104.7 ft.JPG

At: 88.6 ft. 8/3 DAE - Deposits Attached Encrustation
Joint: No 5 %

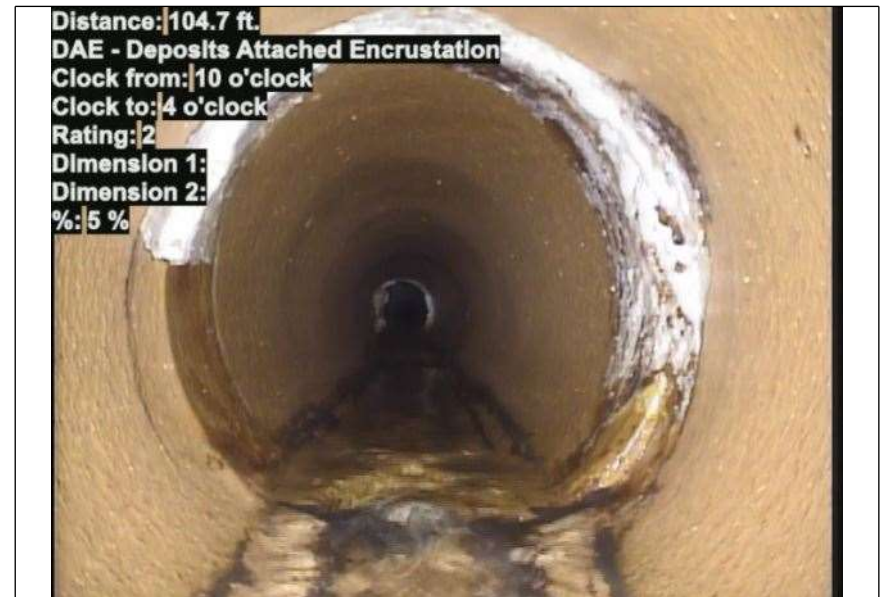
At: 104.7 ft. 10/4 DAE - Deposits Attached Encrustation
Joint: No 5 %

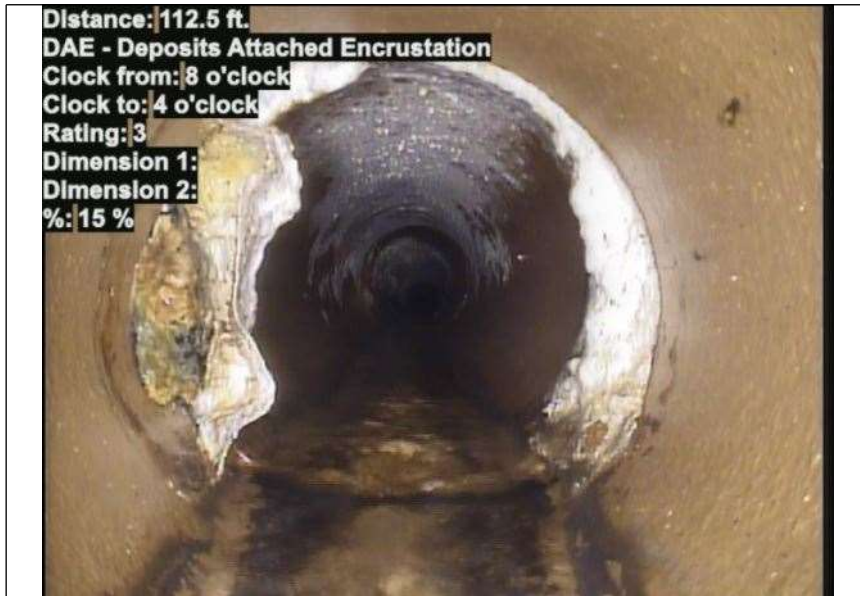
112.5 ft.	00:12:03	DAE					15	<input type="checkbox"/>	8 / 4		3	SMH122_SMH123_DA E_112.5 ft.JPG	
117.8 ft.	00:01:28	DAE					10	<input type="checkbox"/>	8 / 4		2	SMH122_SMH123_DA E_117.8 ft.JPG

At: 112.5 ft. 8/4 DAE - Deposits Attached Encrustation
Joint: No 15 %

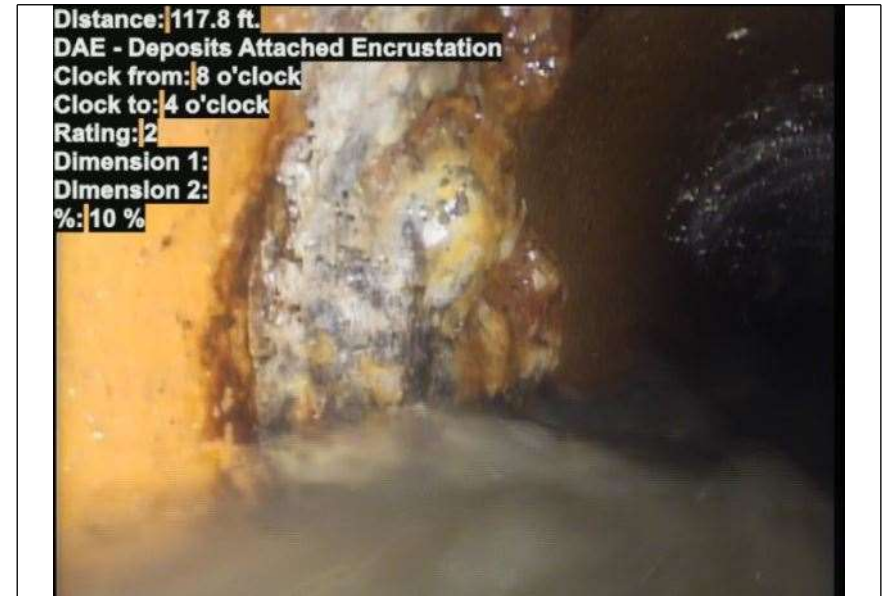
At: 117.8 ft. 8/4 DAE - Deposits Attached Encrustation
Joint: No 10 %

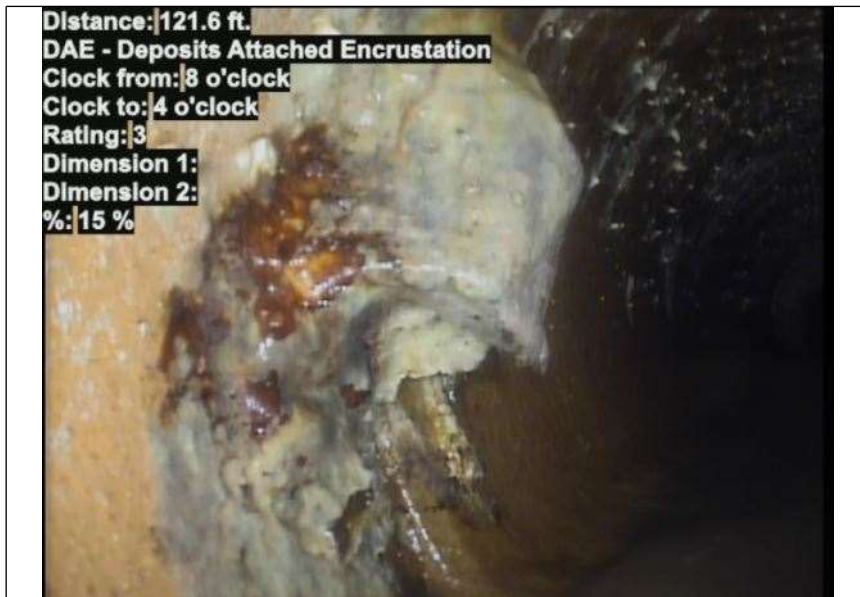
121.6 ft.	00:03:34	DAE					15	<input type="checkbox"/>	8 / 4		3	SMH122_SMH123_DA E_121.6 ft.JPG	
126.7 ft.	00:05:48	TFA			6.000			<input type="checkbox"/>	9 /			SMH122_SMH123_TF A_126.7 ft.JPG

At: 121.6 ft. 8/4 DAE - Deposits Attached Encrustation
Joint: No 15 %

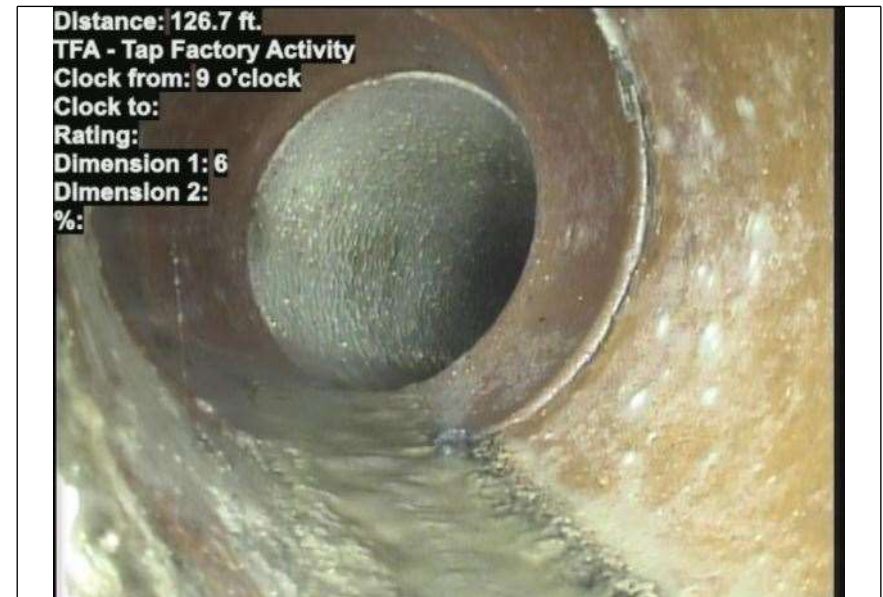
At: 126.7 ft. 9/. TFA - Tap Factory Activity
Joint: No

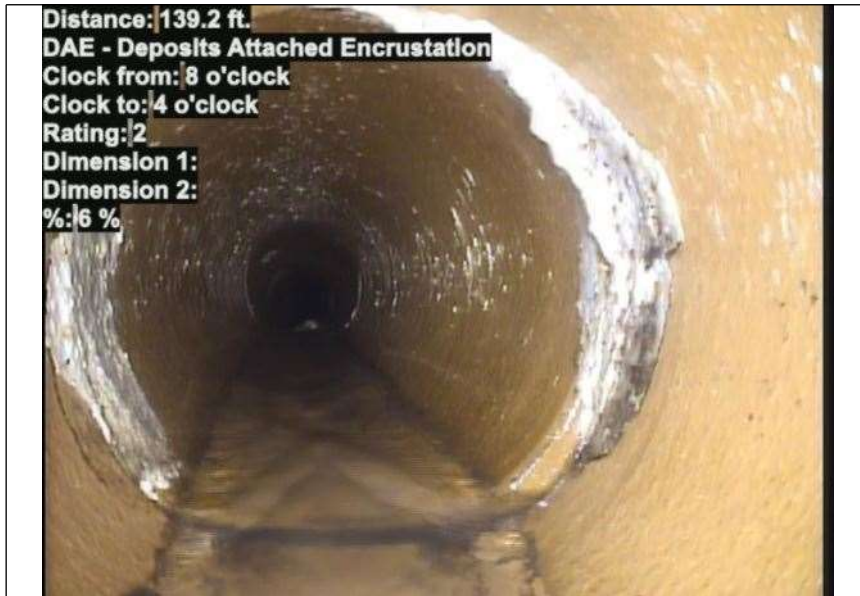
139.2 ft.	00:06:50	DAE					6	<input type="checkbox"/>	8 / 4		2	SMH122_SMH123_DA E_139.2 ft.JPG	
148.9 ft.	00:12:02	DAE					5	<input type="checkbox"/>	8 / 4		2	SMH122_SMH123_DA E_148.9 ft.JPG

At: 139.2 ft. 8/4 DAE - Deposits Attached Encrustation
Joint: No 6 %

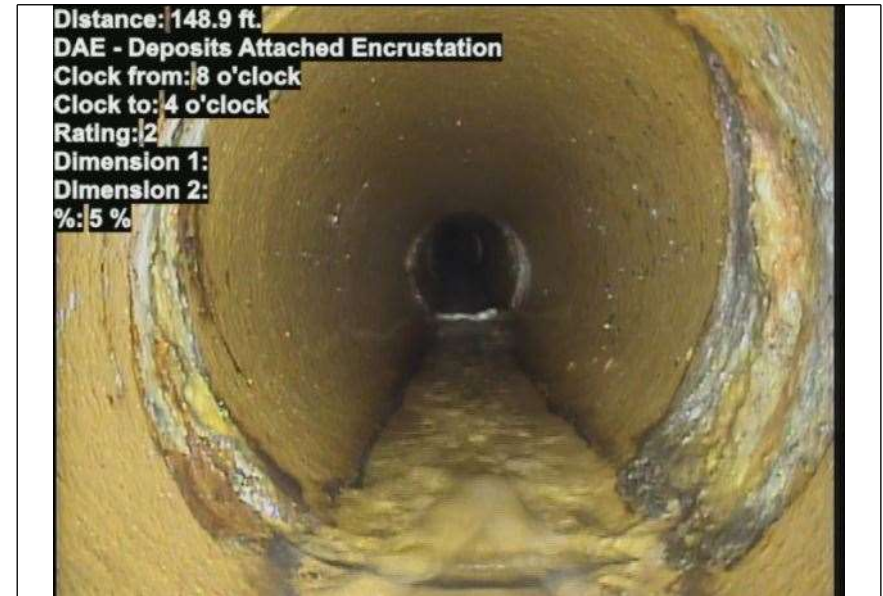
At: 148.9 ft. 8/4 DAE - Deposits Attached Encrustation
Joint: No 5 %

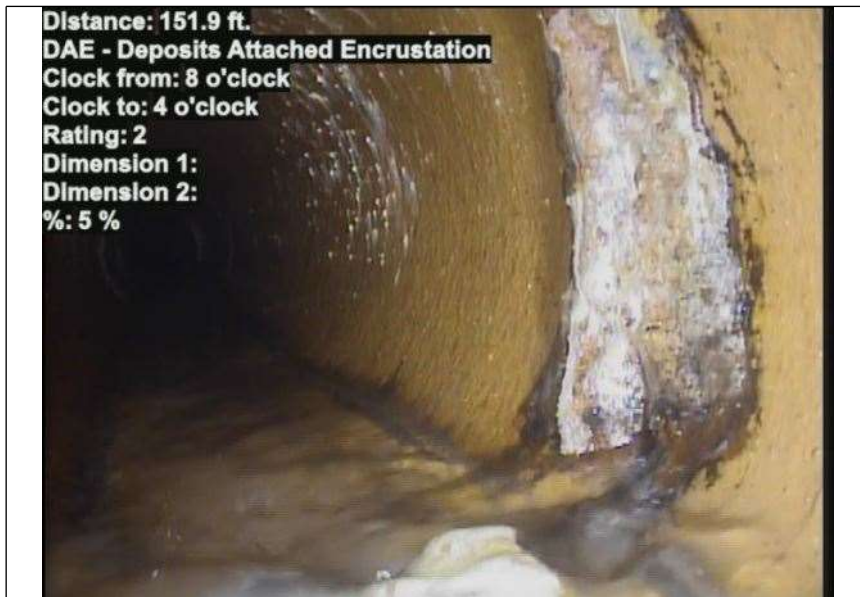
151.9 ft.	00:02:47	DAE					5	<input type="checkbox"/>	8 / 4		2	SMH122_SMH123_DA E_151.9 ft.JPG

At: 151.9 ft. 8/4 DAE - Deposits Attached Encrustation
Joint: No 5 %

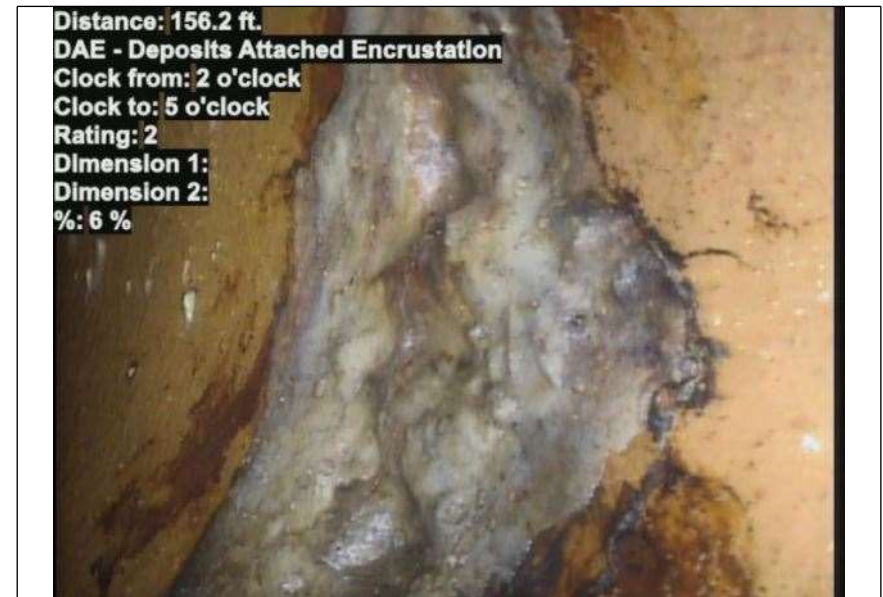
156.2 ft.	00:05:57	DAE					6	<input type="checkbox"/>	2 / 5		2	SMH122_SMH123_DAE_156.2 ft.JPG	
159.8 ft.	00:06:45	TBA			6.000			<input type="checkbox"/>	3 /			SMH122_SMH123_TBA_159.8 ft.JPG

At: 156.2 ft. 2/5 DAE - Deposits Attached Encrustation
Joint: No 6 %

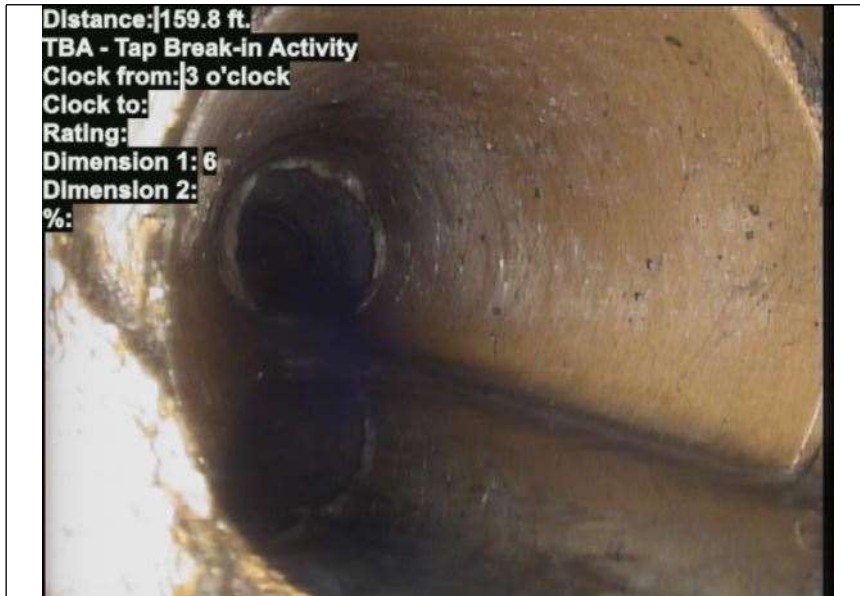
At: 159.8 ft. 3/. TBA - Tap Break-in Activity
Joint: No

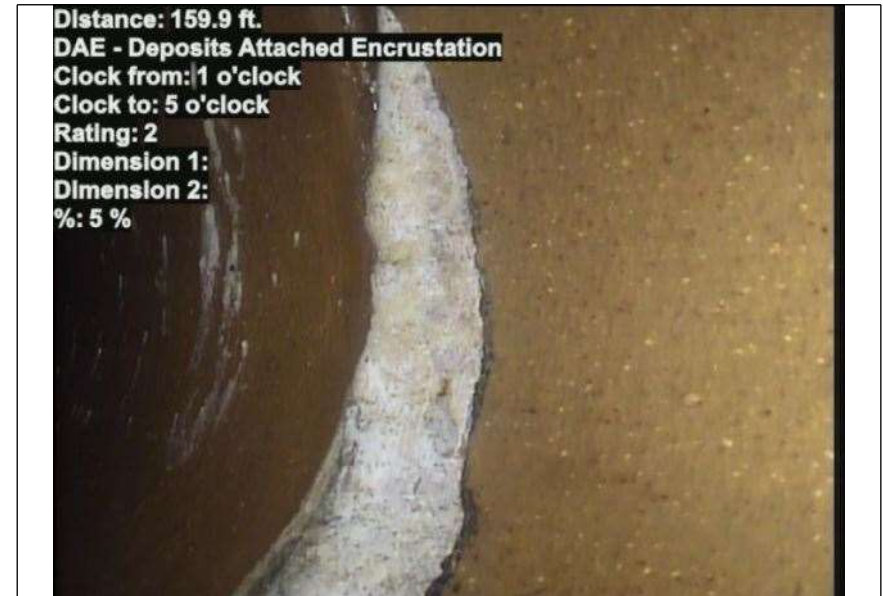
159.9 ft.	00:07:23	DAE					5	<input type="checkbox"/>	1 / 5		2	SMH122_SMH123_DAE_159.9 ft.JPG	
169.2 ft.	00:07:59	TFC			6.000			<input type="checkbox"/>	3 /			SMH122_SMH123_TFC_169.2 ft.JPG

At: 159.9 ft. 1/5 DAE - Deposits Attached Encrustation
Joint: No 5 %

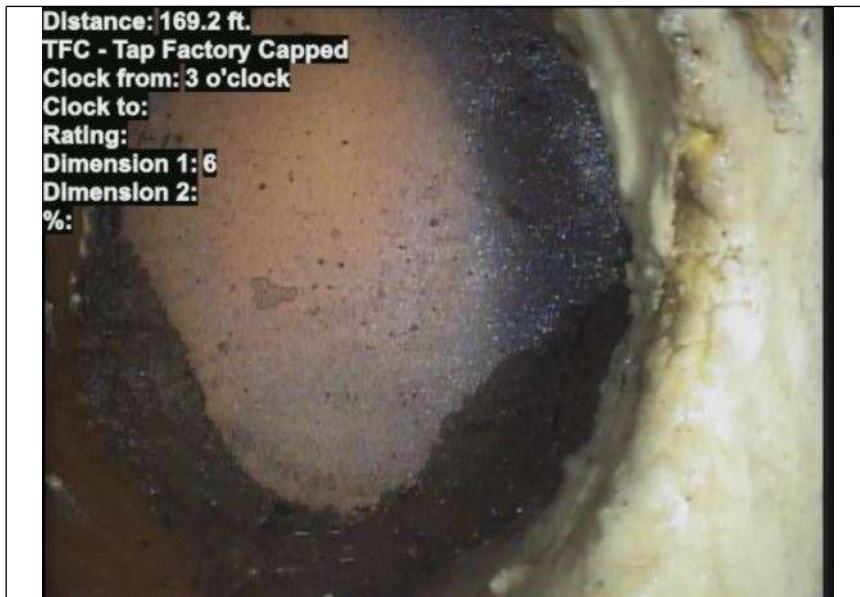
At: 169.2 ft. 3/. TFC - Tap Factory Capped
Joint: No

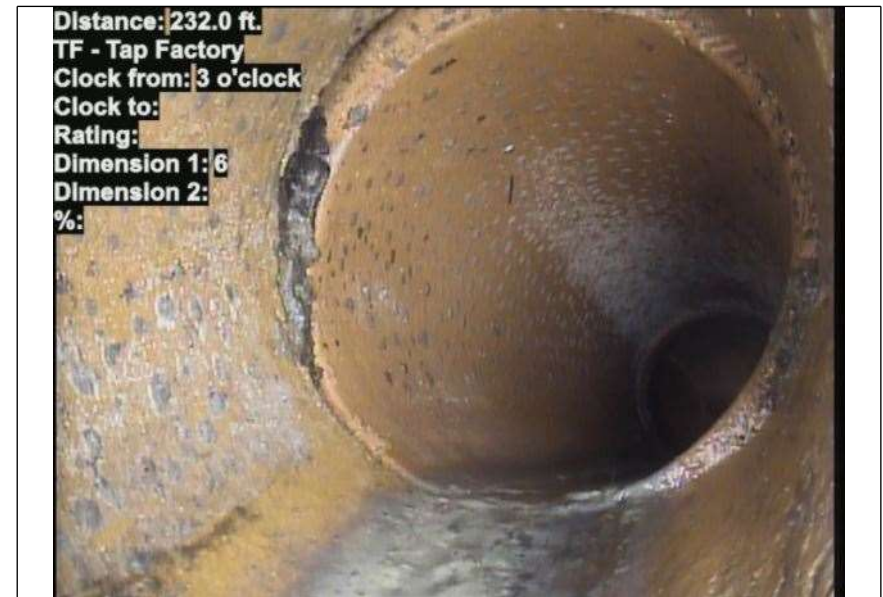
At: 232 ft. 3/. TF - Tap Factory
Joint: No

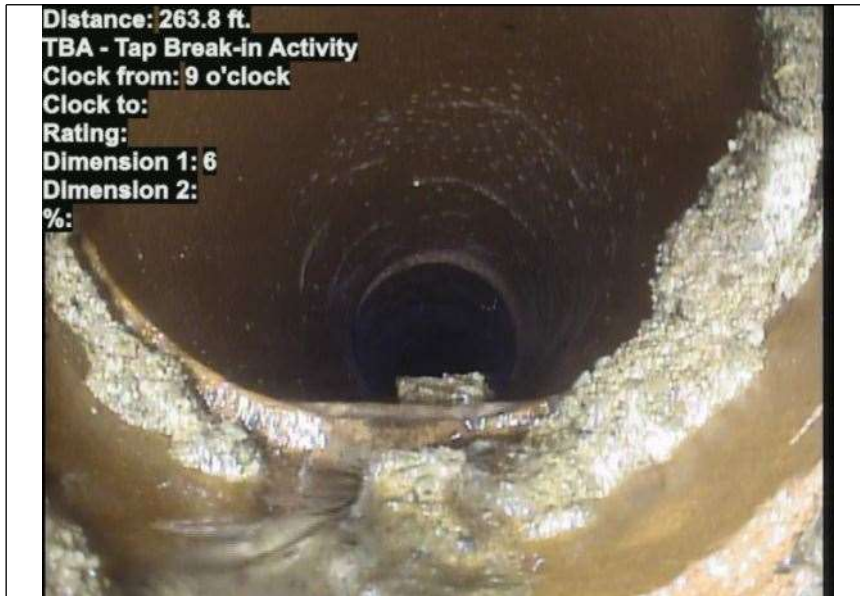
At: 263.8 ft. 9/. TBA - Tap Break-in Activity
Joint: No

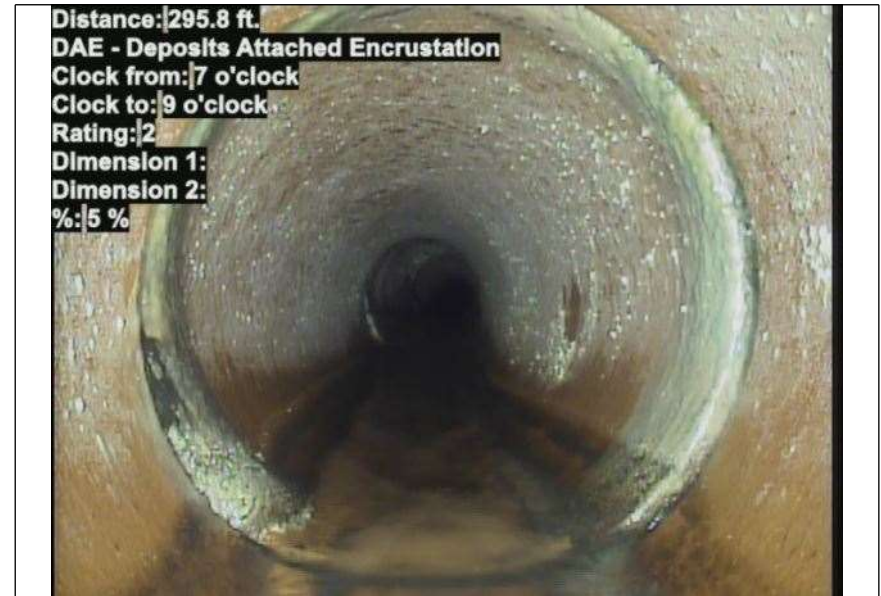
295.8 ft.	00:02:29	DAE					5	<input type="checkbox"/>	7 / 9		2	SMH122_SMH123_DAE_295.8 ft.JPG	
305.9 ft.	00:03:23	DAE					5	<input type="checkbox"/>	7 / 11		2	SMH122_SMH123_DAE_305.9 ft.JPG

At: 295.8 ft. 7/9 DAE - Deposits Attached Encrustation
Joint: No 5 %

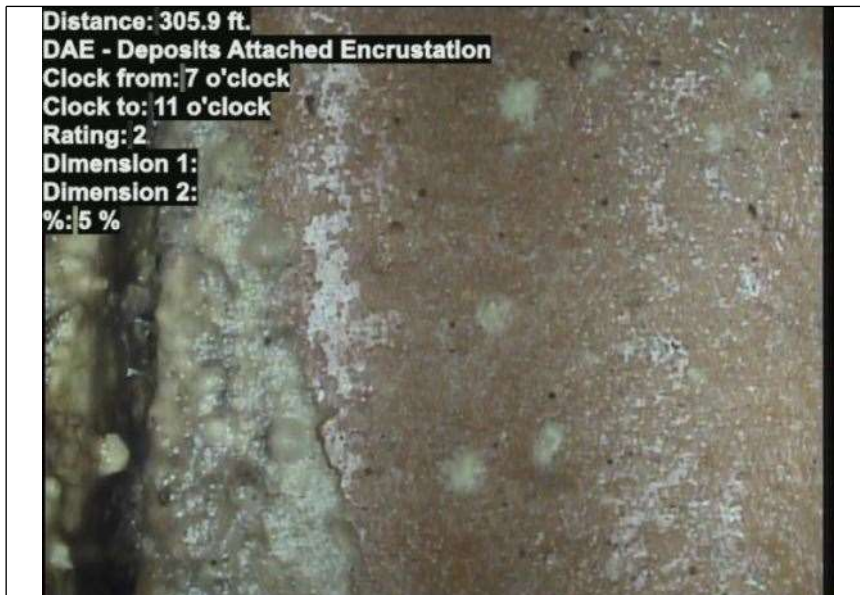
At: 305.9 ft. 7/11 DAE - Deposits Attached Encrustation
Joint: No 5 %

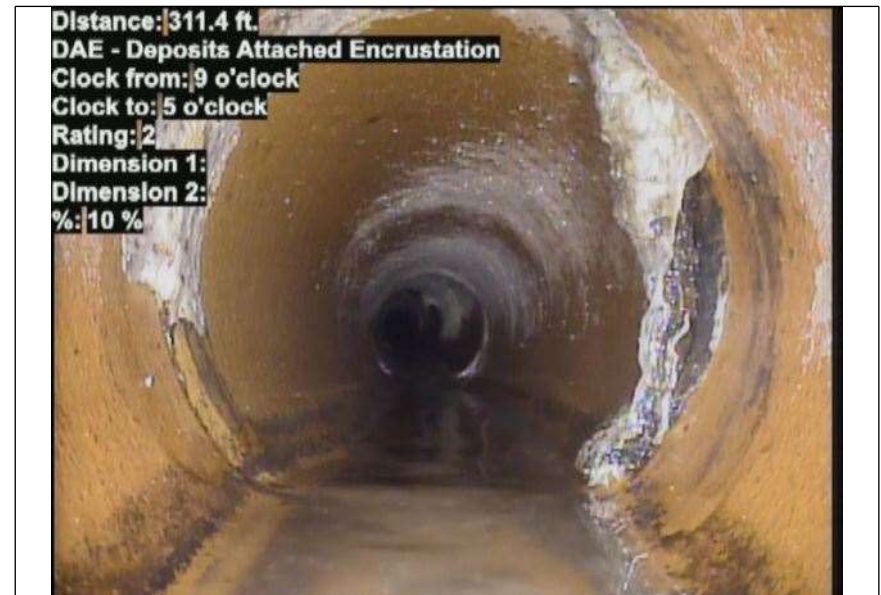
311.4 ft.	00:04:03	DAE					10	<input type="checkbox"/>	9 / 5		2	SMH122_SMH123_DAE_311.4 ft.JPG	
320.2 ft.	00:10:23	DAE					5	<input type="checkbox"/>	1 / 2		2	SMH122_SMH123_DAE_320.2 ft.JPG

At: 311.4 ft. 9/5 DAE - Deposits Attached Encrustation
Joint: No 10 %

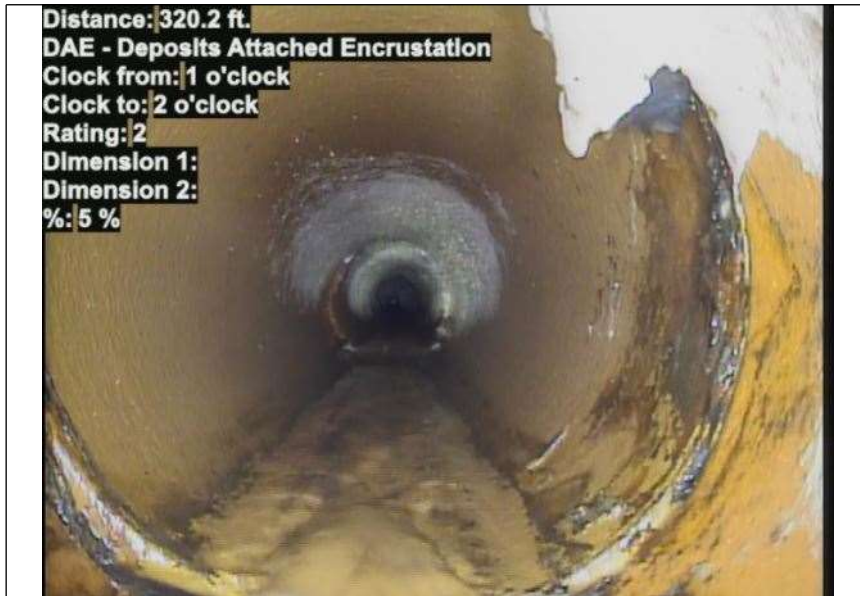
At: 320.2 ft. 1/2 DAE - Deposits Attached Encrustation
Joint: No 5 %

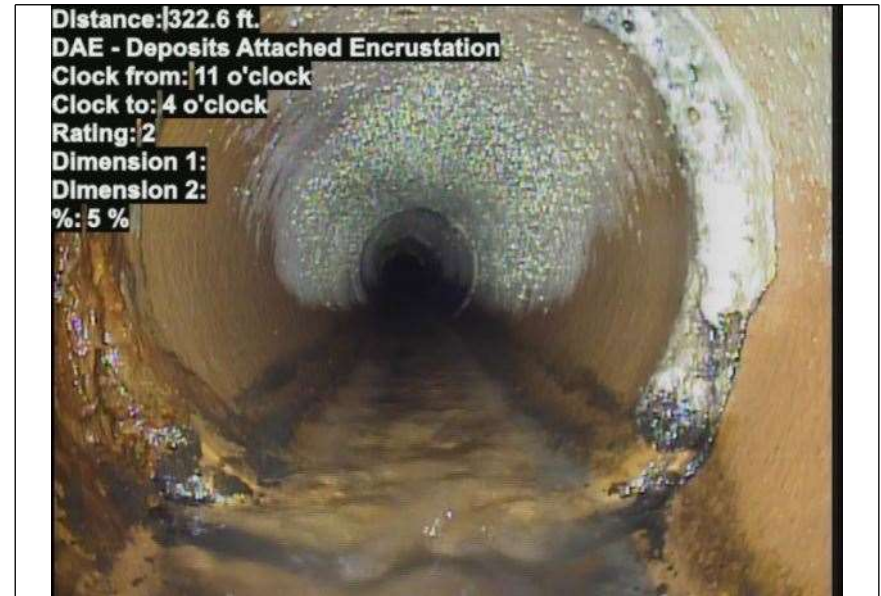
322.6 ft.	00:10:42	DAE					5	<input type="checkbox"/>	11 / 4		2	SMH122_SMH123_DAE_322.6 ft.JPG	
333.4 ft.	00:11:19	DAE	S01				5	<input type="checkbox"/>	8 / 4		2	SMH122_SMH123_DAE_333.4 ft.JPG

At: 322.6 ft. 11/4 DAE - Deposits Attached Encrustation
Joint: No 5 %

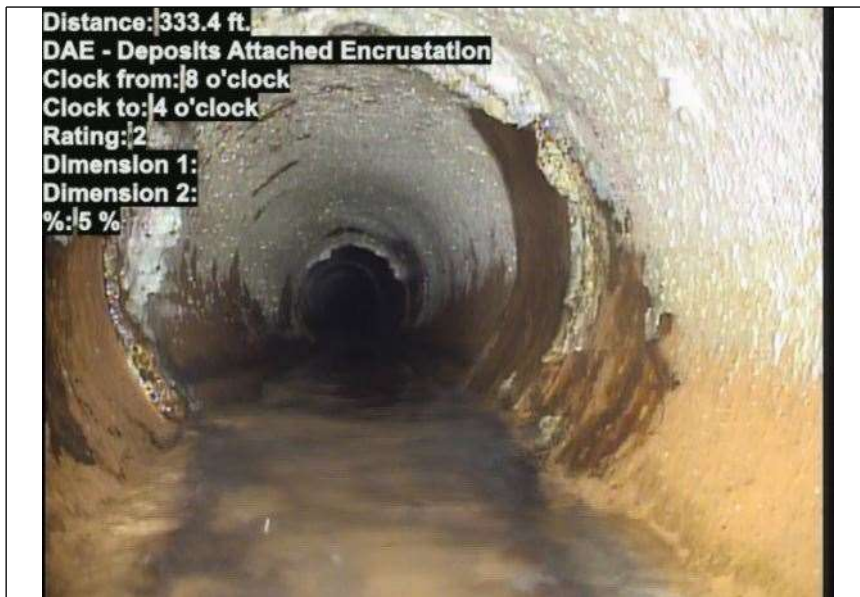
At: 333.4 ft. 8/4 DAE - Deposits Attached Encrustation
Joint: No 5 %

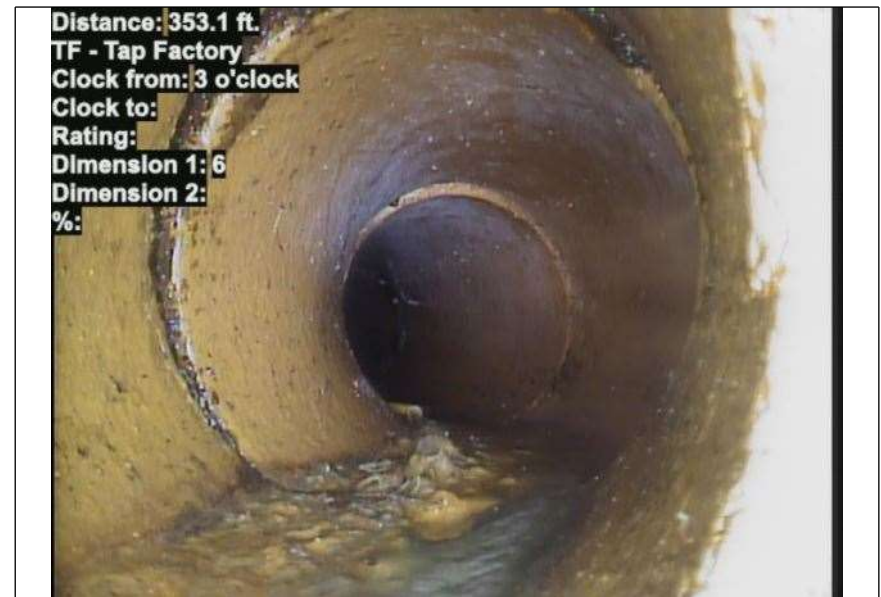
At: 353.1 ft. 3/ TF - Tap Factory
Joint: No

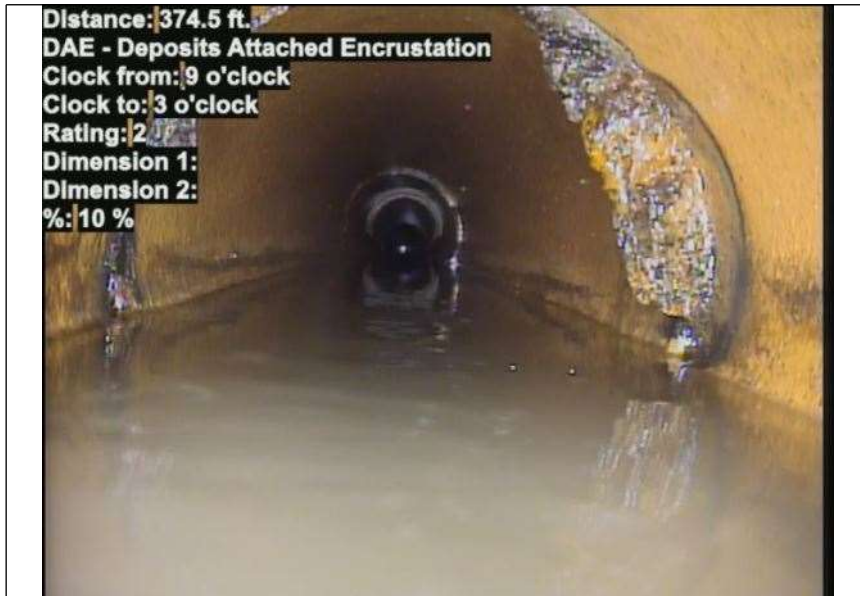
353.1 ft.	00:00:43	TF			6.000			<input type="checkbox"/>	3 /			SMH122_SMH123_TF_353.1 ft.JPG	
374.5 ft.	00:01:25	DAE					10	<input type="checkbox"/>	9 / 3		2	SMH122_SMH123_DAE_374.5 ft.JPG

At: 374.5 ft. 9/3 DAE - Deposits Attached Encrustation

Joint: No 10 %

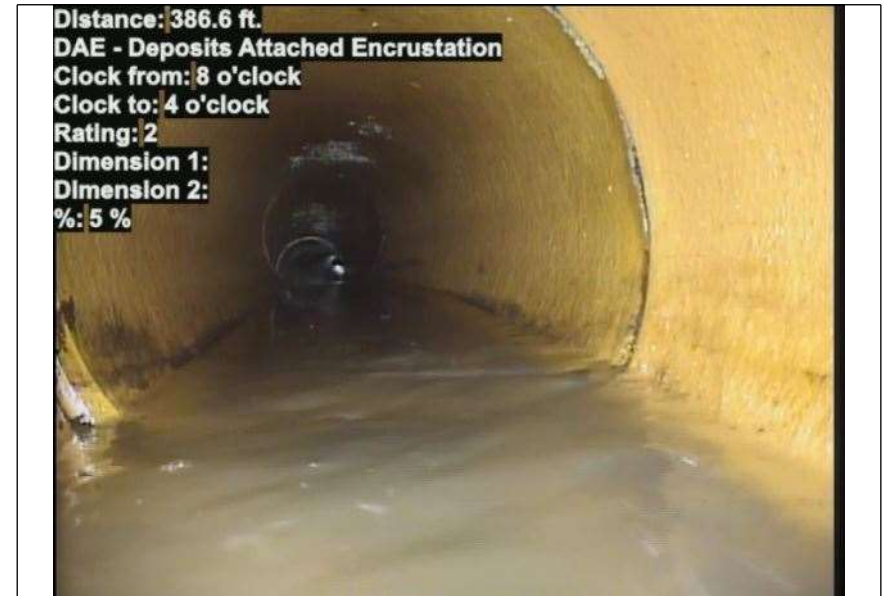
386.6 ft.	00:02:29	DAE	F01				5	<input type="checkbox"/>	8 / 4		2	SMH122_SMH123_DAE_386.6 ft.JPG

At: 386.6 ft. 8/4 DAE - Deposits Attached Encrustation

Joint: No 5 %
