PACP Report with Pipe Run and Incident Snapshots

Surveyed by: Mike Brooks	Certificate number: Mike Brooks	Owner:	Customer:	Drainage area:	P/O number:	Sheet number:
Pipe segment ref.: SMH123_SMH110	Start date/time: 20220414 13:16	Street: W MAIN ST		City: SMITHVILLE		
Location details: PARKING LOT		Upstream MH No: SMH123	Rim to invert:	Grade to invert:	Rim to grade:	
Pipe use: SS	Direction: U	Flow control:	Downstream MH No: SMH110	Rim to invert:	Grade to invert:	Rim to grade:
Height: 8 in.	Width:	Shape: C	Material: VCP	Lining method:	Pipe joint length:	Total length: 68.200 ft.
Length surveyed: 68.200 ft.	Purpose:	Sewer category:		Media label:	PreCleaning: L	Date cleaned:
Weather: 1	Location code:	Pressure value:		Project name: Sewer Cleaning & CCTV - Project No. 210670	Additional info:

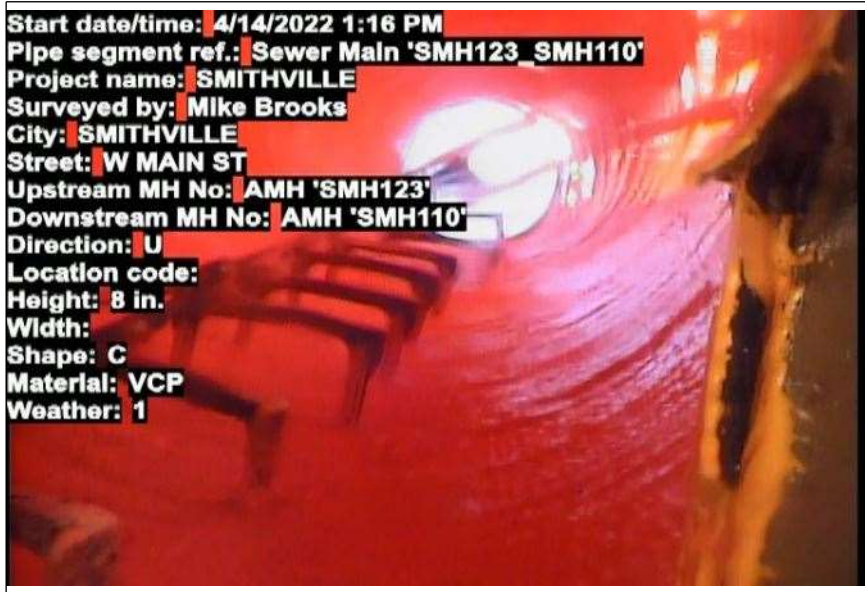
At: 0 ft. AMH - Manhole
Joint: No SMH110

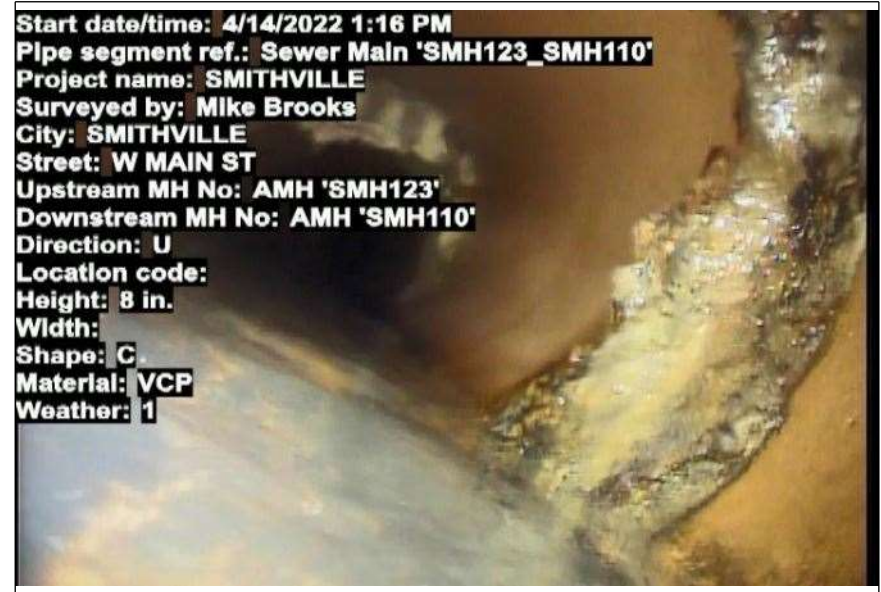
At: 0 ft. MWL - Miscellaneous Water Level
Joint: No 5 %

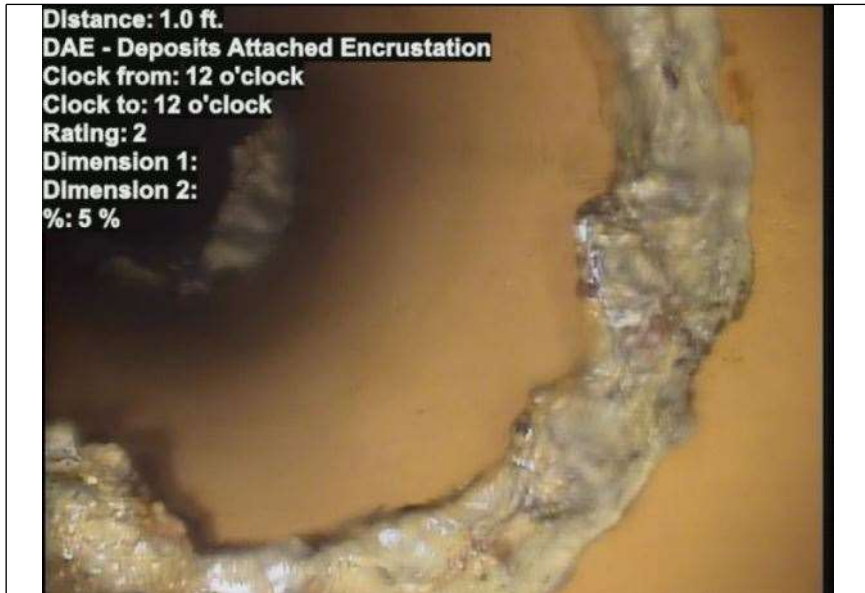
At: 1 ft. 12/12 DAE - Deposits Attached Encrustation
Joint: No 5 %

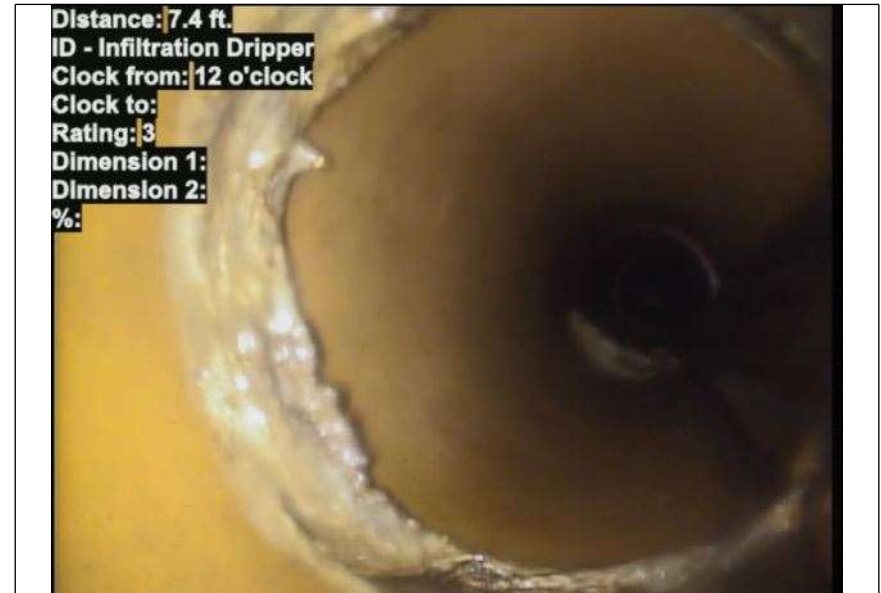
At: 7.4 ft. 12/. ID - Infiltration Dripper
Joint: No

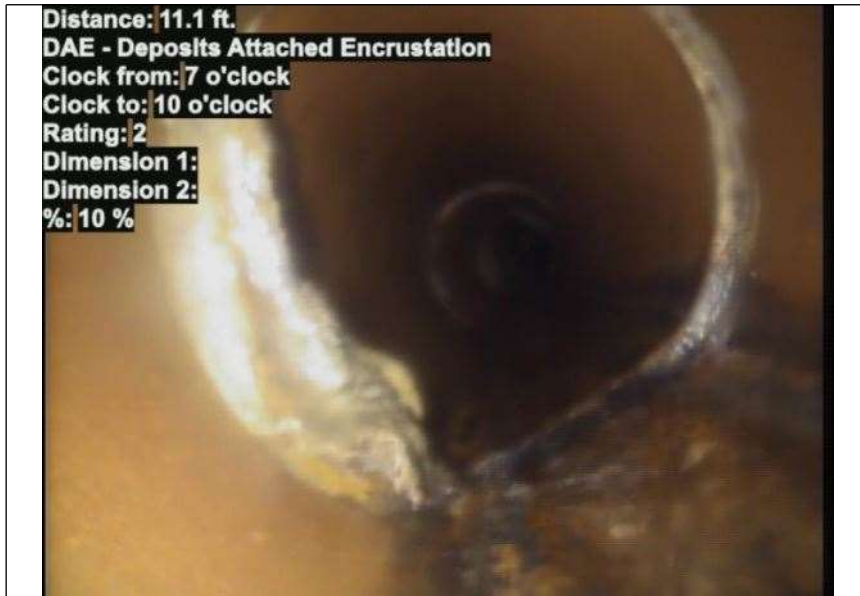
At: 11.1 ft. 7/10 DAE - Deposits Attached Encrustation
Joint: No 10 %

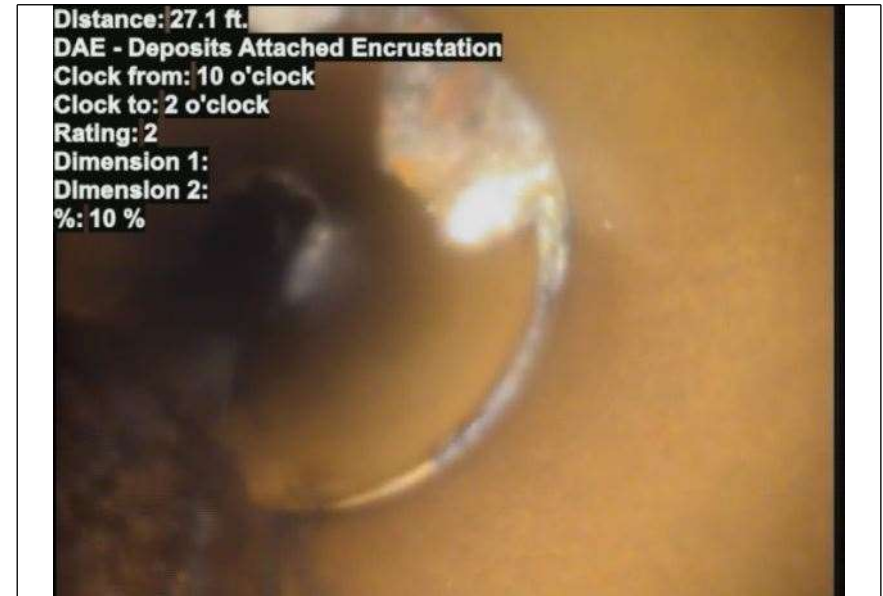
At: 27.1 ft. 10/2 DAE - Deposits Attached Encrustation
Joint: No 10 %

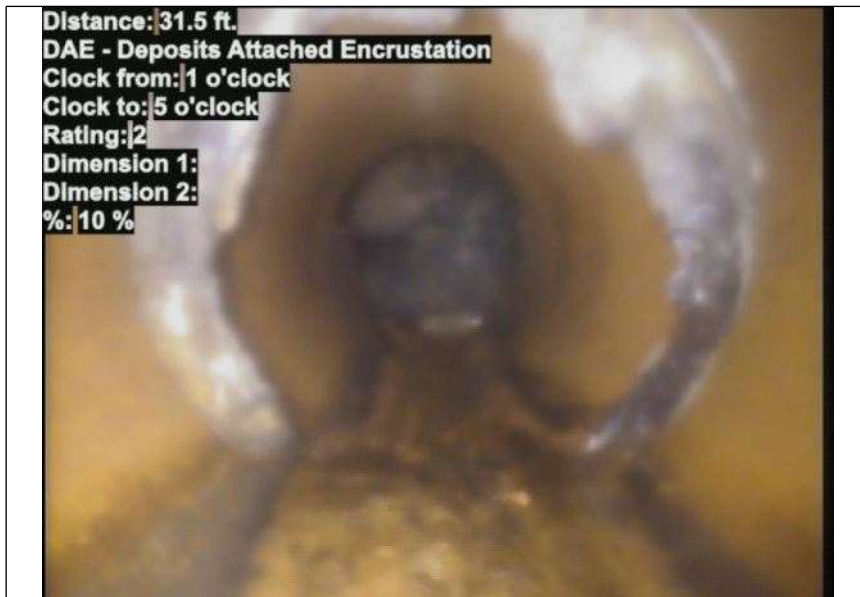
At: 31.5 ft. 1/5 DAE - Deposits Attached Encrustation
Joint: No 10 %

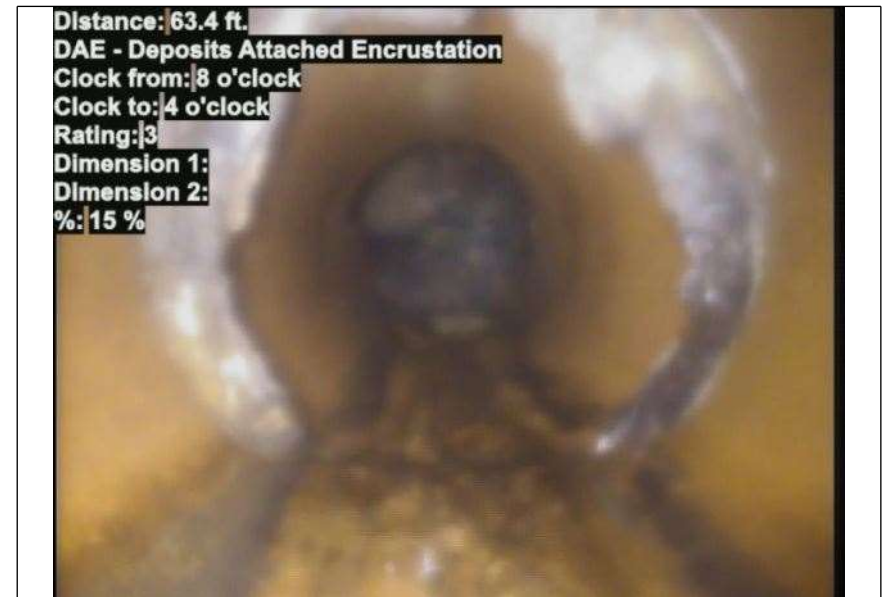
At: 63.4 ft. 8/4 DAE - Deposits Attached Encrustation
Joint: No 15 %
