## PACP Report with Pipe Run and Incident Snapshots

Surveyed by: <b>Mike Brooks</b>	Certificate number: <b>Mike Brooks</b>	Owner:	Customer:	Drainage area:	P/O number:	Sheet number:
Pipe segment ref.: <b>SMH131_SMH131A</b>	Start date/time: <b>20220329 13:59</b>	Street: <b>S MILTON ST</b>		City: <b>SMITHVILLE</b>		
Location details: <b>STREET</b>		Upstream MH No: <b>SMH131</b>	Rim to invert:	Grade to invert:	Rim to grade:	
Pipe use: <b>SS</b>	Direction: <b>U</b>	Flow control:	Downstream MH No: <b>SMH131A</b>	Rim to invert:	Grade to invert:	Rim to grade:
Height: <b>8 in.</b>	Width:	Shape: <b>C</b>	Material: <b>VCP</b>	Lining method:	Pipe joint length:	Total length: <b>267.100 ft.</b>
Media label:	PreCleaning: <b>L</b>	Date cleaned:	Weather: <b>1</b>	Length surveyed: <b>259.500 ft.</b>	Purpose:	Sewer category:
Project name: <b>Sewer Cleaning &amp; CCTV - Project No. 210670</b>		Additional info:

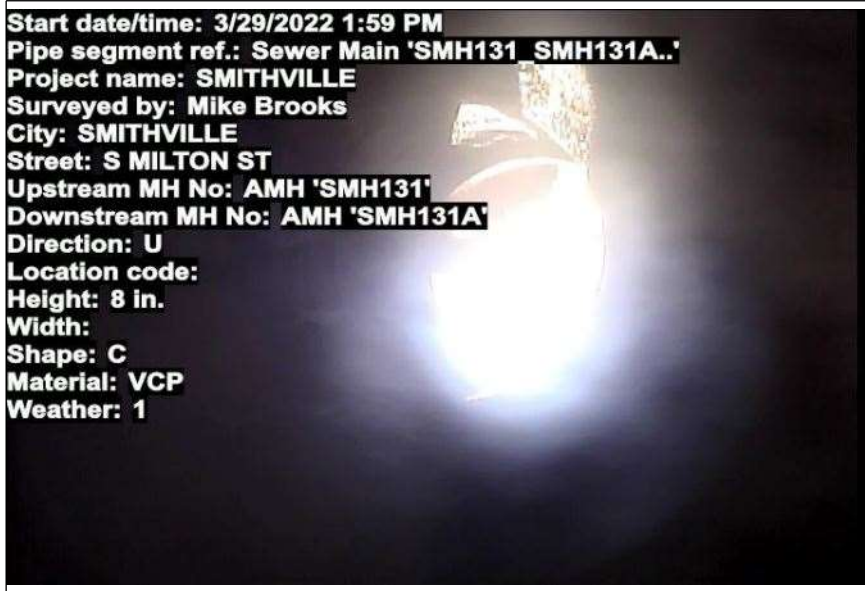
At: 0 ft. AMH - Manhole  
Joint: No SMH131A

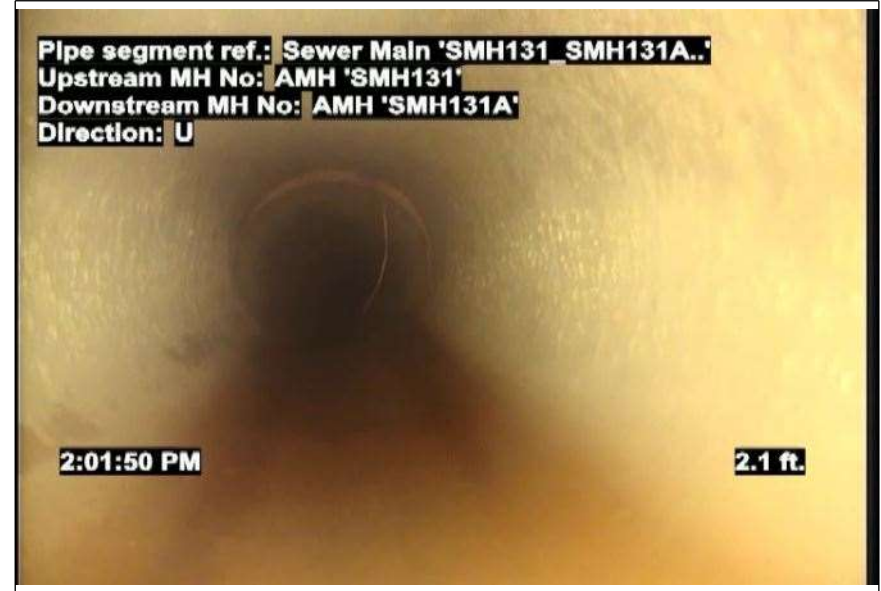
At: 0 ft. MWL - Miscellaneous Water Level  
Joint: No 5%

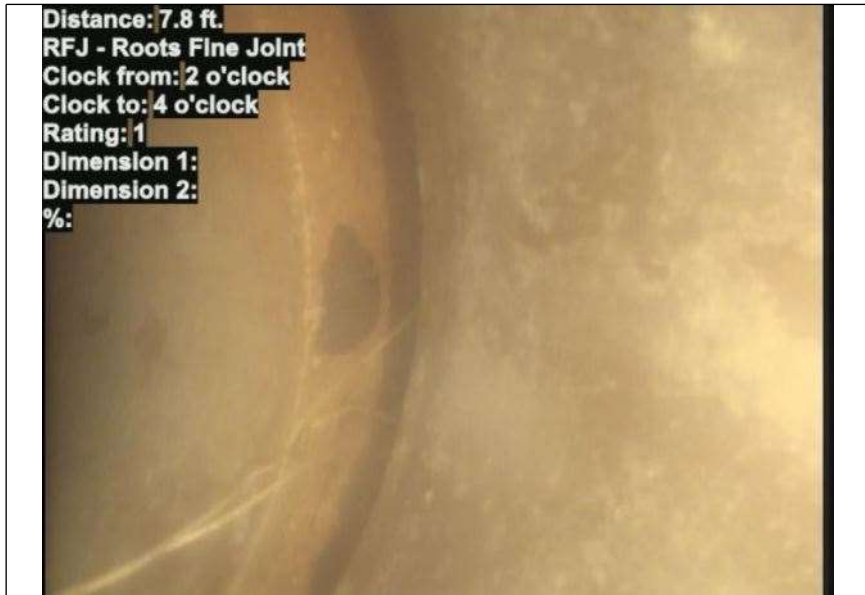
At: 7.8 ft. 2/4 RFJ - Roots Fine Joint  
Joint: Yes

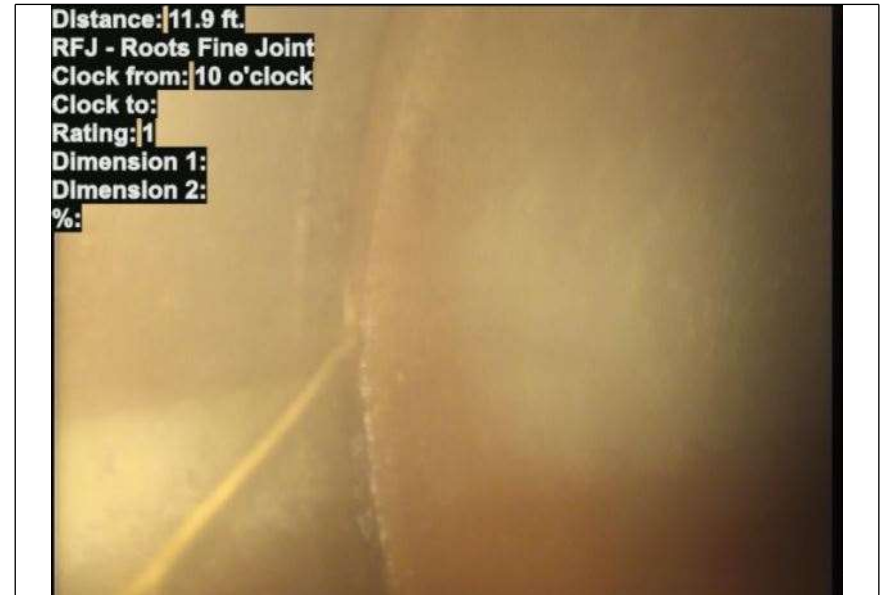
At: 11.9 ft. 10/ RFJ - Roots Fine Joint  
Joint: Yes

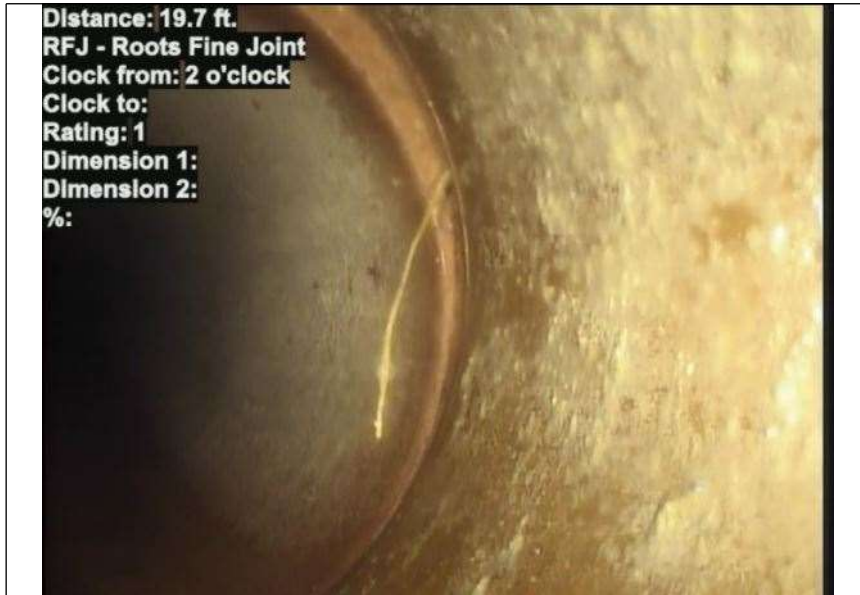
At: 19.7 ft. 2/. RFJ - Roots Fine Joint  
Joint: Yes

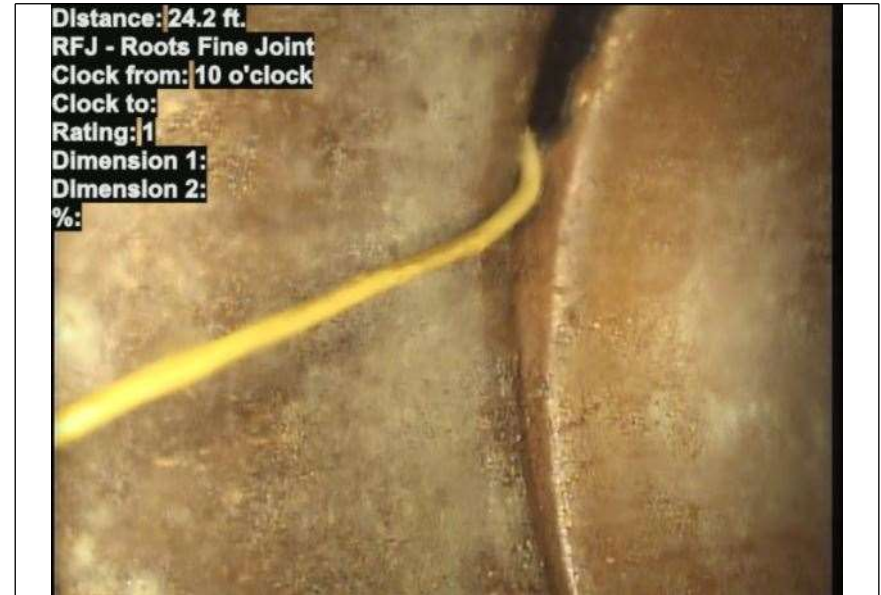
At: 24.2 ft. 10/. RFJ - Roots Fine Joint  
Joint: Yes

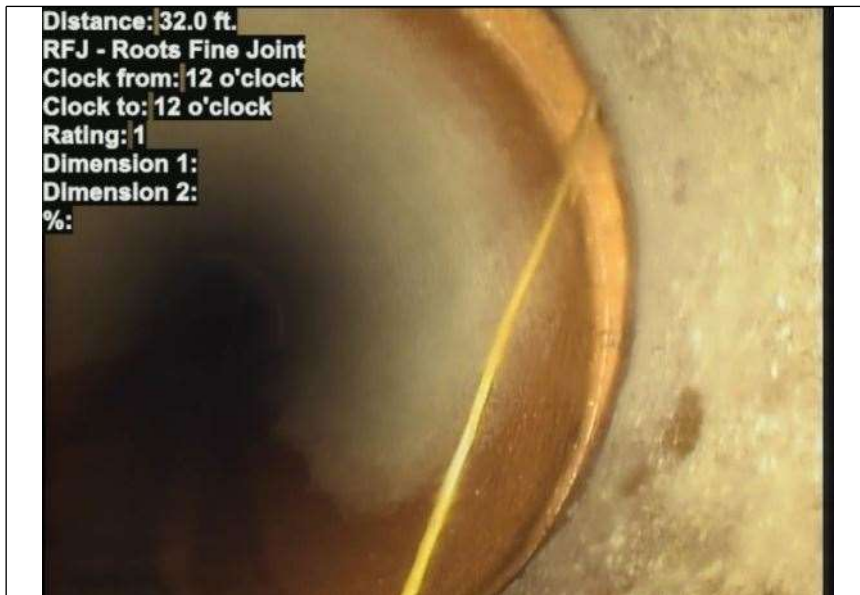
At: 32 ft. 12/12 RFJ - Roots Fine Joint  
Joint: Yes

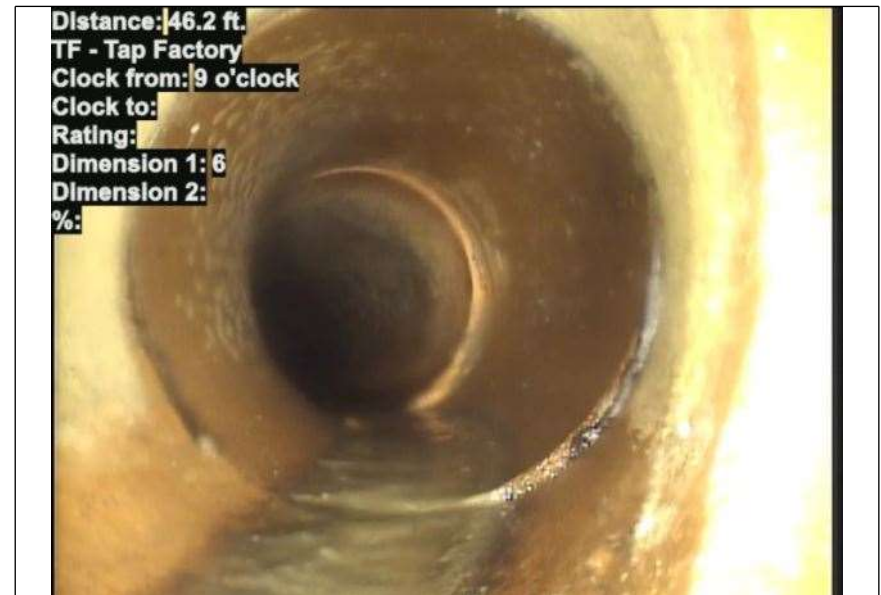
At: 46.2 ft. 9/. TF - Tap Factory  
Joint: No

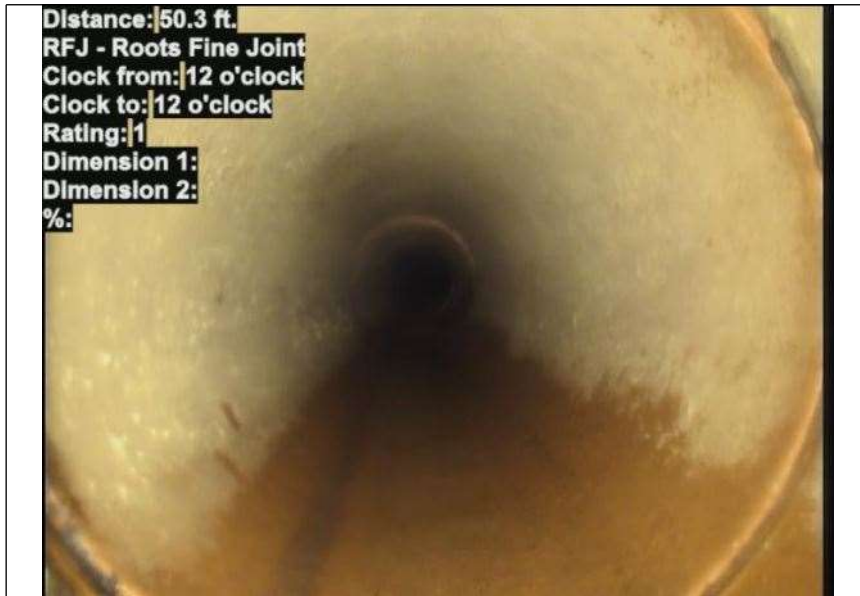
At: 50.3 ft. RFJ - Roots Fine Joint  
12/12

Joint: Yes

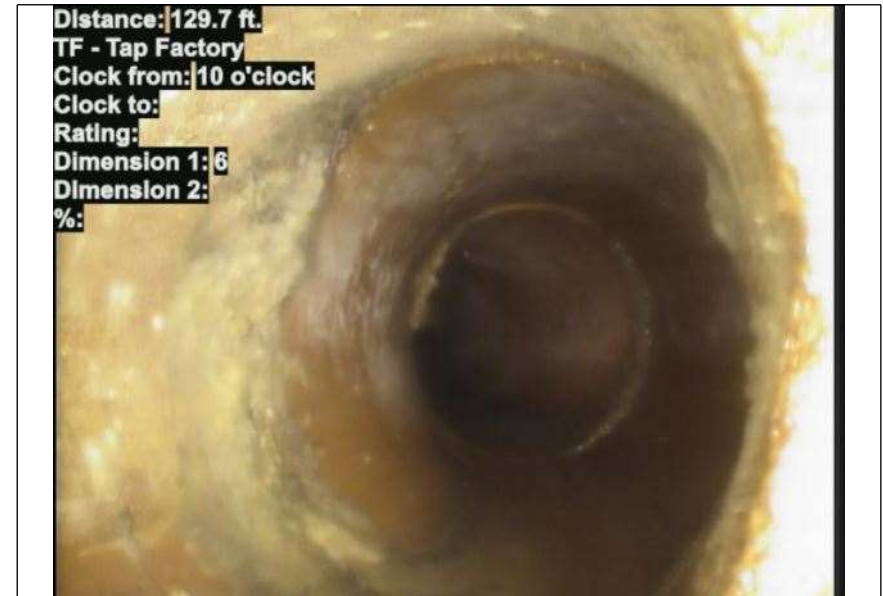
At: 129.7 ft. 10/. TF - Tap Factory

Joint: No

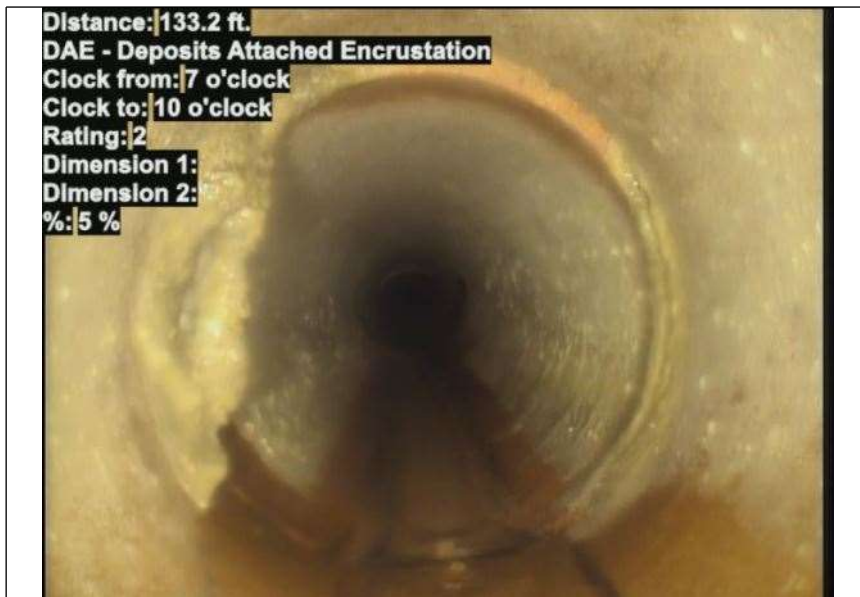
At: 133.2 ft. DAE - Deposits Attached Encrustation  
7/10

Joint: No 5 %

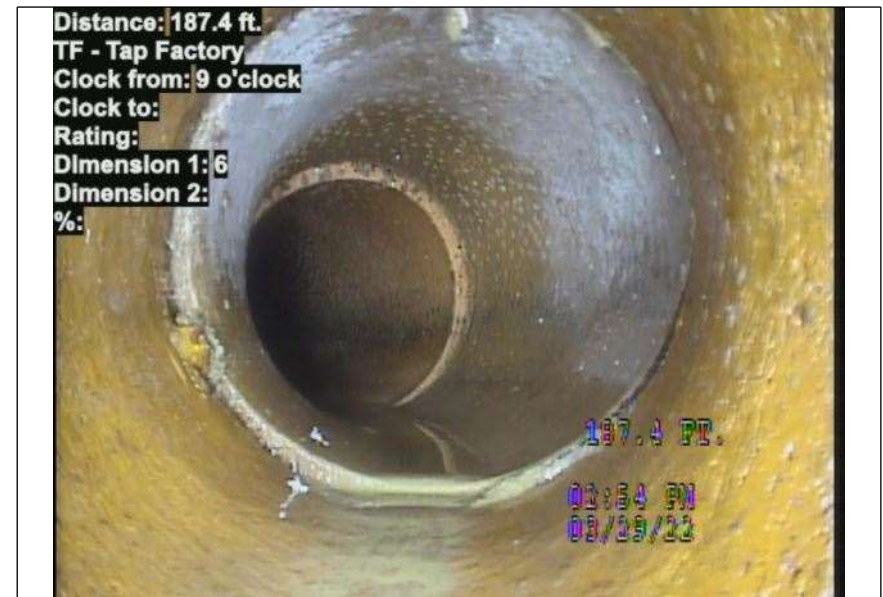
At: 187.4 ft. 9/. TF - Tap Factory

Joint: No

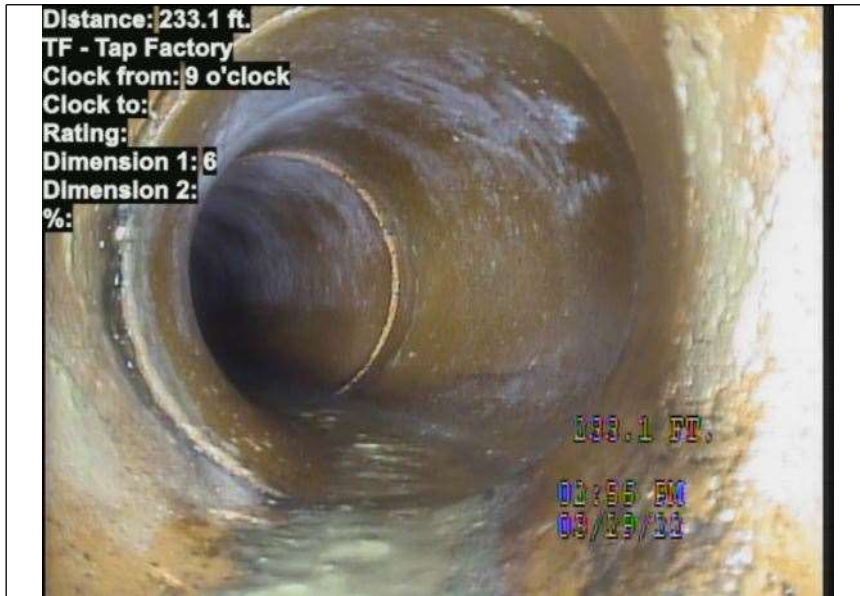
At: 233.1 ft. 9/. TF - Tap Factory

Joint: No

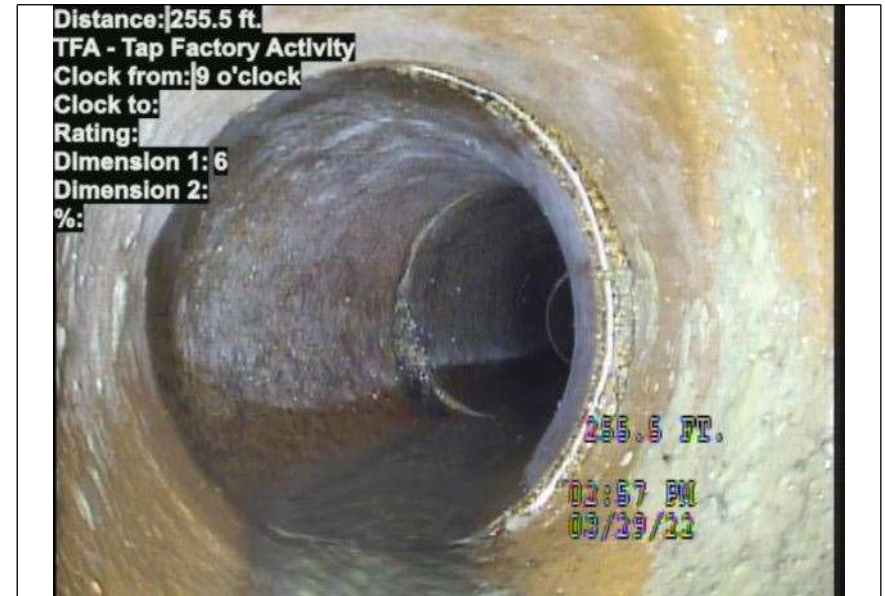
At: 255.5 ft. 9/. TFA - Tap Factory Activity

Joint: No

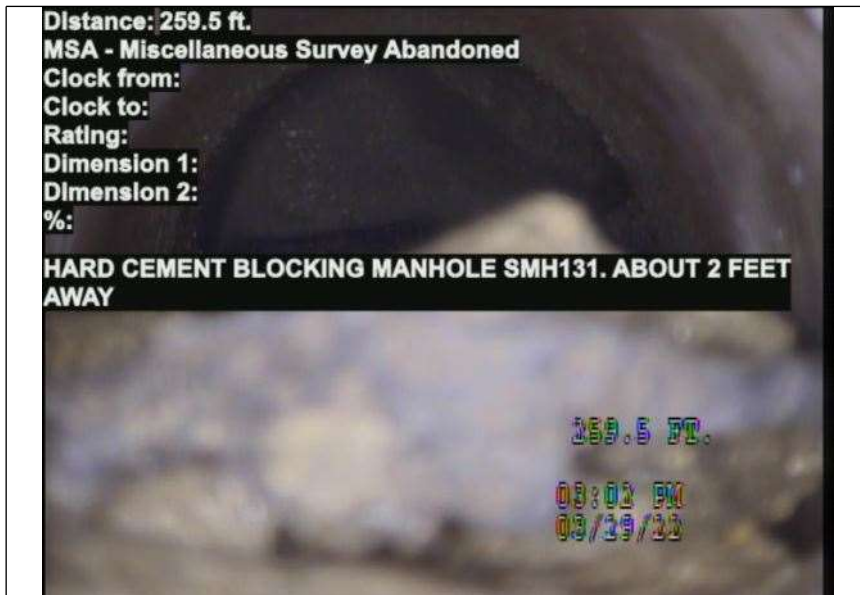
At: 259.5 ft. MSA - Miscellaneous Survey Abandoned

Joint: No HARD CEMENT BLOCKING MANHOLE SMH131. ABOUT 2 FEET AWAY
