PACP Report with Pipe Run and Incident Snapshots

Surveyed by: Mike Brooks	Certificate number: Mike Brooks	Owner:	Customer:	Drainage area:	P/O number:	Sheet number:
Pipe segment ref.: SMH131_SMH131A	Start date/time: 20220331 15:54	Street: S MILTON ST		City: SMITHVILLE		
Location details: STREET		Upstream MH No: SMH131	Rim to invert:	Grade to invert:	Rim to grade:	
Pipe use: SS	Direction: D	Flow control:	Downstream MH No: SMH131A	Rim to invert:	Grade to invert:	Rim to grade:
Height: 8 in.	Width:	Shape: C	Material: VCP	Lining method:	Pipe joint length:	Total length: 267.100 ft.
Media label:	PreCleaning: L	Date cleaned:	Weather:	Length surveyed: 7.600 ft.	Purpose: F	Sewer category:
Project name: Sewer Cleaning & CCTV - Project No. 210670		Additional info:

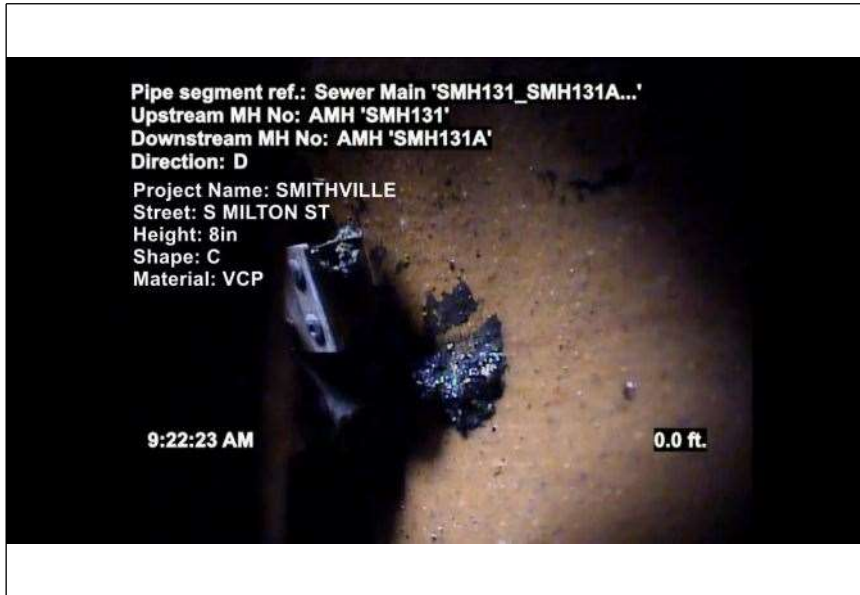
At: 0 ft. AMH - Manhole
 Joint: No SMH131

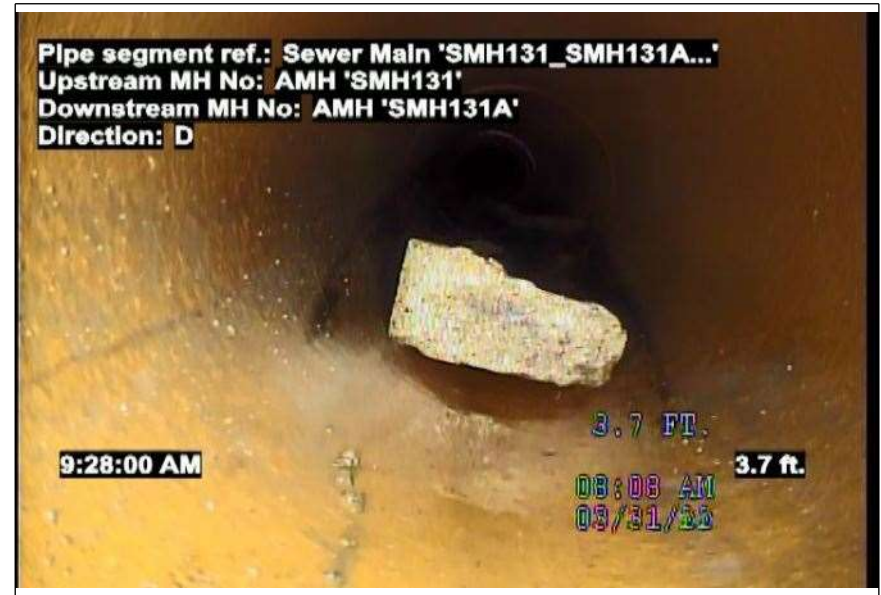
At: 0 ft. MWL - Miscellaneous Water Level
 Joint: No 5%

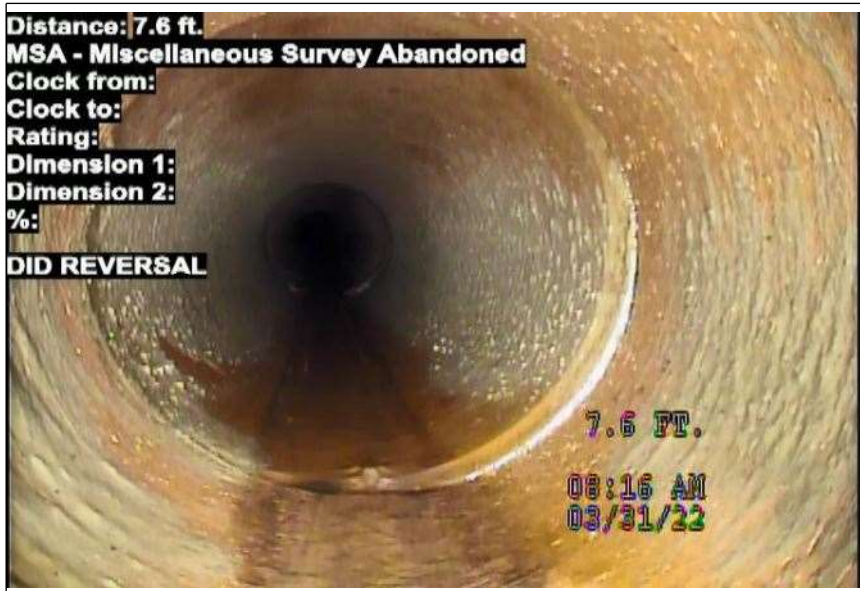
At: 7.6 ft. MSA - Miscellaneous Survey Abandoned
 Joint: No REVERSAL COMPLETED

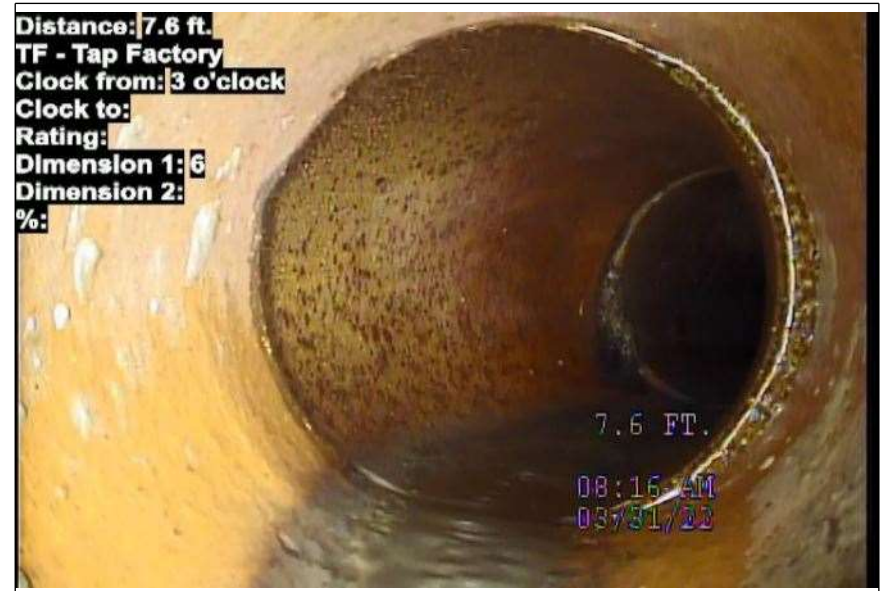
At: 7.6 ft. 3/. TF - Tap Factory
 Joint: No
