PACP Report with Pipe Run and Incident Snapshots

Surveyed by: Mike Brooks	Certificate number: Mike Brooks	Owner:	Customer:	Drainage area:	P/O number:	Sheet number:
Pipe segment ref.: SMH132_SMH061	Start date/time: 20220330 09:06	Street: S MILTON ST		City: SMITHVILLE		
Location details: STREET		Upstream MH No: SMH132	Rim to invert:	Grade to invert:	Rim to grade:	
Pipe use: SS	Direction: D	Flow control:	Downstream MH No: SMH061	Rim to invert:	Grade to invert:	Rim to grade:
Height: 8 in.	Width:	Shape: C	Material: VCP	Lining method:	Pipe joint length:	Total length: 448.600 ft.
Media label:	PreCleaning: L	Date cleaned:	Weather: 1	Length surveyed: 448.600 ft.	Purpose:	Sewer category:
Project name: Sewer Cleaning & CCTV - Project No. 210670		Additional info:

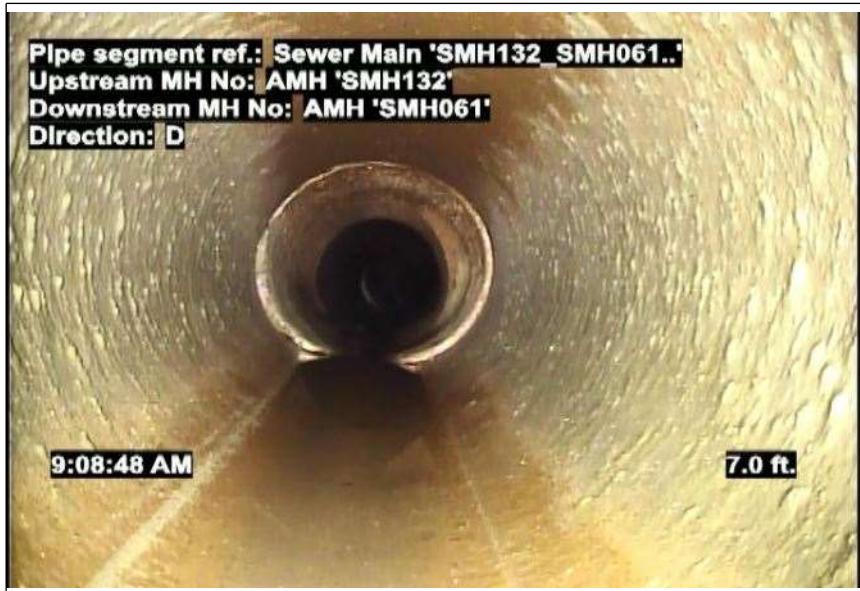
At: 0 ft. MWL - Miscellaneous Water Level
Joint: No 5 %

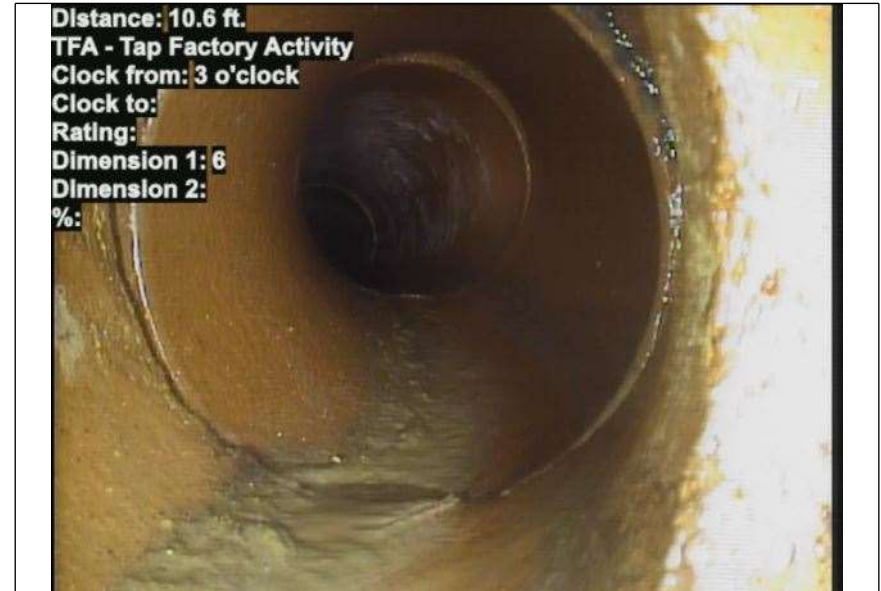
At: 10.6 ft. 3/. TFA - Tap Factory Activity
Joint: No

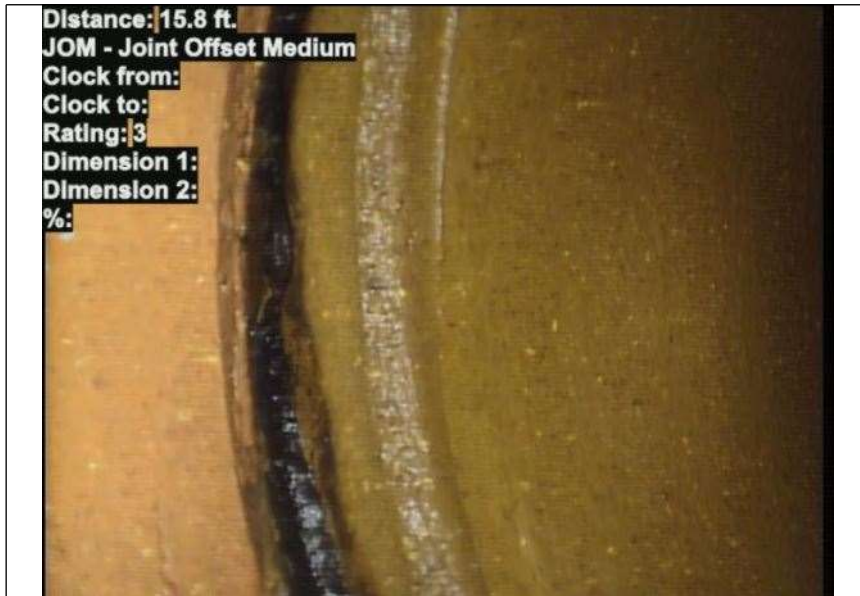
At: 15.8 ft. JOM - Joint Offset Medium
Joint: No

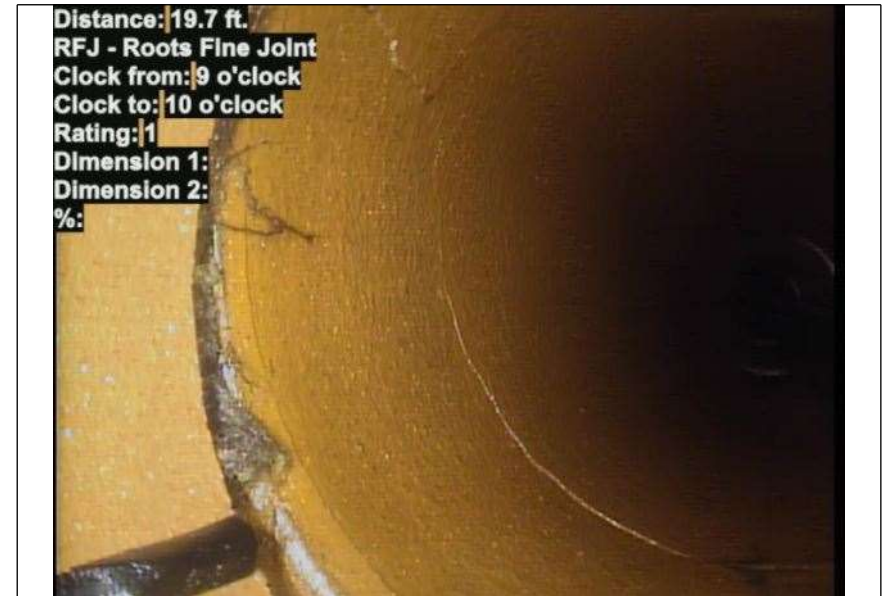
At: 19.7 ft. 9/10 RFJ - Roots Fine Joint
Joint: Yes

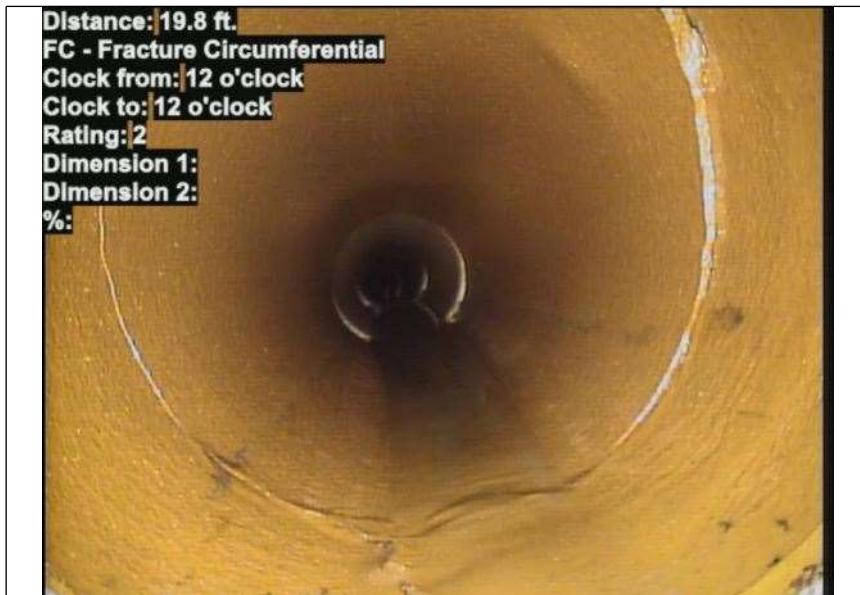
At: 19.8 ft. FC - Fracture Circumferential
12/12
Joint: No

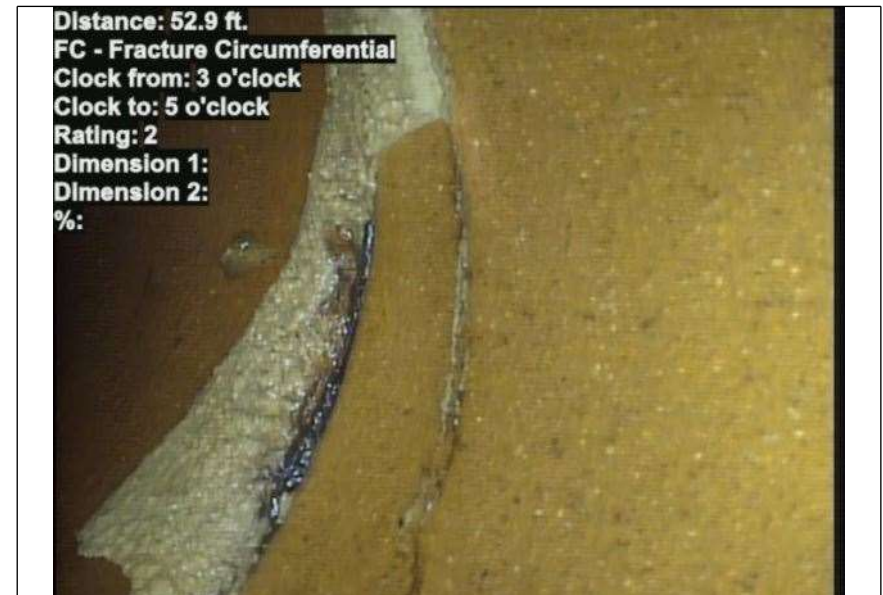
At: 52.9 ft. 3/5 FC - Fracture Circumferential
Joint: No

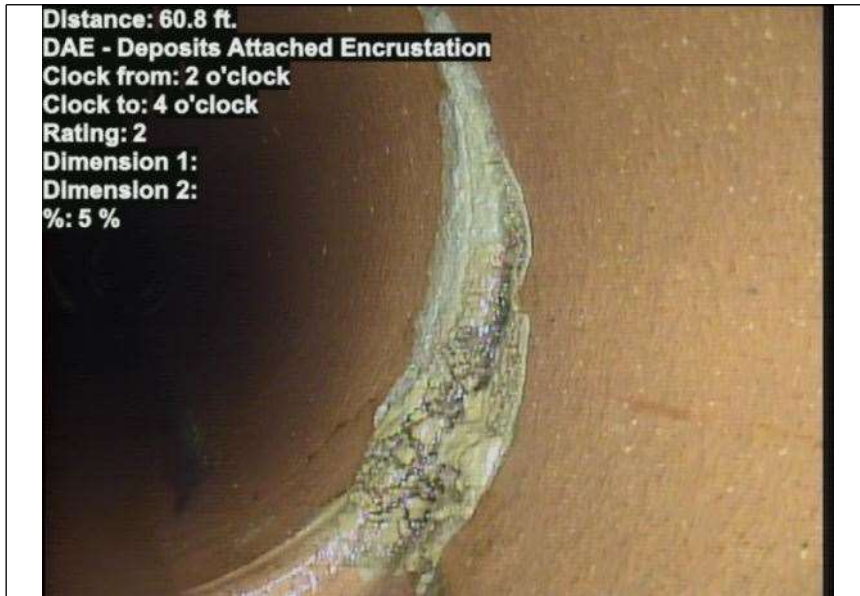
At: 60.8 ft. 2/4 DAE - Deposits Attached Encrustation
Joint: No 5 %

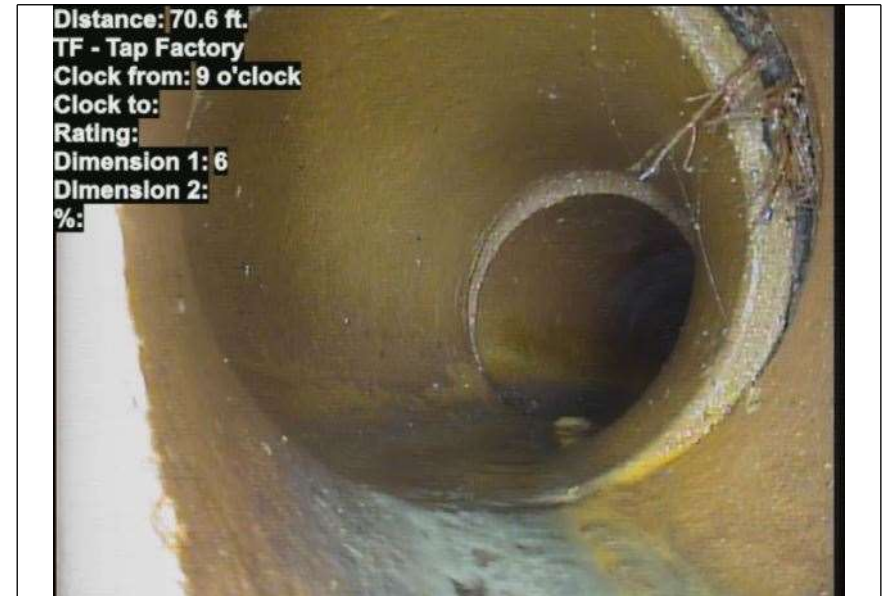
At: 70.6 ft. 9/ TF - Tap Factory
Joint: No

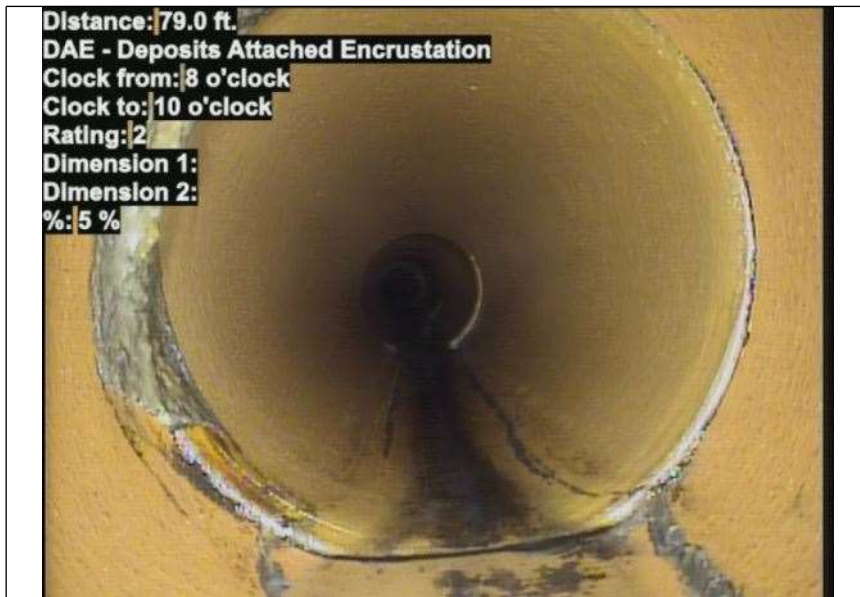
At: 79 ft. 8/10 DAE - Deposits Attached Encrustation
Joint: No 5 %

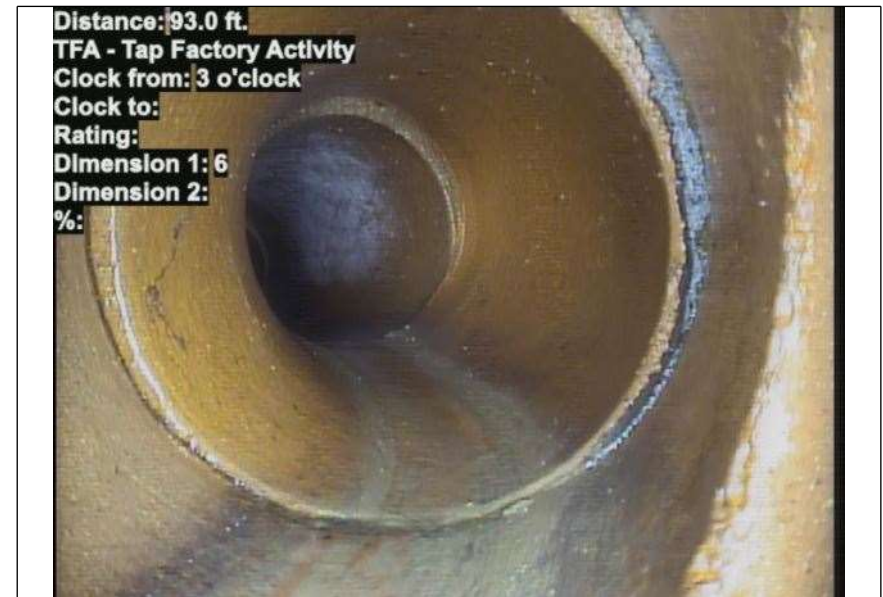
At: 93 ft. 3/ TFA - Tap Factory Activity
Joint: No

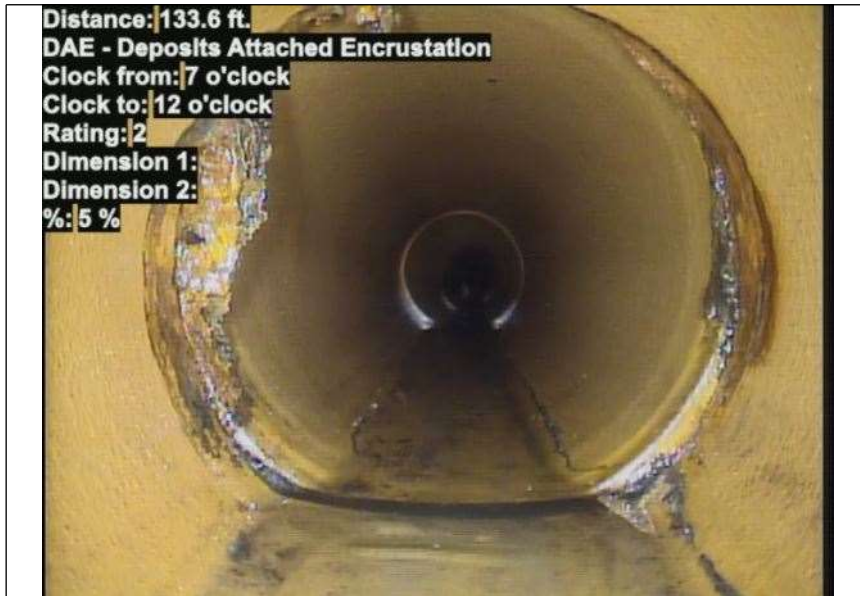
At: 133.6 ft. DAE - Deposits Attached Encrustation
7/12

Joint: No 5 %

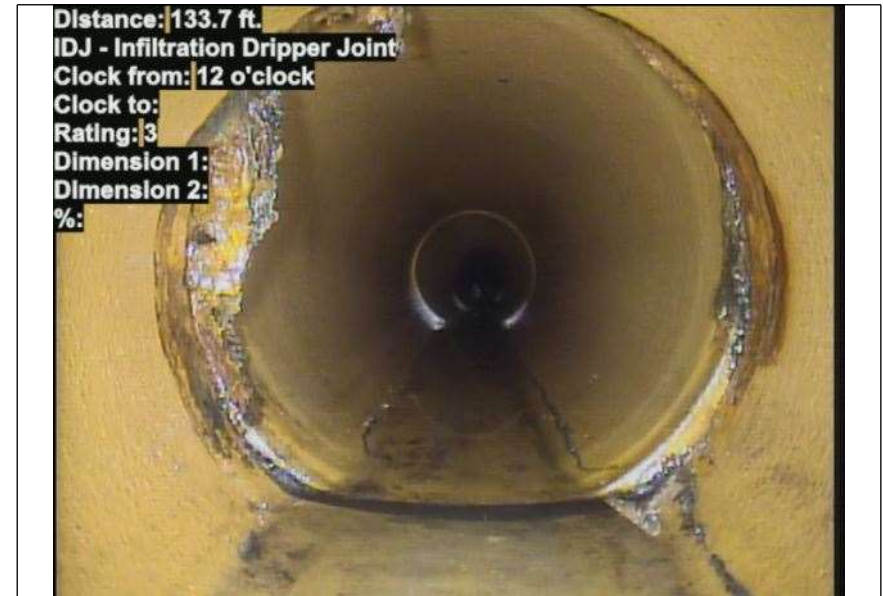
At: 133.7 ft. 12/ IDJ - Infiltration Dripper Joint

Joint: Yes

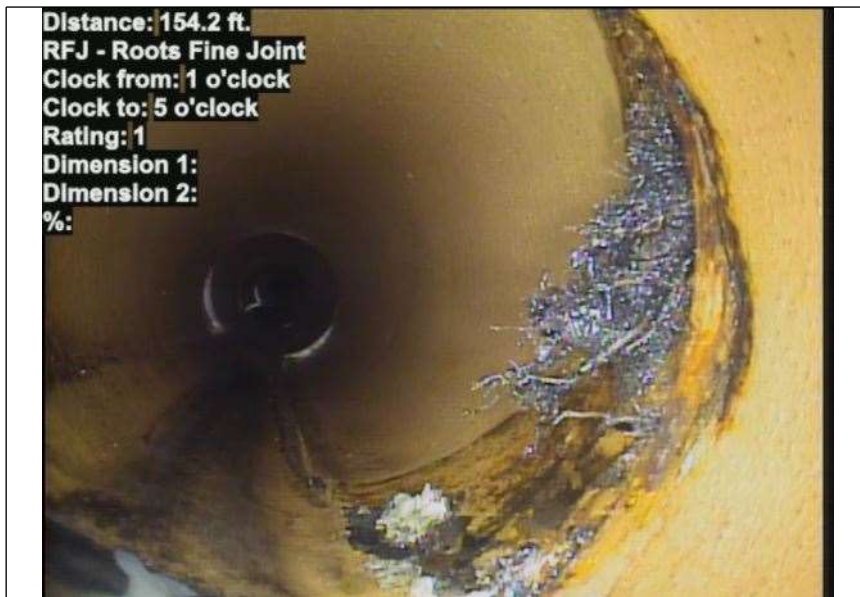
At: 154.2 ft. 1/5 RFJ - Roots Fine Joint

Joint: Yes

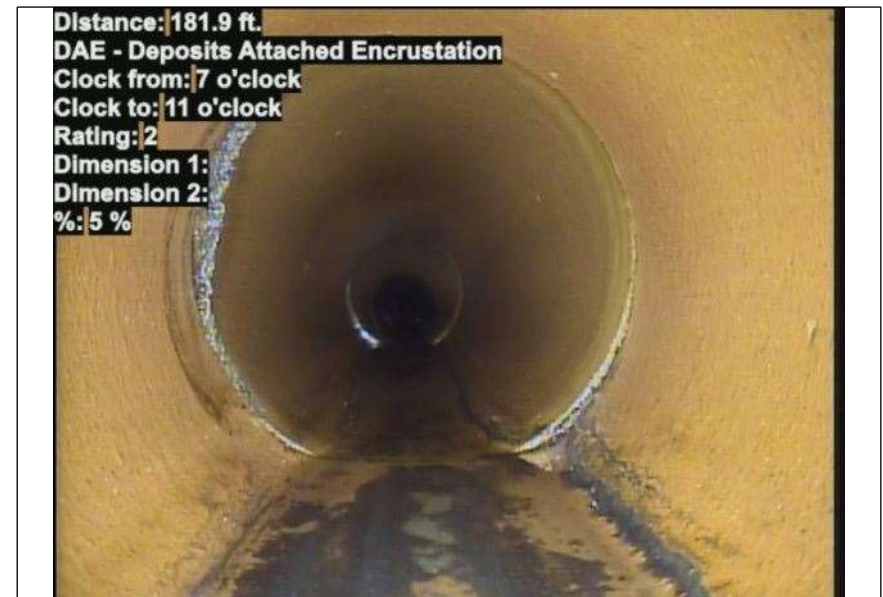
At: 181.9 ft. DAE - Deposits Attached Encrustation
7/11

Joint: No 5 %

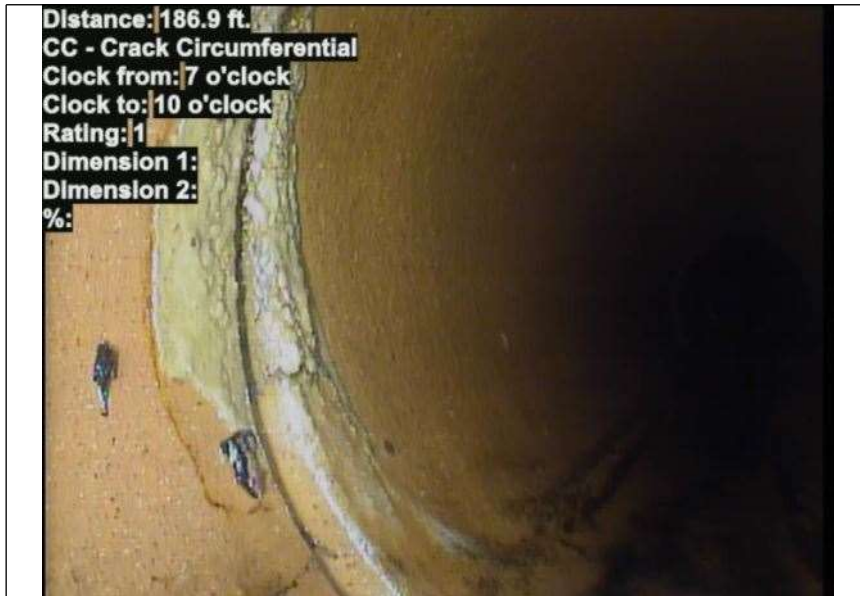
At: 186.9 ft. CC - Crack Circumferential
7/10

Joint: No

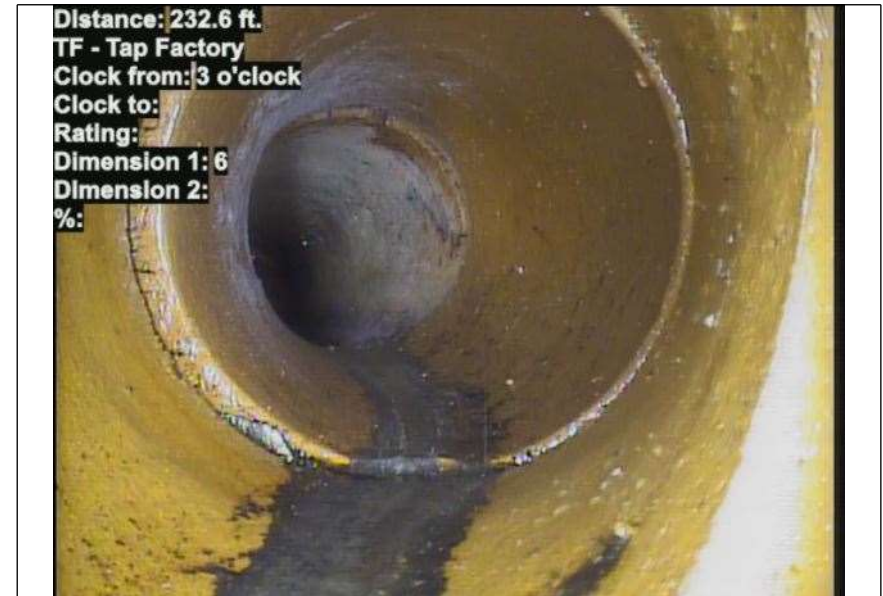
At: 232.6 ft. 3/. TF - Tap Factory

Joint: No

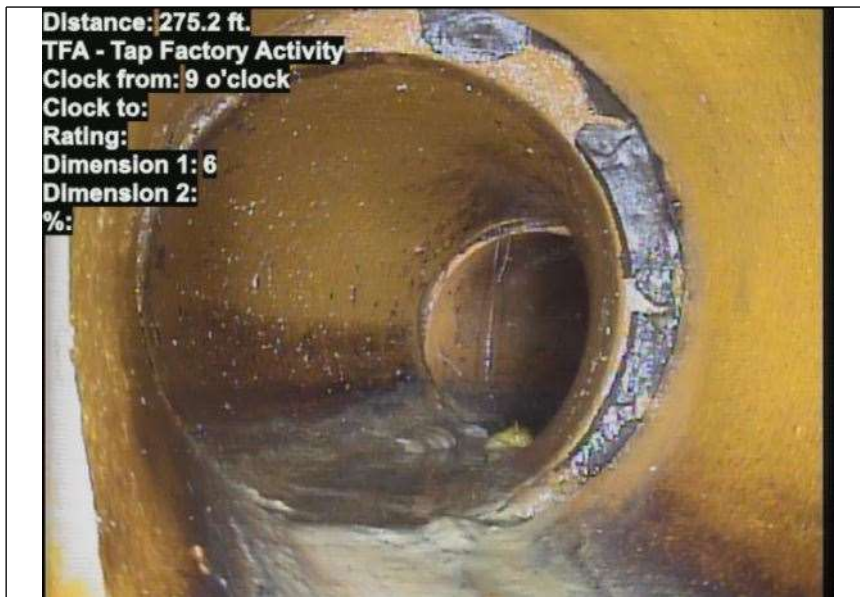
At: 275.2 ft. 9/. TFA - Tap Factory Activity

Joint: No

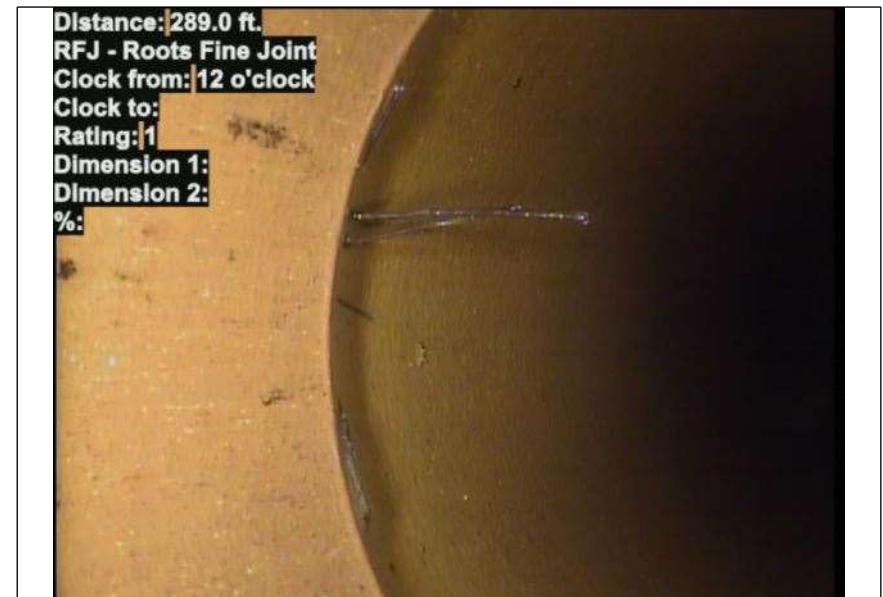
At: 289 ft. 12/. RFJ - Roots Fine Joint

Joint: Yes

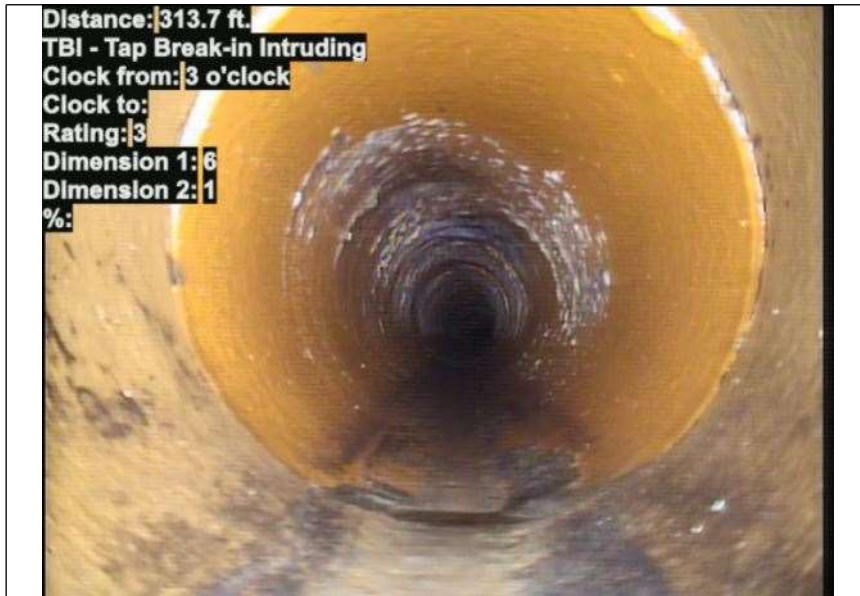
At: 313.7 ft. 3/ TBI - Tap Break-in Intruding
Joint: No

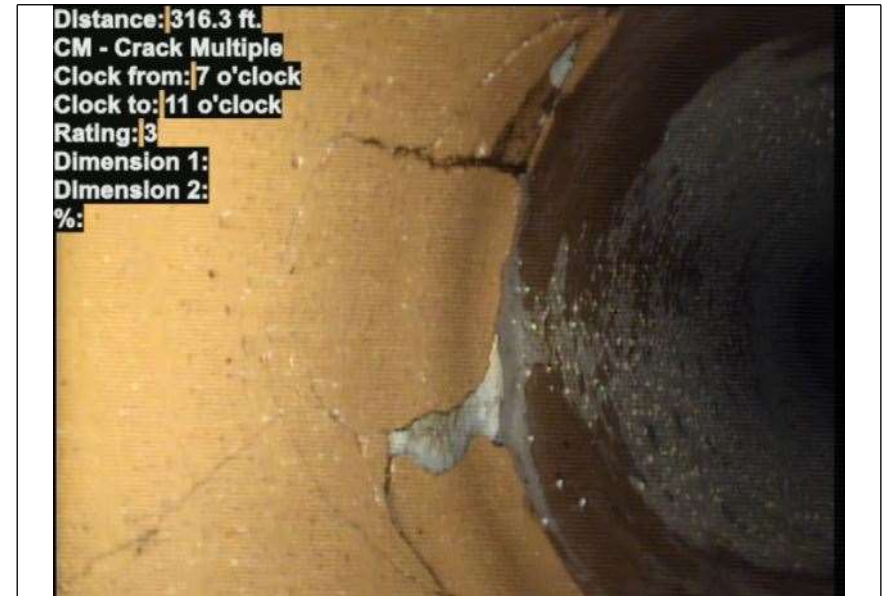
At: 316.3 ft. CM - Crack Multiple
7/11
Joint: No

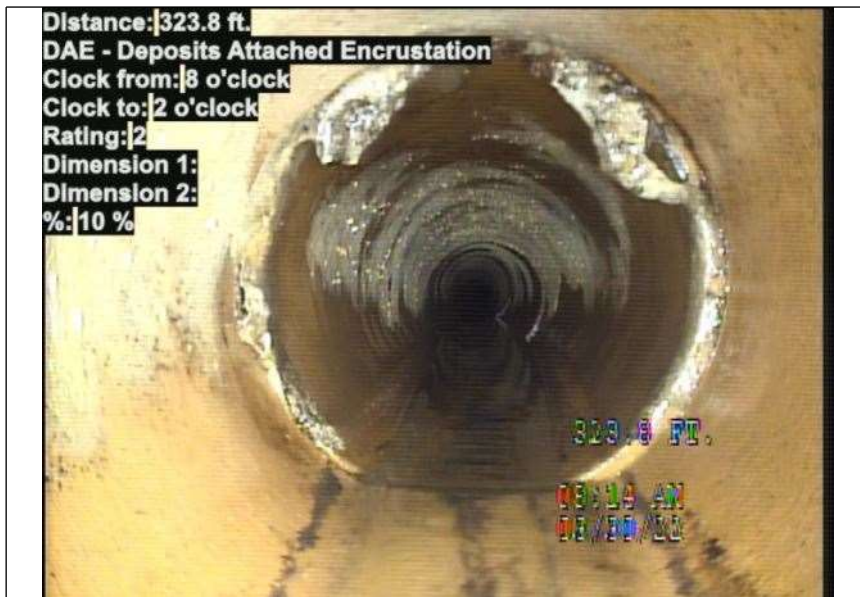
At: 323.8 ft. 8/2 DAE - Deposits Attached Encrustation
Joint: No 10 %

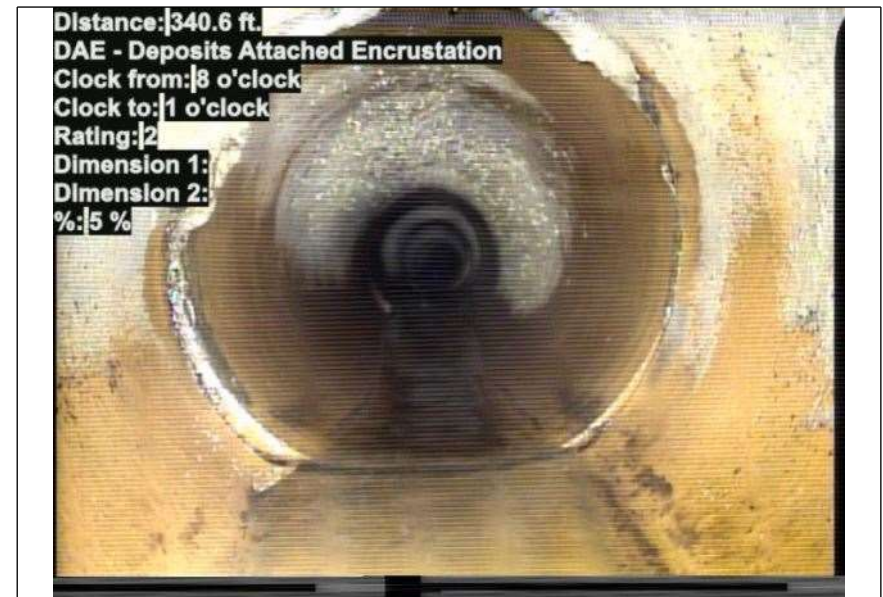
At: 340.6 ft. 8/1 DAE - Deposits Attached Encrustation
Joint: No 5 %

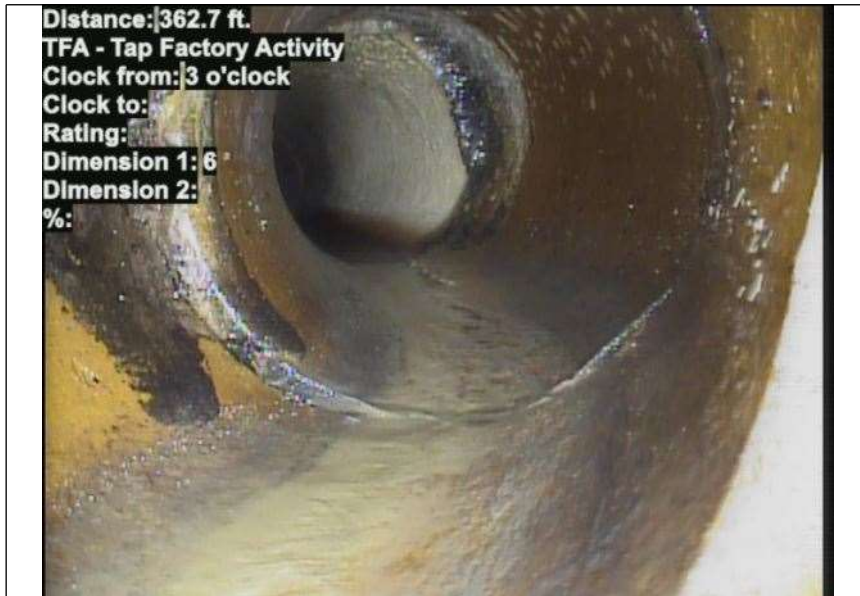
At: 362.7 ft. 3/. TFA - Tap Factory Activity
Joint: No

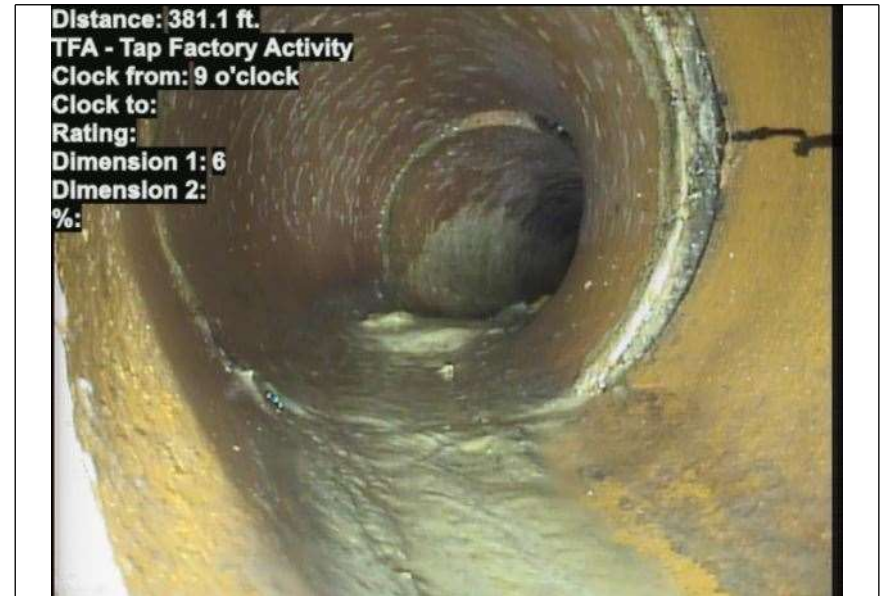
At: 381.1 ft. 9/. TFA - Tap Factory Activity
Joint: No

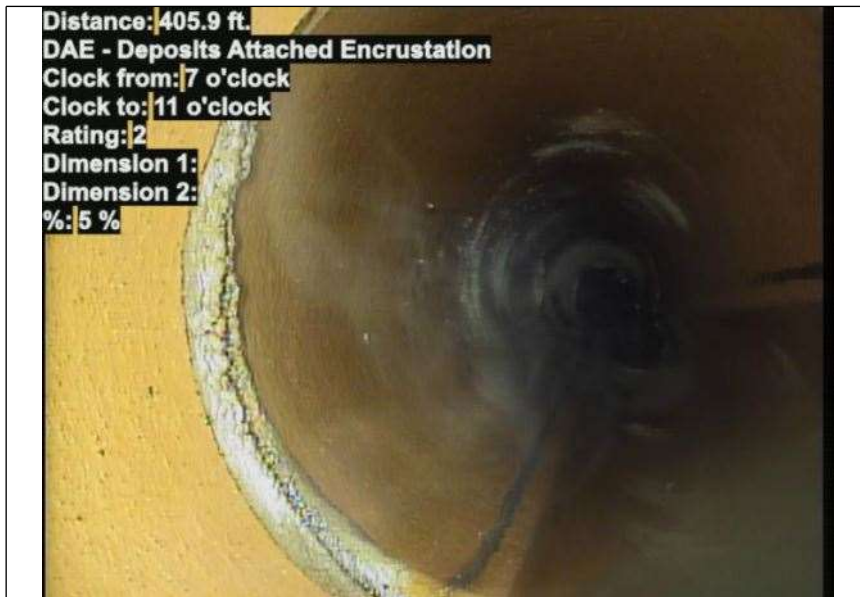
At: 405.9 ft. DAE - Deposits Attached Encrustation
7/11
Joint: No 5 %

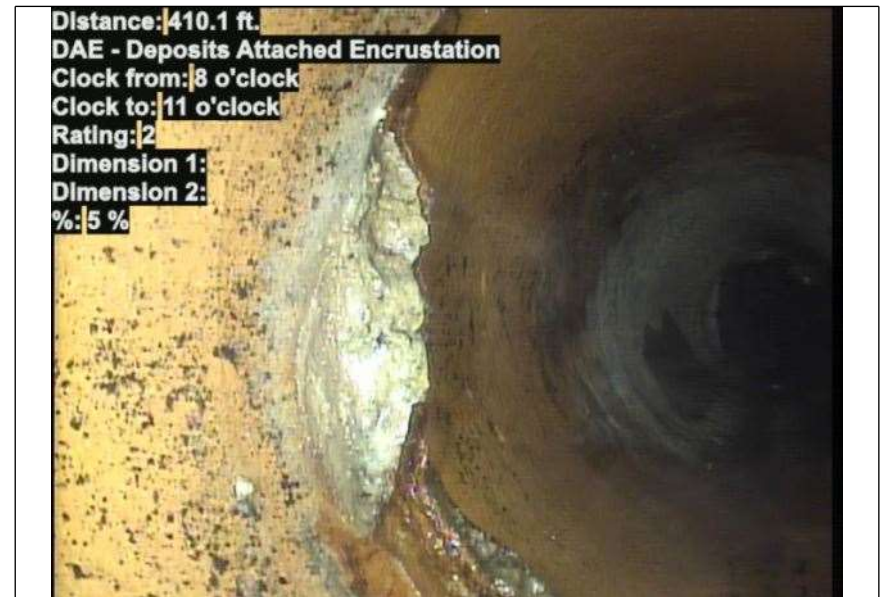
At: 410.1 ft. DAE - Deposits Attached Encrustation
8/11
Joint: No 5 %

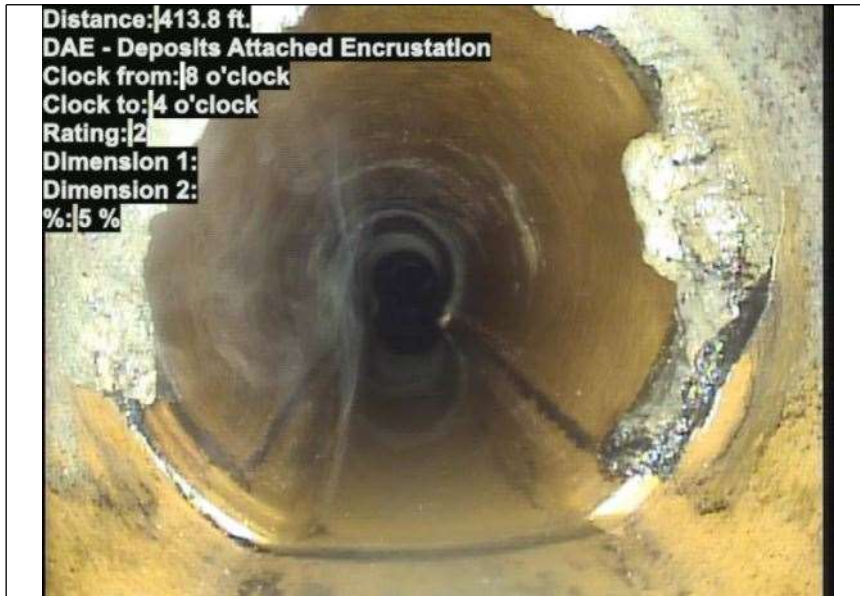
At: 413.8 ft. 8/4 DAE - Deposits Attached Encrustation
Joint: No 10 %

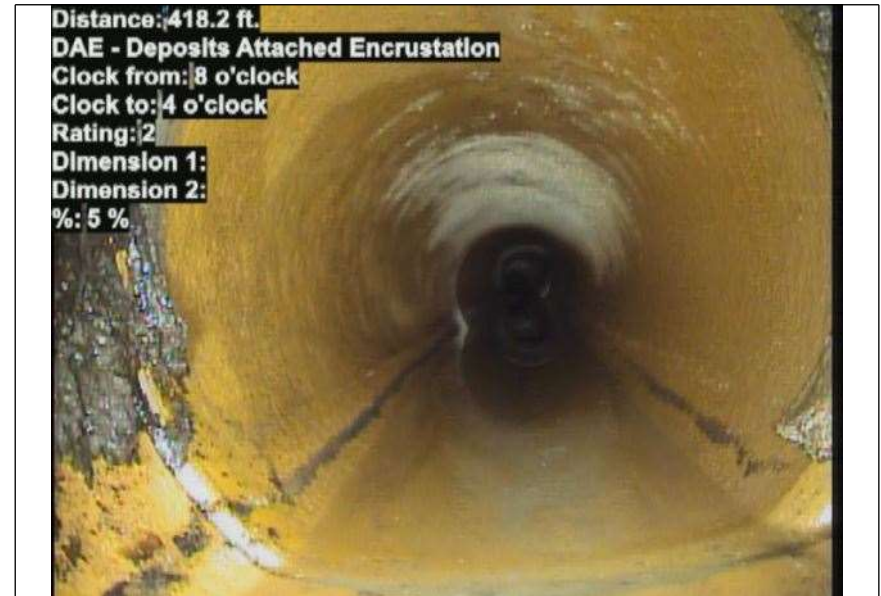
At: 418.2 ft. 8/4 DAE - Deposits Attached Encrustation
Joint: No 5 %

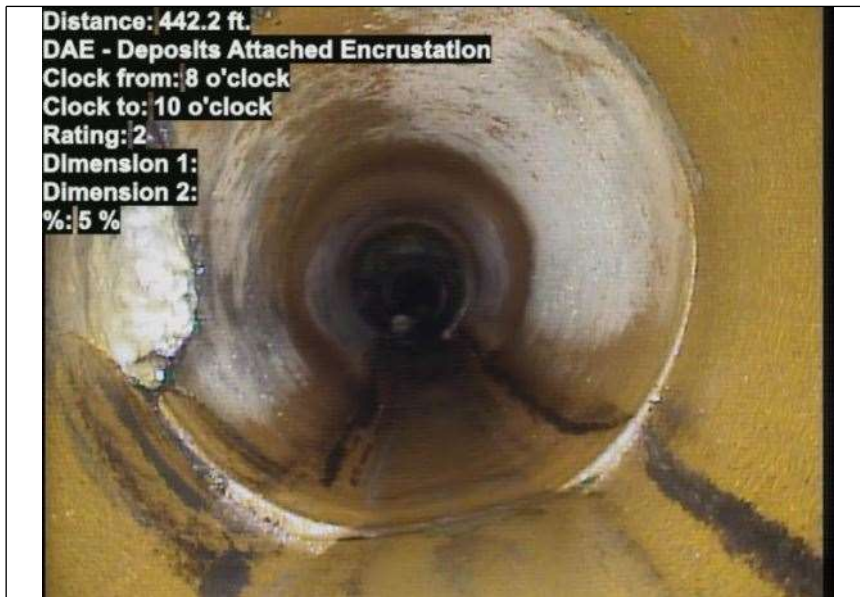
At: 442.2 ft. DAE - Deposits Attached Encrustation
8/10
Joint: No 5 %
