PACP Report with Pipe Run and Incident Snapshots

Surveyed by: Mike Brooks		Certificate number: Mike Brooks		Owner:		Customer:		Drainage area:		P/O number:		Sheet number:							
Pipe segment ref.: SMH133_SMH134				Start date/time: 20220329 17:17		Street: S MILTON ST				City: SMITHVILLE									
Location details: STREET				Upstream MH No: SMH133				Rim to invert:		Grade to invert:		Rim to grade:							
Pipe use: SS		Direction: D		Flow control:		Downstream MH No: SMH134				Rim to invert:		Grade to invert:		Rim to grade:					
Height: 8 in.		Width:		Shape: C		Material: VCP		Lining method:		Pipe joint length:		Total length: 256.700 ft.		Length surveyed: 256.700 ft.		Purpose:		Sewer category:	
Media label:				PreCleaning: L		Date cleaned:		Weather: 1		Location code:		Pressure value:							
Project name: Sewer Cleaning & CCTV - Project No. 210670				Additional info:

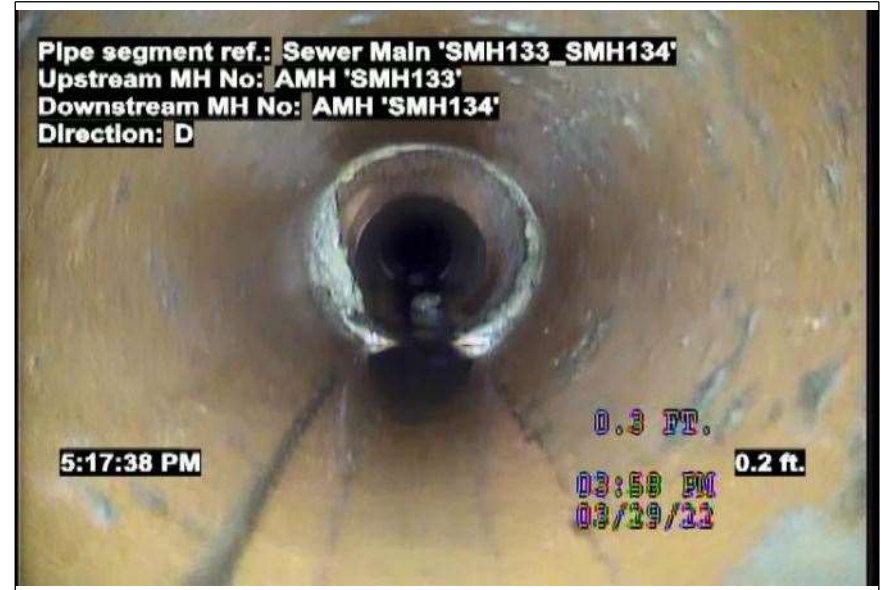
At: 0 ft. MWL - Miscellaneous Water Level
 Joint: No 5 %

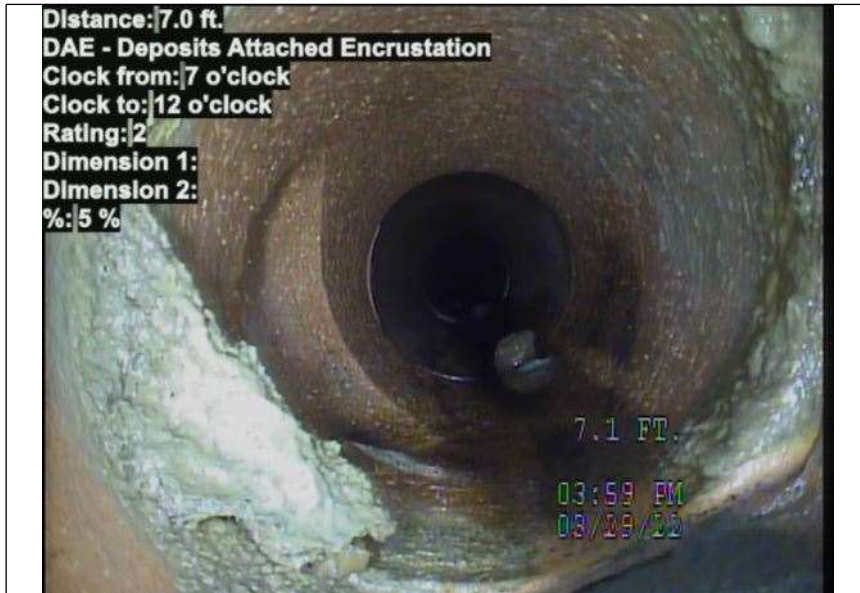
7.0 ft.	00:01:09	DAE					5	<input type="checkbox"/>	7 / 5		2	SMH133_SMH134_DAE_7.0 ft.JPG	
8.3 ft.	00:01:52	TF				6.000		<input type="checkbox"/>	9 /			SMH133_SMH134_TF_8.3 ft.JPG

At: 7 ft. 7/5 DAE - Deposits Attached Encrustation
 Joint: No 5 %

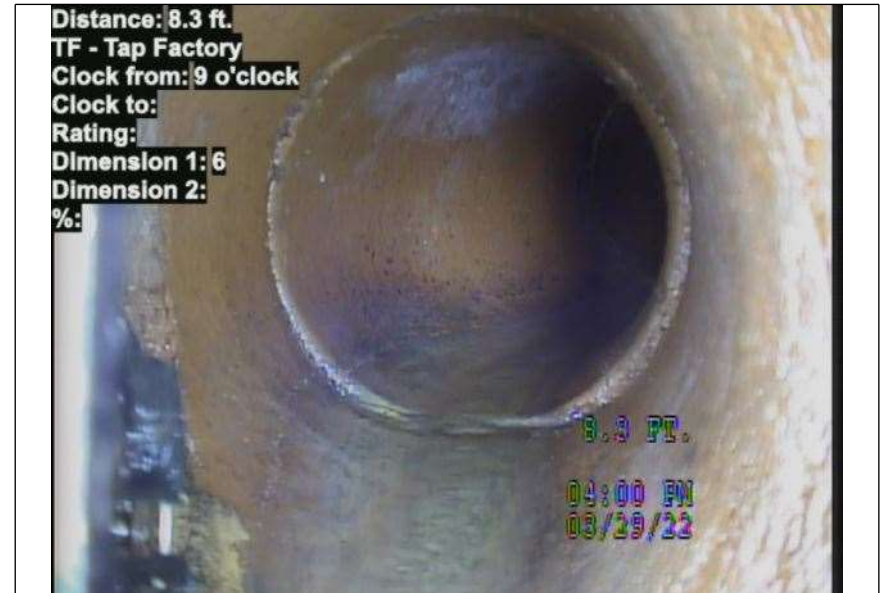
At: 8.3 ft. 9/. TF - Tap Factory
 Joint: No

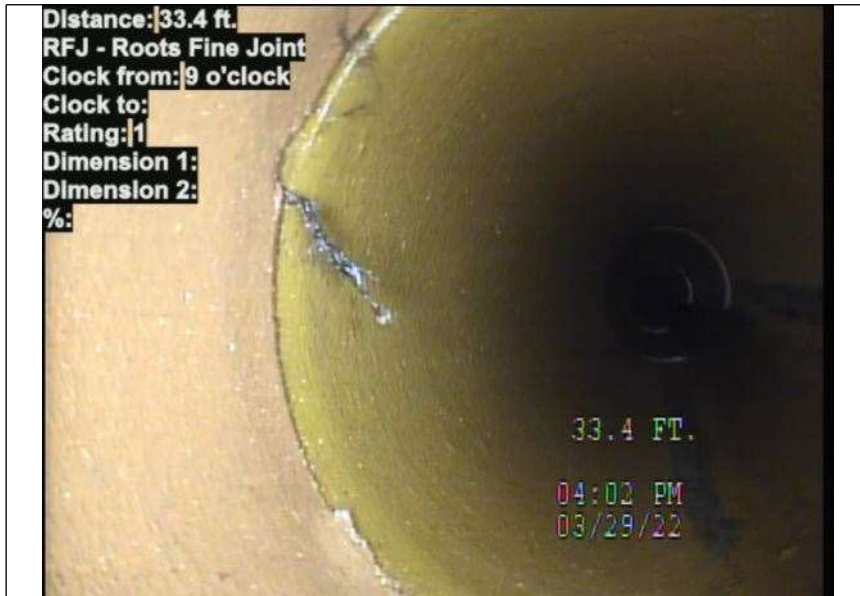
33.4 ft.	00:04:09	RFJ						<input checked="" type="checkbox"/>	9 /		1	SMH133_SMH134_RFJ_33.4 ft.JPG	
63.5 ft.	00:05:18	TFA				6.000		<input type="checkbox"/>	3 /			SMH133_SMH134_TFA_63.5 ft.JPG

At: 33.4 ft. 9/. RFJ - Roots Fine Joint
Joint: Yes

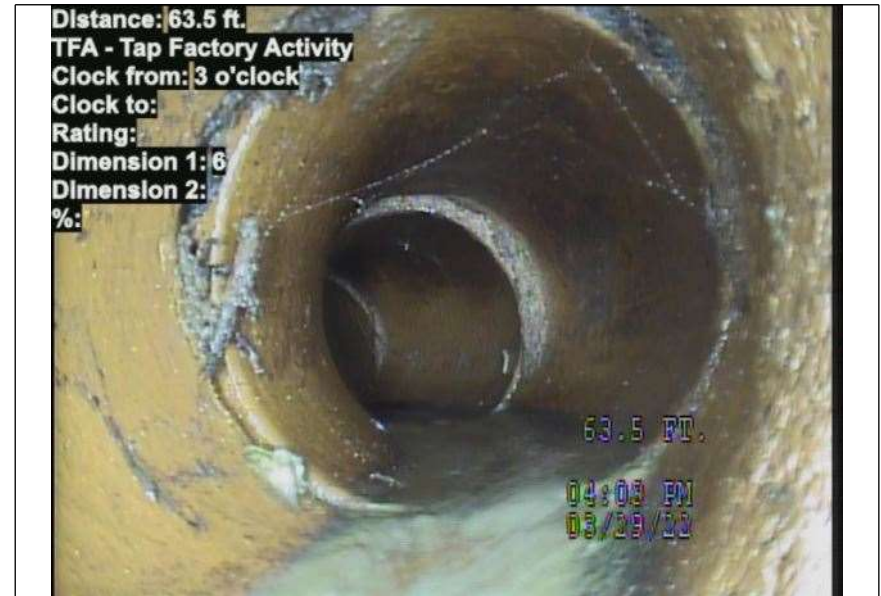
At: 63.5 ft. 3/. TFA - Tap Factory Activity
Joint: No

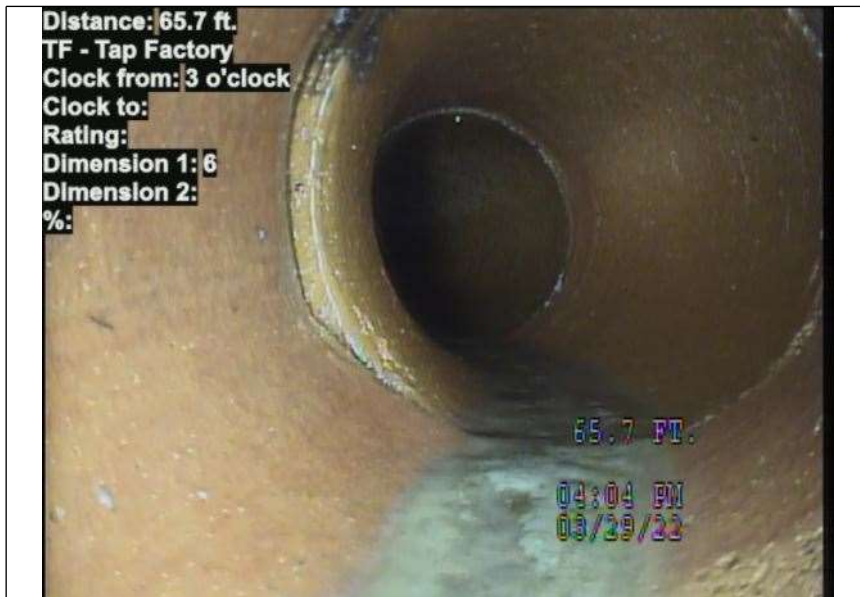
At: 65.7 ft. 3/. TF - Tap Factory
Joint: No

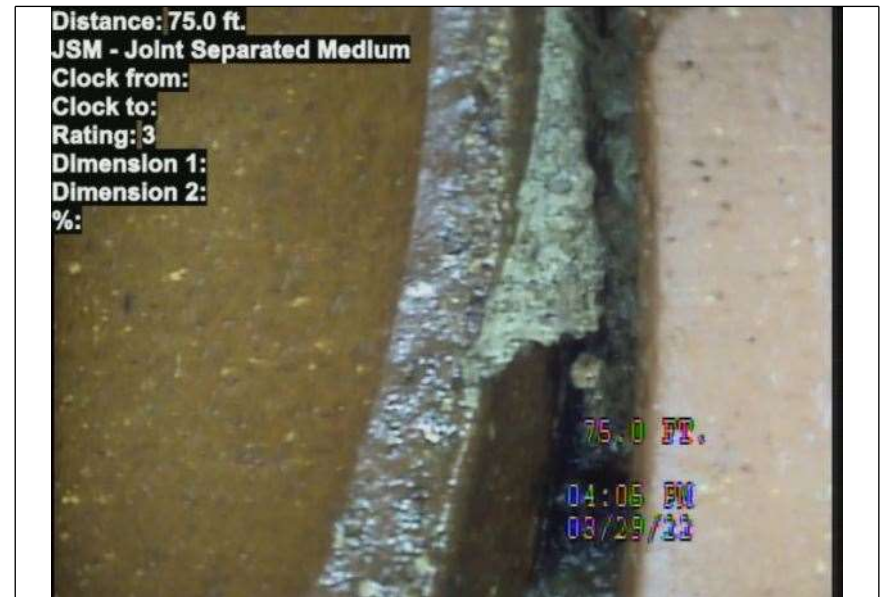
65.7 ft.	00:05:53	TF				6.000		<input type="checkbox"/>	3 /			SMH133_SMH134_TF_65.7 ft.JPG	
75.0 ft.	00:06:37	JSM		M				<input type="checkbox"/>	/		3	SMH133_SMH134_JSM_75.0 ft.JPG

At: 75 ft. JSM - Joint Separated Medium
Joint: No

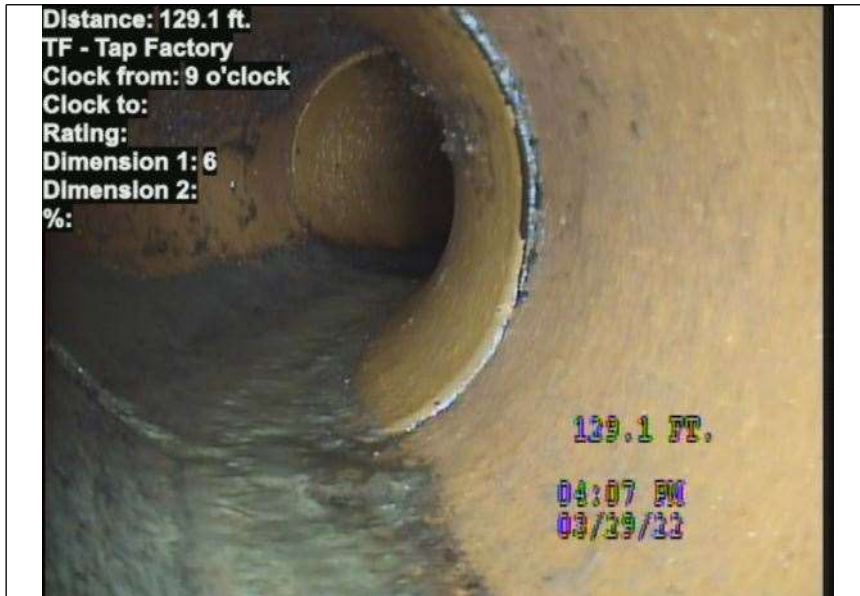
At: 129.1 ft. 9/. TF - Tap Factory
Joint: No

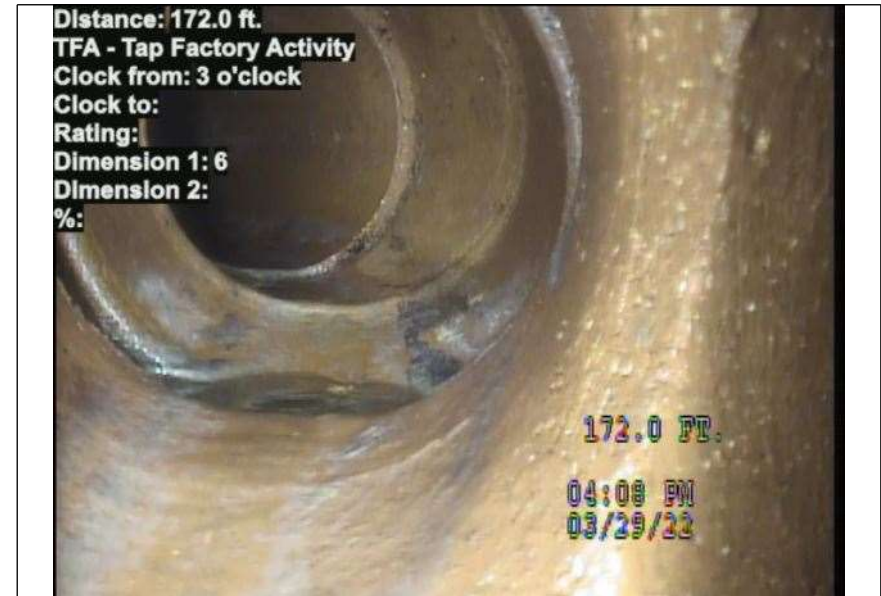
At: 172 ft. 3/. TFA - Tap Factory Activity
Joint: No

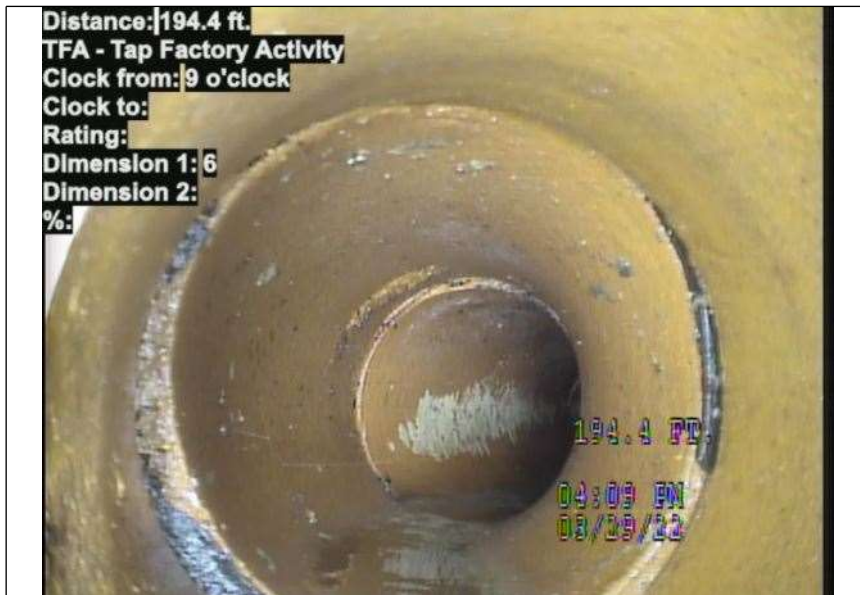
At: 194.4 ft. 9/. TFA - Tap Factory Activity
Joint: No

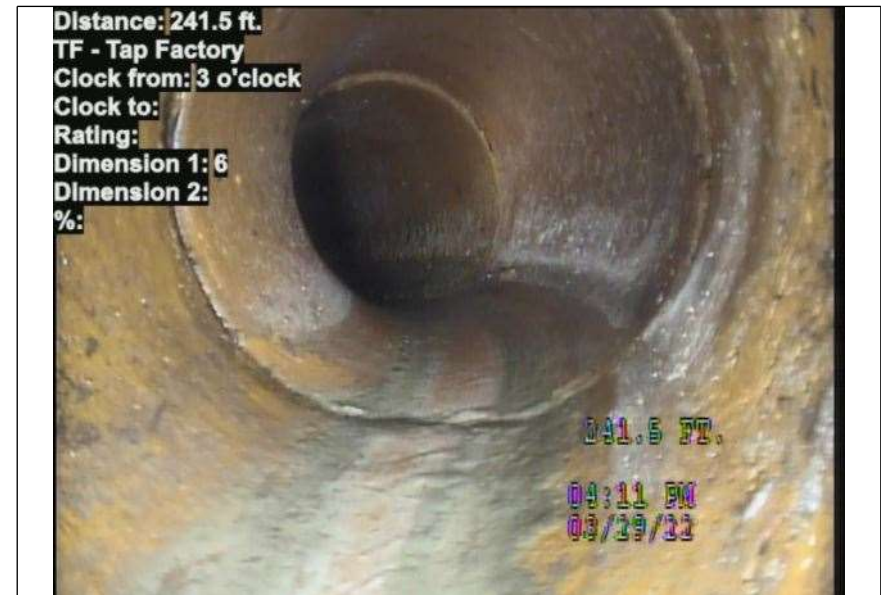
At: 241.5 ft. 3/. TF - Tap Factory
Joint: No
