PACP Report with Pipe Run and Incident Snapshots

Surveyed by: AARON H		Certificate number: U-813-18986		Owner:		Customer:		Drainage area:		P/O number:		Sheet number:							
Pipe segment ref.: SMH134A_SMH015				Start date/time: 20220419 10:51		Street: MILTON ST				City: SMITHVILLE									
Location details:				Upstream MH No: SMH134A				Rim to invert:		Grade to invert:		Rim to grade:							
Sewer use:		Direction: D		Flow control:		Downstream MH No: SMH015				Rim to invert:		Grade to invert:		Rim to grade:					
Height: 18 in.		Width:		Shape: C		Material: VCP		Lining method:		Pipe joint length:		Total length: 479.3 ft.		Length surveyed: 479.3 ft.		Reason:		Sewer category:	
Media label:				Pre-cleaning: J		Date cleaned:		Weather:		Location code:		Pressure value:							
Project name: Sewer Cleaning & CCTV - Project No. 210670				Additional info:

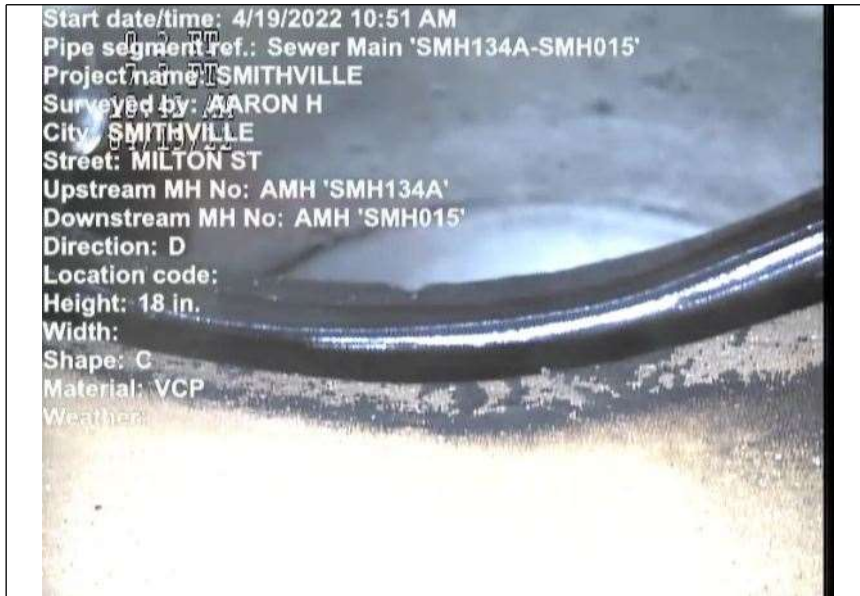
At: 0 ft. AMH - Manhole
 Joint: No SMH134A

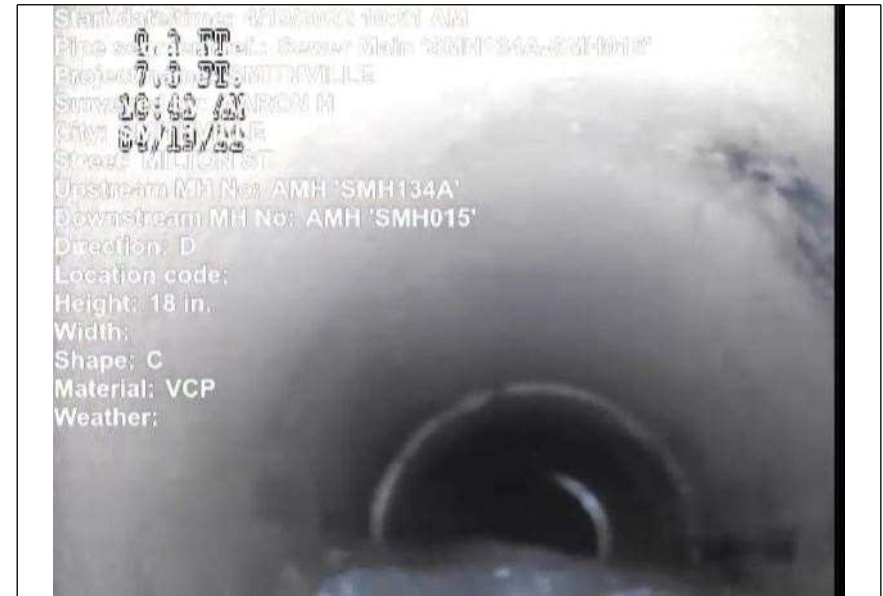
At: 0 ft. MWL - Water Level
 Joint: No 25 %

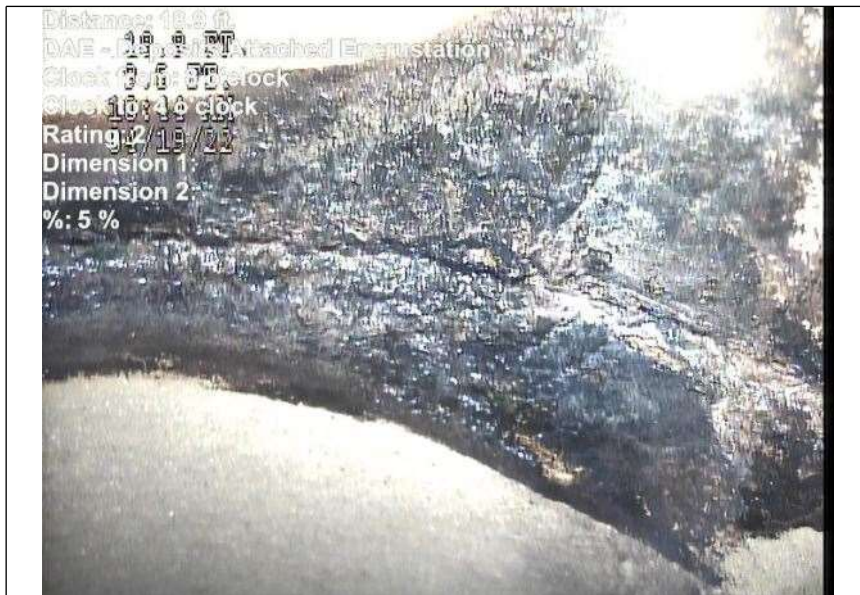
At: 18.9 ft. 8/4 DAE - Deposits Attached Encrustation
 Joint: Yes 5 %

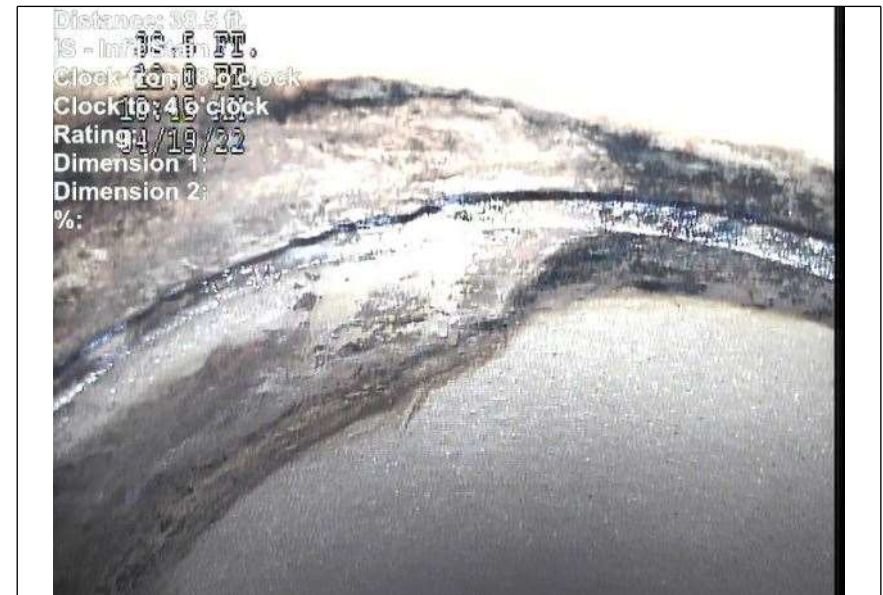
At: 38.5 ft. 8/4 IS - Infil Stain
 Joint: Yes

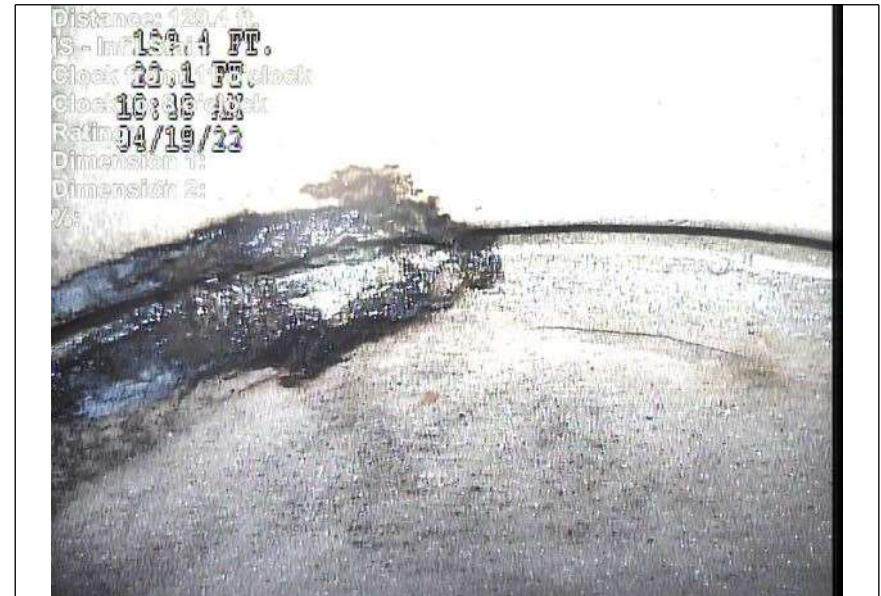
At: 129.4 ft. IS - Infil Stain 11/8
Joint: Yes

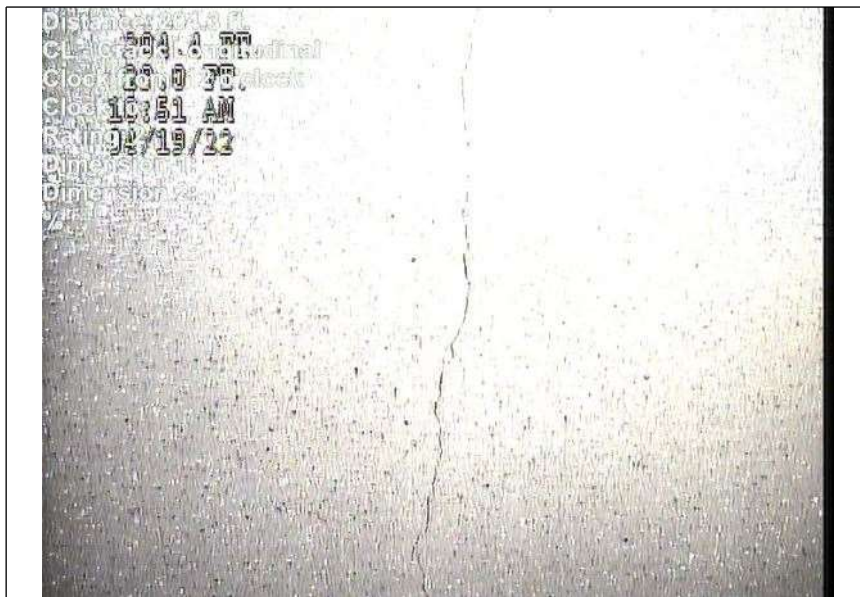
At: 204.3 ft. 12/ CL - Crack Longitudinal
Joint: No

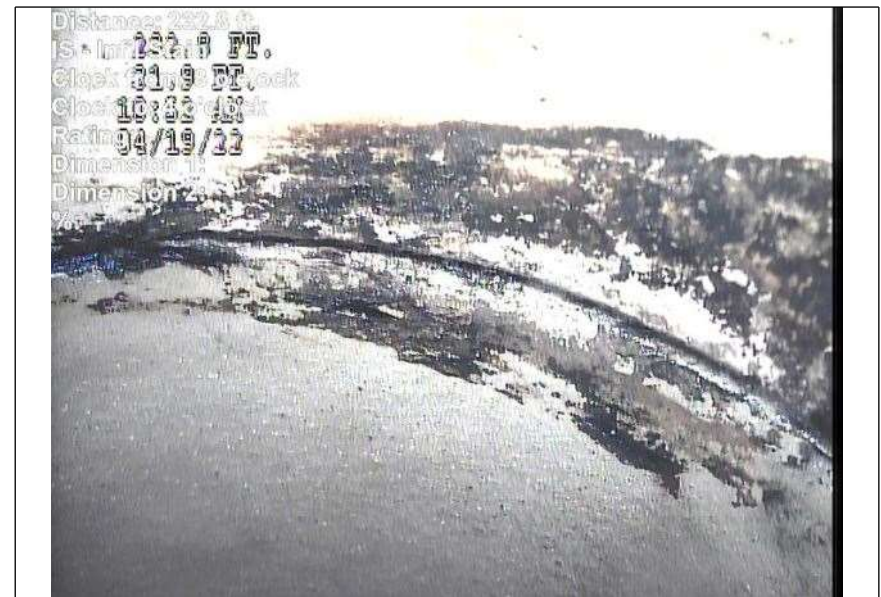
At: 232.8 ft. 8/4 IS - Infil Stain
Joint: Yes

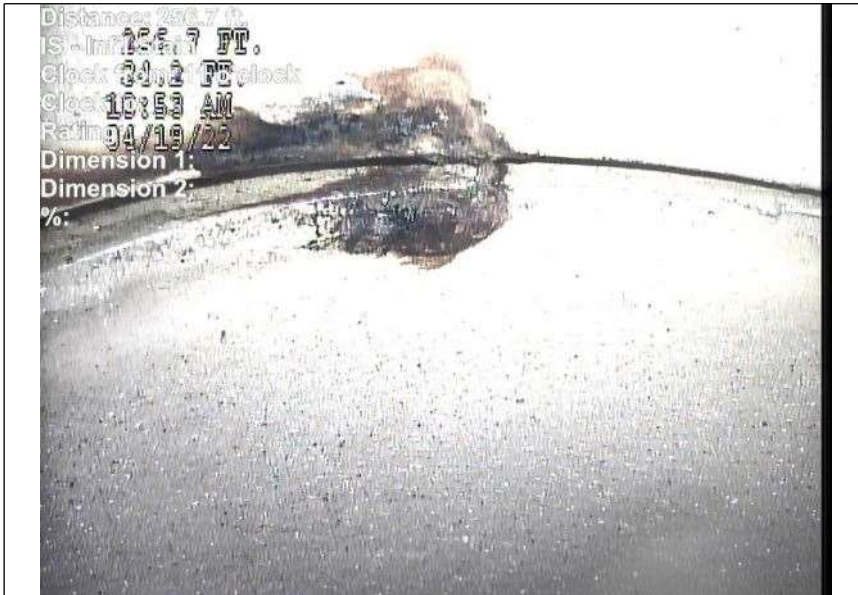
At: 256.7 ft. 11/ IS - Infil Stain
Joint: Yes

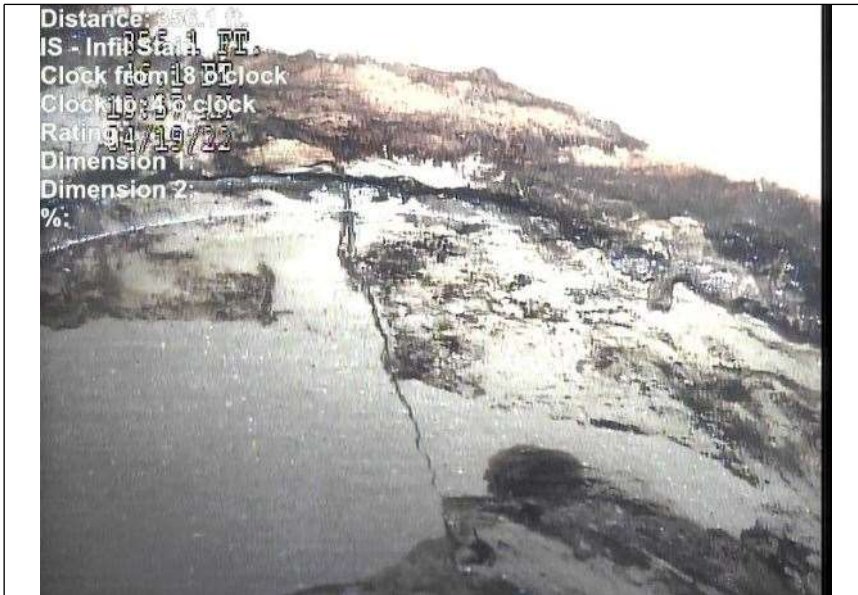
At: 356.1 ft. 8/4 IS - Infil Stain
Joint: Yes

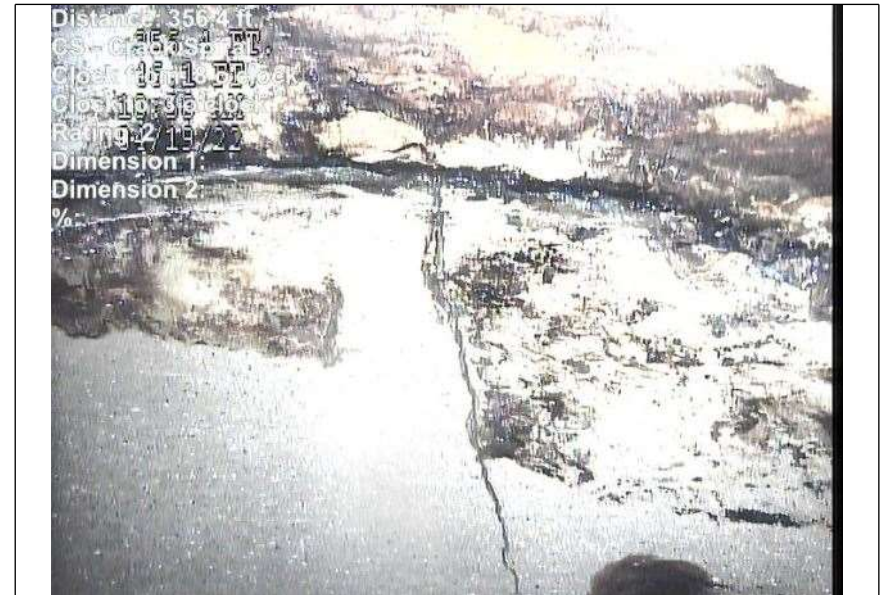
At: 356.4 ft. 8/3 CS - Crack Spiral
Joint: Yes
