PACP Report with Pipe Run and Incident Snapshots

Surveyed by: Mike Brooks	Certificate number: Mike Brooks	Owner:	Customer:	Drainage area:	P/O number:	Sheet number:
Pipe segment ref.: SMH134_SMH134B	Start date/time: 20220329 17:39	Street: S MILTON ST		City: SMITHVILLE		
Location details: STREET		Upstream MH No: SMH134	Rim to invert:	Grade to invert:	Rim to grade:	
Pipe use: SS	Direction: D	Flow control:	Downstream MH No: SMH134B	Rim to invert:	Grade to invert:	Rim to grade:
Height: 8 in.	Width:	Shape: C	Material: VCP	Lining method:	Pipe joint length:	Total length: 223.600 ft.
Media label:	PreCleaning: L	Date cleaned:	Weather: 1	Length surveyed: 223.600 ft.	Purpose:	Sewer category:
Project name: Sewer Cleaning & CCTV - Project No. 210670		Additional info:

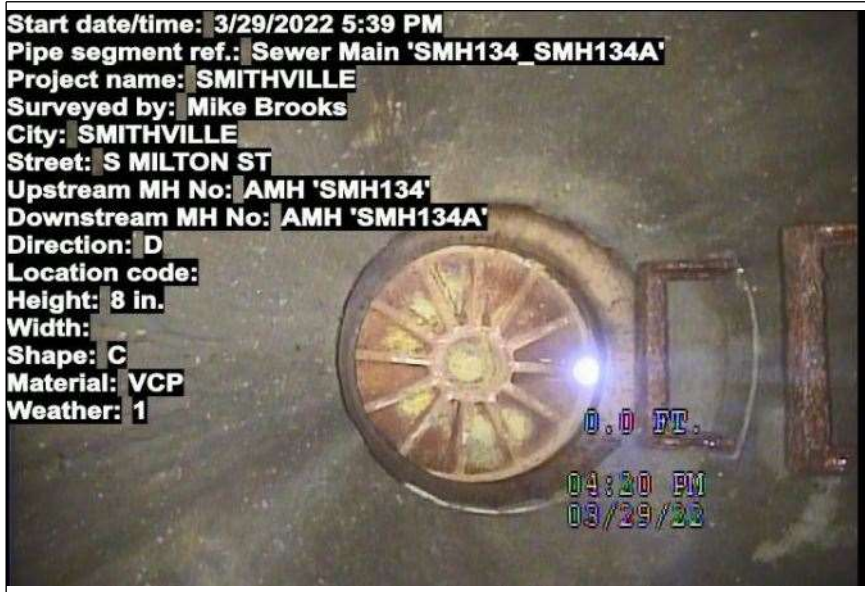
At: 0 ft. AMH - Manhole
 Joint: No SMH134

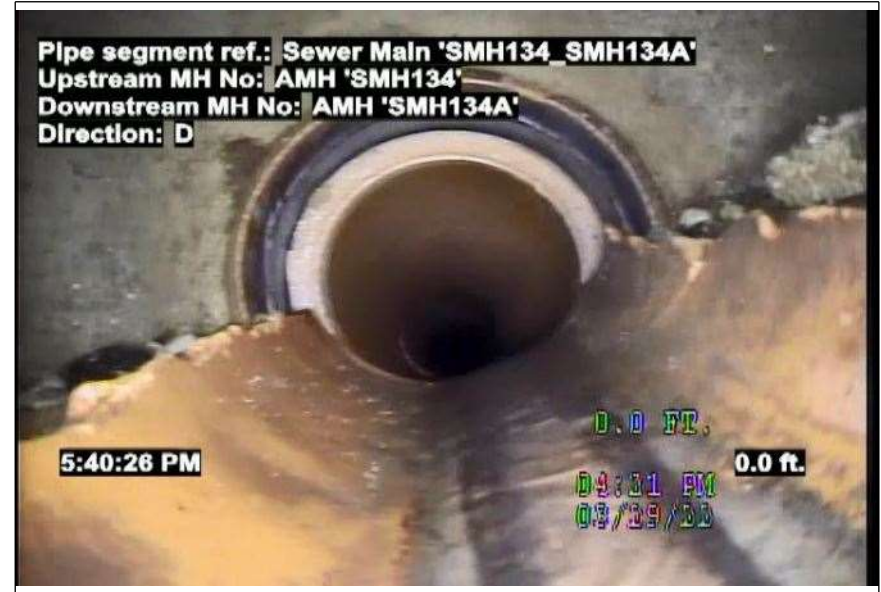
At: 0 ft. MWL - Miscellaneous Water Level
 Joint: No 5 %

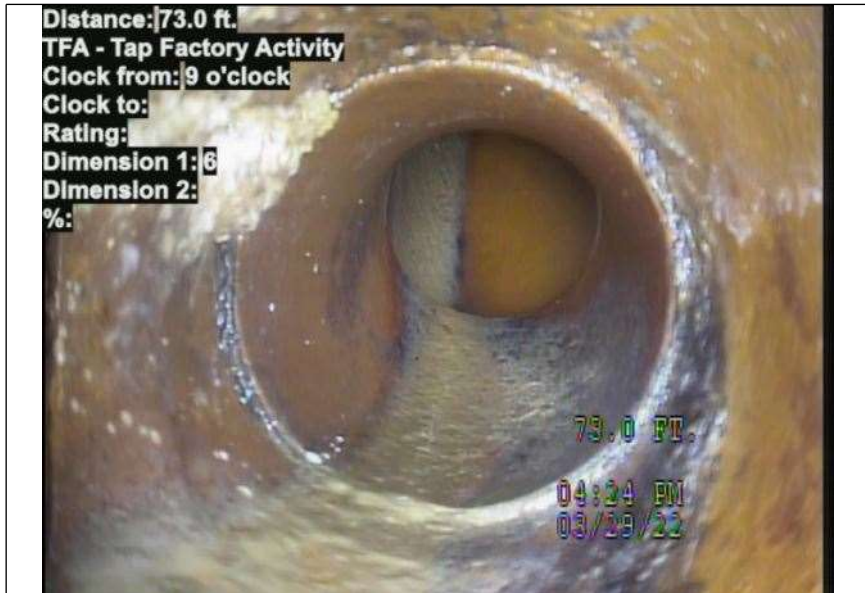
At: 73 ft. 9/ TFA - Tap Factory Activity
 Joint: No

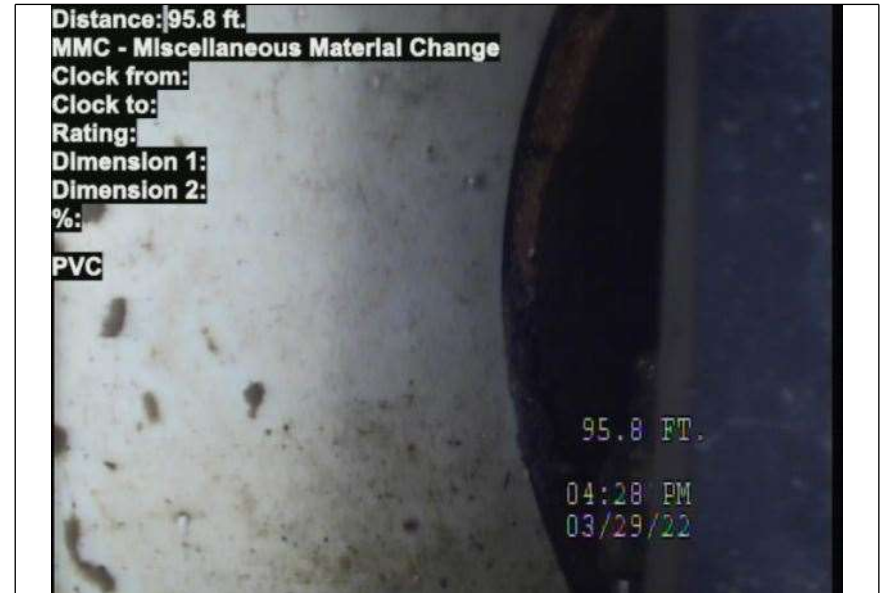
At: 95.2 ft. MMC - Miscellaneous Material Change
 Joint: No PVC

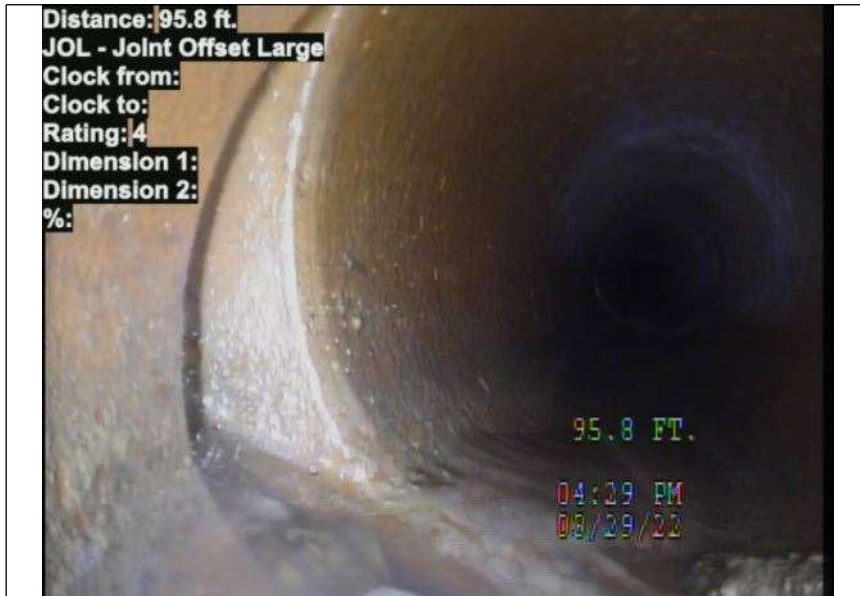
At: 95.8 ft. JOL - Joint Offset Large
Joint: No

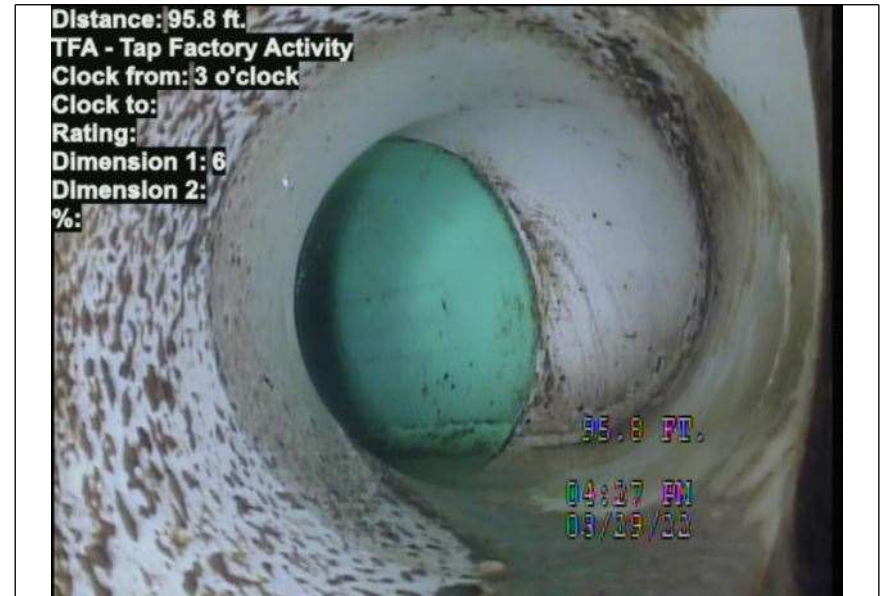
At: 95.8 ft. 3/ TFA - Tap Factory Activity
Joint: No

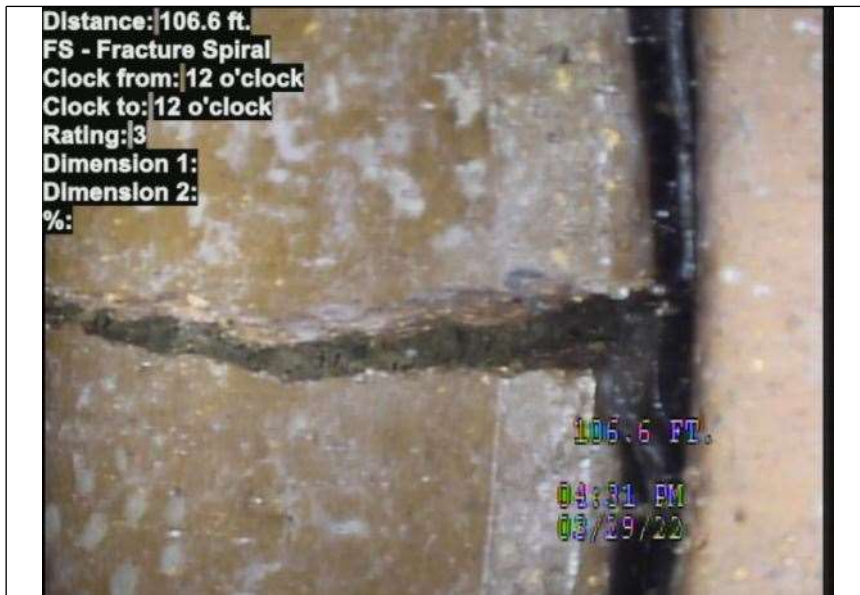
At: 106.6 ft. FS - Fracture Spiral
12/12
Joint: No

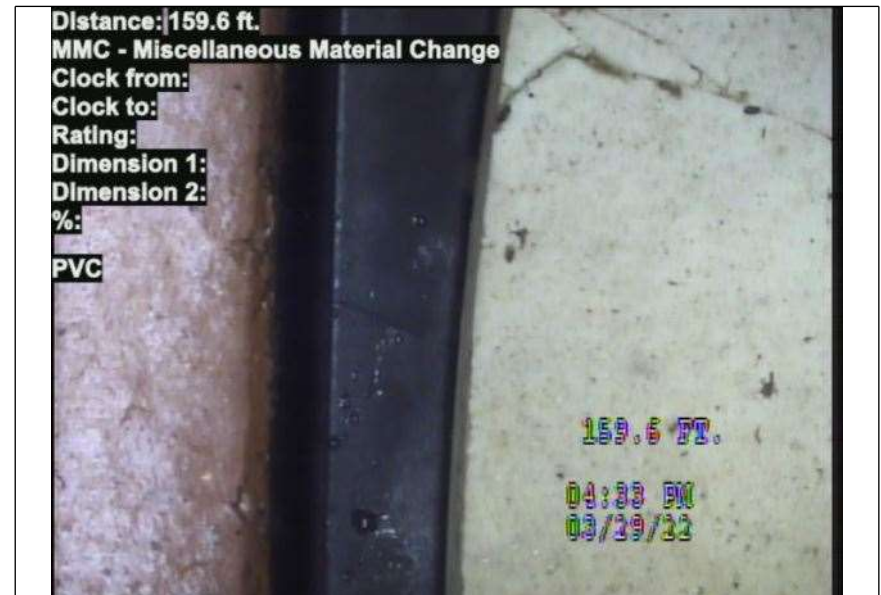
At: 159.6 ft. MMC - Miscellaneous Material Change
Joint: No PVC

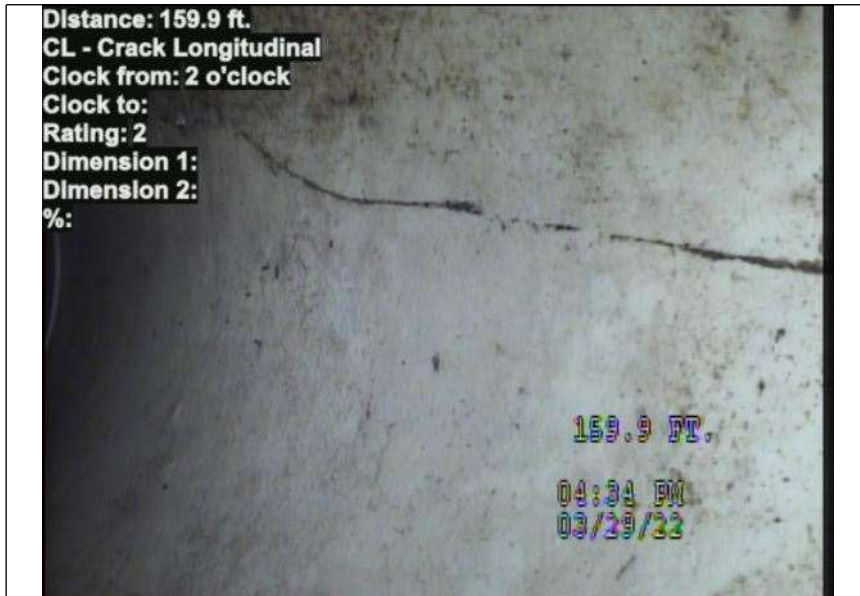
At: 159.9 ft. 2/. CL - Crack Longitudinal
Joint: No

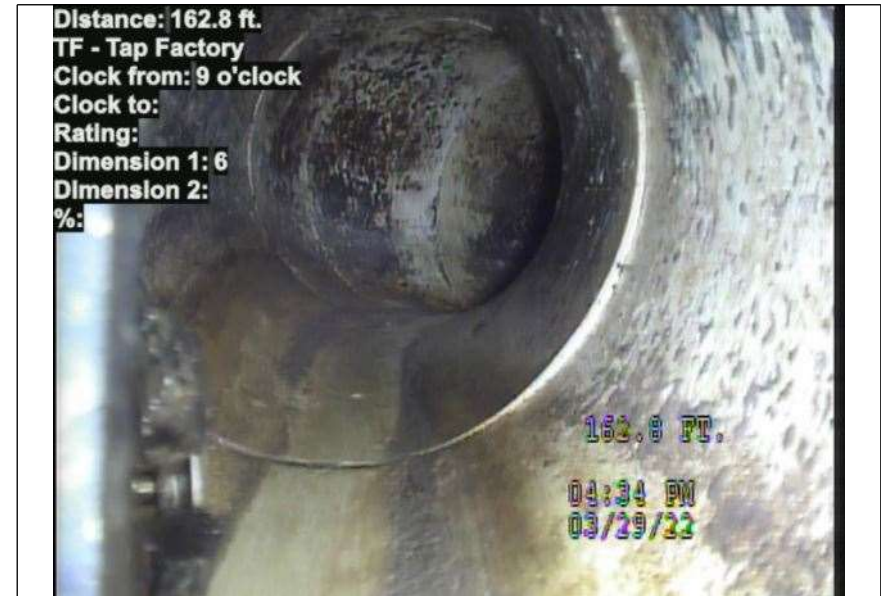
At: 162.8 ft. 9/. TF - Tap Factory
Joint: No

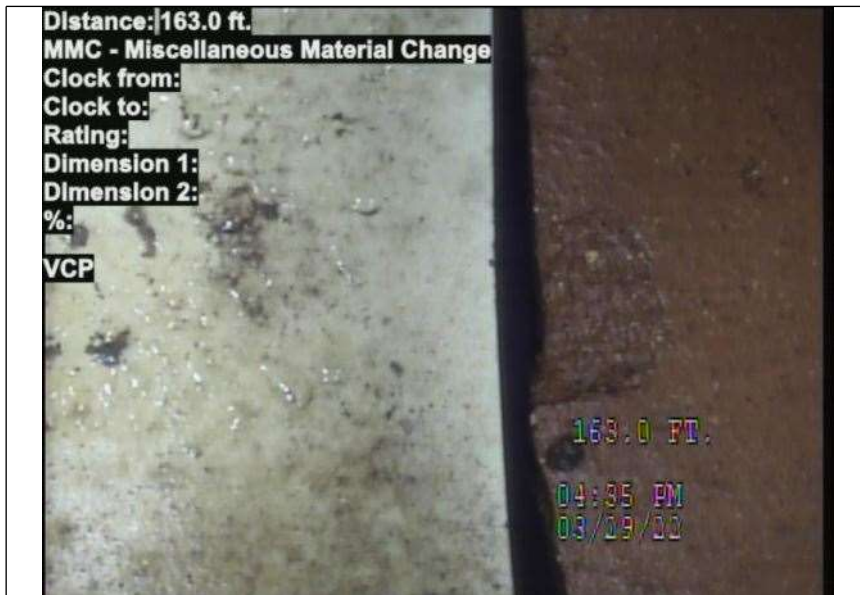
At: 163 ft. RPR - Point Repair Replacement
Joint: No VCP

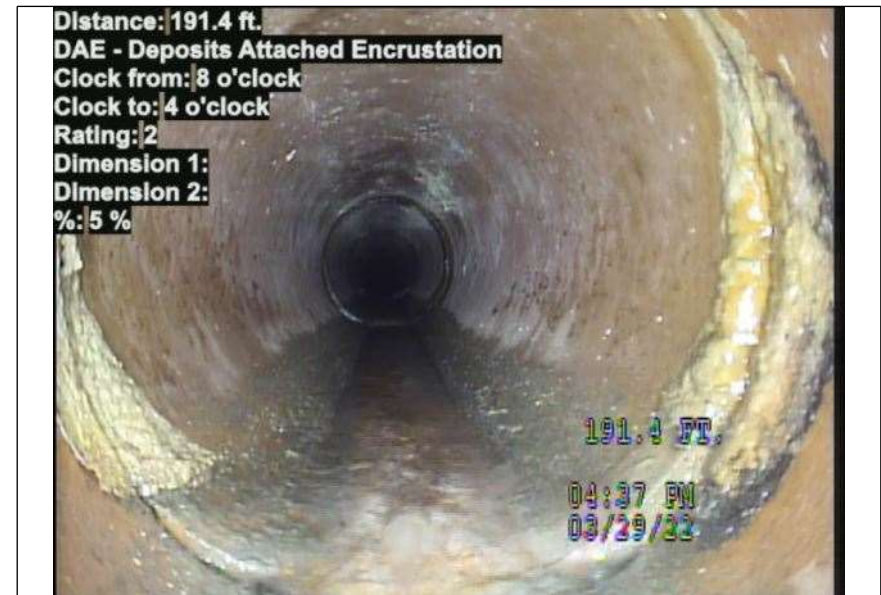
At: 191.4 ft. 8/4 DAE - Deposits Attached Encrustation
Joint: No 5 %

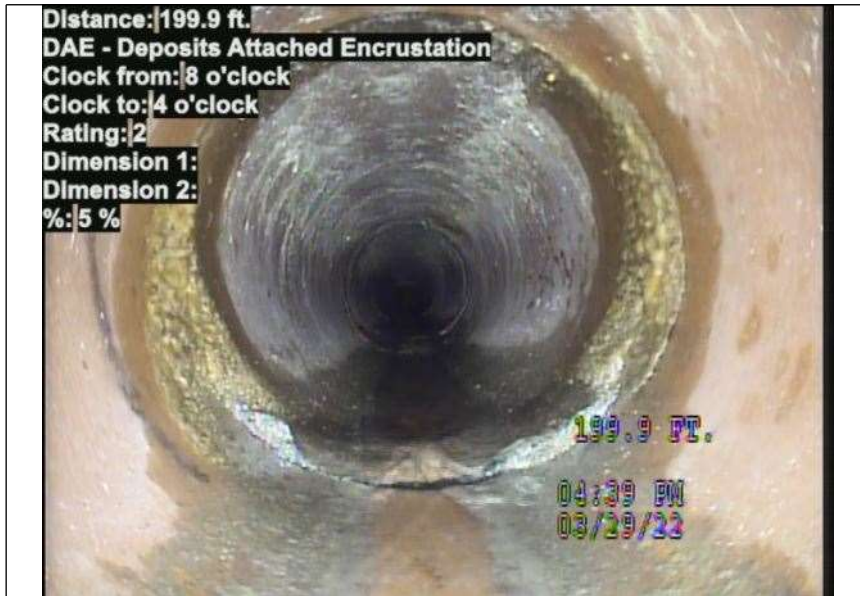
At: 199.9 ft. 8/4 DAE - Deposits Attached Encrustation
Joint: No 5 %

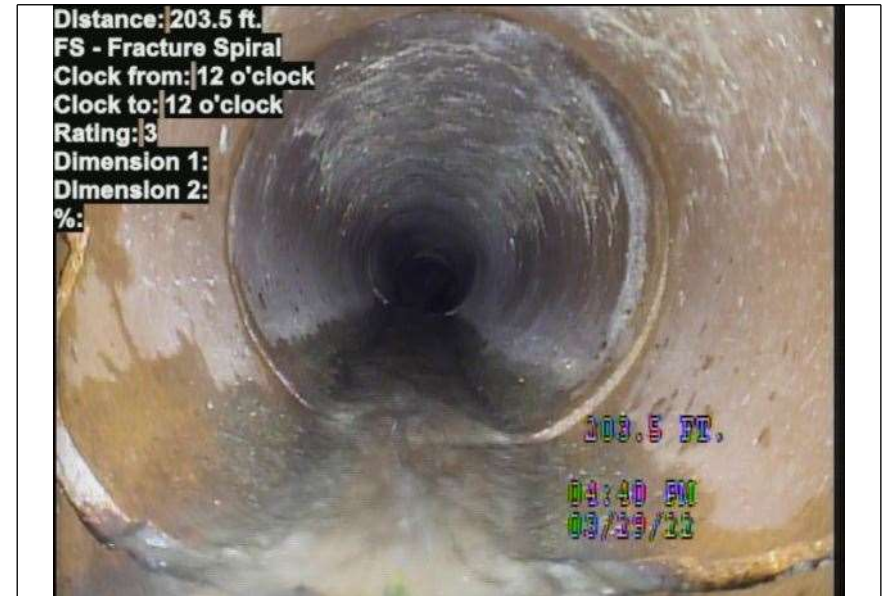
At: 203.5 ft. FC - Fracture Circumferential
12/12
Joint: No

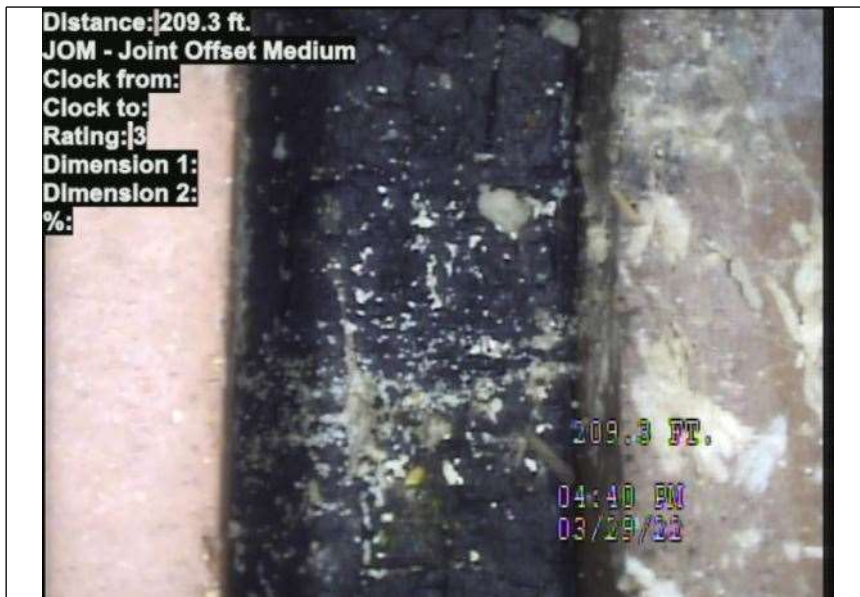
At: 209.3 ft. JOM - Joint Offset Medium
Joint: No

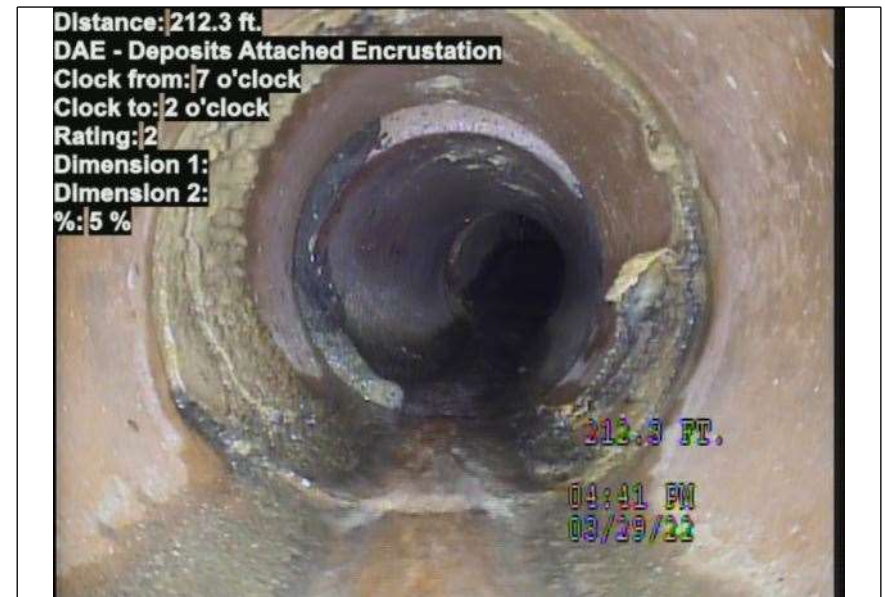
At: 211 ft. 7/2 DAE - Deposits Attached Encrustation
Joint: No 5 %

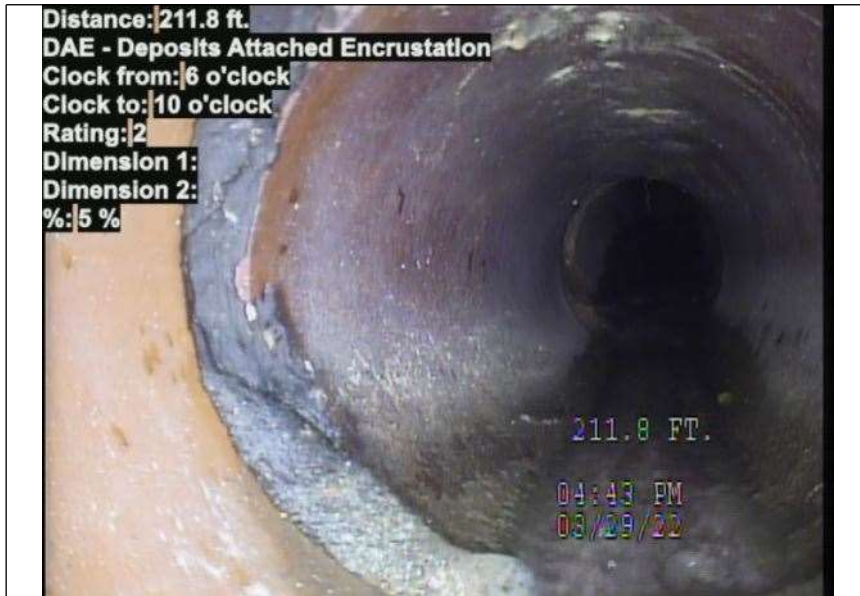
At: 211.8 ft. DAE - Deposits Attached Encrustation
6/10

Joint: No 5 %

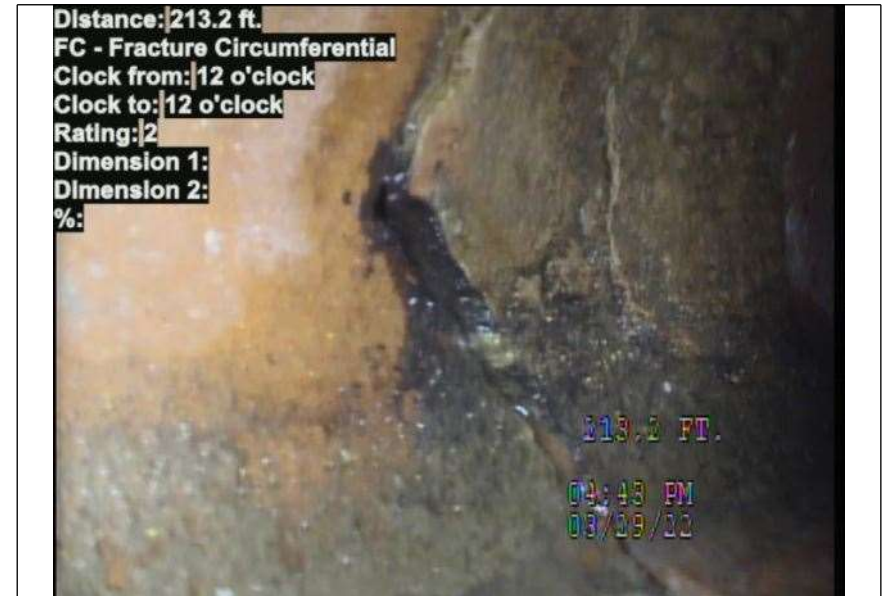
At: 213.2 ft. FC - Fracture Circumferential
12/12

Joint: No

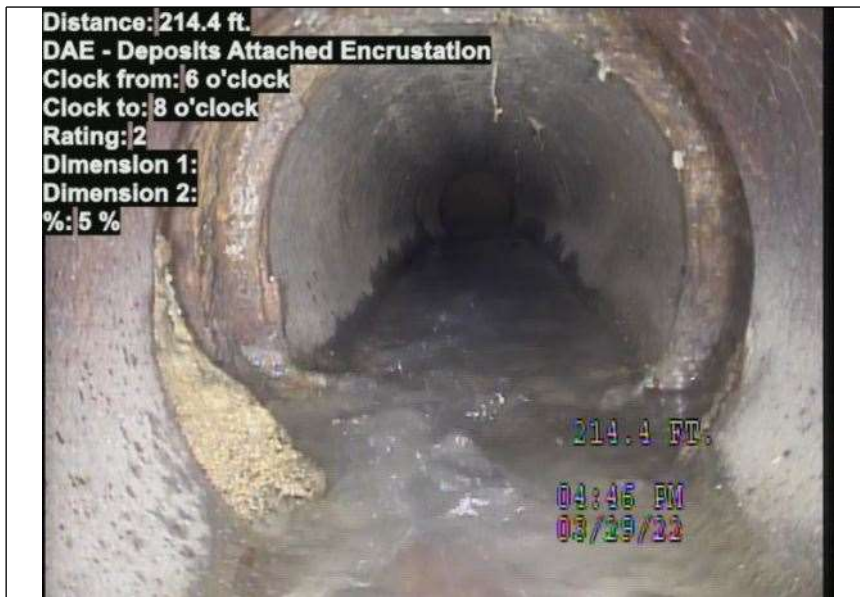
At: 214.4 ft. 6/8 DAE - Deposits Attached Encrustation

Joint: No 5 %

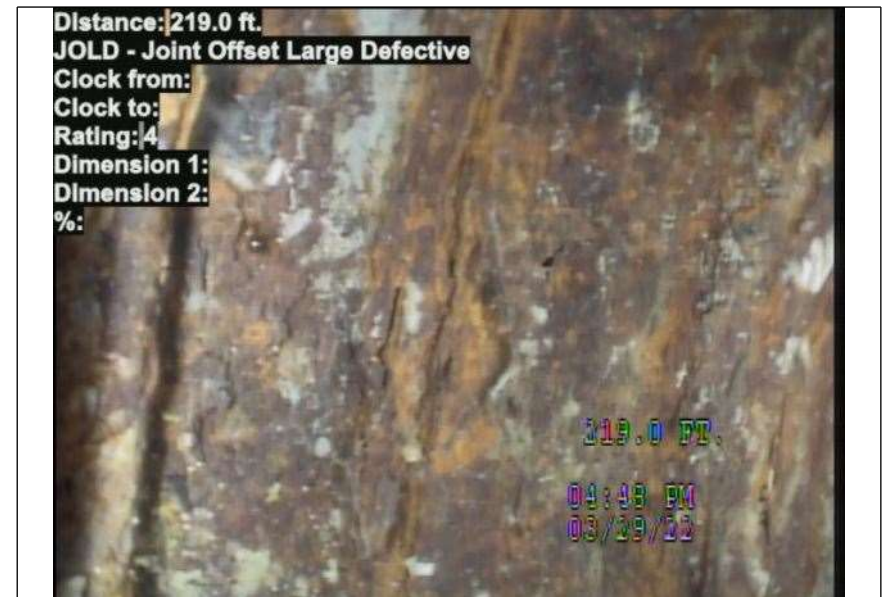
- At 219.0 ft.
JOLD - Joint Offset Large
Defective
Rating:
Category: Structural
219.000 ft.
- At 223.6 ft.
AMH - Manhole
Comments: SMH134B THOUGHT IT
WAS GOING TO BE
SMH134A
223.600 ft.

At: 219 ft. JOLD - Joint Offset Large Defective

Joint: No

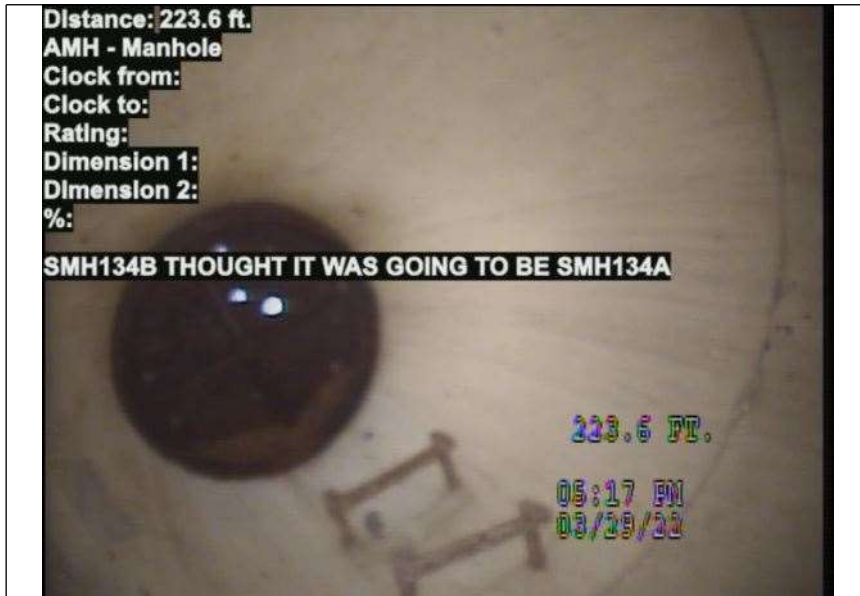
At: 223.6 ft. AMH - Manhole
Joint: No SMH134B
