Coring Report

2026 Paving Program

PREPARED FOR
Village of Hartville

Verdantas Project No. 41933
January 27, 2026

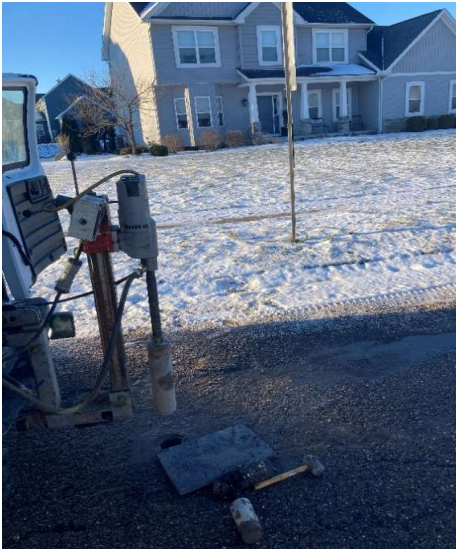
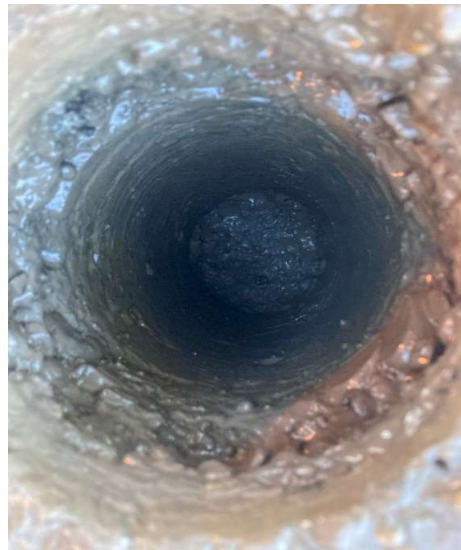
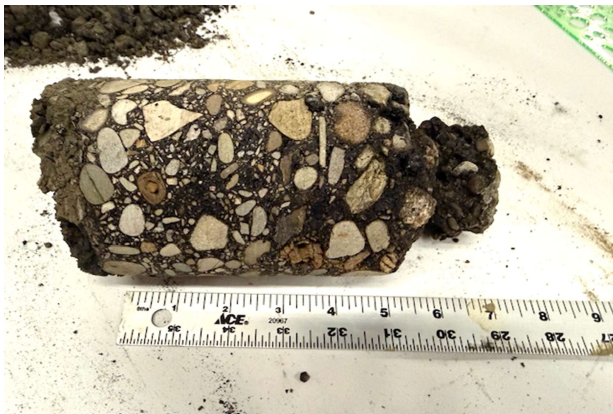
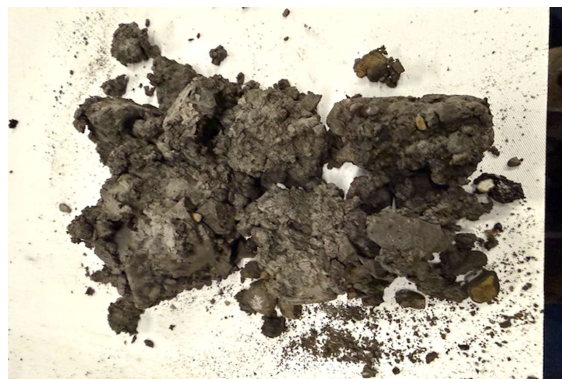
CORE #1

Core #	Location	Cored Material Description	Actual Material Thickness In Inches	Plan Depth	Condition/Type of Subgrade -Aggregate Size -Remarks
1	Hse #564 Byeberry Dr. 7' from back of curb, east bound lane. see attached map	Asphalt	3.0	N/A	3/8" max aggregate - gravel
		Asphalt	5.0	"	1 1/4" max aggregate - limestone and gravel
		Sub-total cored	8.0		Top 3" wearing course of finish pavement is consolidated the first 1 to 1.5". The bottom of that layer is friable and crumbles easily. The Base is a clay gravel mix.
2	Hse #544 Byeberry Dr. 9' from back of curb, NW bound lane. see attached map	Asphalt	3.5	N/A	3/8" max aggregate - limestone & slag
		Asphalt	5.0	"	1 1/2" max aggregate -gravel
		base material	4.0		304 limestone 1 1/4" max aggregate
		sub-base material	10.5		Gravel 1" max aggregate
		Sub-total cored	8.5		Top 3" wearing course of finish pavement is consolidated the first 1 to 1.5". The bottom of that layer is friable and crumbles easily. The sub-base is a clay gravel mix.

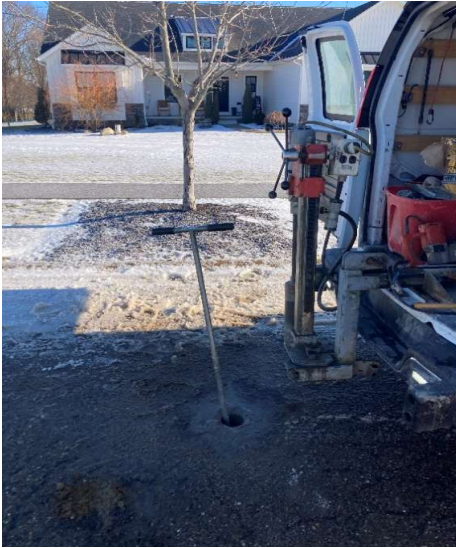
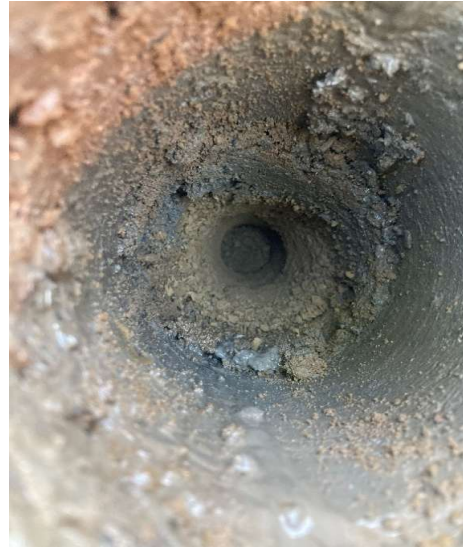
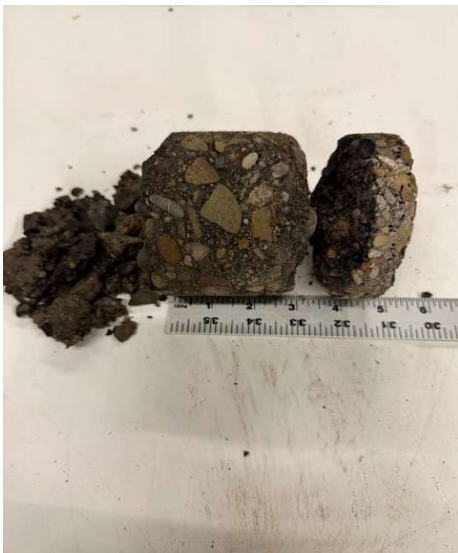
CORE #3

3	Hse #490 Byeberry Dr. 7'9" from back of curb, NW bound lane. see attached map	Asphalt	2.0	N/A	3/8" max aggregate - gravel
		Asphalt	4.0	"	1 1/8" max aggregate - gravel
		base material	3.8		304 limestone 1 1/4" max aggregate
		sub-base material	6.0		Gravel 1" max aggregate
		Sub-total cored	6.0		Top 3" wearing course of finish pavement is consolidated the first 1 to 1.5". The bottom of that layer is friable and crumbles easily. The sub-base is a clay gravel mix.
		Total Cored	22.5

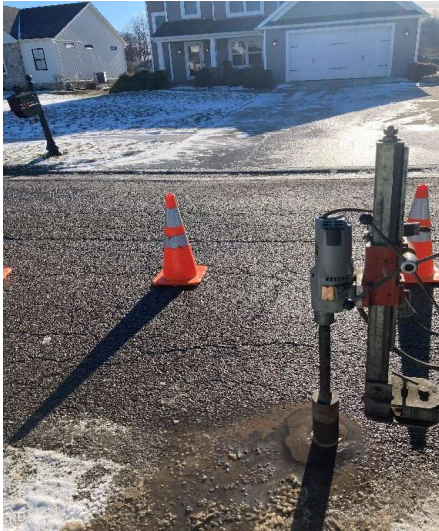
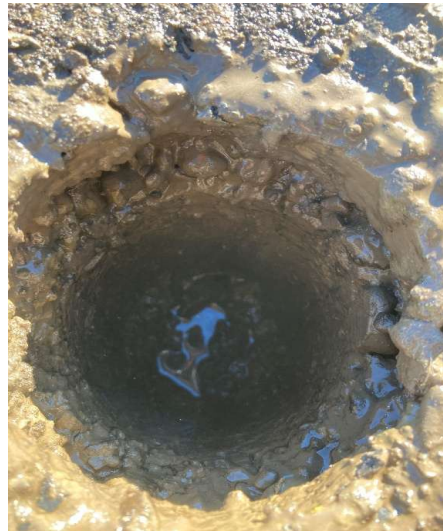
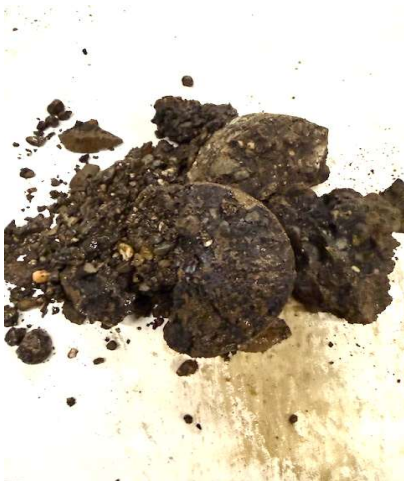
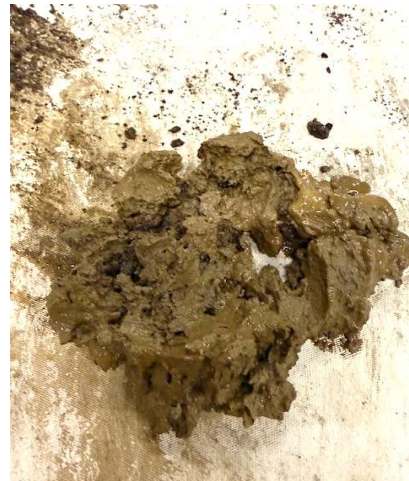
CORE #4

Core #	Location	Cored Material Description	Actual Material Thickness In Inches	Plan Depth	Condition/Type of Subgrade -Aggregate Size -Remarks
4	Hse #924 Northampton St. 5' from back of curb, SW bound lane. see attached map	Asphalt	3.0	N/A	3/8" max aggregate - gravel
		Asphalt	5.0	"	3/8" max aggregate - gravel
		base material	4.0		304 limestone
					Top 3" wearing course of finish pavement is consolidated the first 1 to 1.5". The bottom of that layer is friable and crumbles easily. Bottom courses solid but broken when extracting from bit with hammer.
		Sub-total cored	8.0		
5	Hse #351 Heatherby Ln. 5'4" from back of curb, south bound lane. see attached map	Asphalt	1.5	N/A	3/8" max aggregate - gravel
		Asphalt	3.5	"	1" max aggregate - gravel
					Base material is bank gravel with 1 3/4" max aggregate.
		Sub-total cored	5.0		
6	Hse #800/814 Northampton St. 9' from back of curb, west bound lane. see attached map	Asphalt	1.5	N/A	3/8" max aggregate - gravel

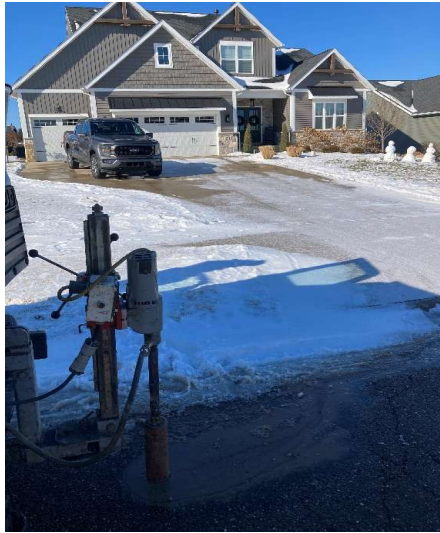
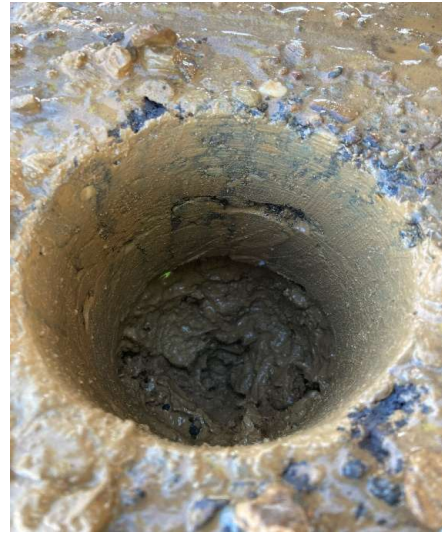
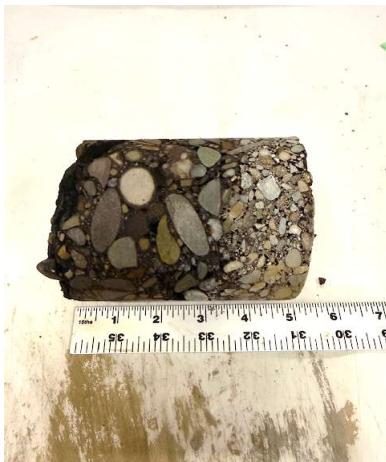
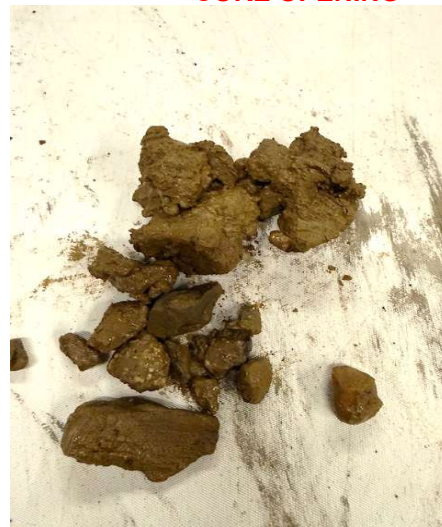
CORE #5

Asphalt	1.5	"	3/8" max aggregate - gravel friable
		Asphalt	5.0	"	1 1/4" max aggregate - limestone & gravel
		base material	6.5		Clay, gravel mix. 1" max aggregate.
		Sub-total cored	8.0

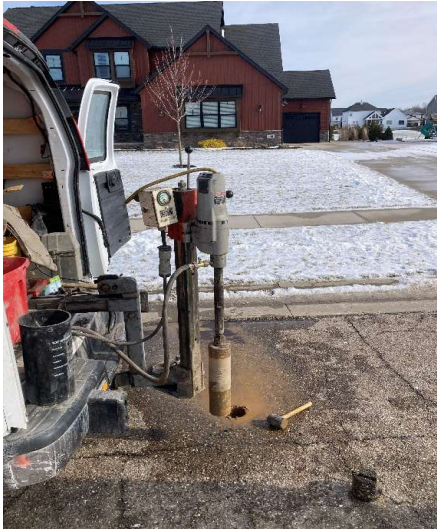
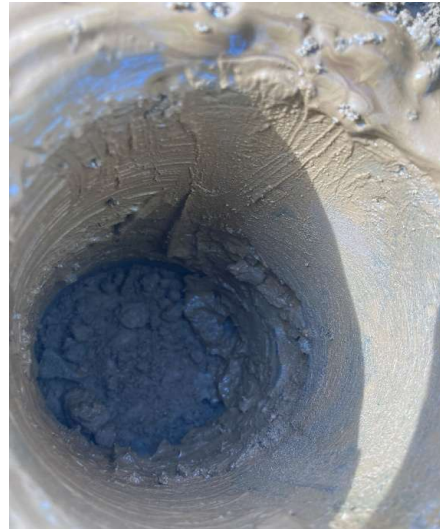
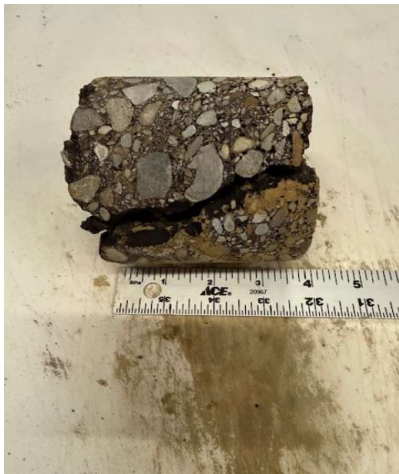
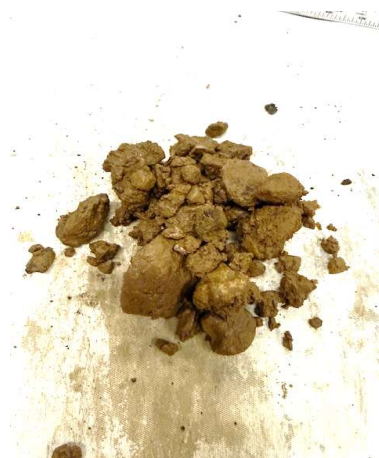
CORE #7

Core #	Location	Cored Material Description	Actual Material Thickness In Inches	Plan Depth	Condition/Type of Subgrade -Aggregate Size -Remarks
7	Hse #338 Leighfeild Ln. 7' from back of curb, north bound lane. see attached map	Asphalt	1.3	N/A	3/8" max aggregate - gravel
		Asphalt	2.4	"	1 1/4" max aggregate - gravel
		Sub-total cored	3.7		Base material is bank gravel with 1 3/4" max aggregate.
8	Hse #510 Gelnberry Ave. 7' from back of curb, north bound lane. see attached map	Asphalt	1.3	N/A	3/8" max aggregate - gravel
		Asphalt	3.7	"	1 1/4" max aggregate - gravel
		Asphalt	3.0	"	1" max aggregate - gravel, friable
		base material	8.0		bank gravel with 1 3/4" max aggregate.
		Sub-total cored	16.0		
9	Hse #206 Howard Ct. Centerline of road nearest Mill St. see attached map	Asphalt	3.0		3/8" max aggregate - gravel, friable
		Asphalt	2.5		1" max aggregate - gravel
		Asphalt	1.5		3/8" max aggregate - gravel
		base material	3.5		bank gravel with 1/2" max aggregate.

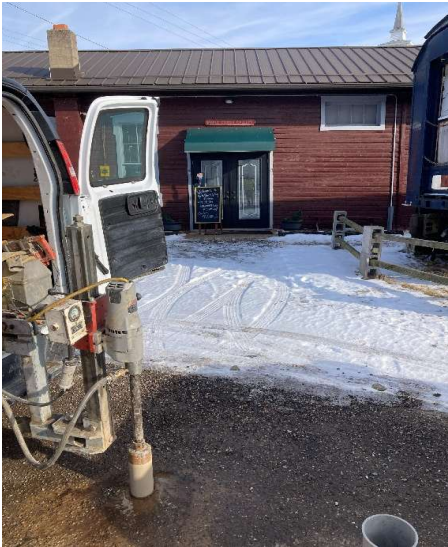
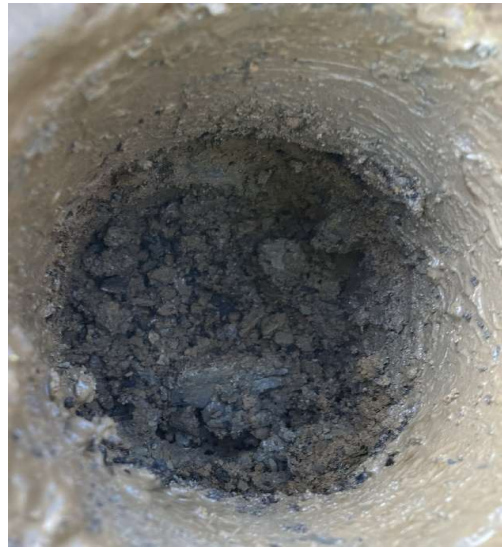
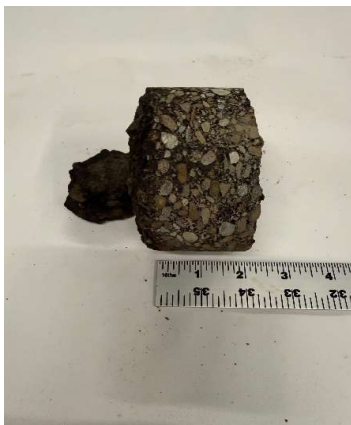
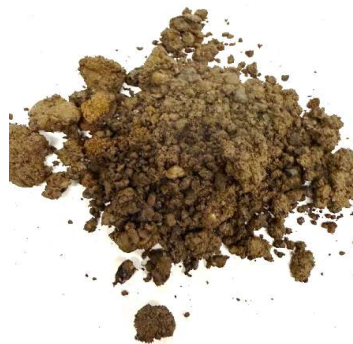
CORE #10

Core #	Location	Cored Material Description	Actual Material Thickness In Inches	Plan Depth	Condition/Type of Subgrade -Aggregate Size -Remarks
10	Maple St. Gallery Howard Ct. 6' from EOP, north bound lane. see attached map	Asphalt	2.0	N/A	3/8" max aggregate - gravel
		Asphalt	2.0	"	3/8" max aggregate - gravel
		base material	3.0		bank gravel with 1 1/2" max aggregate.
		Sub-total cored	4.0		
11	Park Lane Dr. 7' from EOP, south bound lane. Near pickle balls courts. see attached map	Asphalt	3.0	N/A	3/4" max aggregate - gravel
		Asphalt	4.5	"	1" max aggregate - gravel
		Sub-total cored	7.5		Top 3" wearing course of finish pavement is consolidated the first 1 to 1.5". The bottom of that layer is friable and crumbles easily. Base material is bank gravel with 1 1/4" max aggregate.
12	Park Lane Dr. 5' from EOP, north bound lane. South of intersection with Cora Place. see attached map	Asphalt	1.7	N/A	3/8" max aggregate - gravel

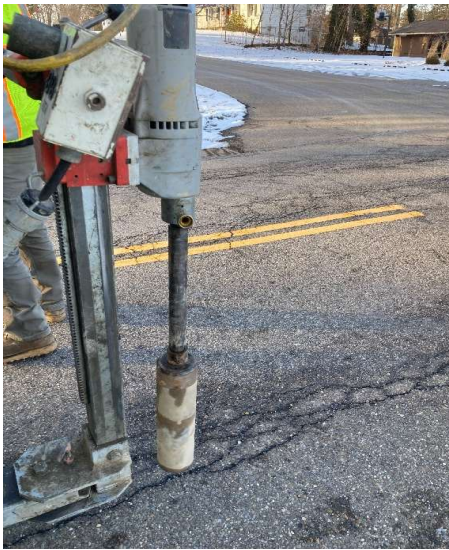
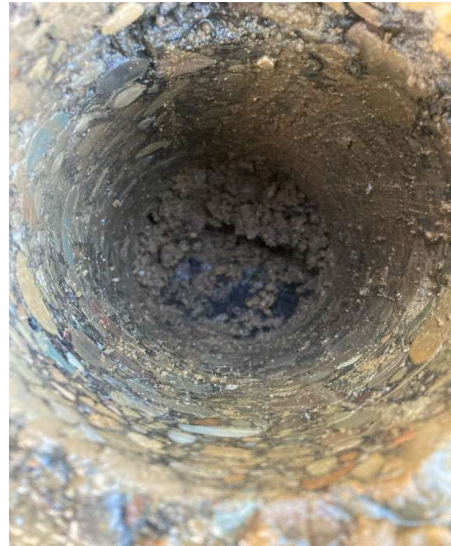
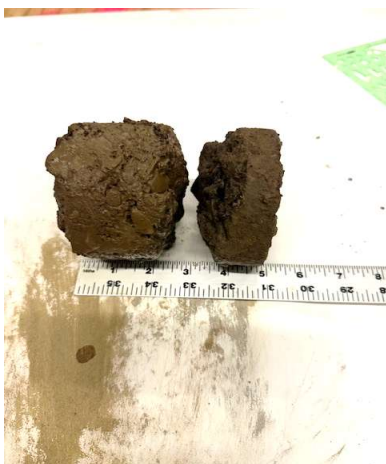
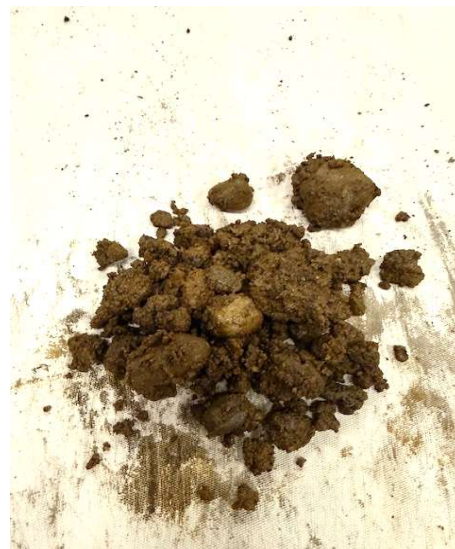
CORE #12

Asphalt	4.5	"	1" max aggregate - gravel, friable
		Asphalt	2.8	"	1" max aggregate - gravel
					Base material is bank gravel with 1 1/4" max aggregate.

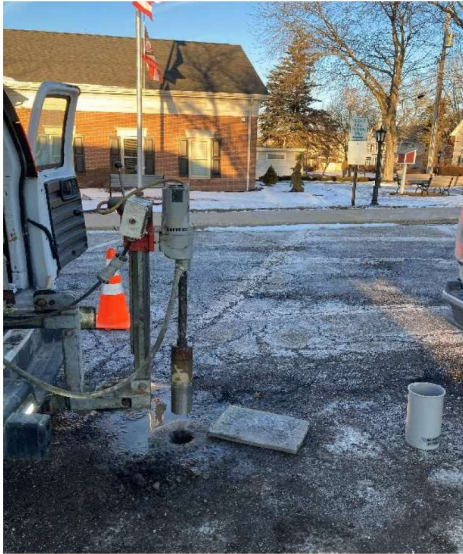
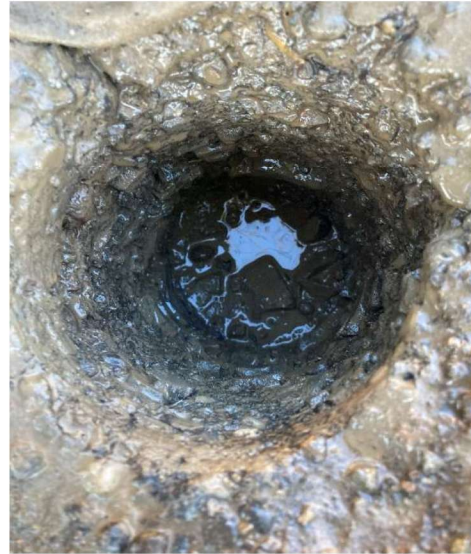
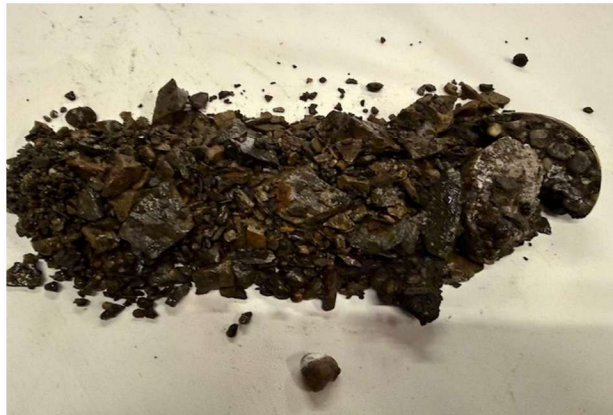
CORE #13

Core #	Location	Cored Material Description	Actual Material Thickness In Inches	Plan Depth	Condition/Type of Subgrade -Aggregate Size -Remarks
13	Robson Ave. At Village Hall Parking area. see attached map	Asphalt	1.0	N/A	3/8" max aggregate - gravel
		Asphalt	4.0	"	3/8" max aggregate - gravel
					Base material is bank gravel with 1 1/4" max aggregate.
		Sub-total cored	5.0		
14	Alley #3 Southernly end nearest Wagner Ct. see attached map	Asphalt	2.5	N/A	3/8" max aggregate - gravel, friable
		Asphalt	2.5	"	3/8" max aggregate - gravel
		base material	4.0		bank gravel with 1 1/2" max aggregate.
		Sub-total cored	5.0		
15	Alley #2 Southernly end nearest Wagner Ct. see attached map	Asphalt	4.3	N/A	3/8" max aggregate - gravel
		base material	3.3		bank gravel with 1 1/2" max aggregate.
		Sub-total cored	4.3		
		Total Cored	14.3

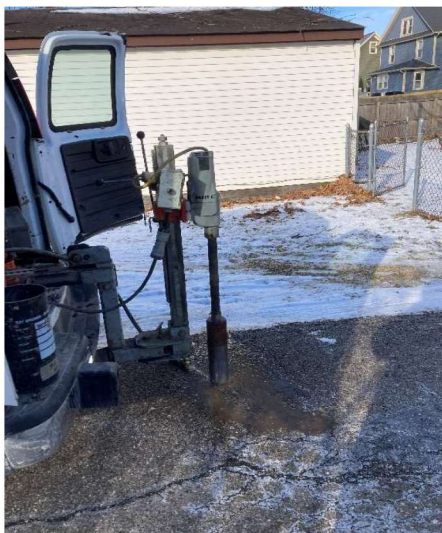
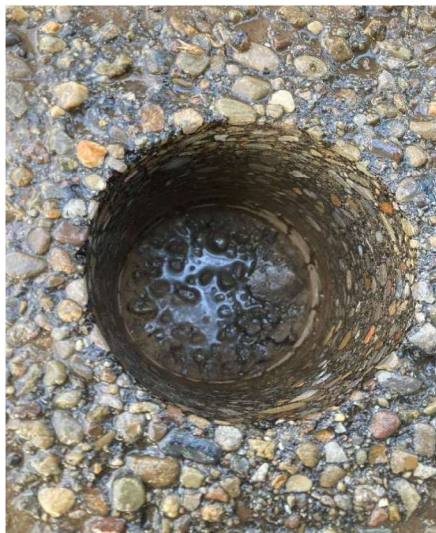
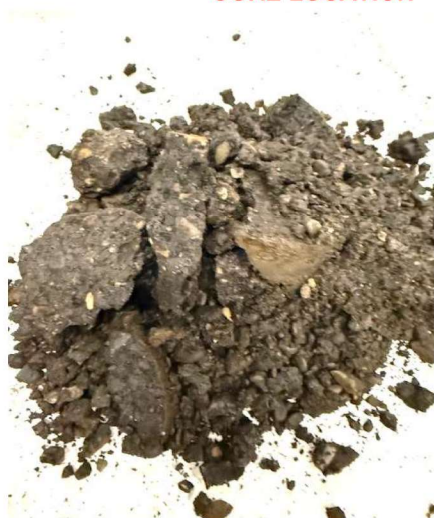
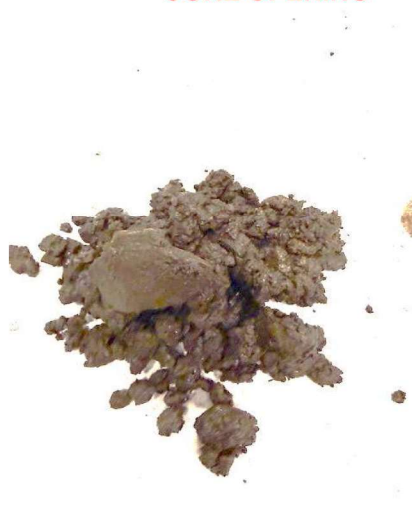
CORE #16

Core #	Location	Cored Material Description	Actual Material Thickness In Inches	Plan Depth	Condition/Type of Subgrade -Aggregate Size -Remarks
16	Alley #1 Southernly end nearest Wagner Ct. see attached map	Asphalt	4.7	N/A	3/8" max aggregate - gravel
		Sub-total cored	4.7		Sample was broken up removing from coring bit. Base material is bank gravel with 1 1/4" max aggregate.
