**Job #:** 242762      **Project Title:** AJ JOLLY PARK: CONCRETE RISER & VALVE REPLACEMENT AND ANNUAL INSPECTION & EXERCISING OF CONTROL VALVE

# **ANNUAL INSPECTION AND EXERSIZING OF CONTROL VALVE AT AJ JOLLY PARK DAM REPORT:**

**CAMPBELL COUNTY, KY**

**August 11, 2025**

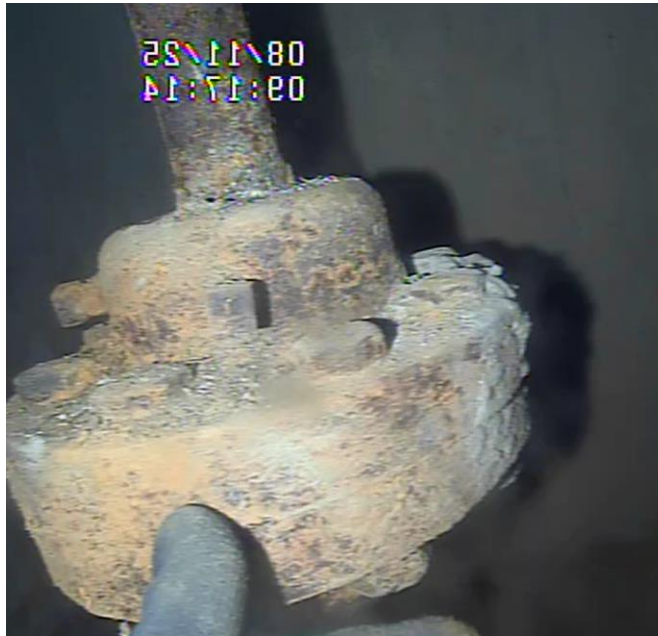
Fig. 1 Coupler 1

- Coupler 1
  - 8" Diameter held together with 8 bolts and 2 set screws
  - 18 ½" off east wall
- Stem guide 1
  - Mounted on east wall with 4 bolts
  - The bolts are still there but they are slightly pulled out of the wall

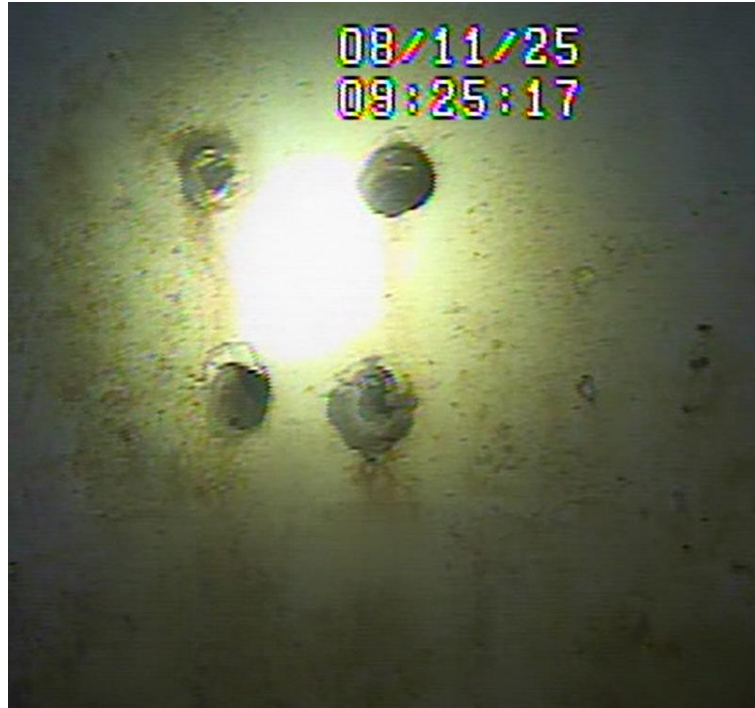
Fig. 3 Stem Guide 2

- Broken and non-operational
- Stem guide 2
  - Completely gone, just 4 holes in the east wall from where the fasteners used to be
- Coupler 2
  - 8" Diameter held together with 8 bolts

Overall, the entire system is in mediocre condition, yet operational. No structural deficiencies were found in the riser or outfall structure. Although some additional debris has accumulated over the last year and with the removal of hard packed sediment in the immediate area it is still the opinion of ES-Divers that a top grating is not needed at this time. We will check next year and assess what if any accumulation has occurred. If it is planned to replace the intake gate valve in the near future, then no immediate action is needed in our opinion, and the stem and guides should be replaced with the gate valve. If replacement will be on hold for a prolonged period of time, we recommend replacing the stem guides sooner than later at a minimum.

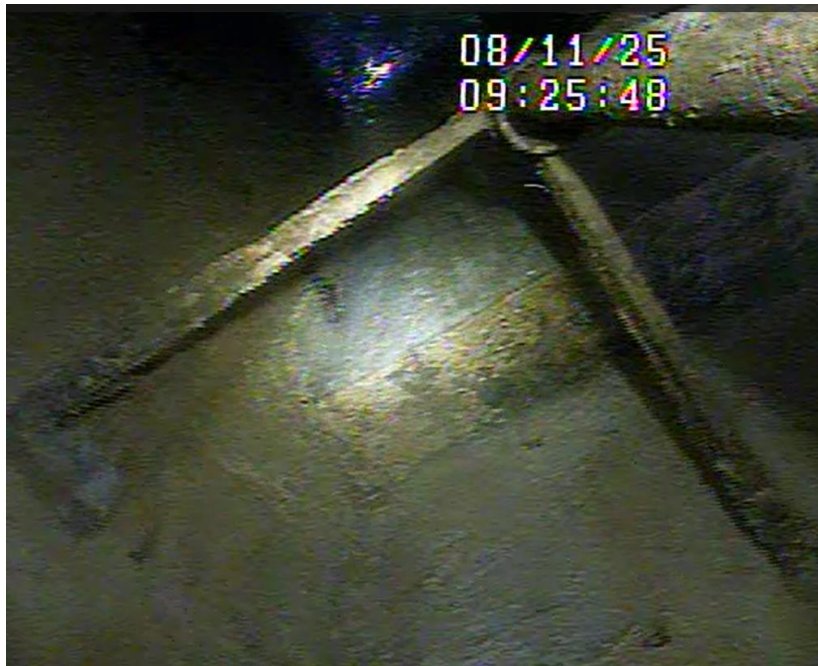
Fig. 5 Stem Guide 3

- 19 ½" off east wall
- Stem guide 3
  - Connected to the north, east, and south walls
  - 2 ½" tube stock around the stem held in place by ½" steel brackets connected to the north, east, and south walls with 1 bolt on each wall

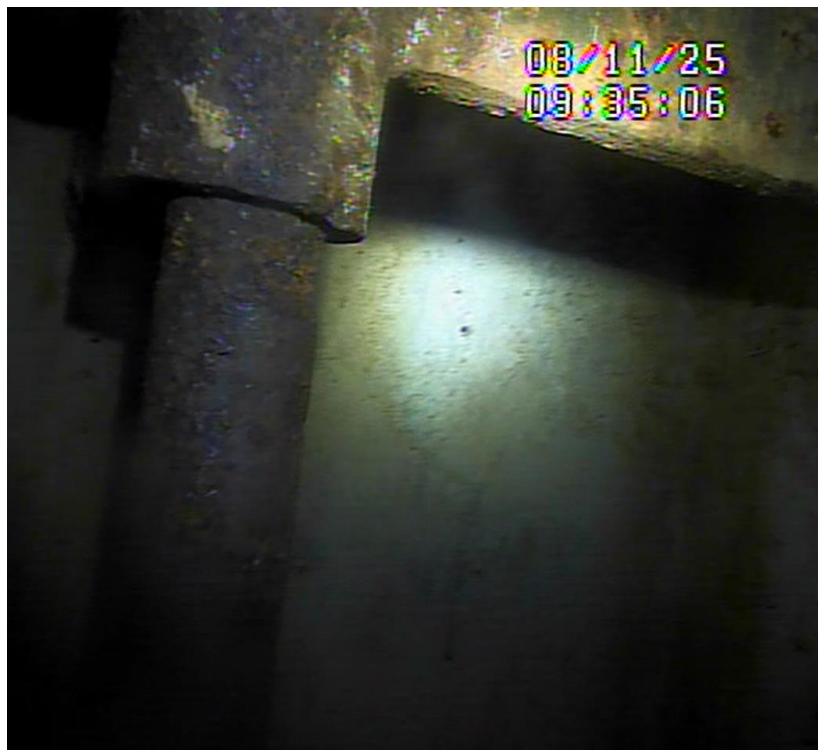
Fig. 6 Wear on Stem at Stem Guide 3

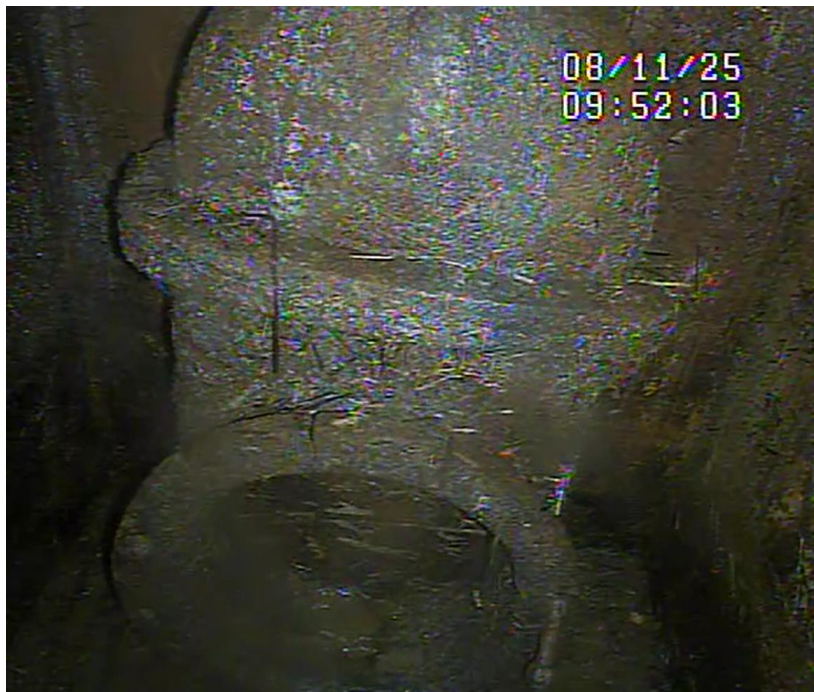
Fig. 8 Gate valve

- The valve was found to be in good condition with all bolts and guides in place. It was able to be opened and closed completely with no leaks once closed completely. (same as 2024, no change)

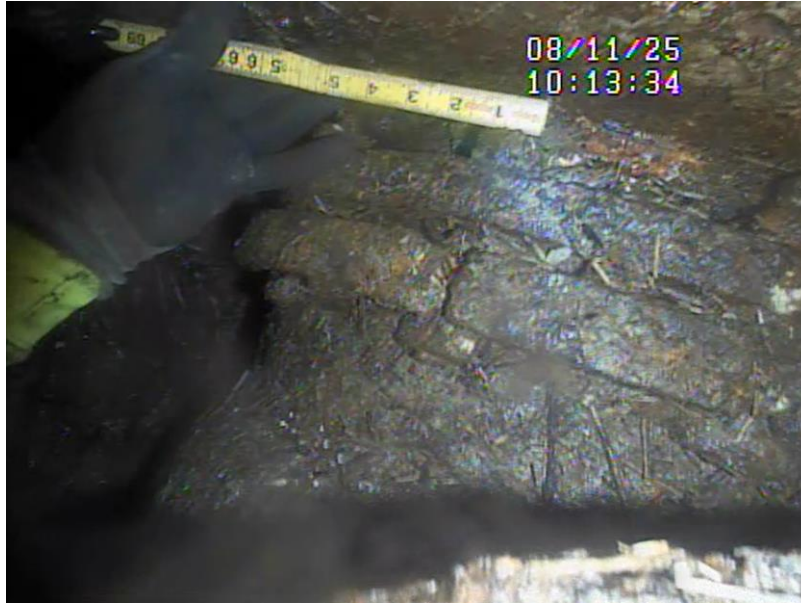
Fig. 9 Typical Condition of Gate Mounting Bolts

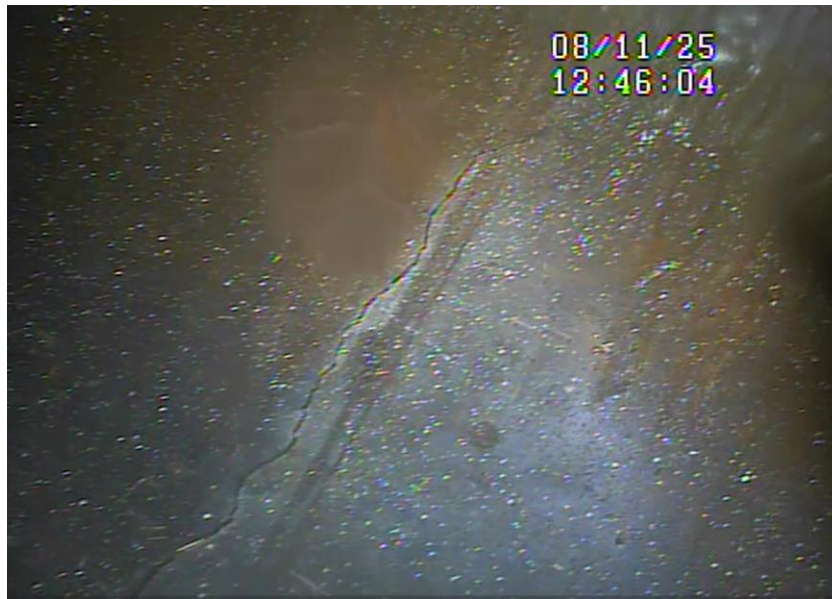
- 35' in from the outlet structure moving east into the culvert some minor cracks were found in the ceiling and left wall (looking east). No more than 1/16" wide. In this same area there is some aggregate showing in the ceiling, however it looks to be from poor formwork during construction not wear overtime. (same as 2024, no change)

Fig. 1 C left wall 35' E. of outlet structure 2025

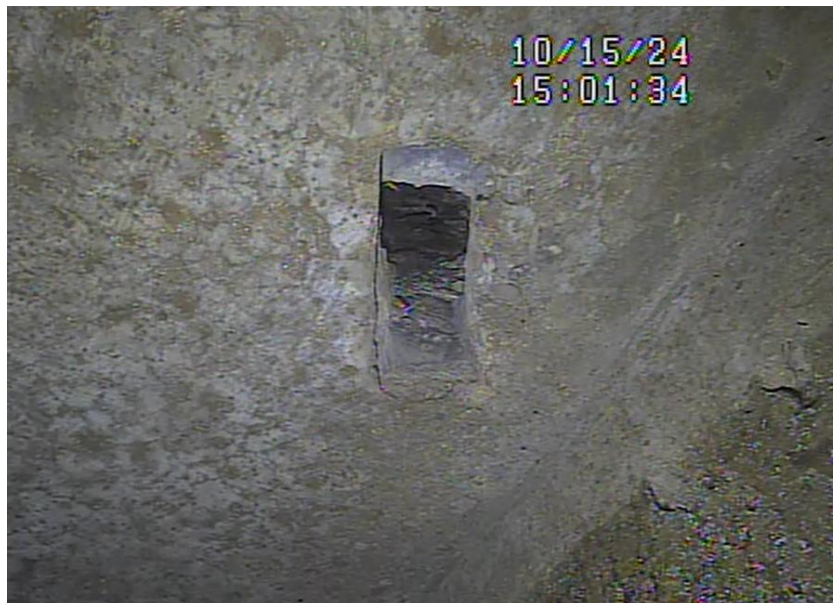
- 45' in from the outlet structure moving east into the culvert a void from a 2x4 used in the construction form work was found, however it did not pass through the wall and no exterior infiltration was found. (same as 2024, no change)

Fig. 2 2x4 void at 45' on outlet structure (no new photo)

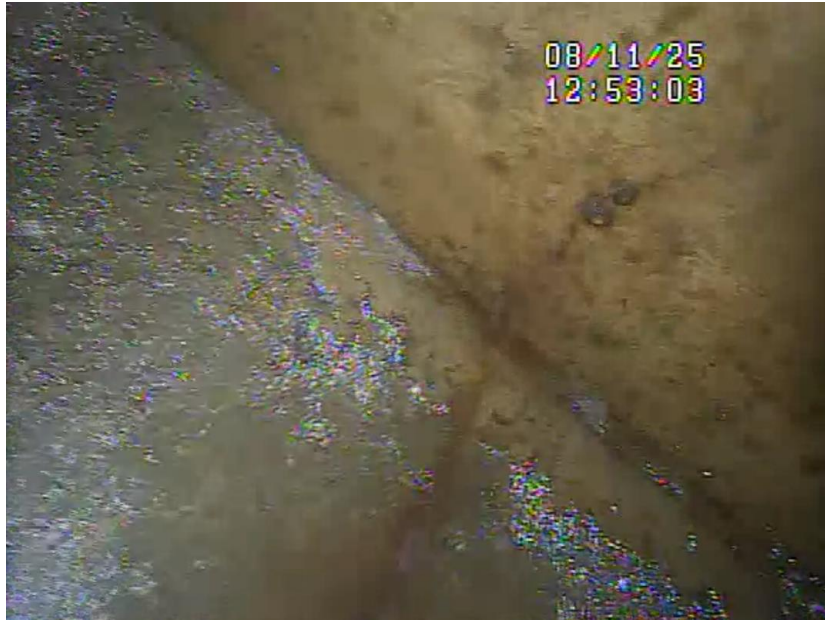
- 50' in from the outlet structure moving east into the culvert minor cracks were found running from the left wall across the ceiling and back down the right wall (looking east). No more than 1/16" wide. Some efflorescence was present. (same as 2024, no change)

Fig. 3 crack in ceiling 50' E. of outlet structure 2025

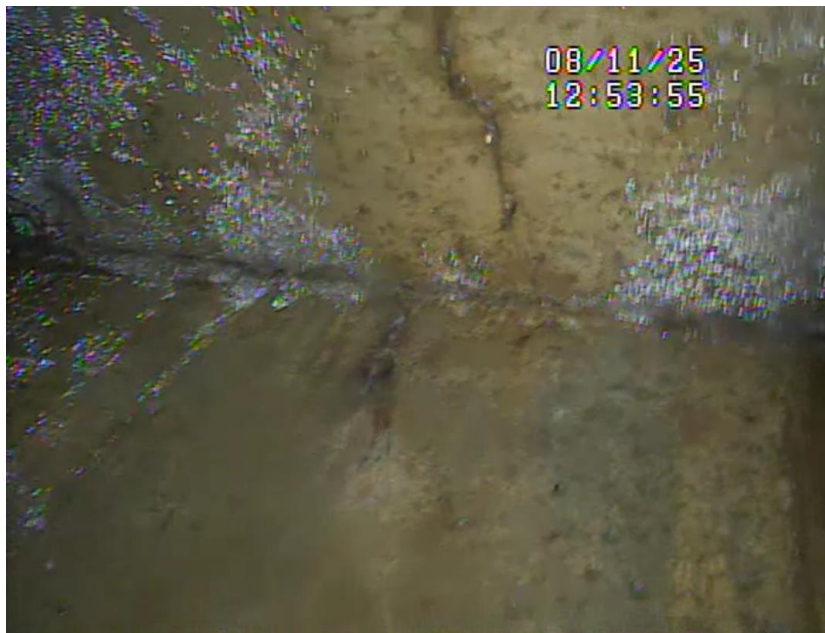
- 65' in from the outlet structure moving east into the culvert minor cracks were found running from the left wall across the ceiling and back down the right wall (looking east). No more than 1/8" wide. Some efflorescence was present. (same as 2024, no change)

Fig. 4 crack in right wall at 65' E. of outlet structure 2025

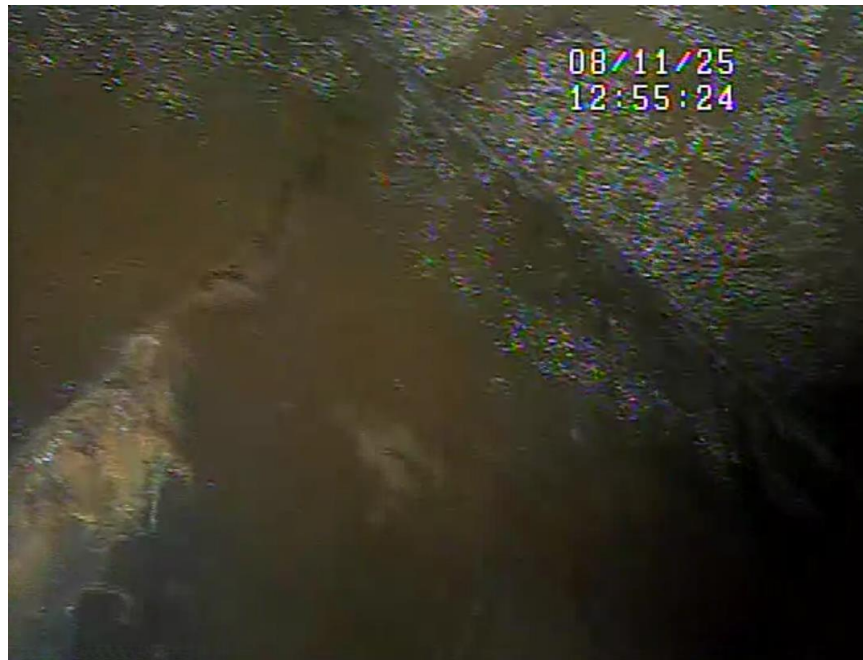
- 110' in from the outlet structure moving east into the culvert cracks were found running across the ceiling. Between 1/8"- 1/4" wide. Some small amounts of concrete were missing from the areas around the cracks, but no exterior infiltration was found. This was filled with an underwater repair epoxy during the inspection process. (same as 2024, no change)

Fig. 5 crack in ceiling at 110' E. of outlet structure 2025

Fig. 6 crack in ceiling at 110' E. of outlet structure (repaired with epoxy 2024) 2025

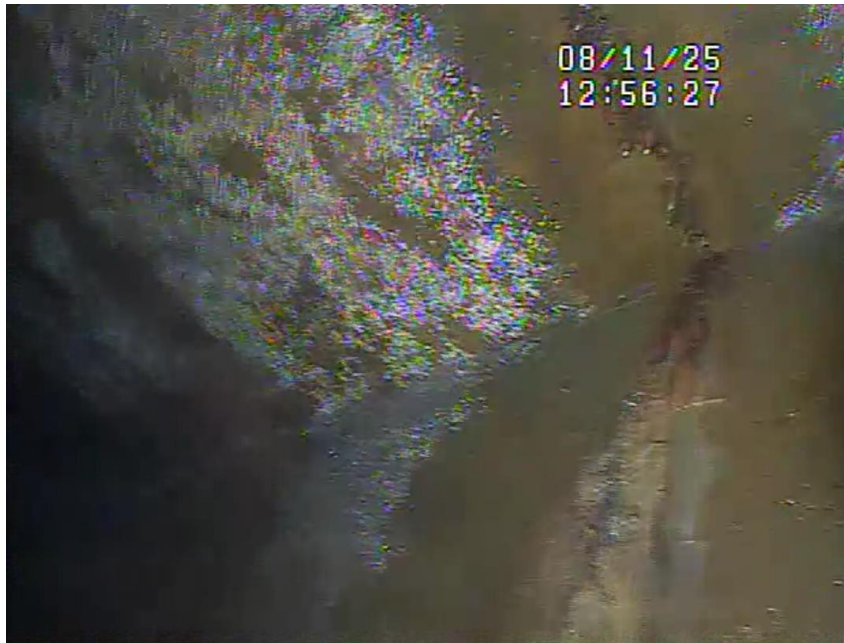
- 165' in from the outlet structure moving east into the culvert some minor cracks were found on both north and south walls and the ceiling. (new in 2025)

Fig. 7 crack in right wall 165' E. of outlet structure 2025

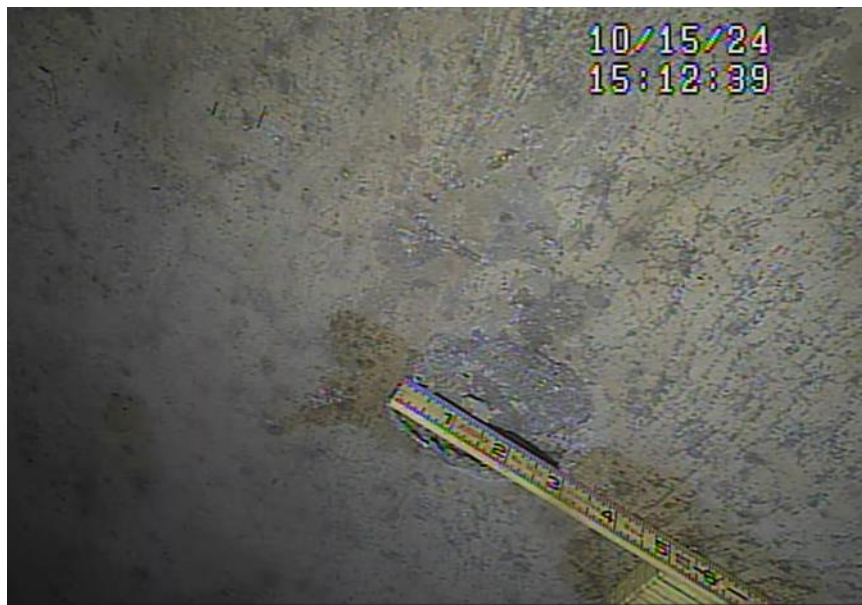
- 180' in from the outlet structure moving east into the culvert two 3" diameter abandon pipes and one shallow spall 3.5" in diameter where found grouped together in the ceiling. (same as 2024, no change)

Fig. 8 shallow spall in ceiling 180' E. of outlet structure (no new photo) 2025
