# NESHAP Asbestos and Lead Based Paint Survey

Operations Building Number One  
Wastewater Treatment Plant  
127 Middleview Drive  
Sunbury, Ohio

CT Project No. 21000706

ISSUED: 1.26.2024

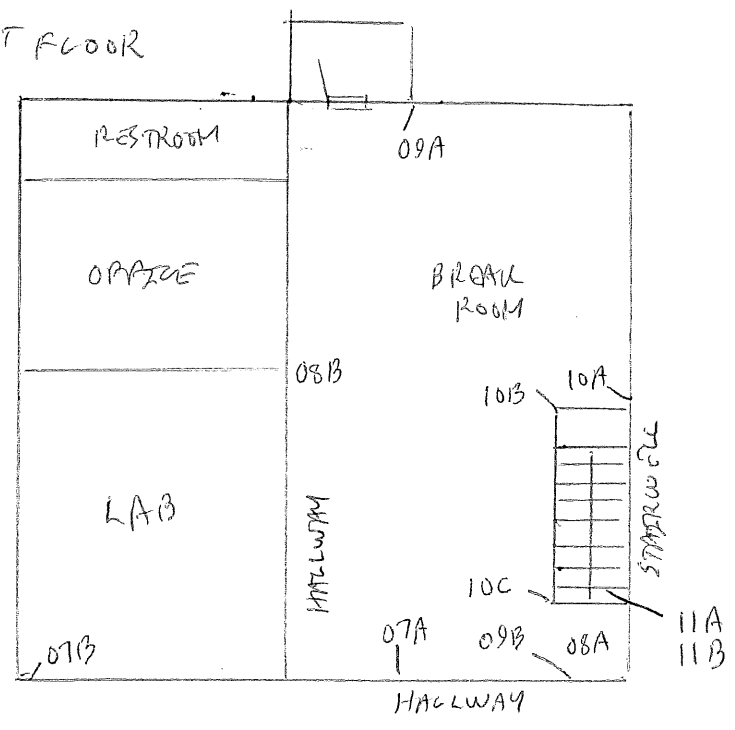
1ST FLOOR

Subject 127 MIDDLAND DR, SUNBURY OH BUILDING #1 ASBESTOS SAMPLE LOCATION

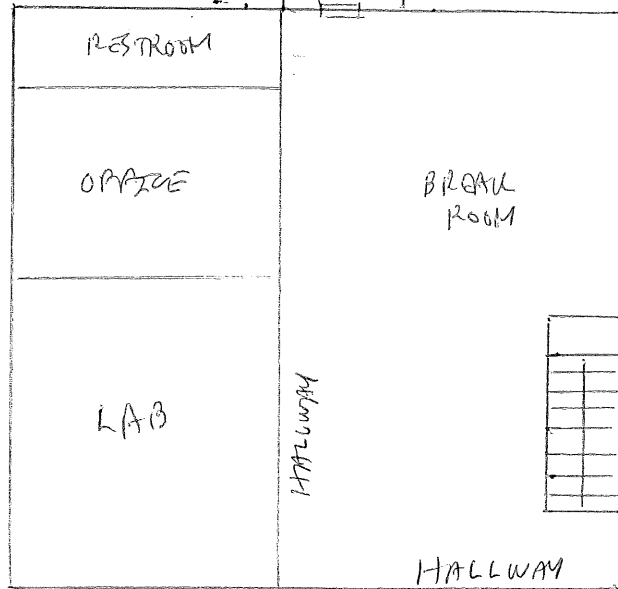
1ST FLOOR

Subject 127 MEDPLEAZEN DR, SUNBURY OH BUILDING #1 LEAD MAP
