Re: *Addendum No. 3*
IIJA Richmond Heights Sanitary Sewer Improvements
City of Richmond Heights

**IIJA Richmond Heights Sanitary Sewer
Improvements**

Project:	IJA - RICHMOND HTS	Date/Time:	July 30 2024 - 07:32
Street and City:	RICHMOND RD - RICHMOND HTS	Weather:	Dry - No precipitation during survey
Owner:	NEORS	P.O. #	
Customer:	CT CONSULTANTS	Inspection Status:	Remote Inspection
Surveyor Name and Certificate:	Robert Dean U-821-70402841	Inspection Level:	2
Reviewer Name and Certificate:	Steev Saddler P0039131-092022	MH:	HEI00010_TO GRATE

Project:	232002-46	Date/Time:	July 29 2024 - 08:00
Street and City:	RICHMOND RD - RICHMOND HTS	Weather:	Dry - No precipitation during survey
Owner:	NEORSD	P.O. #	
Customer:	CT CONSULTANTS	Inspection Status:	Remote Inspection
Surveyor Name and Certificate:	Shawn Dunnell U-915-70001437	Inspection Level:	2
Reviewer Name and Certificate:	Jessy Vargas-Bloom P0034044-102021	MH:	HIE00010_BELOW GRATE

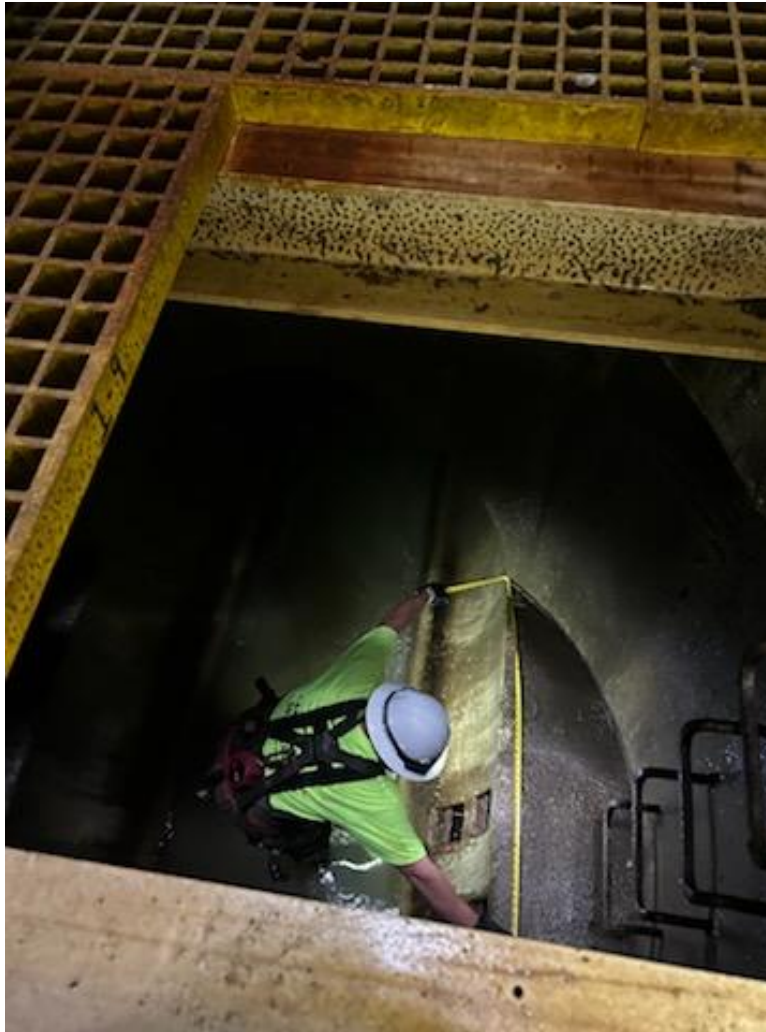
A1. There is a concrete shelf where the plate for the stanchion is to attach to. Please refer to picture on next page for visual of bench. Attached are two MACP Level II reports from C&K Industrial for reference (listed in REFERENCE DOCUMENTS).

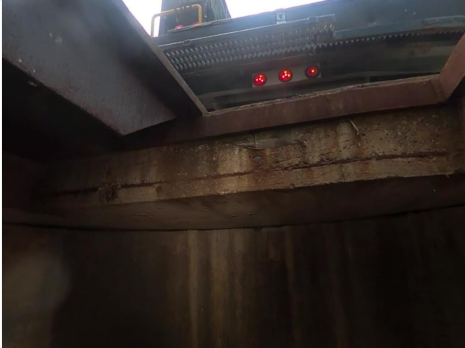
0.8	SRC - component:CMI Clock from 7 to 11 Grade = 5	000020

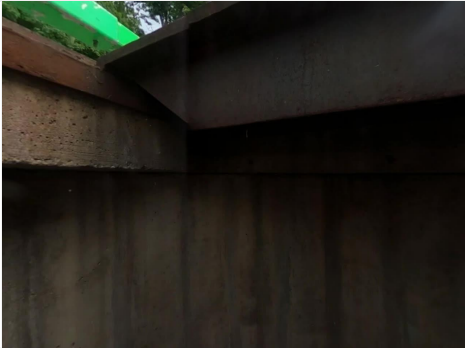
1.1	ISJ - component:WI Joint: True Clock from 12 to 12 Grade = 1	000019

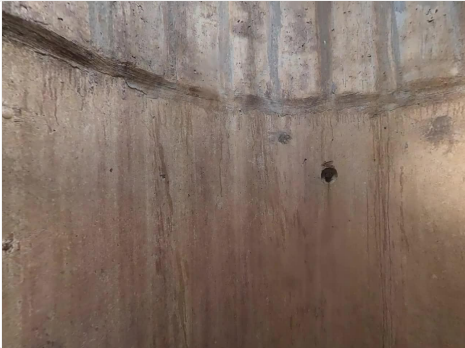
12	MGO - component:WI Remark = WI - LIFT PONTS IN EACH CAST SECTION	000030

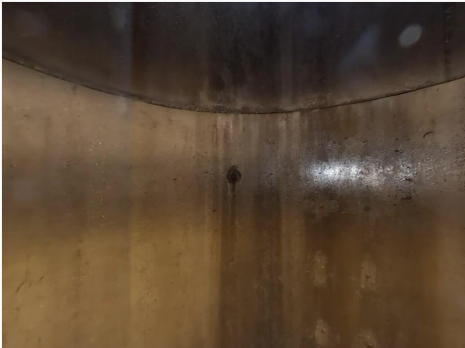
60	MGO - component:WI Remark = LIFTING POINT	000127

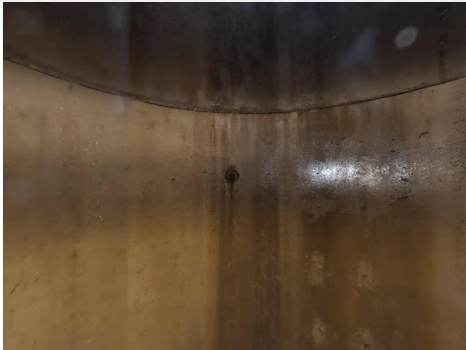
68	ISB - component:WI Clock At 7 Grade = 1	000127

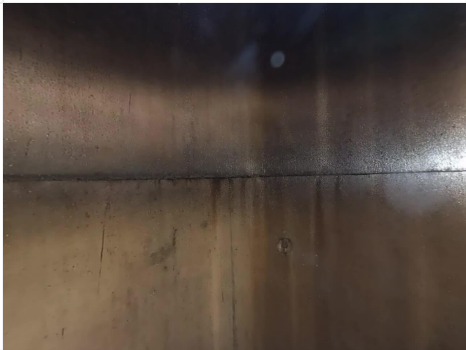
86	ISJ - component:WI Joint: True Clock from 5 to 7 Grade = 1	000208

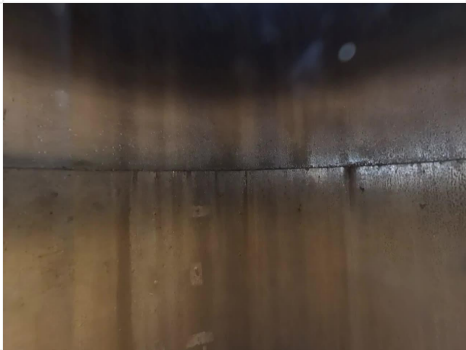
105	ISJ - component:WI Joint: True Clock from 5 to 8 Grade = 1	000302

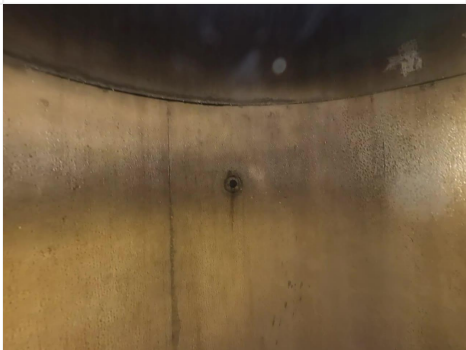
141	ISB - component:WI Clock At 6 Grade = 1	000338

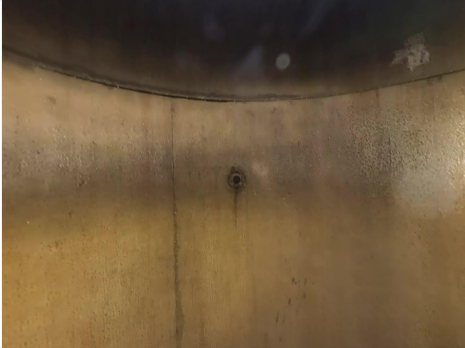
141	MGO - component:WI Remark = LIFTING POINT	000338

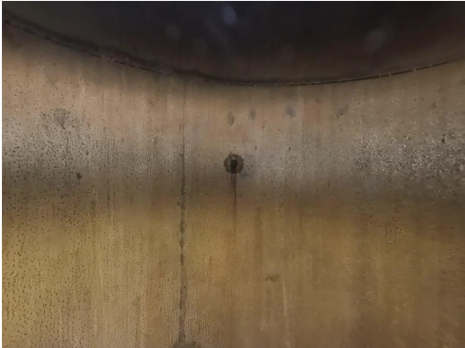
149	ISB - component:WI Clock At 8 Grade = 1	000403

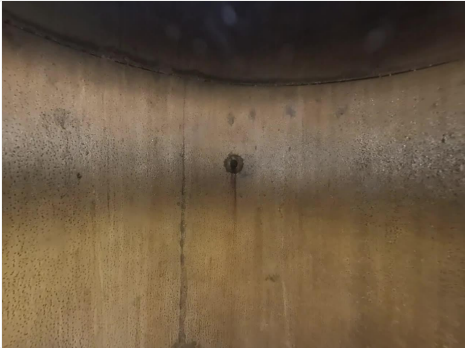
149	MGO - component:WI Remark = LIFTING POINT	000403

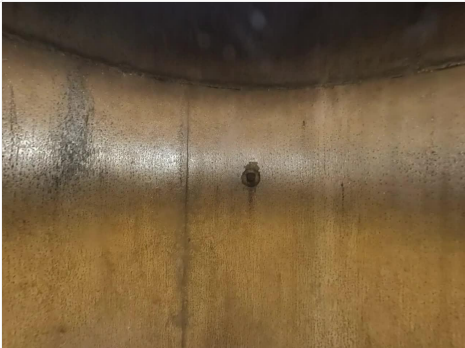
155	ISB - component:WI Clock At 3 Grade = 1	000416

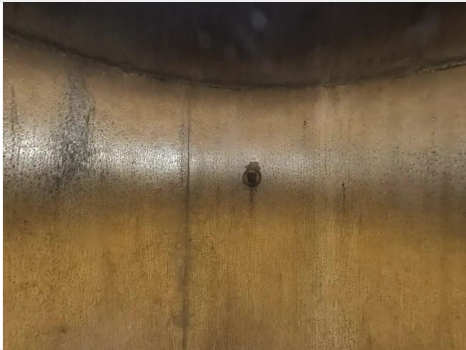
155	MGO - component:WI Remark = LIFTING POINT	000416

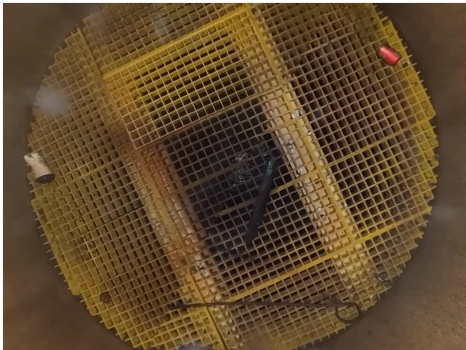
163.8	MGO - component:B Remark = B - ACCESS LANDING	000420

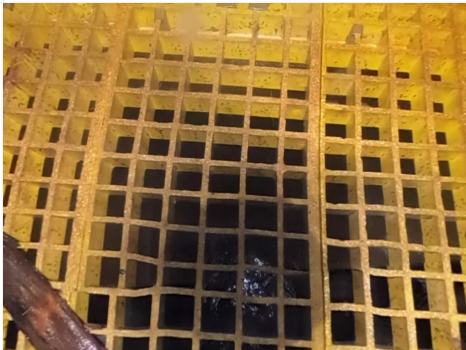
163.8	MGO - component:B Remark = B - FLOW VISIBLE THROUGH GRATE / NO PIPE INFORMATION AVAILABLE	000429

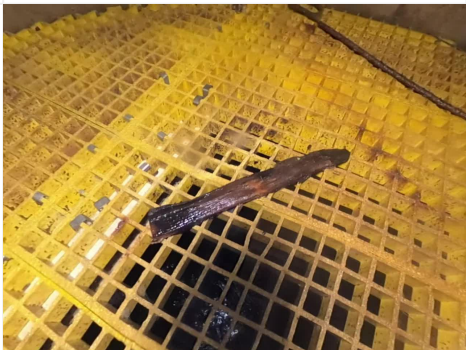
163.8	OBZ - component:B Percent: 10 Clock from 1 to 2 Remark = B - WOOD Grade = 1	000429

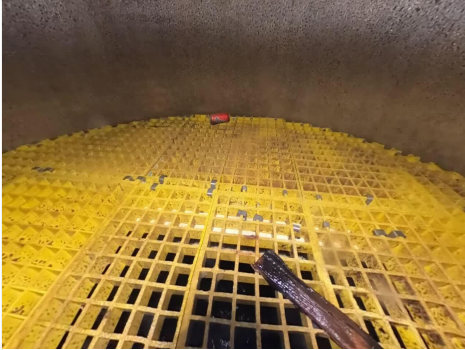
163.8	DSZ - component:B Percent: 5 Clock At 12 Remark = B - TRASH Grade = 1	000429

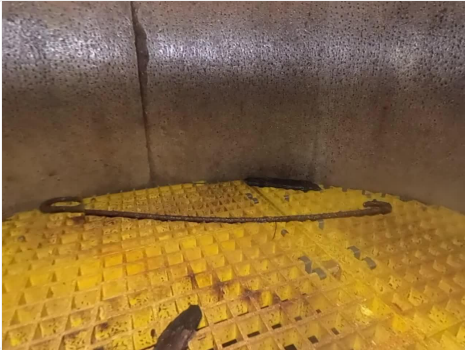
163.8	OBZ - component:B Percent: 15 Clock from 2 to 5 Remark = B - MH HOOK Grade = 1	000429

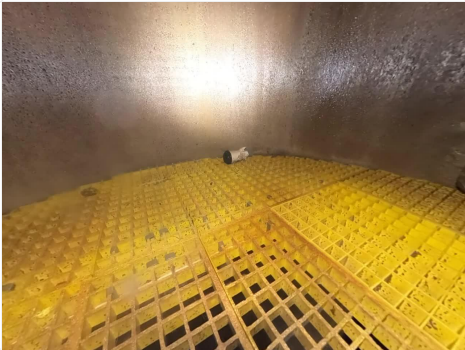
163.8	DSZ - component:B Percent: 5 Clock from 7 to 2 Remark = B - TRASH Grade = 1	000429

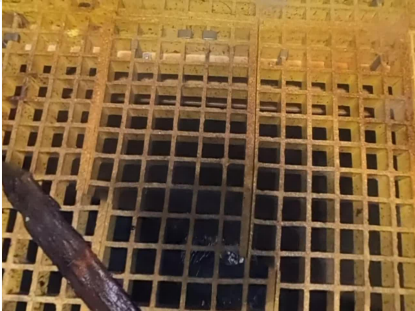
1	Outgoing Connection Shape = Z Height = 9 width = 9 Pipe Condition = D Pipe Seal Condition = D Pipe type = GR Comments = B - FLOW VISIBLE THROUGH GRATE / NO PIPE INFORMATION AVAILABLE	163.8	6

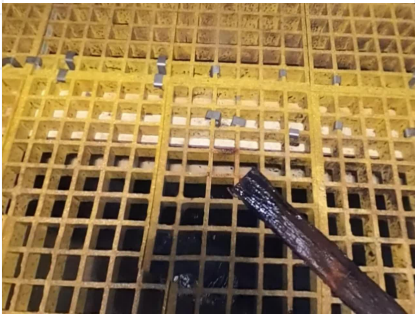
2	Incoming Connection Shape = Z Height = 9 width = 9 Pipe Condition = D Pipe Seal Condition = D Pipe type = GR Comments = B - FLOW VISIBLE THROUGH GRATE / NO PIPE INFORMATION AVAILABLE	163.7	12

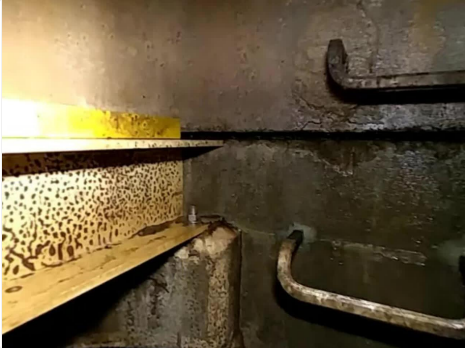
43.1	MGO - component:WI Remark = GRATE	000000

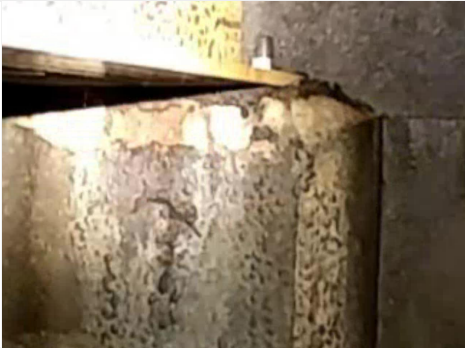
44.2	DAE - component:WI Percent: 5 Clock from 7 to 8 Grade = 1	000001

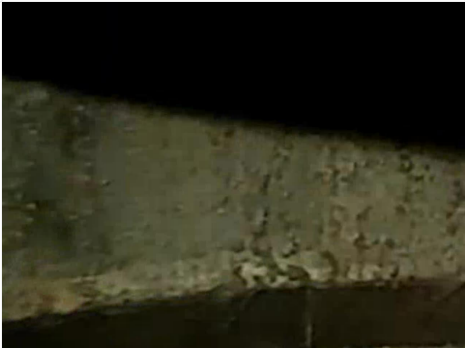
44.2	MSC - component:WI Measurement 1: 93	000001

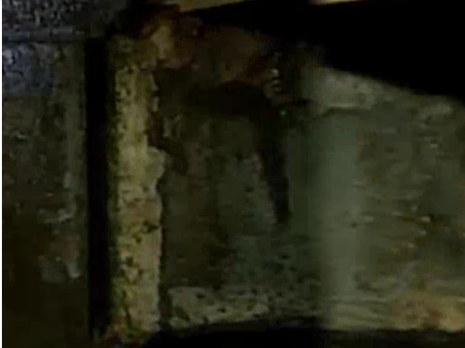
44.2	DAE - component:WI Percent: 5 Clock from 10 to 11 Grade = 1	000001

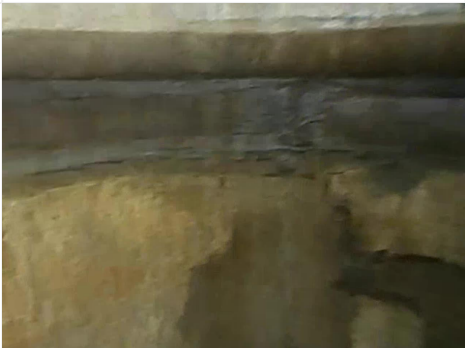
45.5	MSC - component:WI Measurement 1: 100	000003

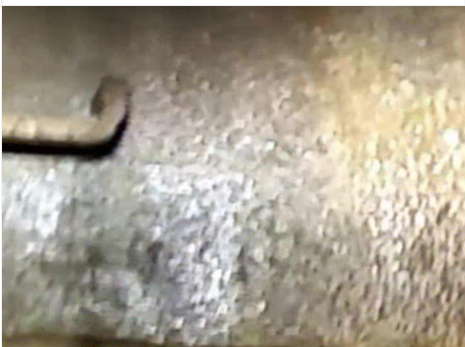
49.8	SRI - component:WI Continuous: F01 Clock from 12 to 12 Grade = 1	000011

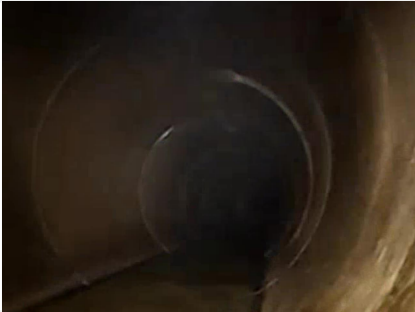
1	Outgoing Connection Shape = Circle Height = 60 Pipe Condition = S Pipe Seal Condition = S Pipe type = GR	53.1	6

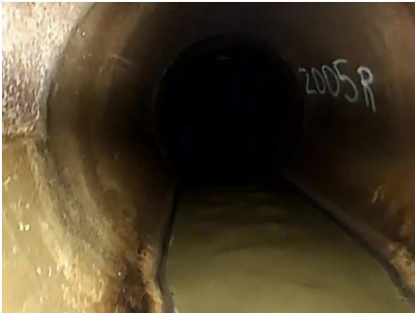
2	Incoming Connection Shape = Circle Height = 60 Pipe Condition = S Pipe Seal Condition = S Pipe type = GR	53	12
