Insight Pipe Contracting LLC
 232 East Lancaster Rd.
 Harmony, PA 16037
 Phone: 724-452-6060
 Fax: 724-452-3226

Main Inspections Small Photos

Mainline ID: A1_B1	City: BOARDMAN	Street: COLLEEN DR	Project name: 011023.221159.ABC STORMWATER.CTV.1123
Start date/time: 1/10/2023 8:04 AM	Total length:	Weather: 3 - Light Rain	Surveyed by: JHIPC
Upstream MH No: A1	Depth US:	Downstream MH No: B1	Depth DS:
Shape: C - Circular	Material: CMP - Corrugated Metal Pipe	Height: 36 in.	Width: 36 in.
Customer: BOARDMAN TWP	Owner: BOARDMAN TWP	Sewer use: SW - Stormwater	Lining method:
Length surveyed: 157.7 ft.	Purpose: F - Routine Assessment	Media label: 221159-1	Pre-cleaning: N - No Pre-Cleaning
Additional info:

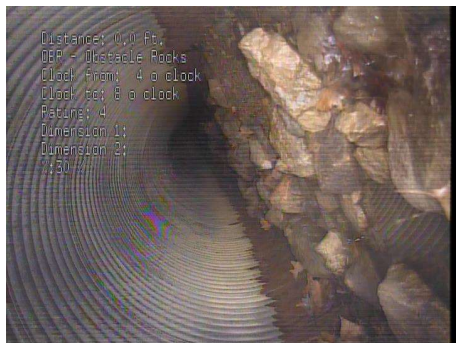
Distance	Dir.	Code	Description	Cont.	From/To	%	Joint	Rating	Remarks
0.0 ft.	D	AMH	Manhole		/		<input type="checkbox"/>		A1
0.0 ft.	D	MWL	Water Level		/	10	<input type="checkbox"/>		
0.0 ft.	D	OBR	Obstacle Rocks	S01	4 / 8	30	<input type="checkbox"/>	4

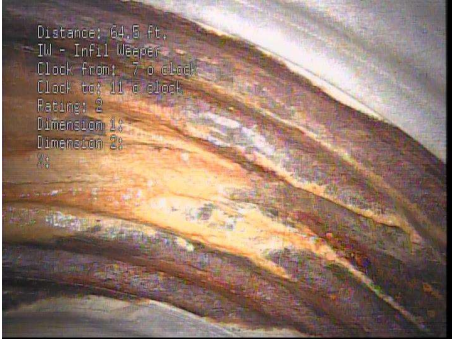
Distance	Dir.	Code	Description	Cont. From/To	%	Joint Rating	Remarks
64.5 ft.	D	IW	Infil Weeper	7 / 11		<input type="checkbox"/> 2

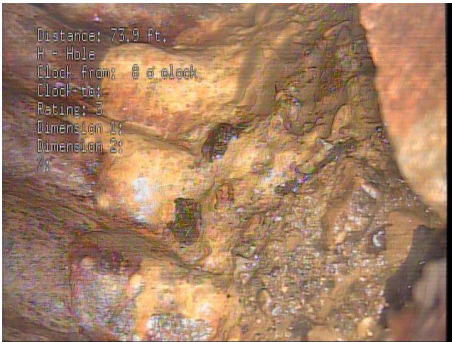
73.9 ft.	D	H	Hole	8 /		<input type="checkbox"/> 3

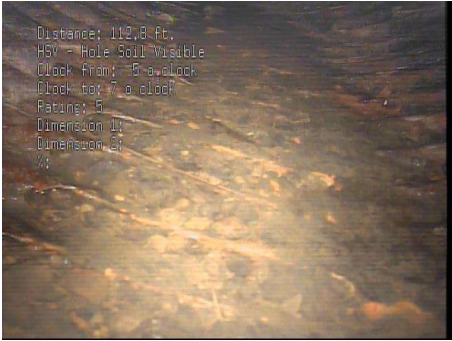
79.8 ft.	D	TBA	Tap Break-in Active	10 /		<input type="checkbox"/>	
106.6 ft.	D	H	Hole	1 /		<input type="checkbox"/> 3	
112.8 ft.	D	HSV	Hole Soil Visible	5 / 7		<input type="checkbox"/> 5

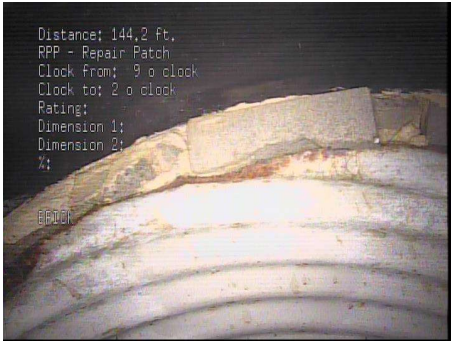
144.2 ft.	D	RPP	Repair Patch	9 / 2		<input type="checkbox"/>	BRICK
-----------	---	-----	--------------	-------	--	--------------------------	--------------

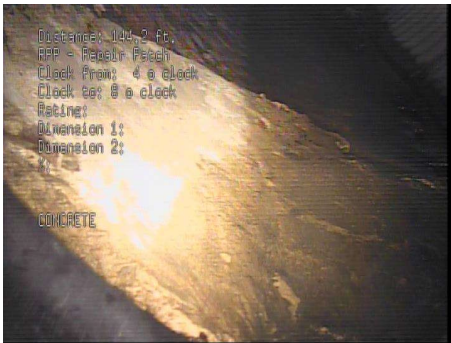
144.2 ft.	D	RPP	Repair Patch	4 / 8		<input type="checkbox"/>	CONCRETE
-----------	---	-----	--------------	-------	--	--------------------------	-----------------

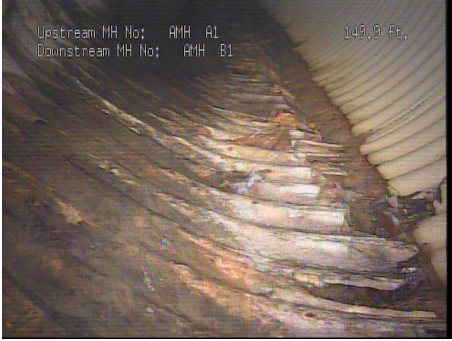
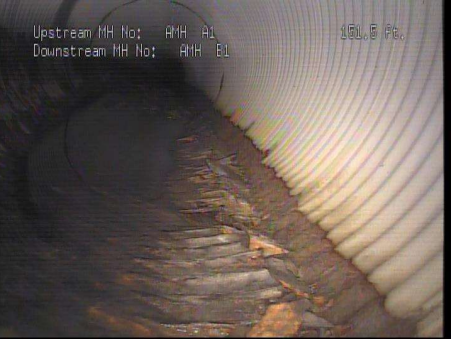
Distance	Dir.	Code	Description	Cont.	From/To	%	Joint	Rating	Remarks
146.7 ft.	D	BSV	Broken Soil Visible	S03	3 / 6		<input type="checkbox"/>	5	
<div style="display: flex; justify-content: space-around;"> <div style="text-align: center;">

<p>Distance: 146.7 Ft. BSV - Broken Soil Visible Clock from: 3 o'clock Clock to: 6 o'clock Rating: 5 Dimension 1: Dimension 2: %:</p> </div> <div style="text-align: center;">

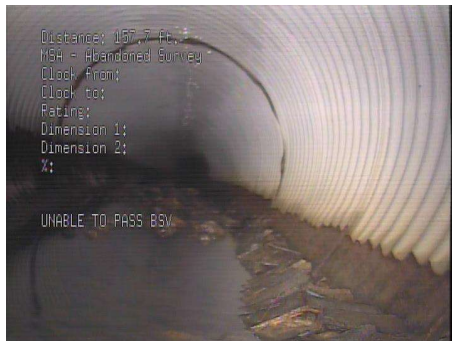
157.7 ft.	D	OBR	Obstacle Rocks	F01	4 / 8	30	<input type="checkbox"/>	4	
157.7 ft.	D	SCP	Surface Corrosion Metal Pipe	F02	3 / 9		<input type="checkbox"/>	3

157.7 ft.	D	BSV	Broken Soil Visible	F03	3 / 6		<input type="checkbox"/>	5	
157.7 ft.	D	MSA	Abandoned Survey		/		<input type="checkbox"/>		UNABLE TO PASS BSV

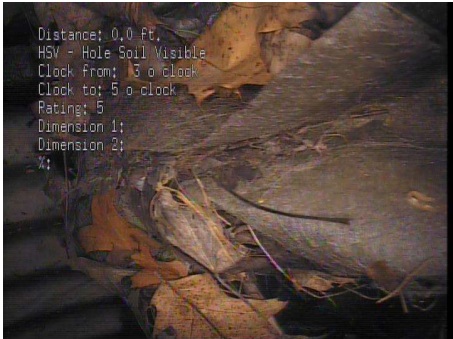
Distance	Dir.	Code	Description	Cont.	From/To	%	Joint	Rating	Remarks
0.0 ft.	U	AMH	Manhole		/		<input type="checkbox"/>		B2
0.0 ft.	U	MWL	Water Level		/	10	<input type="checkbox"/>		
0.0 ft.	U	HSV	Hole Soil Visible		3 / 5		<input type="checkbox"/>	5

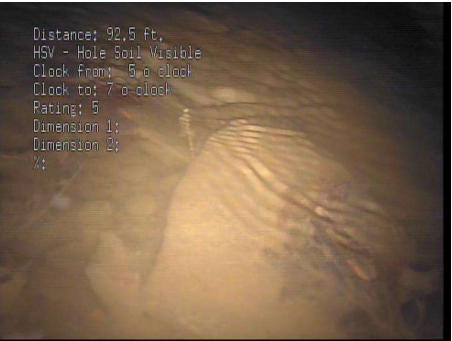
Distance	Dir.	Code	Description	Cont.	From/To	%	Joint	Rating	Remarks
92.5 ft.	U	HSV	Hole Soil Visible	S03	5 / 7		<input type="checkbox"/>	5	
<div style="display: flex; flex-wrap: wrap;"> <div style="width: 33%; text-align: center;">

<p style="font-size: 8px; color: gray;">Distance: 92.5 ft. HSV - Hole Soil Visible Clock from: 5 o'clock Clock to: 7 o'clock Rating: 5 Dimension 1: Dimension 2: %:</p> </div> </div>

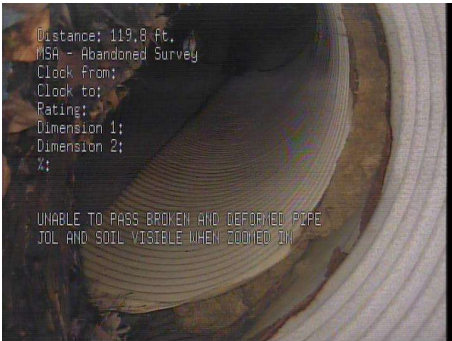
119.8 ft.	U	D	Deformed		/	20	<input type="checkbox"/>	5	
119.8 ft.	U	MSA	Abandoned Survey		/		<input type="checkbox"/>		UNABLE TO PASS BROKEN AND DEFORMED PIPE JOL AND SOIL VISIBLE WHEN ZOOMED IN
<div style="display: flex; flex-wrap: wrap;"> <div style="width: 100%; text-align: center;">

<p style="font-size: 8px; color: gray;">Distance: 119.8 ft. MSA - Abandoned Survey Clock from: Clock to: Rating: Dimension 1: Dimension 2: %:</p> <p style="font-size: 8px; color: gray;">UNABLE TO PASS BROKEN AND DEFORMED PIPE JOL AND SOIL VISIBLE WHEN ZOOMED IN</p> </div> </div>

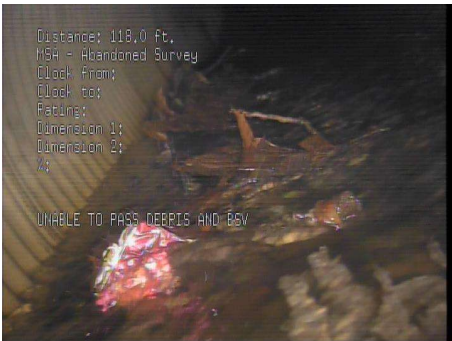
</div> </div>									
118.0 ft.	D	HSV	Hole Soil Visible	F02	4 /		<input type="checkbox"/>	5	
118.0 ft.	D	H	Hole	F03	8 /		<input type="checkbox"/>	3	
118.0 ft.	D	MSA	Abandoned Survey		/		<input type="checkbox"/>		UNABLE TO PASS DEBRIS AND BSV

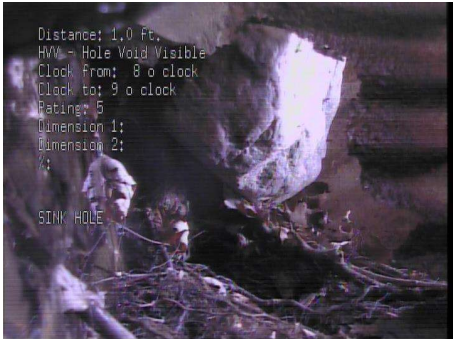
Distance	Dir.	Code	Description	Cont.	From/To	%	Joint	Rating	Remarks
0.0 ft.	U	AMH	Manhole		/		<input type="checkbox"/>		B2
0.0 ft.	U	MWL	Water Level		/	15	<input type="checkbox"/>		
1.0 ft.	U	HVV	Hole Void Visible		8 / 9		<input type="checkbox"/>	5	SINK HOLE

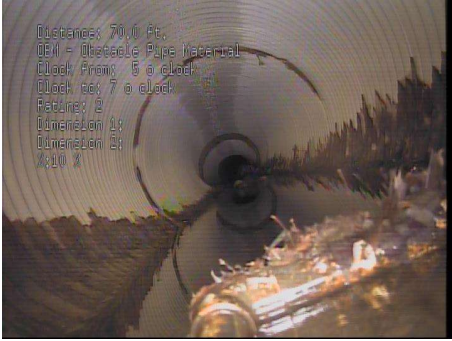
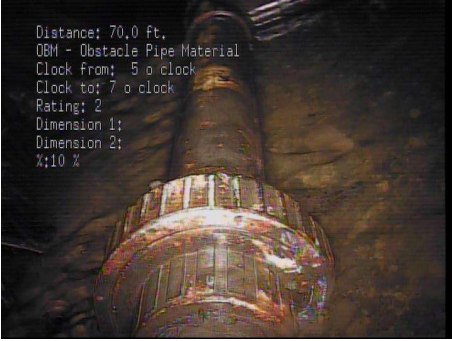
Distance	Dir.	Code	Description	Cont.	From/To	%	Joint	Rating	Remarks
56.0 ft.	U	OBM	Obstacle Pipe Material	S02	5 / 7	10	<input type="checkbox"/>	2	
<div style="display: flex; justify-content: space-around;"> <div style="width: 45%;"> <p>Distance: 70.0 ft. OBM - Obstacle Pipe Material Clock from: 5 o'clock Clock to: 7 o'clock Rating: 2 Dimension 1: Dimension 2: %:10 %</p>

</div> <div style="width: 45%;"> <p>Distance: 70.0 ft. OBM - Obstacle Pipe Material Clock from: 5 o'clock Clock to: 7 o'clock Rating: 2 Dimension 1: Dimension 2: %:10 %</p>

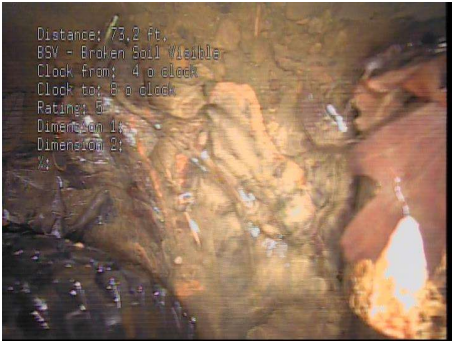
73.2 ft.	U	BSV	Broken Soil Visible		4 / 8		<input type="checkbox"/>	5	
<div style="display: grid; grid-template-columns: repeat(3, 1fr); gap: 10px;"> <div style="width: 33%;"> <p>Distance: 73.2 ft. BSV - Broken Soil Visible Clock from: 4 o'clock Clock to: 8 o'clock Rating: 5 Dimension 1: Dimension 2: %:</p>

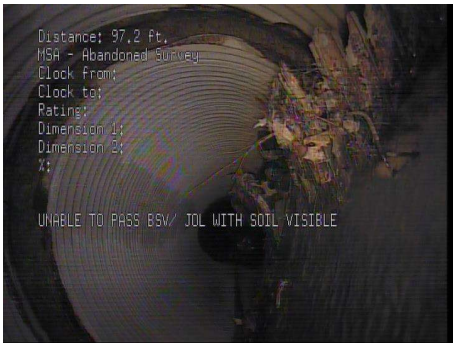
Distance	Dir. Code	Description	Cont. From/To	%	Joint Rating	Remarks	
97.2 ft.	U	BSV	Broken Soil Visible	8 / 4	<input type="checkbox"/>	5	
<div data-bbox="115 218 565 558" data-label="Image"> </div>							
97.2 ft.	U	OBR	Obstacle Rocks	F01 5 / 7	15	<input type="checkbox"/>	3
97.2 ft.	U	MSA	Abandoned Survey	/	<input type="checkbox"/>	UNABLE TO PASS BSV/ JOL WITH SOIL VISIBLE

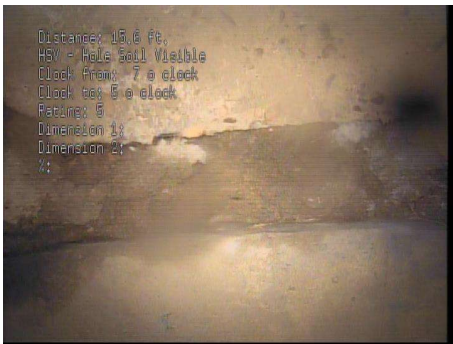
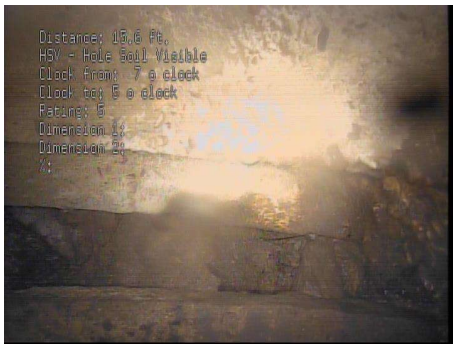
15.6 ft.	U	HSV	Hole Soil Visible		7 / 5		<input type="checkbox"/>	5	
<div style="display: flex; justify-content: space-around;"> <div style="text-align: center;">

<p>Distance: 15.6 ft. HSV - Hole Soil Visible Clock From: 7 o'clock Clock to: 6 o'clock Rating: 5 Dimension 1: Dimension 2: %</p> </div> <div style="text-align: center;">

<p>Distance: 15.6 ft. HSV - Hole Soil Visible Clock From: 7 o'clock Clock to: 6 o'clock Rating: 5 Dimension 1: Dimension 2: %</p> </div> </div>

15.6 ft.	U	RPPD	Repair Patch Defective		10 / 2		<input type="checkbox"/>	4	MESH DOES NOT FULLY REPAIR
25.6 ft.	U	RPP	Repair Patch	S01	12 /		<input type="checkbox"/>		LIFT HOLES

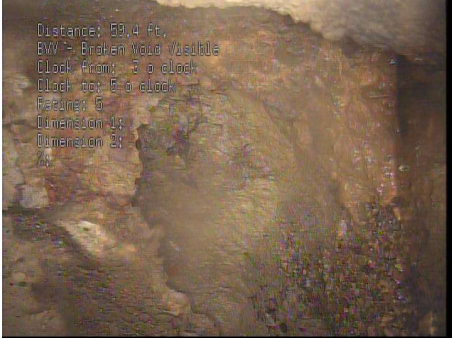
Distance	Dir.	Code	Description	Cont.	From/To	%	Joint Rating	Remarks
52.1 ft.	U	RPP	Repair Patch		11 / 2		<input type="checkbox"/>	BRICK
59.4 ft.	U	BVV	Broken Void Visible		3 / 5		<input type="checkbox"/>	5

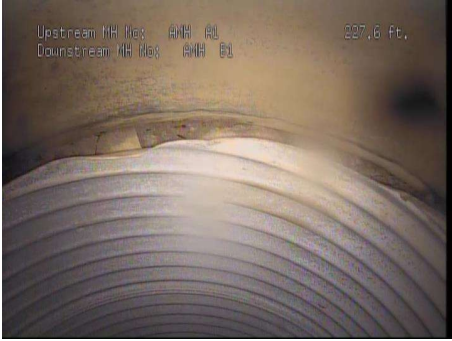
Distance	Dir.	Code	Description	Cont.	From/To	%	Joint	Rating	Remarks
227.6 ft.	U	HSV	Hole Soil Visible		10 / 2		<input type="checkbox"/>	5

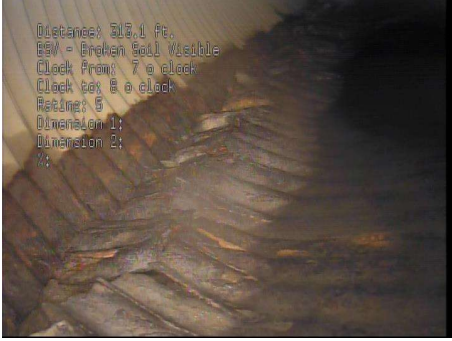
227.6 ft.	U	MMC	Material Change		/		<input type="checkbox"/>		CMP
313.1 ft.	U	TBI	Tap Break-in Intruding		2 /		<input type="checkbox"/>	2	
313.1 ft.	U	BSV	Broken Soil Visible		7 / 8		<input type="checkbox"/>	5

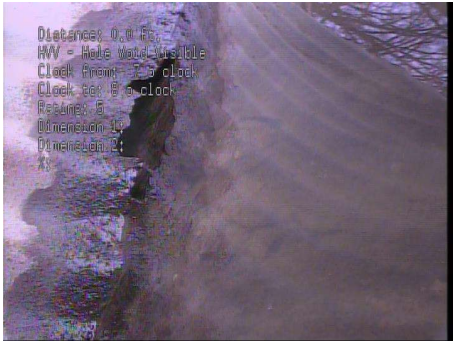
Distance	Dir.	Code	Description	Cont.	From/To	%	Joint	Rating	Remarks
0.0 ft.	D	AMH	Manhole		/		<input type="checkbox"/>		B1
0.0 ft.	D	MWL	Water Level		/	40	<input type="checkbox"/>		
0.0 ft.	D	MGO	General Observation		/		<input type="checkbox"/>		CREEK FLOW OVER PIPE GRADE
0.0 ft.	D	HVV	Hole Void Visible		7 / 8		<input type="checkbox"/>	5

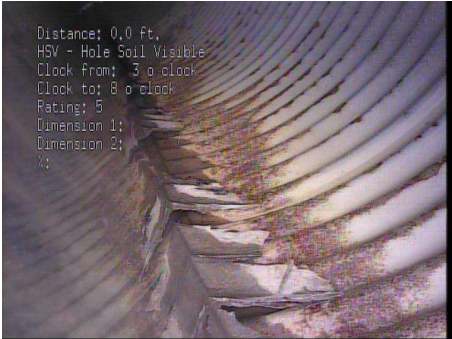
Distance	Dir.	Code	Description	Cont.	From/To	%	Joint	Rating	Remarks
0.0 ft.	U	AMH	Manhole		/		<input type="checkbox"/>		C3
0.0 ft.	U	MWL	Water Level		/	40	<input type="checkbox"/>		
0.0 ft.	U	MGO	General Observation		/		<input type="checkbox"/>		CREEK FLOW IS HIGHER THAN DISCHARGE POINT
0.0 ft.	U	HSV	Hole Soil Visible		3 / 8		<input type="checkbox"/>	5

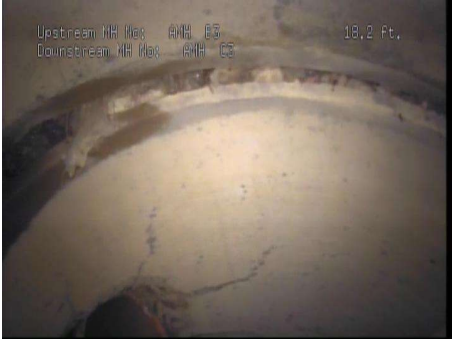
Distance	Dir.	Code	Description	Cont. From/To	%	Joint Rating	Remarks
18.2 ft.	U	HSV	Hole Soil Visible	9 / 2		<input type="checkbox"/> 5

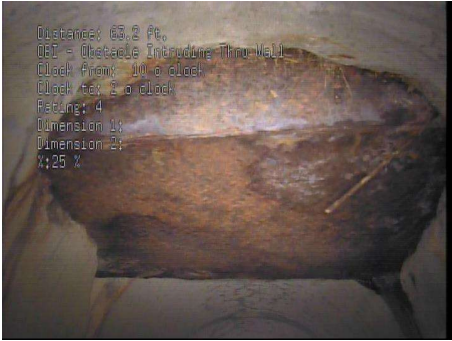
20.0 ft.	U	TBI	Tap Break-in Intruding	10 /		<input type="checkbox"/> 2	
26.1 ft.	U	RFJ	Roots Fine Joint	1 / 2		<input checked="" type="checkbox"/> 1	
63.2 ft.	U	OBI	Obstacle Intruding Thru Wall	10 / 2	25	<input type="checkbox"/> 4	POSSIBLE METAL JUNCTION BOX

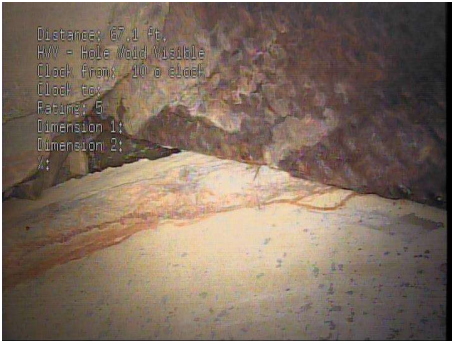
67.1 ft.	U	HVV	Hole Void Visible	10 /		<input type="checkbox"/> 5

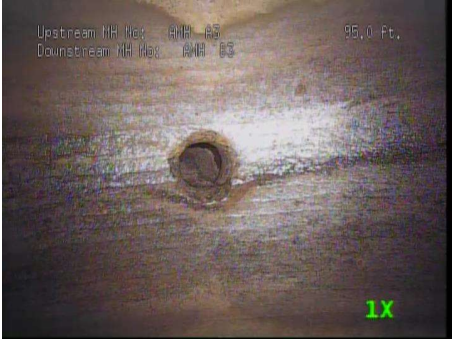
Distance	Dir.	Code	Description	Cont.	From/To	%	Joint	Rating	Remarks
95.0 ft.	U	RPRD	Repair Point Defective		/		<input type="checkbox"/>	4	LIFT HOLE

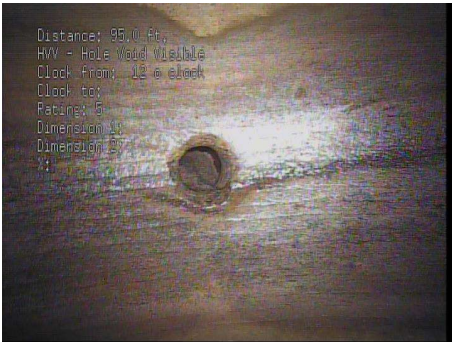
95.0 ft.	U	HVV	Hole Void Visible		12 /		<input type="checkbox"/>	5

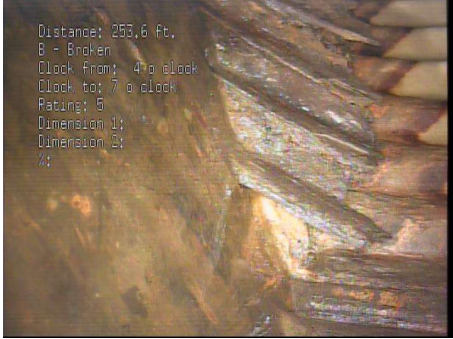
Distance	Dir.	Code	Description	Cont.	From/To	%	Joint Rating	Remarks
202.1 ft.	U	MWL	Water Level		/	40	<input type="checkbox"/>	
224.8 ft.	U	TBI	Tap Break-in Intruding		10 /		<input type="checkbox"/>	2
224.8 ft.	U	TBI	Tap Break-in Intruding		11 /		<input type="checkbox"/>	2
253.6 ft.	U	BSV	Broken Soil Visible	S03	4 / 7		<input type="checkbox"/>	5

Distance: 253.6 Ft.
 B - Broken
 Clock from: 4 o'clock
 Clock to: 7 o'clock
 Rating: 5
 Dimension 1:
 Dimension 2:
 %:

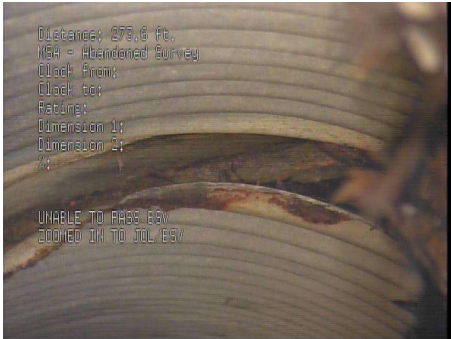
Distance	Dir. Code	Description	Cont. From/To	%	Joint Rating	Remarks
273.7 ft.	U	MSA	Abandoned Survey	/	<input type="checkbox"/>	UNABLE TO PASS BSV ZOOMED IN TO JOL/BSV REVERSAL TO LOG
