PACP Report with Pipe Run and Incident Snapshots

Surveyed by: ANDREW	Certificate number: T-507-4975	Owner: CITY OF MARION	Customer:	Drainage area:	P/O number:	Sheet number:
Pipe segment ref.: MH1_HB	Start date/time: 20240627 13:44	Street: HOLLAND ROAD NEAR ROCK SWALE	City: MARION, OH			
Location details:		Upstream MH No: MH1	Rim to invert:	Grade to invert:	Rim to grade:	
Pipe use: CB	Direction: D	Flow control:	Downstream MH No: HB	Rim to invert:	Grade to invert:	Rim to grade:
Height: 72 in.	Width:	Shape: C	Material: BR	Lining method:	Pipe joint length:	Total length: 175.300 ft.
Media label:	Pre-cleaning: N	Date cleaned:	Weather: 1	Length surveyed: 175.300 ft.	Purpose: B	Sewer category:
Project name: ROCK SWALE 72 IN INSPECTION	Additional info:					
Location code: C						
Pressure value:

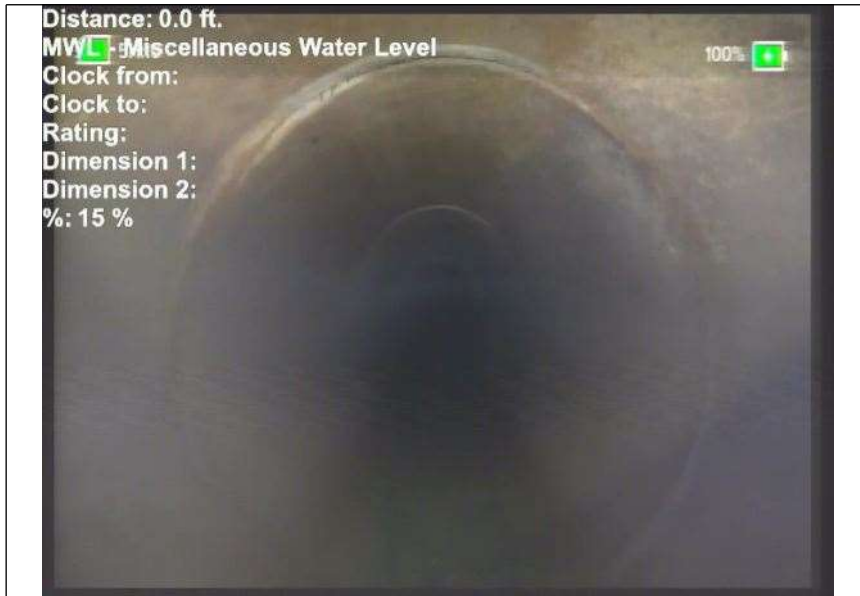
Distance: 0.0 ft.
MWL - Miscellaneous Water Level
Clock from:
Clock to:
Rating:
Dimension 1:
Dimension 2:
%: 15 %

At: 0 ft. MWL - Miscellaneous Water Level

Joint: No 15 %

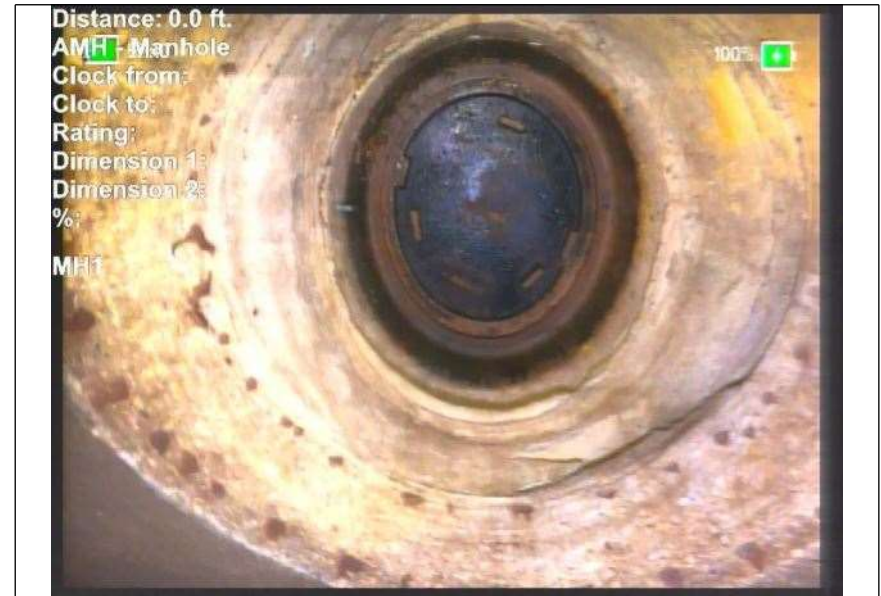
Distance: 0.0 ft.
AMH - Manhole
Clock from:
Clock to:
Rating:
Dimension 1:
Dimension 2:
%:
MH1

At: 0 ft. AMH - Manhole

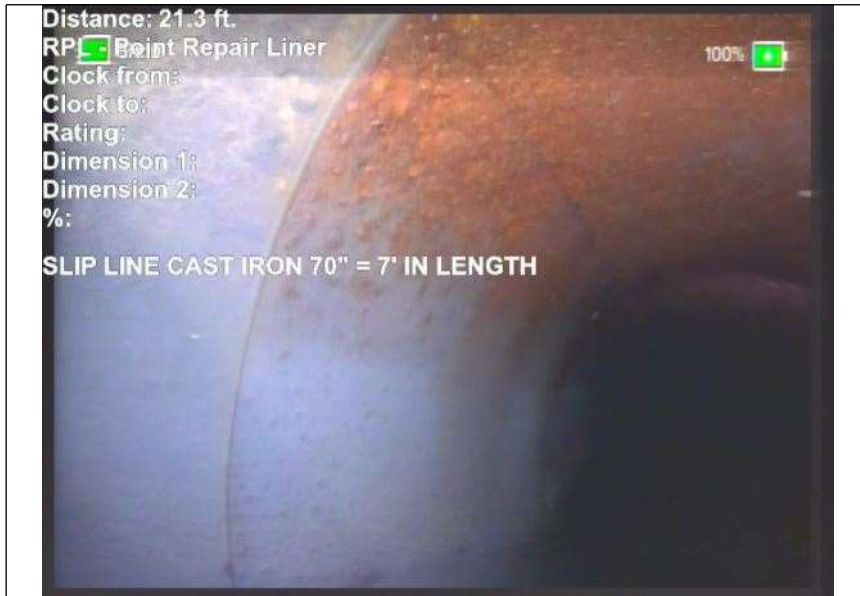
At: 21. RPL - Point Repair Liner
2999992370
605 ft.

Joint: No SLIP LINE CAST IRON 70" = 7' IN LENGTH

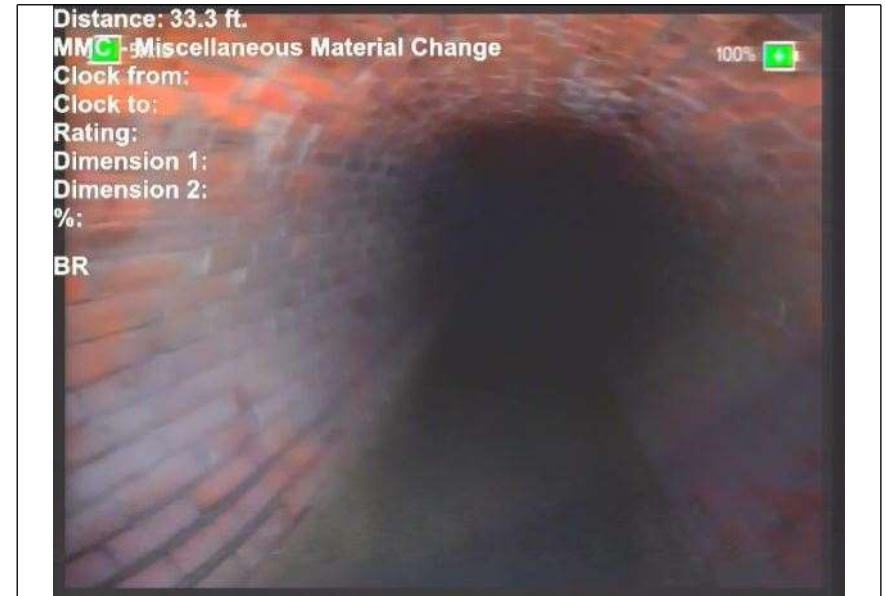
At: 33. MMC - Miscellaneous Material Change
2999992370
605 ft.

Joint: No BR

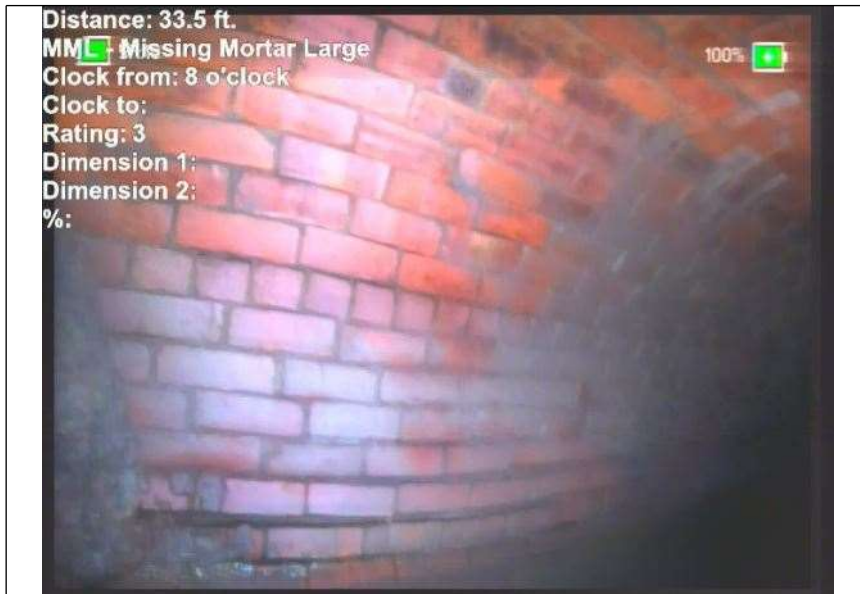
At: 33.5 ft. 8/. MML - Missing Mortar Large

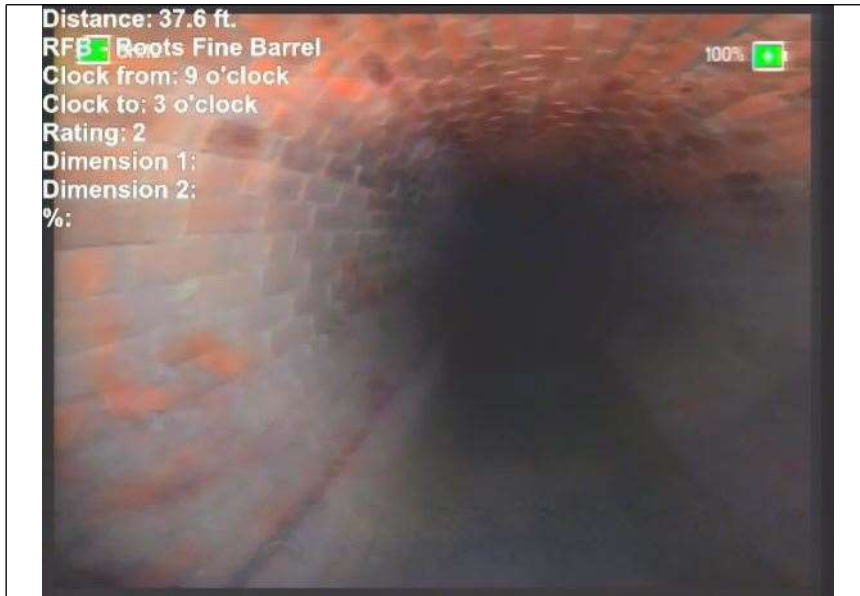
At: 37. RFB - Roots Fine Barrel
5999984741
211 ft. 9/3
Joint: No

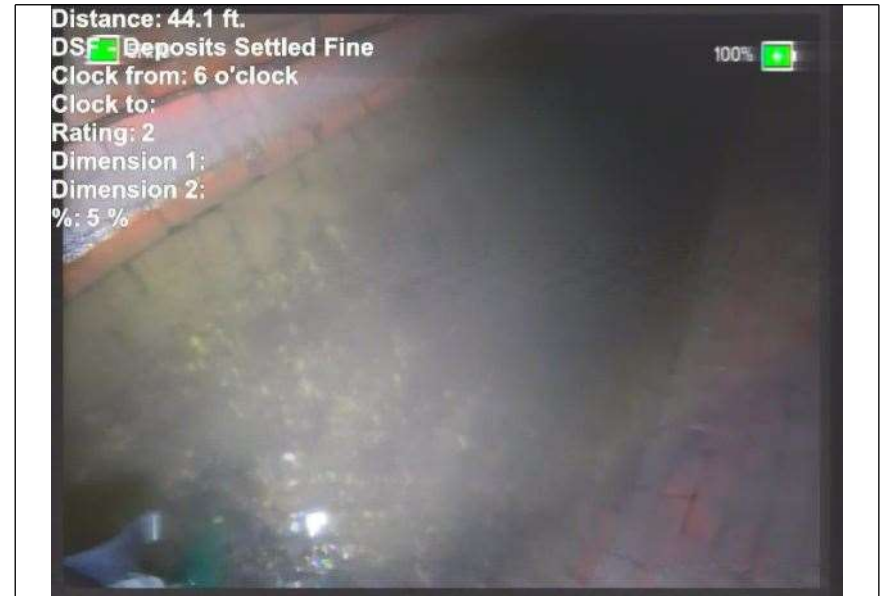
At: 44. DSF - Deposits Settled Fine
0999984741
211 ft. 6/
Joint: No 5 %

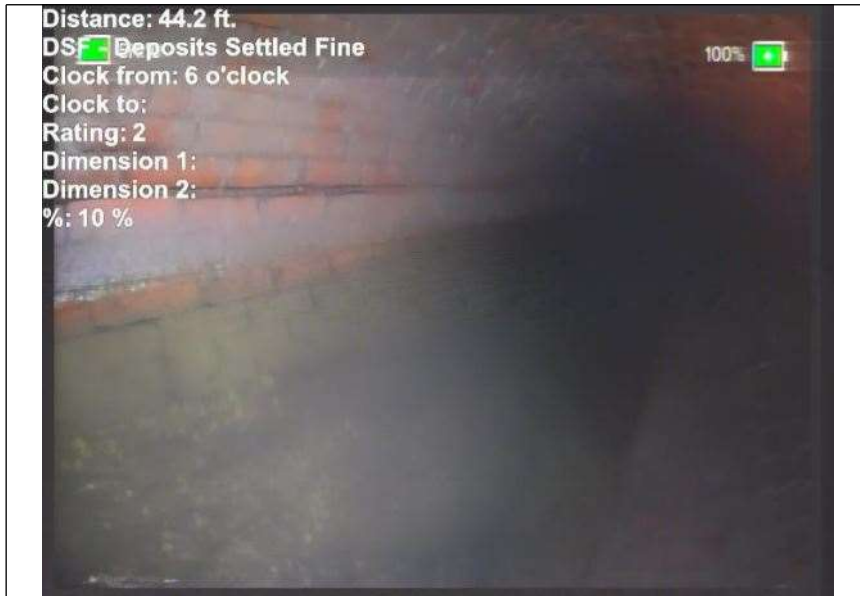
At: 44. DSF - Deposits Settled Fine
2000007629
395 ft. 6/.
Joint: No 10 %

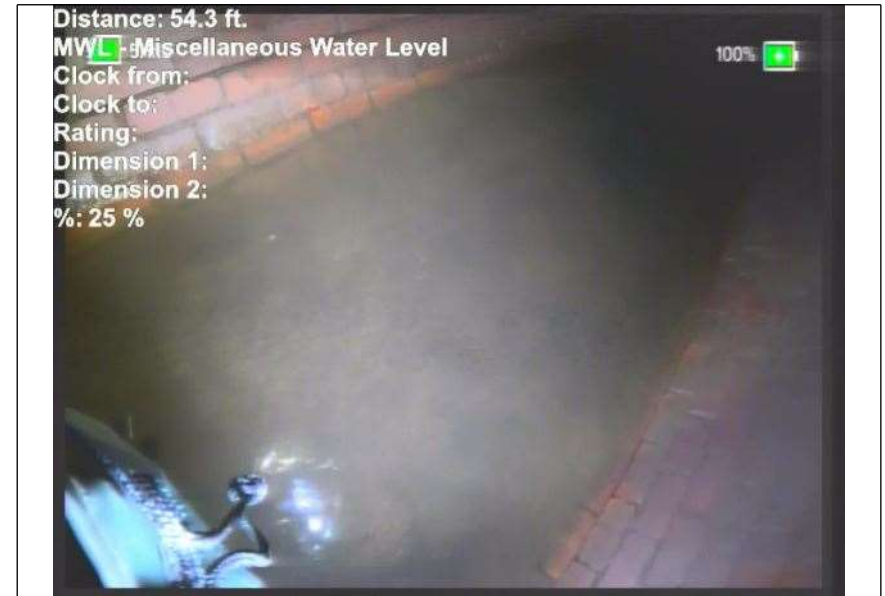
At: 54. MWL - Miscellaneous Water Level
2999992370
605 ft.
Joint: No 25 %

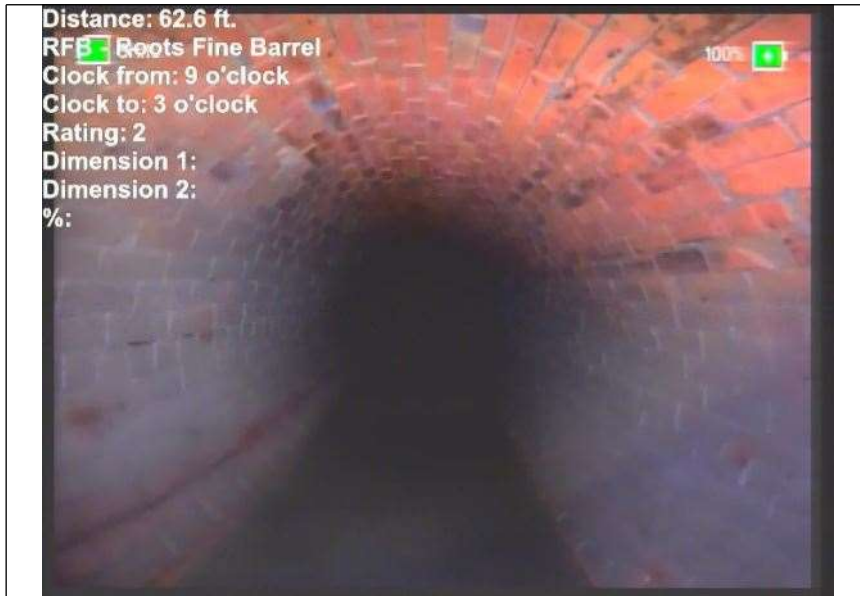
At: 62. 5999984741 RFB - Roots Fine Barrel
211 ft. 9/3
Joint: No

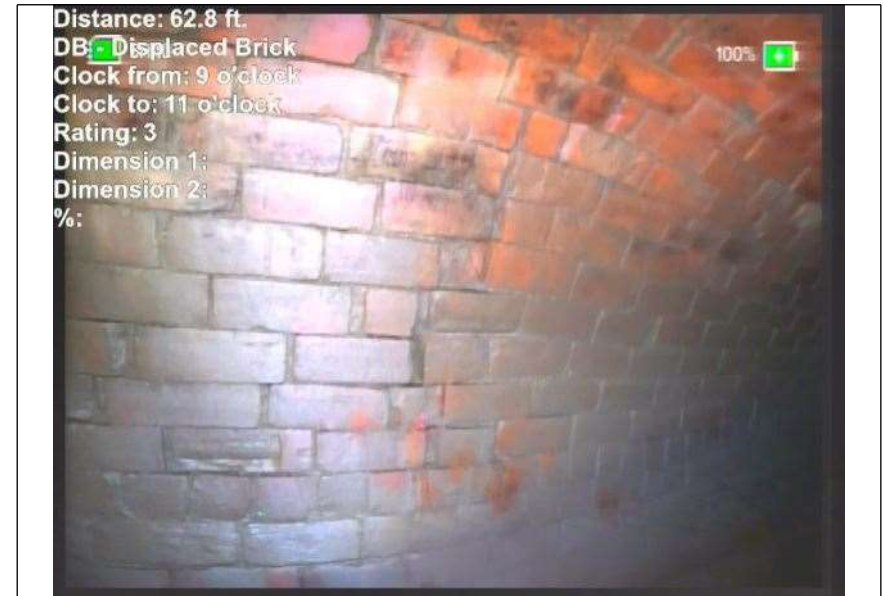
At: 62. 7999992370 DB - Displaced Brick
605 ft. 9/11
Joint: No

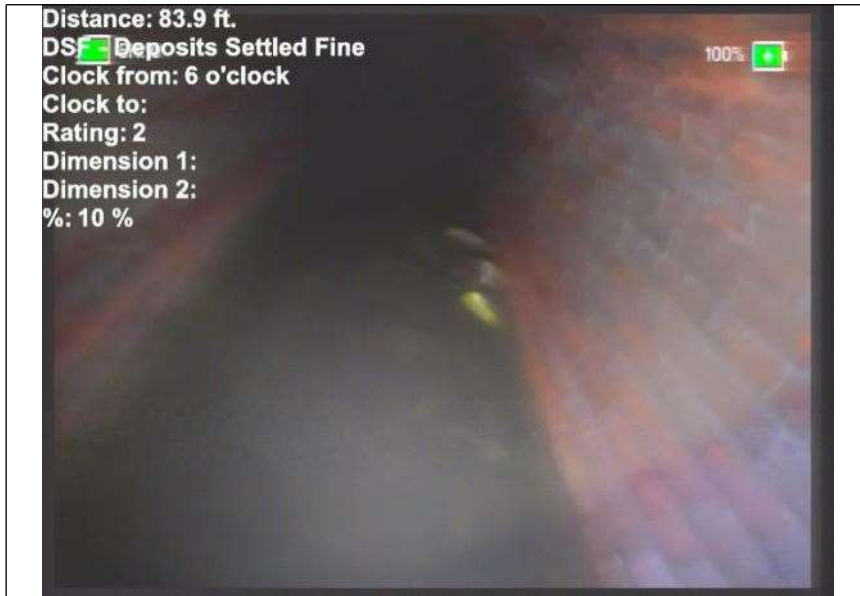
At: 83. DSF - Deposits Settled Fine
9000015258
789 ft. 6/.
Joint: No 10 %

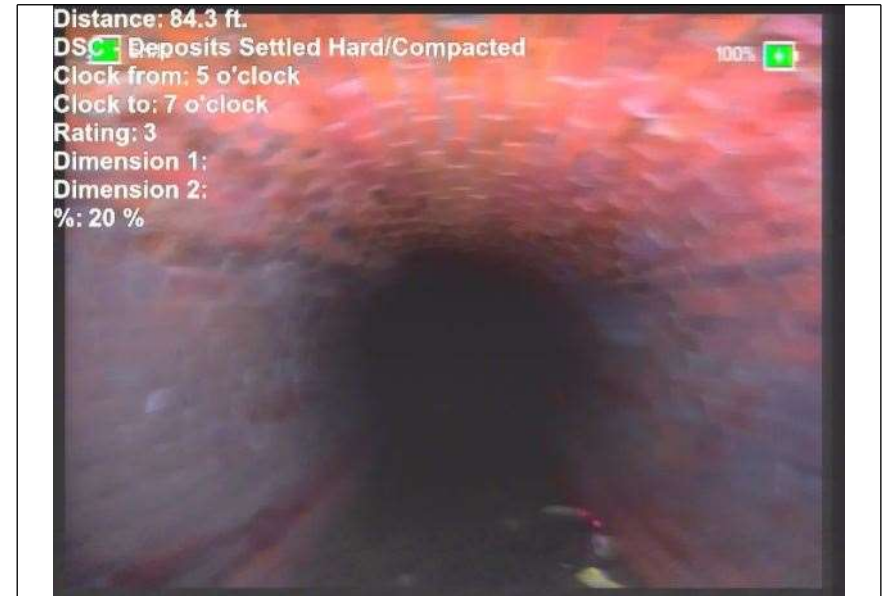
At: 84. DSC - Deposits Settled Hard/Compacted
3000030517
578 ft. 5/7
Joint: No 20 %

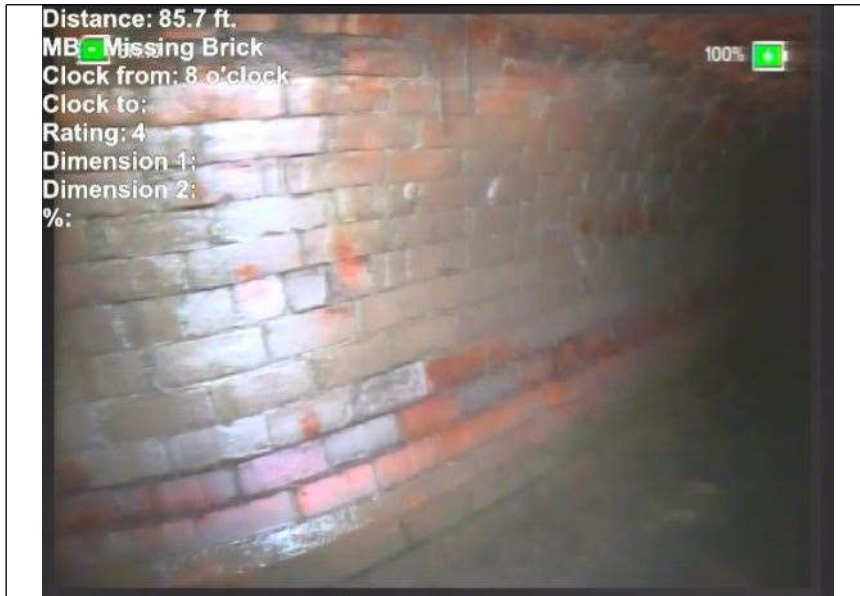
At: 85. MB - Missing Brick
6999969482
422 ft. 8/.

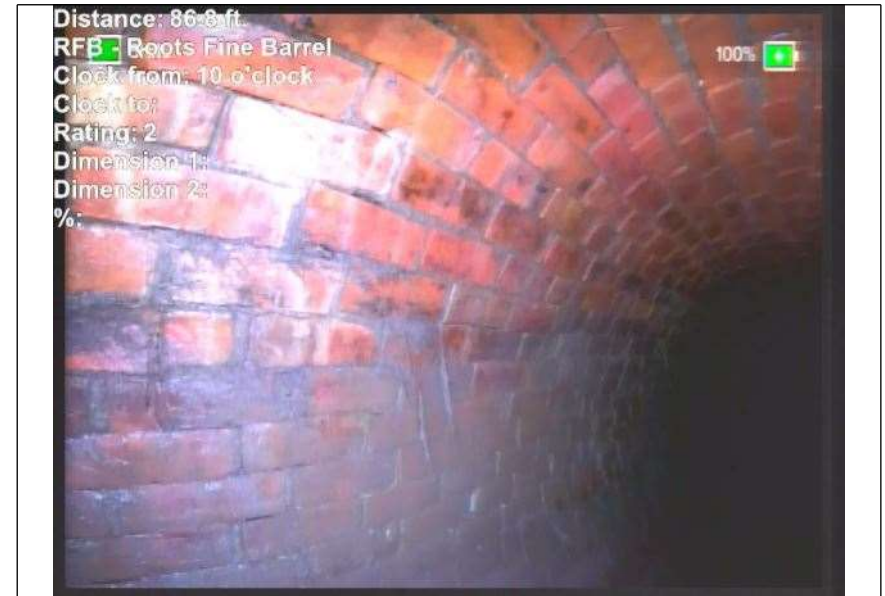
At: 86. RFB - Roots Fine Barrel
8000030517
578 ft. 10/.

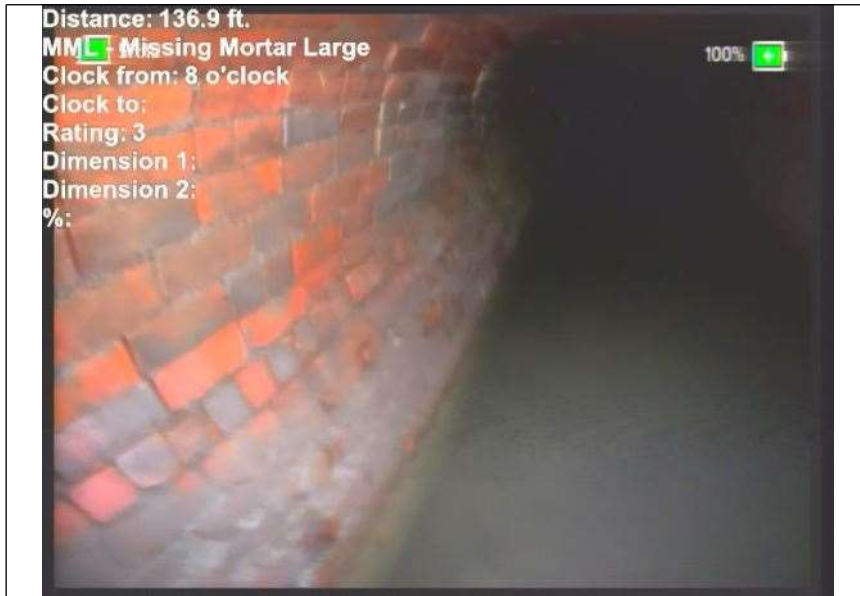
At: 136. MML - Missing Mortar Large
8999938964
84 ft. 8/.

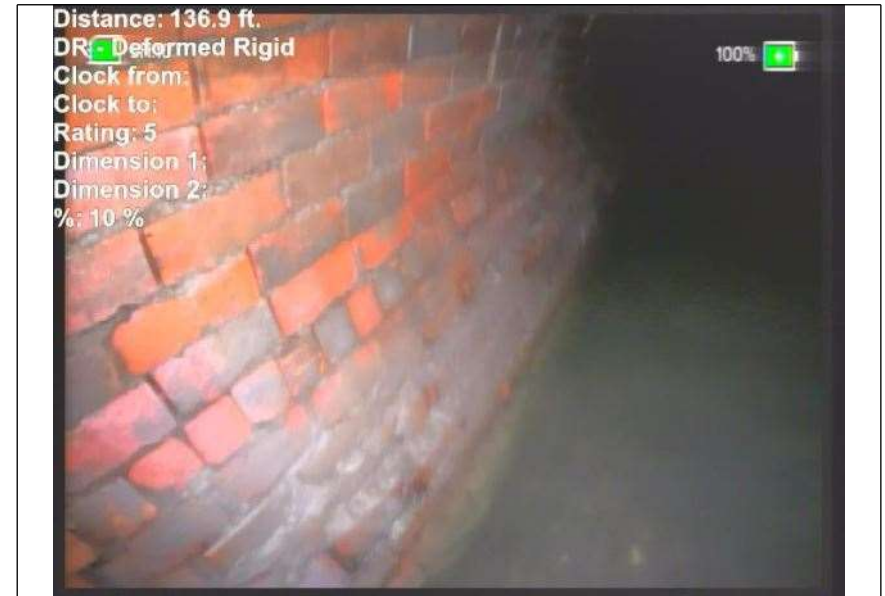
At: 136. DR - Deformed Rigid
8999938964
84 ft.

Joint: No 10 %

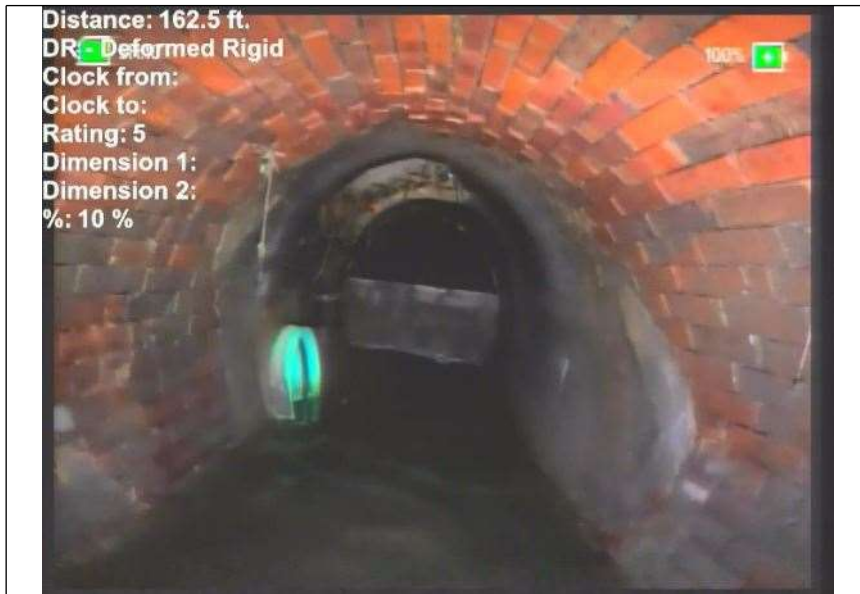
At: 162.5 ft. DR - Deformed Rigid

Joint: No 10 %

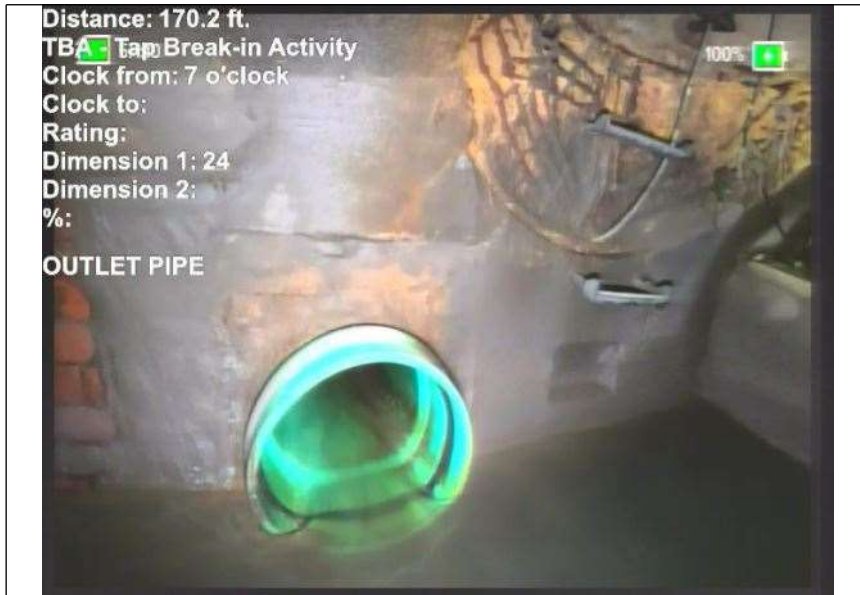
At: 170. TBA - Tap Break-in Activity
1999969482
42 ft. 7/.

Joint: No OUTLET PIPE

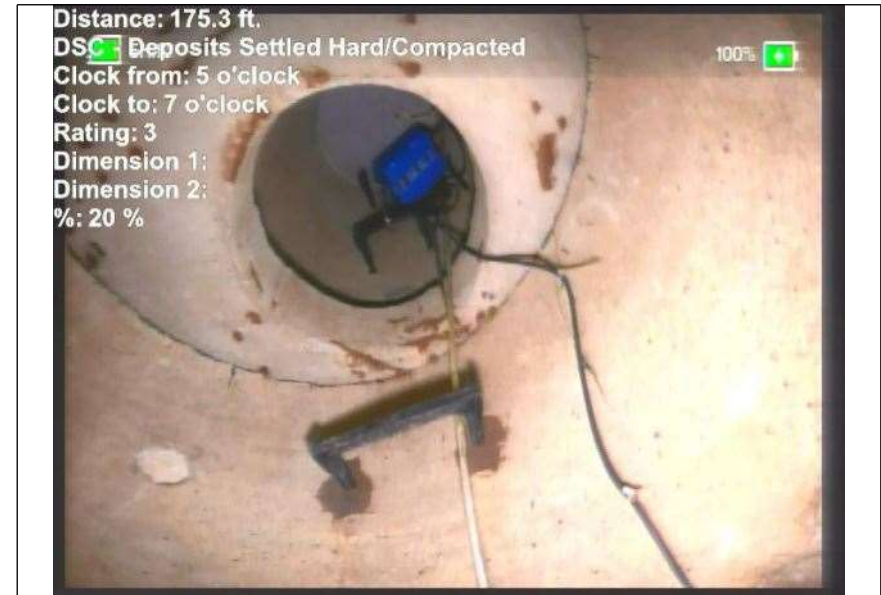
At: 175.2 ft. 5/7 DSC - Deposits Settled Hard/Compacted
Joint: No 20 %

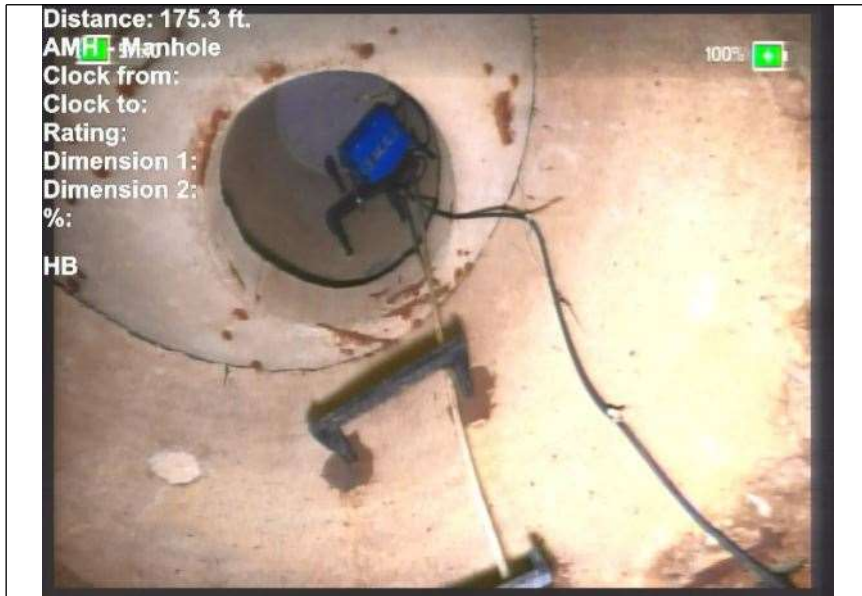
At: 175. AMH - Manhole
3000030517
58 ft.

Joint: No HB
