## PACP Report with Pipe Run and Incident Snapshots

Surveyed by: <b>ANDREW</b>	Certificate number: <b>T-507-4975</b>	Owner: <b>CITY OF MARION</b>	Customer:	Drainage area:	P/O number:	Sheet number:			
Pipe segment ref.: <b>MH2_MH1</b>	Start date/time: <b>20240627 13:12</b>	Street: <b>1432 HOLLAND ROAD</b>	City: <b>MARION, OH</b>						
Location details:	Upstream MH No: <b>MH2</b>	Rim to invert:	Grade to invert:	Rim to grade:					
Pipe use: <b>CB</b>	Direction: <b>D</b>	Flow control:	Downstream MH No: <b>MH1</b>	Rim to invert:	Grade to invert:	Rim to grade:			
Height: <b>72 in.</b>	Width:	Shape: <b>C</b>	Material: <b>BR</b>	Lining method:	Pipe joint length:	Total length: <b>694.800 ft.</b>	Length surveyed: <b>694.800 ft.</b>	Purpose:	Sewer category:
Media label:	Pre-cleaning: <b>N</b>	Date cleaned:	Weather: <b>1</b>	Location code: <b>C</b>	Pressure value:				
Project name: <b>ROCK SWALE 72 IN INSPECTION</b>	Additional info:

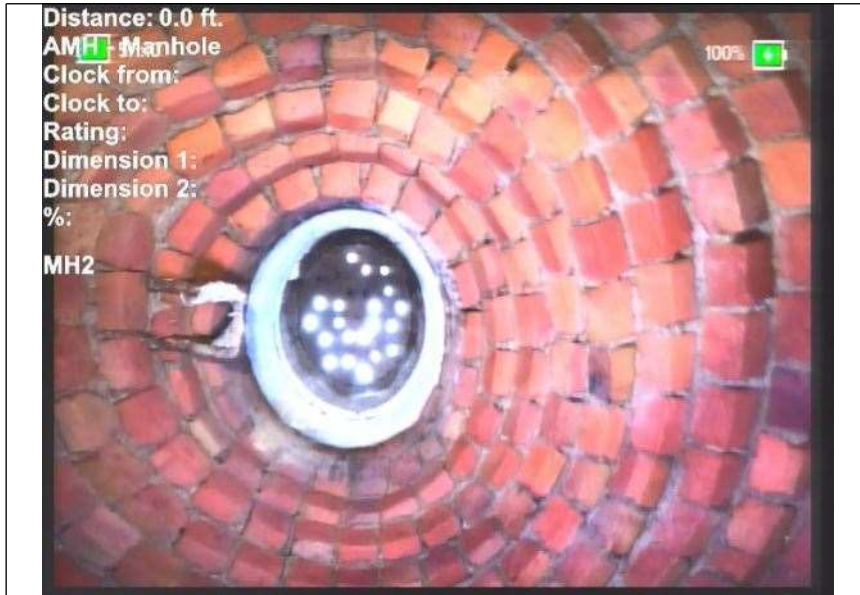
At: 0 ft. AMH - Manhole  
Joint: No MH2

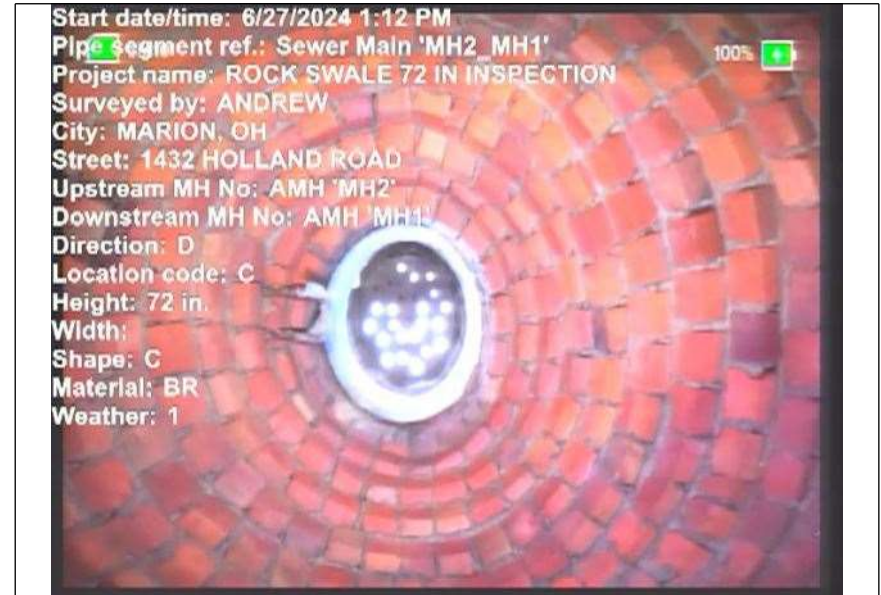
At: 0 ft. AMH - Manhole  
Joint: No MH2

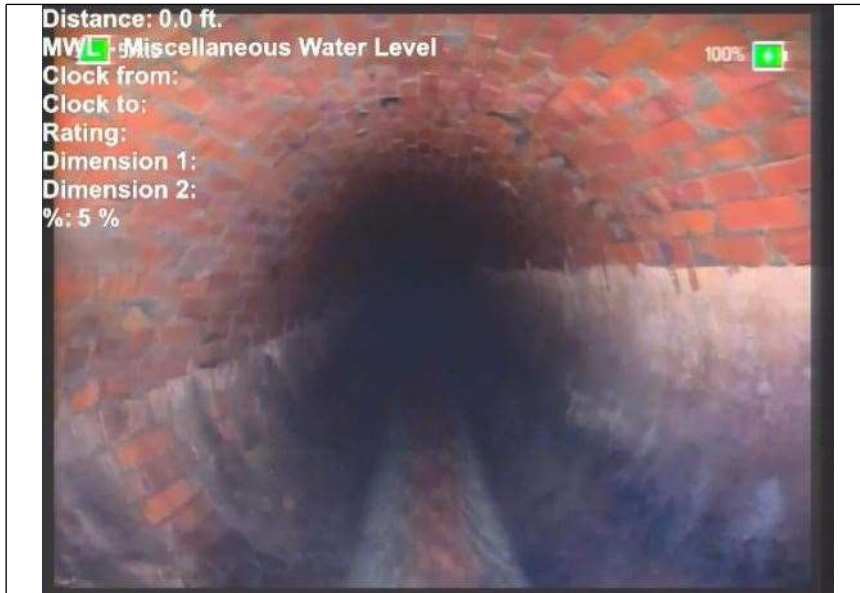
At: 0 ft. MWL - Miscellaneous Water Level  
Joint: No 5 %

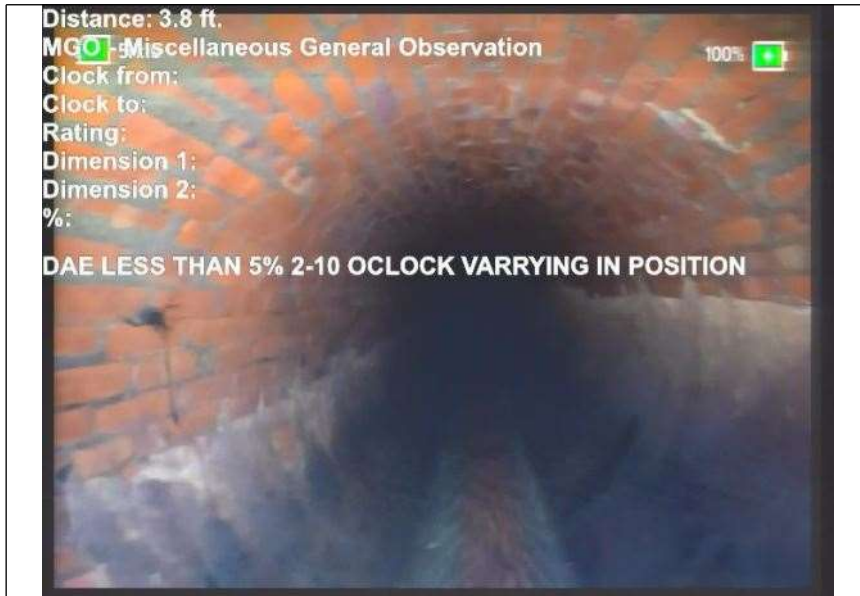
At: 3. MGO - Miscellaneous General Observation  
7999999523  
1628 ft.  
Joint: No DAE LESS THAN 5% 2-10 OCLOCK VARRYING IN POSITION

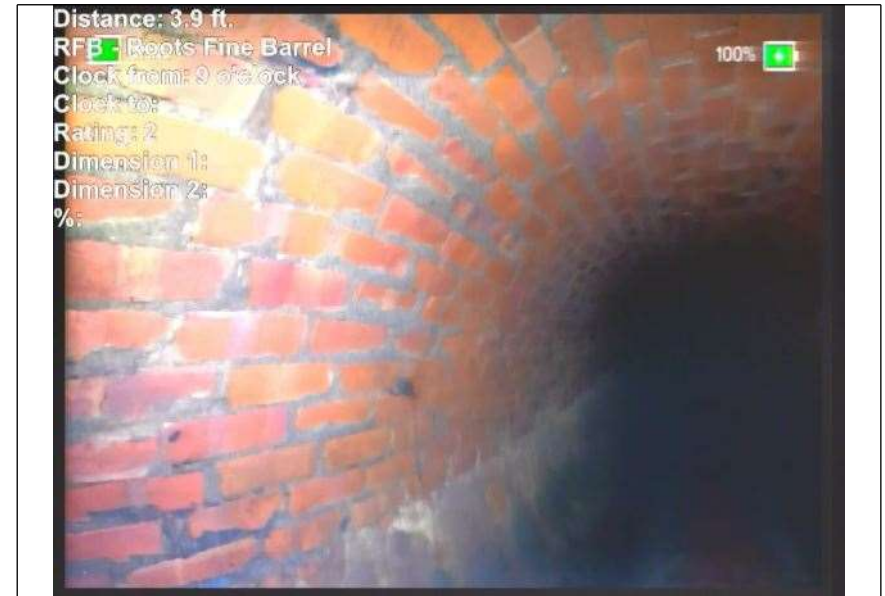
At: 3. RFB - Roots Fine Barrel  
9000000953  
6743 ft. 9/.  
Joint: No

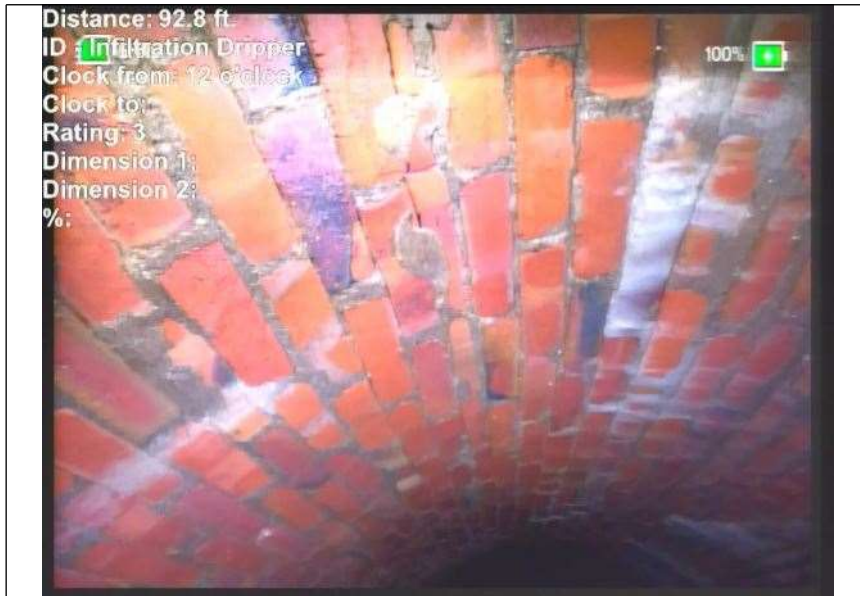
At: 92. ID - Infiltration Dropper  
8000030517  
578 ft. 12/.

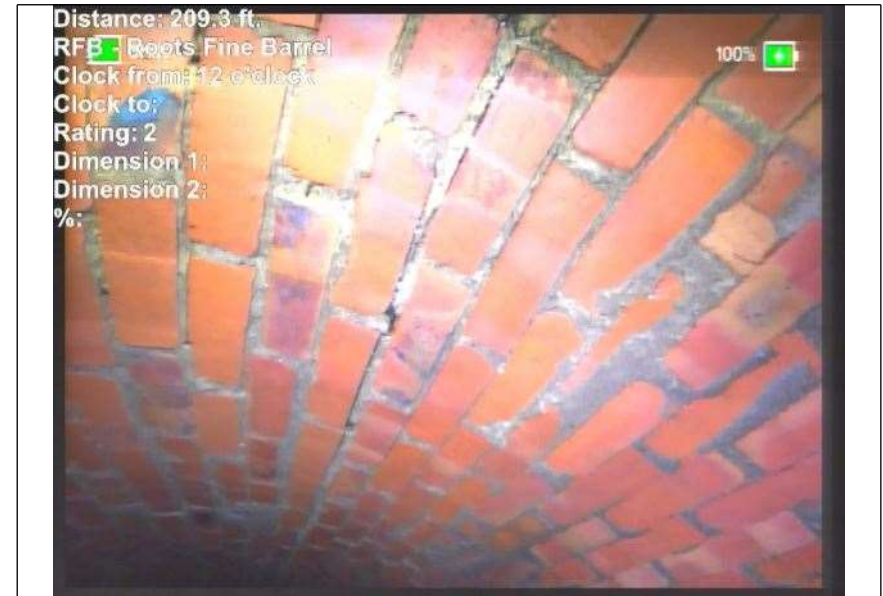
At: 209. RFB - Roots Fine Barrel  
3000030517  
58 ft. 12/.

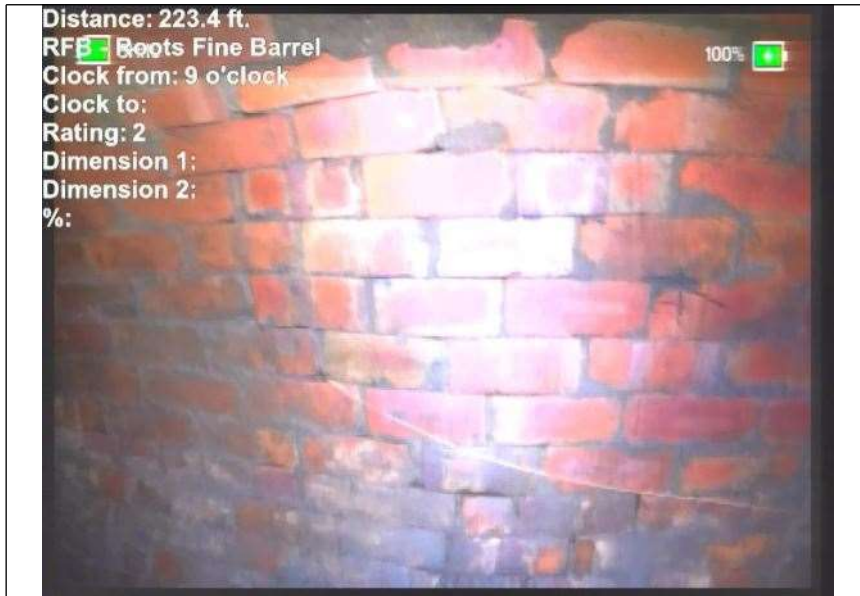
At: 223. RFB - Roots Fine Barrel  
3999938964  
84 ft. 9/.

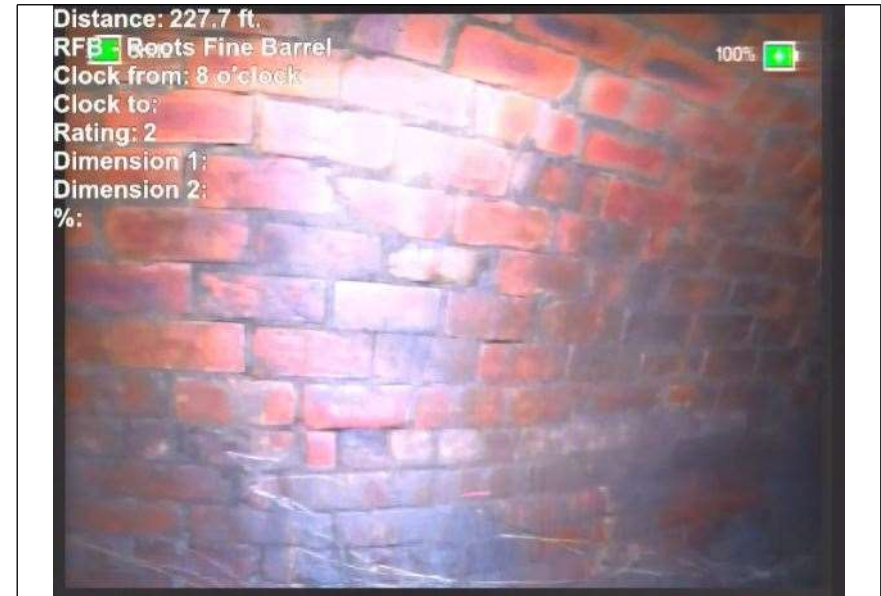
At: 227. RFB - Roots Fine Barrel  
6999969482  
42 ft. 8/.

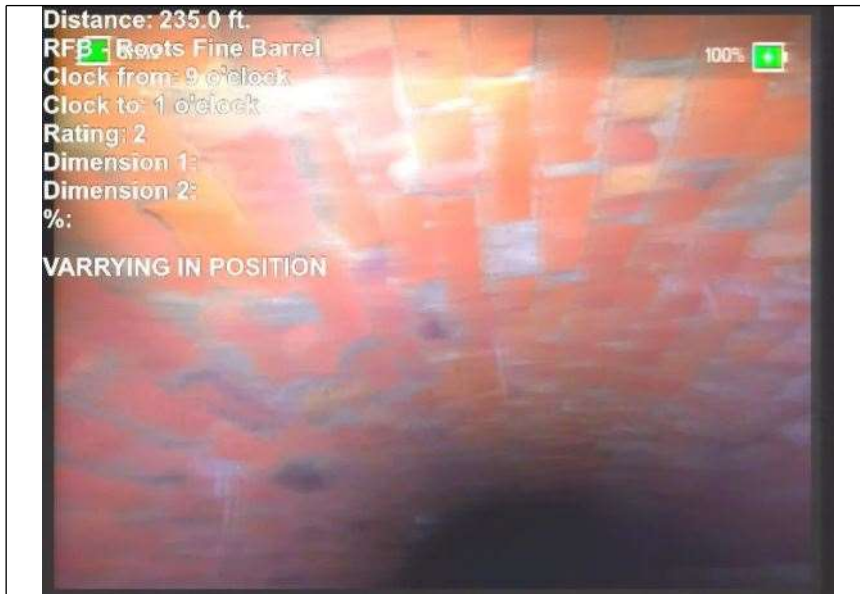
At: 235 ft. 9/1 RFB - Roots Fine Barrel

Joint: No VARRYING IN POSITION

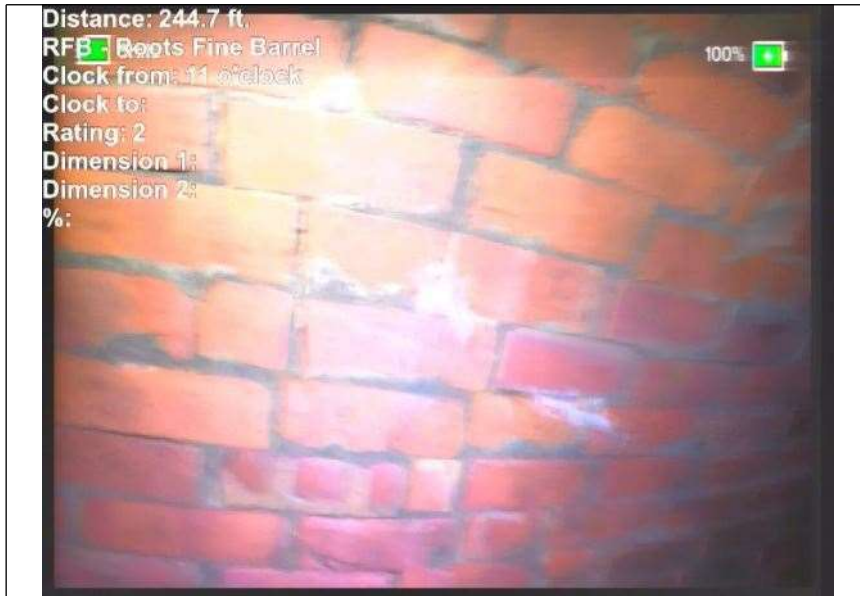
At: 244. RFB - Roots Fine Barrel  
6999969482  
42 ft. 11/.

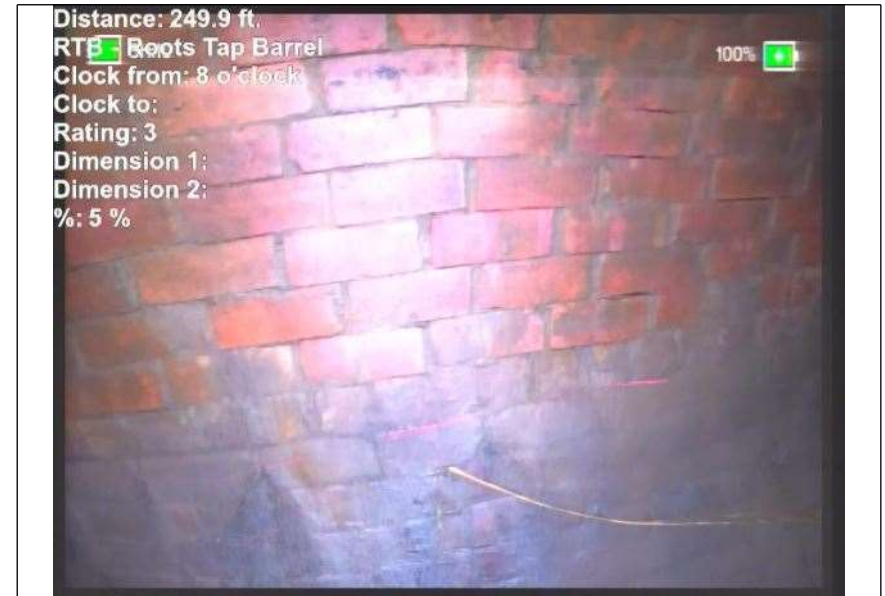
At: 249. RTB - Roots Tap Barrel  
8999938964  
84 ft. 8/.

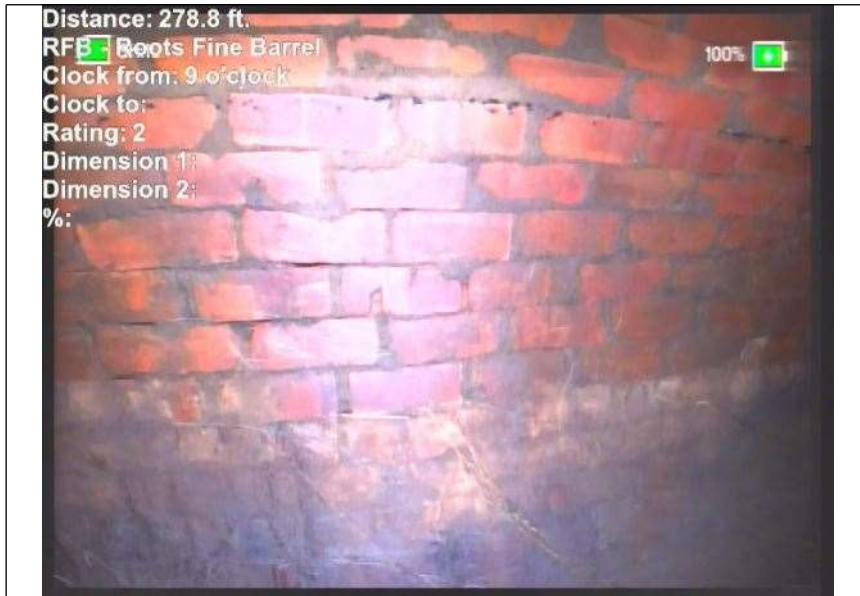
At: 278. RFB - Roots Fine Barrel  
7999877929  
69 ft. 9/.

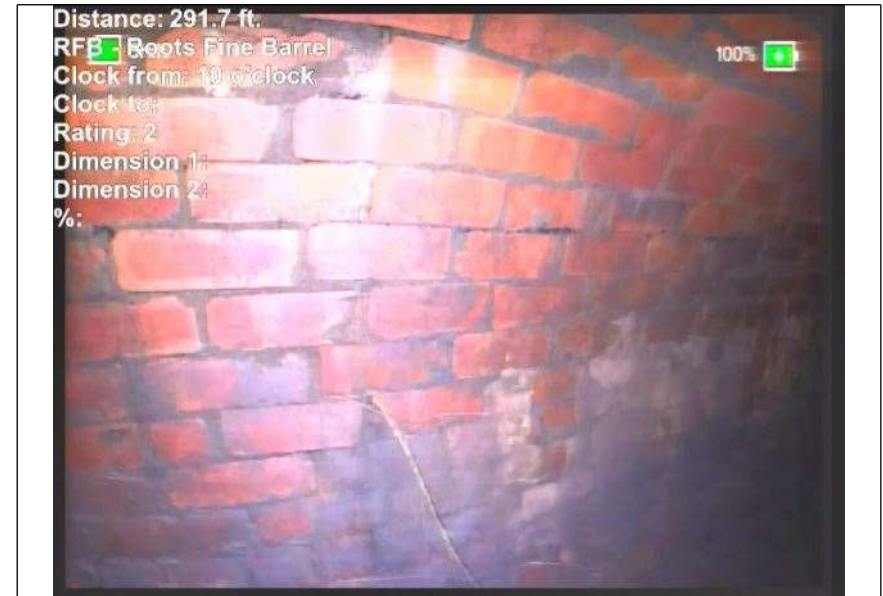
At: 291. RFB - Roots Fine Barrel  
7000122070  
31 ft. 10/.

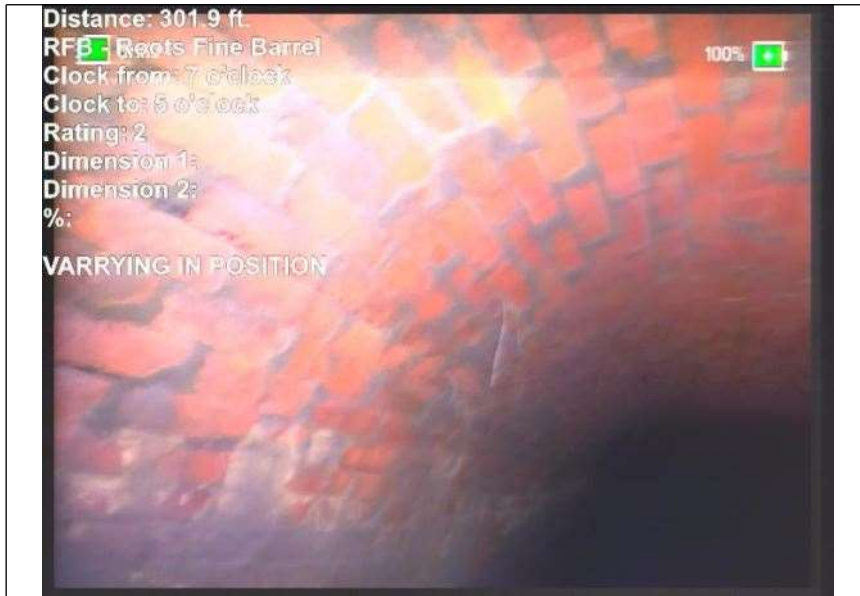
At: 301. RFB - Roots Fine Barrel  
8999938964  
84 ft. 7/5  
Joint: No VARRYING IN POSITION

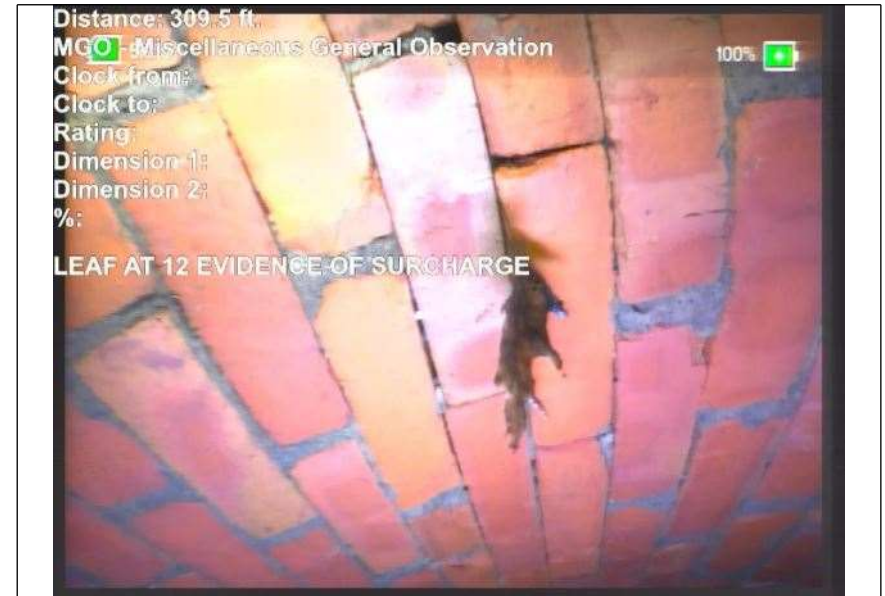
At: 309.5 ft. MGO - Miscellaneous General Observation  
Joint: No LEAF AT 12 EVIDENCE OF SURCHARGE

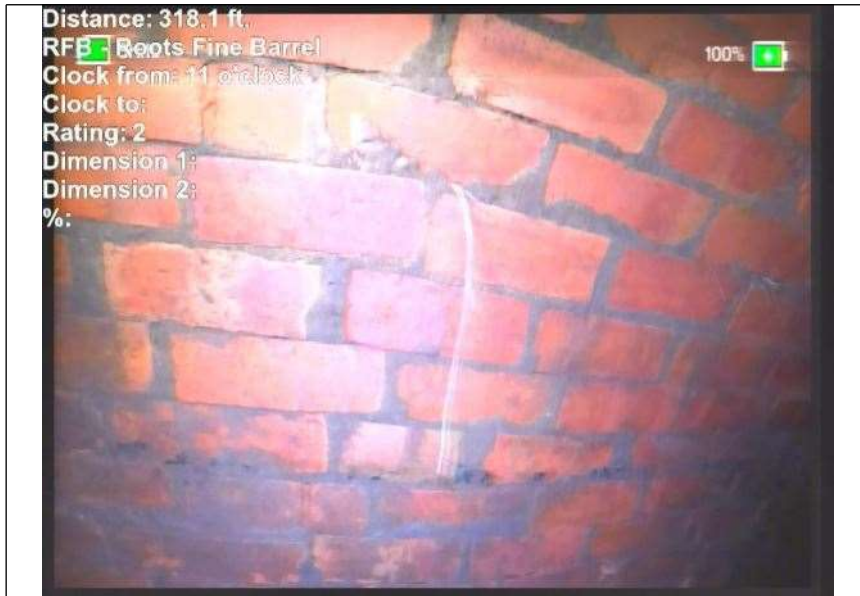
At: 318. RFB - Roots Fine Barrel  
1000061035  
16 ft. 11/.  
Joint: No

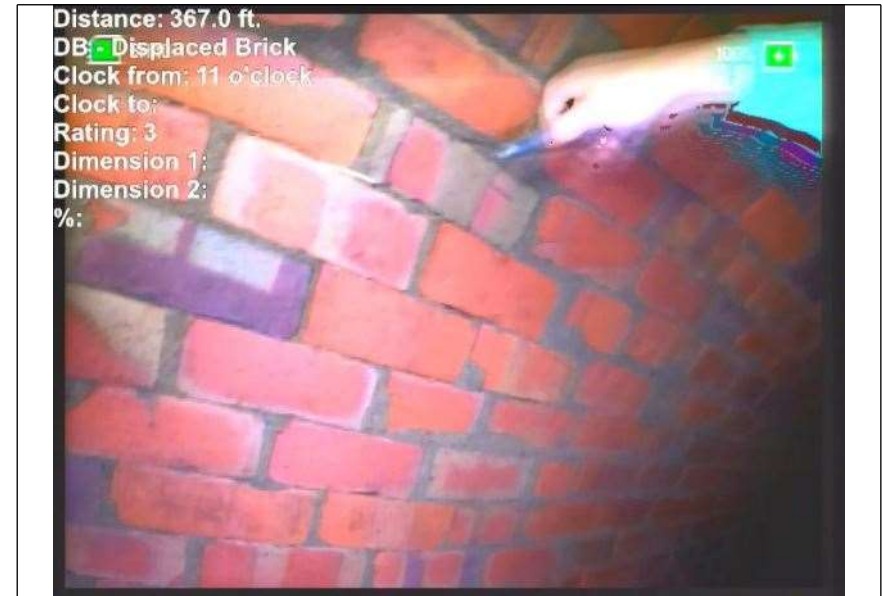
At: 367 ft. 11/. DB - Displaced Brick  
Joint: No

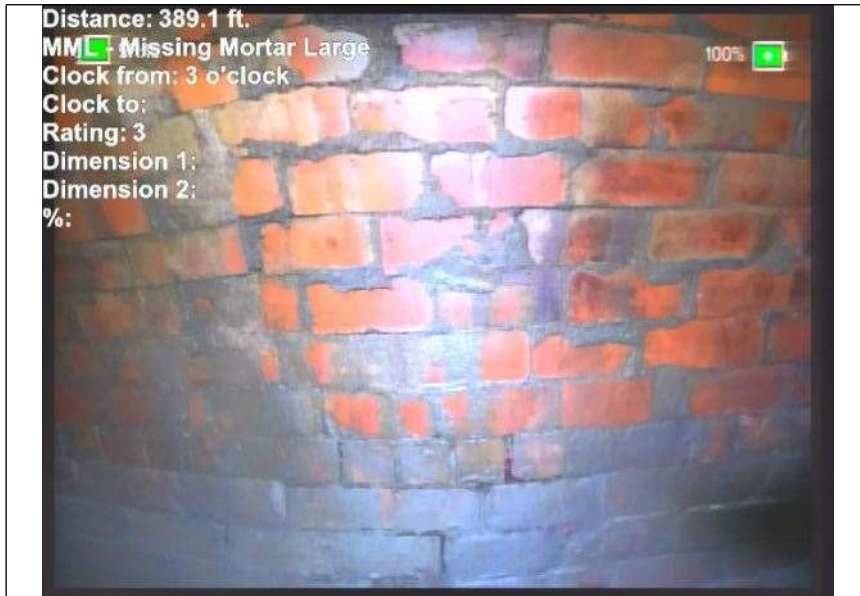
At: 389. MML - Missing Mortar Large  
1000061035  
16 ft. 3/.

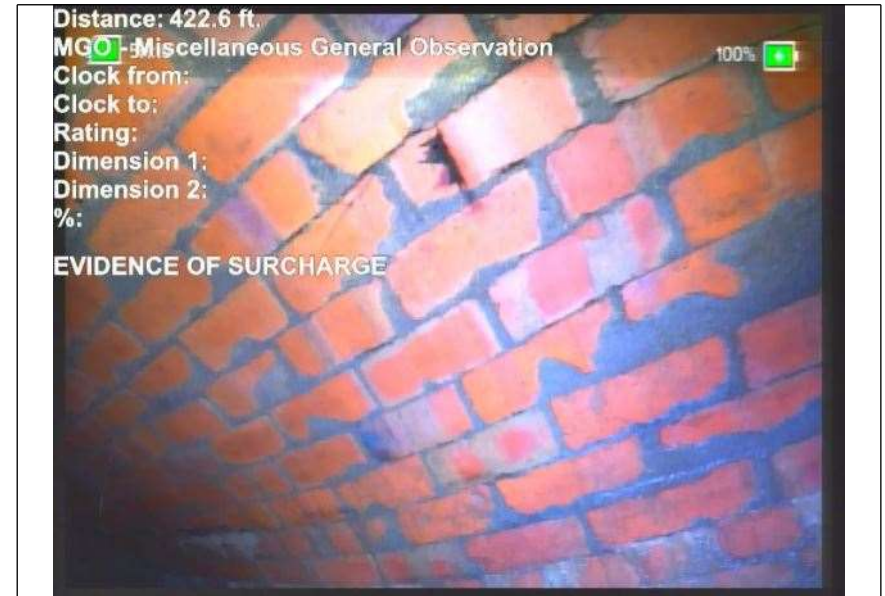
At: 422. MGO - Miscellaneous General Observation  
6000061035  
16 ft.

Joint: No EVIDENCE OF SURCHARGE

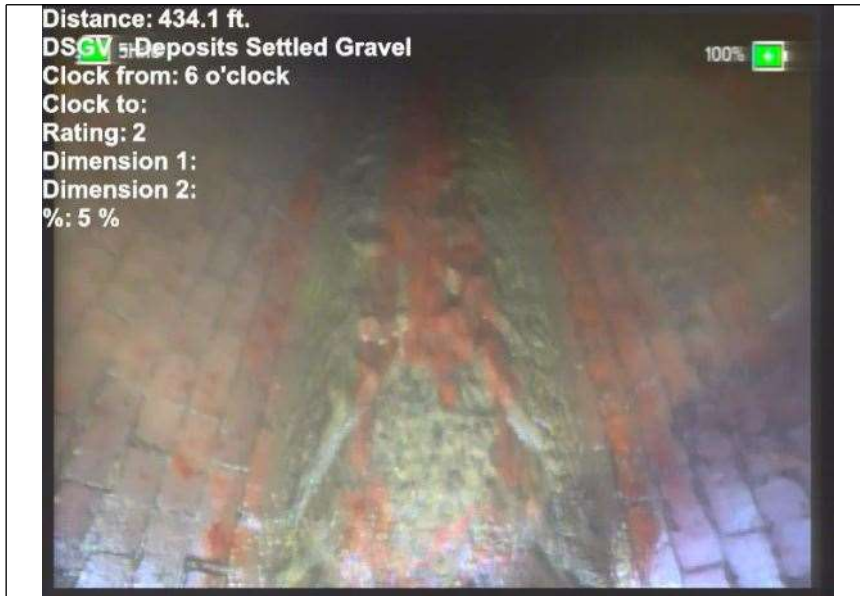
At: 434. DSGV - Deposits Settled Gravel  
1000061035  
16 ft. 6/.  
Joint: No 5 %

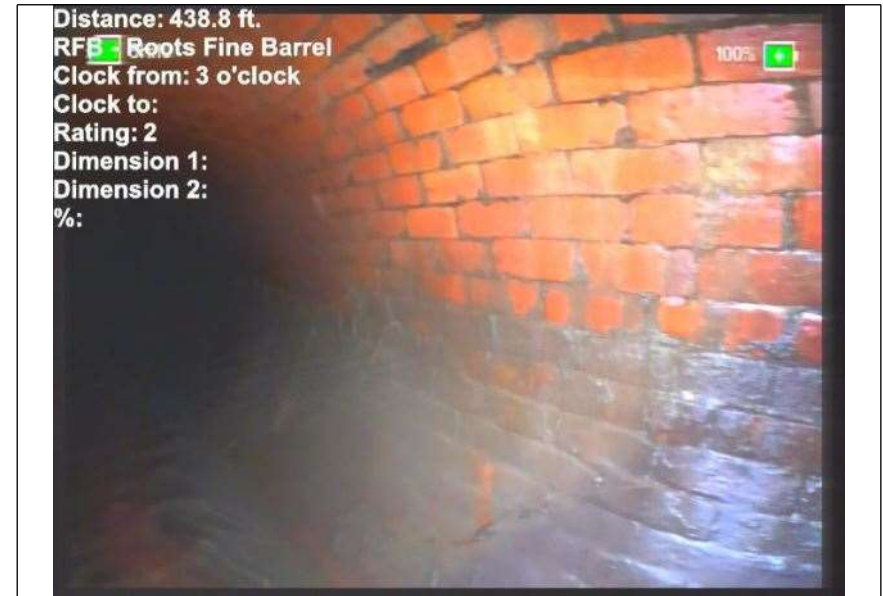
At: 438. RFB - Roots Fine Barrel  
7999877929  
69 ft. 3/.  
Joint: No

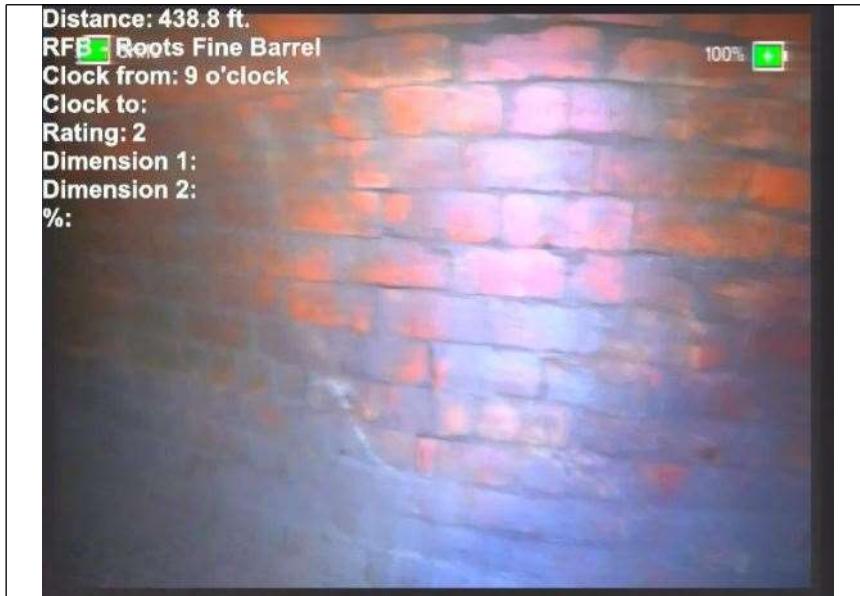
At: 438. RFB - Roots Fine Barrel  
7999877929  
69 ft. 9/.

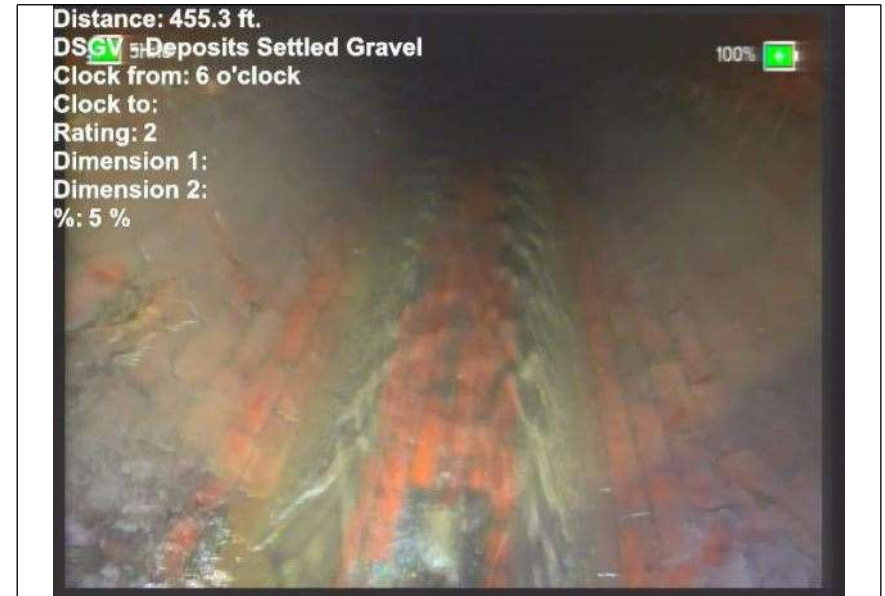
At: 455. DSGV - Deposits Settled Gravel  
2999877929  
69 ft. 6/.

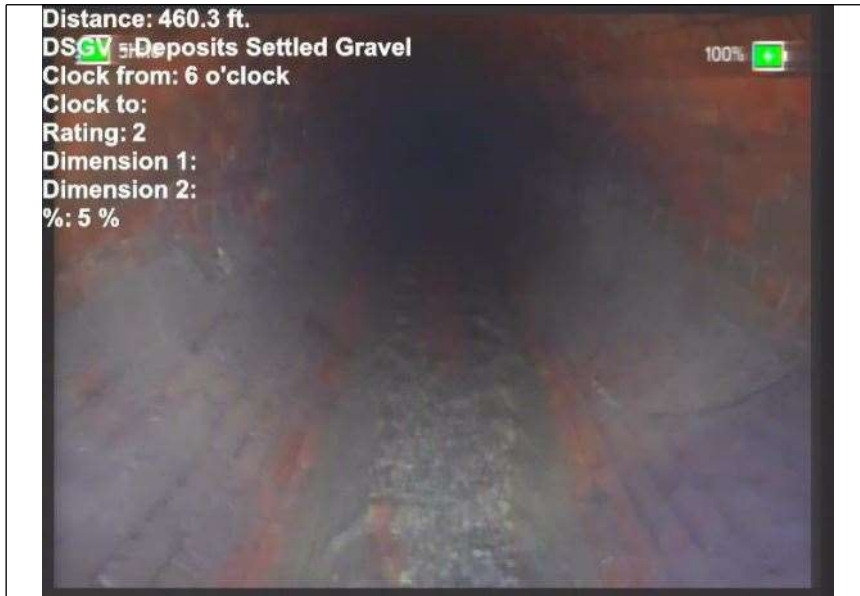
At: 460. DSGV - Deposits Settled Gravel  
2999877929  
69 ft. 6/.  
Joint: No 5 %

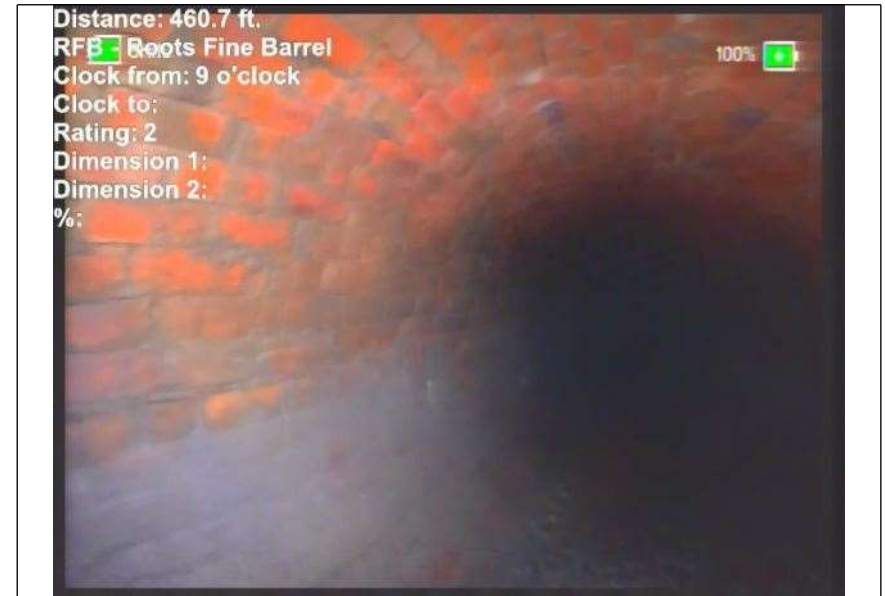
At: 460. RFB - Roots Fine Barrel  
7000122070  
31 ft. 9/.  
Joint: No

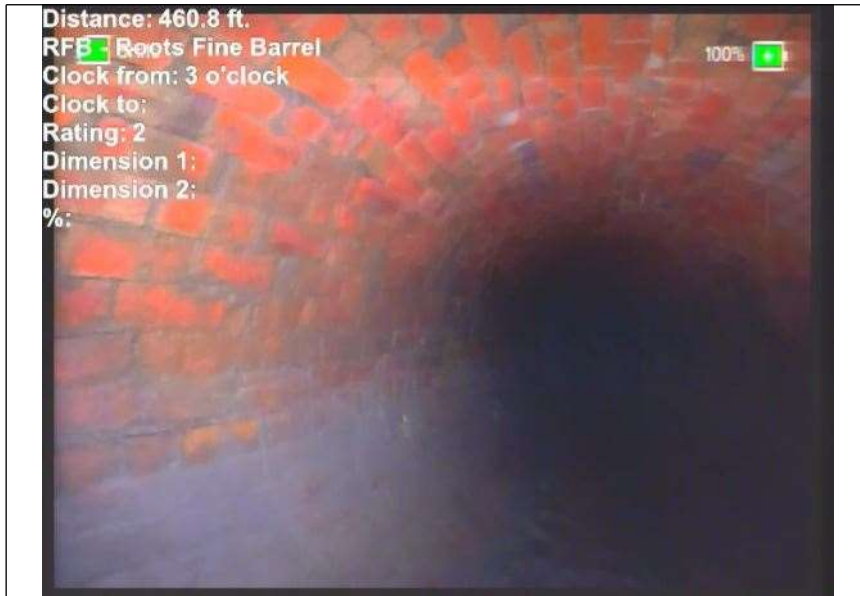
At: 460. RFB - Roots Fine Barrel  
7999877929  
69 ft. 3/.

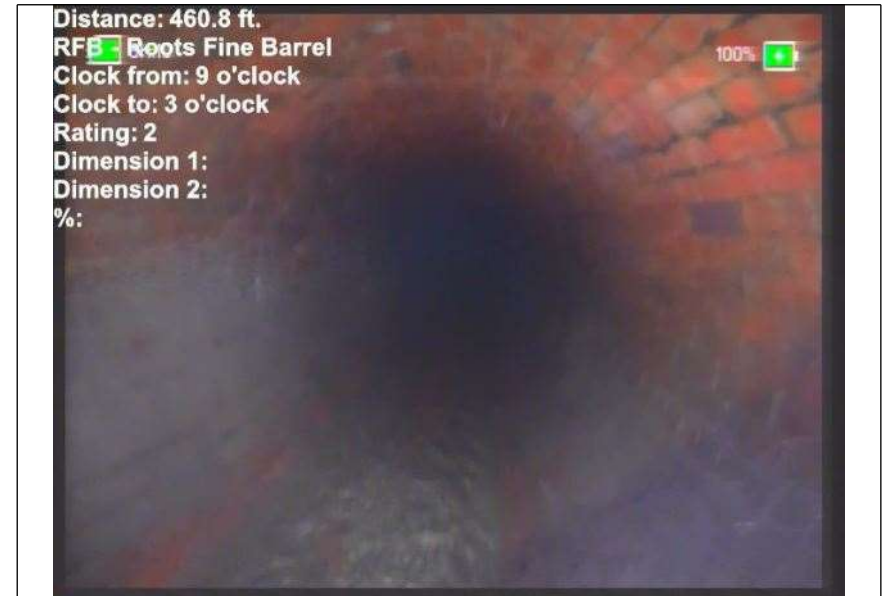
At: 460. RFB - Roots Fine Barrel  
7999877929  
69 ft. 9/3

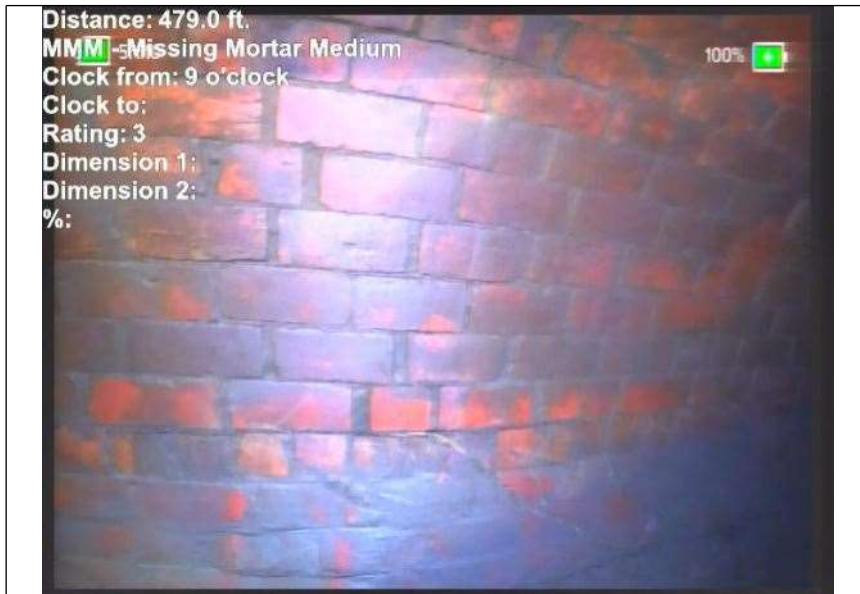
At: 479 ft. 9/. MMM - Missing Mortar Medium

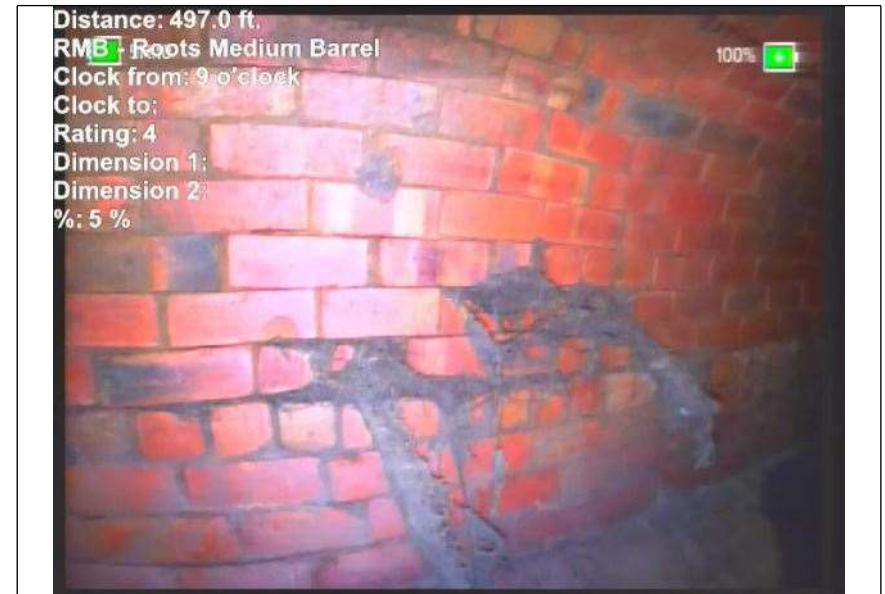
At: 497 ft. 9/. RMB - Roots Medium Barrel

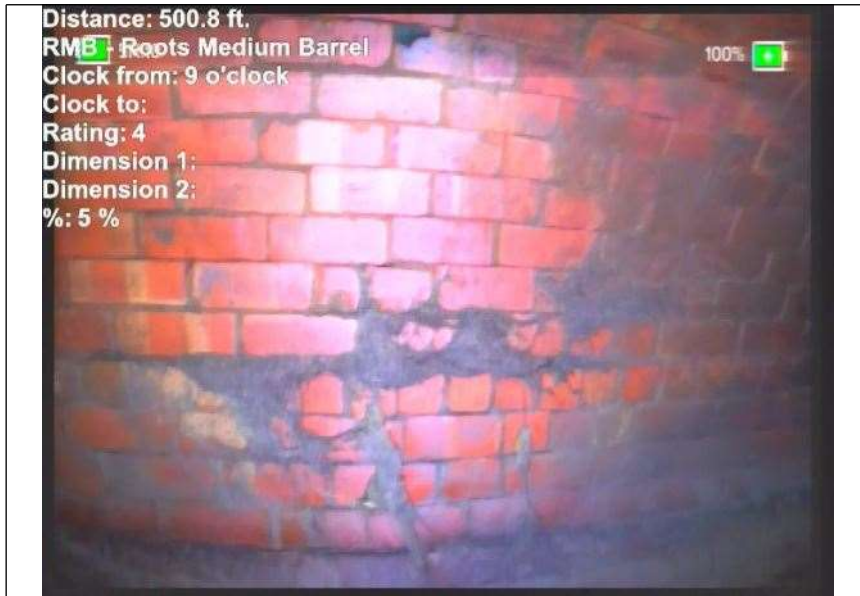
At: 500. RMB - Roots Medium Barrel  
7999877929  
69 ft. 9/.  
Joint: No 5 %

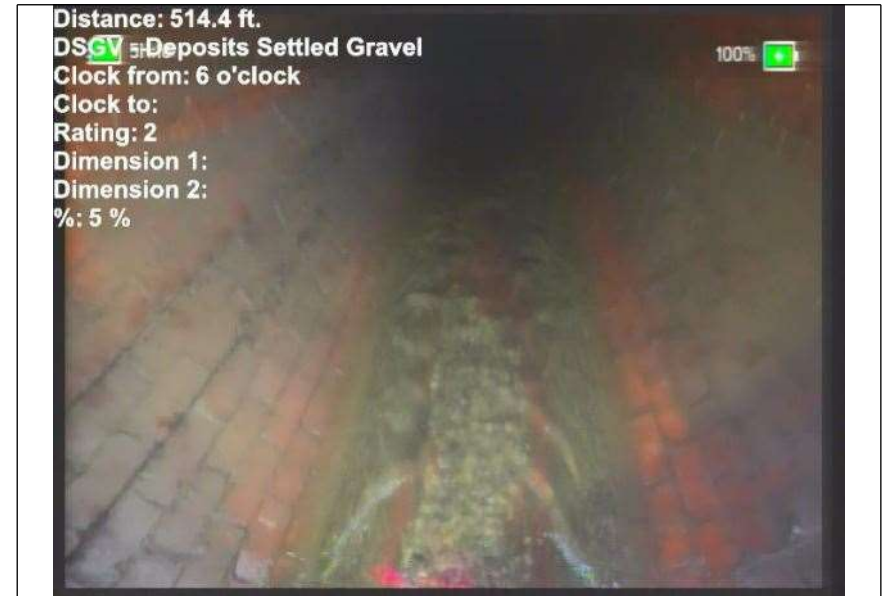
At: 514. DSGV - Deposits Settled Gravel  
4000244140  
63 ft. 6/.  
Joint: No 5 %

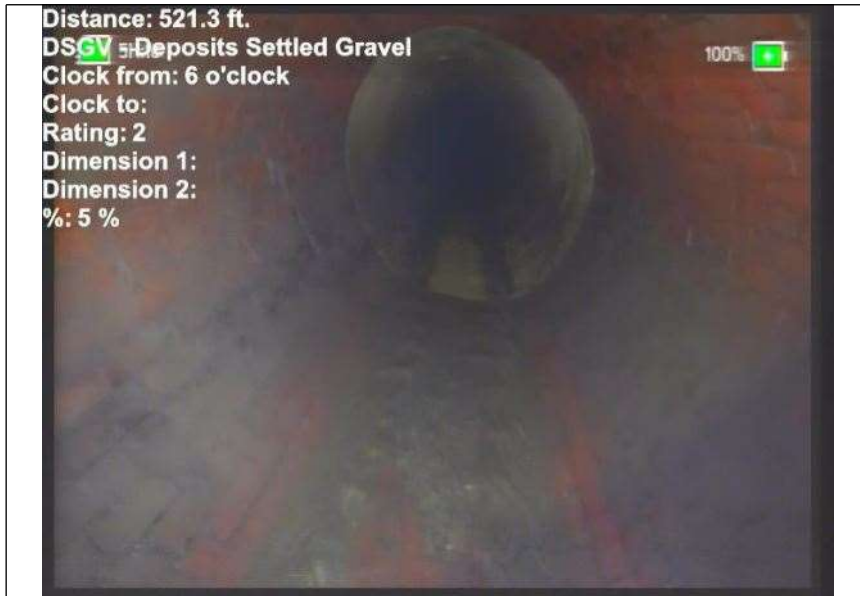
At: 521. DSGV - Deposits Settled Gravel  
2999877929  
69 ft. 6/.  
Joint: No 5 %

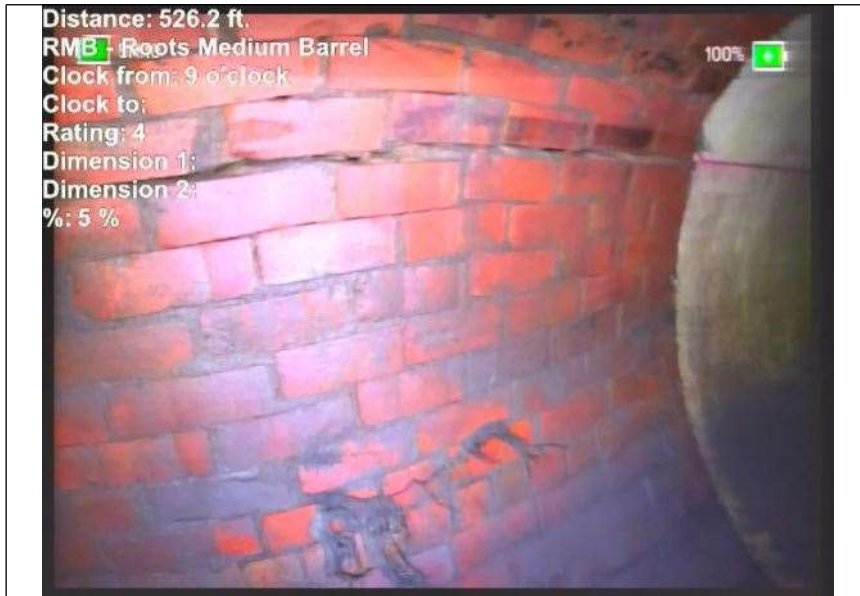
At: 526. RMB - Roots Medium Barrel  
2000122070  
31 ft. 9/.

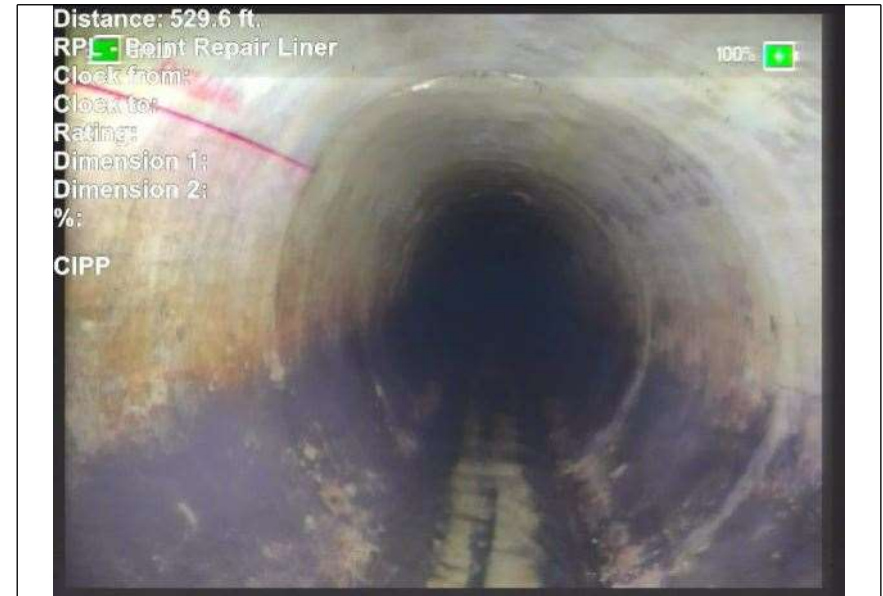
At: 529. RPL - Point Repair Liner  
5999755859  
38 ft.

Joint: No CIPP

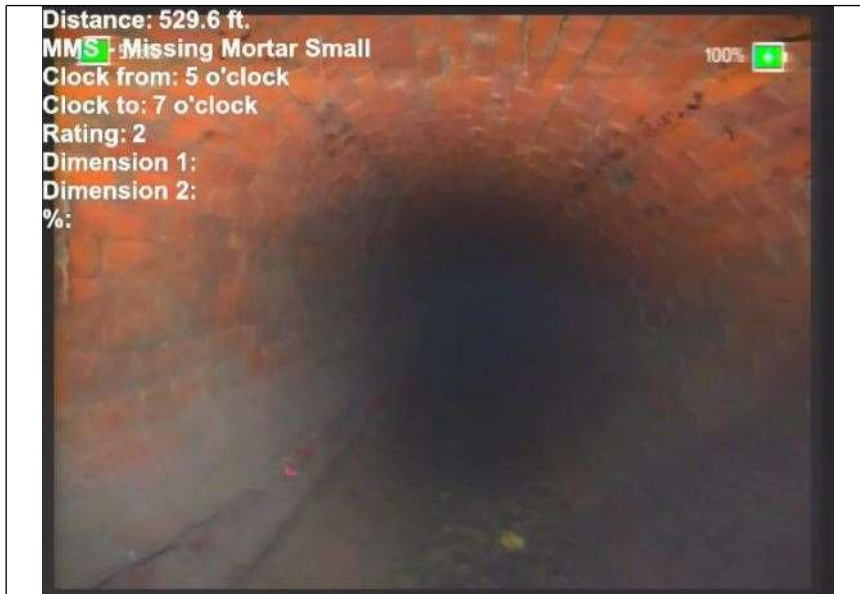
At: 529.6 ft. 5/7 MMS - Missing Mortar Small

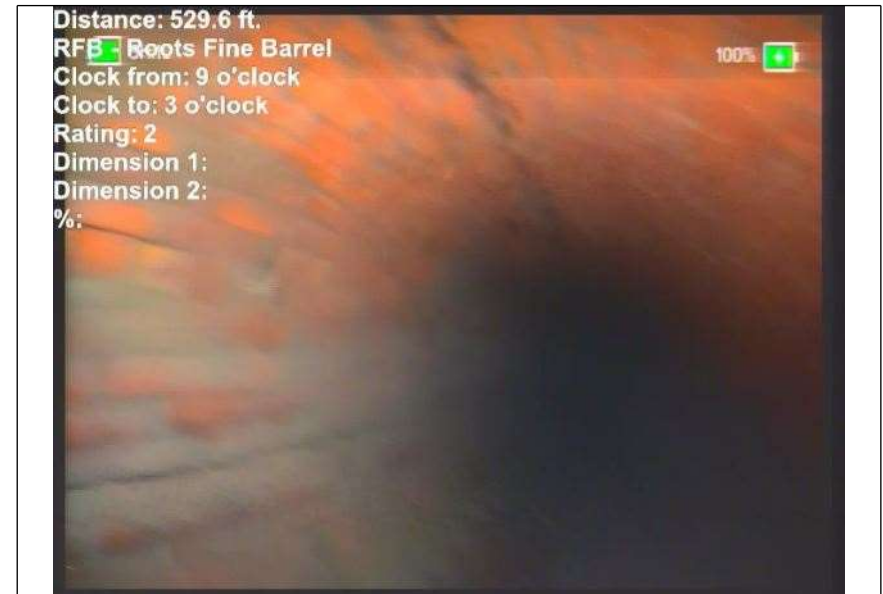
At: 529.6 ft. 9/3 RFB - Roots Fine Barrel

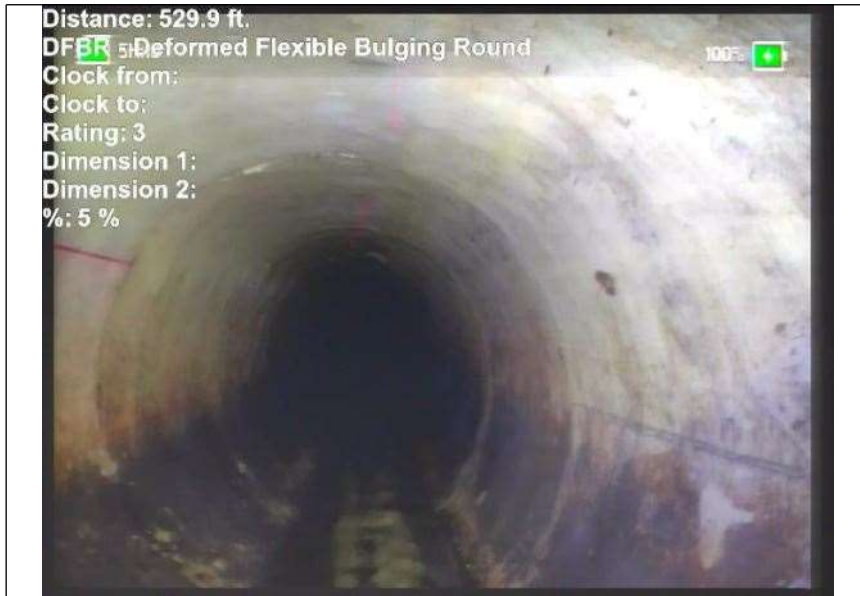
At: 529.9000244140 DFBR - Deformed Flexible Bulging Round  
63 ft.

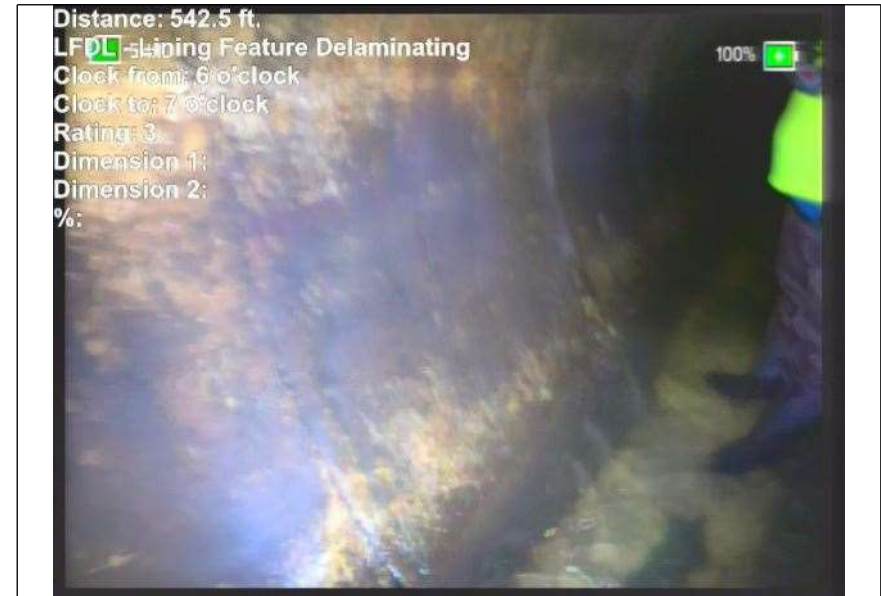
At: 542.5 ft. 6/7 LFDL - Lining Feature Delaminating  
Joint: No

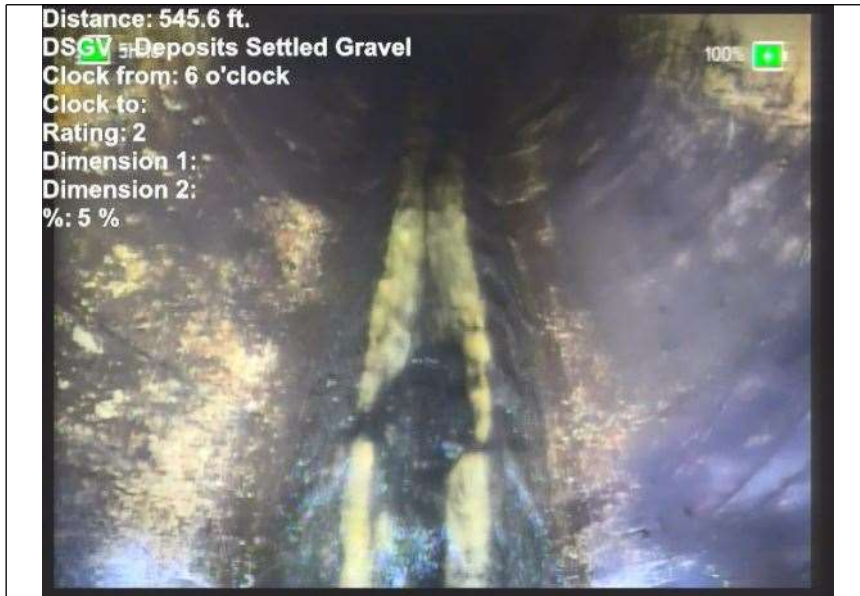
At: 545. DSGV - Deposits Settled Gravel  
5999755859  
38 ft. 6/.

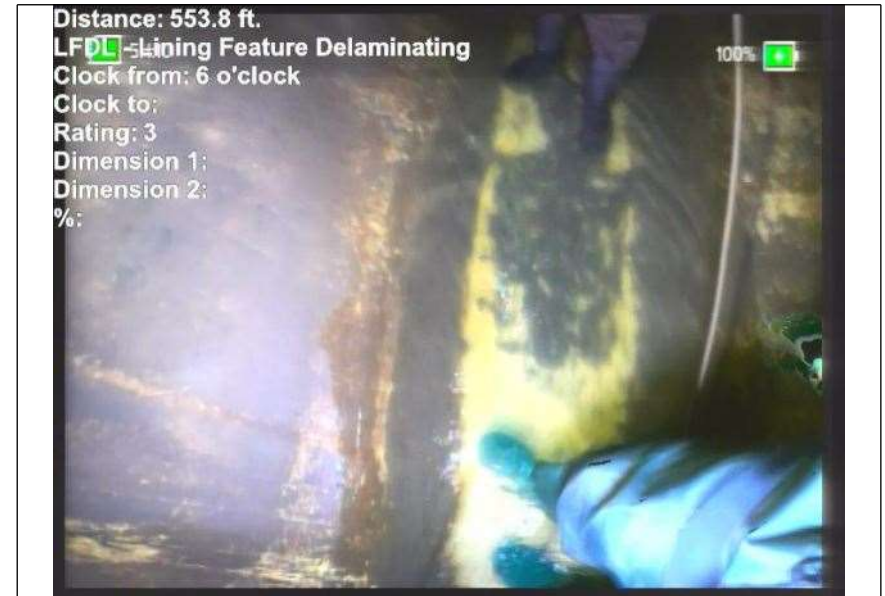
At: 553. LFDL - Lining Feature Delaminating  
7999877929  
69 ft. 6/.

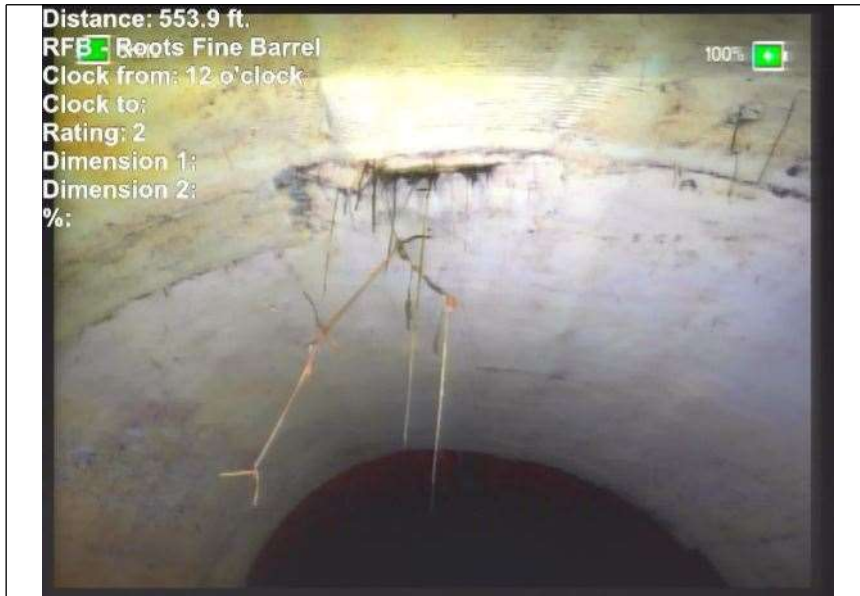
At: 553. RFB - Roots Fine Barrel  
9000244140  
63 ft. 12/.
