## PACP Report with Pipe Run and Incident Snapshots

Surveyed by: <b>ANDREW</b>	Certificate number: <b>T-507-4975</b>	Owner: <b>CITY OF MARION</b>	Customer:	Drainage area:	P/O number:	Sheet number:			
Pipe segment ref.: <b>MH2_MH1</b>	Start date/time: <b>20240627 13:12</b>	Street: <b>1432 HOLLAND ROAD</b>	City: <b>MARION, OH</b>						
Location details:	Upstream MH No: <b>MH2</b>	Rim to invert:	Grade to invert:	Rim to grade:					
Pipe use: <b>CB</b>	Direction: <b>D</b>	Flow control:	Downstream MH No: <b>MH1</b>	Rim to invert:	Grade to invert:	Rim to grade:			
Height: <b>72 in.</b>	Width:	Shape: <b>C</b>	Material: <b>BR</b>	Lining method:	Pipe joint length:	Total length: <b>694.800 ft.</b>	Length surveyed: <b>694.800 ft.</b>	Purpose:	Sewer category:
Media label:	Pre-cleaning: <b>N</b>	Date cleaned:	Weather: <b>1</b>	Location code: <b>C</b>	Pressure value:				
Project name: <b>ROCK SWALE 72 IN INSPECTION</b>	Additional info:

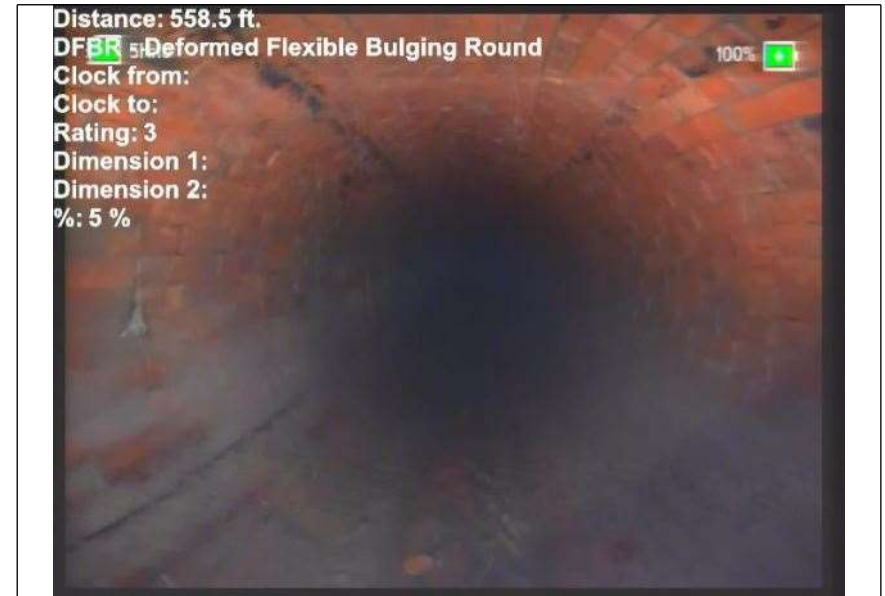
At: 558.5 ft. DFBR - Deformed Flexible Bulging Round  
Joint: No 5 %

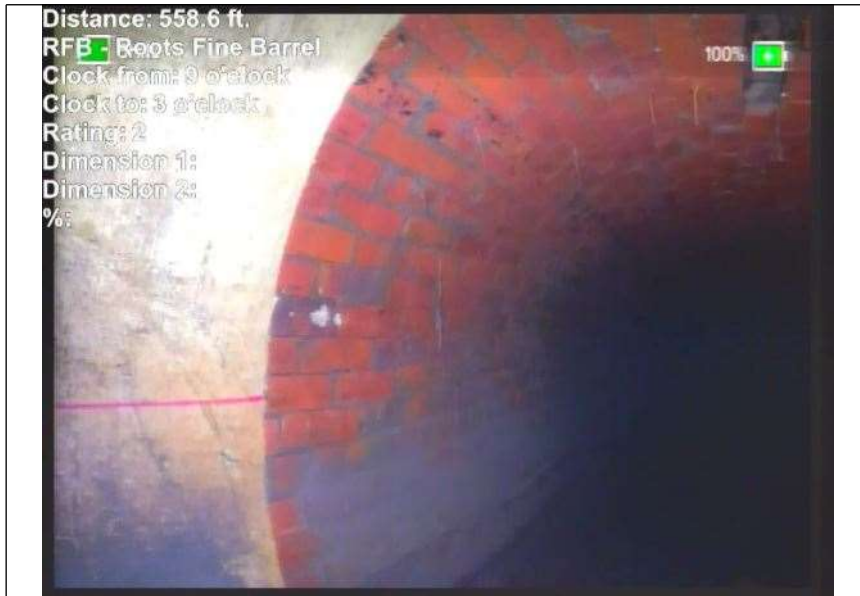
At: 558. RFB - Roots Fine Barrel  
5999755859  
38 ft. 9/3

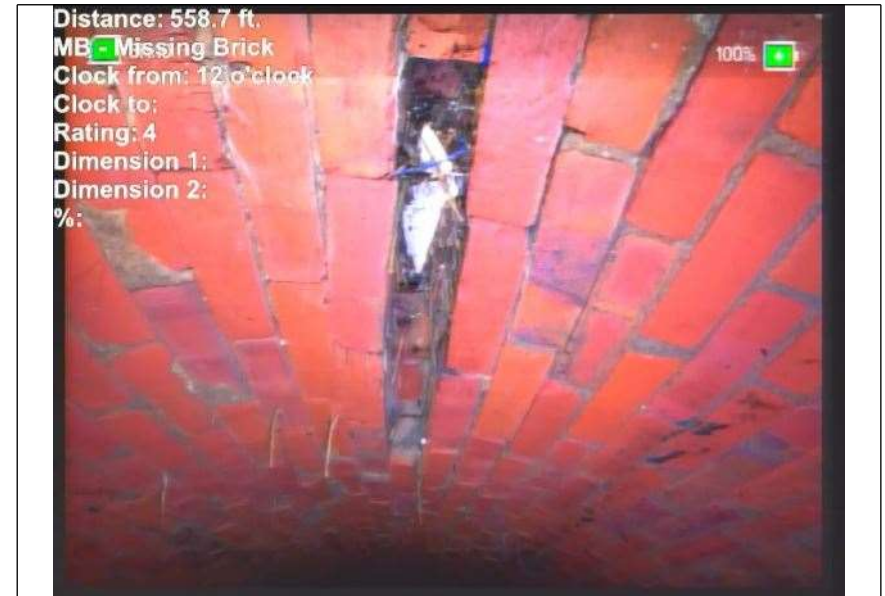
At: 558. MB - Missing Brick  
7000122070  
31 ft. 12/.

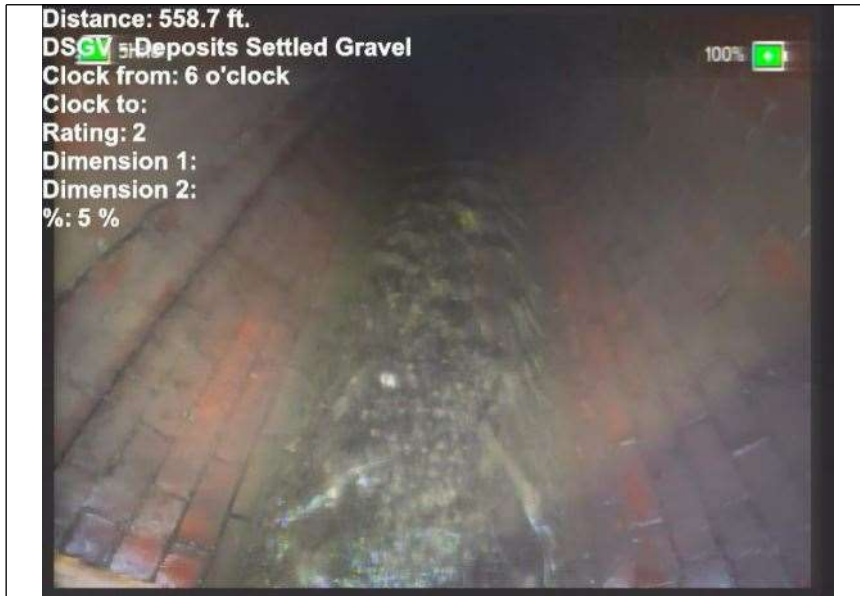
At: 558. 7000122070  
DSGV - Deposits Settled Gravel  
31 ft. 6/.

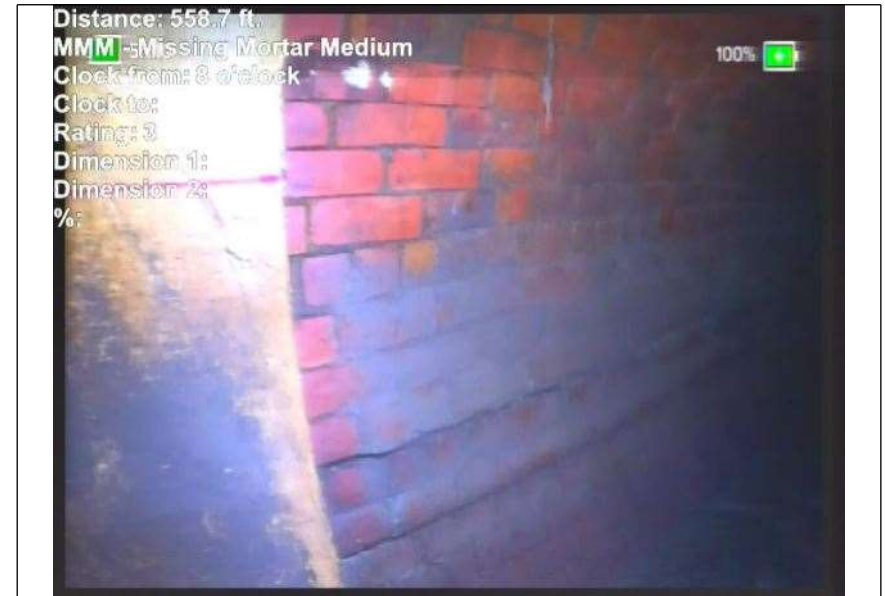
At: 558. 7000122070  
MMM - Missing Mortar Medium  
31 ft. 8/.

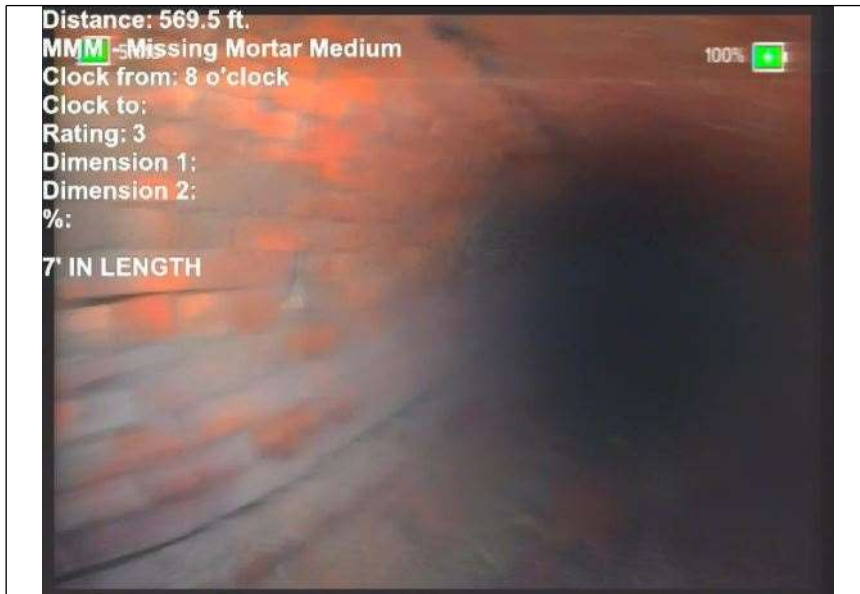
At: 569.5 ft. 8/. 7000122070  
MMM - Missing Mortar Medium

Joint: No 7' IN LENGTH

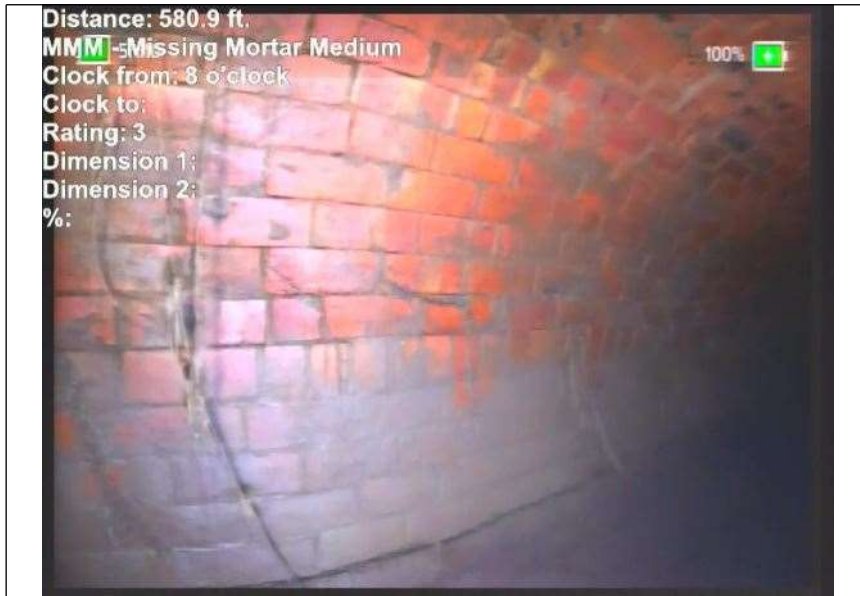
At: 580. MMM - Missing Mortar Medium  
9000244140  
63 ft. 8/.

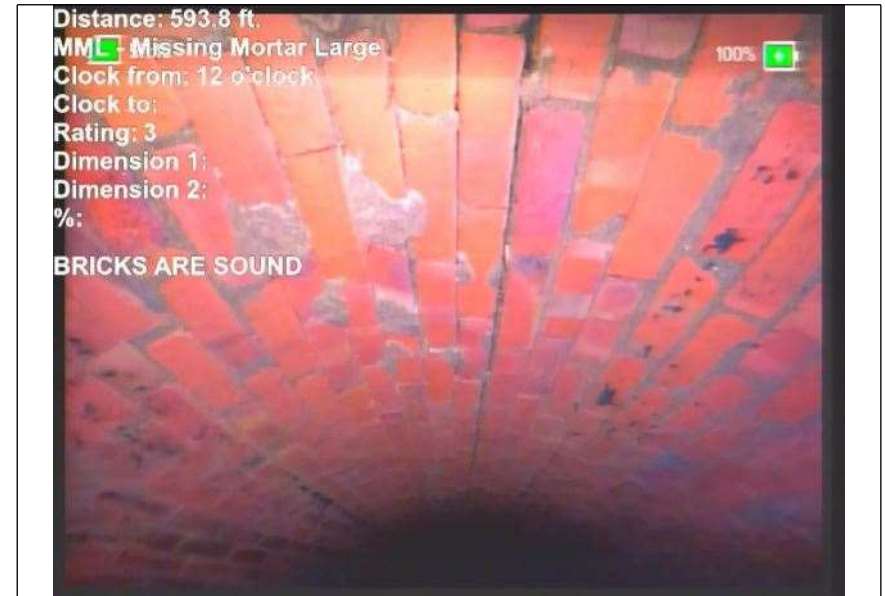
At: 593. MML - Missing Mortar Large  
7999877929  
69 ft. 12/.

Joint: No BRICKS ARE SOUND

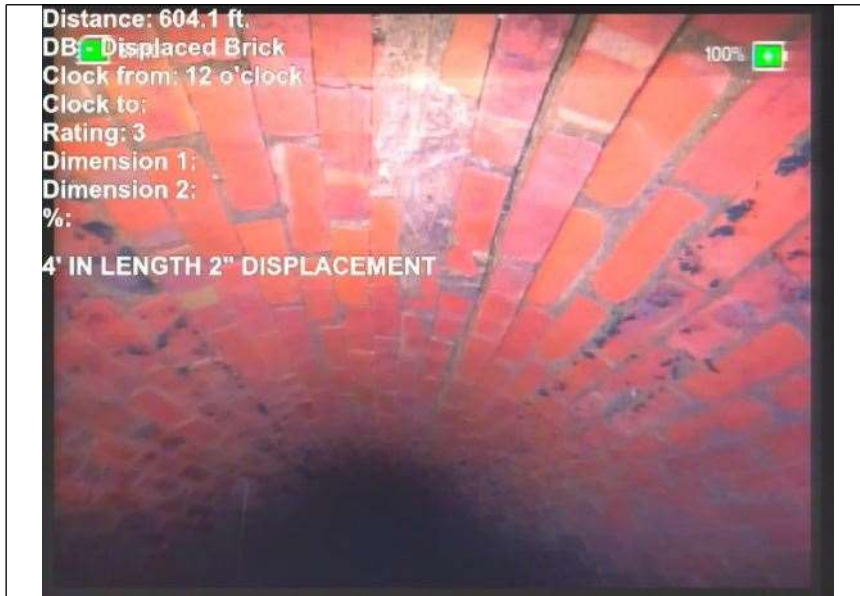
At: 604. DB - Displaced Brick  
0999755859  
38 ft. 12/.

Joint: No 4' IN LENGTH 2" DISPLACEMENT

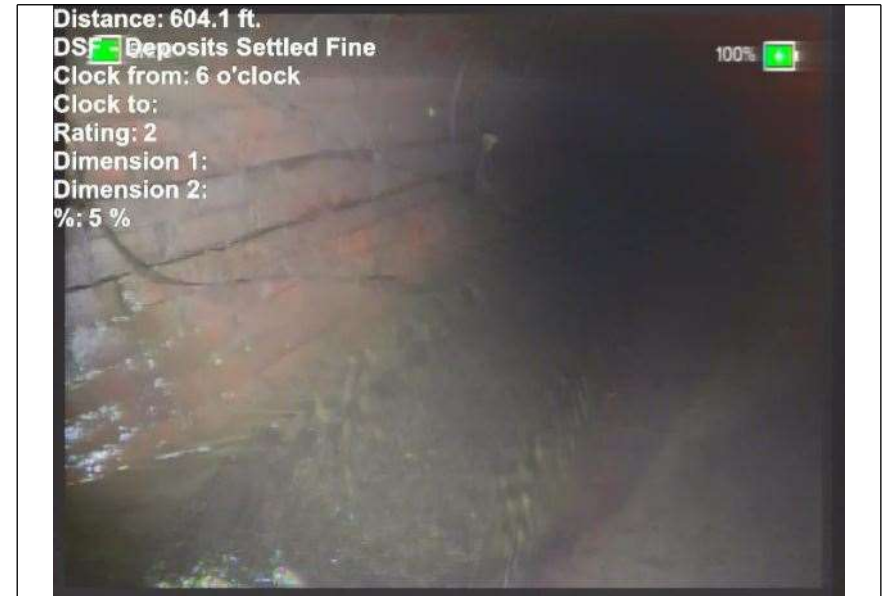
At: 604. DSF - Deposits Settled Fine  
0999755859  
38 ft. 6/.

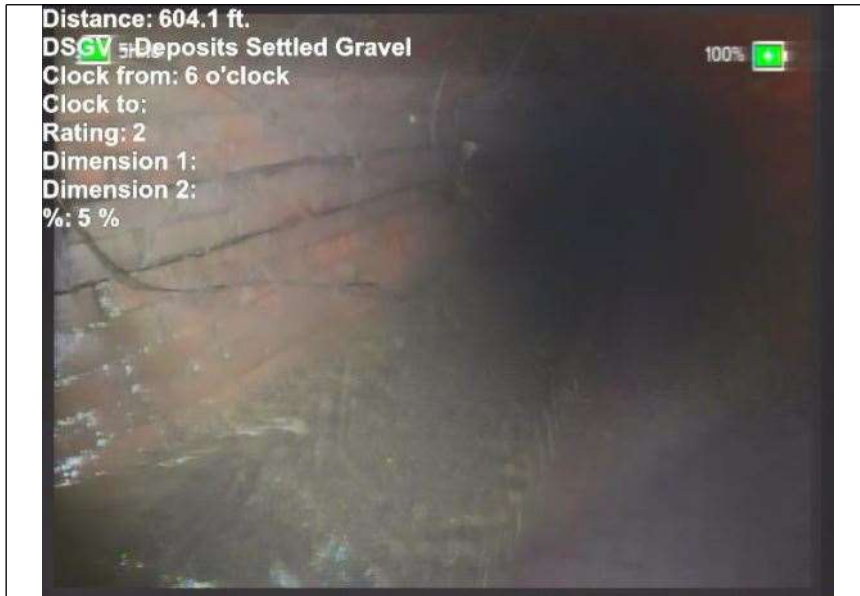
At: 604. DSGV - Deposits Settled Gravel  
0999755859  
38 ft. 6/.  
Joint: No 5 %

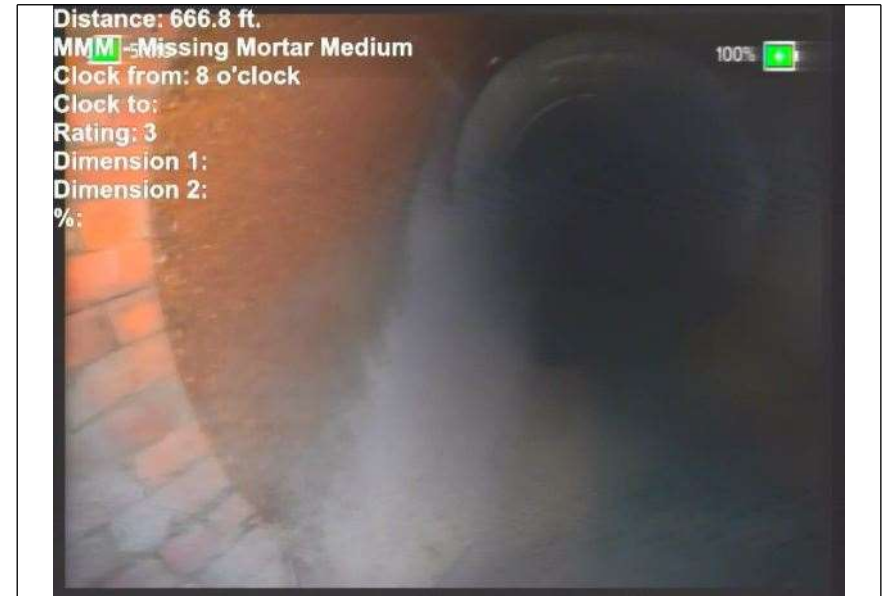
At: 666. MMM - Missing Mortar Medium  
7999877929  
69 ft. 8/.  
Joint: No

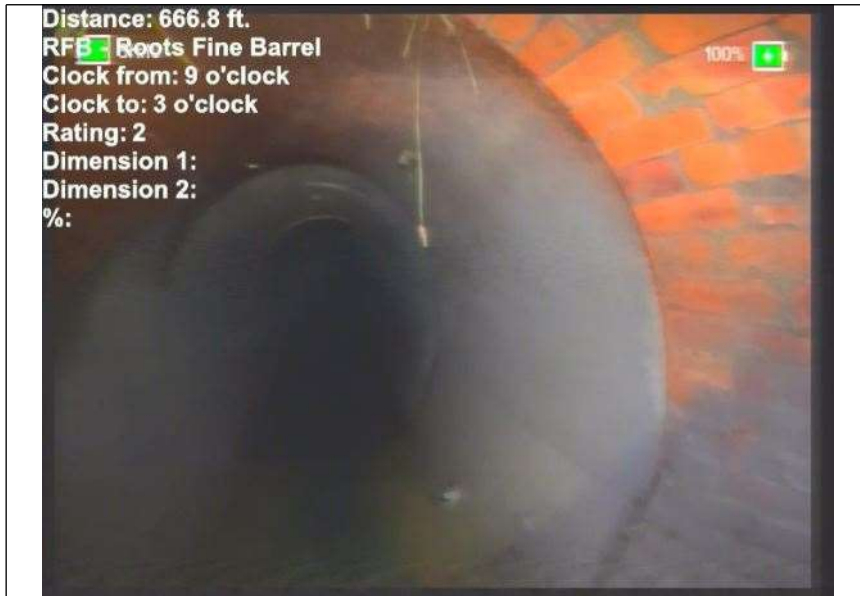
At: 666. RFB - Roots Fine Barrel  
7999877929  
69 ft. 9/3

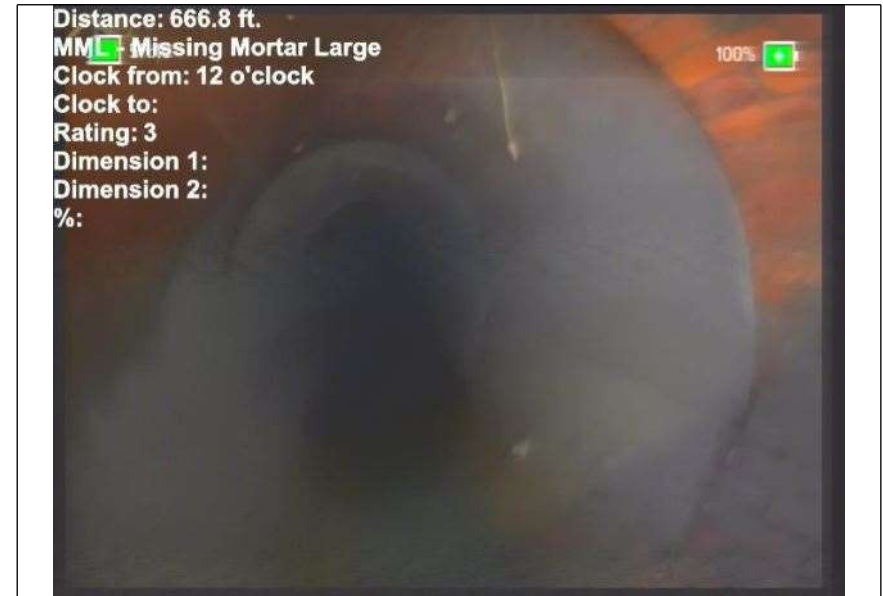
At: 666. MML - Missing Mortar Large  
7999877929  
69 ft. 12/.

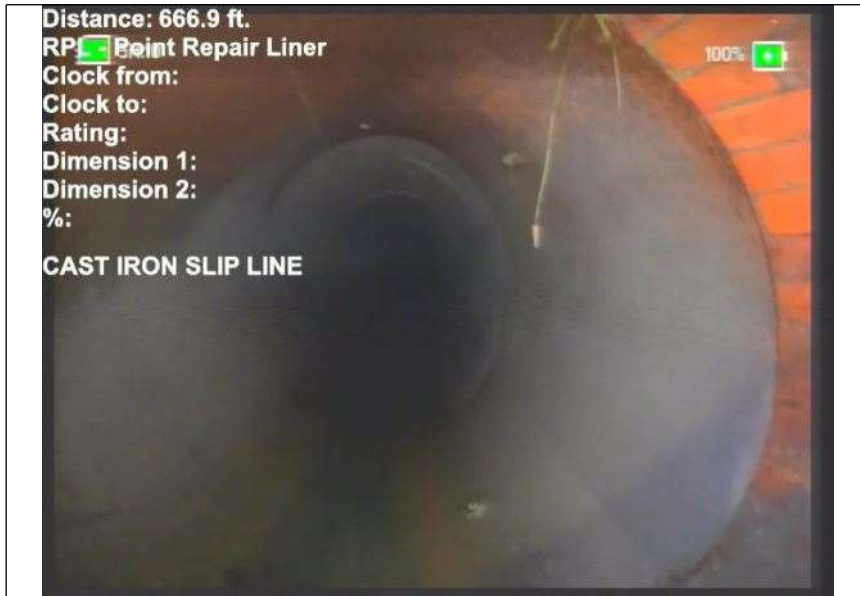
At: 666. 9000244140  
RPL - Point Repair Liner  
63 ft.

Joint: No CAST IRON SLIP LINE

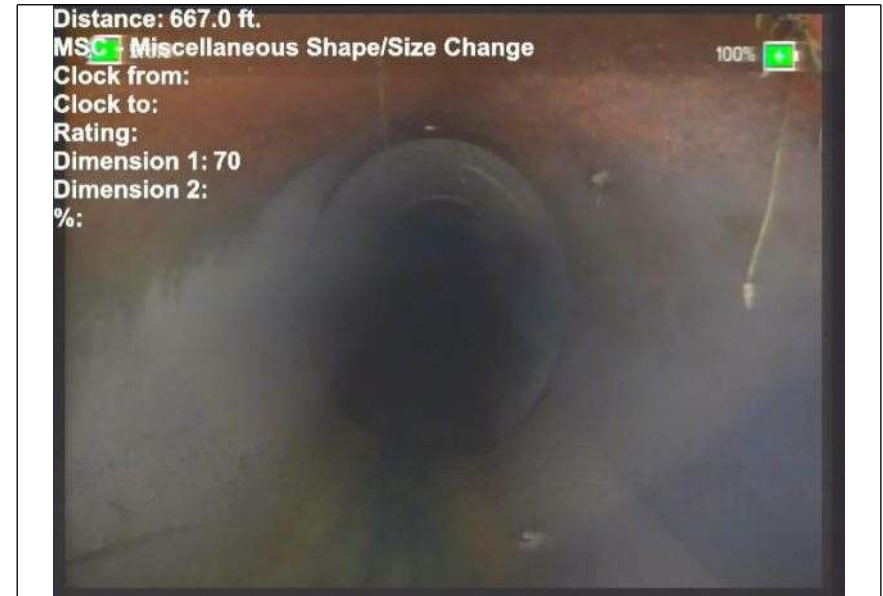
At: 667 ft. MSC - Miscellaneous Shape/Size Change

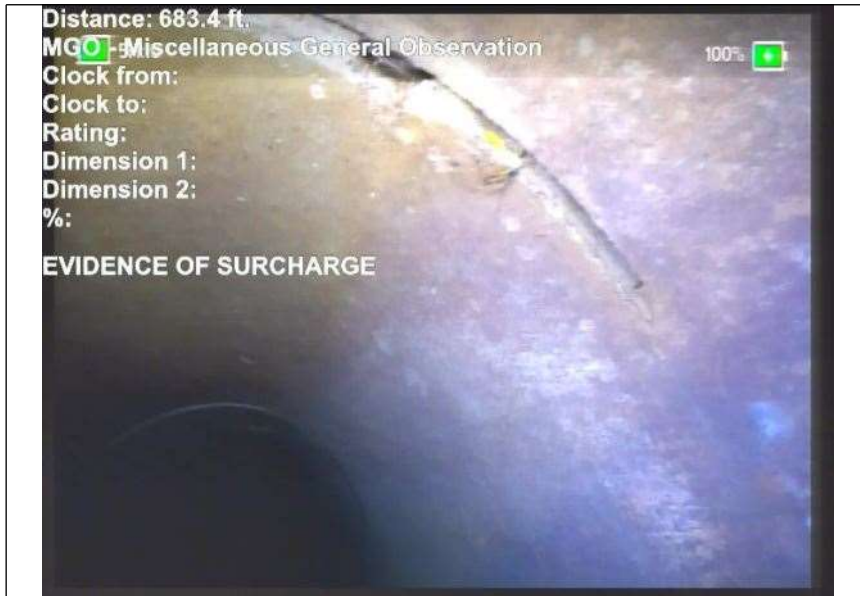
At: 683.4000244140 MGO - Miscellaneous General Observation  
63 ft.

Joint: No EVIDENCE OF SURCHARGE

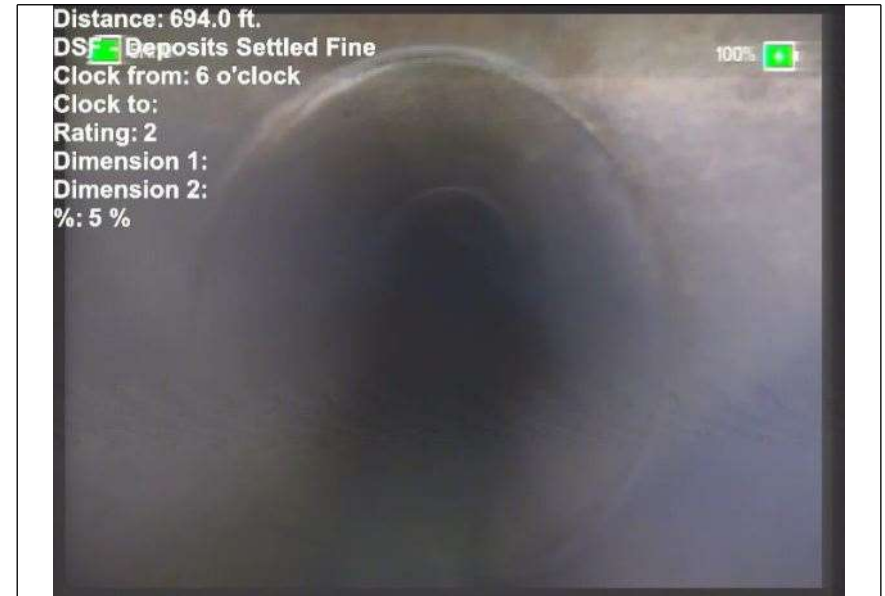
At: 694 ft. 6/. DSF - Deposits Settled Fine
