PACP Report with Pipe Run and Incident Snapshots

Surveyed by: ANDREW		Certificate number: T-507-4975		Owner: CITY OF MARION		Customer:		Drainage area:		P/O number:		Sheet number:							
Pipe segment ref.: MH3_MH2				Start date/time: 20240627 13:01		Street: 1432 HOLLAND ROAD				City: MARION, OH									
Location details:				Upstream MH No: MH3				Rim to invert:		Grade to invert:		Rim to grade:							
Pipe use: CB		Direction: D		Flow control:		Downstream MH No: MH2				Rim to invert:		Grade to invert:		Rim to grade:					
Height: 72 in.		Width:		Shape: C		Material: BR		Lining method:		Pipe joint length:		Total length: 313.300 ft.		Length surveyed: 313.300 ft.		Purpose: B		Sewer category:	
Media label:				Pre-cleaning: N		Date cleaned:		Weather: 1		Location code: C		Pressure value:							
Project name: ROCK SWALE 72 IN INSPECTION				Additional info:

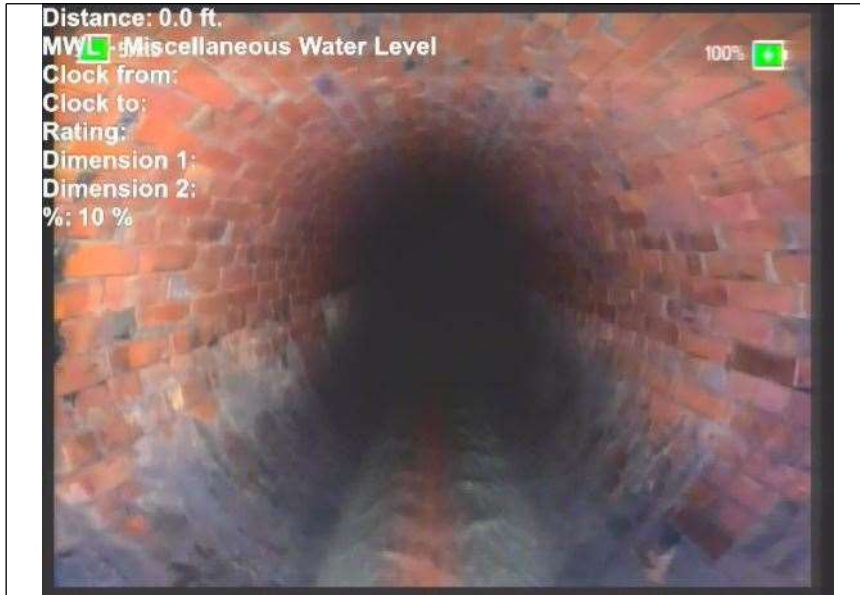
Distance: 0.0 ft.
MWL - Miscellaneous Water Level
Clock from:
Clock to:
Rating:
Dimension 1:
Dimension 2:
%: 10 %

At: 0 ft. MWL - Miscellaneous Water Level
Joint: No 10 %

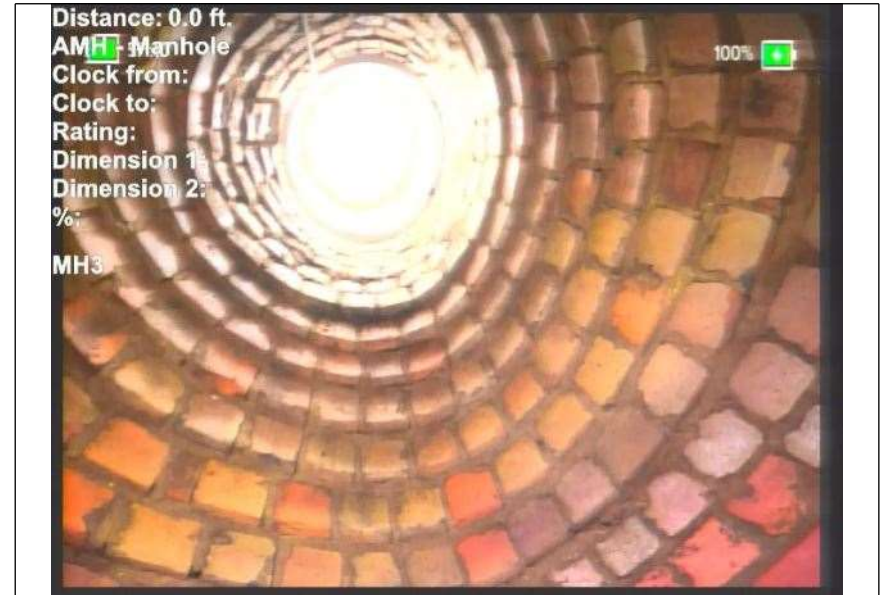
Distance: 0.0 ft.
AMH - Manhole
Clock from:
Clock to:
Rating:
Dimension 1:
Dimension 2:
%:
MH3

At: 0 ft. AMH - Manhole
Joint: No MH3

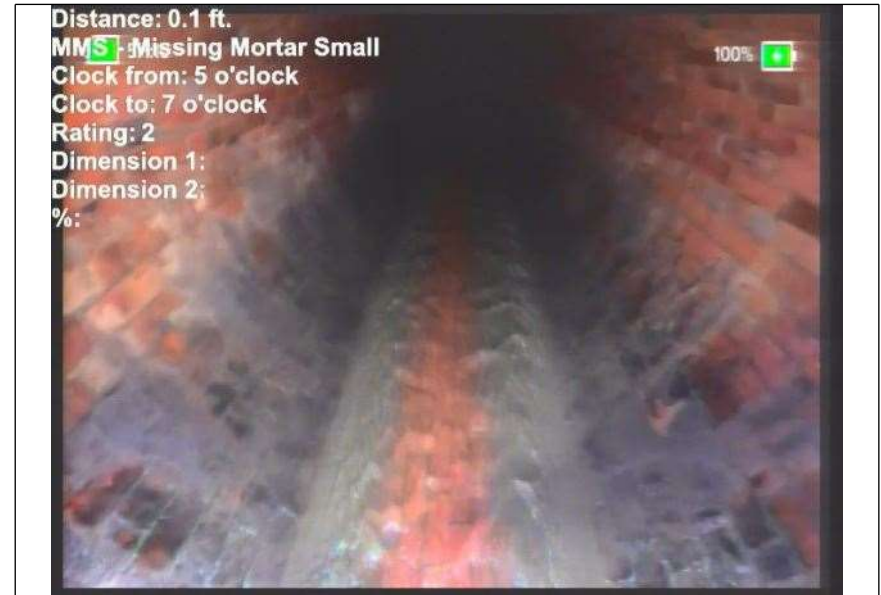
Distance: 0.1 ft.
MMS - Missing Mortar Small
Clock from: 5 o'clock
Clock to: 7 o'clock
Rating: 2
Dimension 1:
Dimension 2:
%:

At: 0.100000014
90116 ft. 5/7
Joint: No

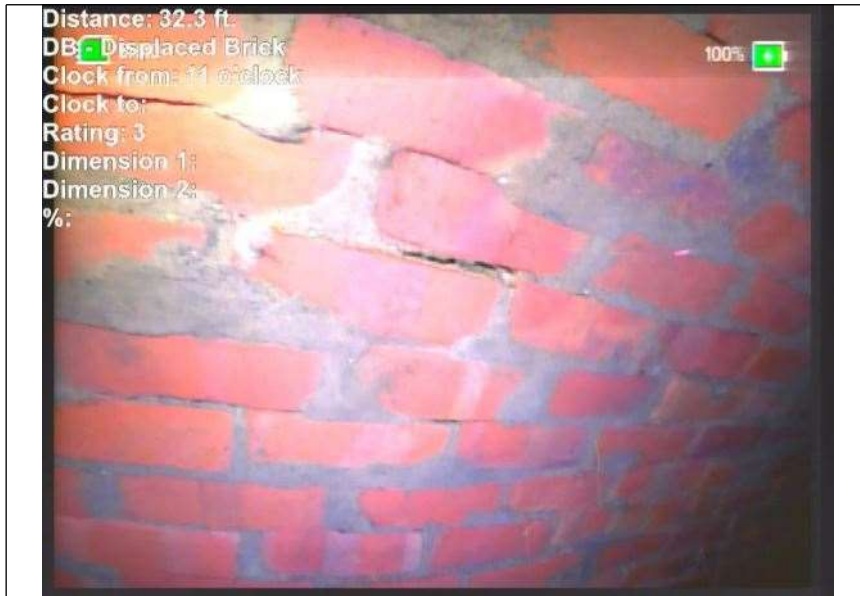
At: 32. DB - Displaced Brick
2999992370
605 ft. 11/.

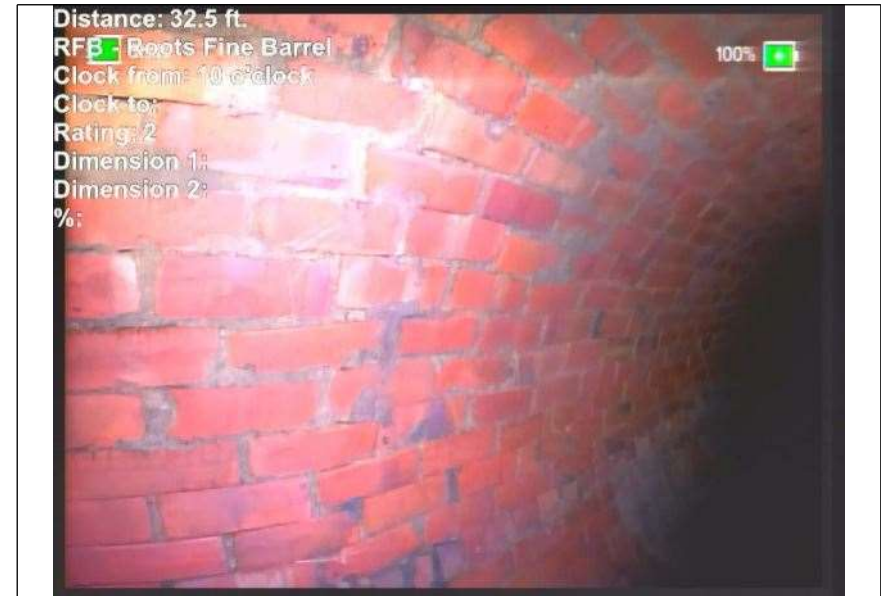
At: 32.5 ft. 10/. RFB - Roots Fine Barrel
Joint: No

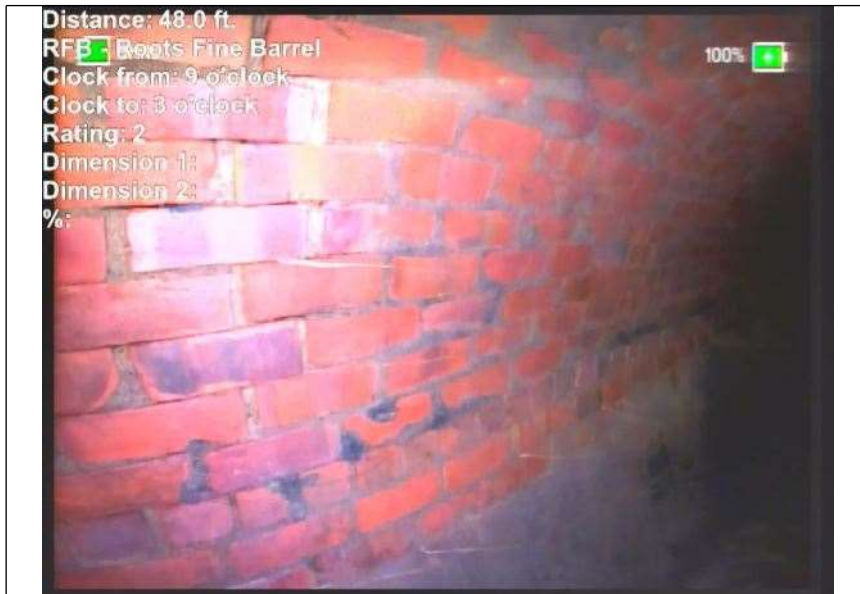
At: 48 ft. 9/3 RFB - Roots Fine Barrel

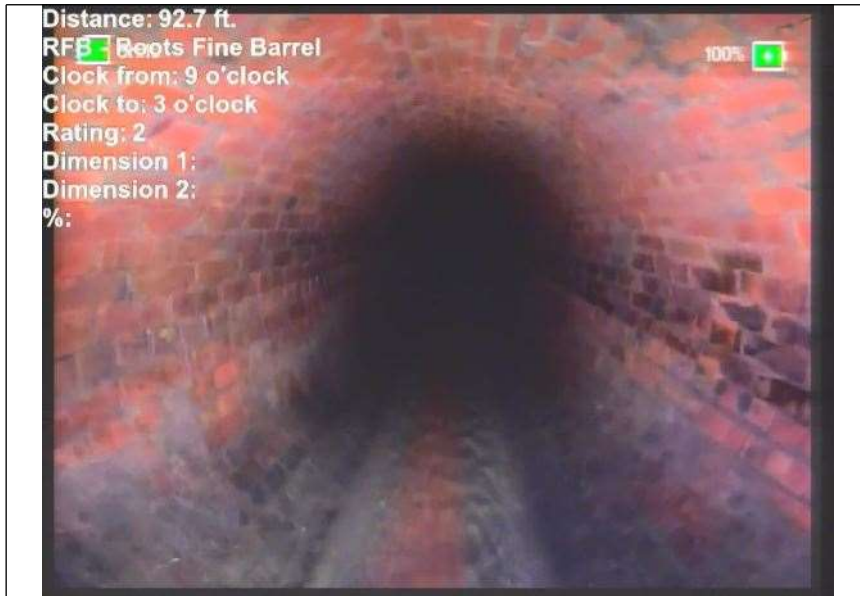
At: 92. RFB - Roots Fine Barrel
6999969482
422 ft. 9/3

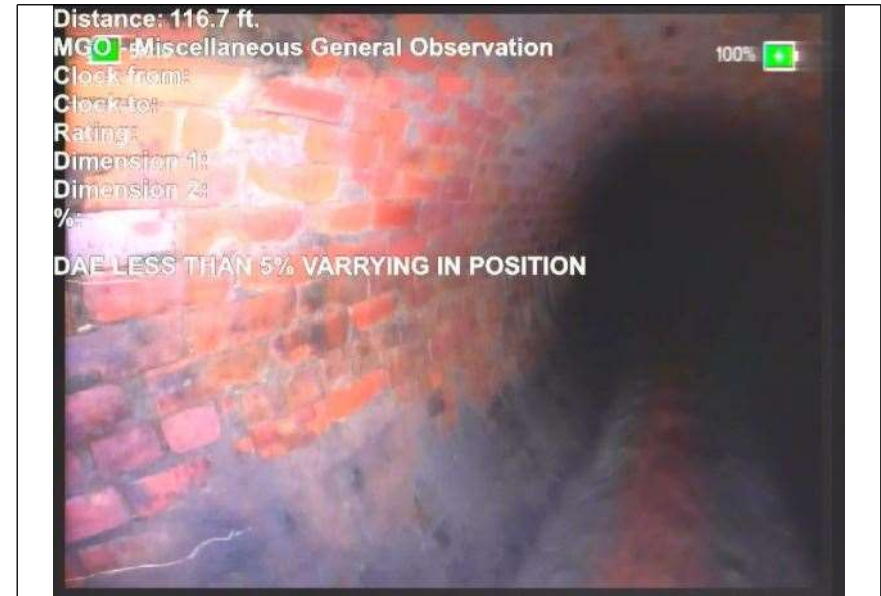
At: 116. MGO - Miscellaneous General Observation
6999969482
42 ft.

Joint: No DAE LESS THAN 5% VARRYING IN POSITION

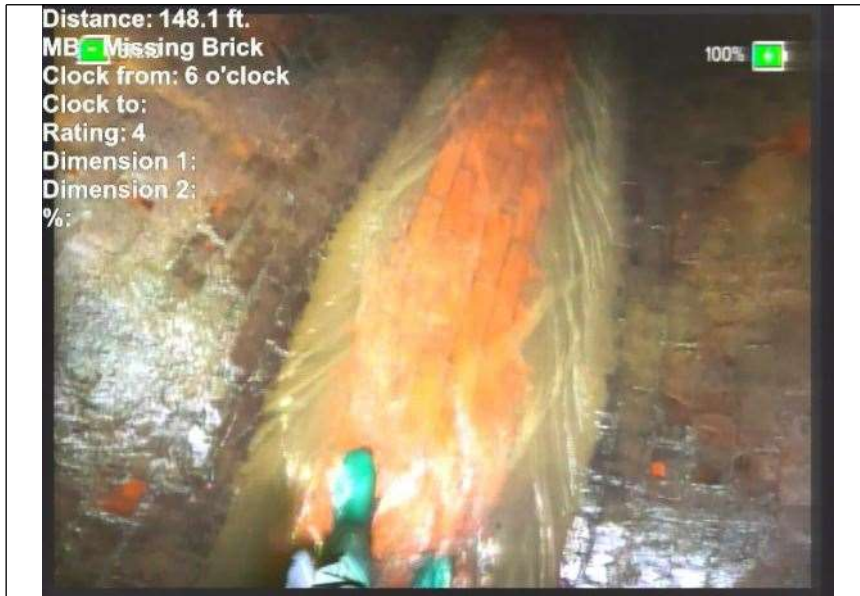
At: 148. MB - Missing Brick
1000061035
16 ft. 6/.

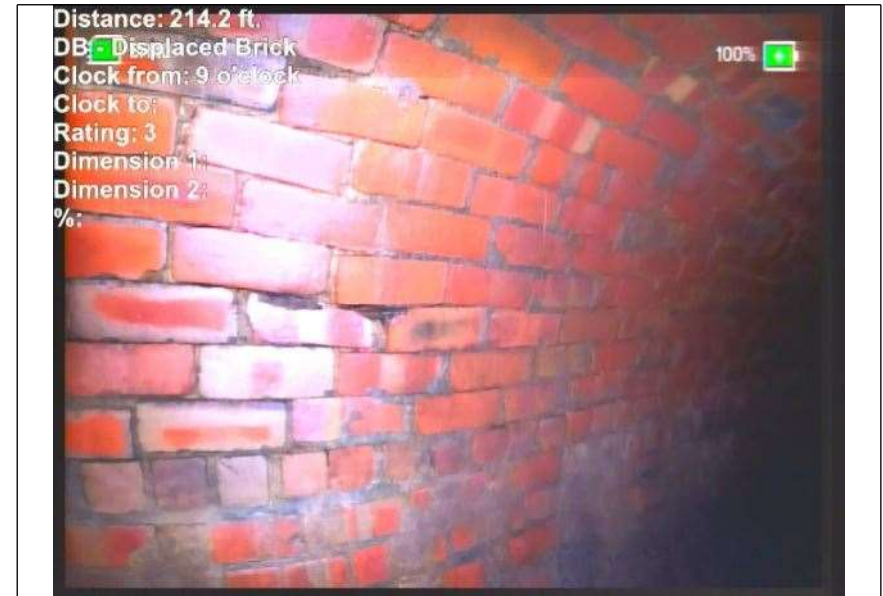
At: 214. DB - Displaced Brick
1999969482
42 ft. 9/.

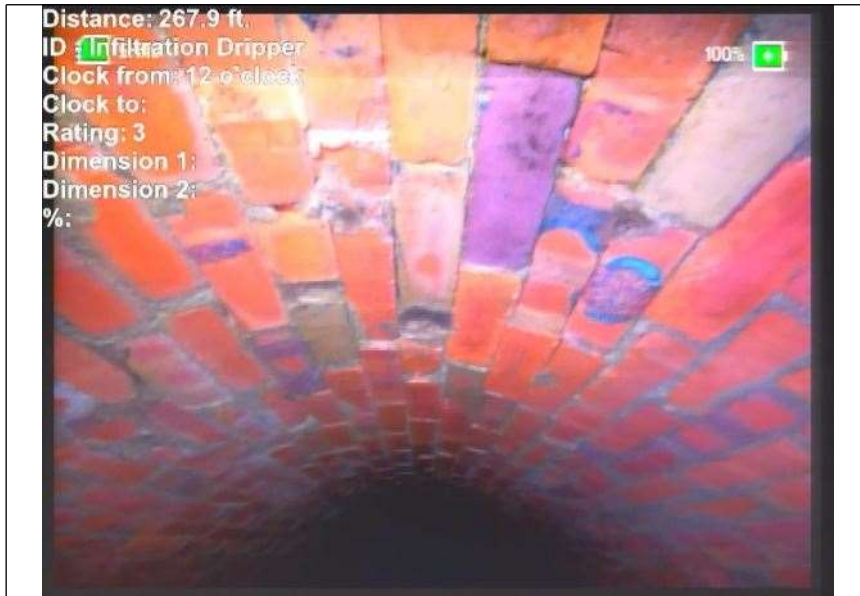
At: 267. ID - Infiltration Dripper
8999938964
84 ft. 12/.

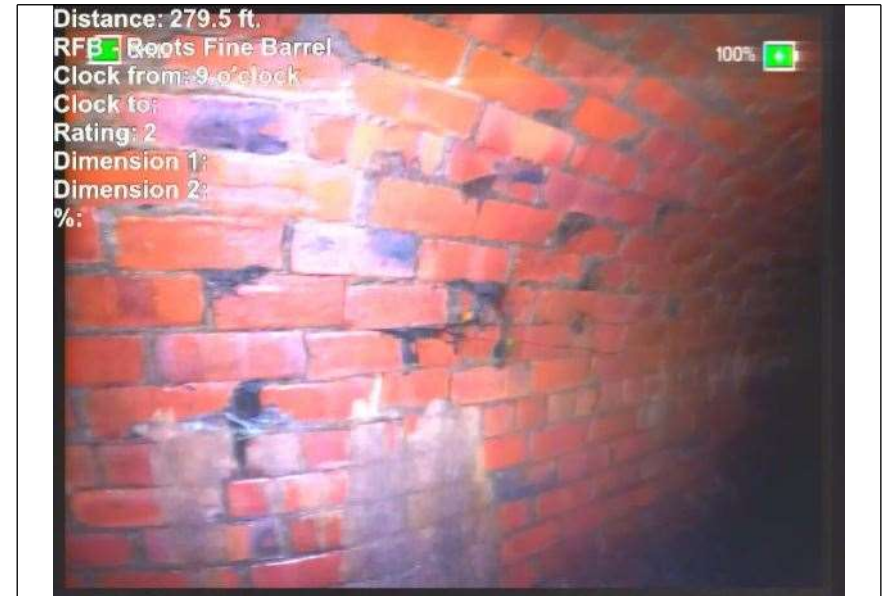
At: 279.5 ft. 9/. RFB - Roots Fine Barrel
Joint: No

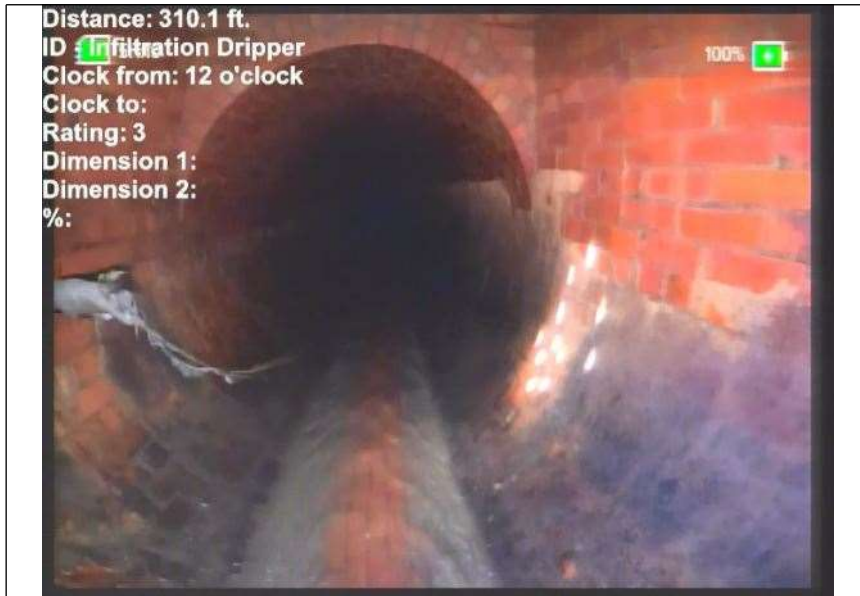
At: 310. ID - Infiltration Dripper
1000061035
16 ft. 12/.

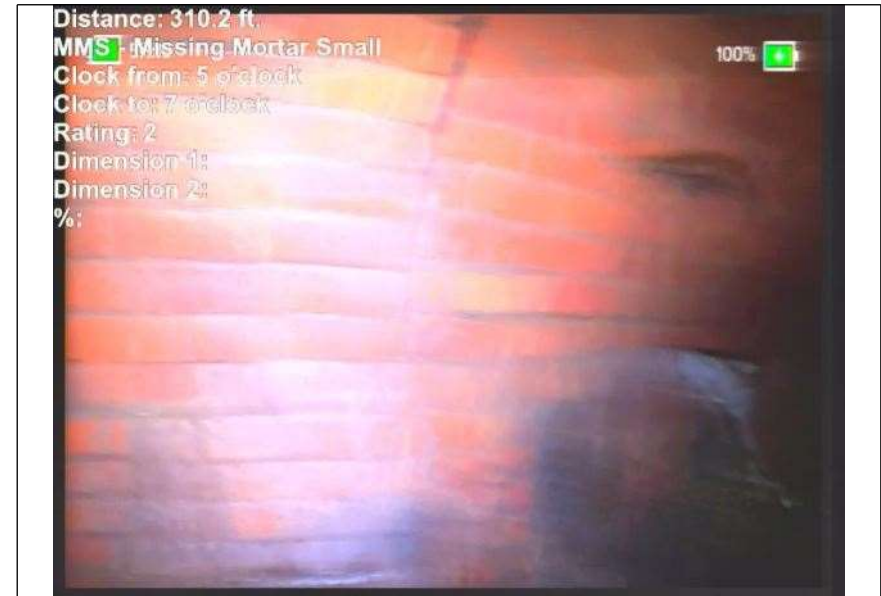
At: 310. MMS - Missing Mortar Small
2000122070
31 ft. 5/7

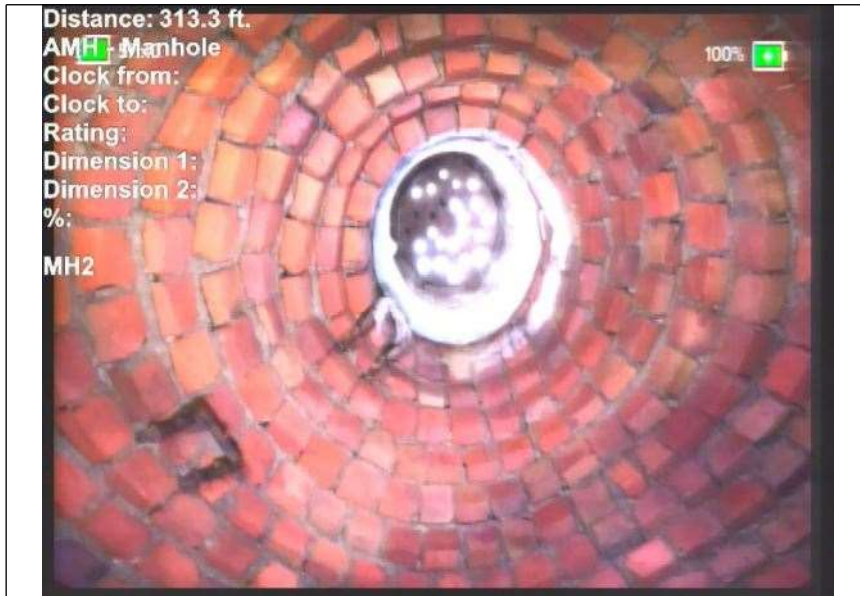
At: 313. AMH - Manhole
2999877929
69 ft.

Joint: No MH2
