PACP Report with Pipe Run and Incident Snapshots

Surveyed by: ANDREW		Certificate number: T-507-4975		Owner: CITY OF MARION		Customer:		Drainage area:		P/O number:		Sheet number:							
Pipe segment ref.: MH4A_MH4				Start date/time: 20240627 09:18		Street: 1432 HOLLAND ROAD				City: MARION, M OH									
Location details:				Upstream MH No: MH4A				Rim to invert:		Grade to invert:		Rim to grade:							
Pipe use: CB		Direction: U		Flow control:		Downstream MH No: MH4				Rim to invert:		Grade to invert:		Rim to grade:					
Height: 72 in.		Width:		Shape: C		Material: BR		Lining method:		Pipe joint length:		Total length: 1,190.200 ft.		Length surveyed: 1,190.200 ft.		Purpose: B		Sewer category:	
Media label:				Pre-cleaning: N		Date cleaned:		Weather: 1		Location code: C		Pressure value:							
Project name: ROCK SWALE 72 IN INSPECTION				Additional info:

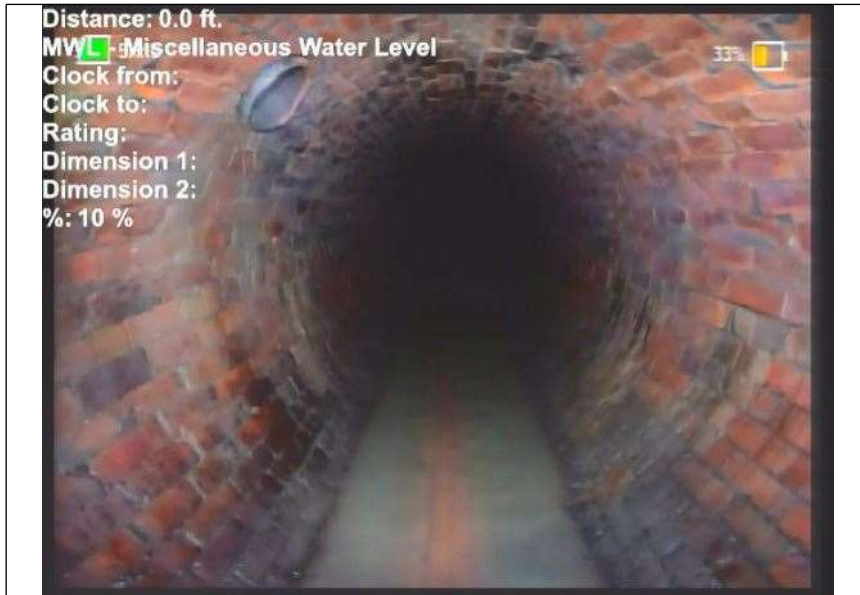
At: 0 ft. MWL - Miscellaneous Water Level
Joint: No 10 %

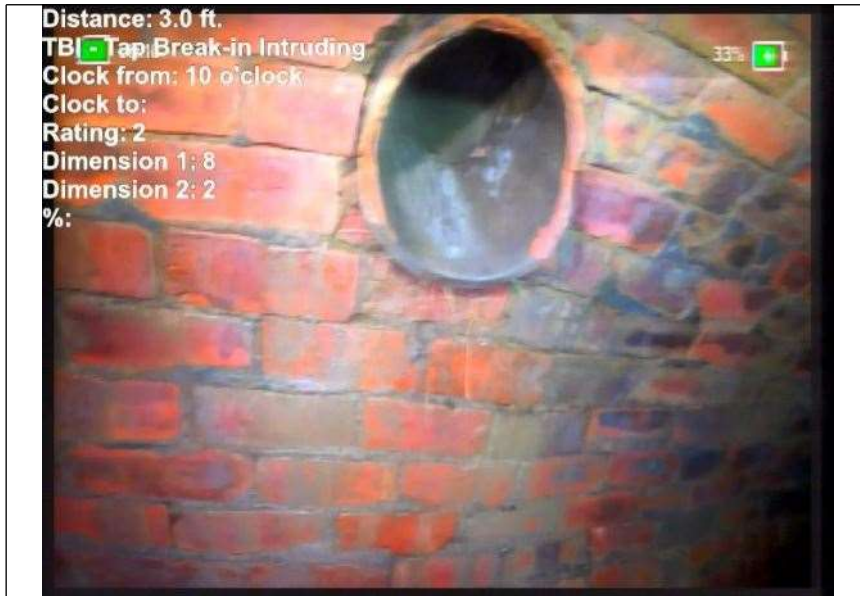
At: 3 ft. 10/ TBI - Tap Break-in Intruding
Joint: No

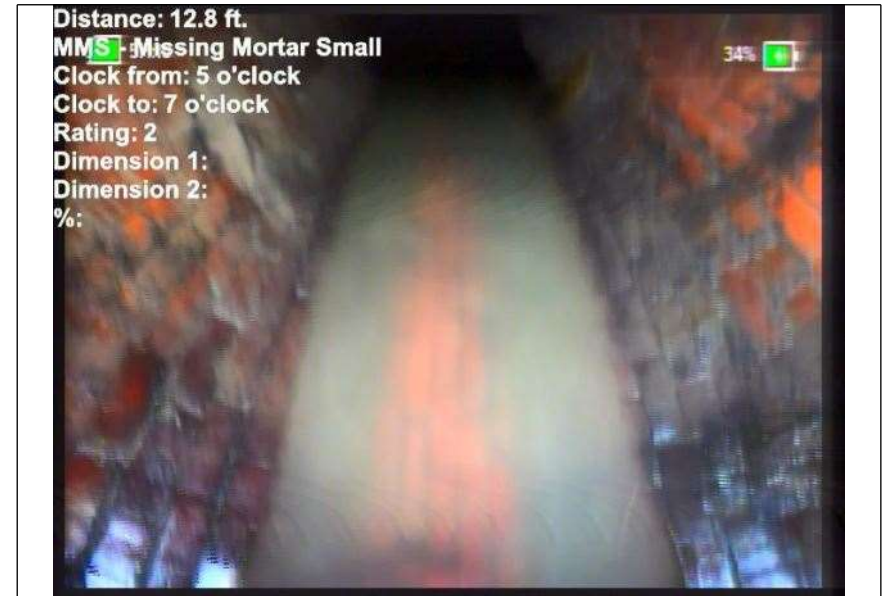
At: 12. MMS - Missing Mortar Small
8000001907
349 ft. 5/7
Joint: No

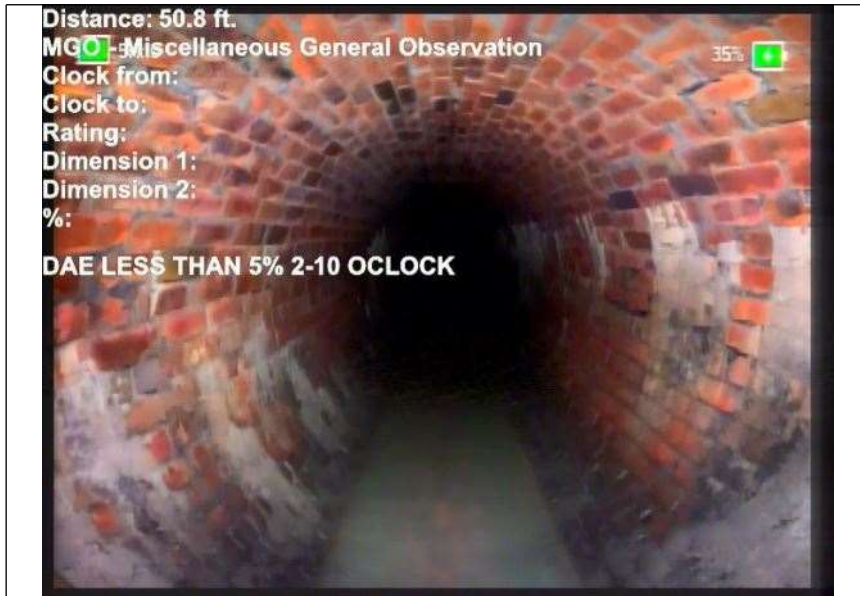
At: 50. 7999992370
MGO - Miscellaneous General Observation
605 ft.

Joint: No DAE LESS THAN 5% 2-10 OCLOCK

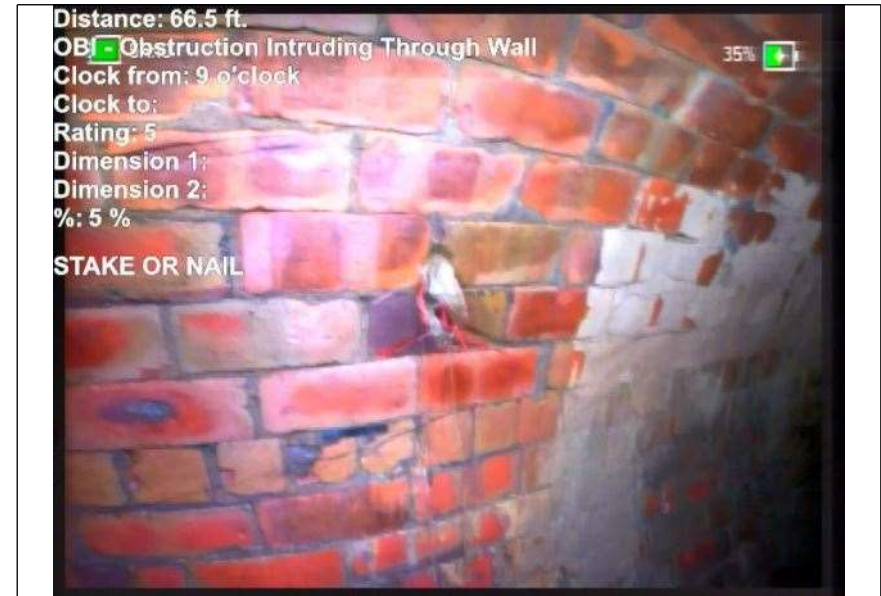
At: 66.5 ft. 9/
OBI - Obstruction Intruding Through Wall
Joint: No 5 % STAKE OR NAIL

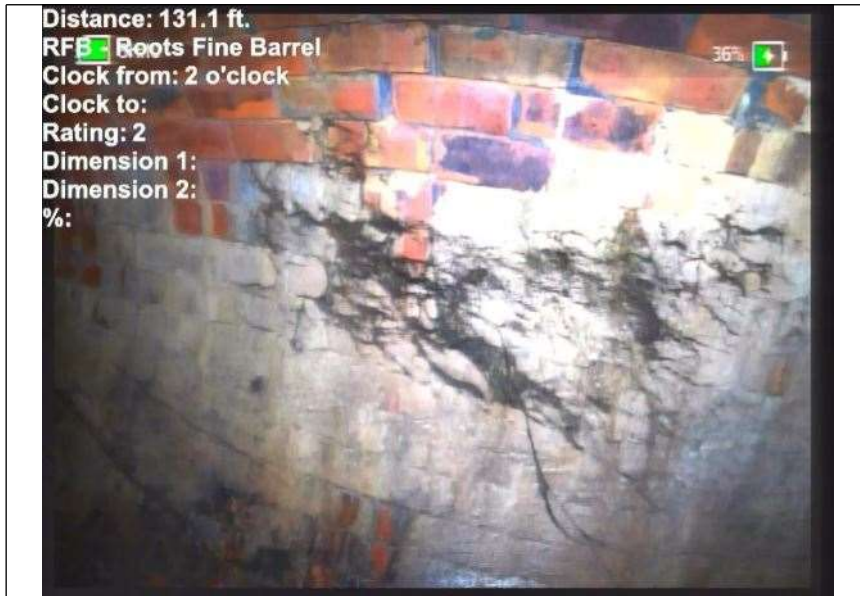
At: 131. RFB - Roots Fine Barrel
1000061035
16 ft. 2/.
Joint: No

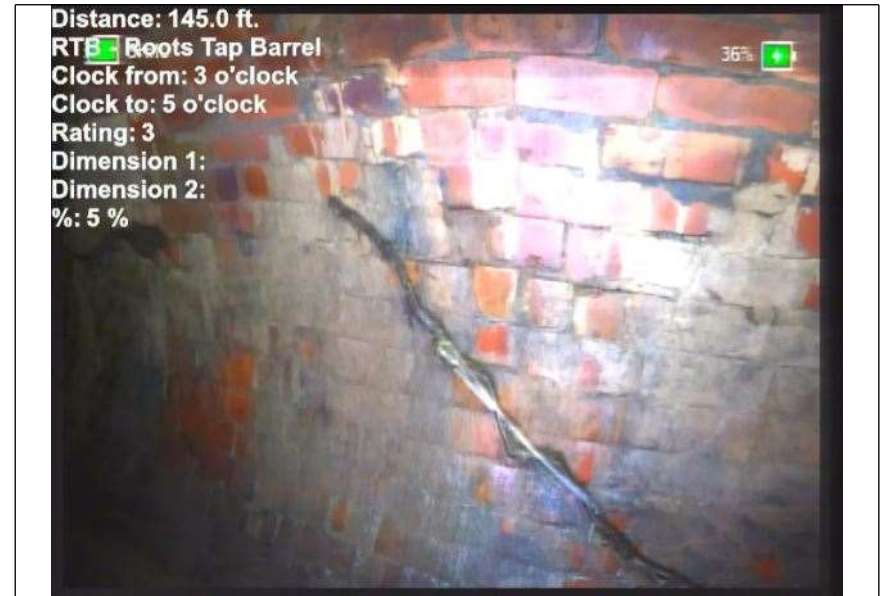
At: 145 ft. 3/5 RTB - Roots Tap Barrel
Joint: No 5 %

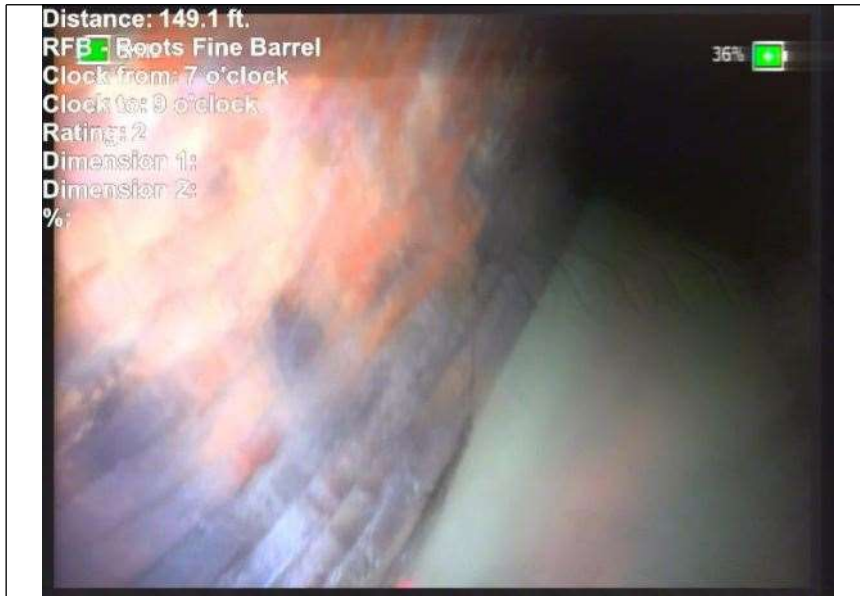
At: 149. RFB - Roots Fine Barrel
1000061035
16 ft. 7/9

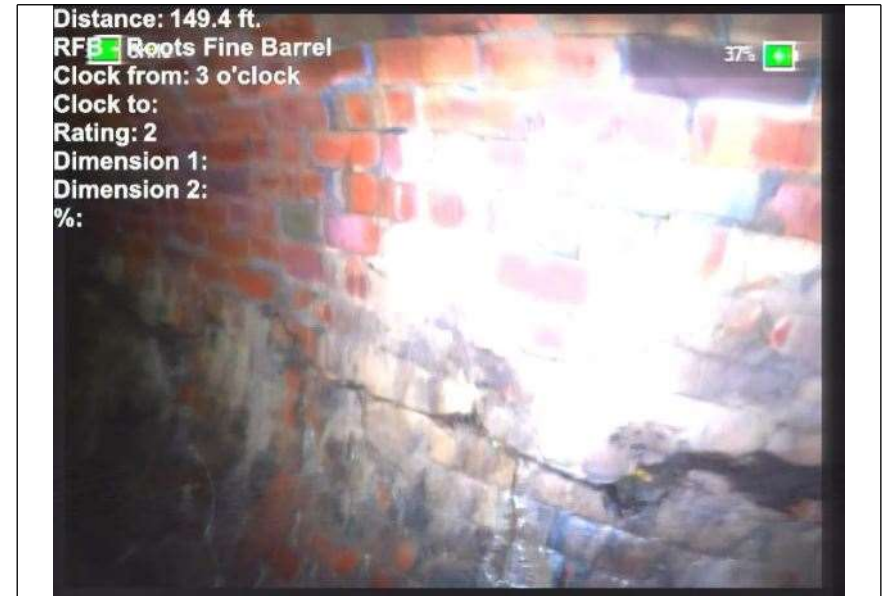
At: 149. RFB - Roots Fine Barrel
3999938964
84 ft. 3/.

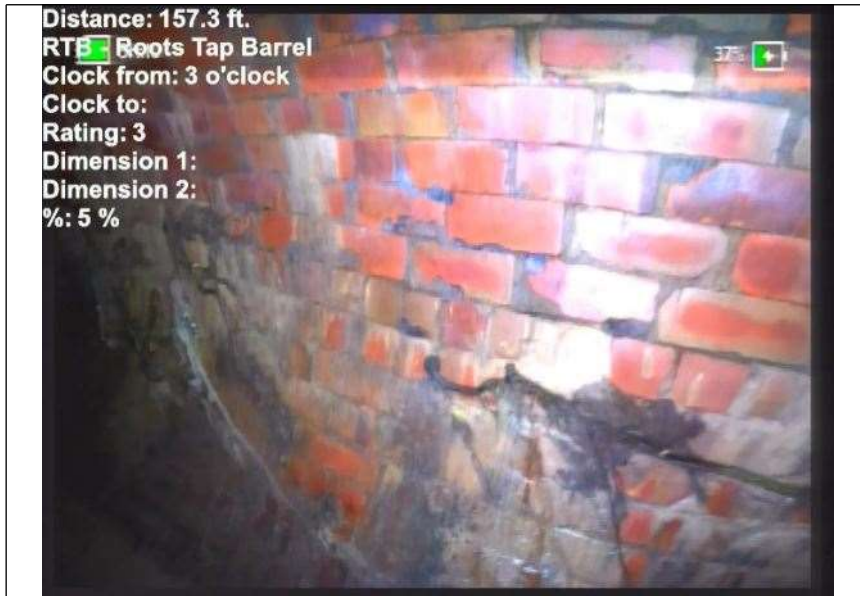
At: 157. RTB - Roots Tap Barrel
3000030517
58 ft. 3/.

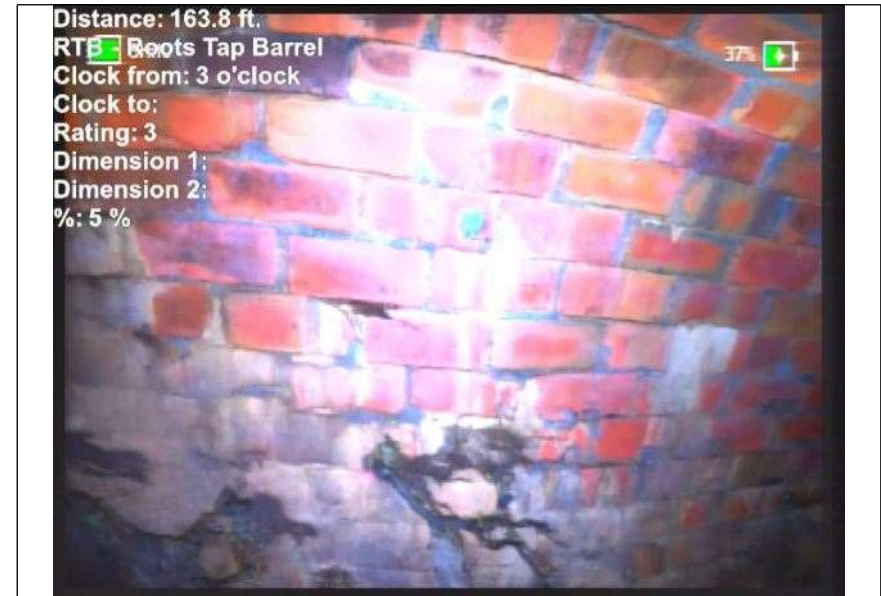
At: 163. RTB - Roots Tap Barrel
8000030517
58 ft. 3/.

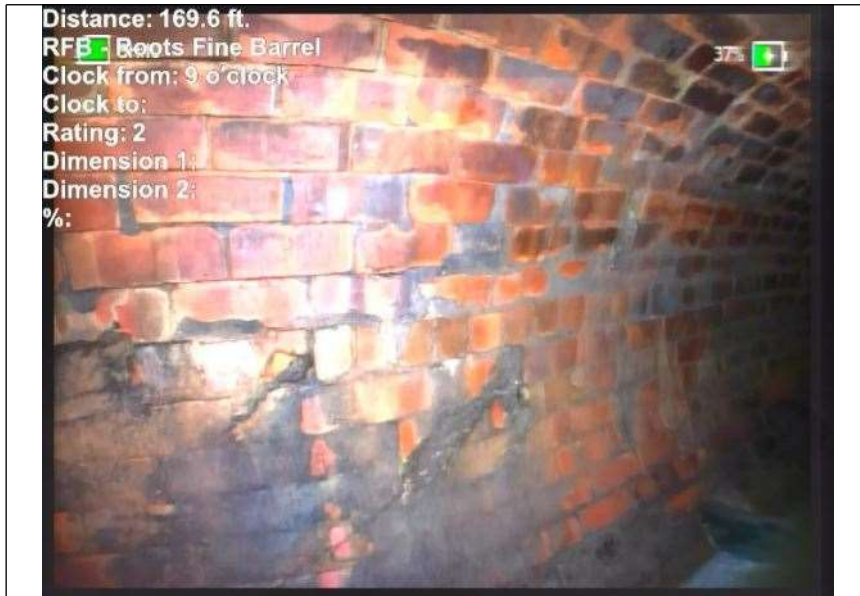
At: 169. RFB - Roots Fine Barrel
6000061035
16 ft. 9/.

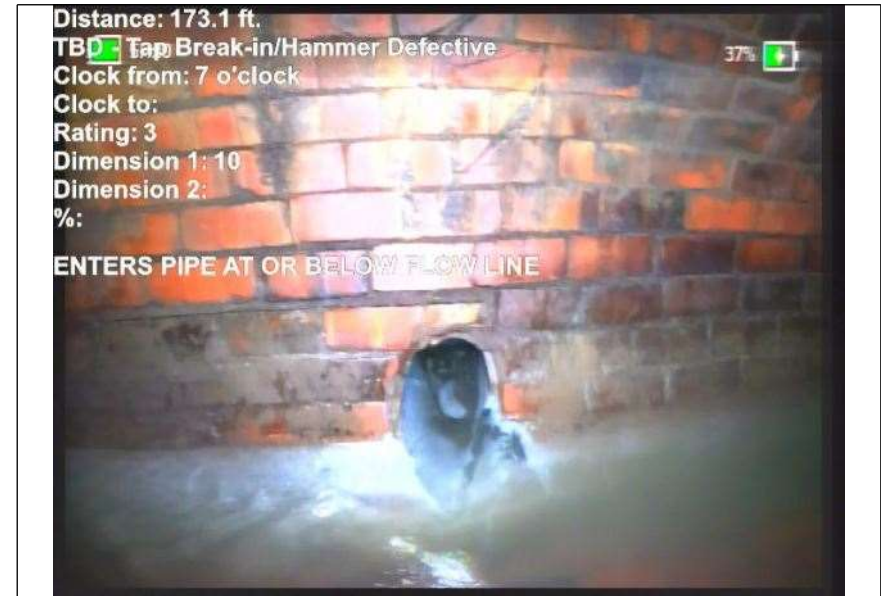
At: 173. TBD - Tap Break-in/Hammer Defective
1000061035
16 ft. 7/.

Joint: No ENTERS PIPE AT OR BELOW FLOW LINE

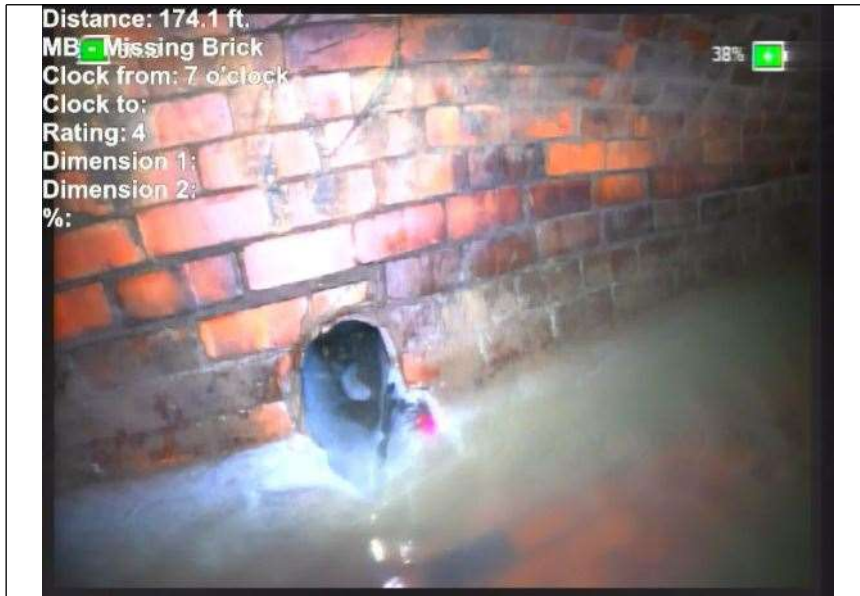
At: 174. MB - Missing Brick
1000061035
16 ft. 7/.

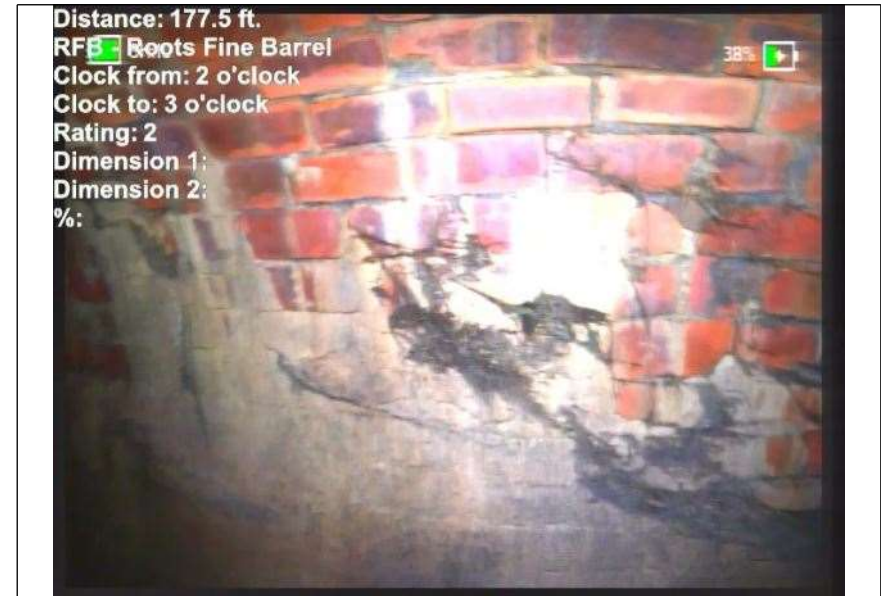
At: 177.5 ft. 2/3 RFB - Roots Fine Barrel
Joint: No

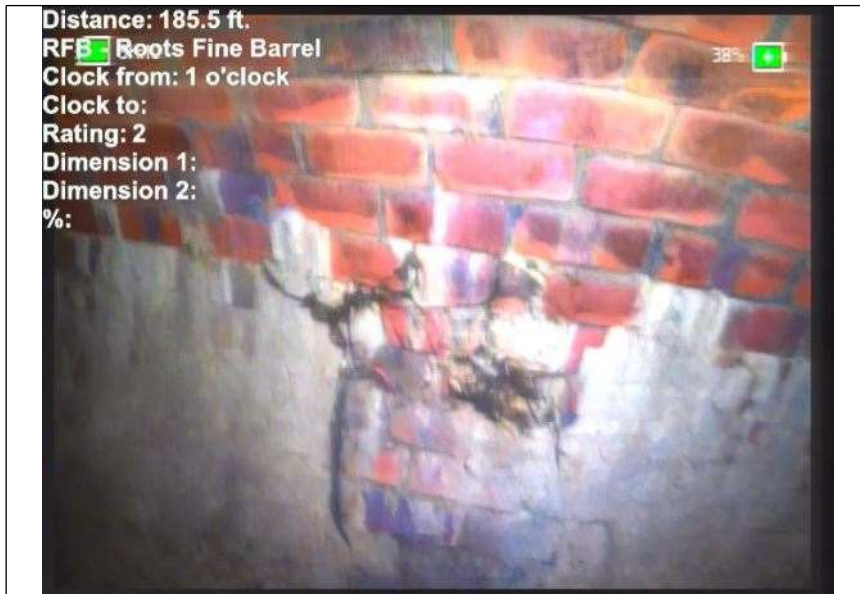
At: 185.5 ft. 1/. RFB - Roots Fine Barrel

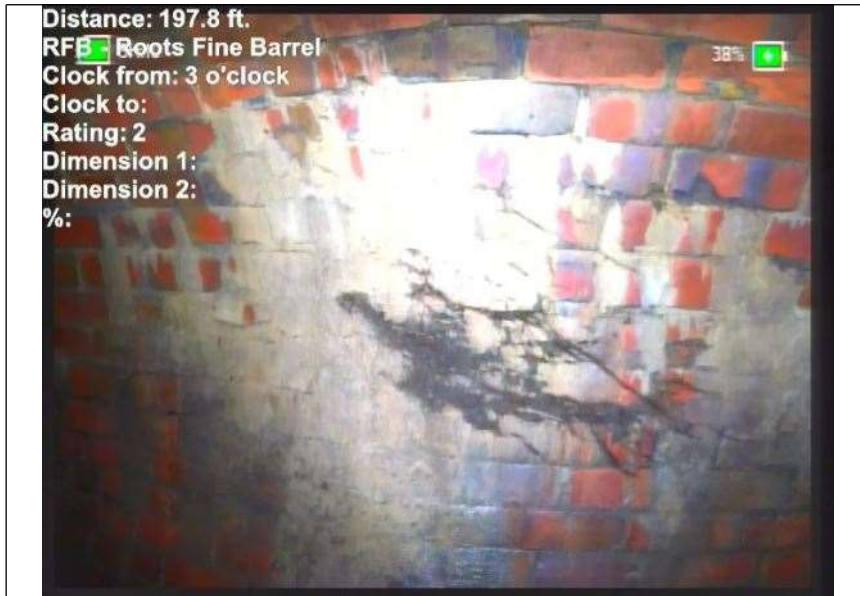
At: 197. RFB - Roots Fine Barrel
8000030517
58 ft. 3/.

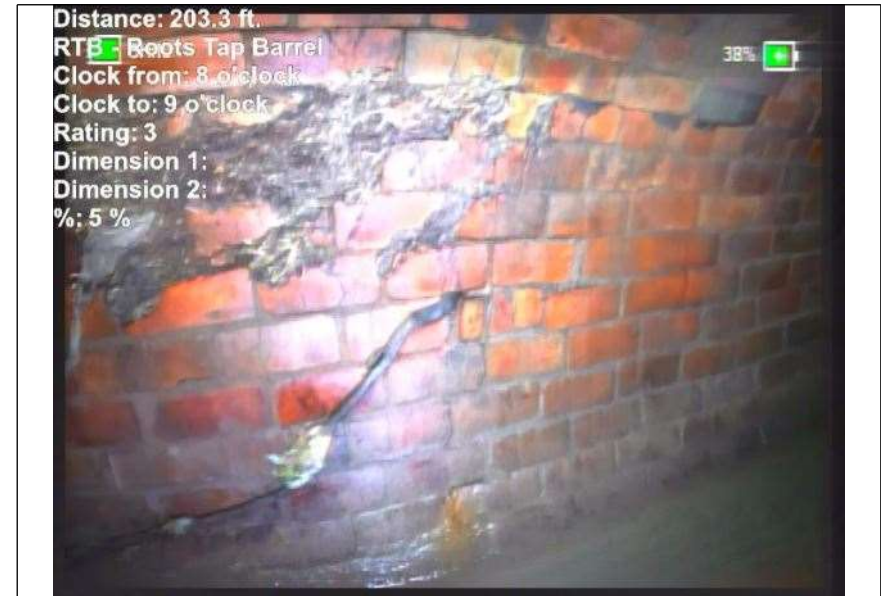
At: 203. RTB - Roots Tap Barrel
3000030517
58 ft. 8/9

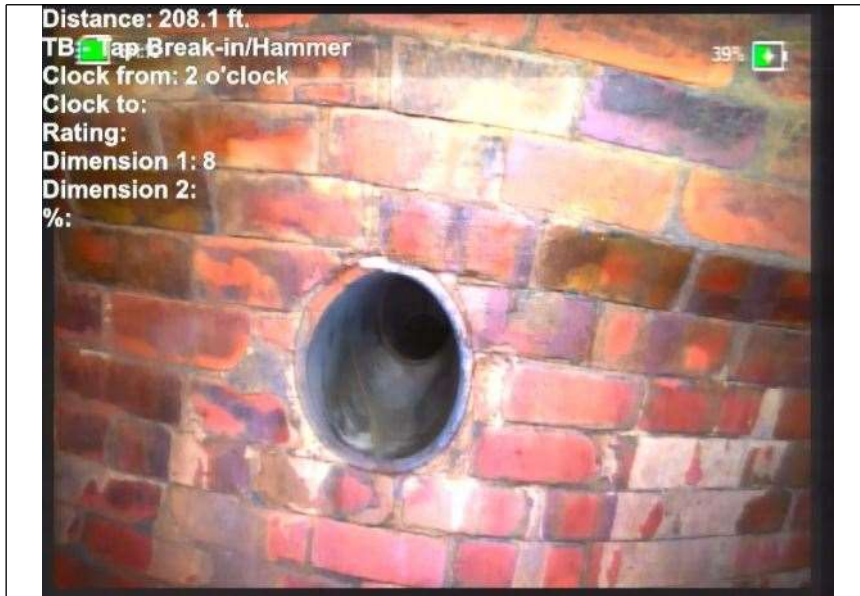
At: 208. TB - Tap Break-in/Hammer
1000061035
16 ft. 2/.

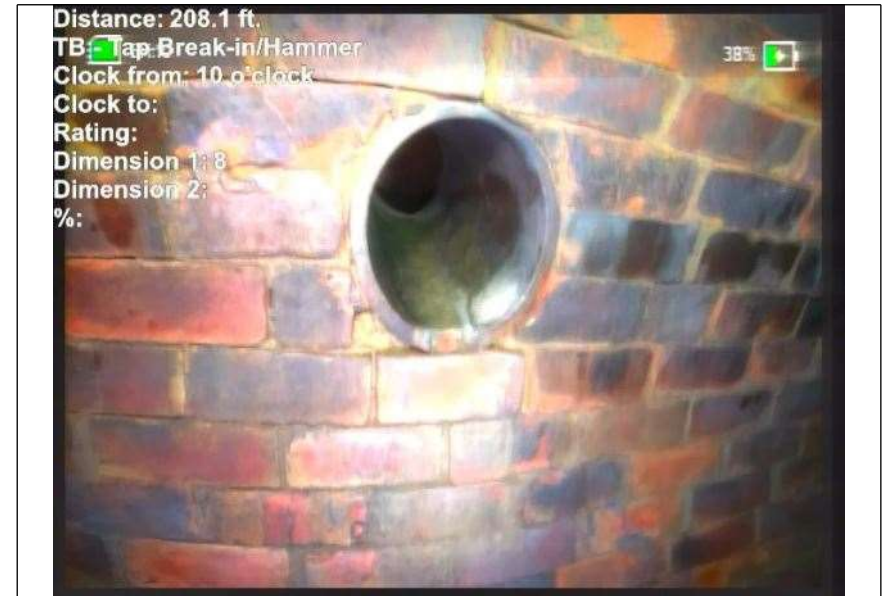
At: 208. TB - Tap Break-in/Hammer
1000061035
16 ft. 10/.

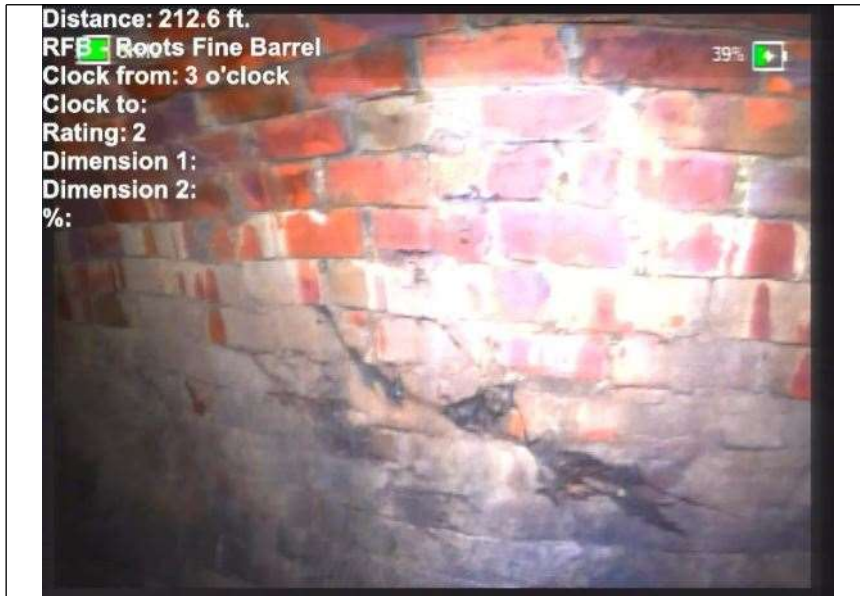
At: 212. RFB - Roots Fine Barrel
6000061035
16 ft. 3/.

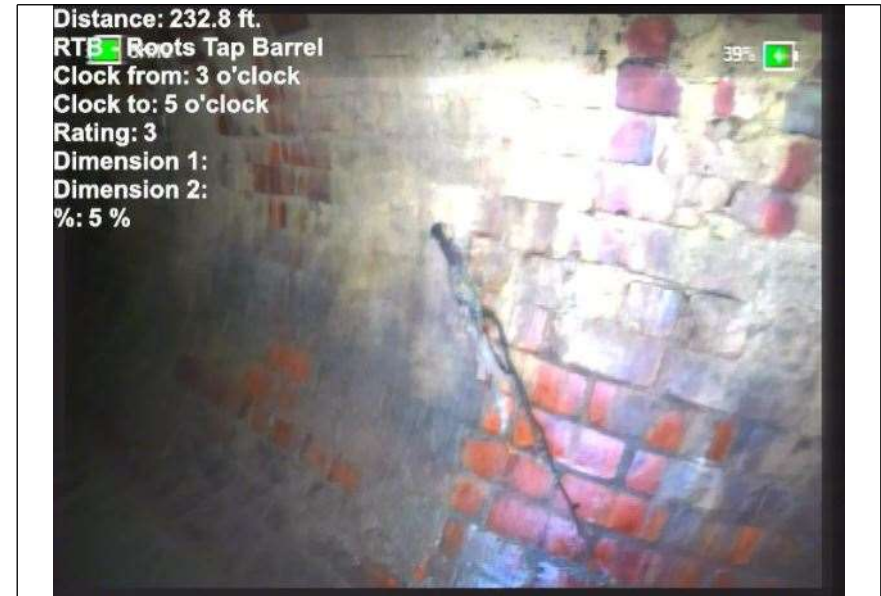
At: 232. RTB - Roots Tap Barrel
8000030517
58 ft. 3/5

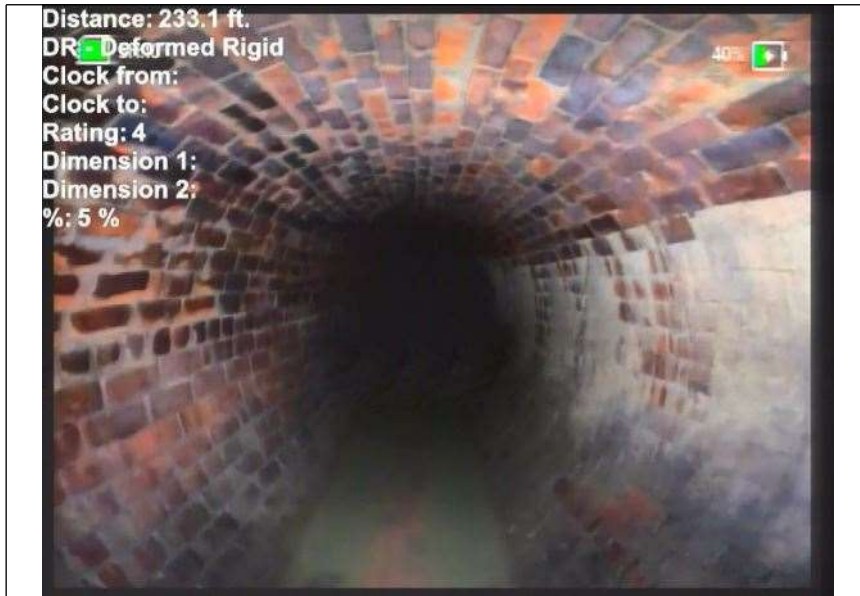
At: 233. 1000061035
DR - Deformed Rigid
16 ft.

Joint: No 5 %

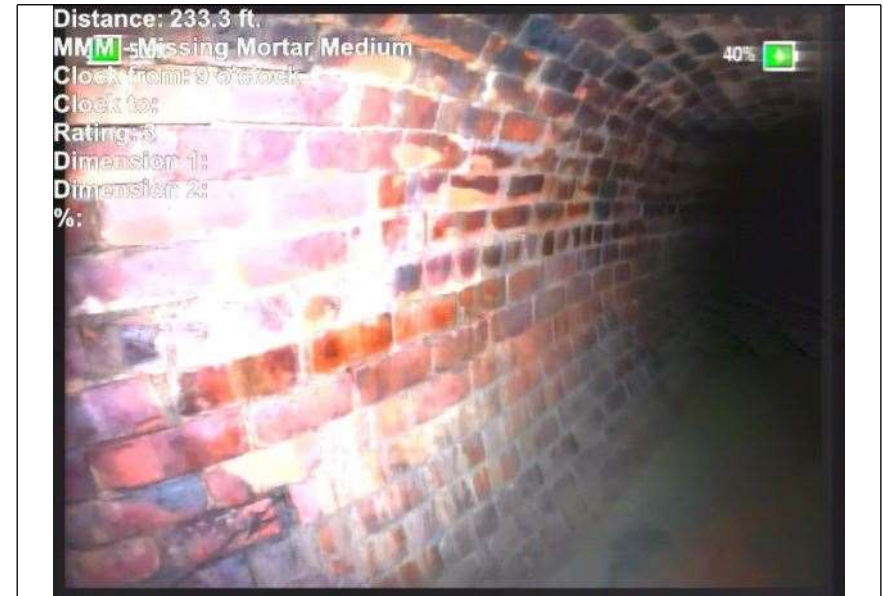
At: 233. 3000030517
MMM - Missing Mortar Medium
58 ft. 9 in.

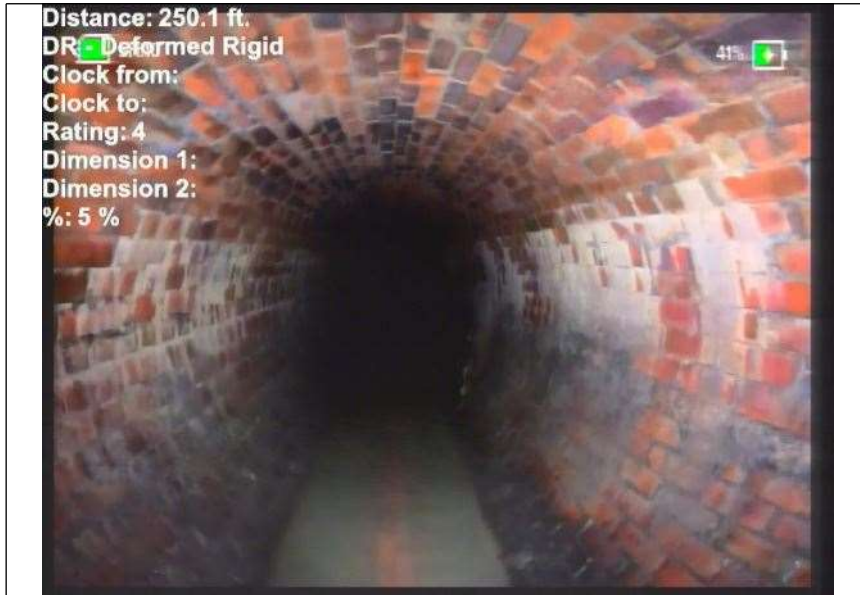
At: 250. DR - Deformed Rigid
1000061035
16 ft.

Joint: No 5 %

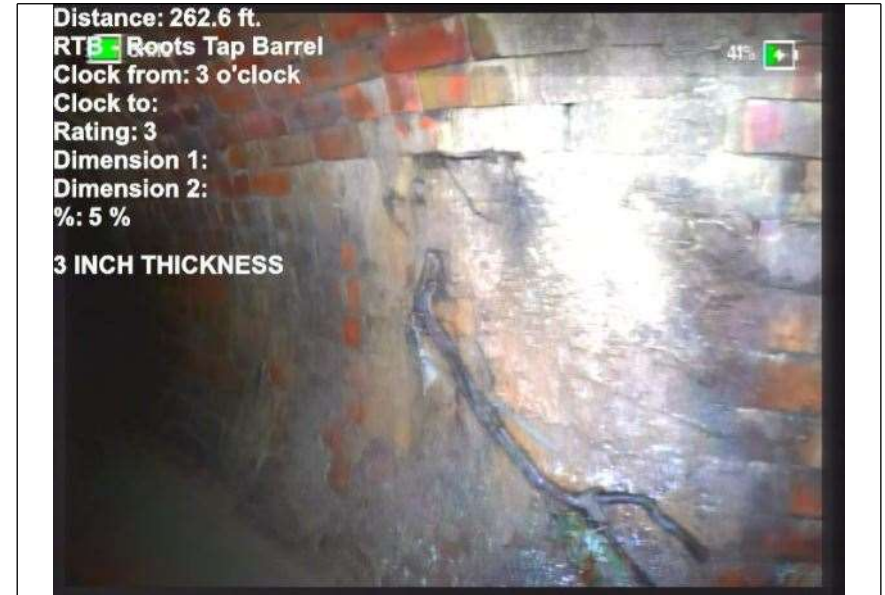
At: 262. RTB - Roots Tap Barrel
6000061035
16 ft. 3/.

Joint: No 5 % **3 INCH THICKNESS**

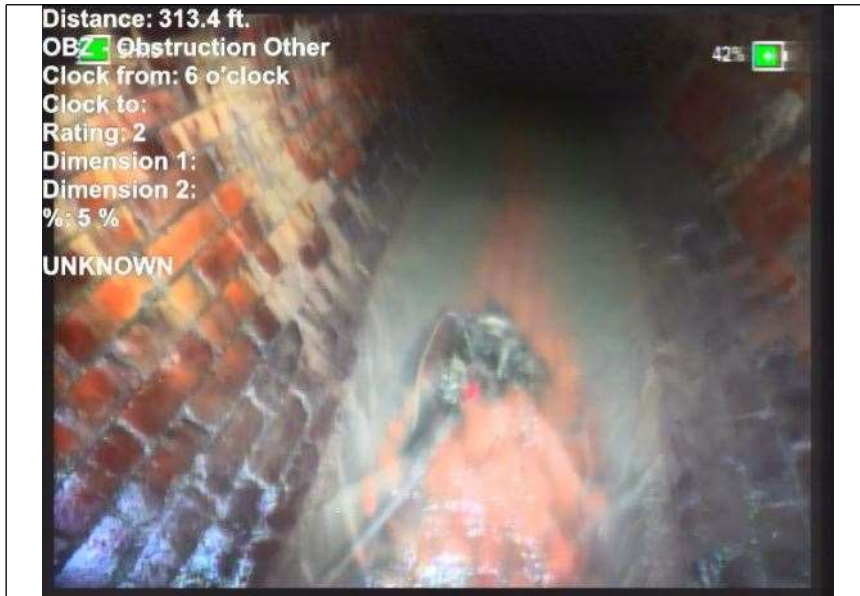
At: 313. OBZ - Obstruction Other
3999938964
84 ft. 6/.

Joint: No 5 % UNKNOWN

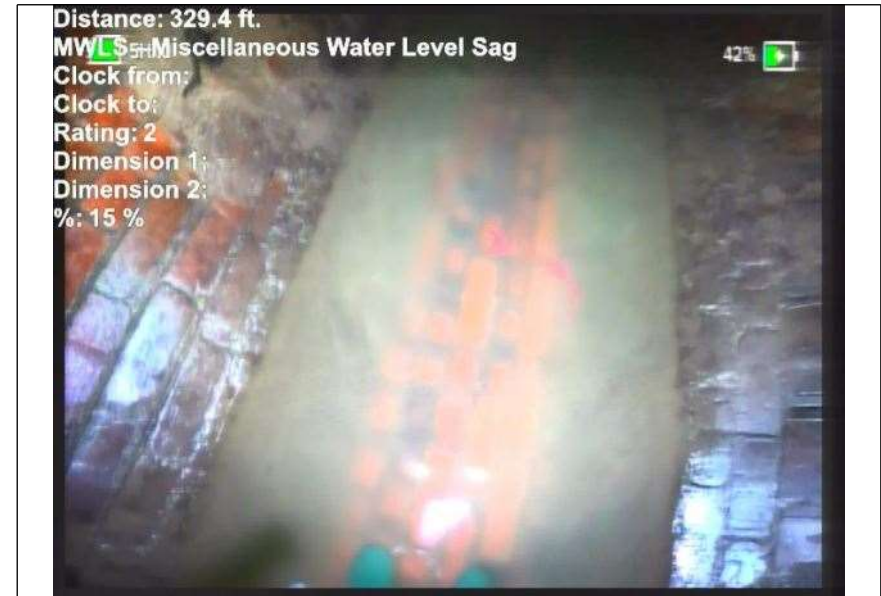
At: 329. MWLS - Miscellaneous Water Level Sag
3999938964
84 ft.

Joint: No 15 %

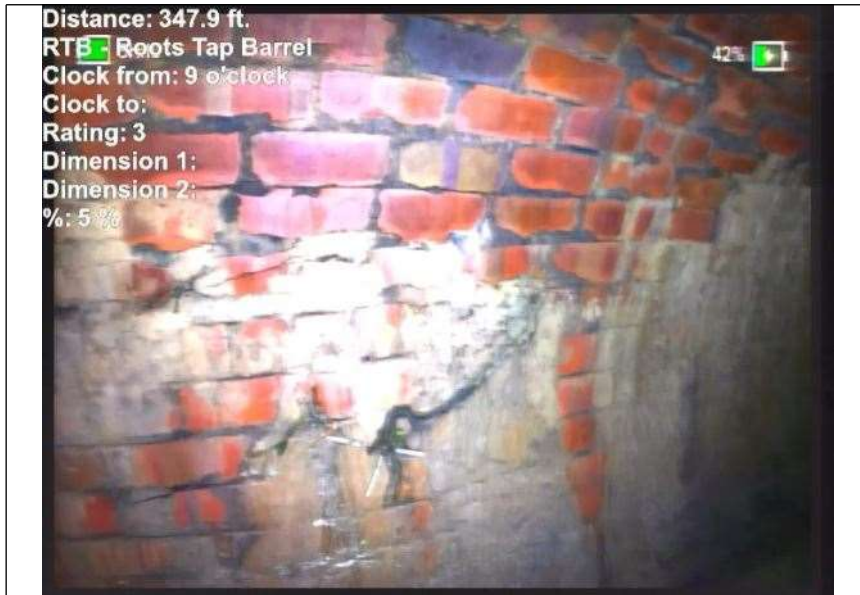
At: 347. RTB - Roots Tap Barrel
8999938964
84 ft. 9/.

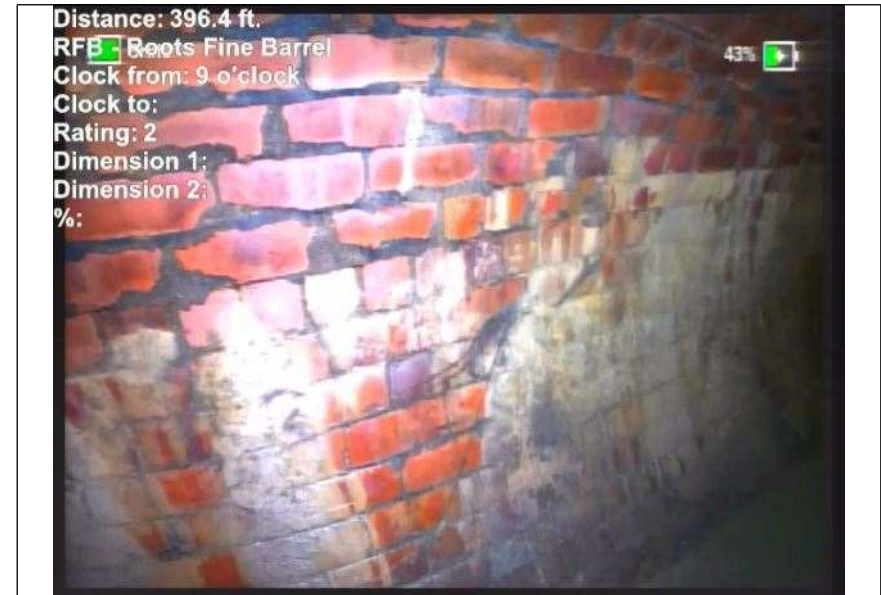
At: 396. RFB - Roots Fine Barrel
3999938964
84 ft. 9/.

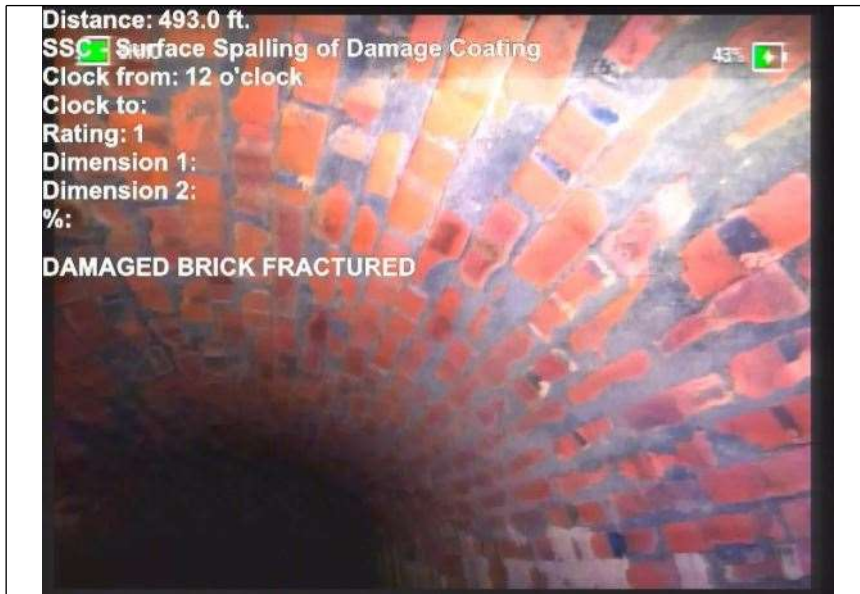
At: 493 ft. 12/. SSC - Surface Spalling of Damage Coating
Joint: No **DAMAGED BRICK FRACTURED**

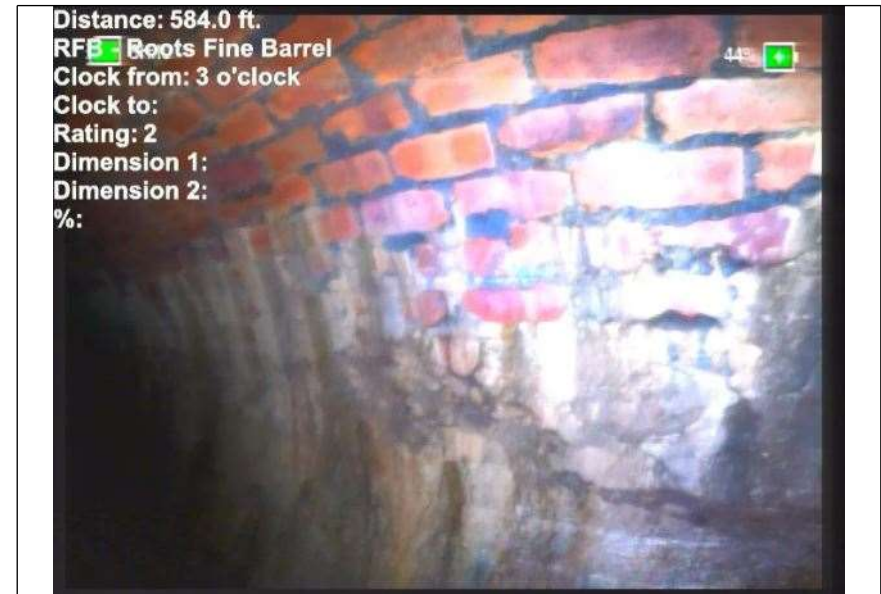
At: 584 ft. 3/. RFB - Roots Fine Barrel
Joint: No

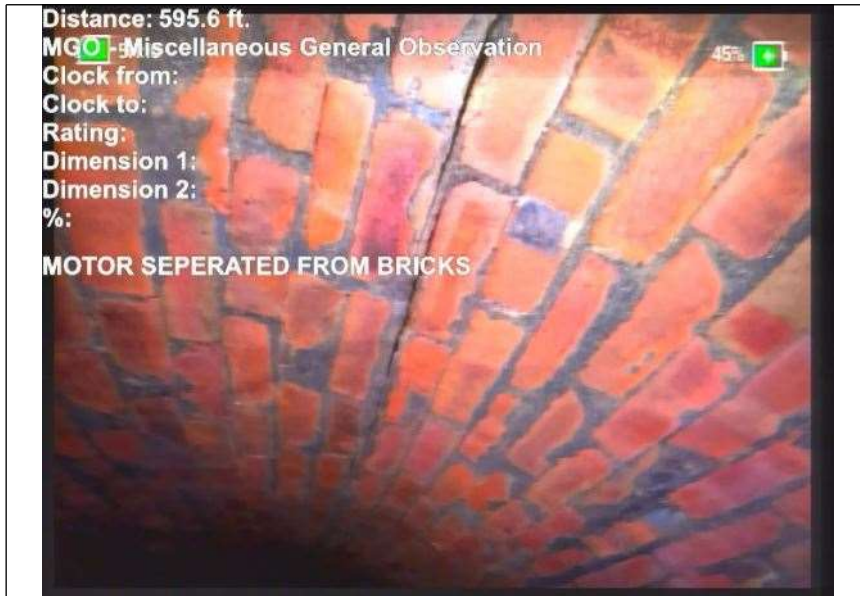
At: 595. MGO - Miscellaneous General Observation
5999755859
38 ft.

Joint: No MOTOR SEPERATED FROM BRICKS

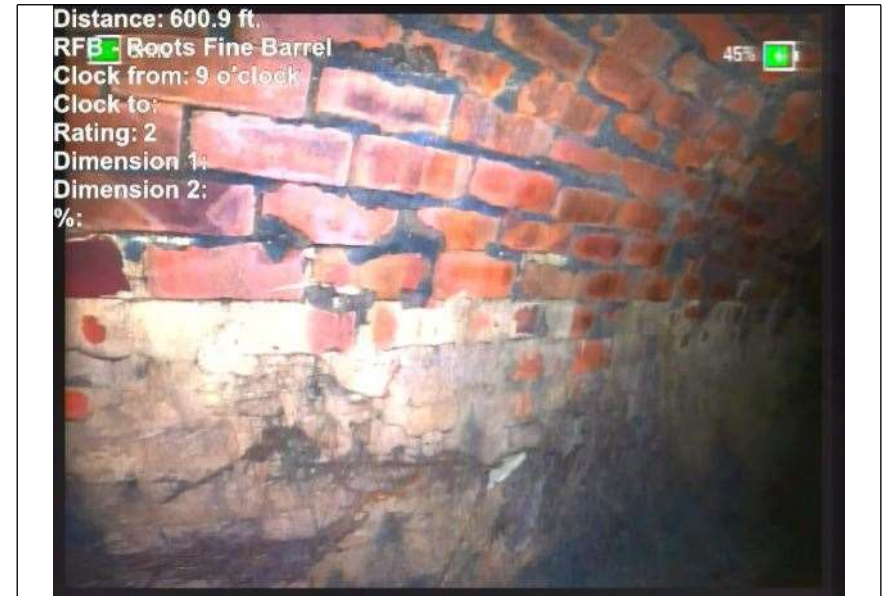
At: 600. RFB - Roots Fine Barrel
9000244140
63 ft. 9/.

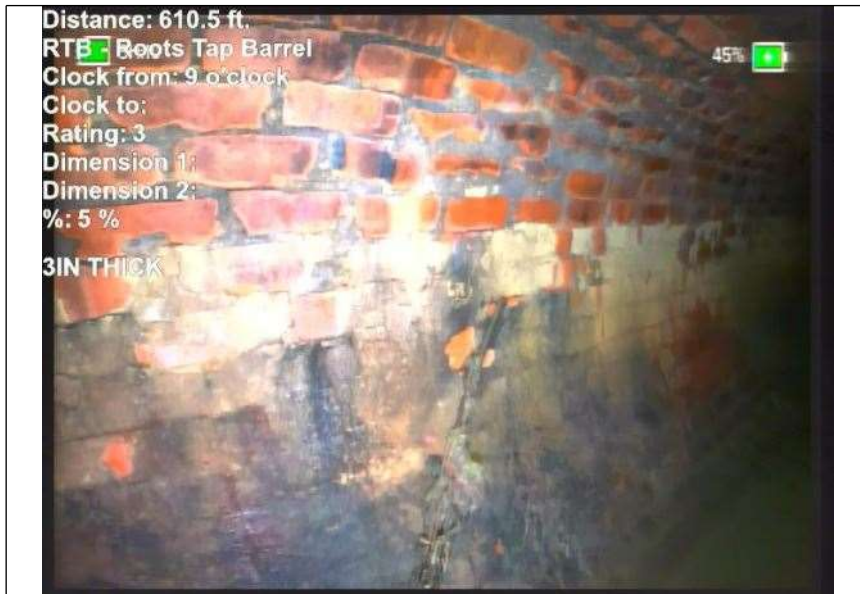
At: 610.5 ft. 9/. RTB - Roots Tap Barrel

Joint: No 5 % 3IN THICK

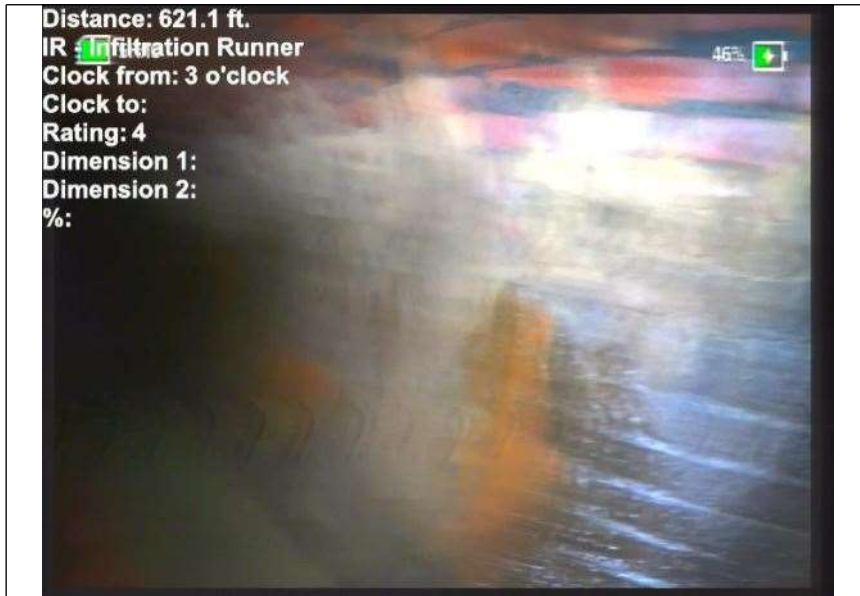
At: 621. IR - Infiltration Runner
0999755859
38 ft. 3/.

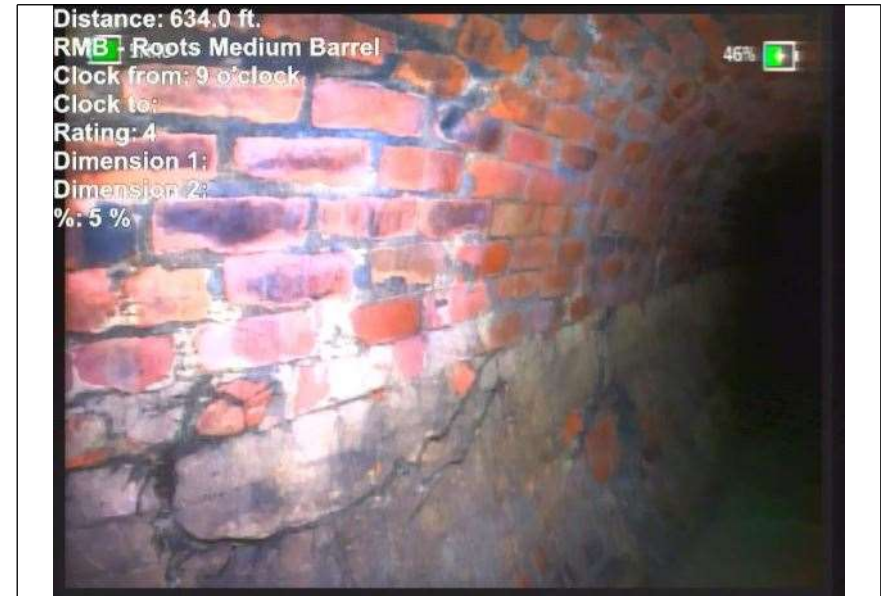
At: 634 ft. 9/. RMB - Roots Medium Barrel

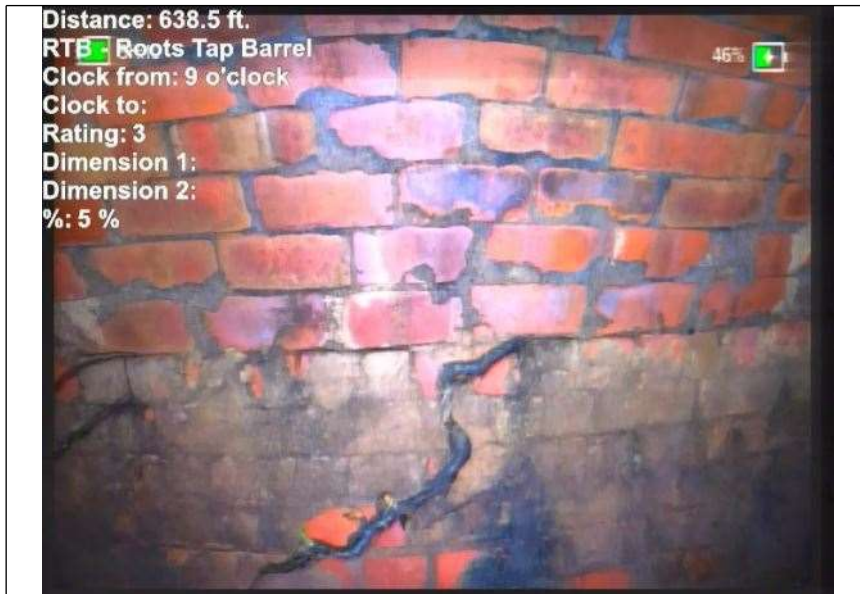
At: 638.5 ft. 9/. RTB - Roots Tap Barrel

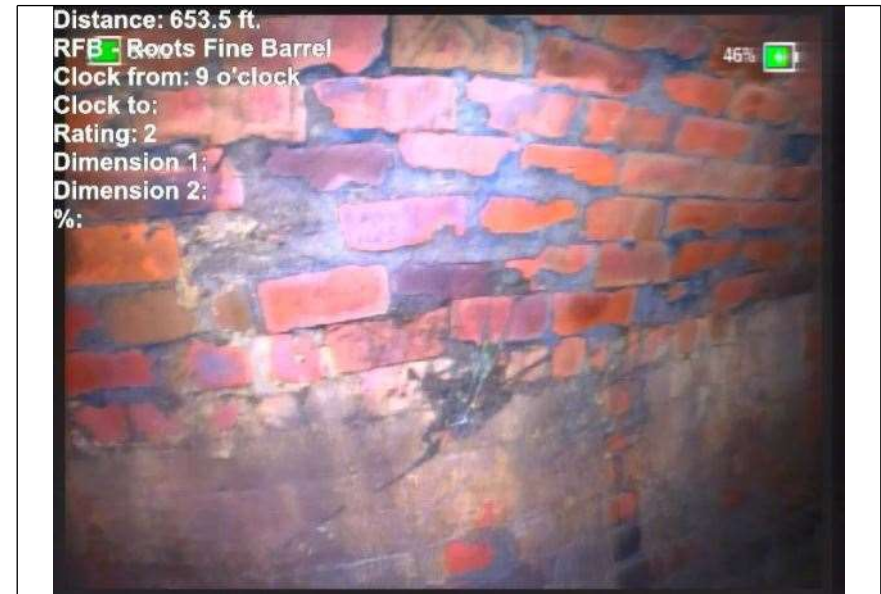
At: 653.5 ft. 9/. RFB - Roots Fine Barrel

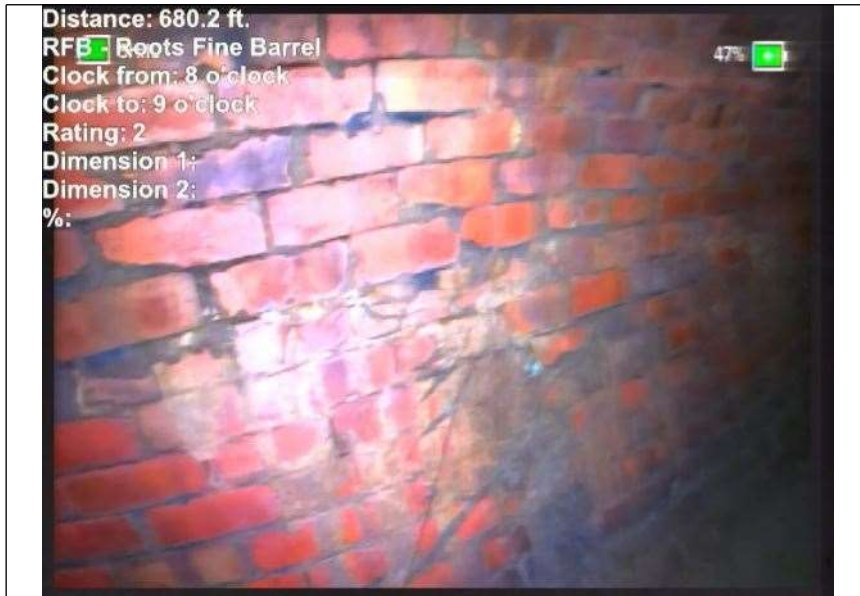
At: 680. RFB - Roots Fine Barrel
2000122070
31 ft. 8/9

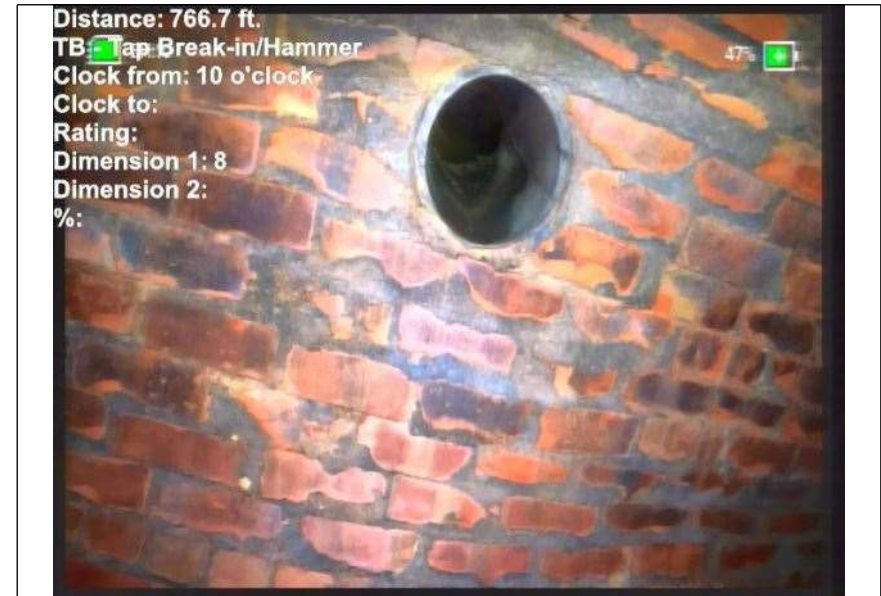
At: 766. TB - Tap Break-in/Hammer
7000122070
31 ft. 10/.

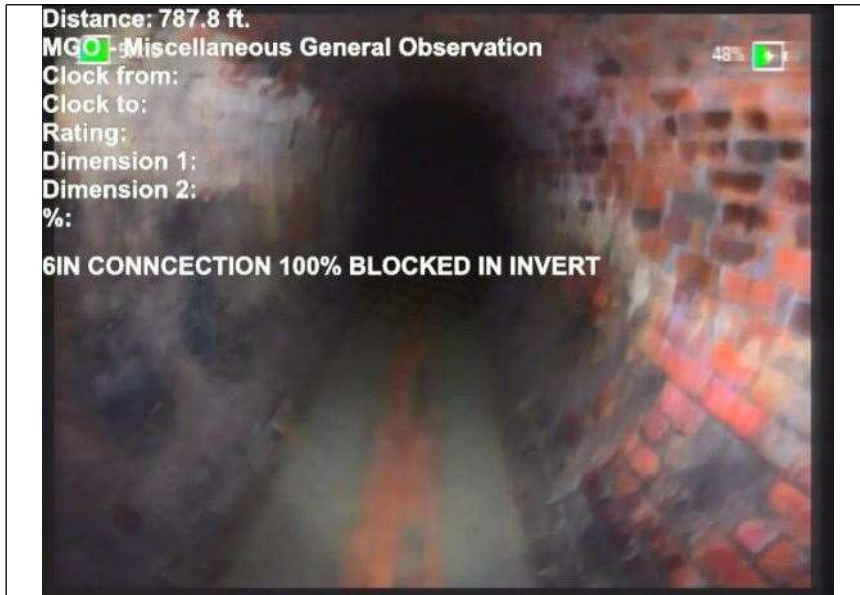
At: 787.7999877929 MGO - Miscellaneous General Observation
69 ft.
Joint: No 6IN CONNCECTION 100% BLOCKED IN INVERT

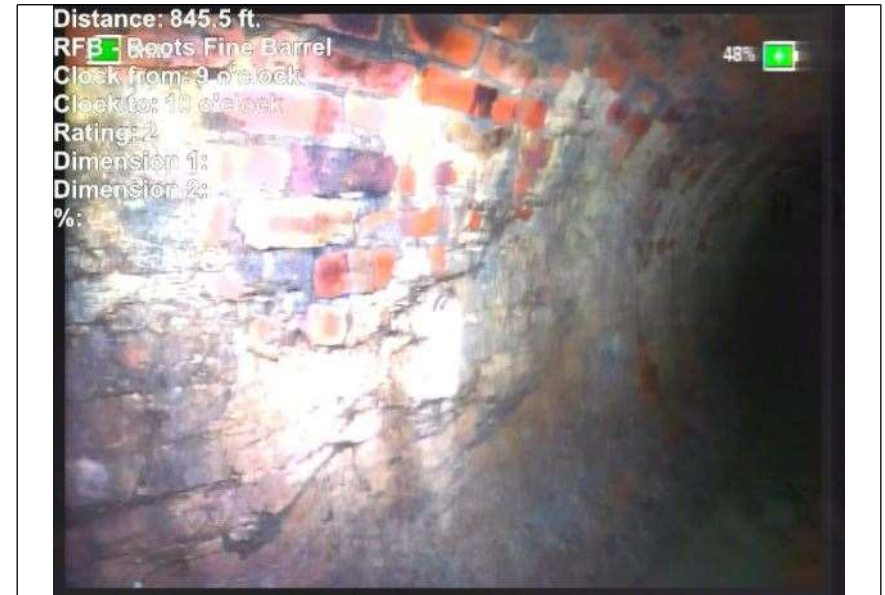
At: 845.5 ft. RFB - Roots Fine Barrel
9/10
Joint: No
