PACP Report with Pipe Run and Incident Snapshots

Surveyed by: ANDREW		Certificate number: T-507-4975		Owner: CITY OF MARION		Customer:		Drainage area:		P/O number:		Sheet number:							
Pipe segment ref.: MH4A_MH4				Start date/time: 20240627 09:18		Street: 1432 HOLLAND ROAD				City: MARION, M OH									
Location details:				Upstream MH No: MH4A				Rim to invert:		Grade to invert:		Rim to grade:							
Pipe use: CB		Direction: U		Flow control:		Downstream MH No: MH4				Rim to invert:		Grade to invert:		Rim to grade:					
Height: 72 in.		Width:		Shape: C		Material: BR		Lining method:		Pipe joint length:		Total length: 1,190.200 ft.		Length surveyed: 1,190.200 ft.		Purpose: B		Sewer category:	
Media label:				Pre-cleaning: N		Date cleaned:		Weather: 1		Location code: C		Pressure value:							
Project name: ROCK SWALE 72 IN INSPECTION				Additional info:

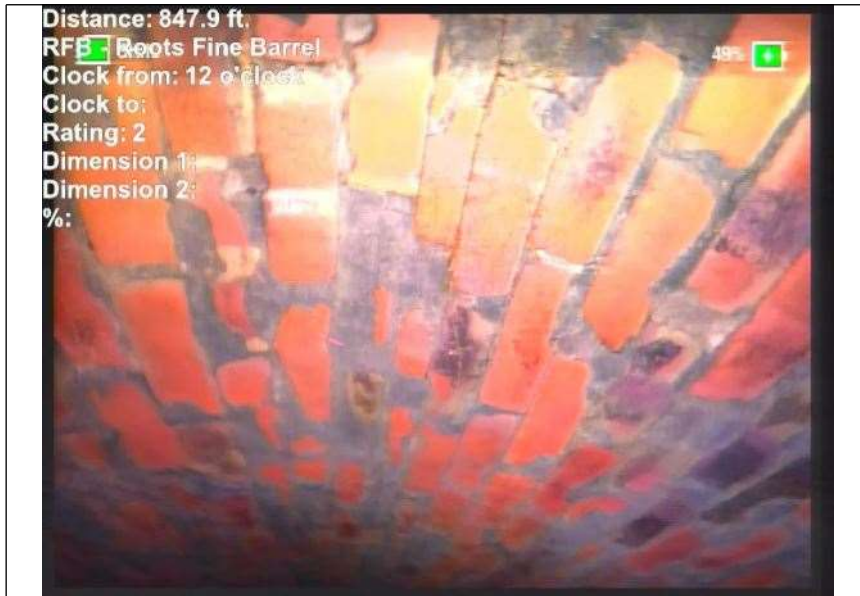
At: 847. RFB - Roots Fine Barrel
9000244140
63 ft. 12/.

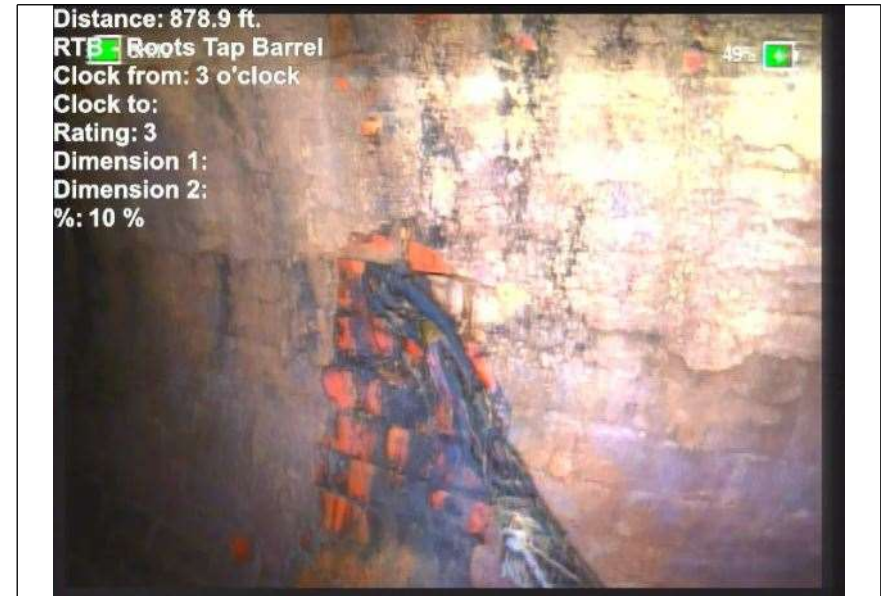
At: 878. RTB - Roots Tap Barrel
9000244140
63 ft. 3/.

Joint: No 10 %

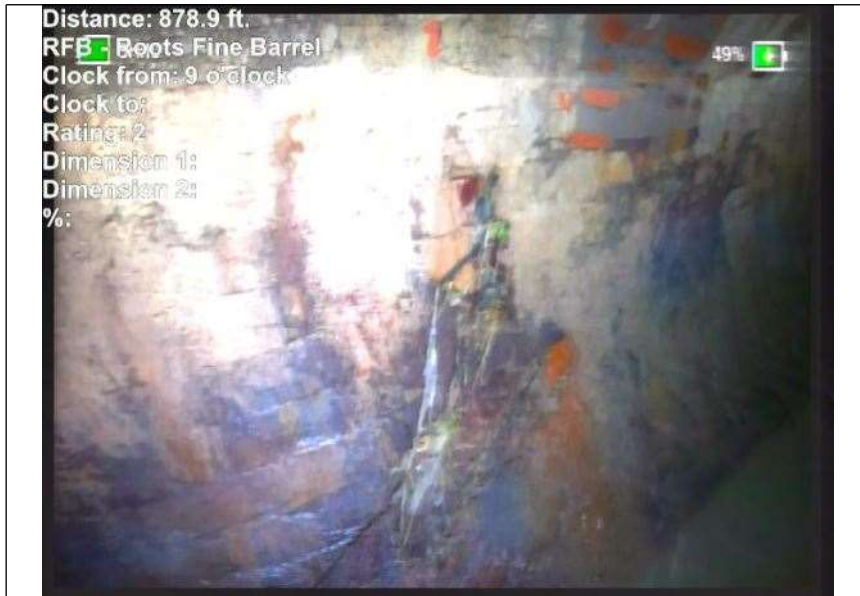
At: 878. RFB - Roots Fine Barrel
9000244140
63 ft. 9/.

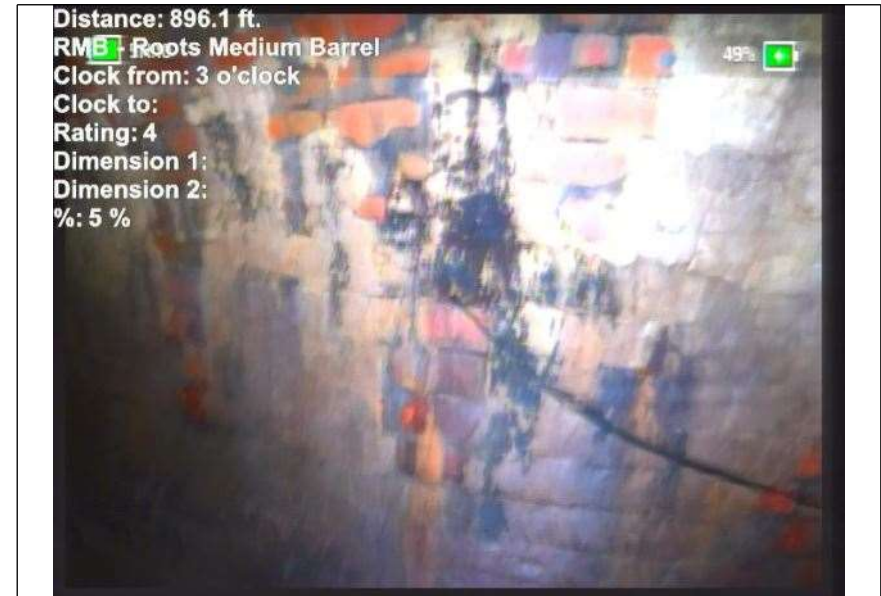
At: 896. RMB - Roots Medium Barrel
0999755859
38 ft. 3/.

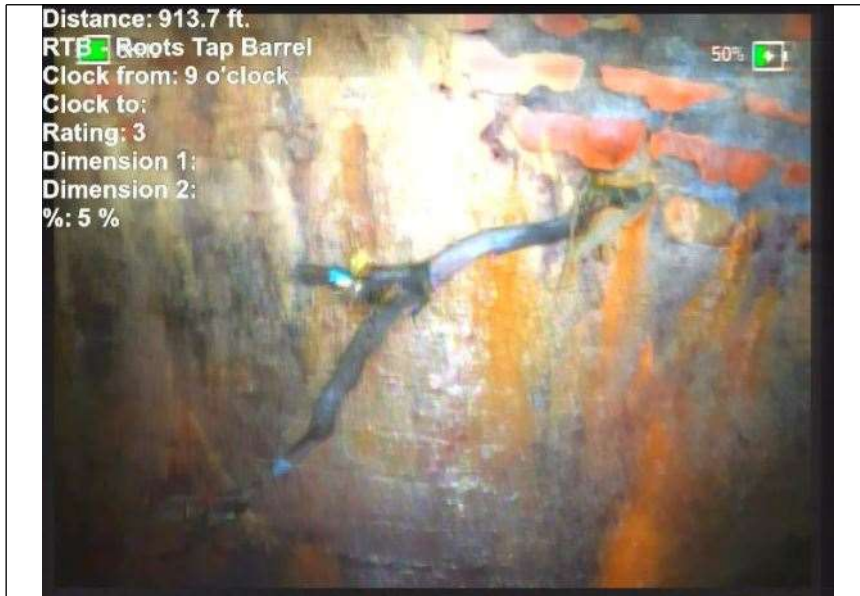
At: 913. RTB - Roots Tap Barrel
7000122070
31 ft. 9/.

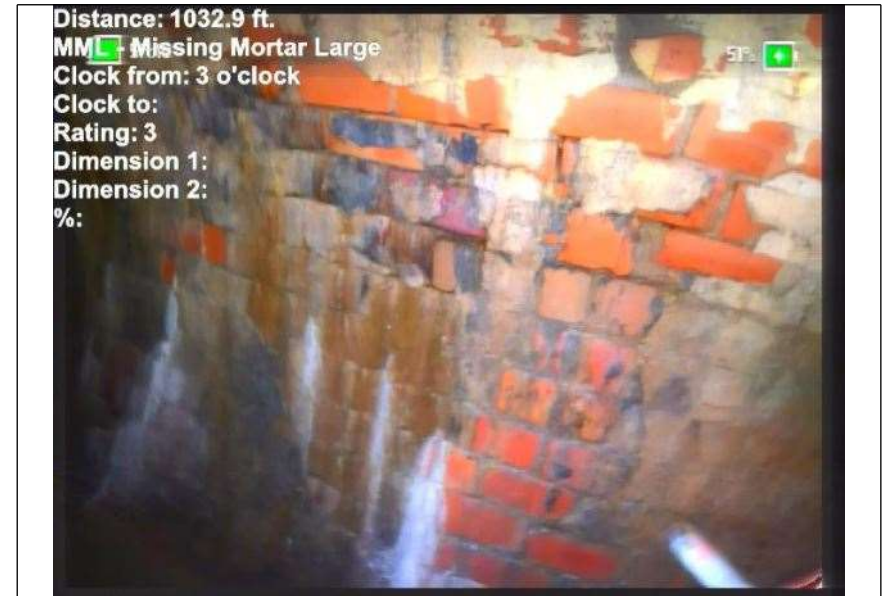
At: 1032. MML - Missing Mortar Large
9000244140
6 ft. 3/.

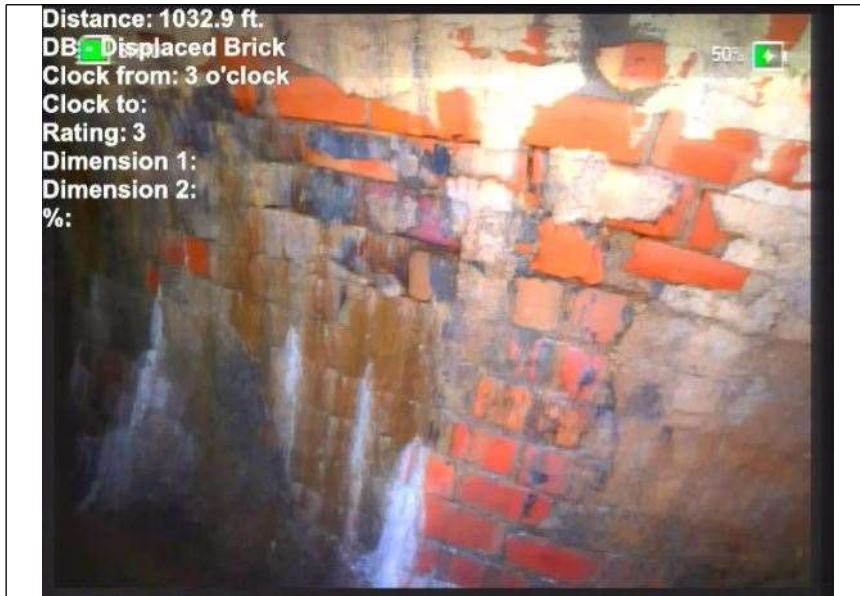
At: 1032. DB - Displaced Brick
9000244140
6 ft. 3/.

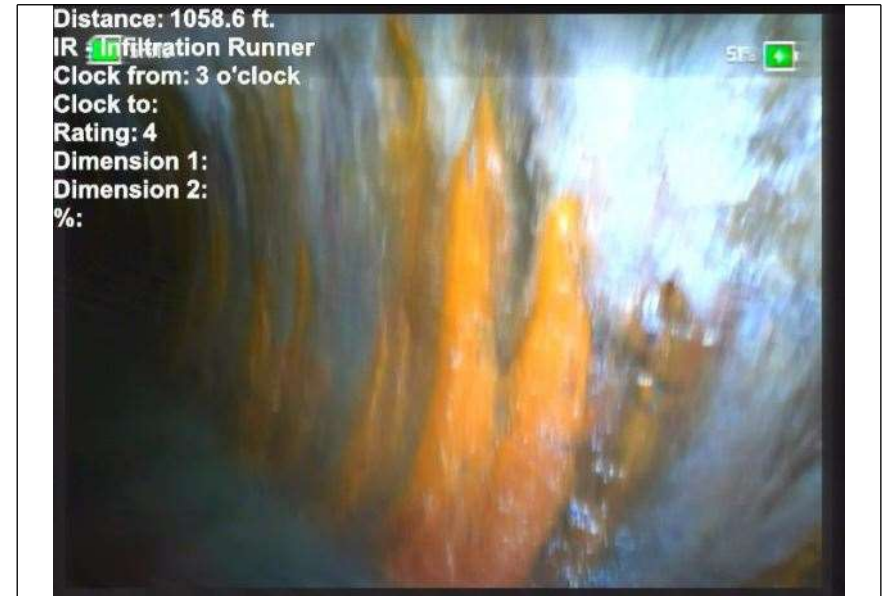
At: 1058. IR - Infiltration Runner
5999755859
4 ft. 3/.

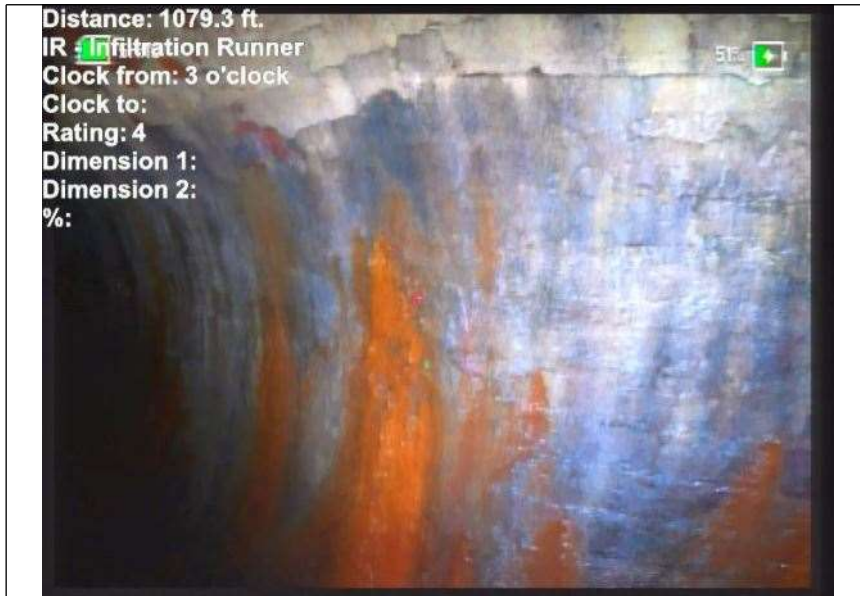
At: 1079. IR - Infiltration Runner
3000488281
3 ft. 3/.

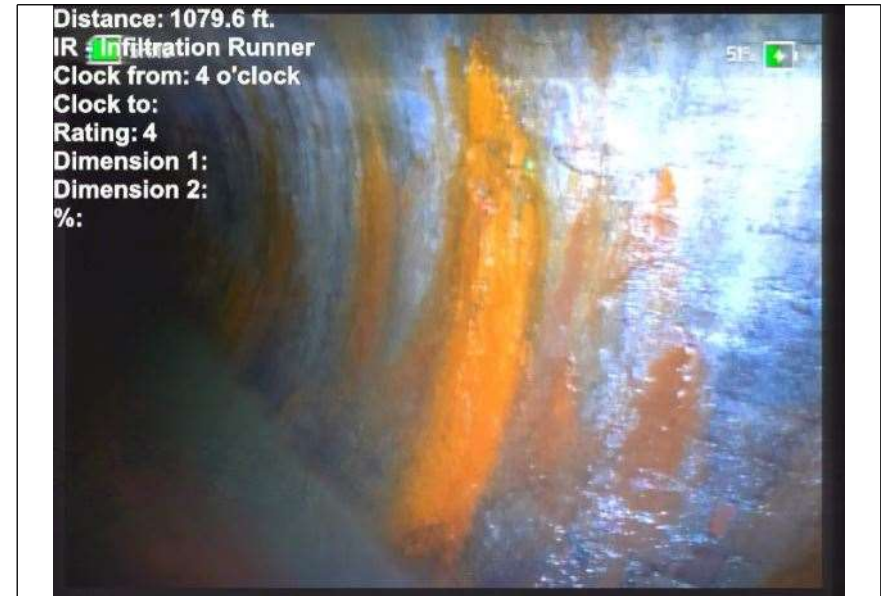
At: 1079. IR - Infiltration Runner
5999755859
4 ft. 4/.

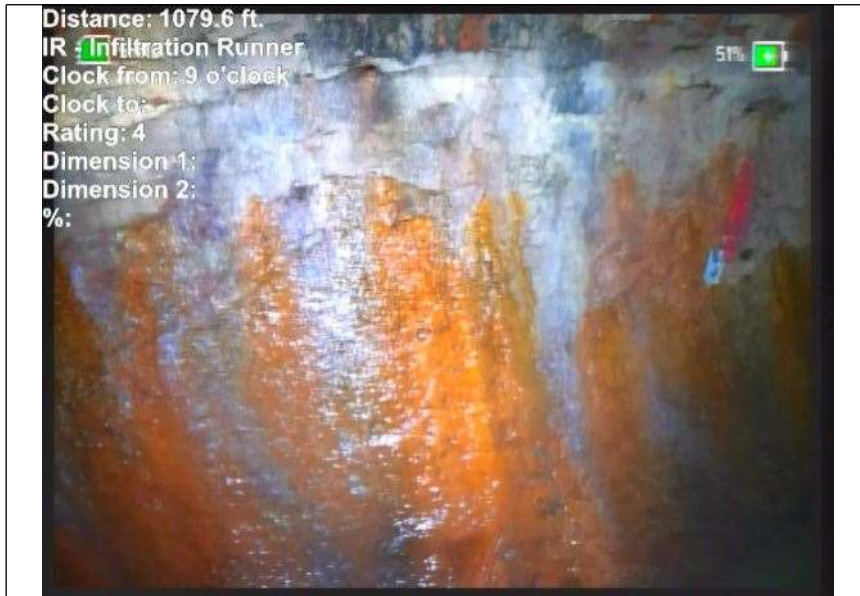
At: 1079. IR - Infiltration Runner
5999755859
4 ft. 9/.

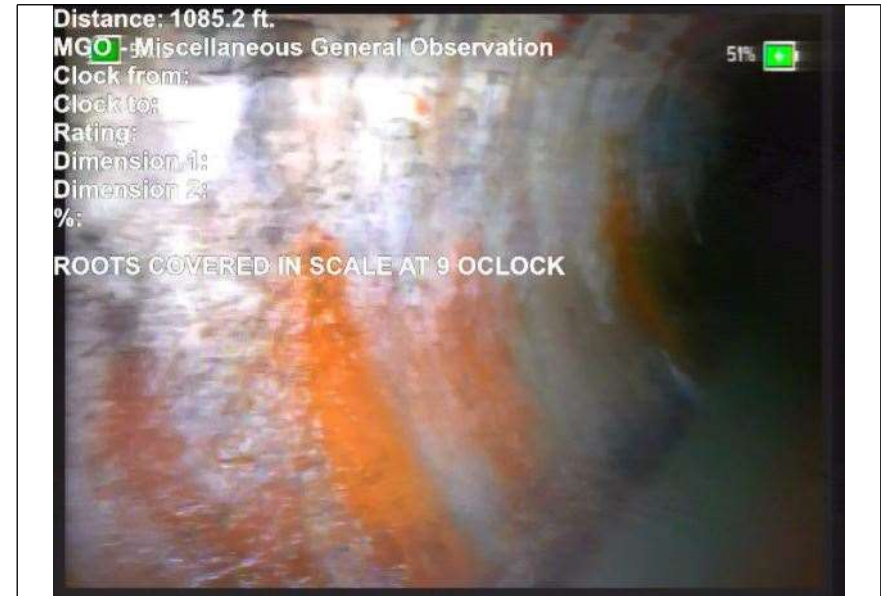
At: 1085. MGO - Miscellaneous General Observation
1999511718
8 ft.

Joint: No ROOTS COVERED IN SCALE AT 9 OCLOCK

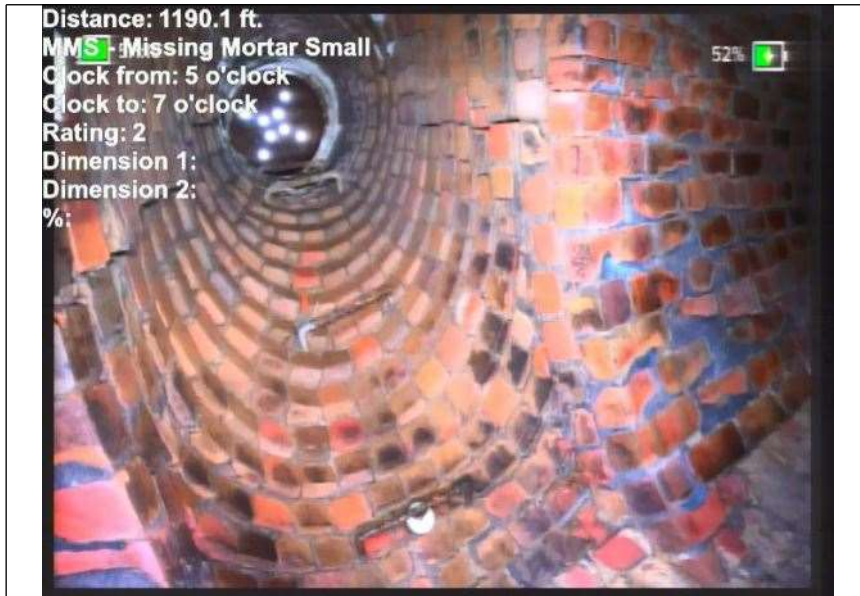
At: 1190. MMS - Missing Mortar Small
0999755859
4 ft. 5/7

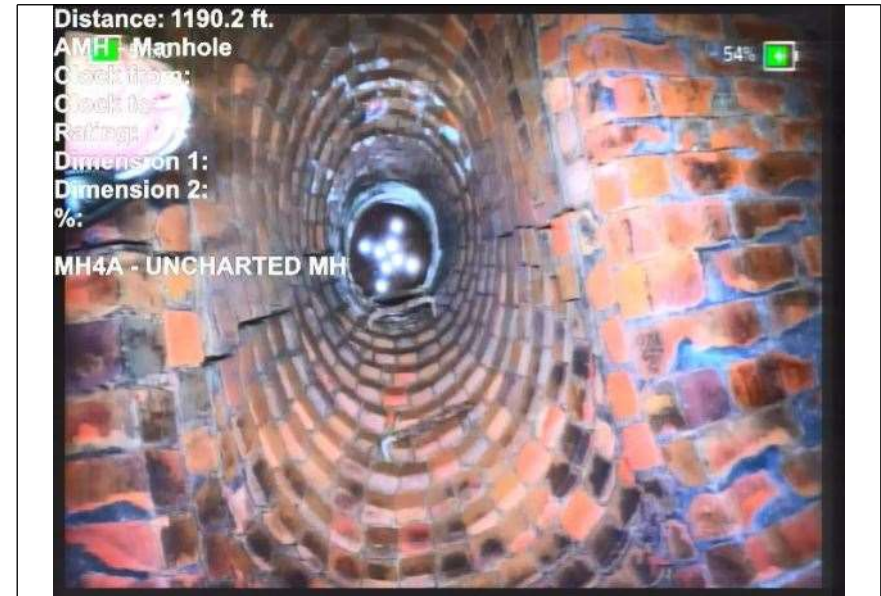
At: 1190. AMH - Manhole
1999511718
8 ft.

Joint: No MH4A - UNCHARTED MH
